Interim Reclamation and Stormwater Inspection

January 17, 2023

Operator: ENERPLUS RESOURCES (USA) CORPORATION - #10177

Location ID: 449968

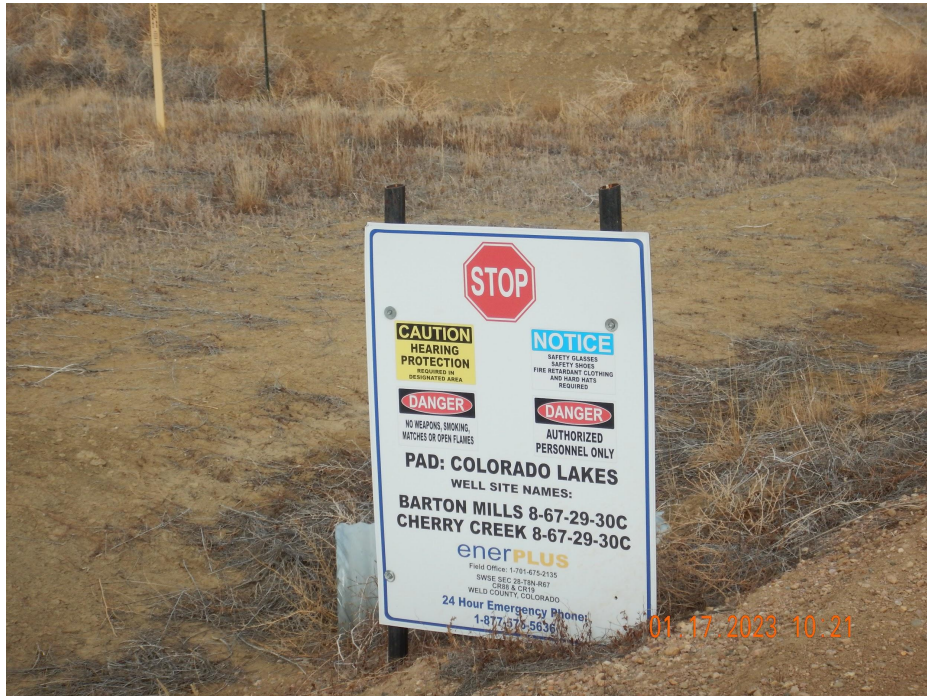
Photo 1. Photo taken from the entrance of location, facing North. Photo illustrates the Operator sign.

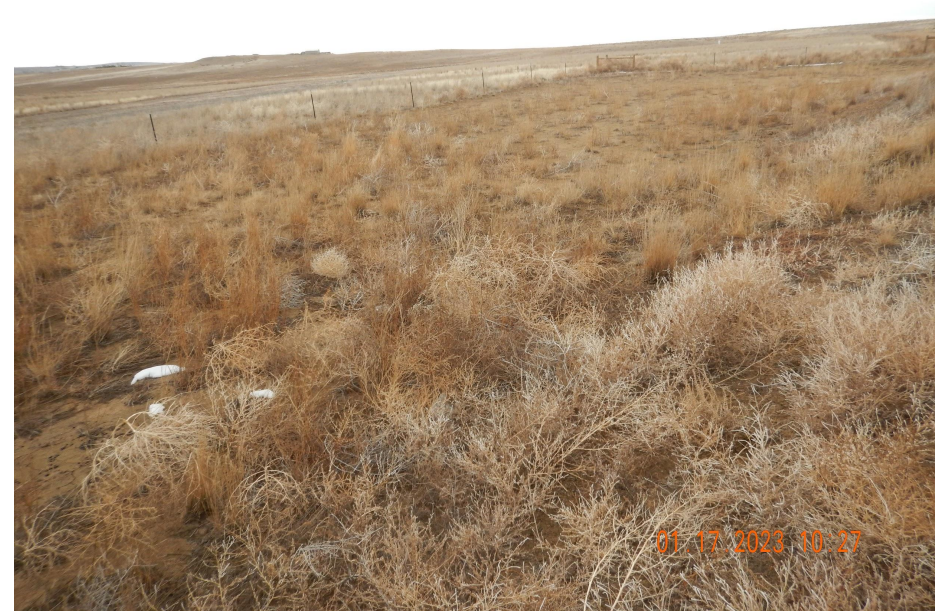
Photo 2. Photo taken from the southeastern perimeter of location, facing Southeast. Photo illustrates an area with predominantly weedy vegetation and bare soil, which is not reflective of reference area vegetative levels.

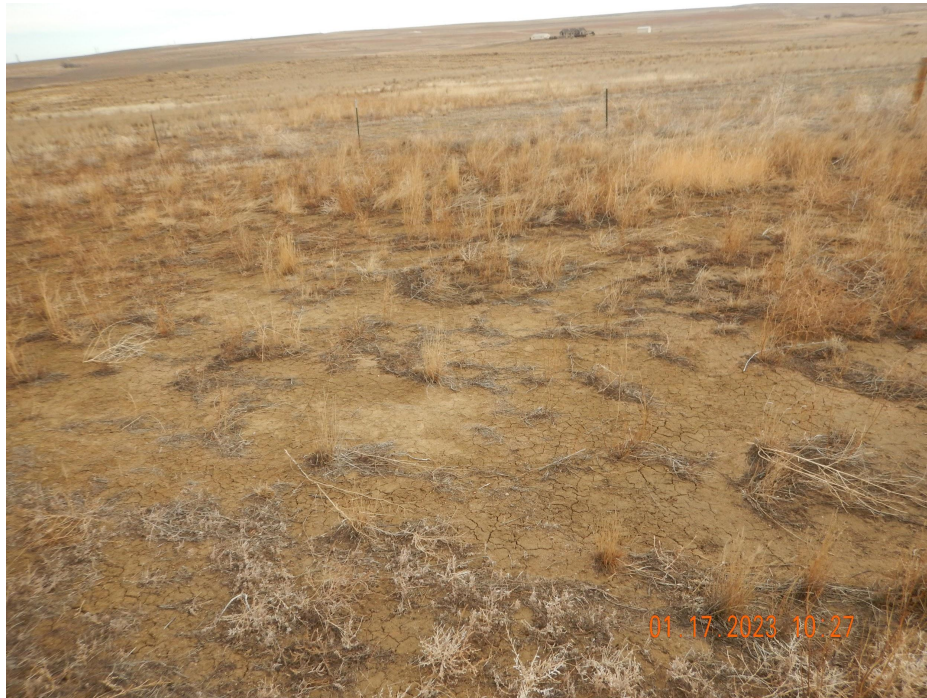
Photo 3. Photo taken from the previous photo location, facing East. See comments under Photo 2.

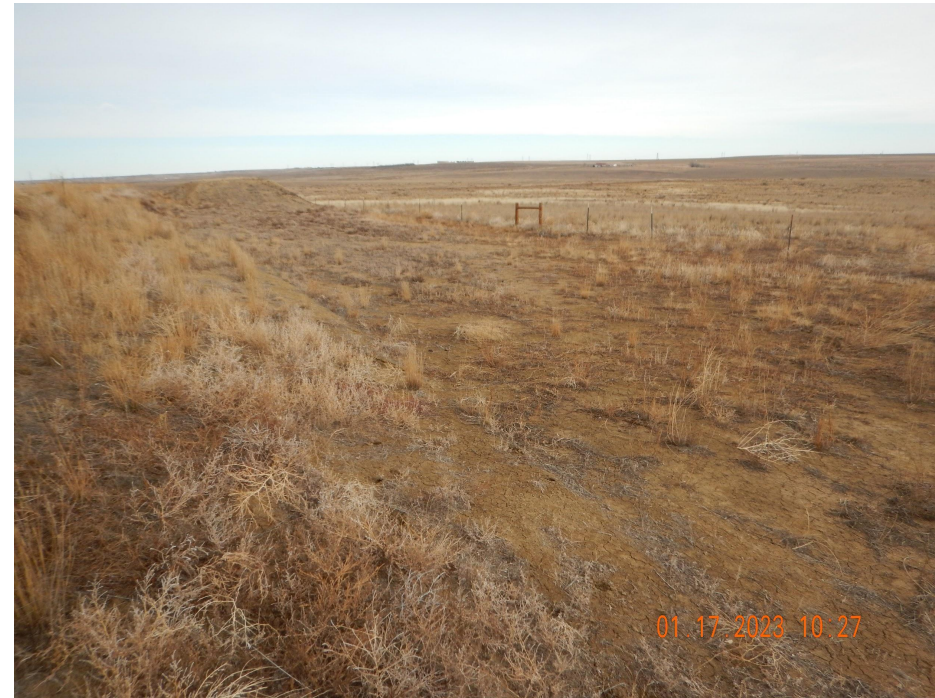
Photo 4. Photo taken from the previous photo location, facing North. See comments under Photo 2.

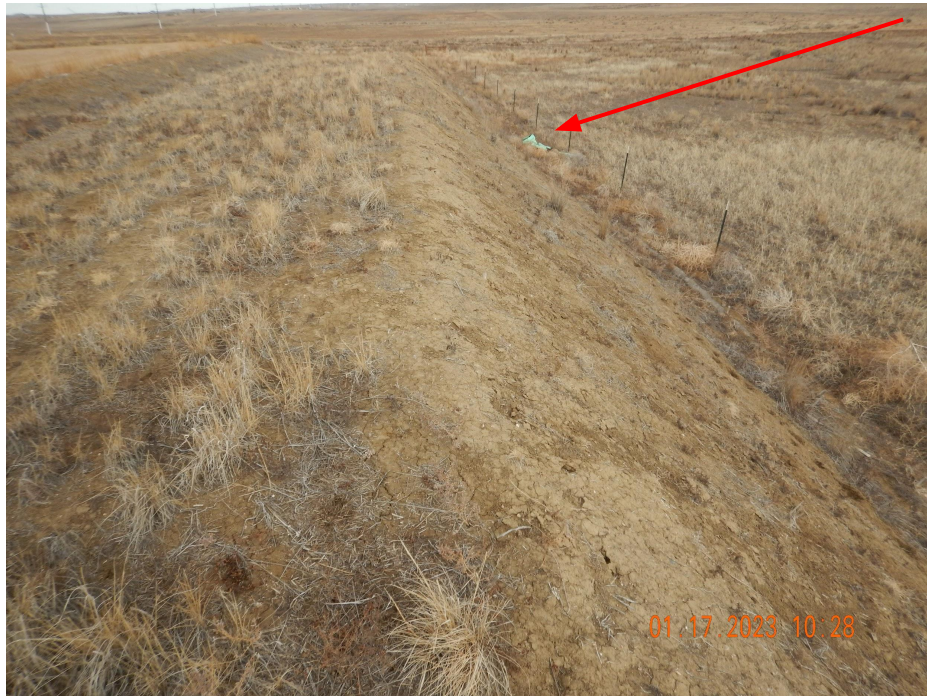
Photo 5. Photo taken from the eastern topsoil stockpile, facing North. Photo illustrates east-facing side of topsoil is not properly stabilized. COGCC staff recommends additional stabilization.

Note- trash was observed along the perimeter of location and shall be removed.

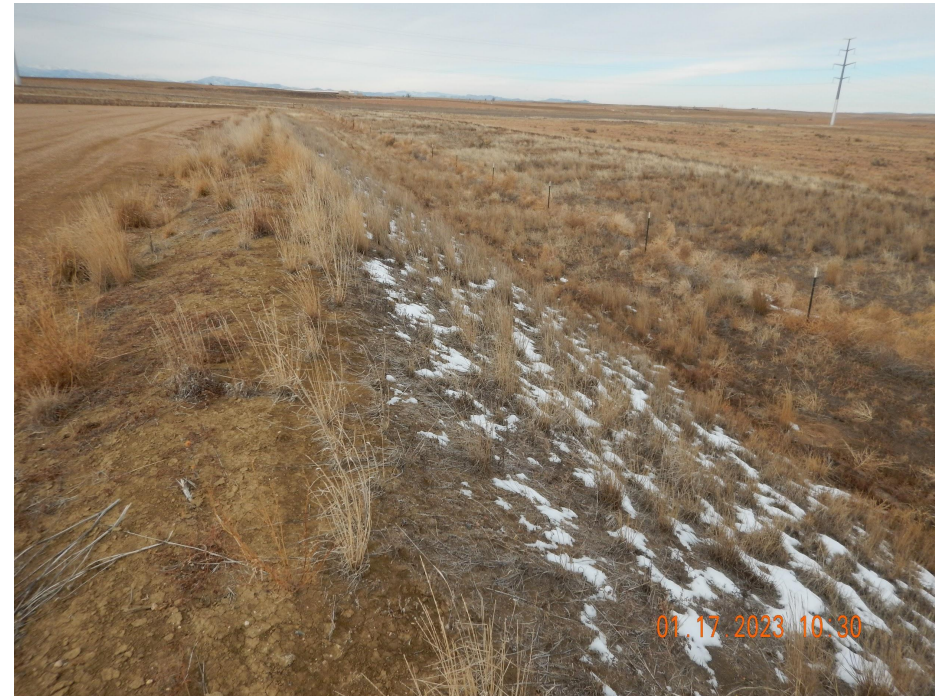
Photo 6. Photo taken from the northeastern perimeter of location, facing West. Photo illustrates the Operator has seeded the fill slopes and stormwater BMP areas.

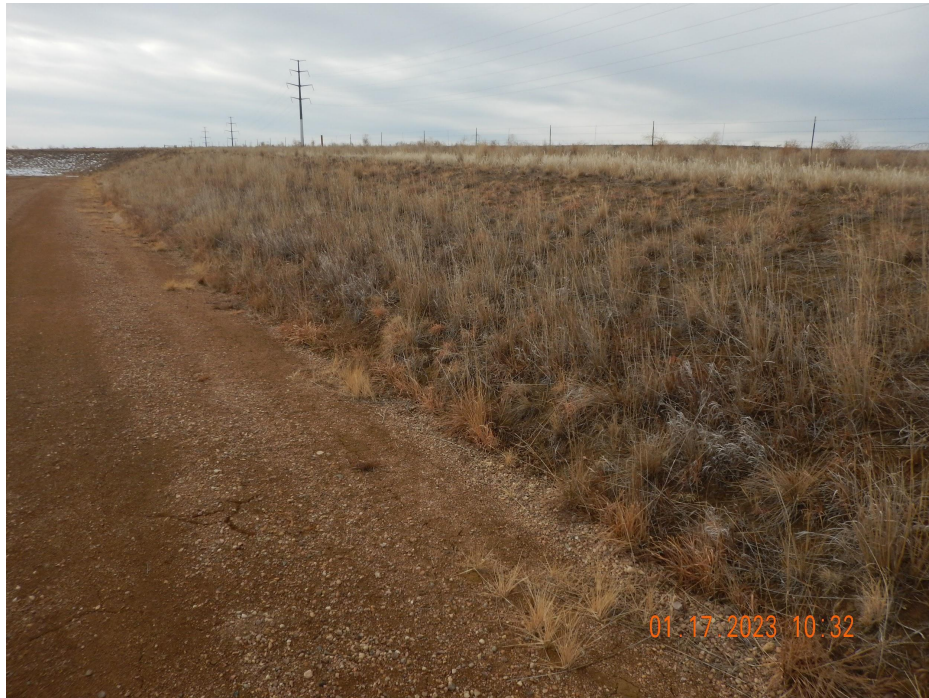
Photo 7. Photo taken from the northwestern perimeter of location, facing South. Photo illustrates the Operator has seeded the cut slopes and stormwater BMP areas.

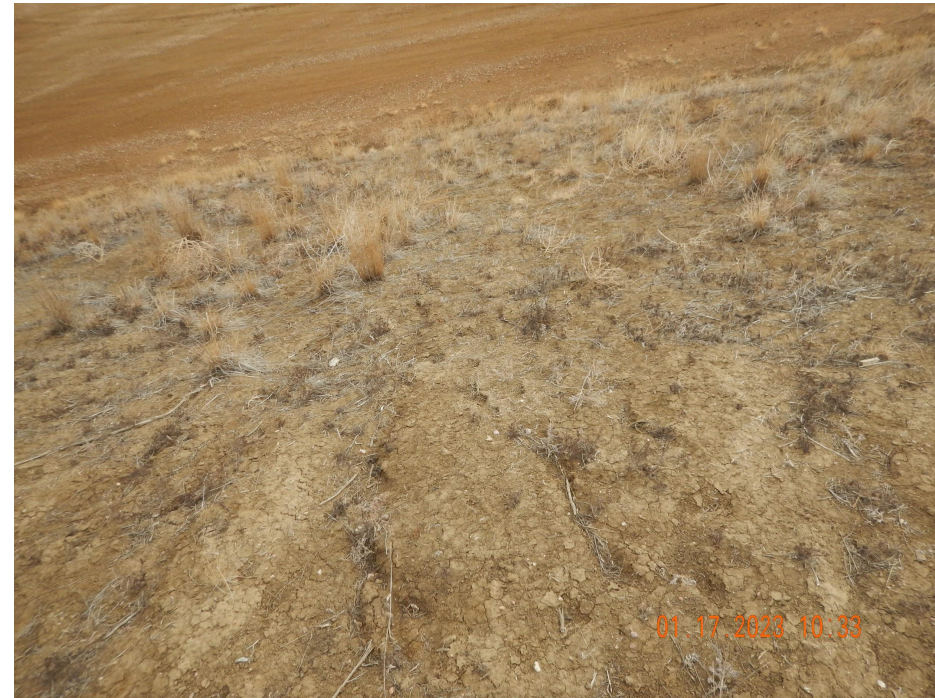
Photo 8. Photo taken from the southwestern cut slope, facing East. Photo illustrates some evidence of rill erosion. There was some erosion control blankets observed near here that were never installed.

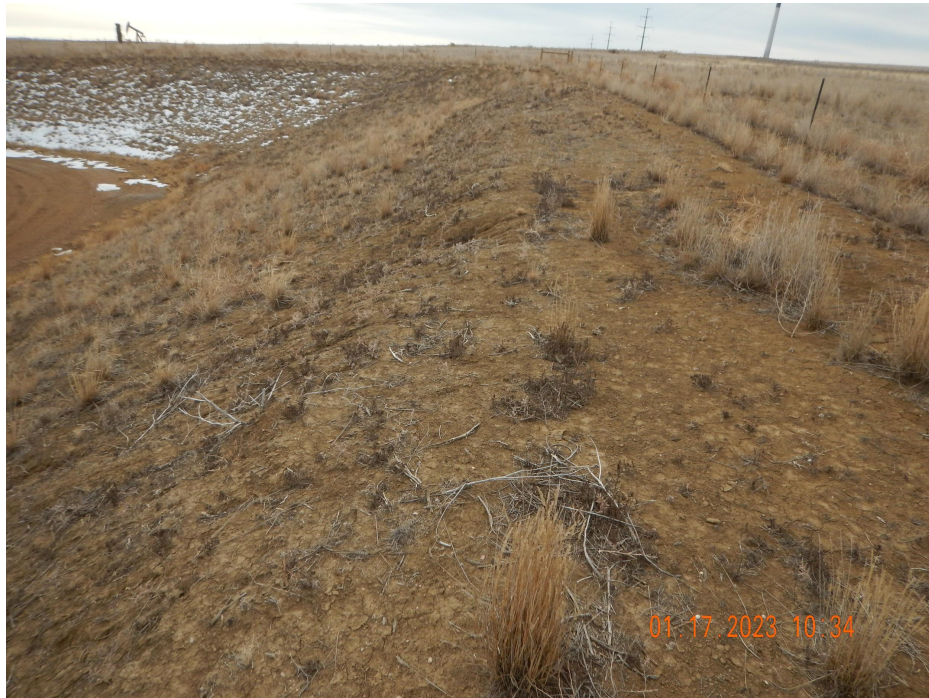
Photo 9. Photo taken from the previous photo location, facing south. See comments under Photo 8.

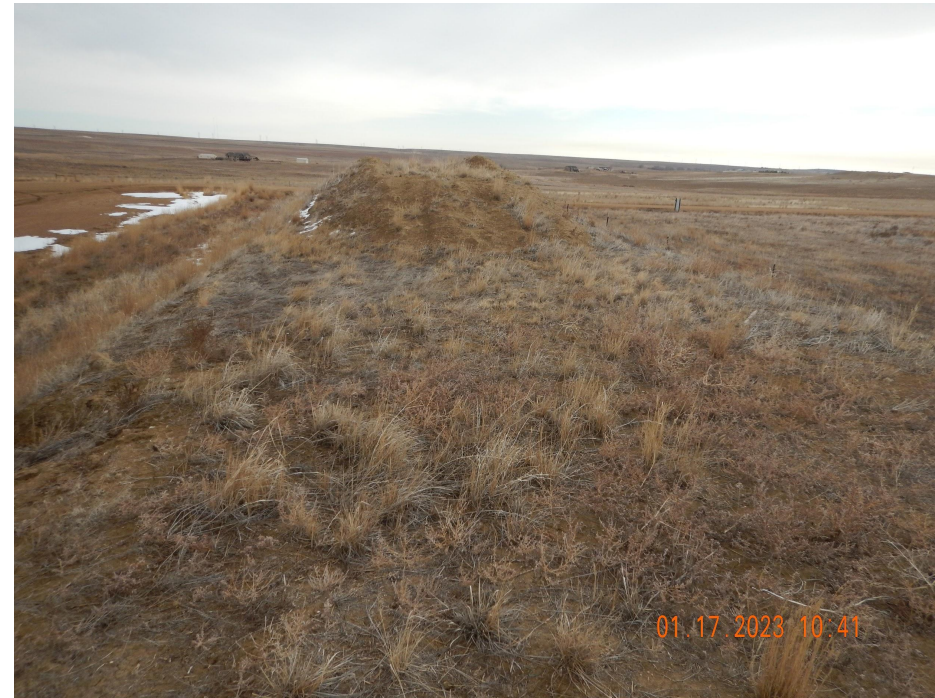
Photo 10. Photo taken from the southeastern perimeter of location, facing East. Photo illustrates the Operator stockpiled additional topsoil onto the original topsoil stockpile and failed to properly stabilize the stockpiles.

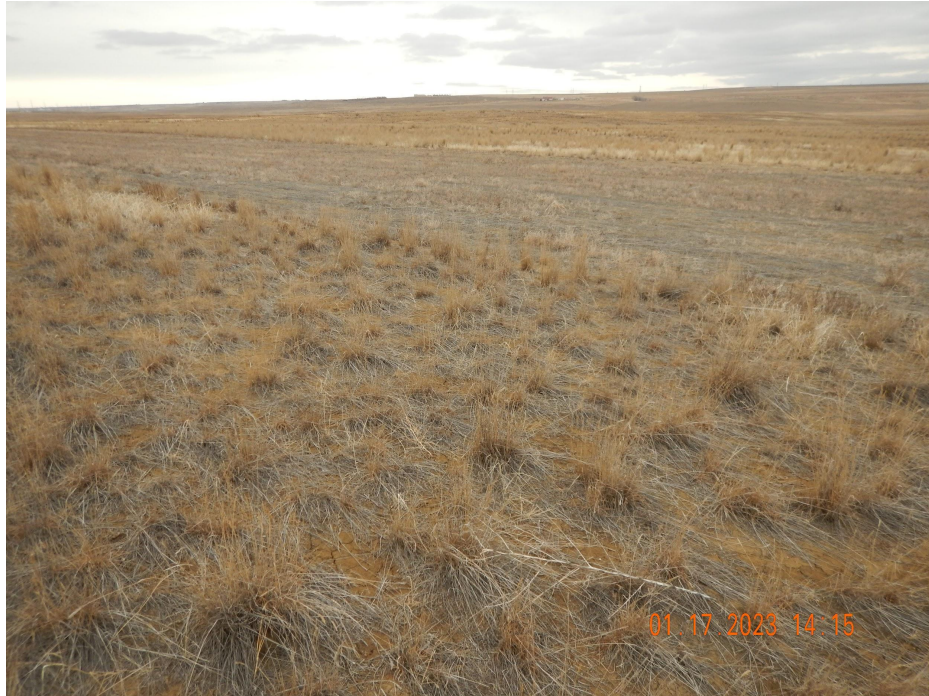
Photo 11. Photo taken from a portion of a previous access road that was reclaimed, facing East. Photo illustrates the access road lacks desirable vegetation and consists of annual weeds which is not reflective of reference area vegetative levels.

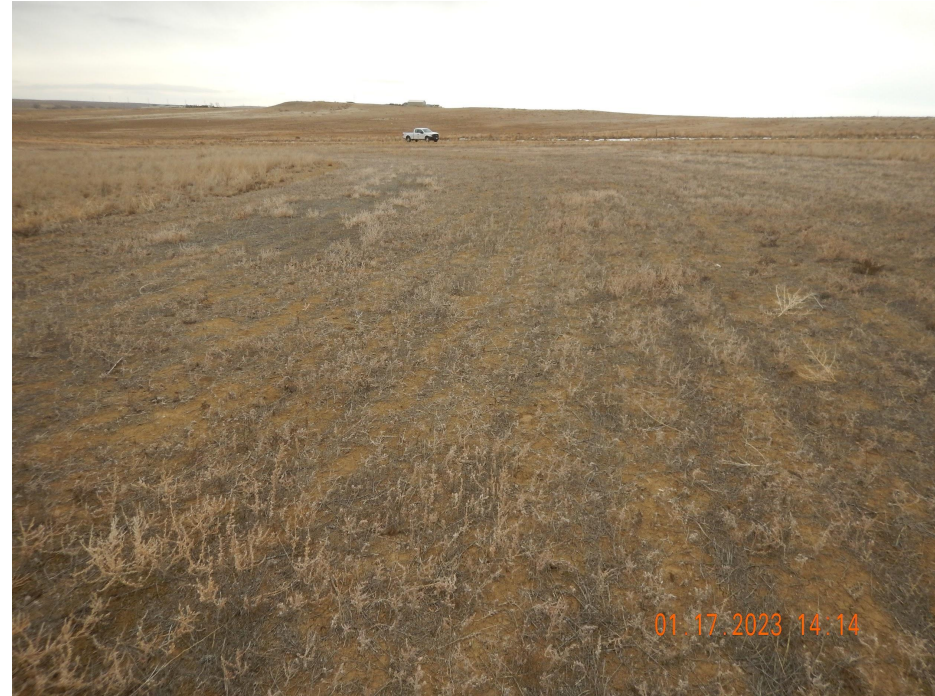
Photo 12. Photo taken from a portion of a previous access road that was reclaimed, facing South. See comments under Photo 11.

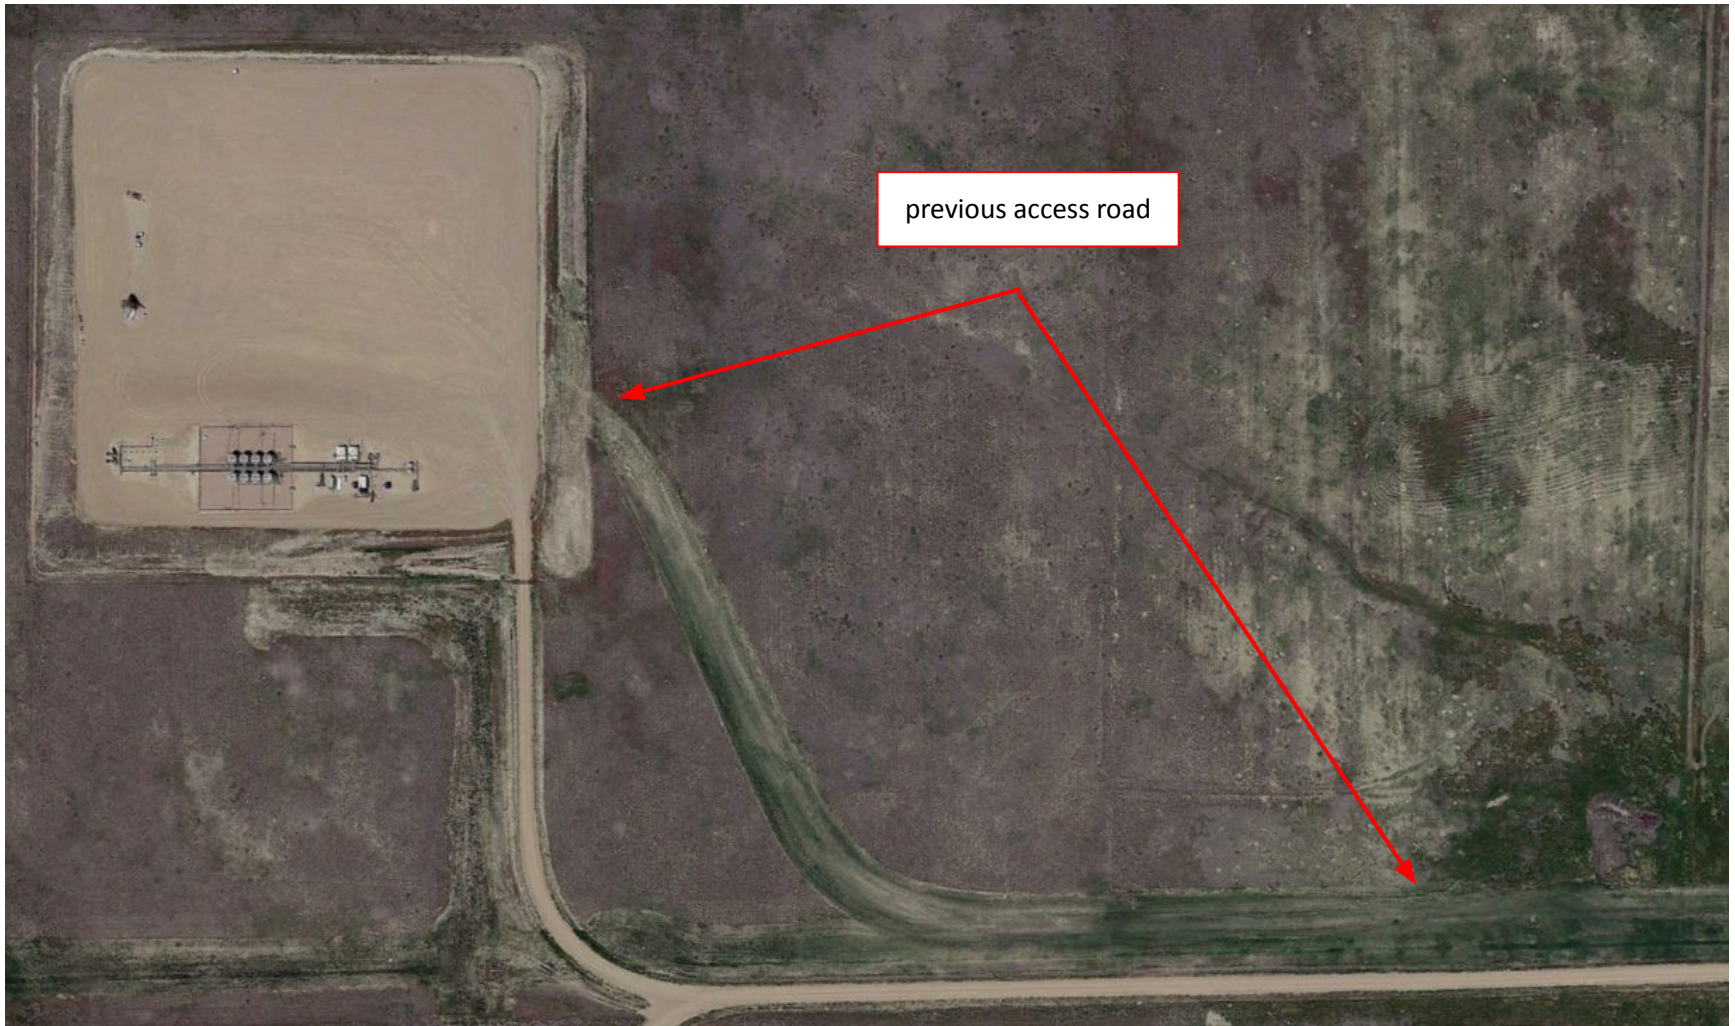
Photo 13. Google Earth aerial imagery from 6/11/2021 illustrates a portion of a previous access road that was reclaimed but fails to meet Rule 1003 vegetative requirements.
