# Inspection Photos

01/23/2023

Operator: VISION ENERGY LLC #10770

Location #312658

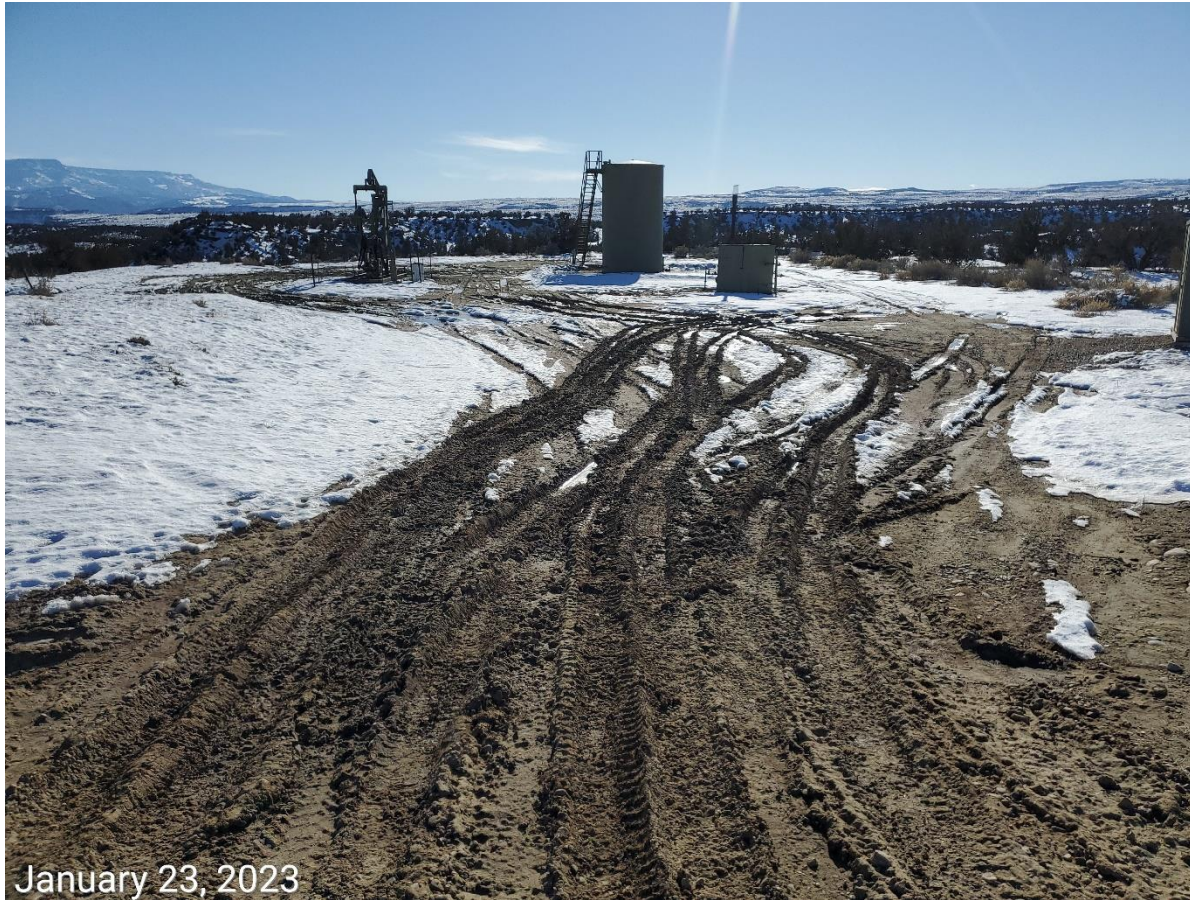
**Photo 1:** Photo taken from the Location entrance facing south. Photos example showing BMPs to stabilize the Location, and to minimize tracking and sediment transport remains missing or insufficient.

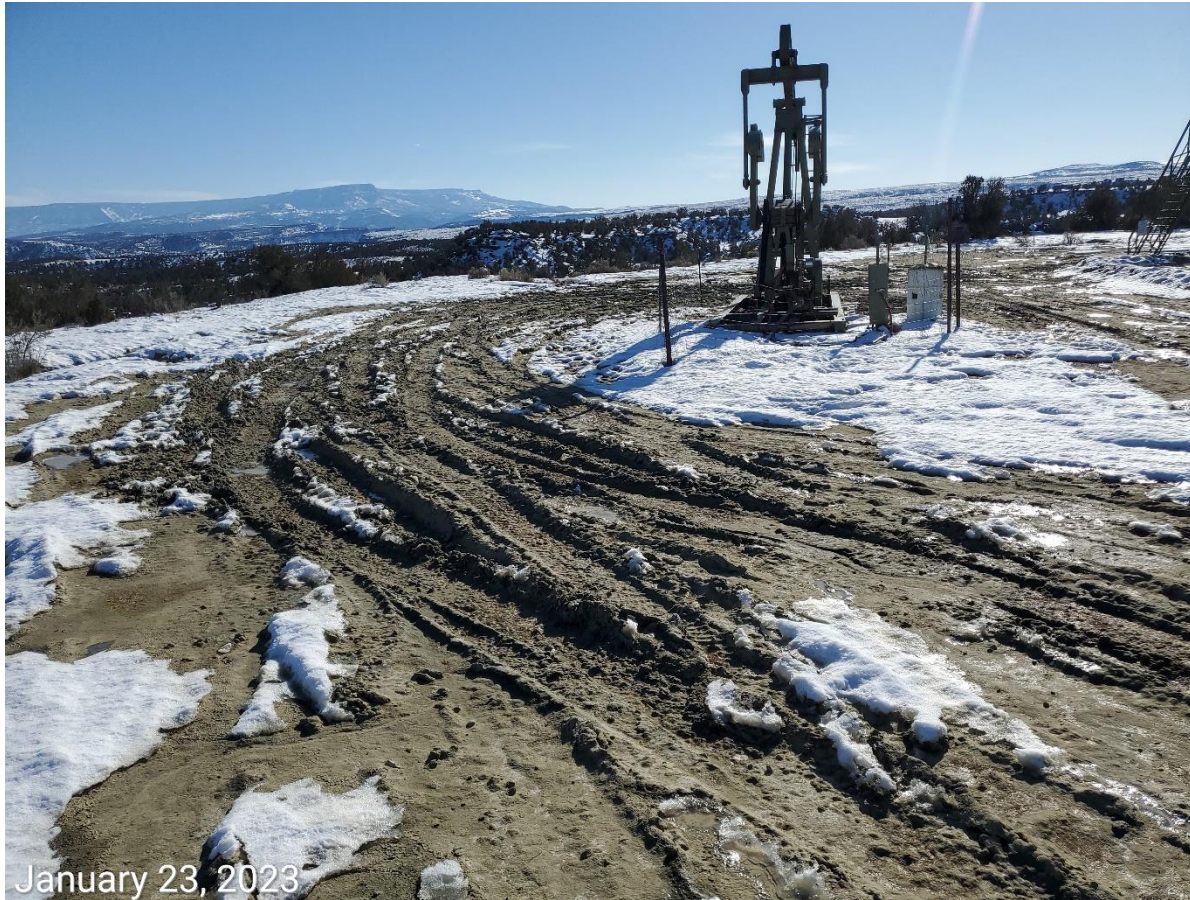
**Photo 2:** Photos example showing BMPs to stabilize the Location, and to minimize tracking and sediment transport remains missing or insufficient.

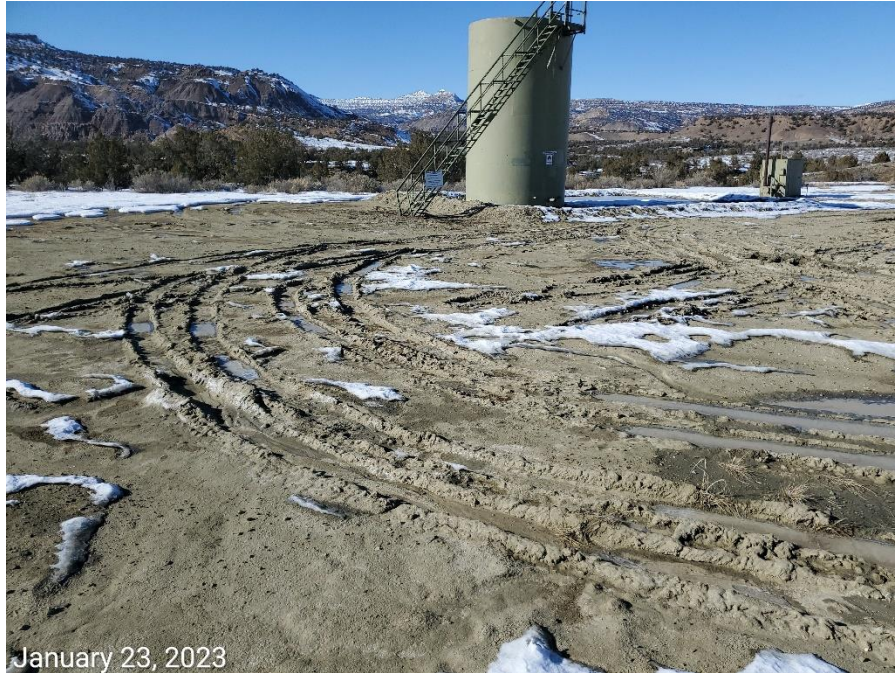
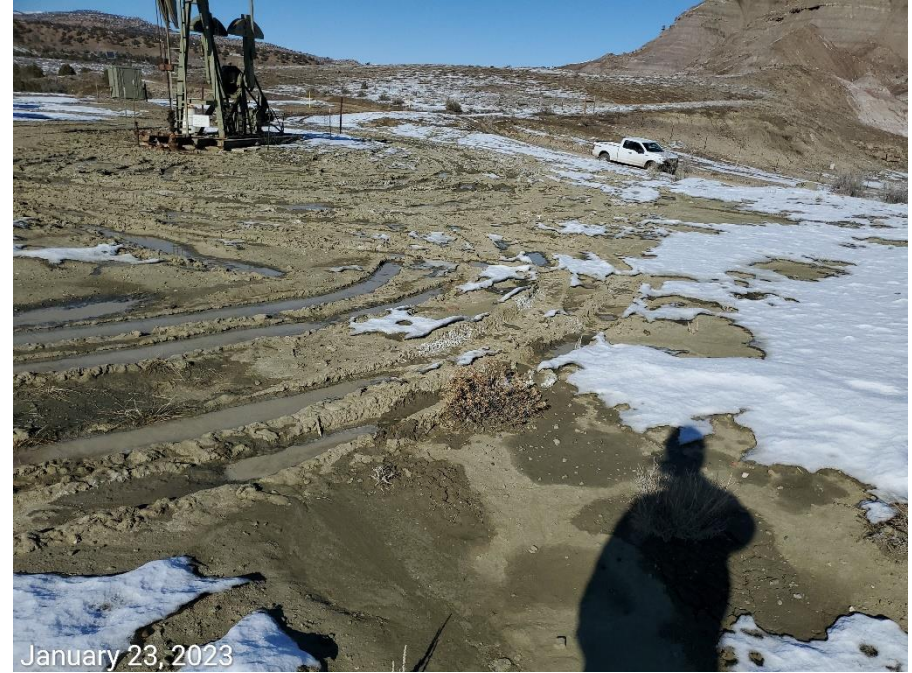
**Photo 3:** Photos taken from the south end of the Location facing west and north. Photos example showing BMPs to stabilize the Location, and to minimize tracking and sediment transport remains missing or insufficient.

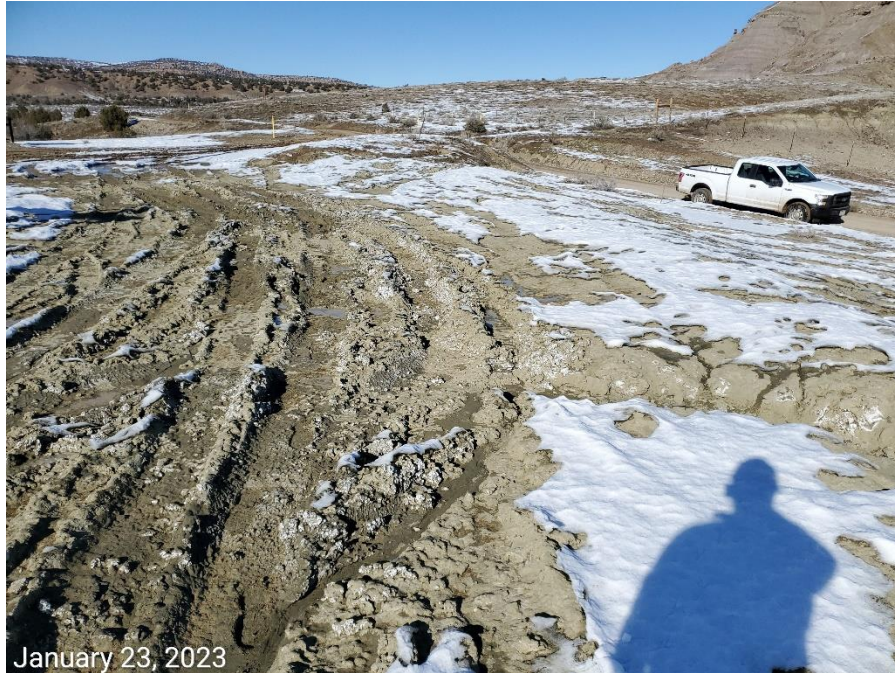
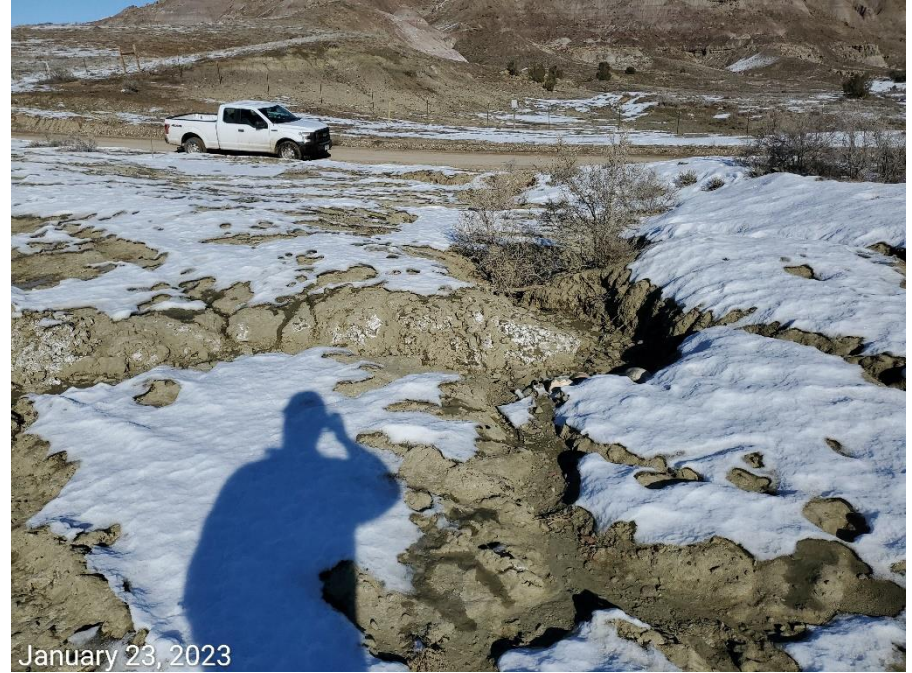
**Photo 4:** Photos taken from the east end of the Location. Photos examples showing stormwater and erosion control BMPs to stabilize the Location, and to manage runoff remain missing or insufficient; erosion degradation has persisted.

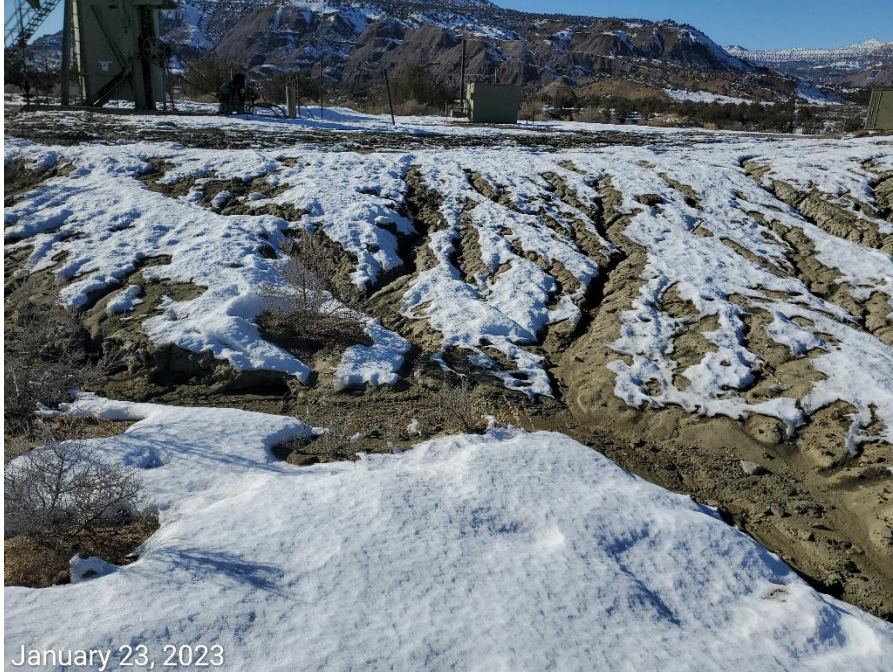
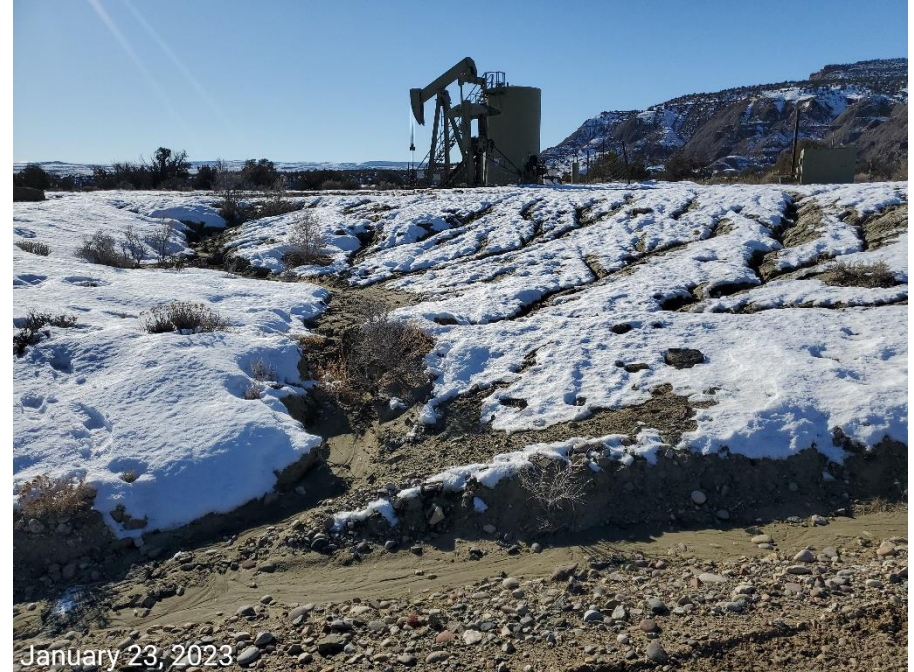
**Photo 5:** See comment under photo 4.

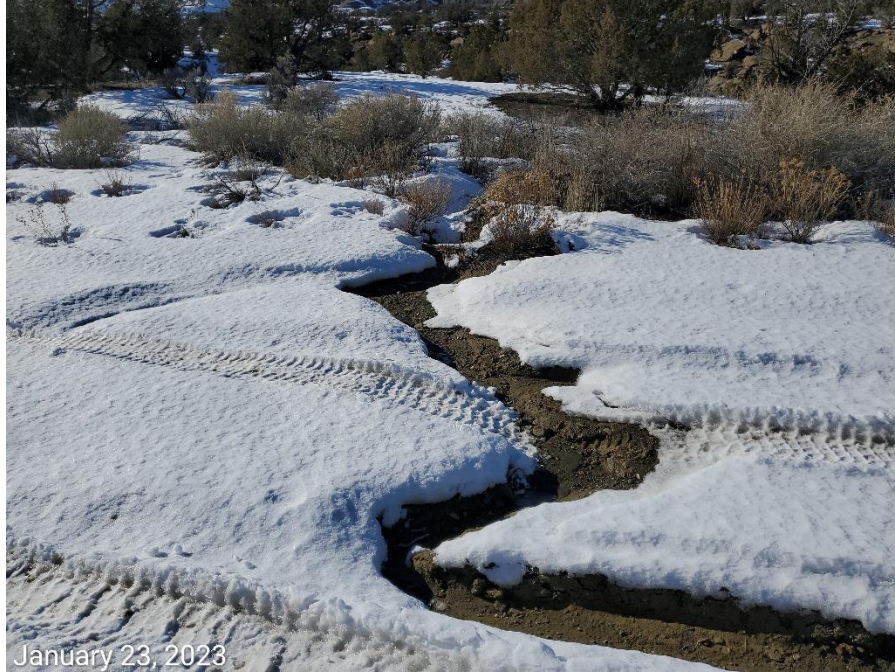
**Photo 6:** Photo taken from the west end of the Location. Photo shows stormwater runoff from the location has not been managed in a manner that minimizes erosion and degradation; gully erosion evident on offsite areas west of Location

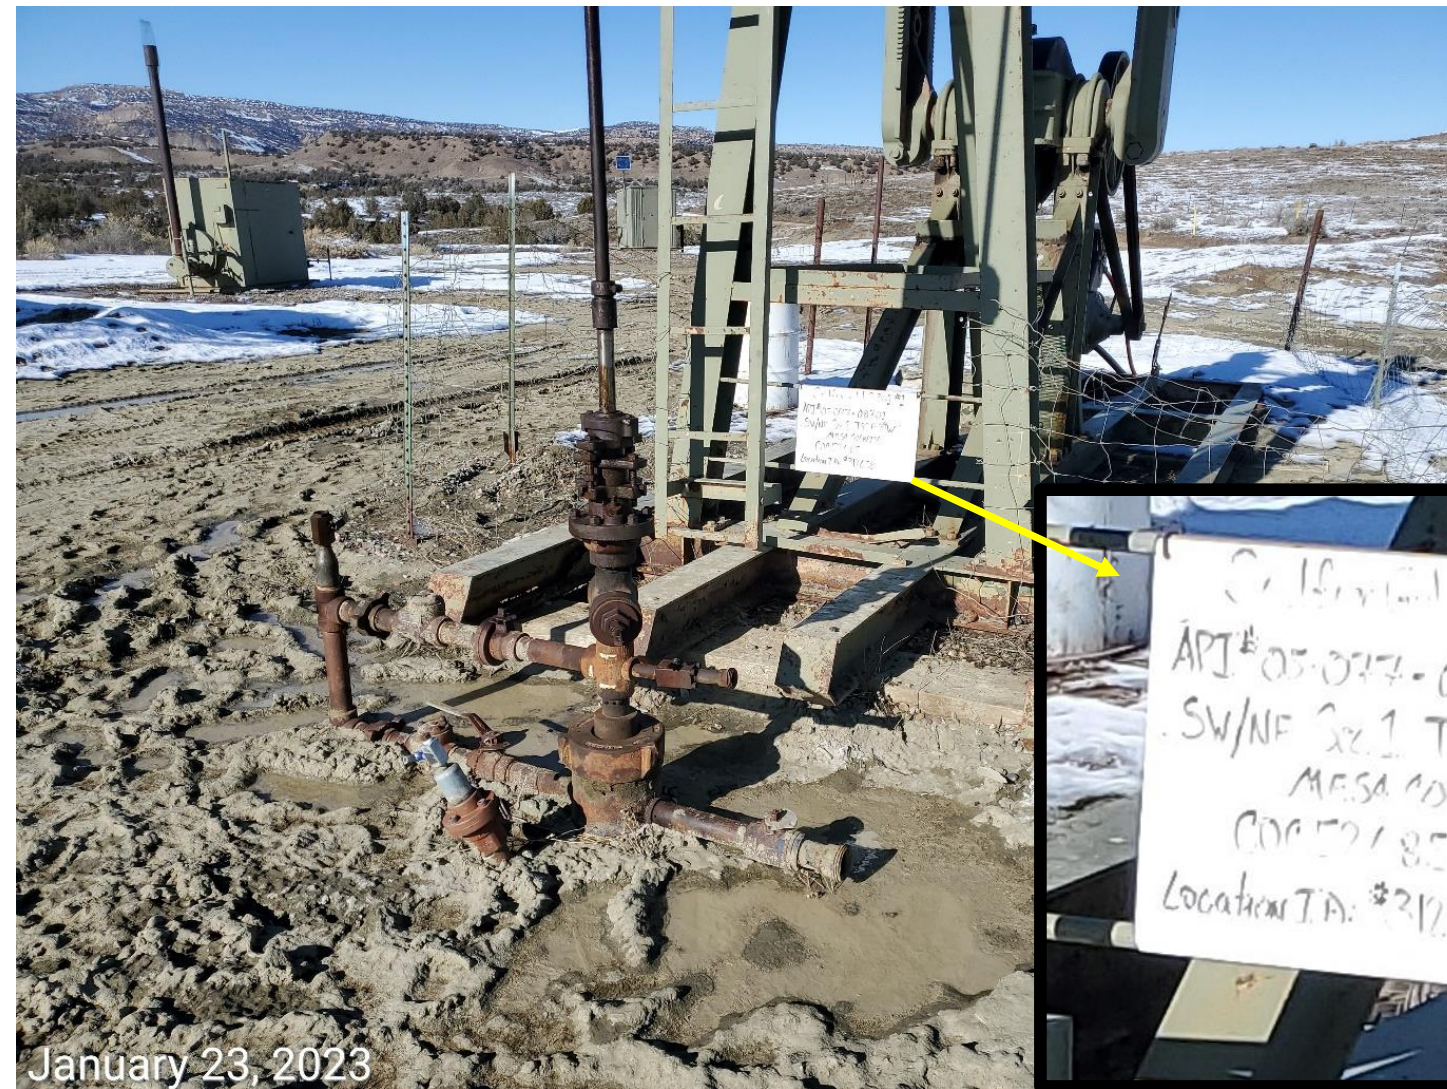
**Photo 7:** Photo shows Operator has attempted to install required signage at the wellhead per Rule 605.d, however, the labeling (marker) has degraded and is once again illegible.

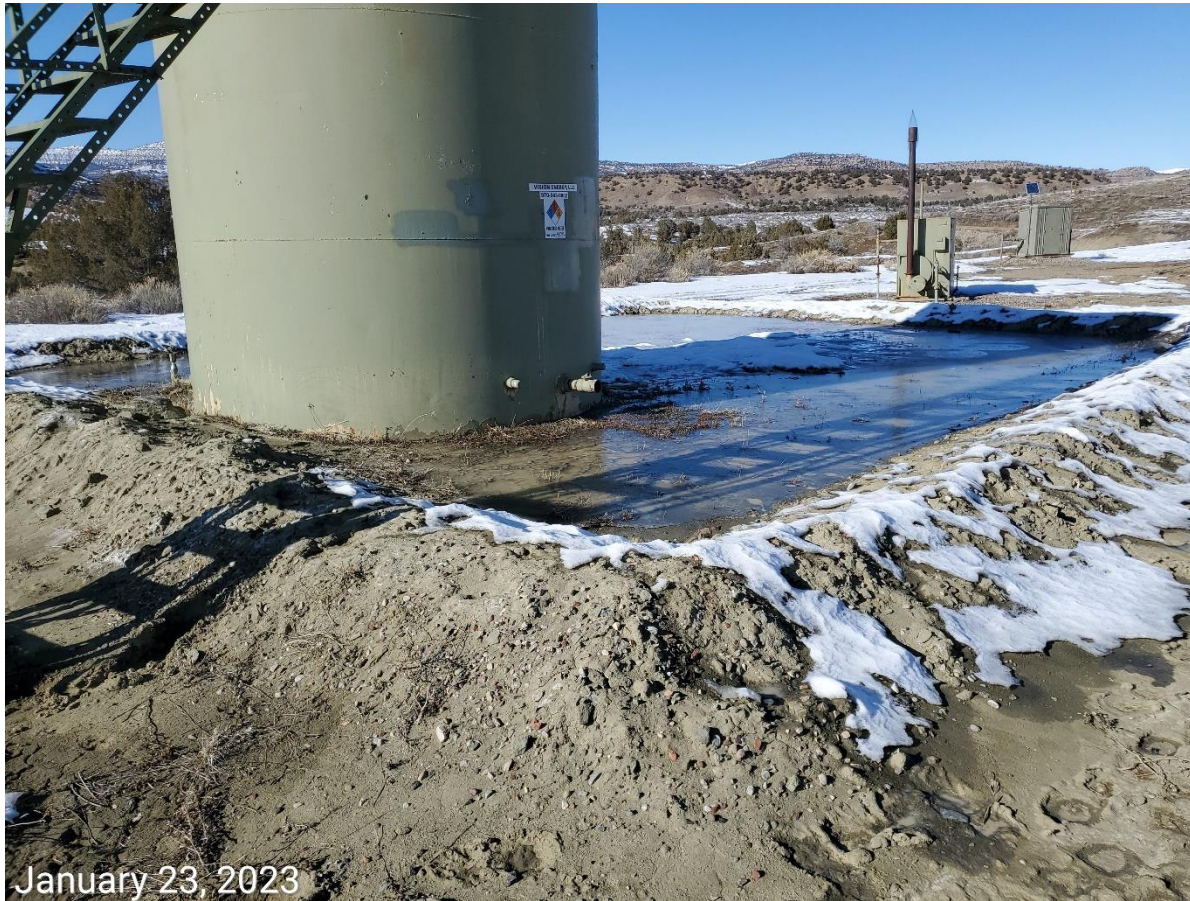
**Photo 8:** Photo taken from the tank battery. Vegetation remains evident within the secondary containment; secondary containment is not in proper functioning condition, or adequate in size to contain a spill from the tank. Vegetation within BMP compromises the impermeability of the containment.

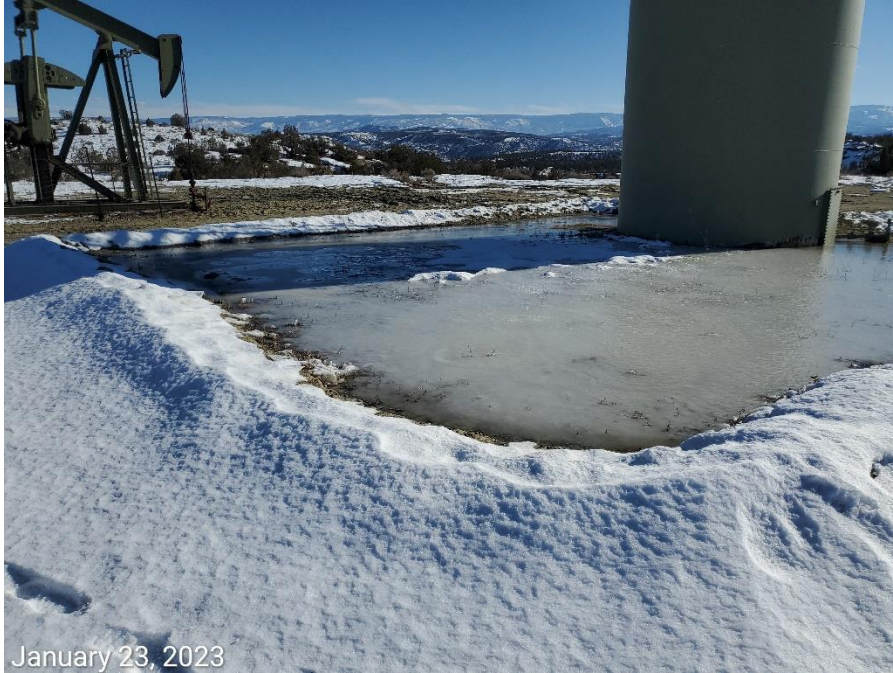
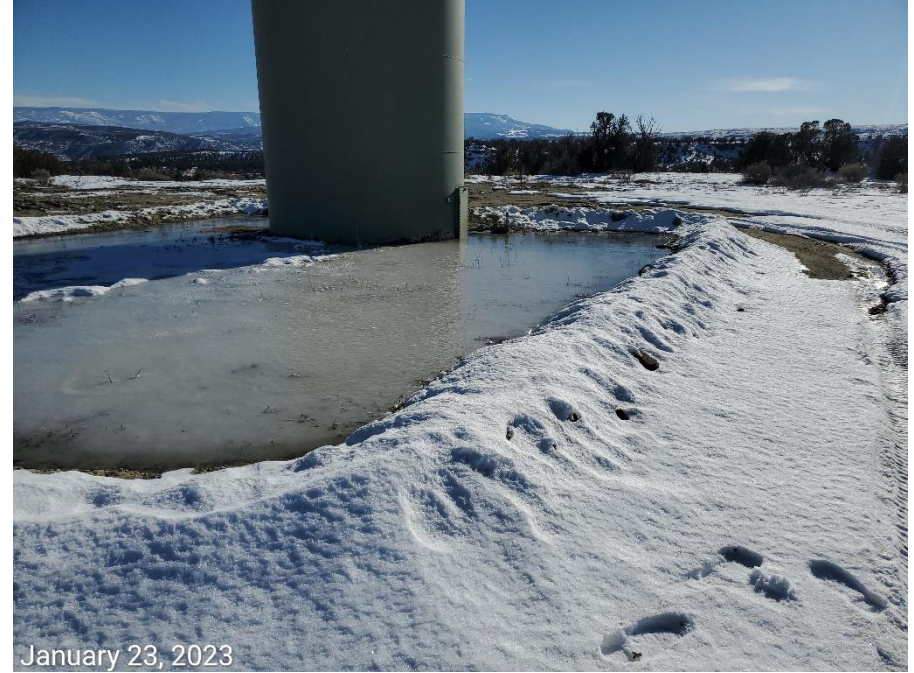
**Photo 9:** See comments under photo 8.

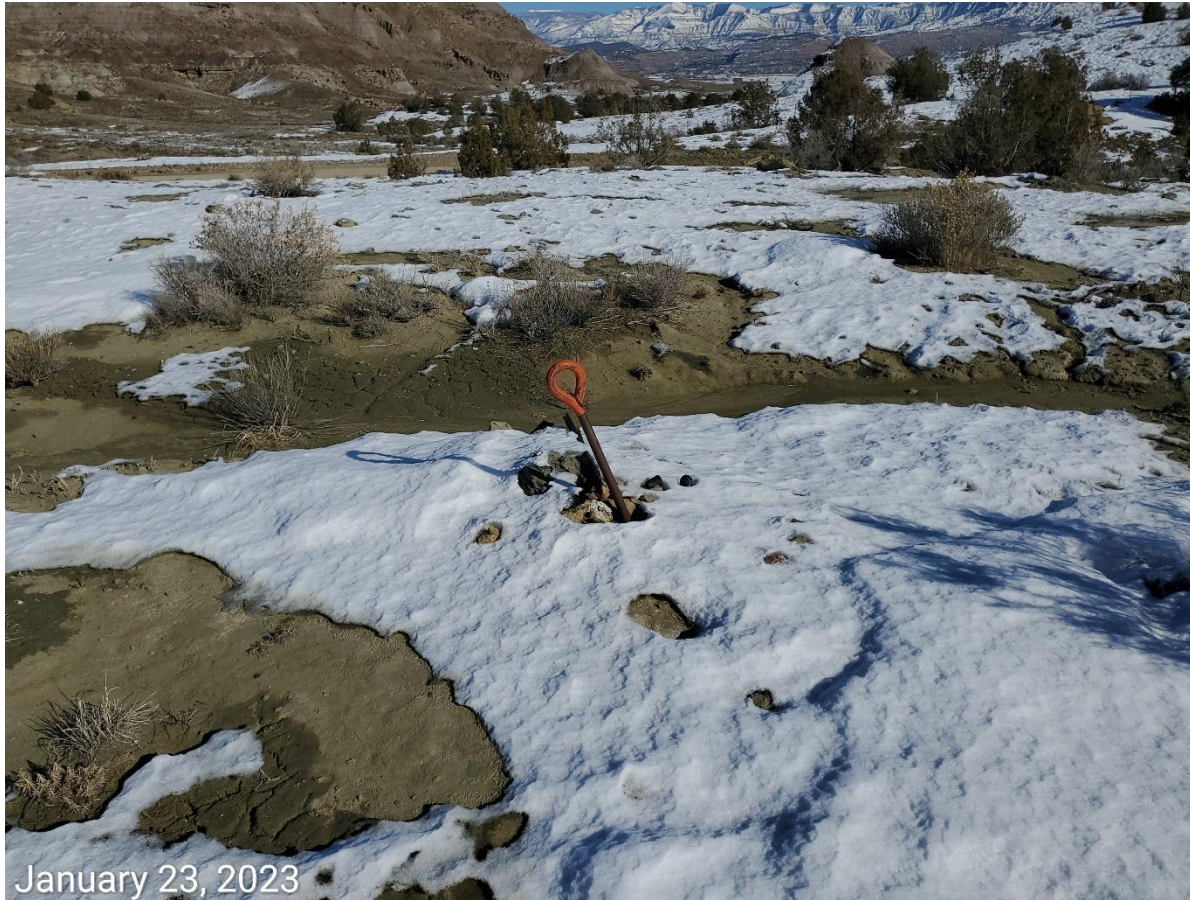
**Photo 10:** Photo example showing anchors missing required marking.
