Interim Reclamation and Stormwater Inspection

January 17, 2023

Operator: ENERPLUS RESOURCES (USA) CORPORATION - #10177

Location ID: 450827

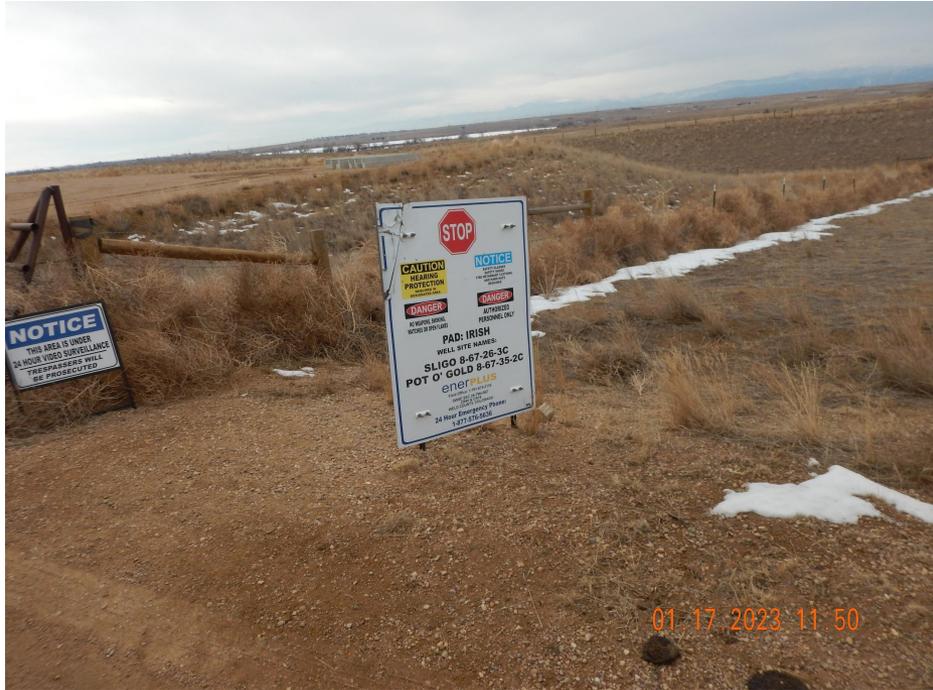
Photo 1. Photo taken from the entrance of location, facing Southwest. Photo illustrates the Operator sign.

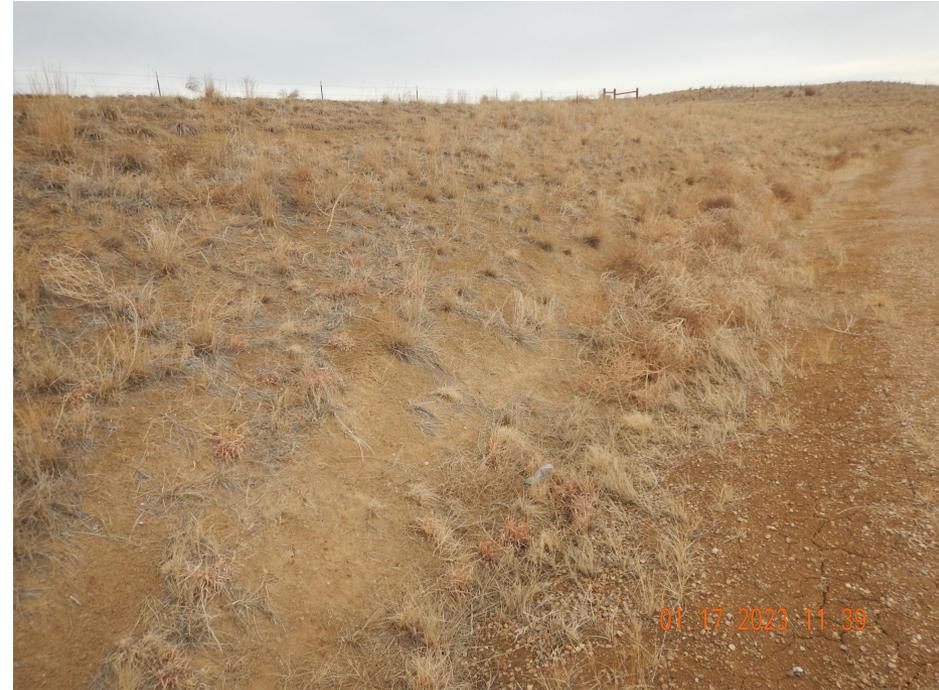
Photo 2. Photo taken from the northern perimeter of location, facing East. Photo illustrates Operator has seeded the cut slope and stormwater BMP areas. Photo illustrates desirable vegetation.

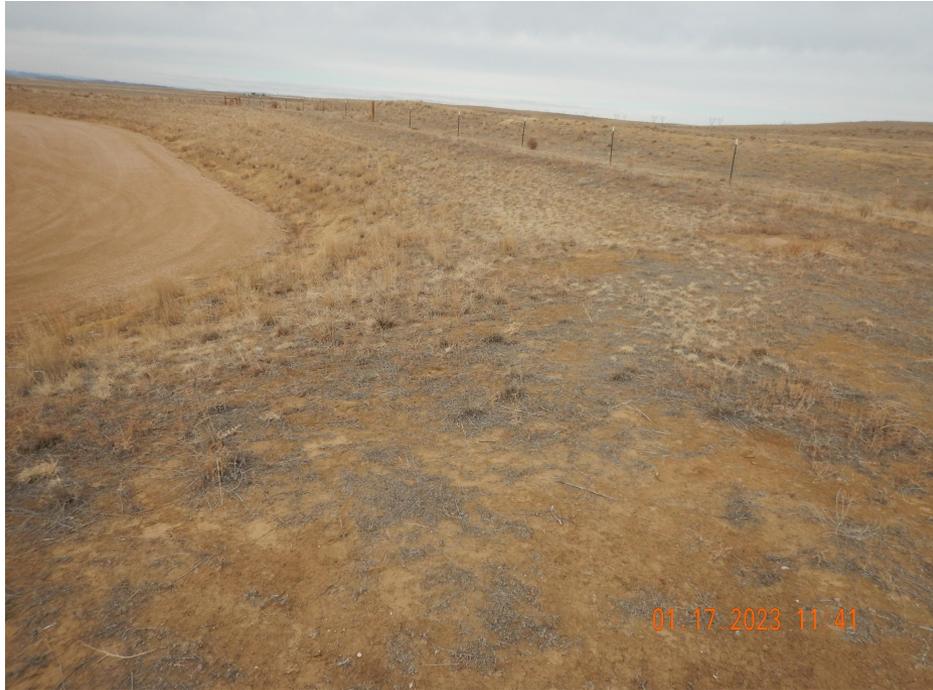
Photo 3. Photo taken from the northeastern location, facing Northwest. Photo illustrates vegetative establishment and stabilization along the northern and northeastern cut slope, but the vegetation becomes sparse to bare ground along the eastern perimeter.

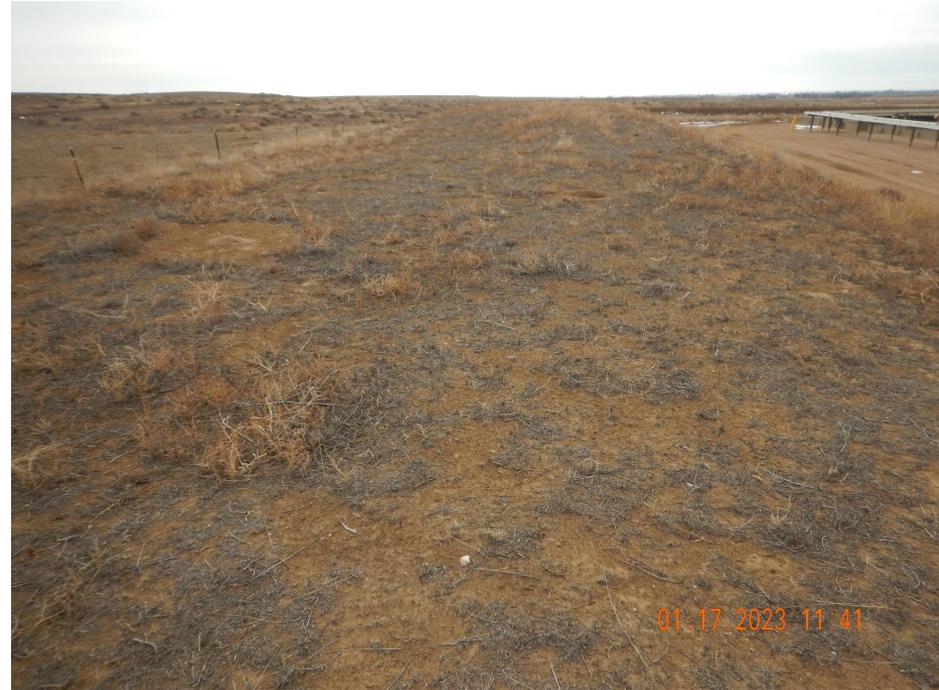
Photo 4. Photo taken from the previous photo location, facing South. See comments under Photo 3. Note- this is the start of the northern extent of the topsoil stockpile which has weedy, annual vegetation and bare ground.

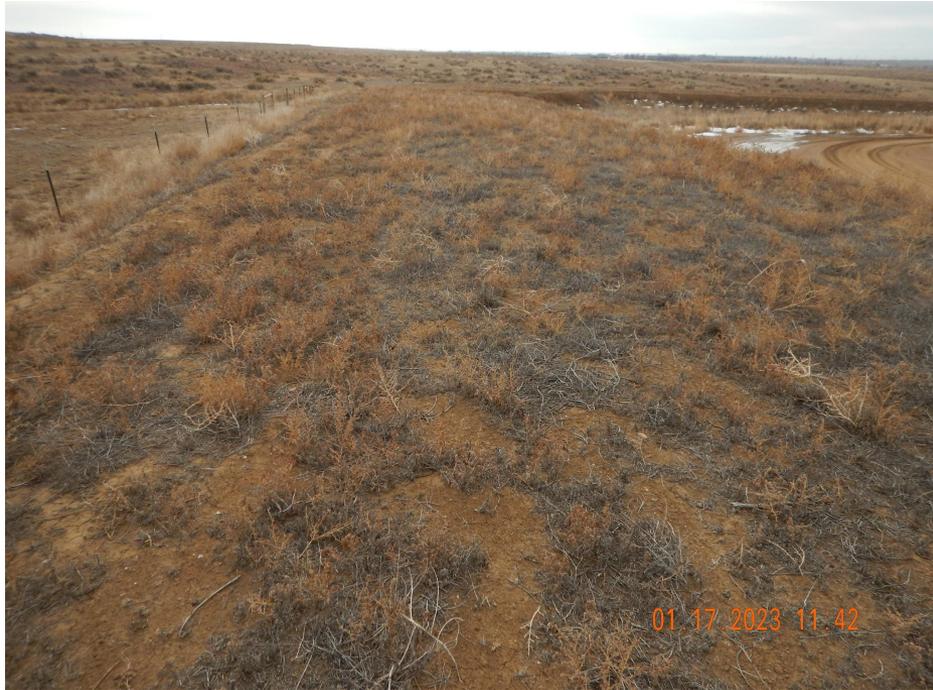
Photo 5. Photo taken from the eastern location, facing South. See comments under Photo 4. Note- weedy vegetation along the fenceline which is considered weed debris and needs to be removed.

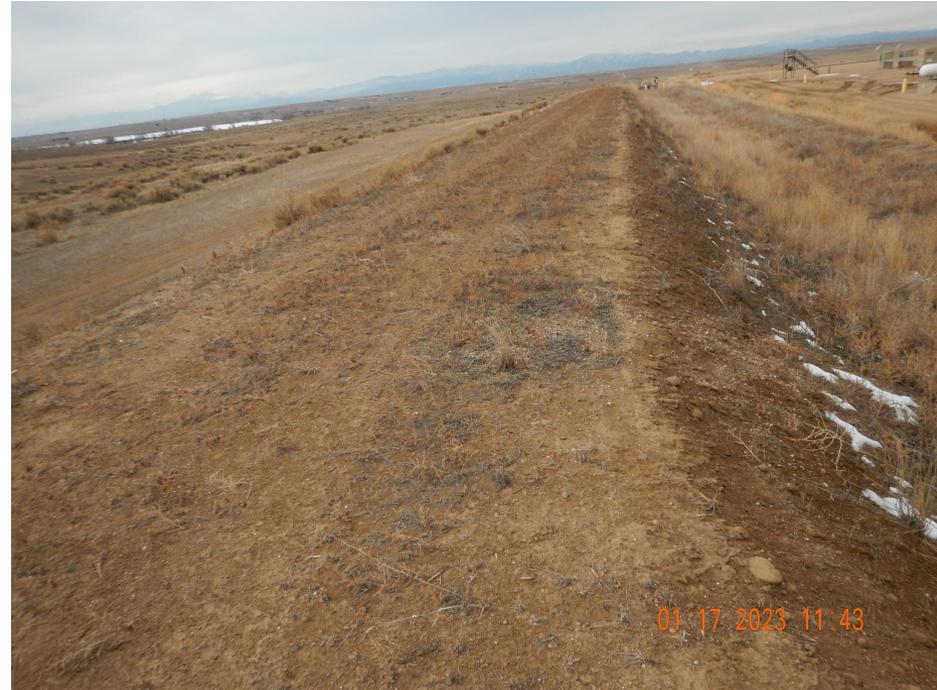
Photo 6. Photo taken from the southeastern location, facing West. Photo illustrates vehicle traffic on the topsoil stockpile which is in violation of Rule 1002.c.

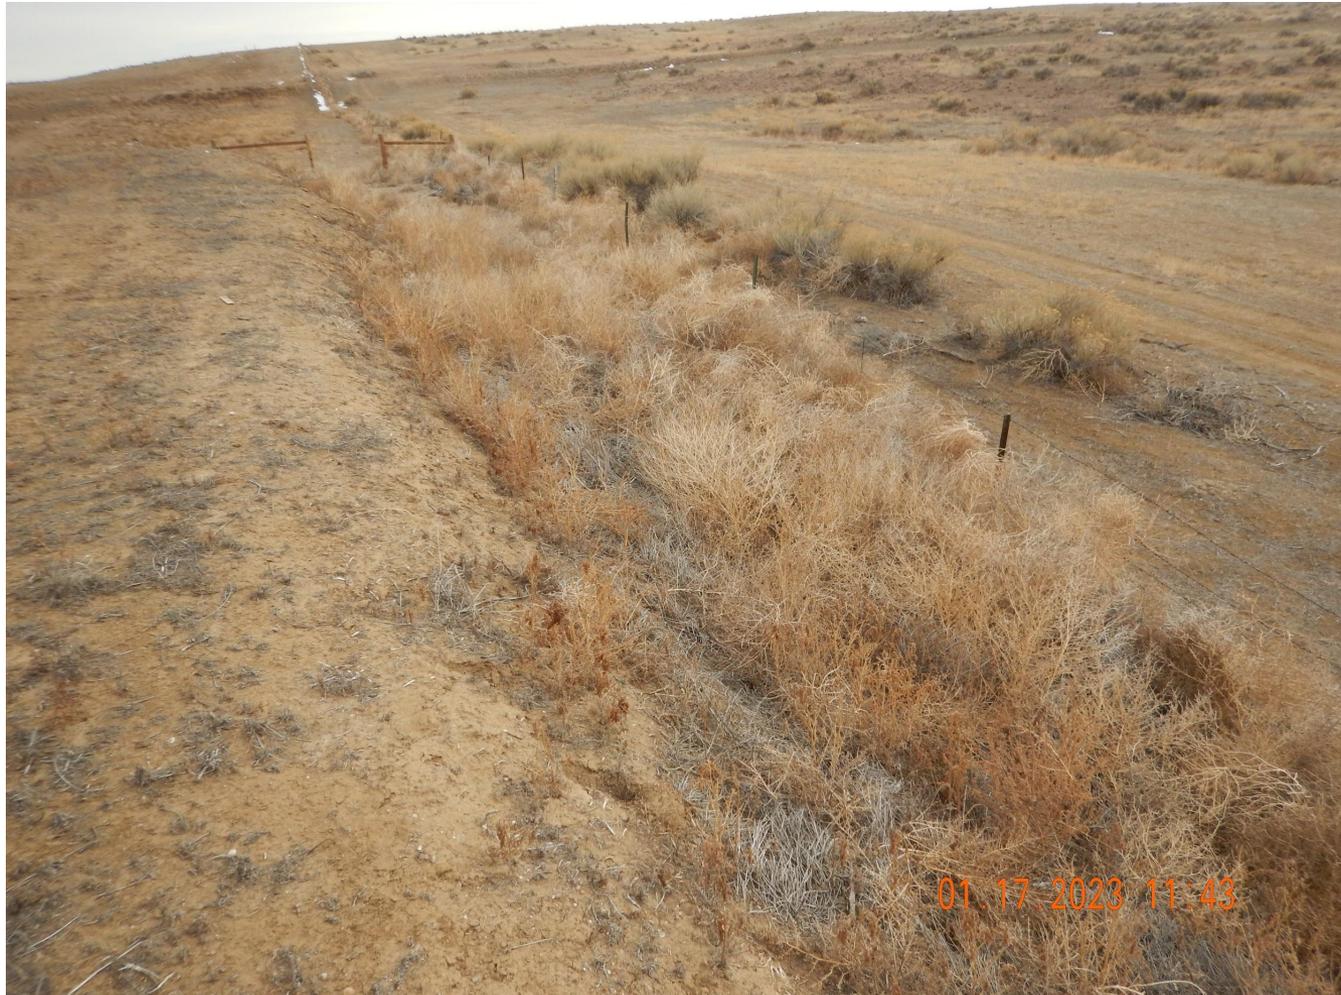
Photo 7. Photo taken from the southeastern location, facing East. Photo illustrates weedy vegetation along the fenceline which is considered weed debris and needs to be removed.

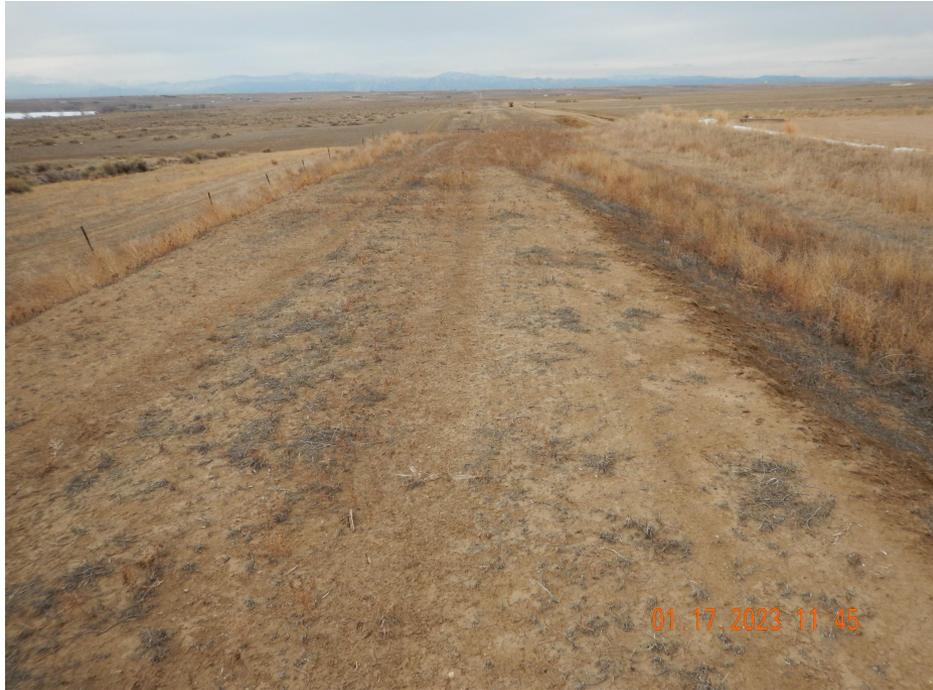
Photo 8. Photo taken from the topsoil stockpile along the southern location, facing West. See comments under Photo 6.

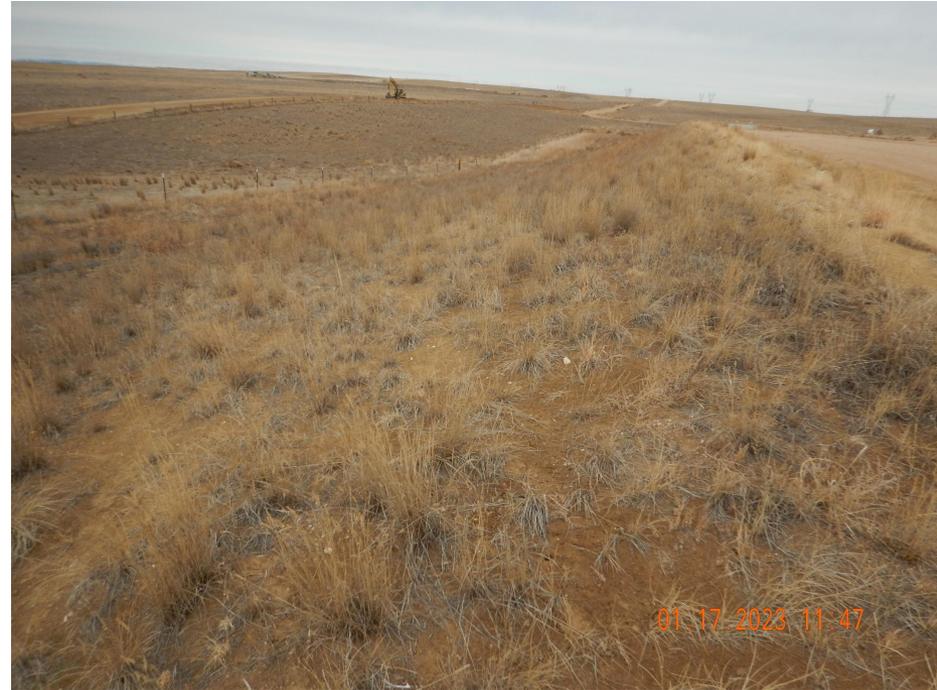
Photo 9. Photo taken from the southwestern location, facing North. Photo illustrates the fill slope and western location have been seeded. Photo illustrates desirable vegetation.
