Inspection Photos

Operator: TEP Rocky Mountain LLC - #96850

Location Name: Dixon Federal Pad (SWNW-23-692)/11A-23-692

Inspection Document #: 702801189

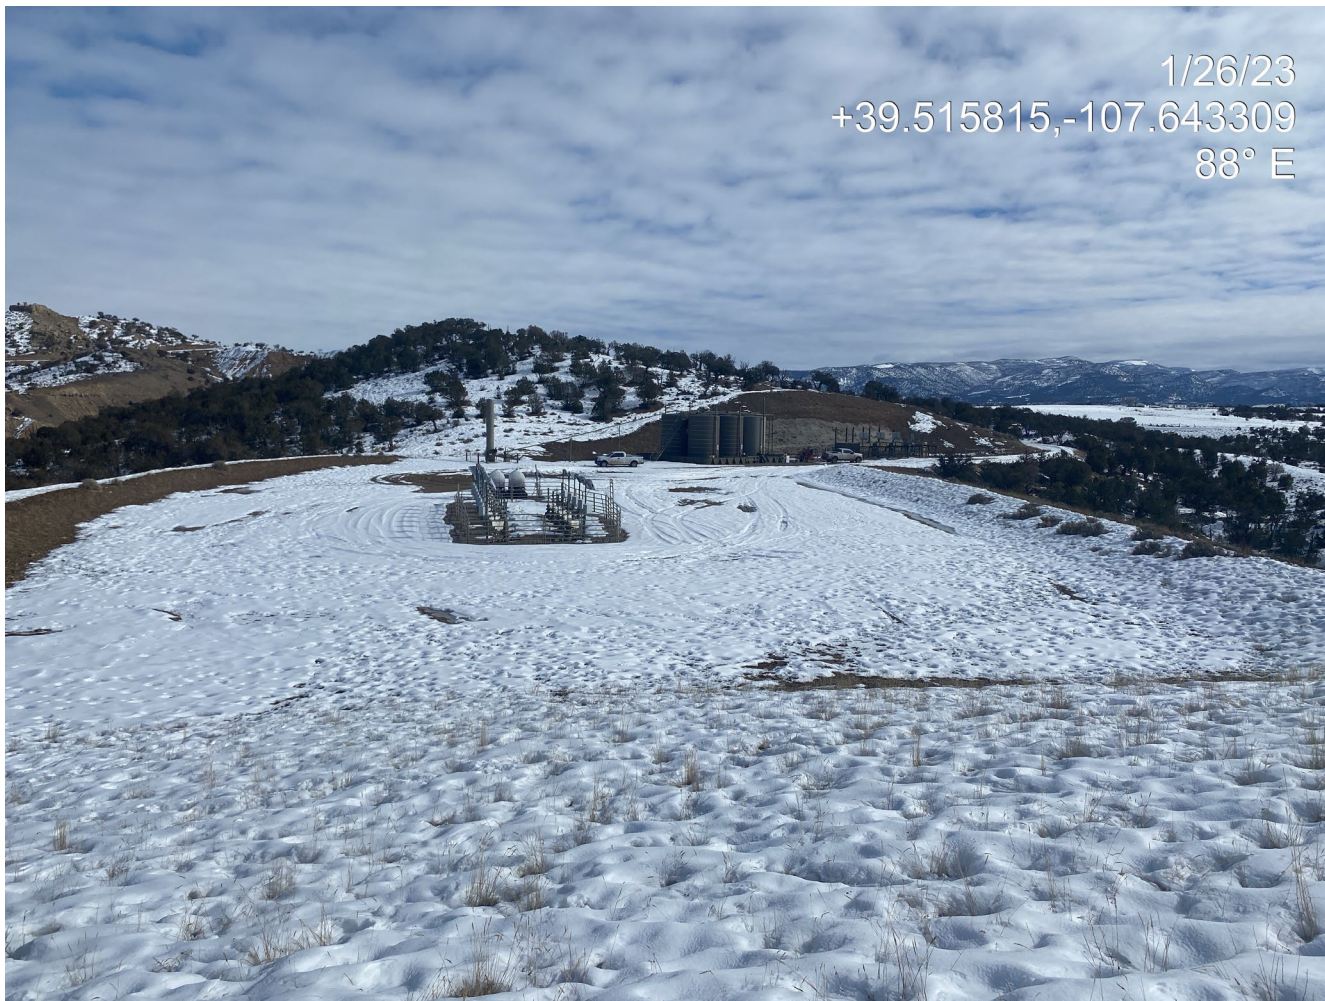
Photo 1. Photo taken from the west shows an overview of the location.

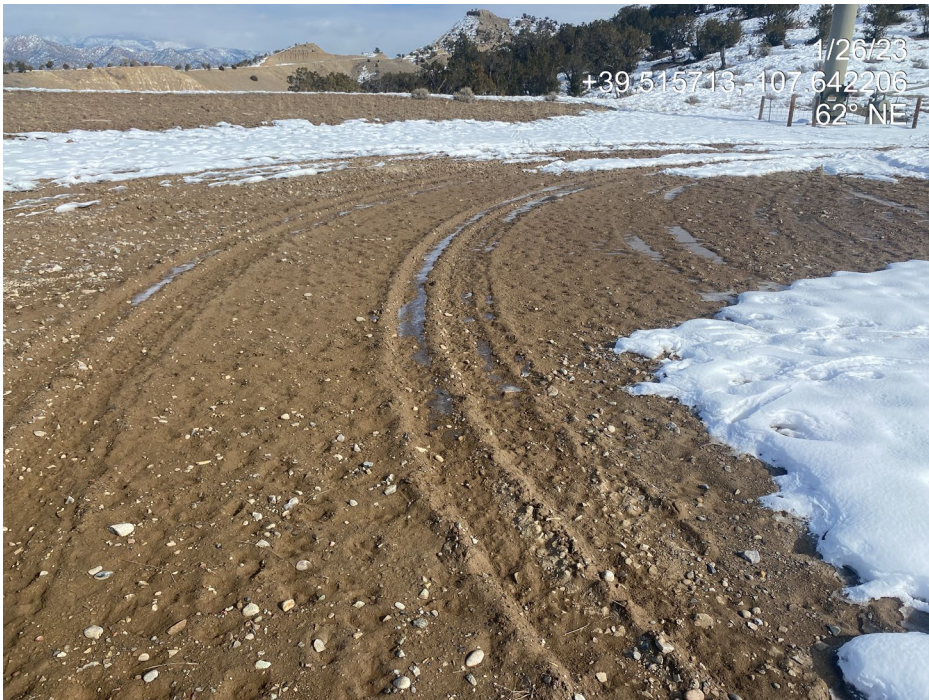
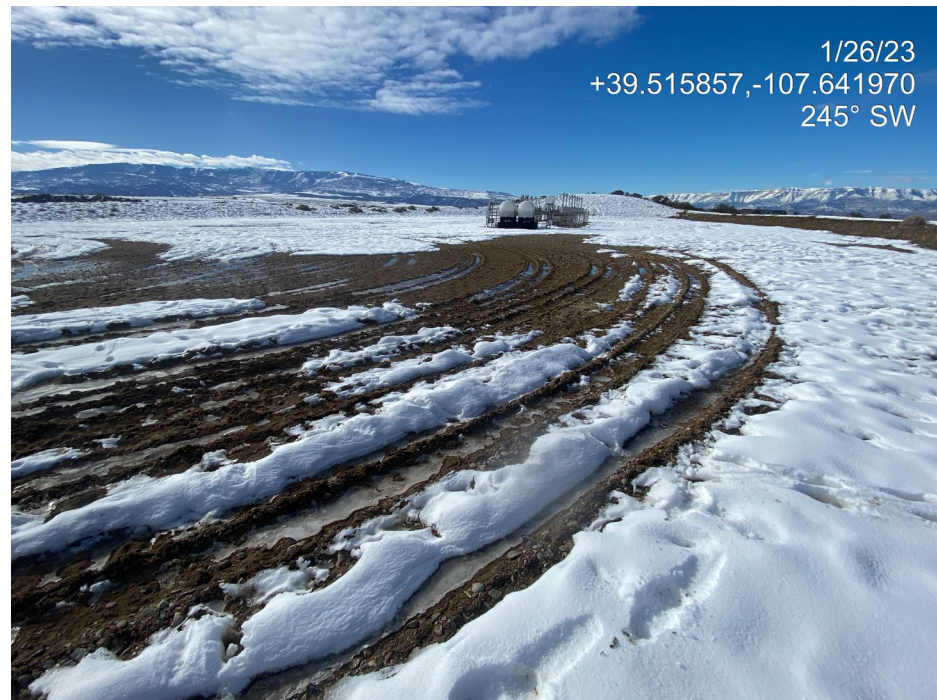
Photo 2. Photos show degradation to the pad surface and a lack of stabilization BMPs and tracking controls.

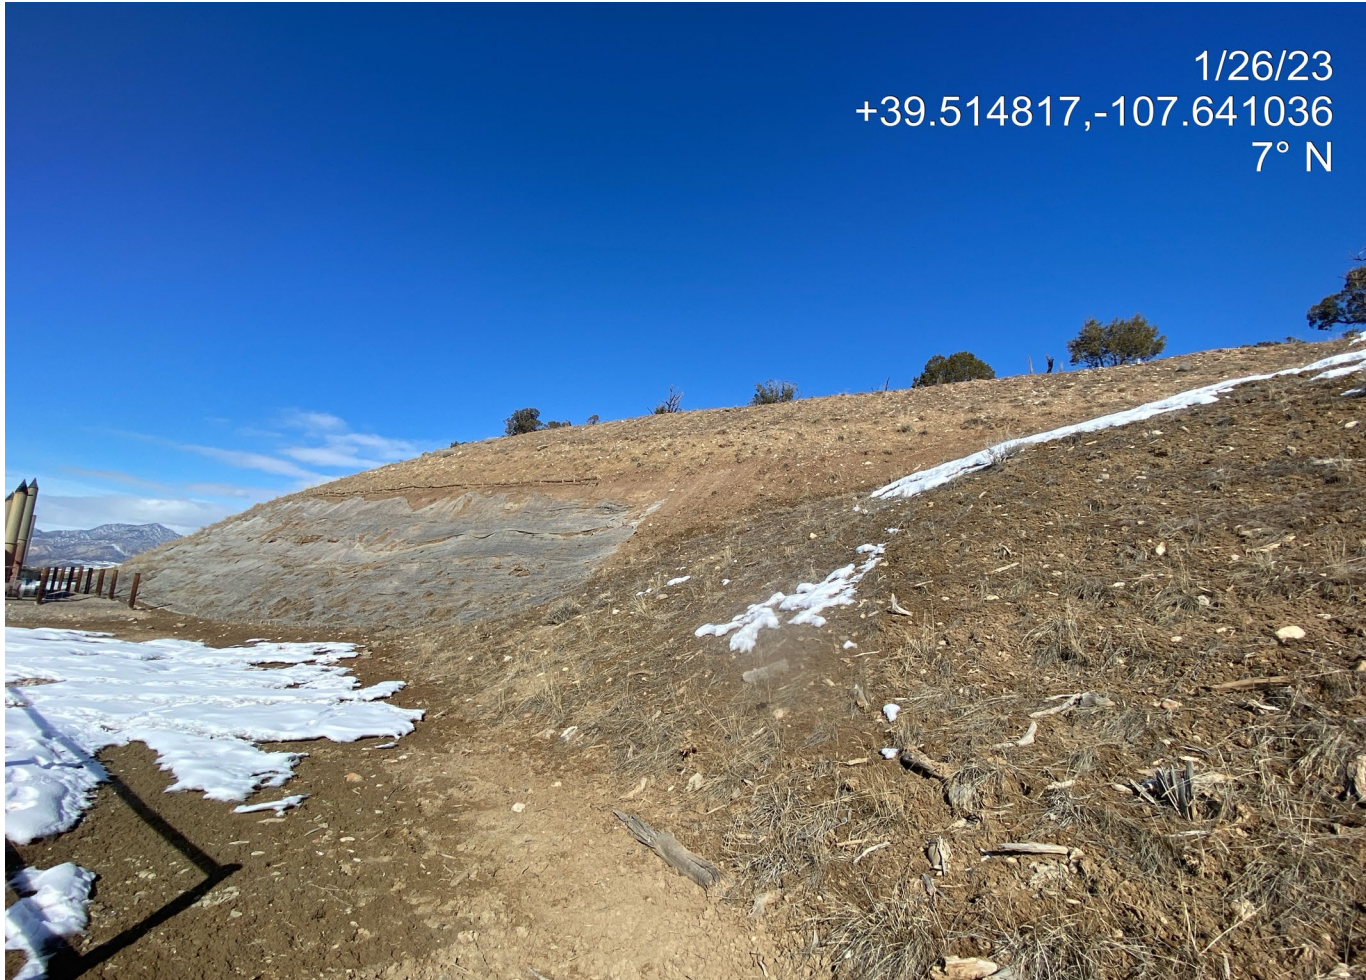
Photo 3. Photo taken at the east of the location shows an overview of the eroding cut slope behind the separators.

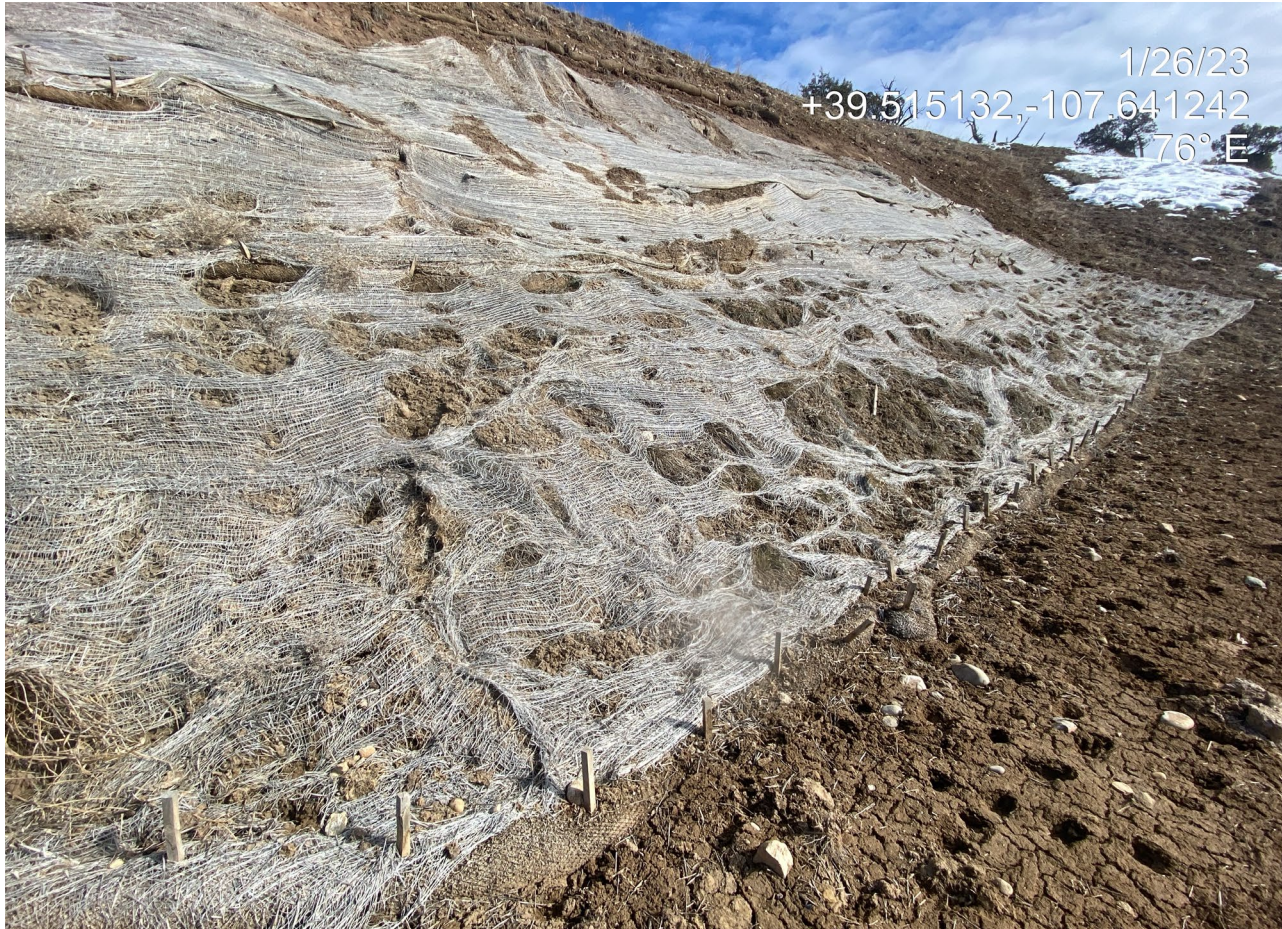
Photo 4. Photos taken at the east of the location show the cut slope behind the separators. The erosion blanket is degraded, sediment has overtopped wattles, stabilizing perennial plants appear sparse. Sediment is accumulating at the base of the slope.

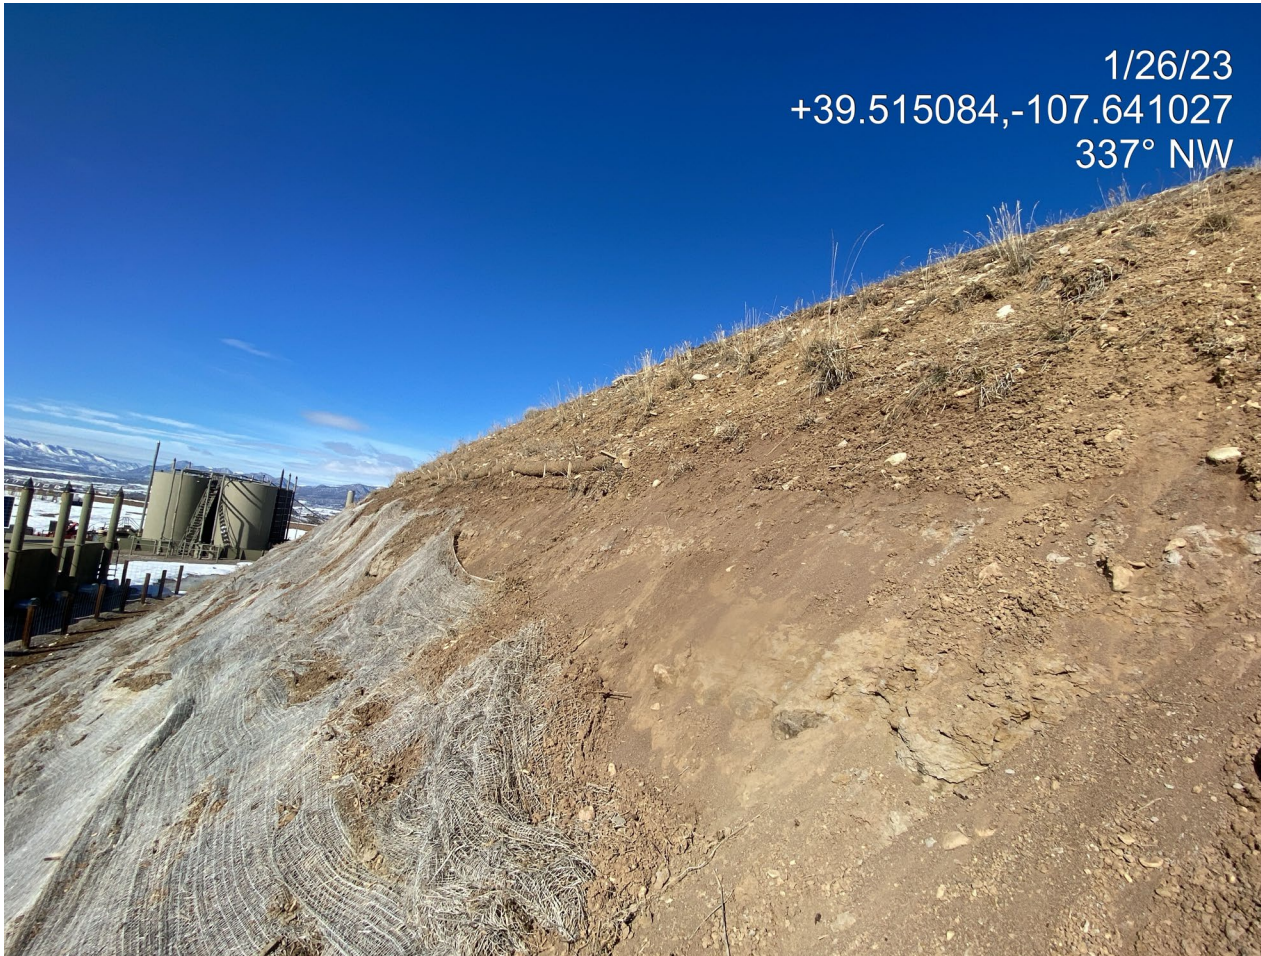
Photo 5. Photo shows BMP degradation and cut slope erosion. Soils were observed to be actively falling from the slope from gravity (not wind or water) indicating a particularly unstable slope. See also attached video.

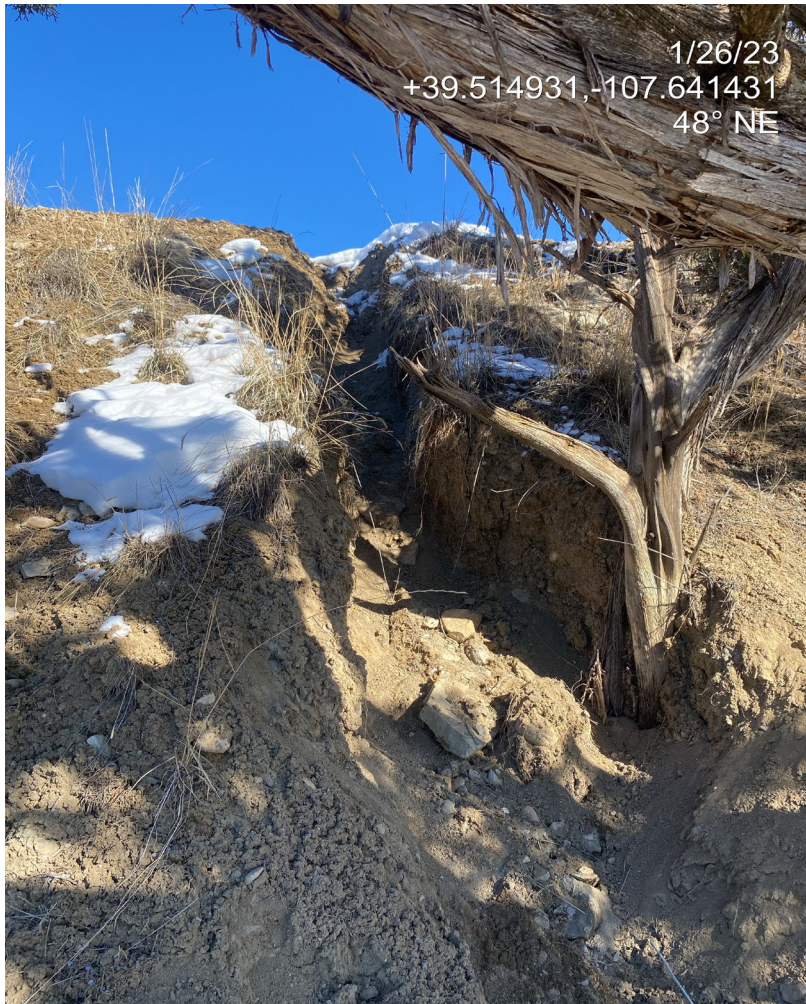
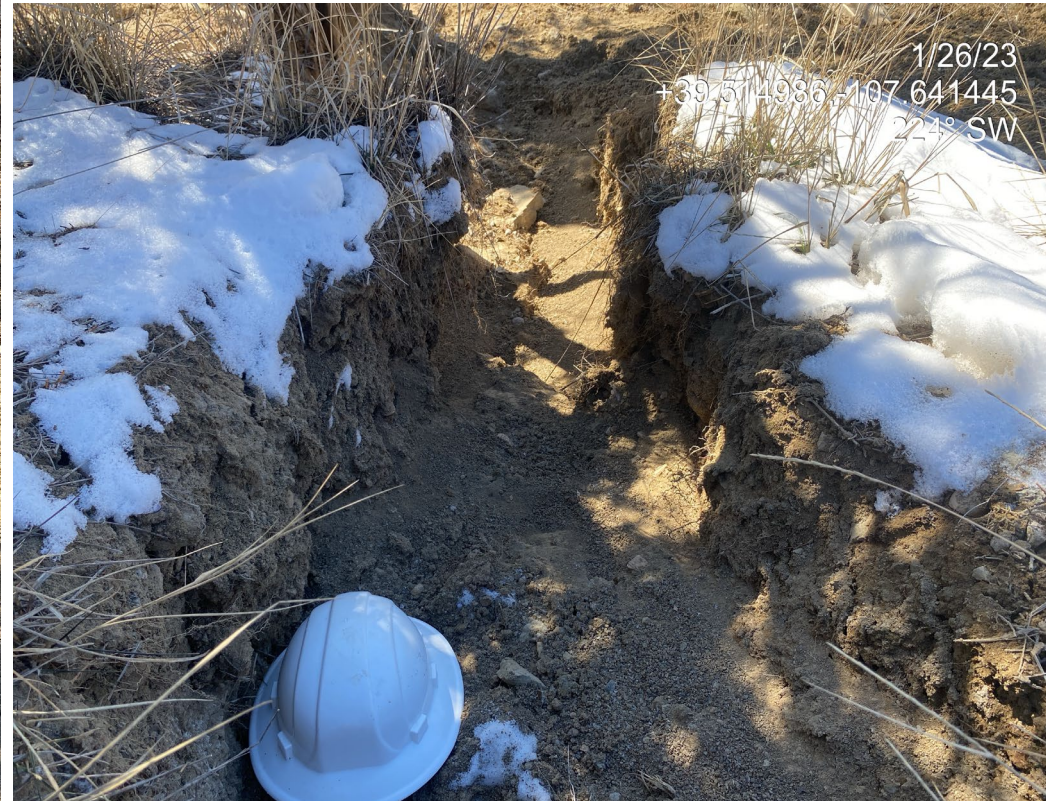
Photo 6. Photos taken to the south of the separators, where the working pad meets the access road shows a large gully.

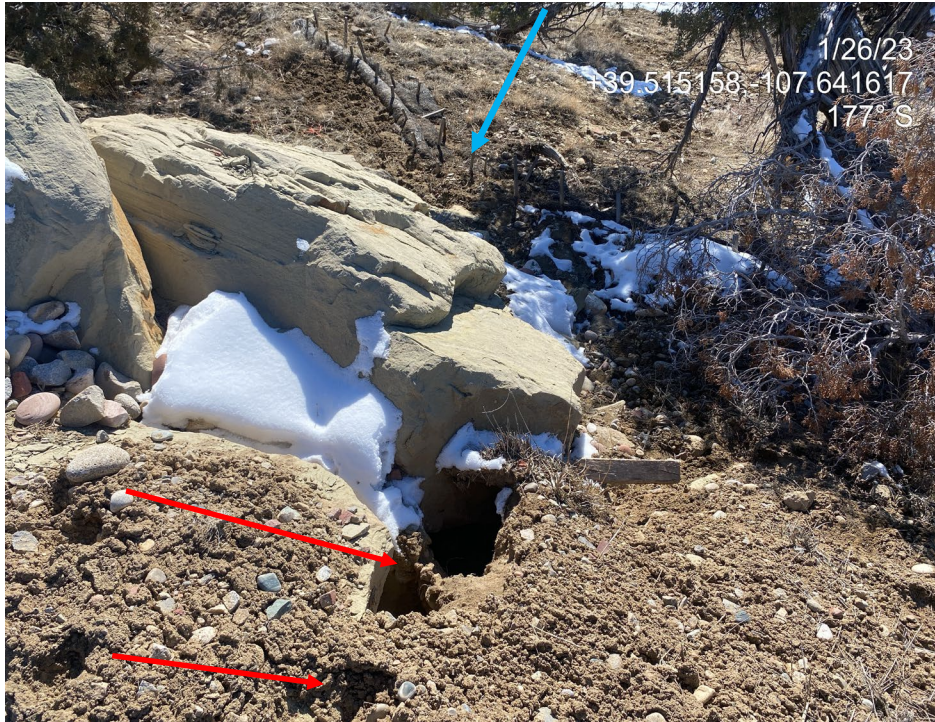
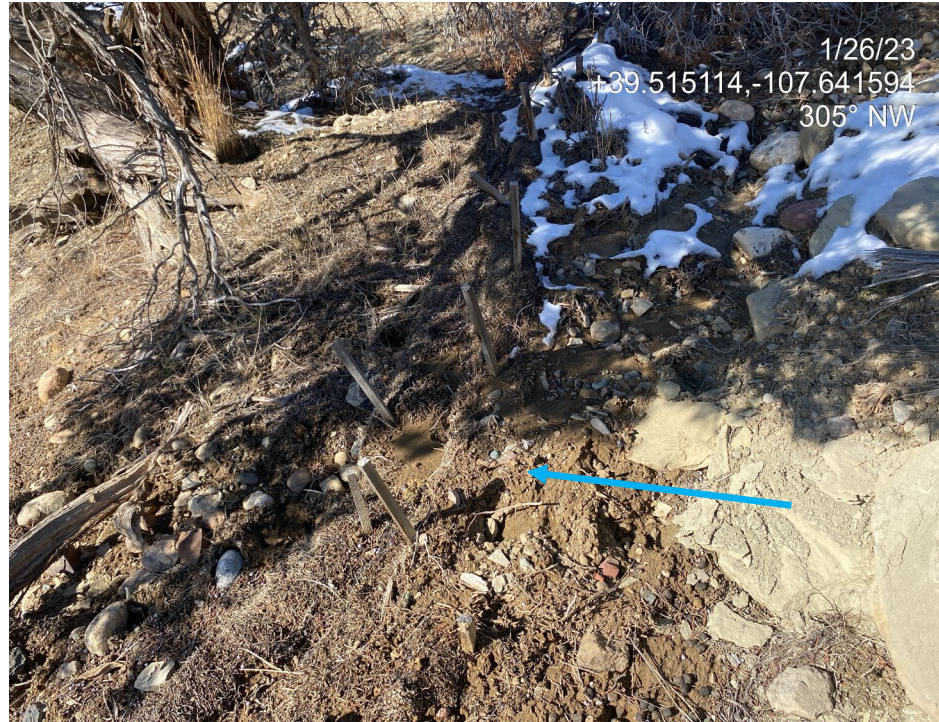
Photo 7. Photos taken from the southern edge of the location shows where stormwater is undermining/cutting beneath rip-rap, armoring the fill slope (left, red arrow). A wattle installed below has been overtopped (blue arrow, right).

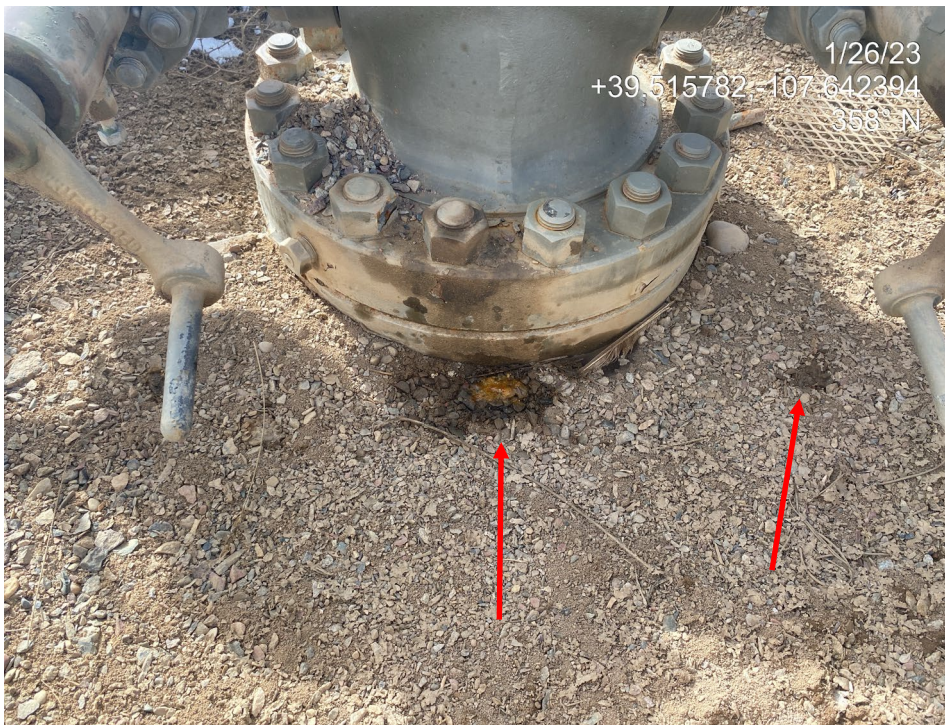
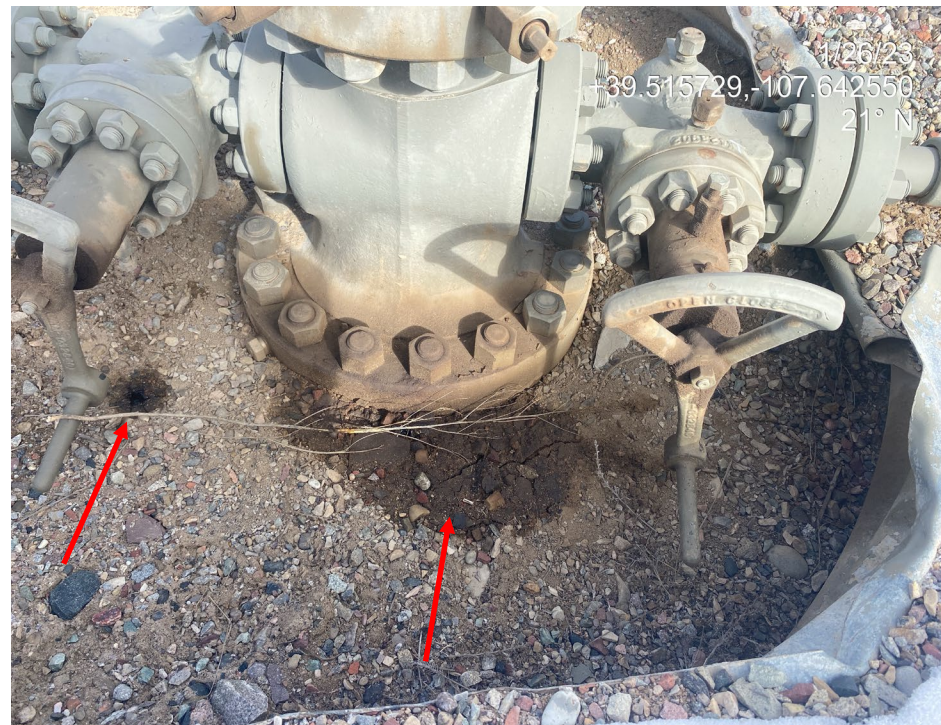
Photo 8. Photos show staining at wellheads.

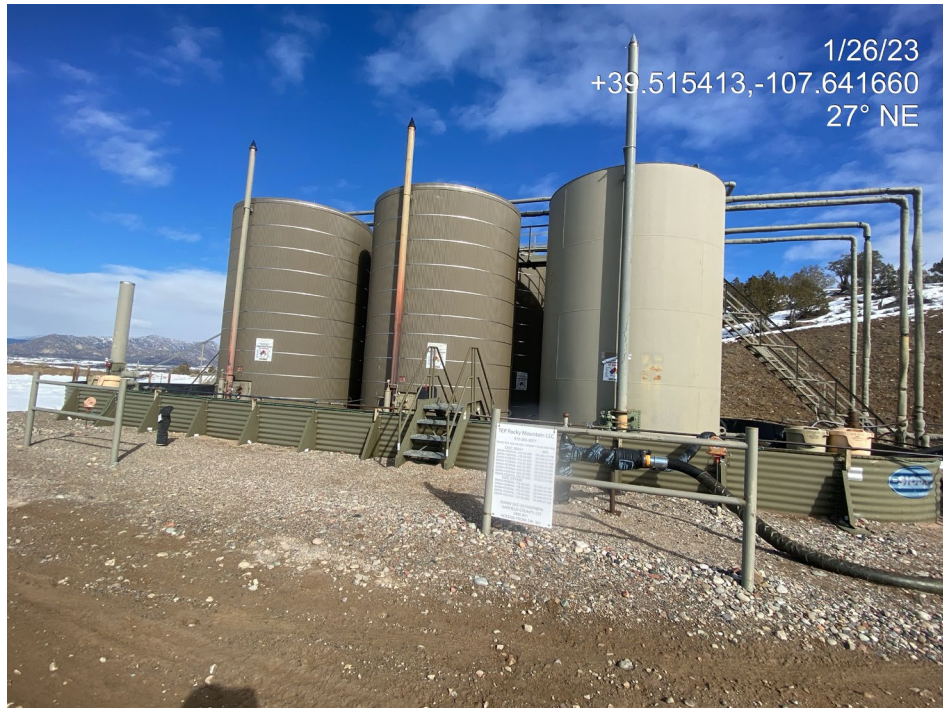
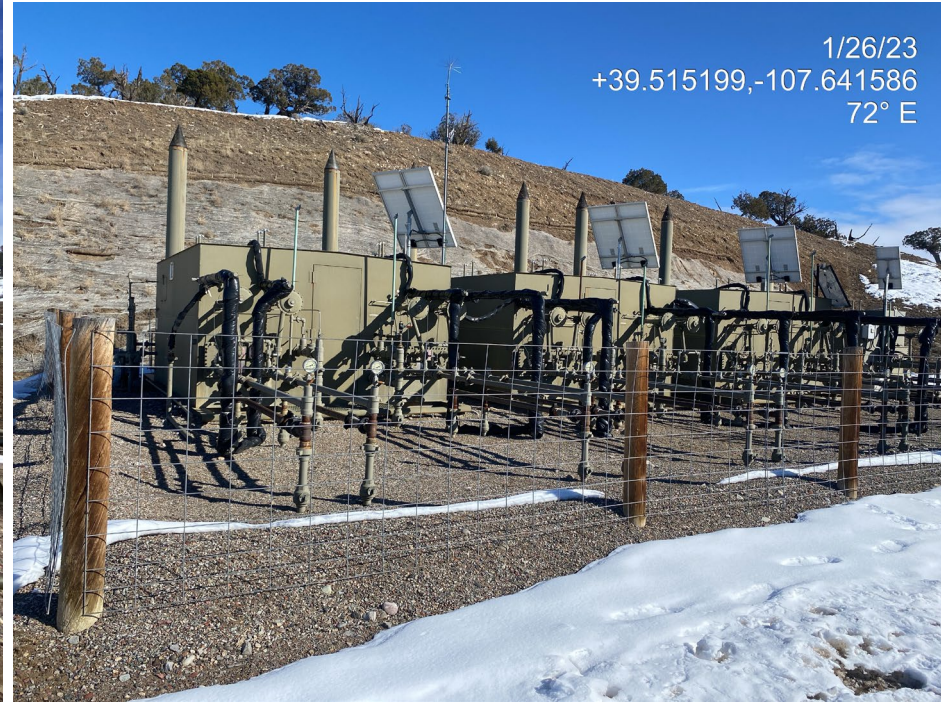
Photo 9. Photos show production areas.

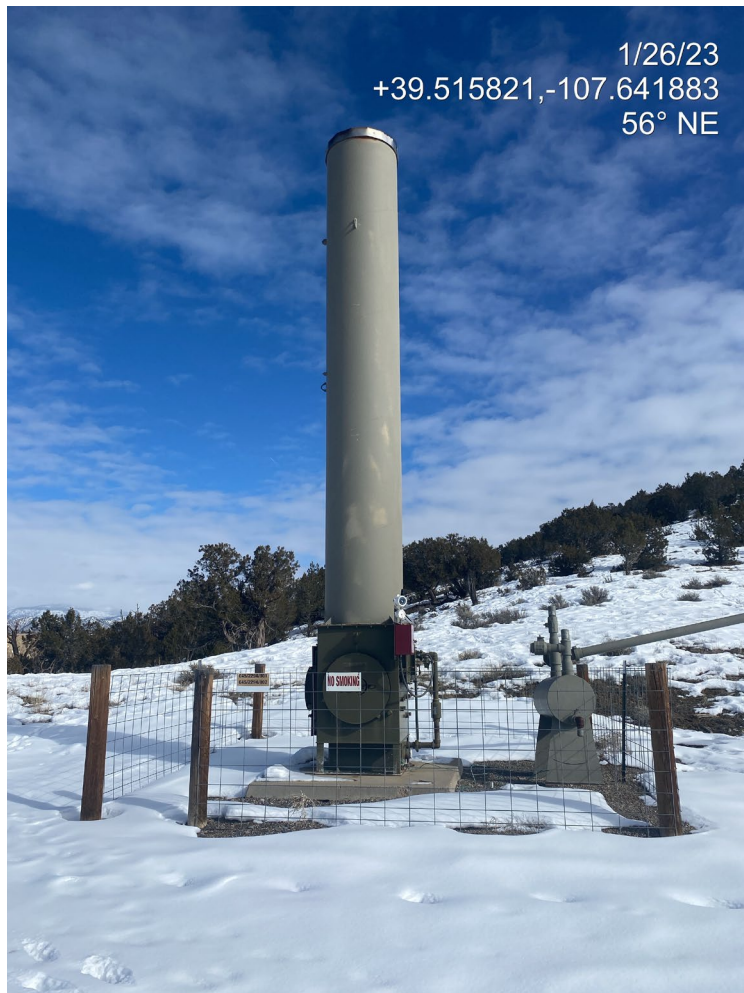
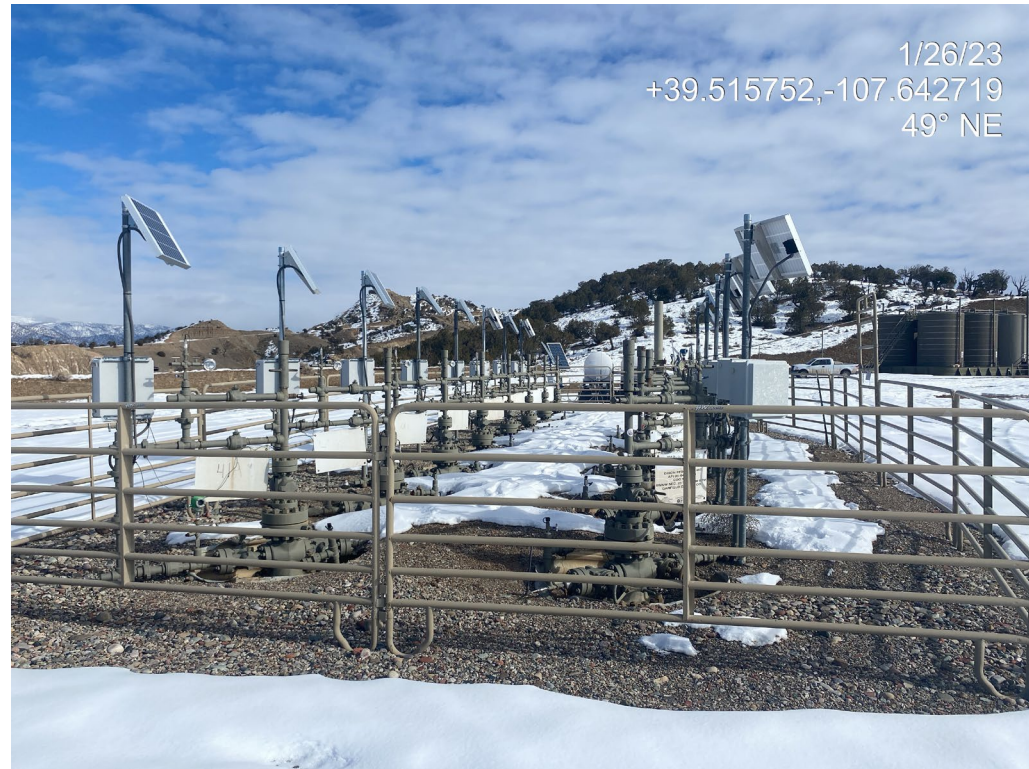
Photo 10. Photos show production areas.

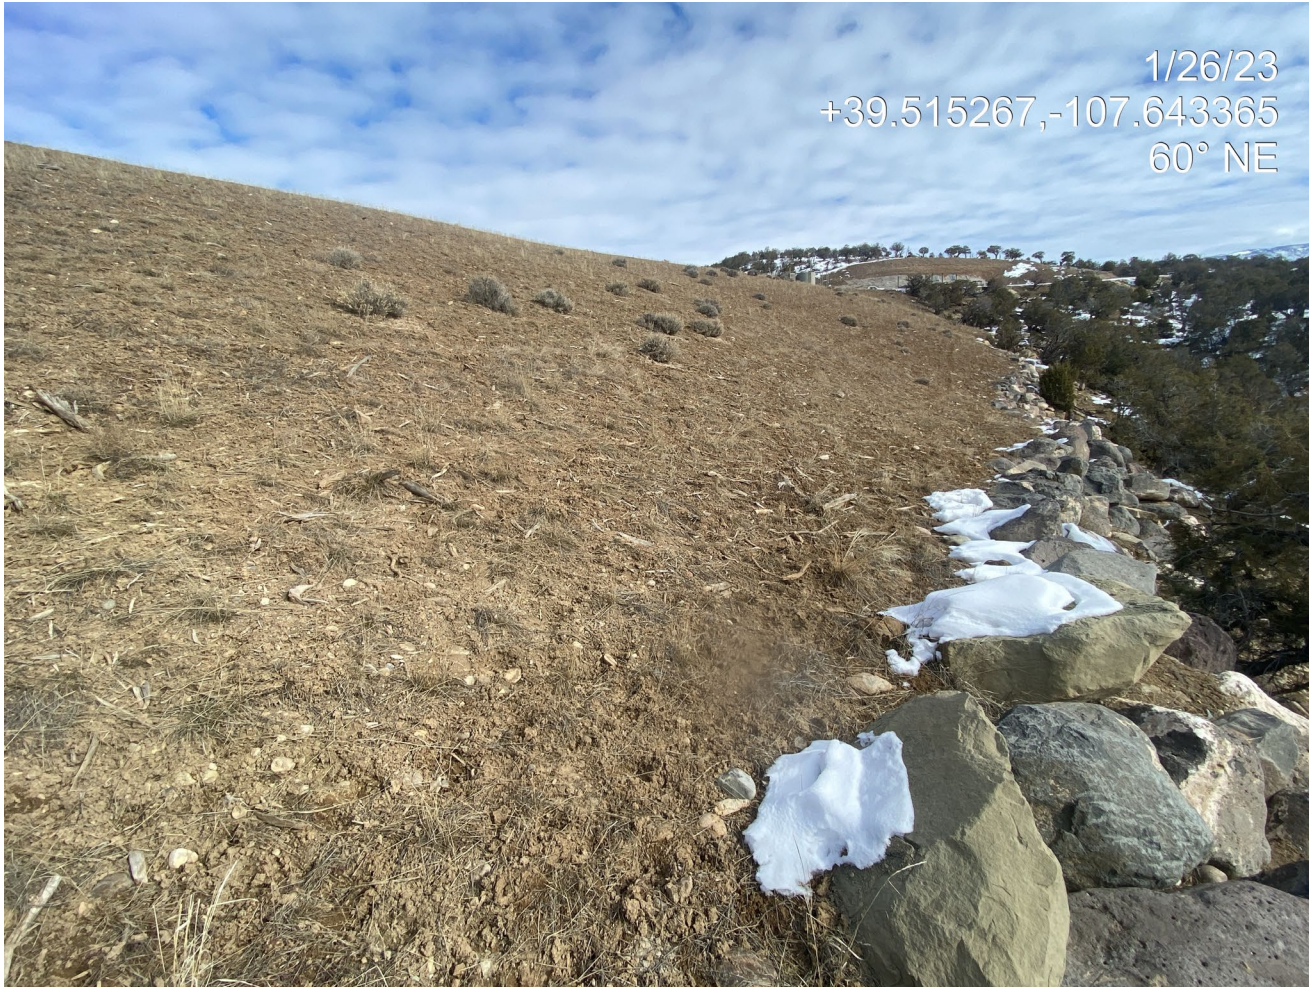
Photo 11. Photo shows the interim area/fill slope at the southwest of the location. The slope appears sparsely vegetated with perennial grasses.
