Construction and Stormwater Inspection

Date: 01/24/2023

Operator: VERDAD RESOURCES LLC - 10651

Inspection Photos
Location Name: Rohn 9-60 14A
Location ID: 457136

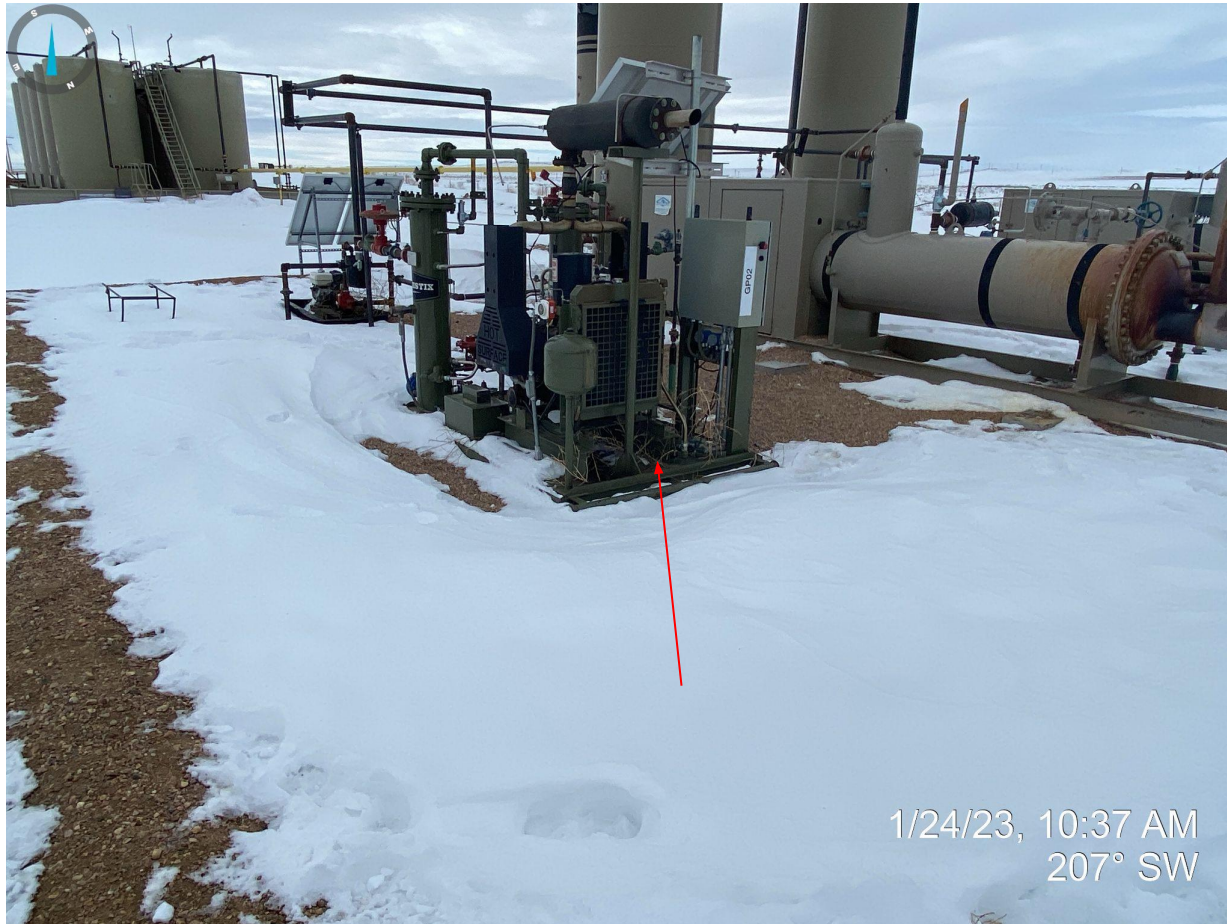
Photo 1. Facing southwest at at production equipment. Photo illustrates tumbleweed accumulations within production equipment.

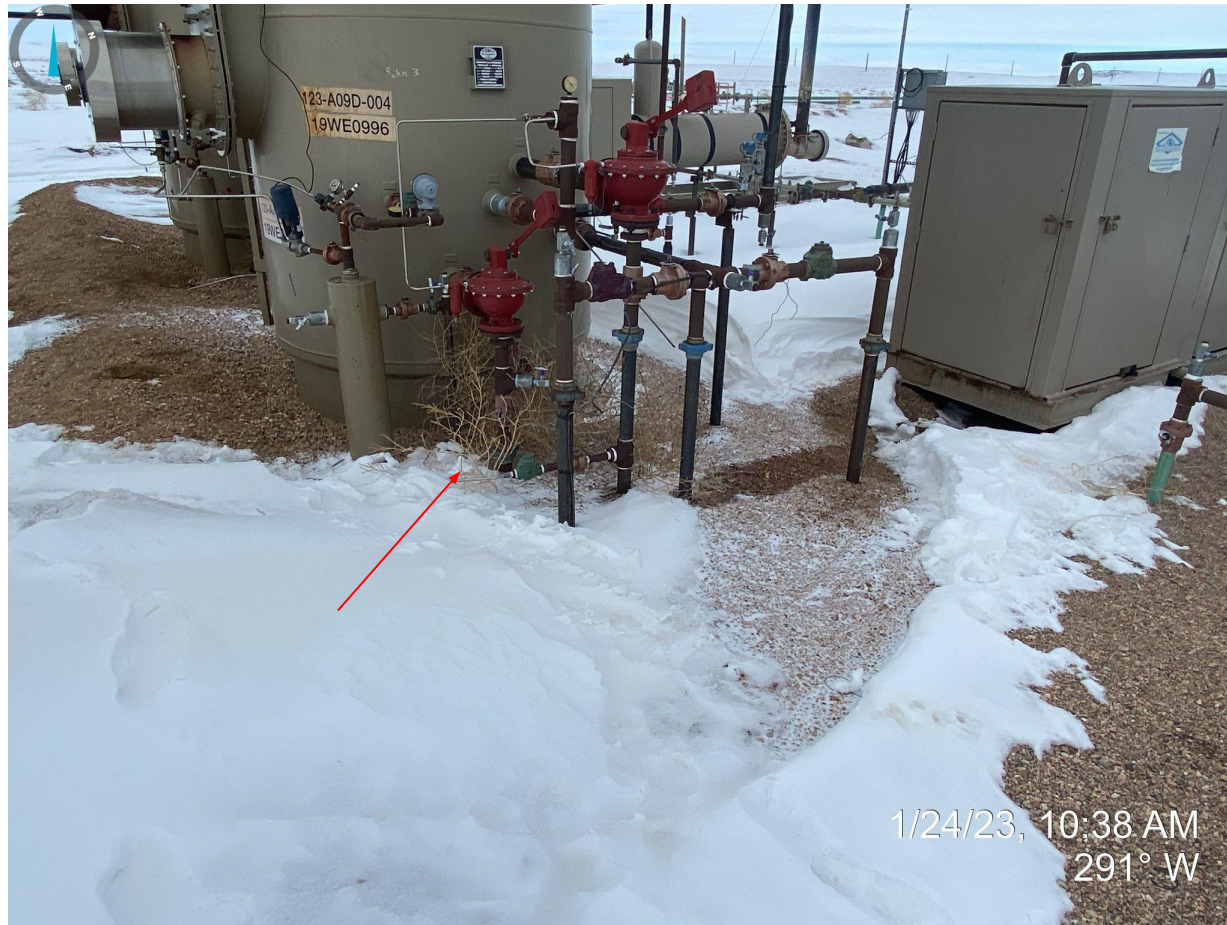
Photo 2. Facing west at production equipment; see comments in Photo 1.

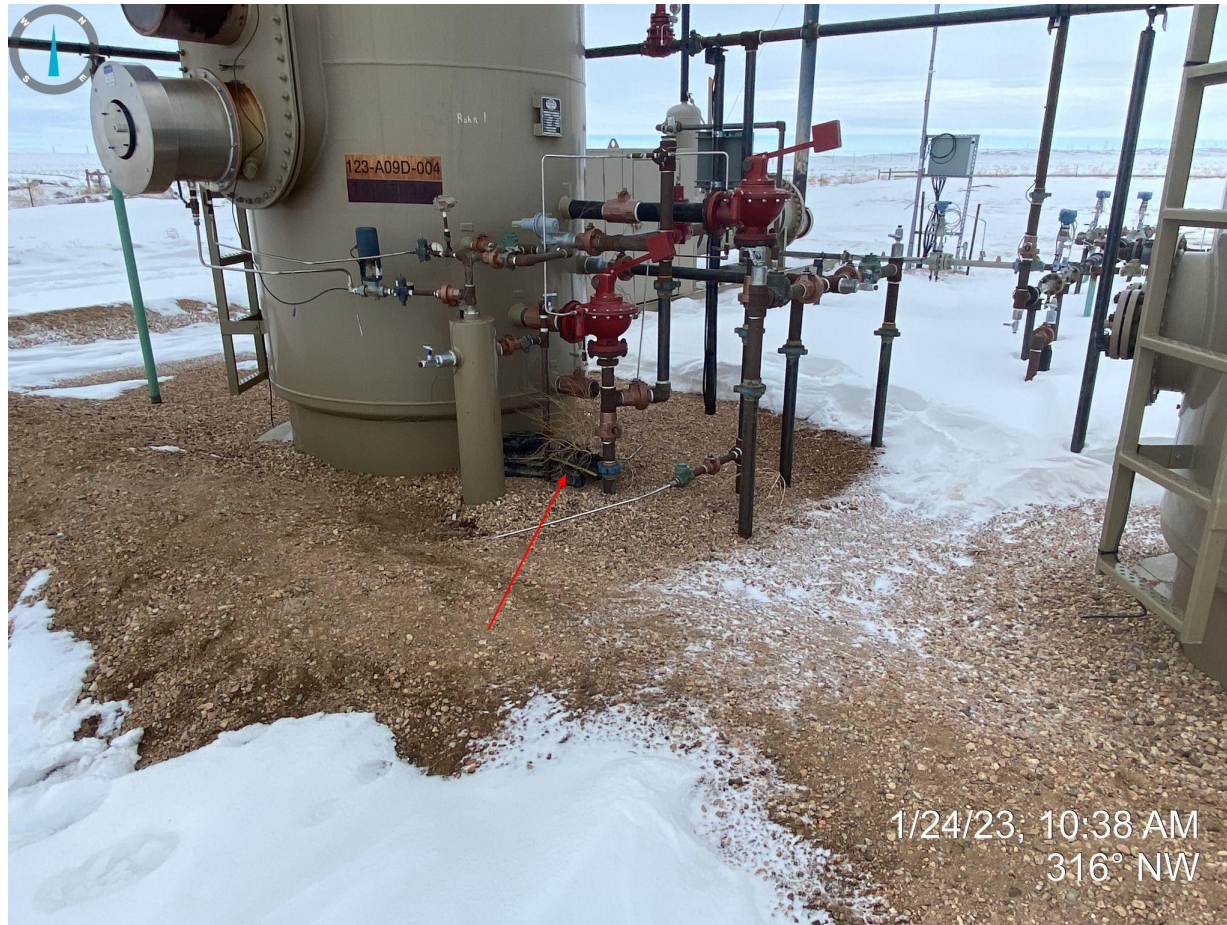
Photo 3. Facing northwest at production equipment; see comments in Photo 1.

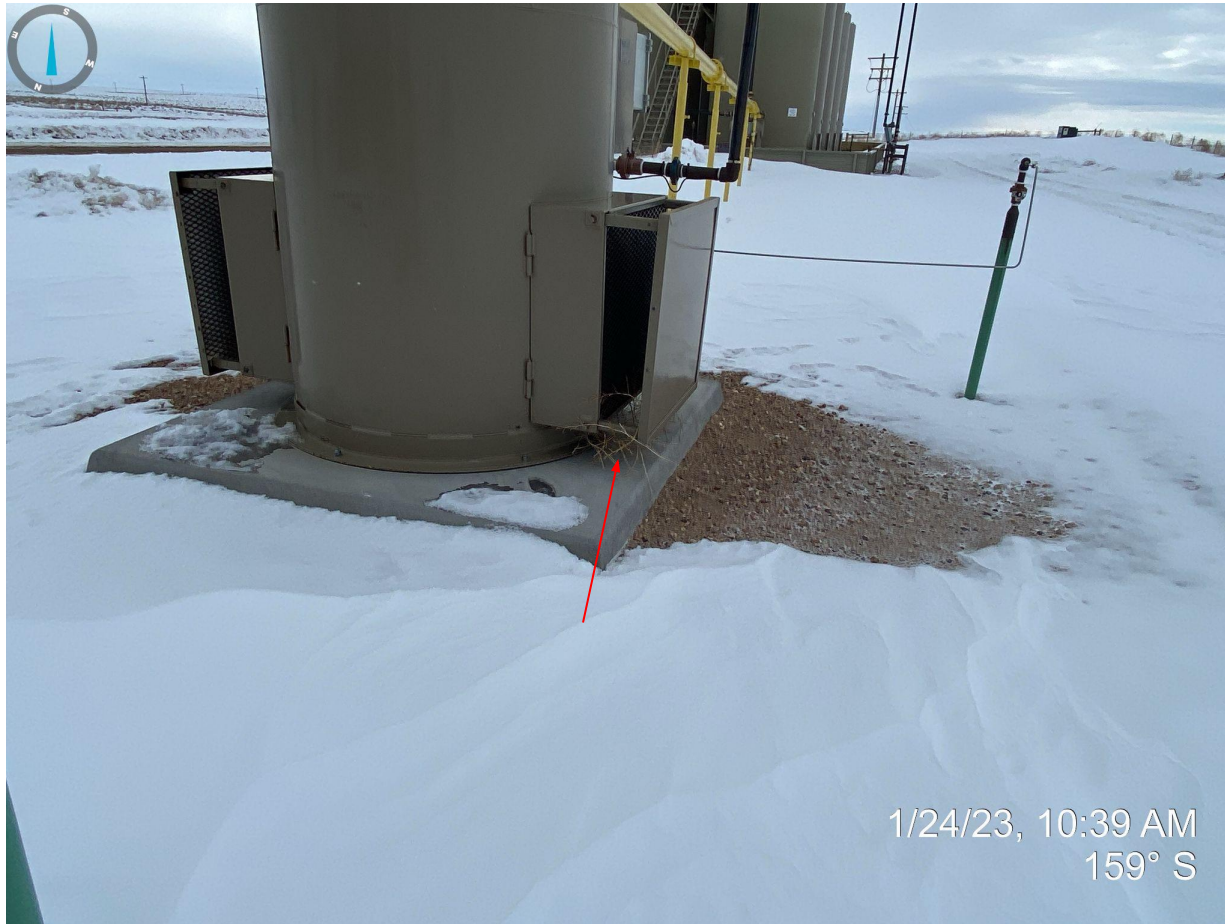
Photo 4. Facing south at production equipment; see comments in Photo 1.

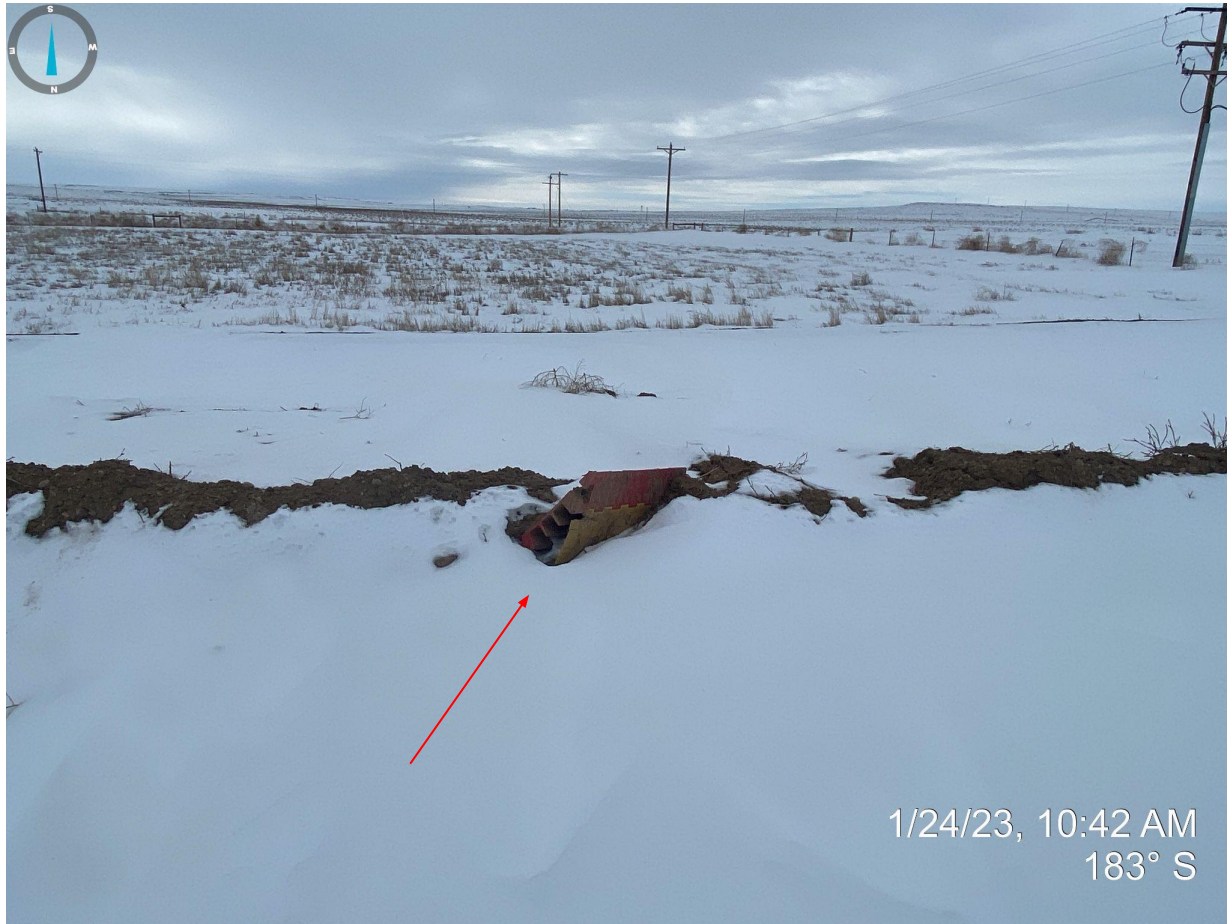
Photo 5. Facing south near the southern portion of the location. Partially buried debris observed on location.

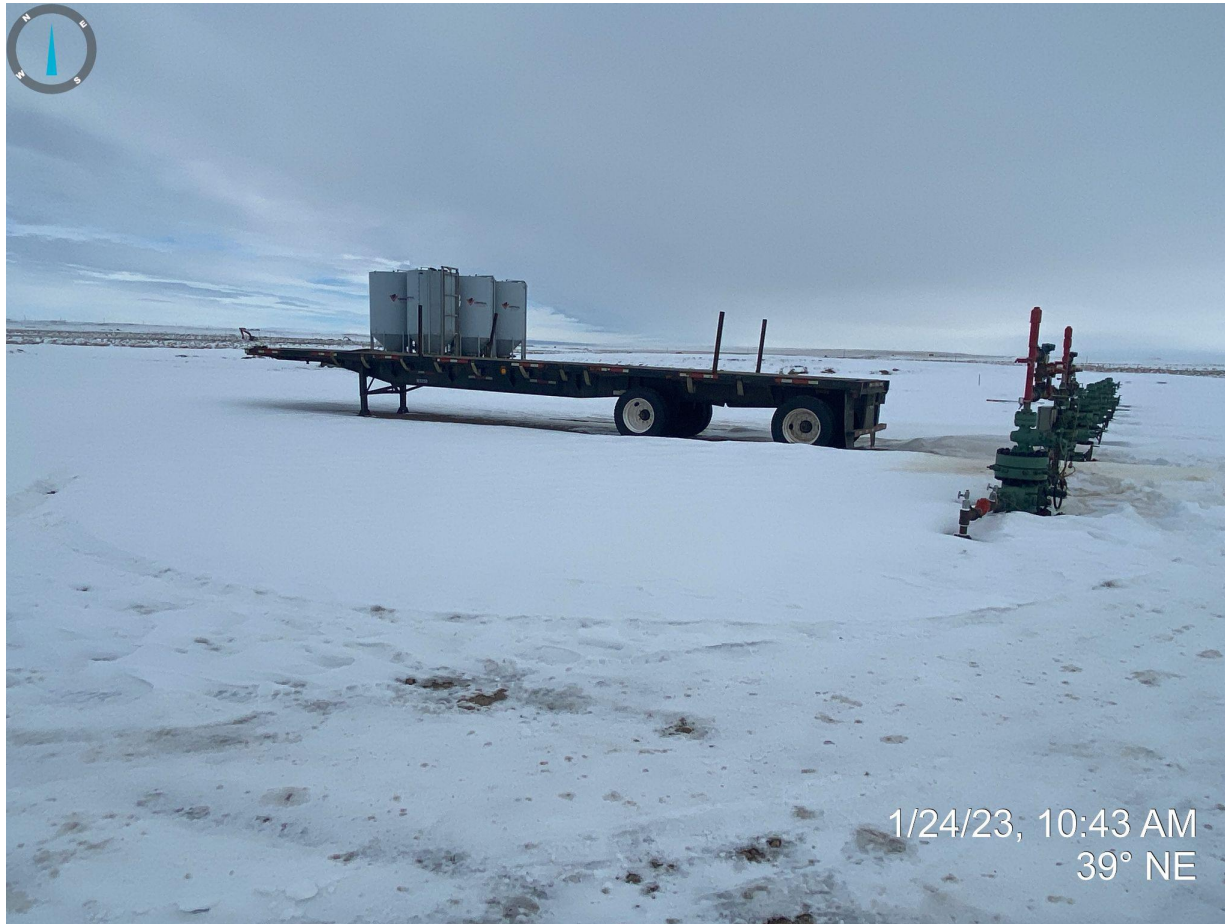
Photo 6. Facing northeast near wellheads. Photo illustrates flatbed trailer being stored on location; this is considered unused equipment and needs to be removed.

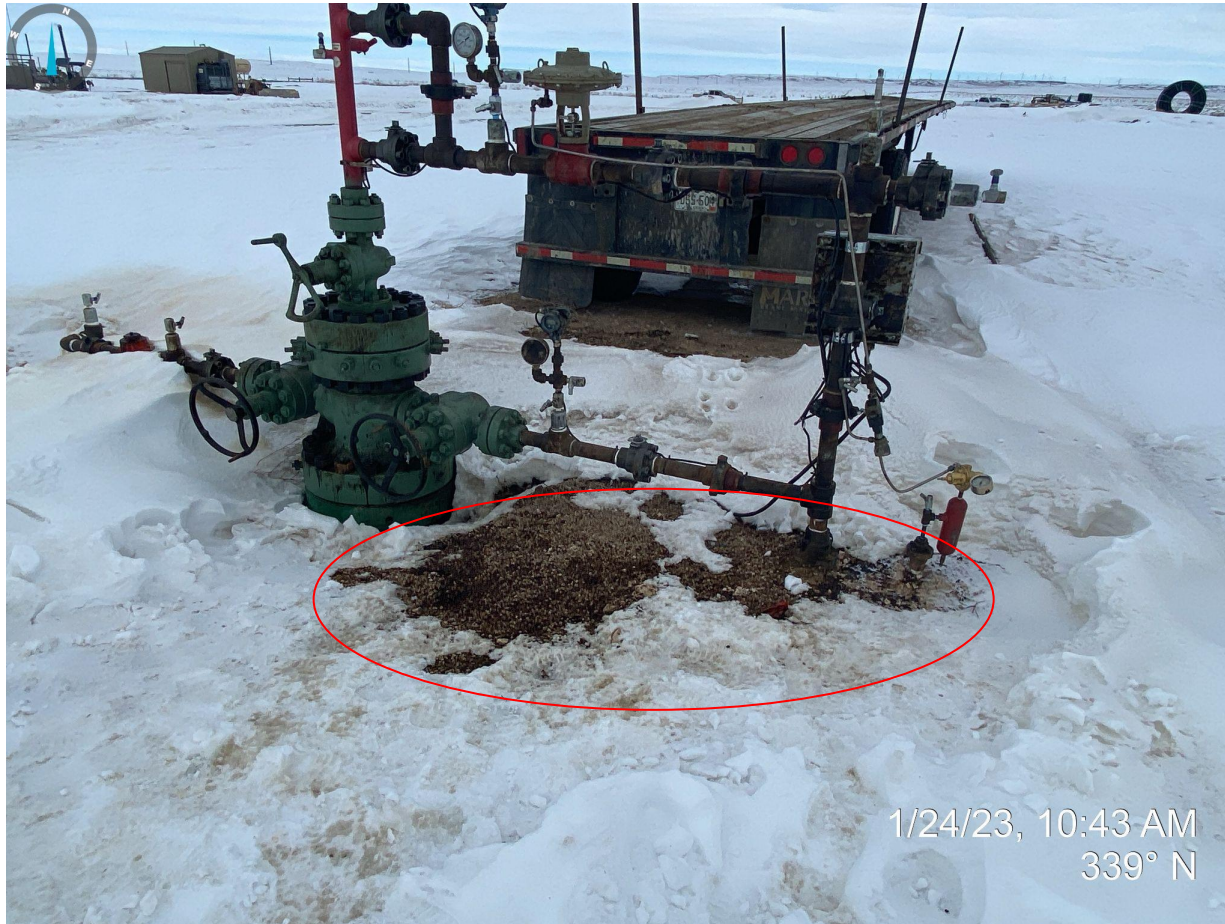
Photo 7. Facing north near the wellhead. Oil stained soil was observed near the wellhead that needs to be properly cleaned up and removed.

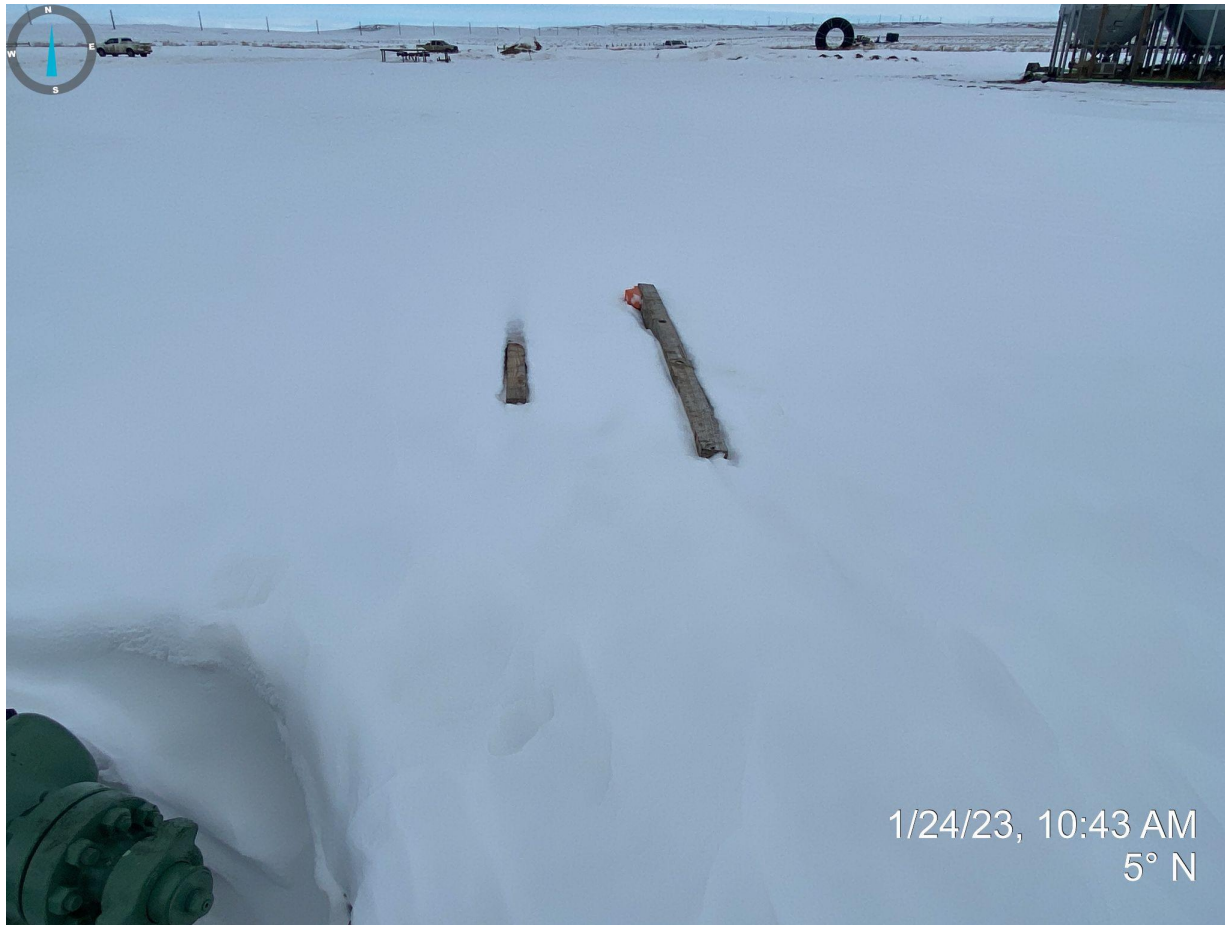
Photo 8. Facing north near the wellheads. Debris (e.g. wood) observed on location and needs to be removed.

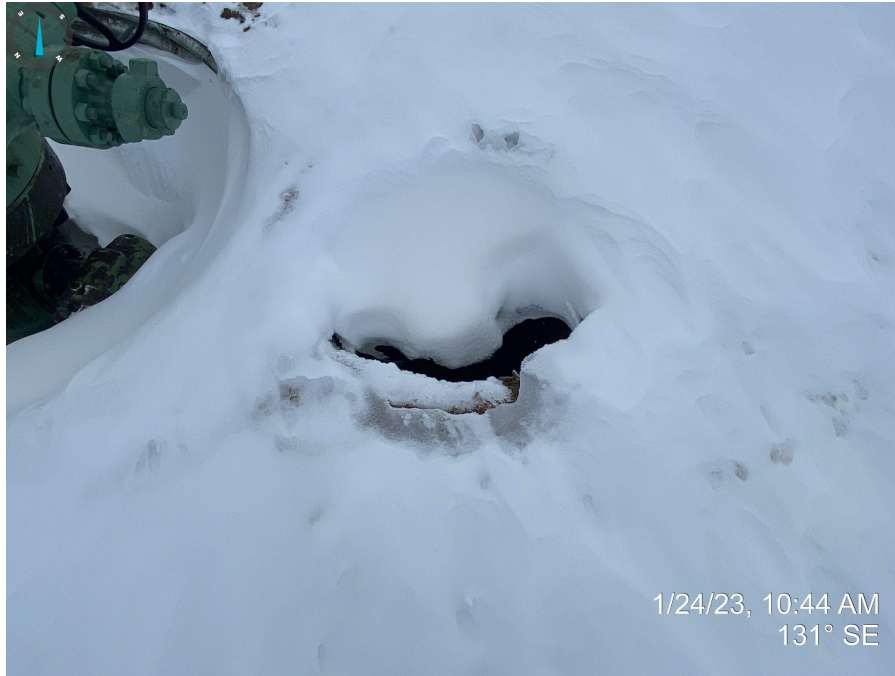
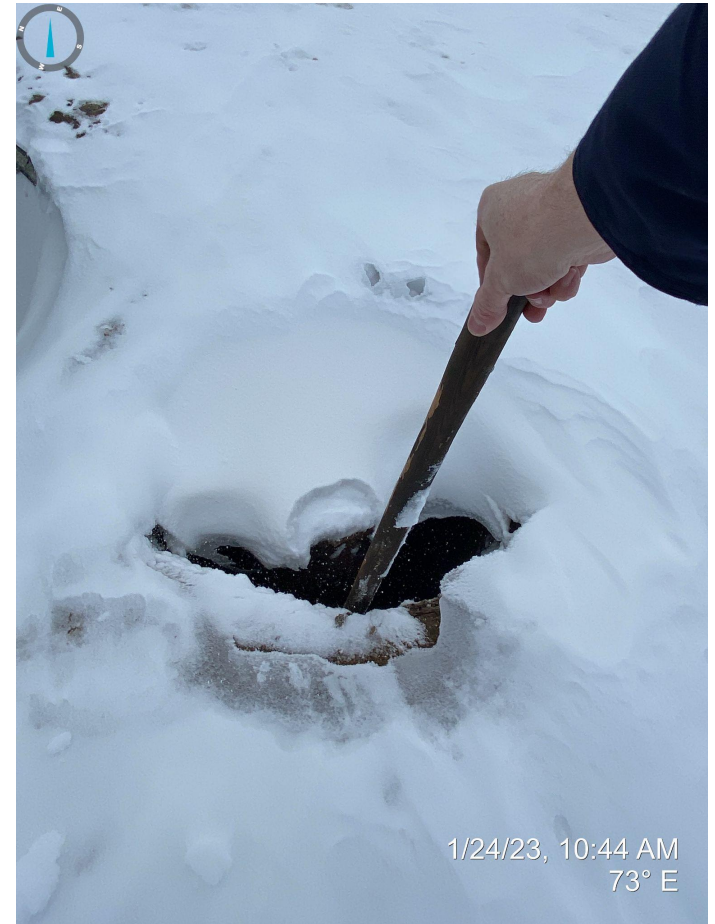
Photos 9 & 10. Close up photo near Well API #123-47788 illustrating an unmarked opening/excavation near the wellhead. Staff was able to stick a 4.5' shovel into the opening without touching the bottom and did not observe any signs/fence/covers to indicate an open excavation was present.

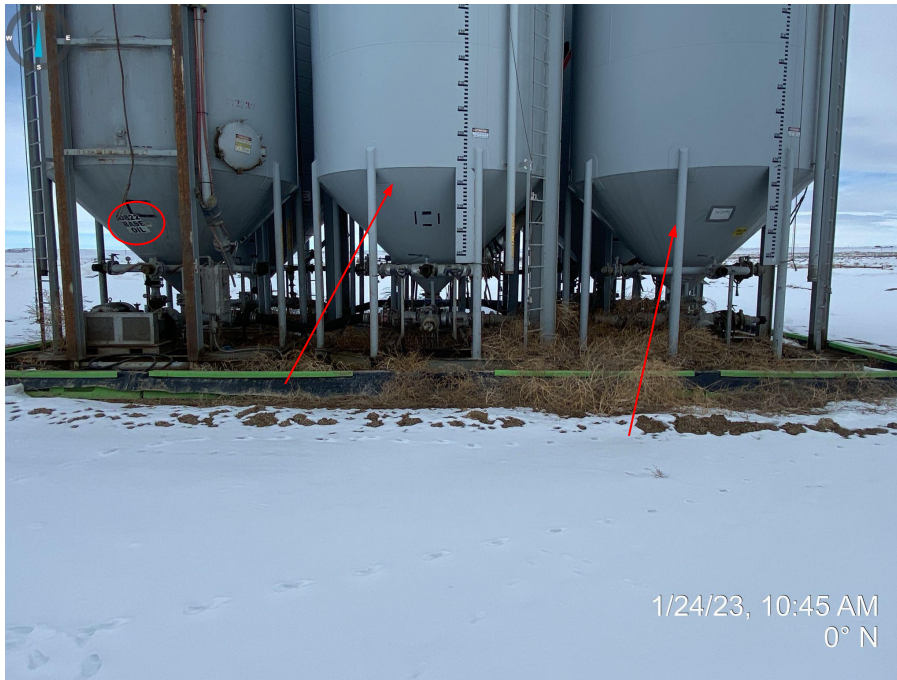
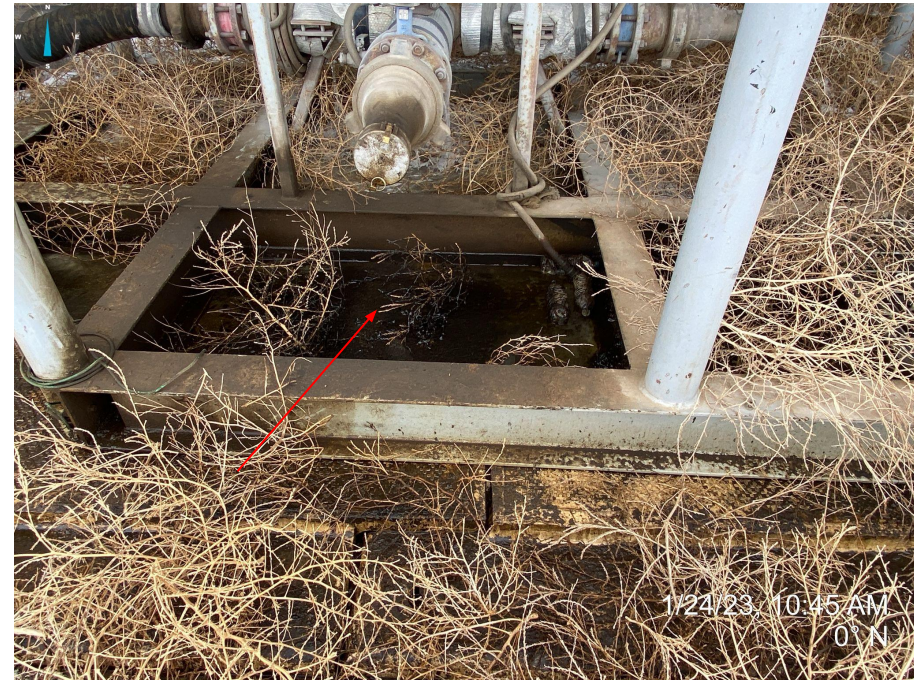
Photos 11 & 12. Facing north near the center/northeastern portion of the location. Photos illustrate accumulation of tumbleweeds within equipment that are now considered debris and need to be removed. Additionally, the tanks do not have adequate labels as no NFPA placards or content labels were observed (with the exception of one content label on the left side in photo 11). Unknown material was also observed around the tank opening (Photo 12) that needs to be properly cleaned up.

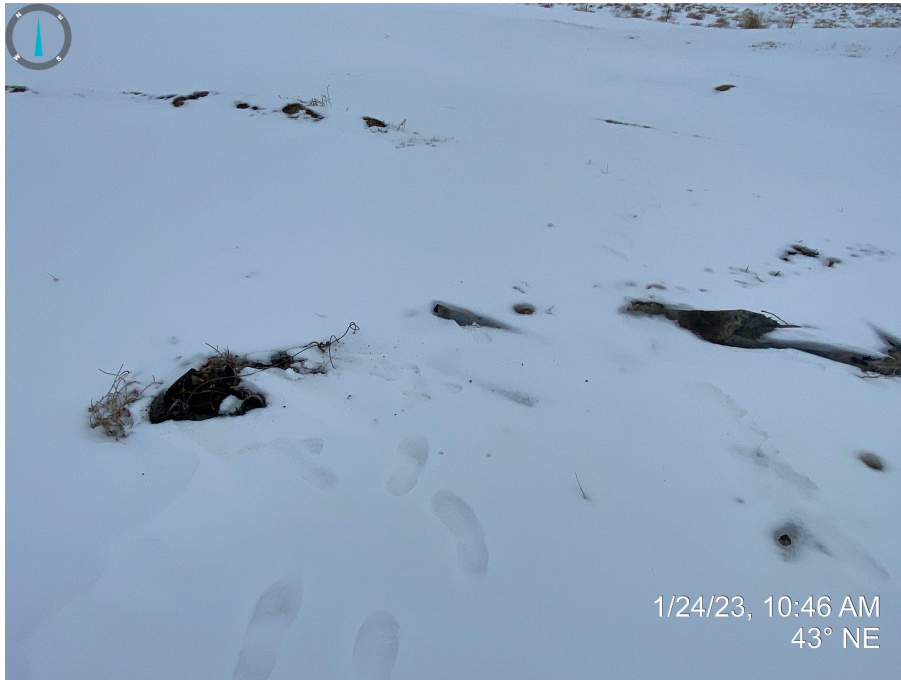
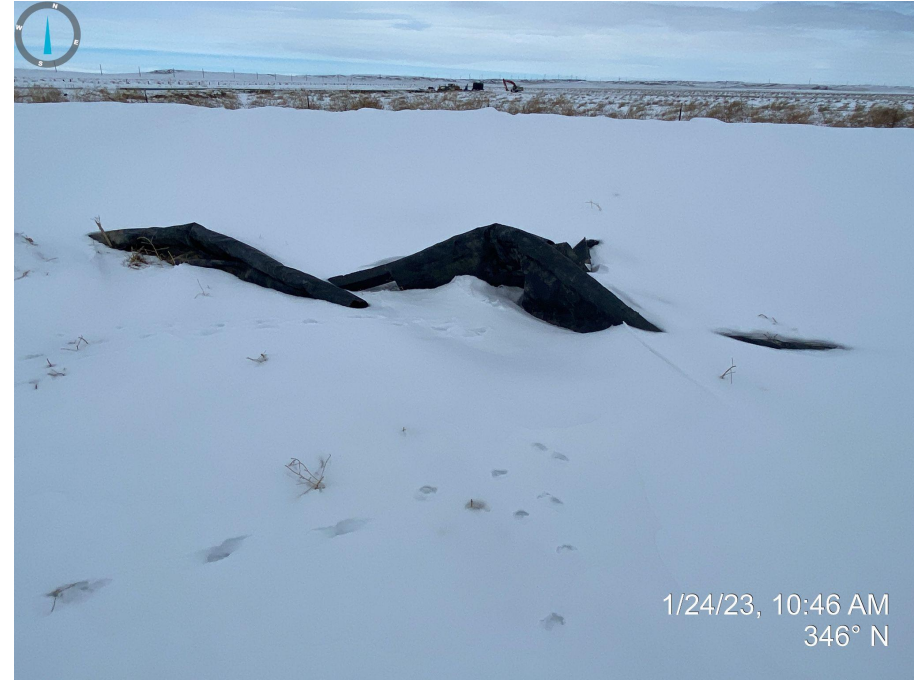
Photos 13 & 14. Facing northeast and north from the northeast corner of the location. Debris was observed partially buried in snow and will need to be removed.

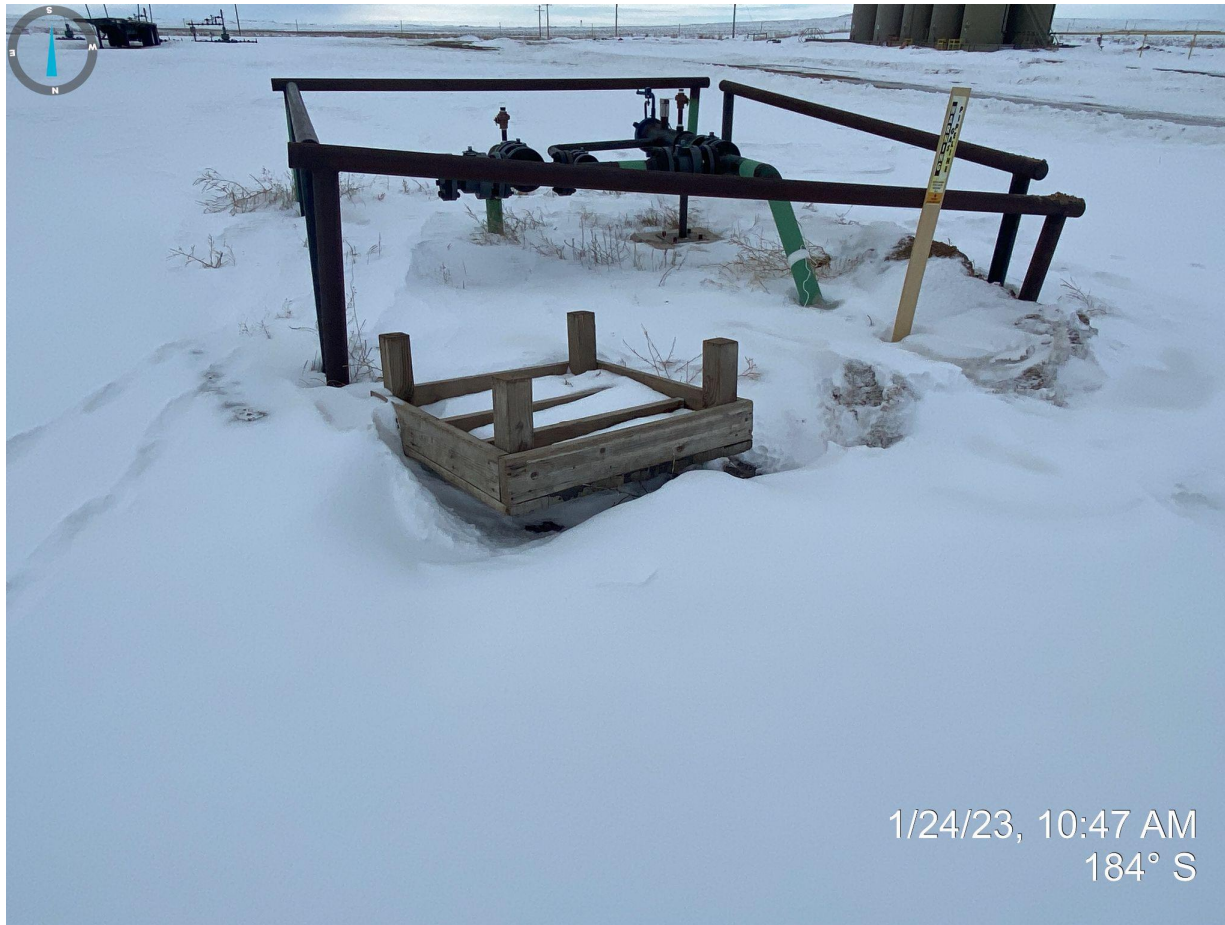
Photo 15. Facing south near the locations entrance; see comments in Photos 13 & 14.

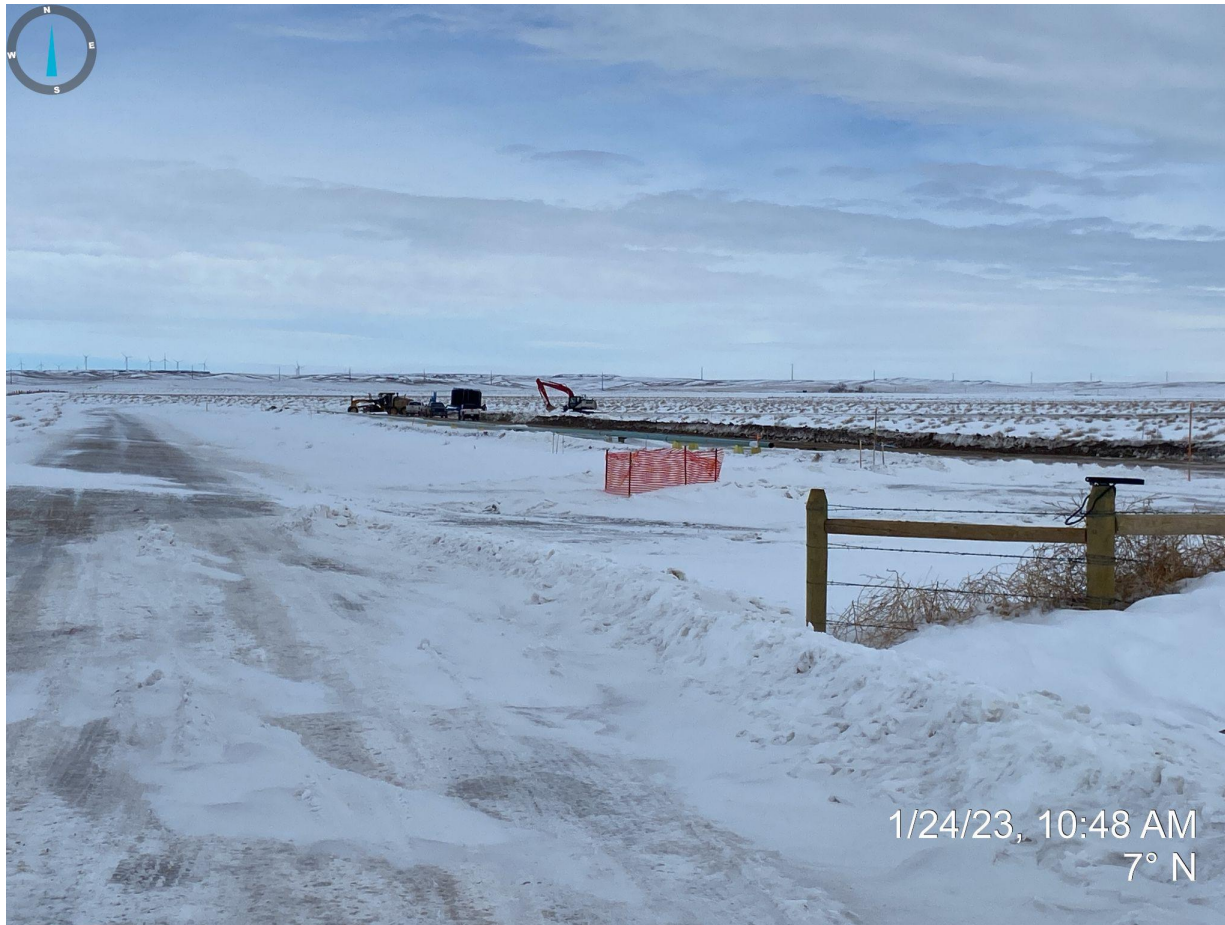
Photo 16. Facing north from the location's entrance. Photo illustrates pipeline construction beginning; crews were on site clearing snow and staging materials and equipment during this inspection.

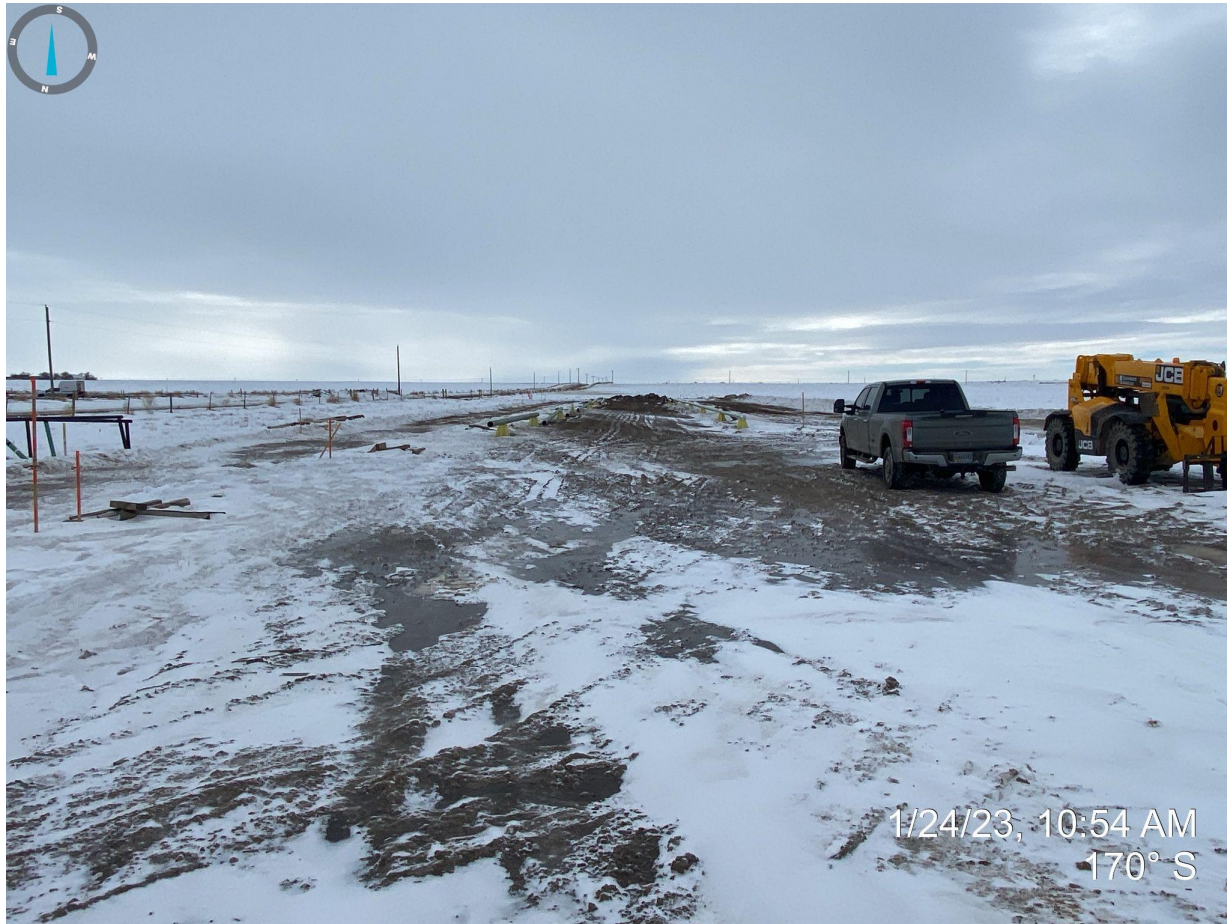
Photo 17. Facing south near county road entrance to the location; see comments in Photo 16.

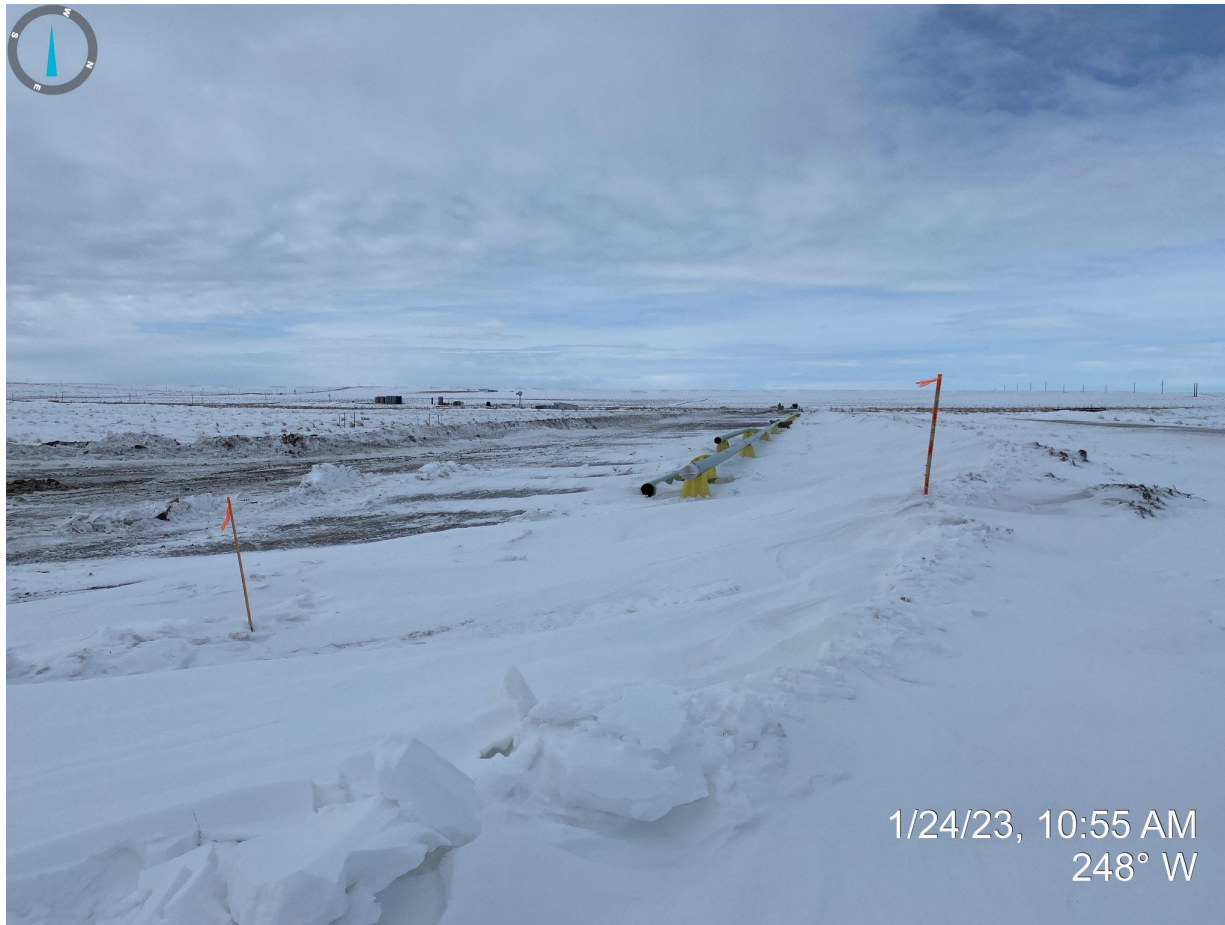
Photo 18. Facing west; see comments in Photo 16.
