Interim Reclamation and Stormwater Inspection

Date: 02/10/2023

Operator: CIVITAS NORTH LLC - 10661

Location Name: Boomslang Fed 8-60 14A

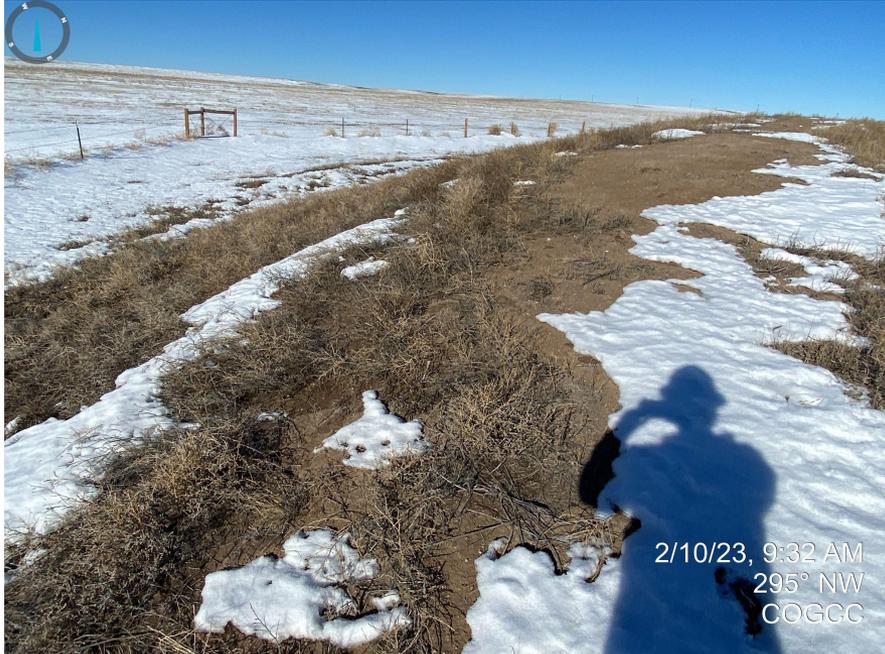
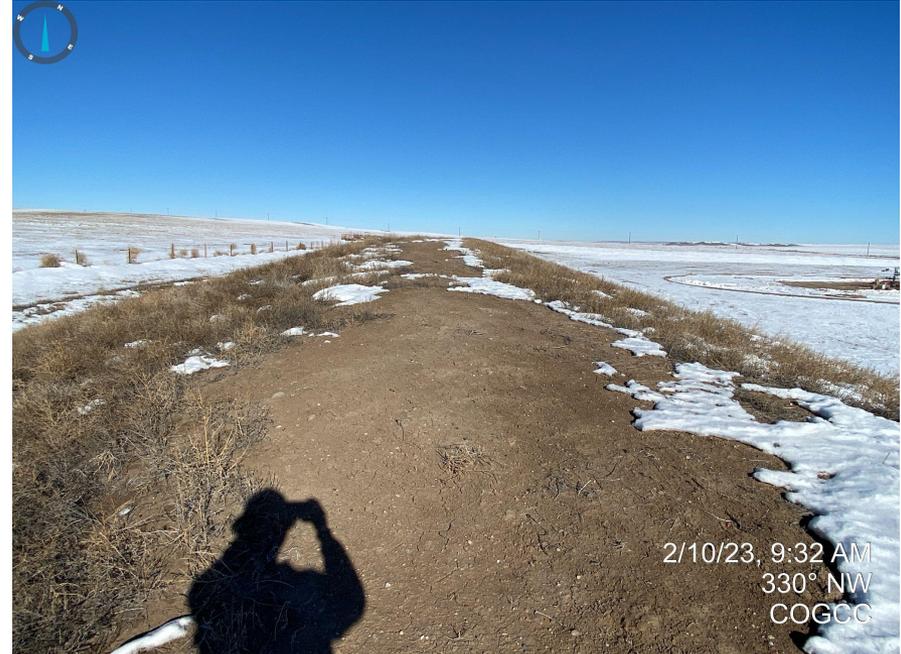
Photos 1 & 2. Facing northwest from the topsoil stockpile. Photos illustrate evidence of bare soil and undesirable vegetation (e.g. kochia and russian thistle).

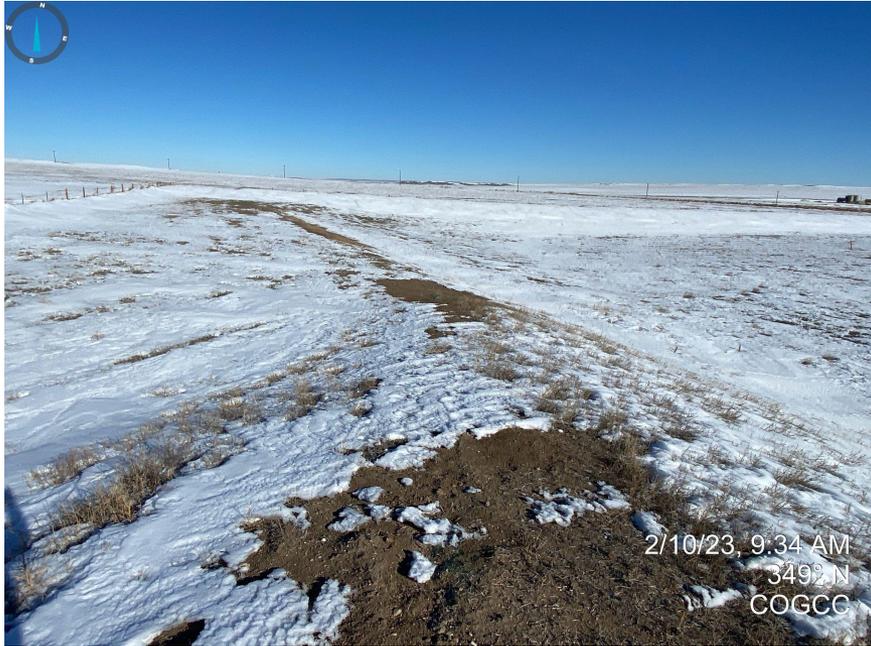
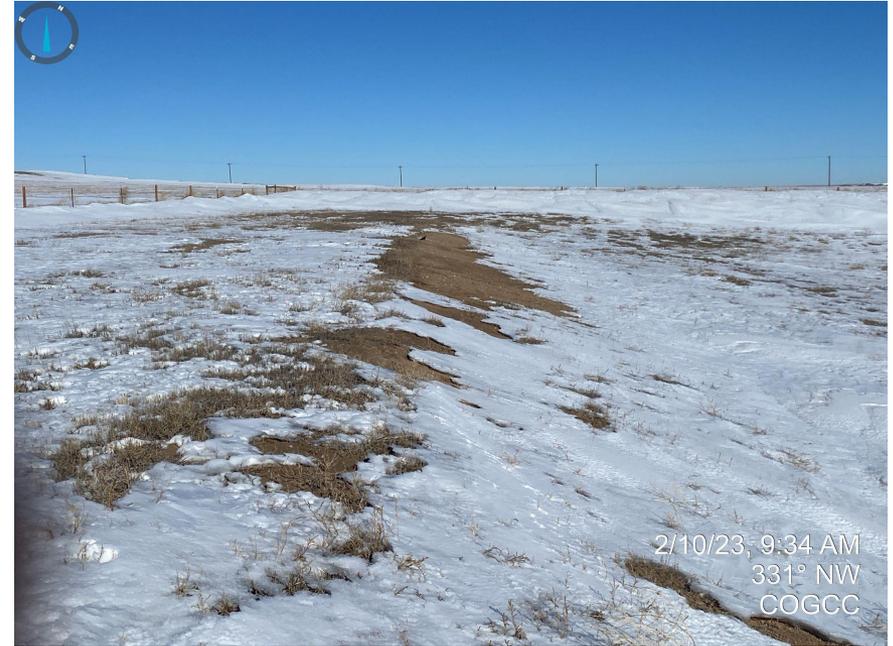
Photos 3 & 4. Facing north and northwest towards interim areas. Evidence of bare soil within the interim area.

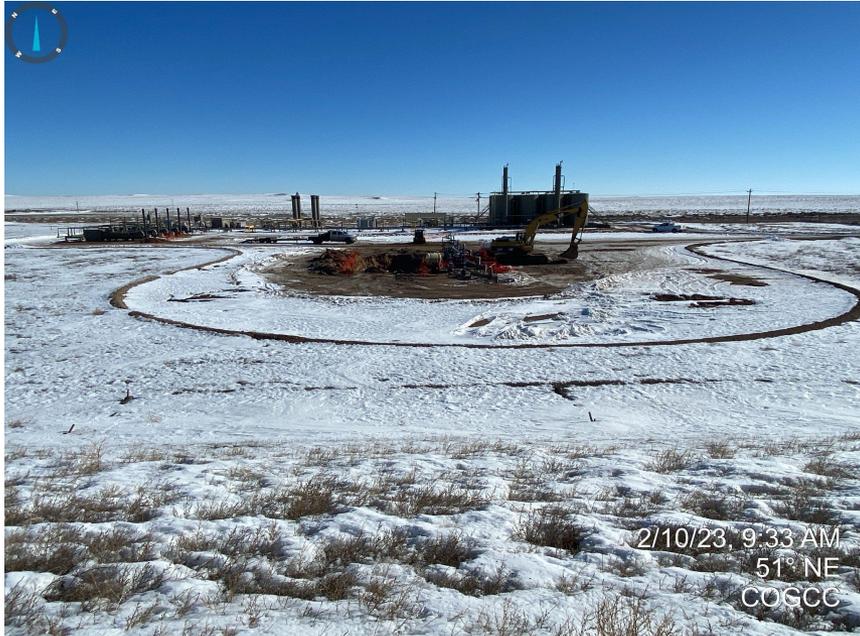
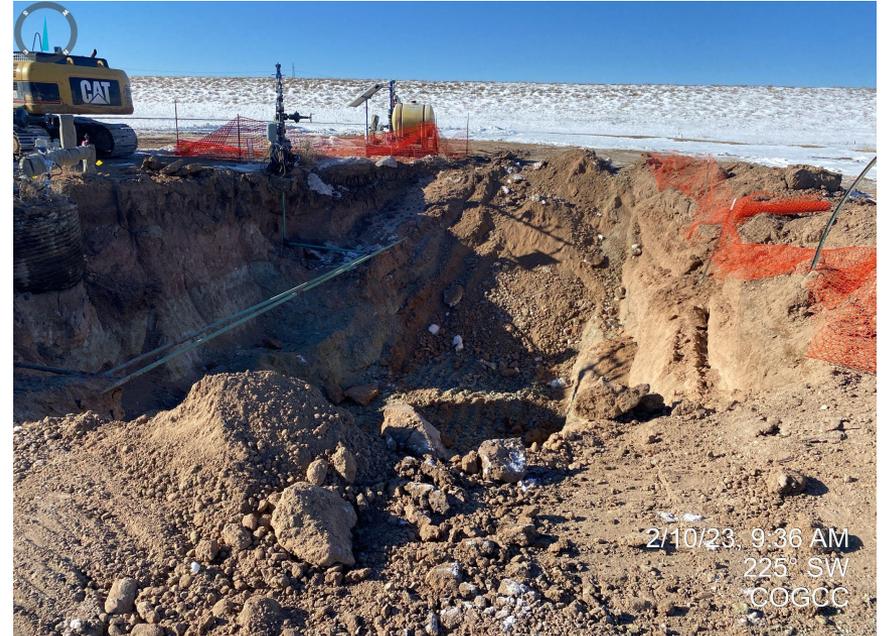
Photos 5 & 6. Facing northeast and southwest at open excavation. Crews were on site and reminded to put fence up when left unattended.

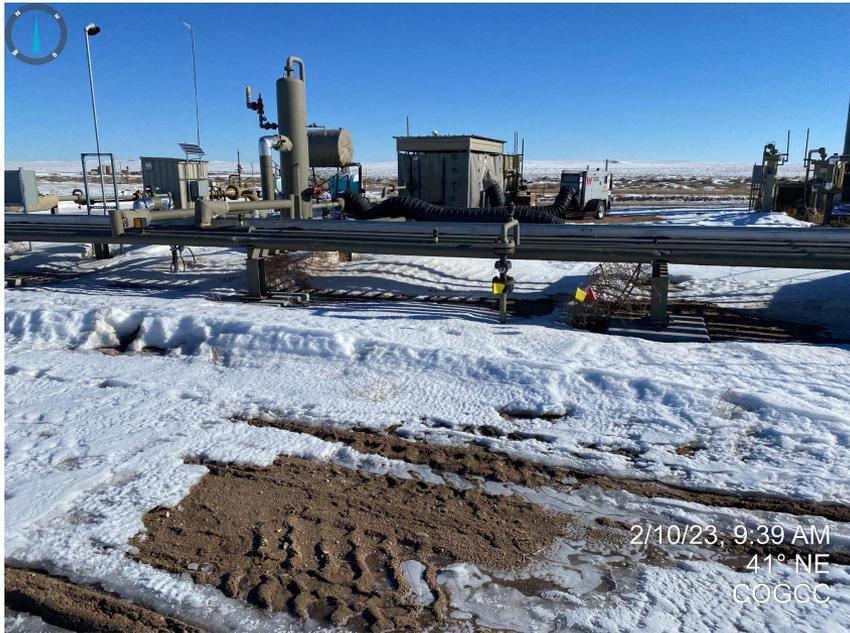
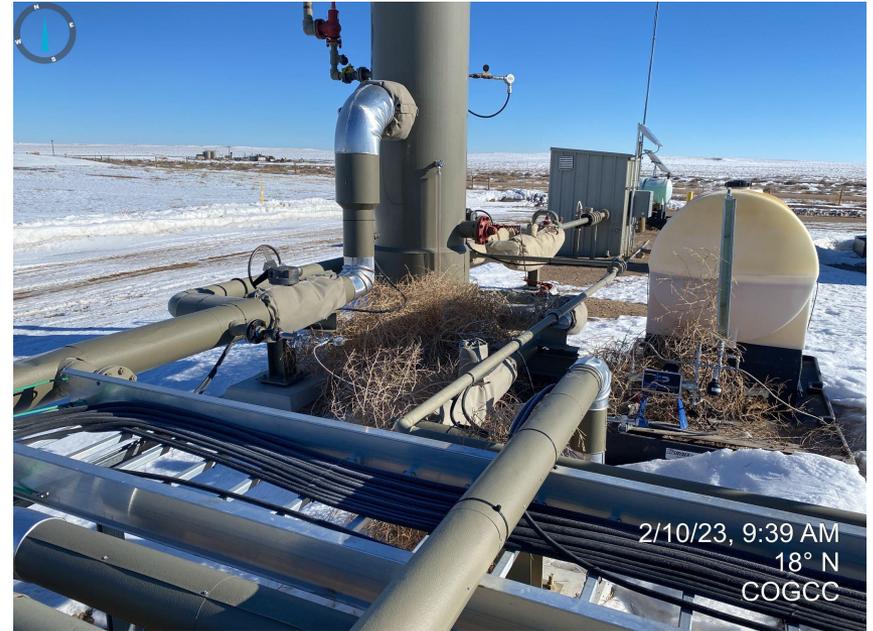
Photos 7 & 8. Tumbleweed accumulations were observed throughout the location and within equipment. This is now considered debris and needs to be removed.

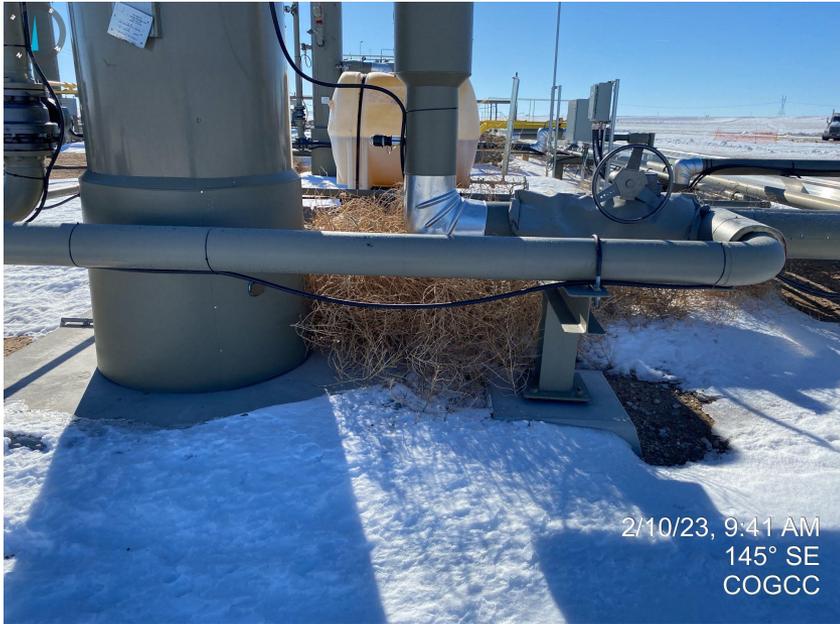
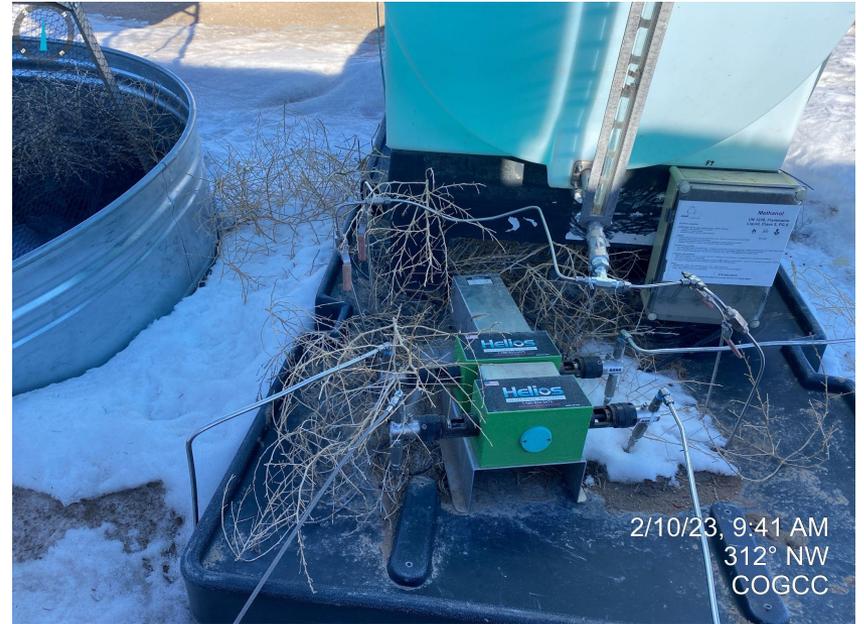
Photos 9 & 10. See comments in Photos 7 & 8.

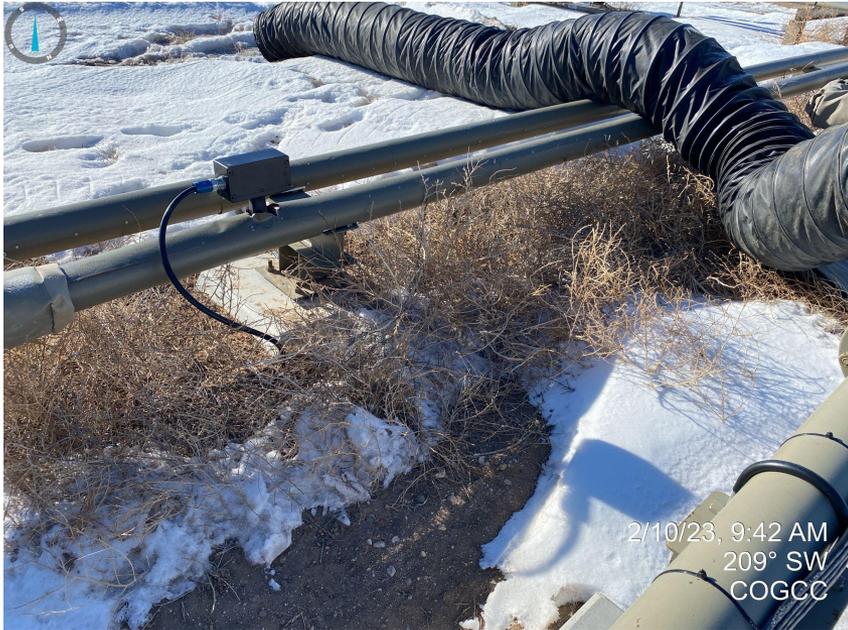
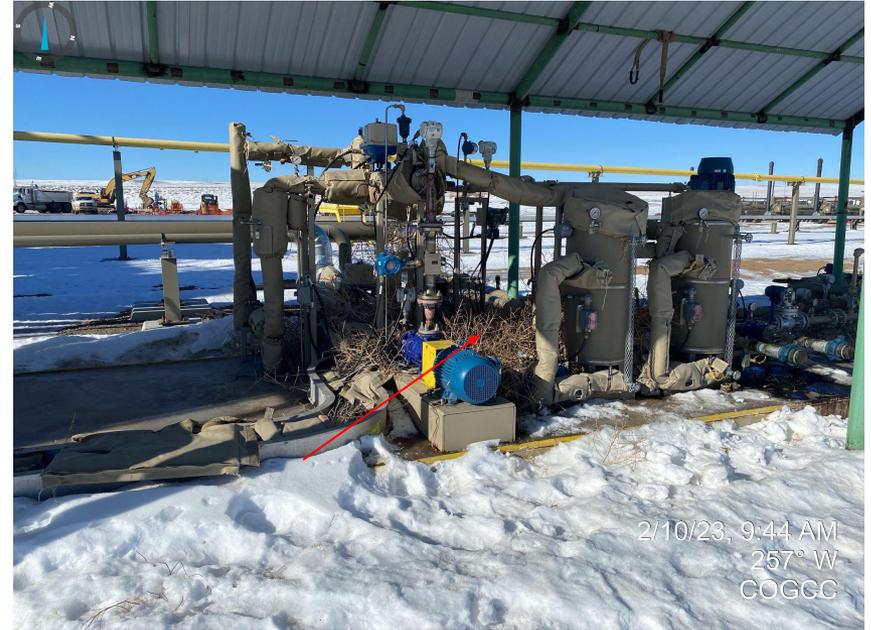
Photos 11 & 12. See comments in Photos 7 & 8.

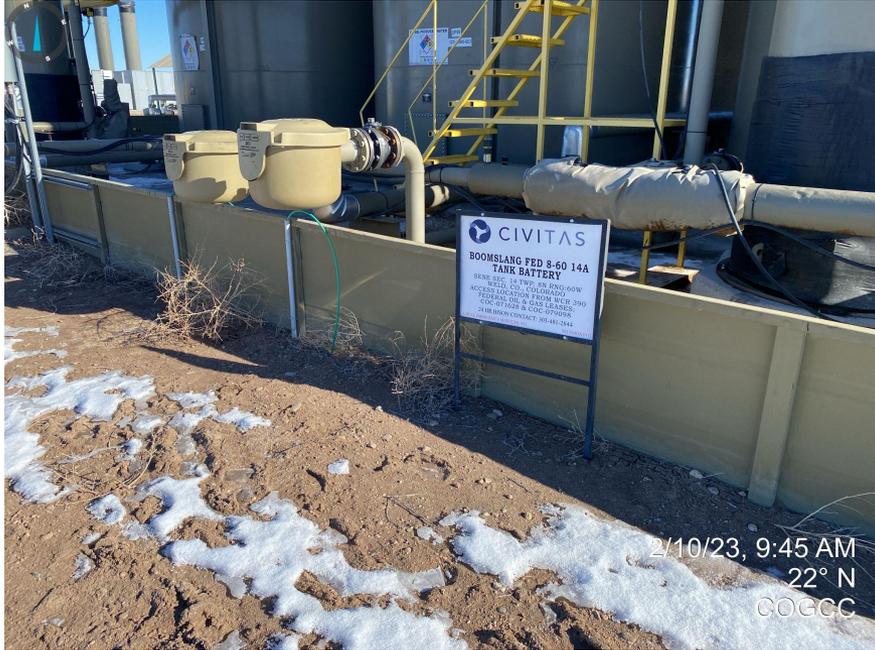
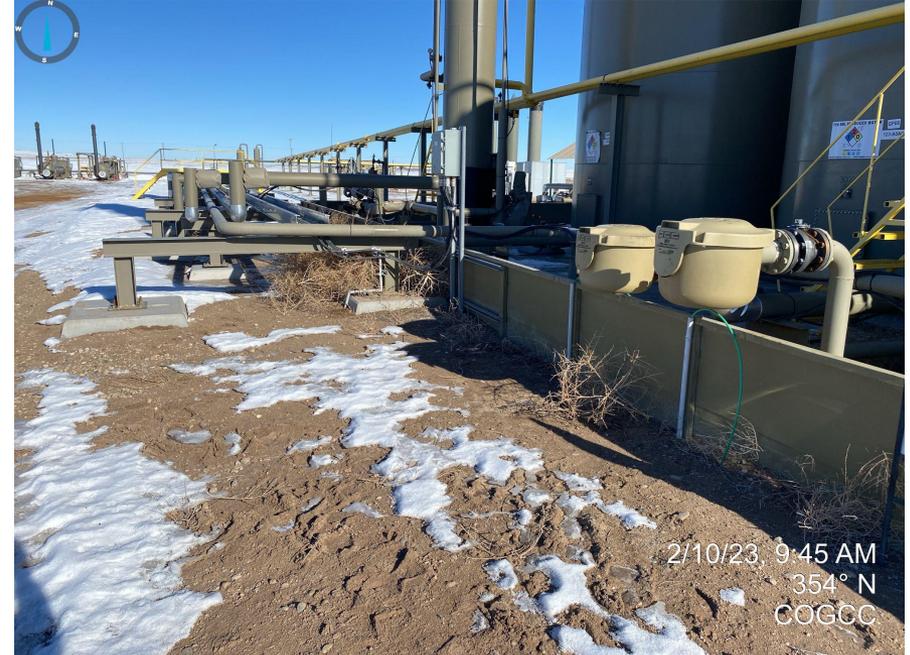
Photos 13 & 14. See comments in Photos 7 & 8.

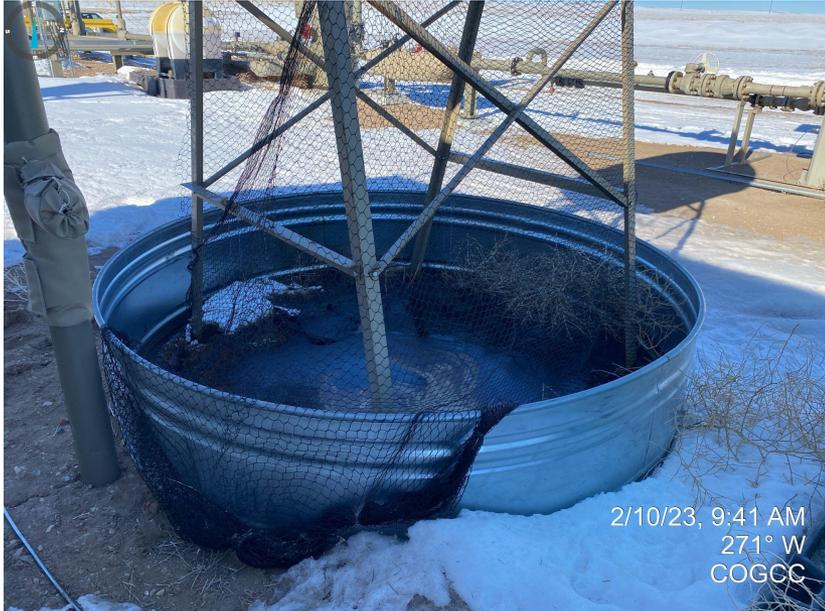
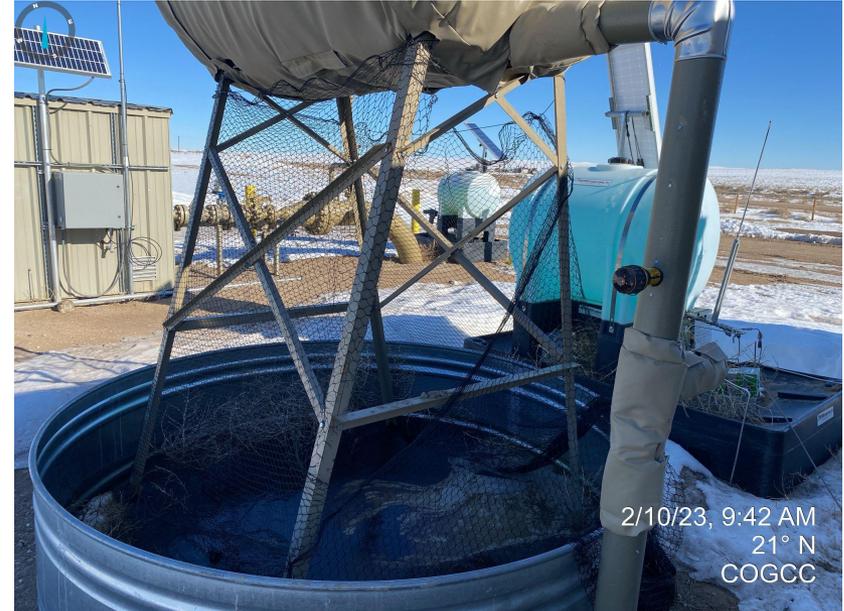
Photos 15 & 16. Wildlife netting around secondary containment is not adequate and will need to be repaired or replaced.

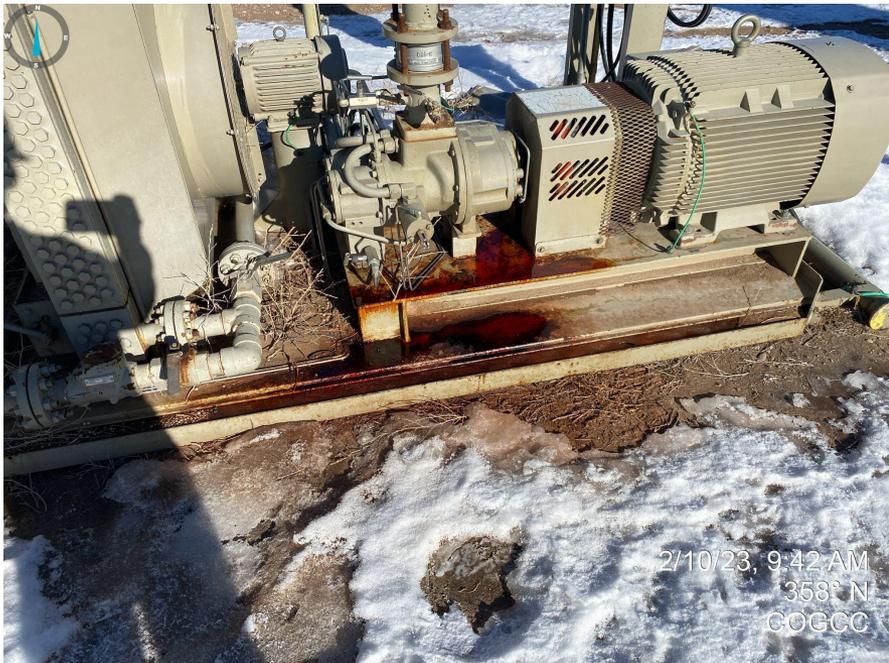
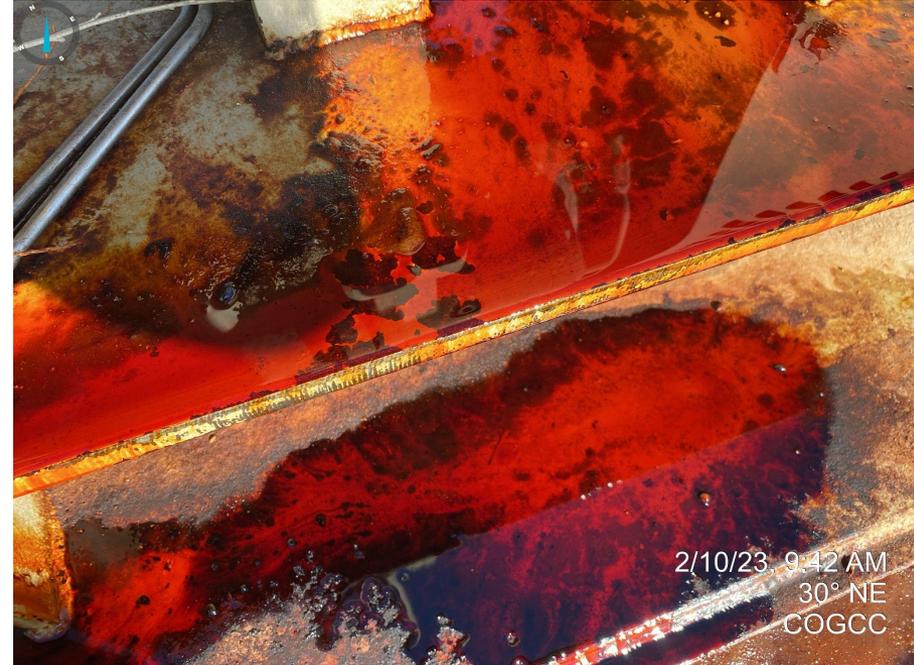
Photos 17 & 18. Unknown red fluid observed on skid of compressor, located on the northeastern portion of the location.

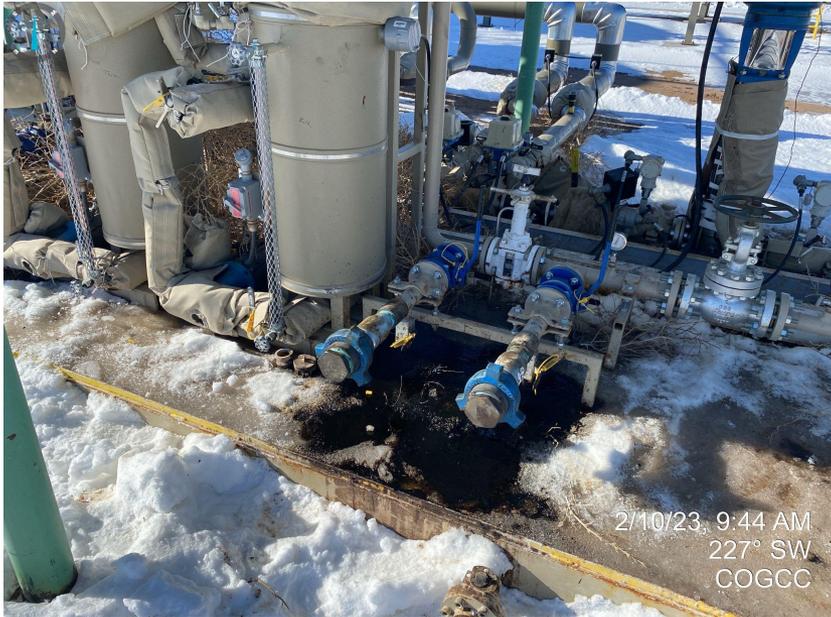
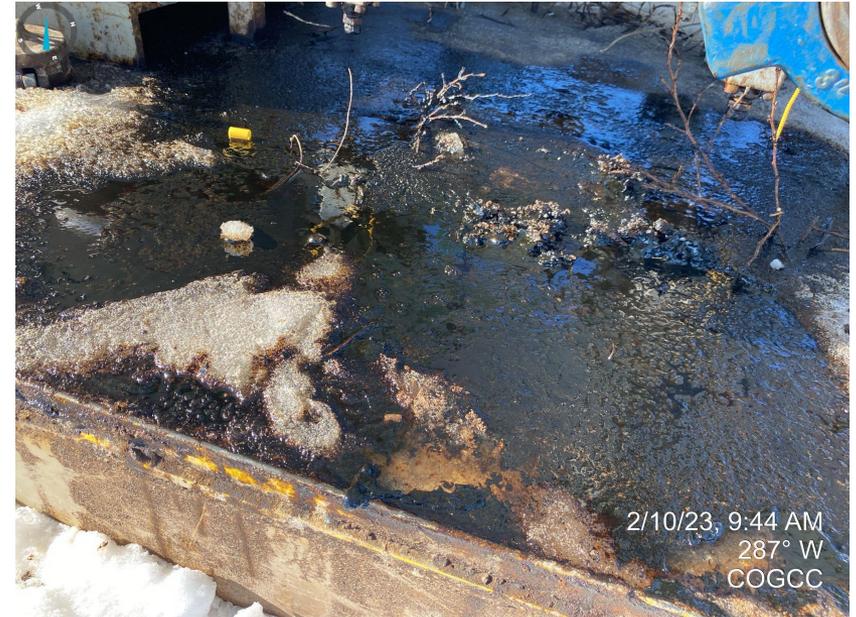
Photos 19 & 20. Crude oil was observed near production equipment on the eastern portion of the location, north of tank battery; this will need to be properly cleaned up per 912.a.
