Interim Reclamation and Stormwater Inspection

Date: 02/14/2023

Operator: RED HAWK PETROLEUM LLC - 430811

Inspection Photos
Location Name: Logan 2H
Location ID: 430811

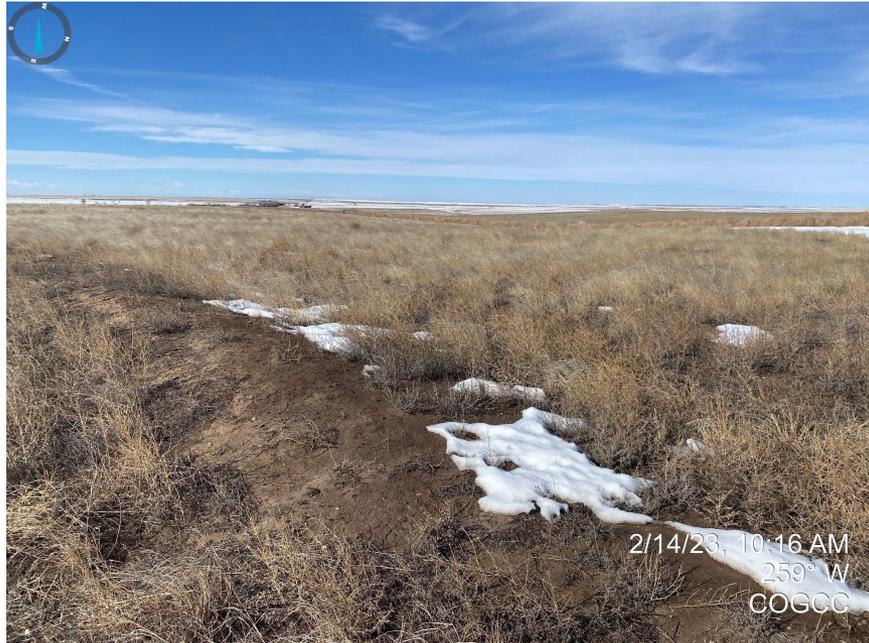
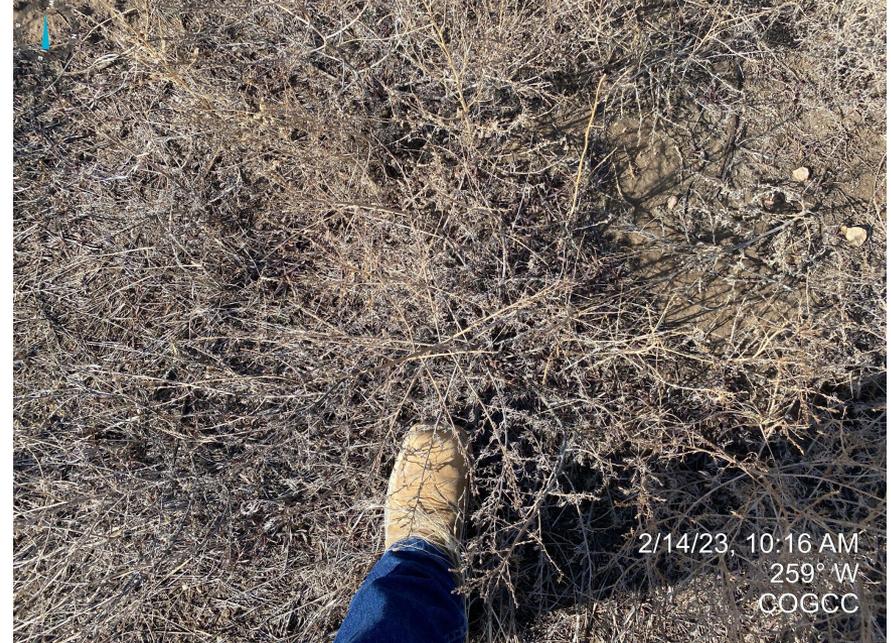
Photos 1 & 2. Facing west towards the interim reclamation areas. During this inspection some desirable vegetation was observed as well as undesirable vegetation (e.g. kochia and russian thistle). The operator will have to manage this location for undesirable vegetation during this next growing season. A follow-up inspection will be conducted at a later date to ensure compliance with Rule 1003 standards.

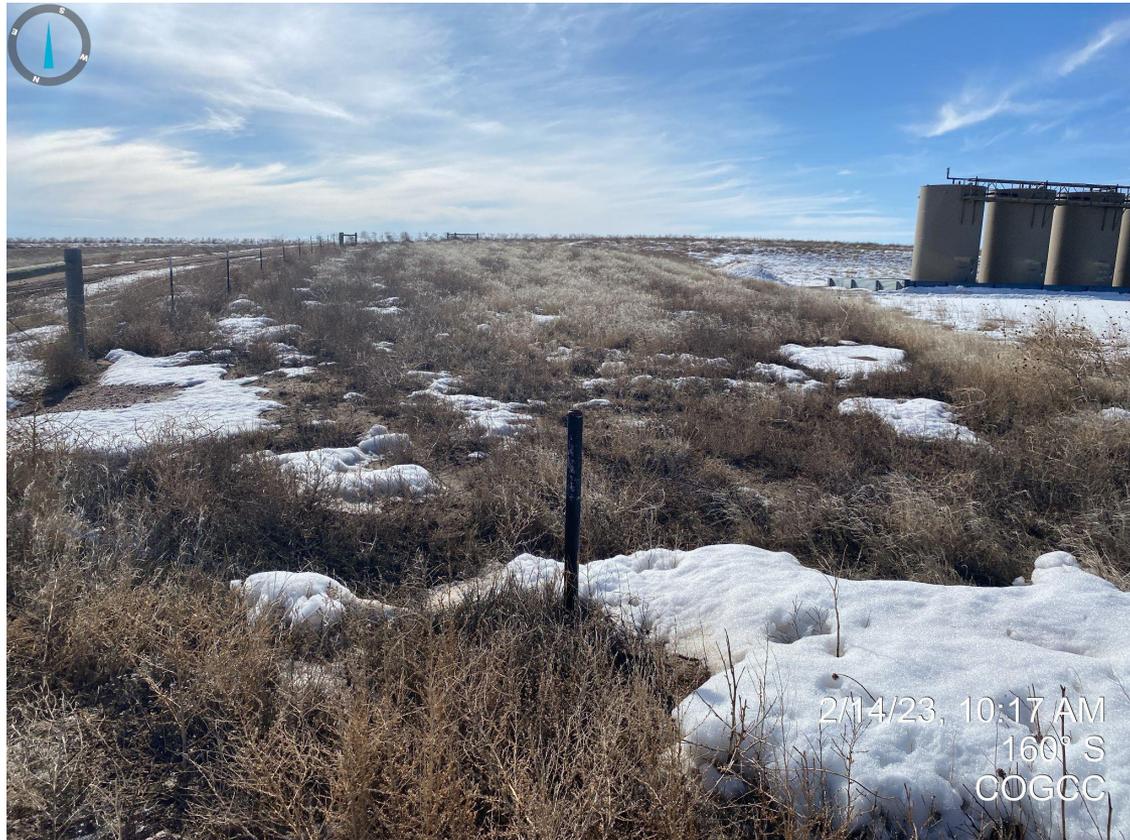
Photo 3. Facing south near the location's entrance; see comments in Photos 1 & 2.

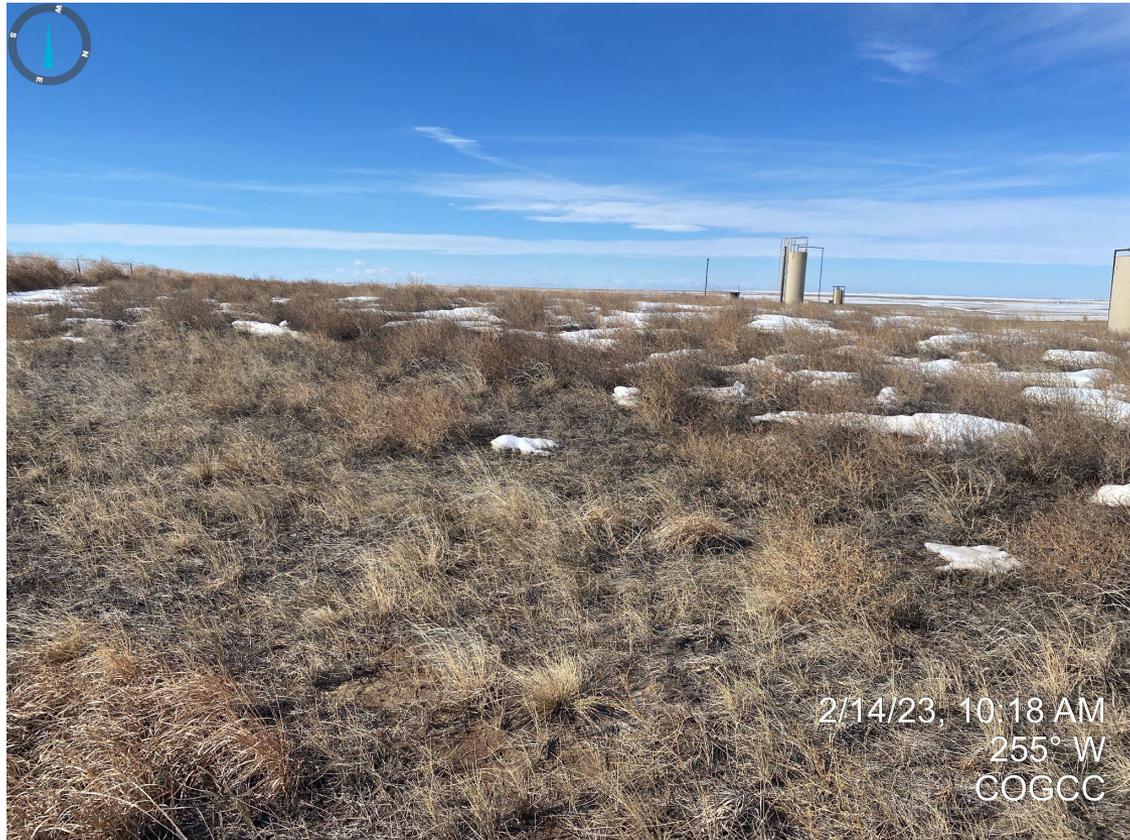
Photo 4. Facing west from the southern portion of the location; see comments in Photos 1 & 2.

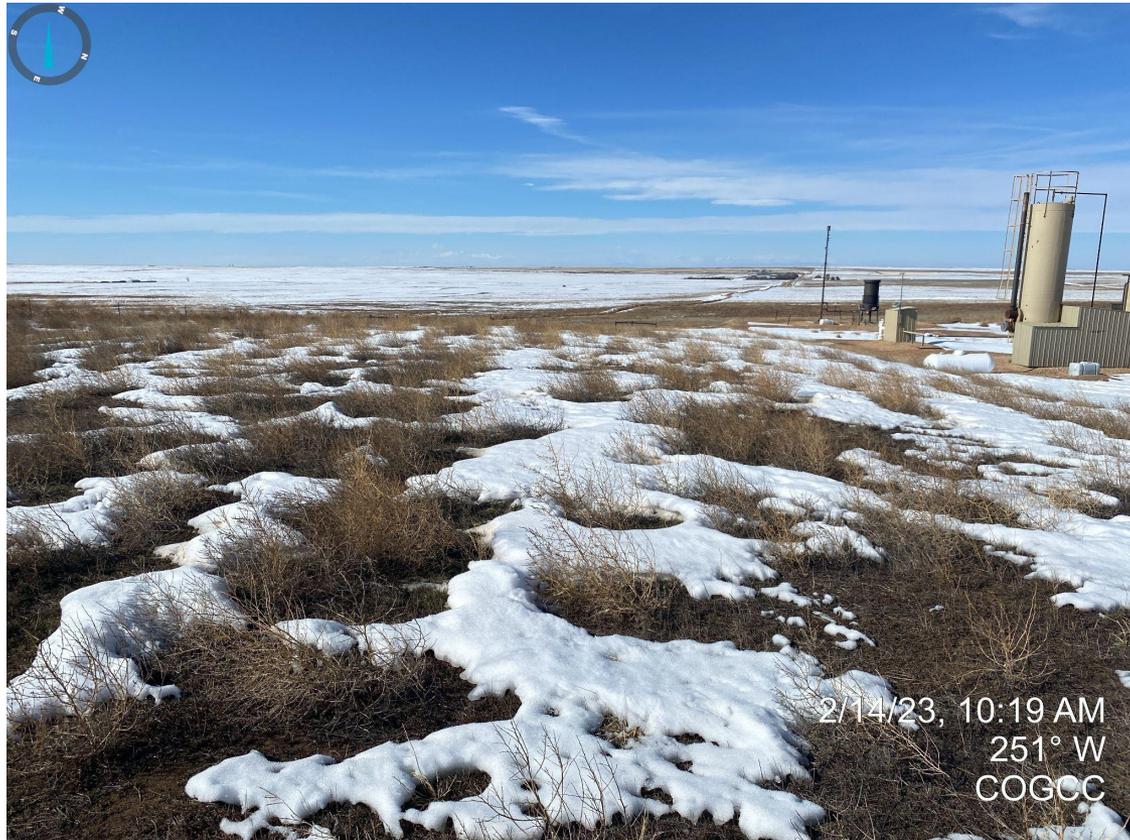
Photo 5. Facing west from the southern portion of the location; see comments in Photos 1 & 2.

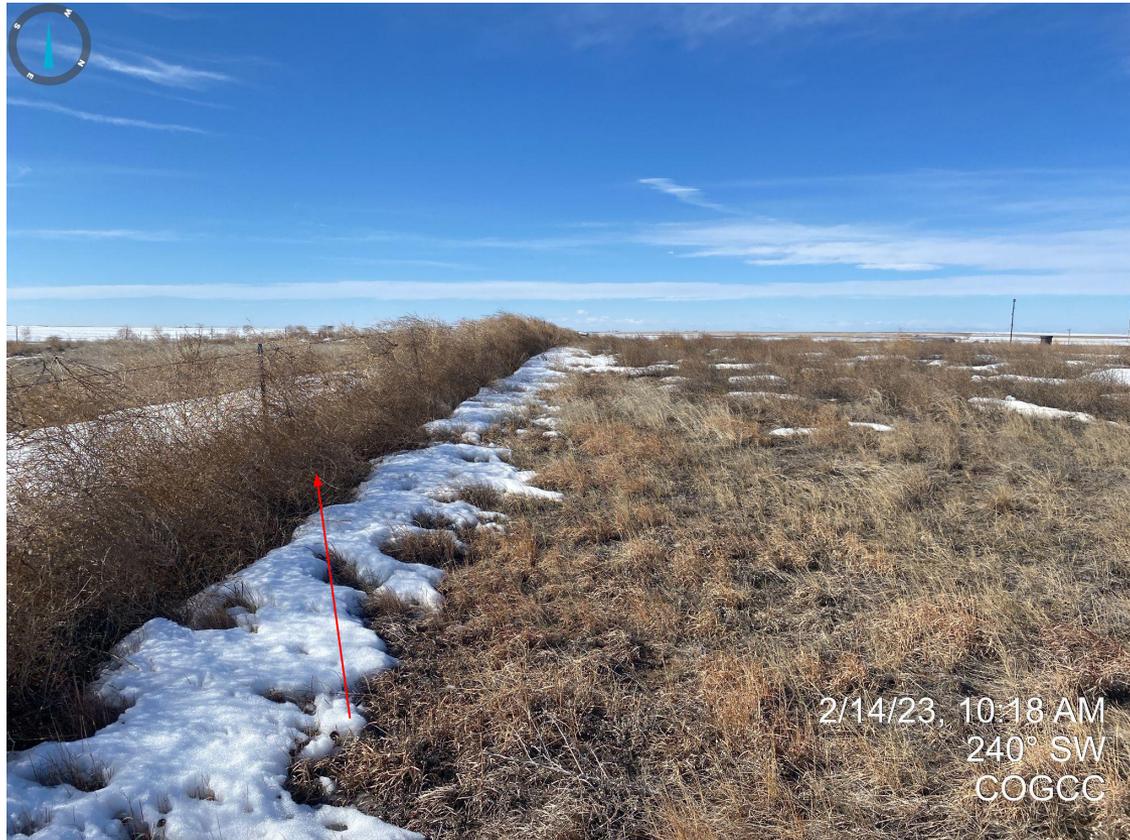
Photo 6. Facing southwest from the southern portion of the location. Photo illustrates tumbleweed accumulations along fence line that are now considered debris and need to be removed.

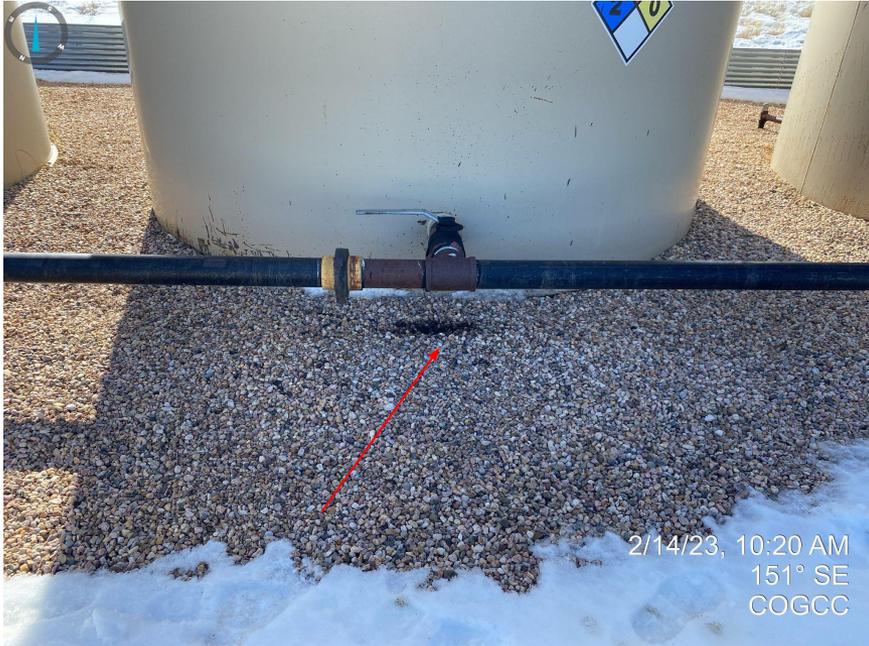
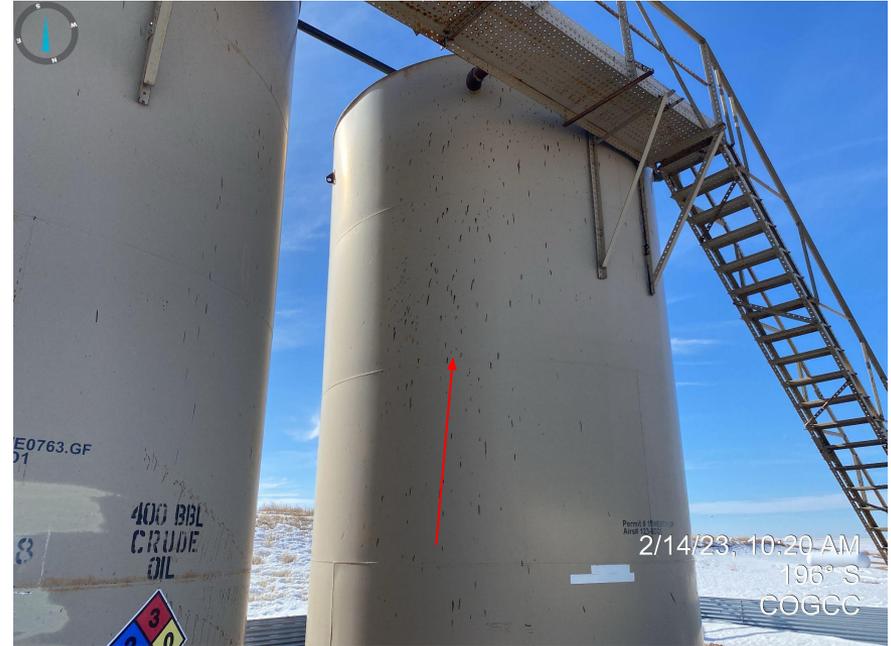
Photos 7 & 8. Close-up photos of tank battery. Photos illustrate oily waste that will need to be properly cleaned up per Rule 905.e.

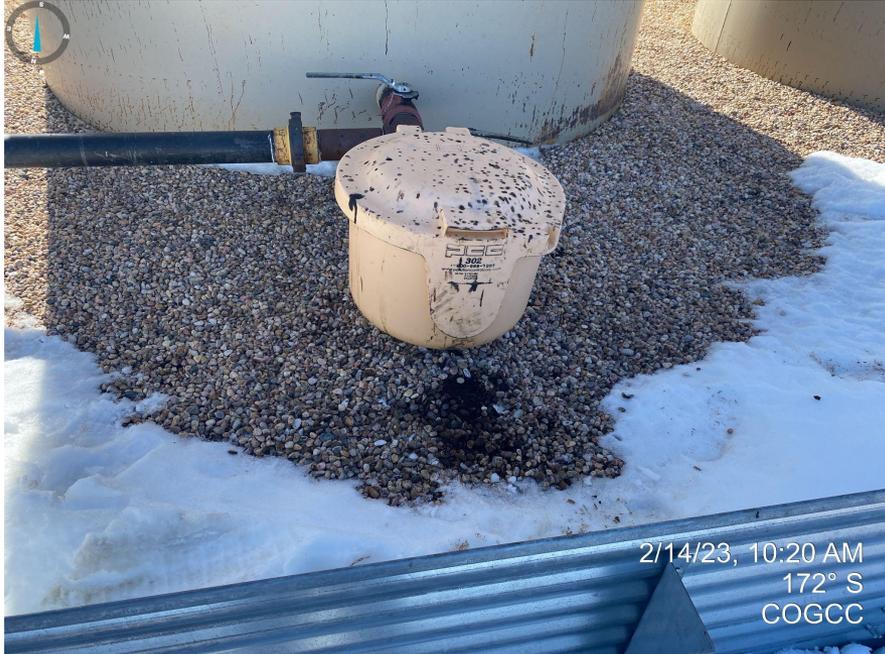
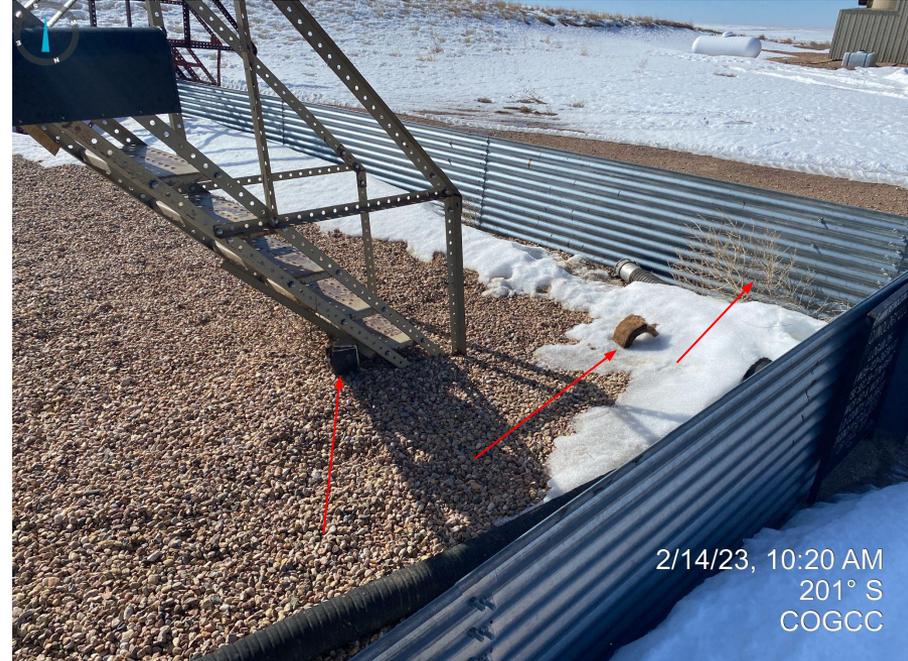
Photos 9 & 10. Close up photos of stained soil and debris. Left photo illustrates oily waste that will need to be cleaned up and right photo shows debris observed within the containment area of the tank battery.

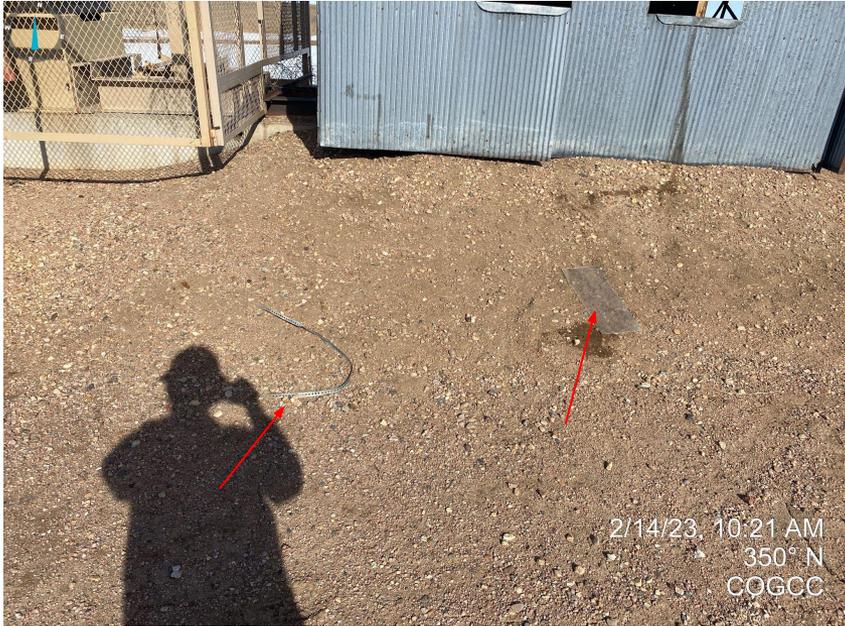
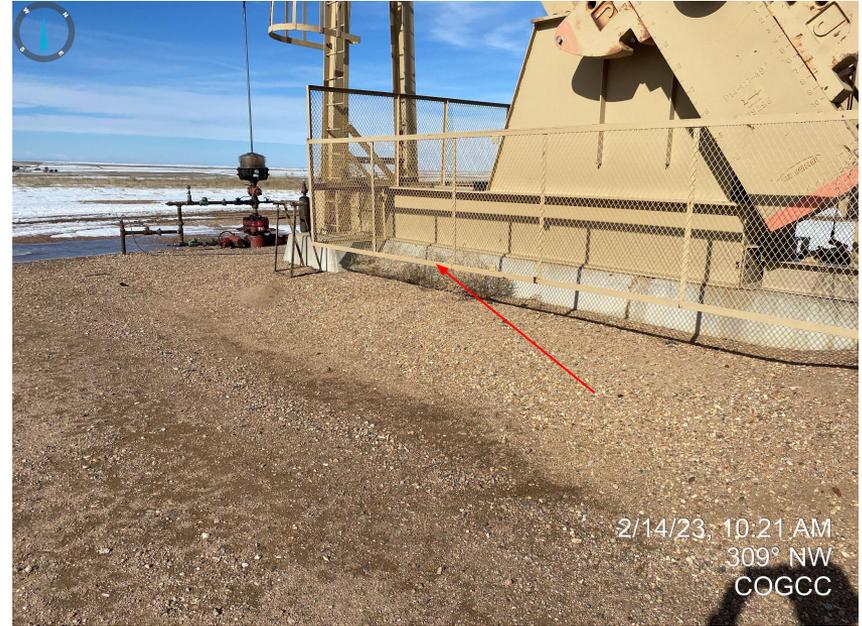
Photos 11 & 12. Close up photos of debris (e.g. glass, metal, tumbleweeds) observed near the pump jack.

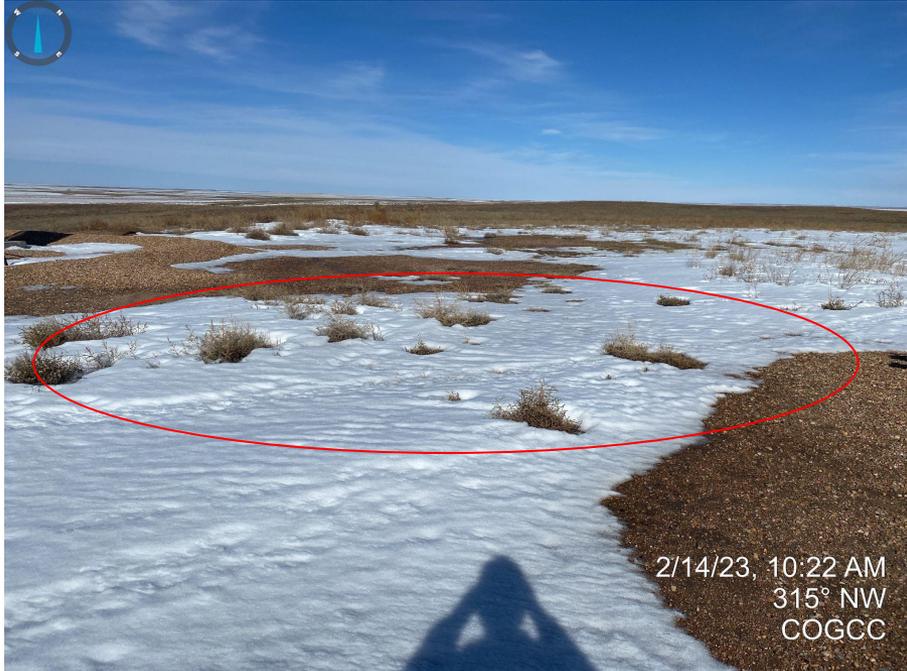
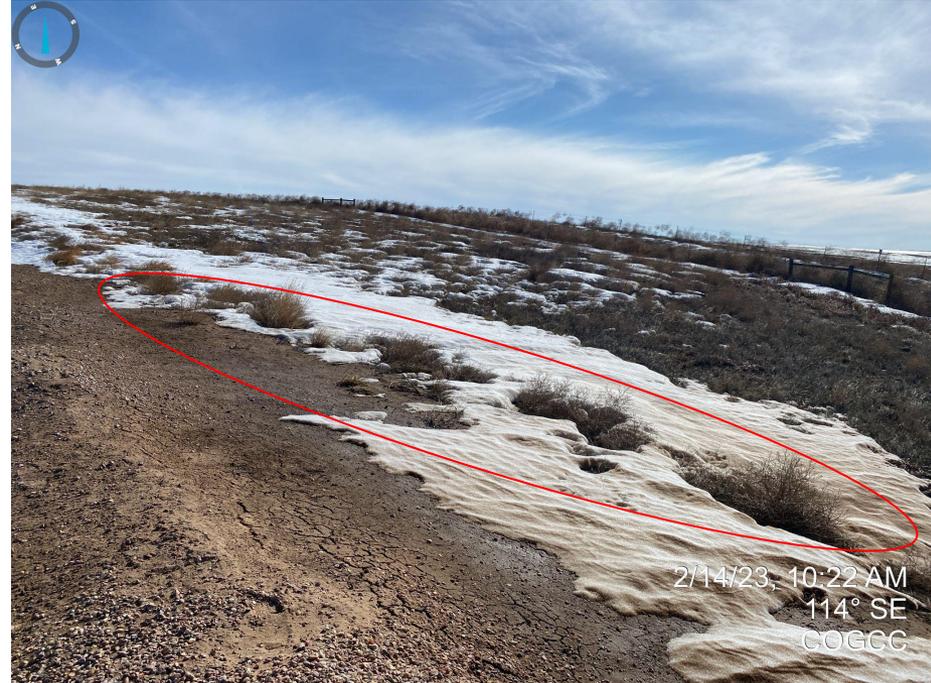
Photos 13 & 14. Facing northwest and southeast along the western portion of the location. Photos illustrate undesirable vegetation throughout the location that will need to be managed in the next growing season.

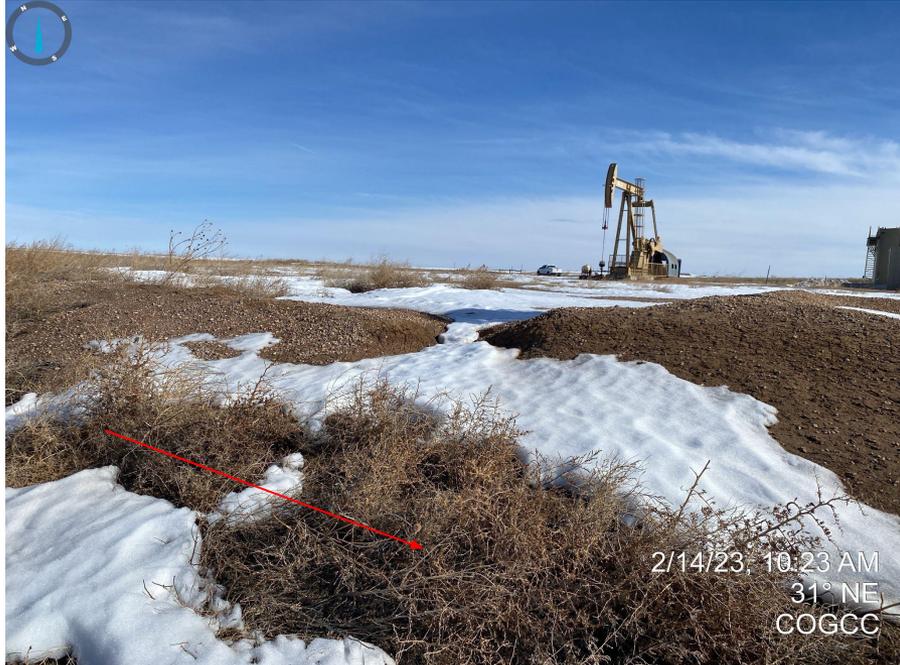
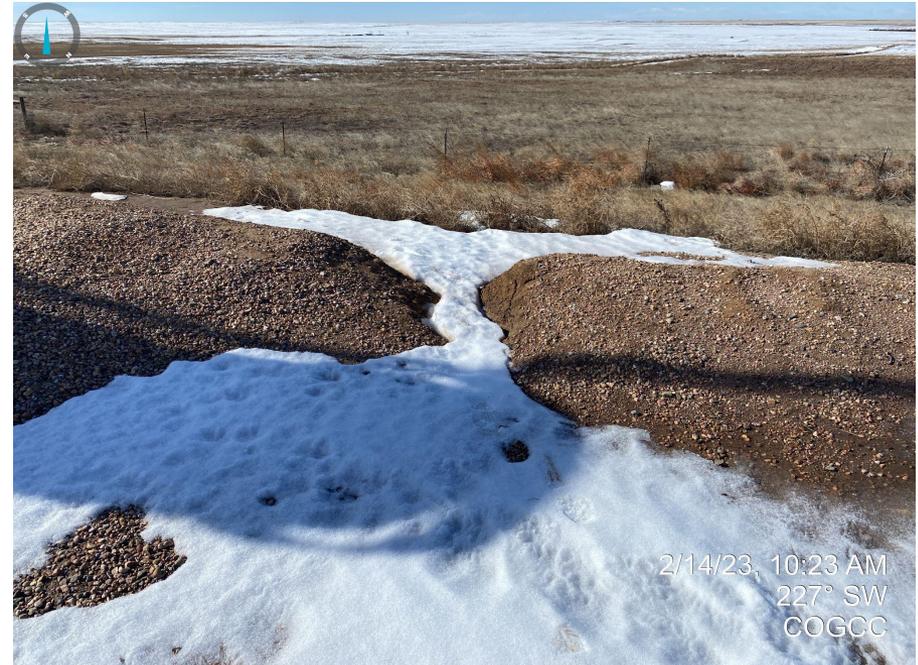
Photos 15 & 16. Facing northeast and southwest from the western earthen berm BMP. Photos illustrate presence of undesirable vegetation and gully erosion, or a breach, in the perimeter BMP. This will need to be repaired to prevent sediment laden stormwater from exiting off location.

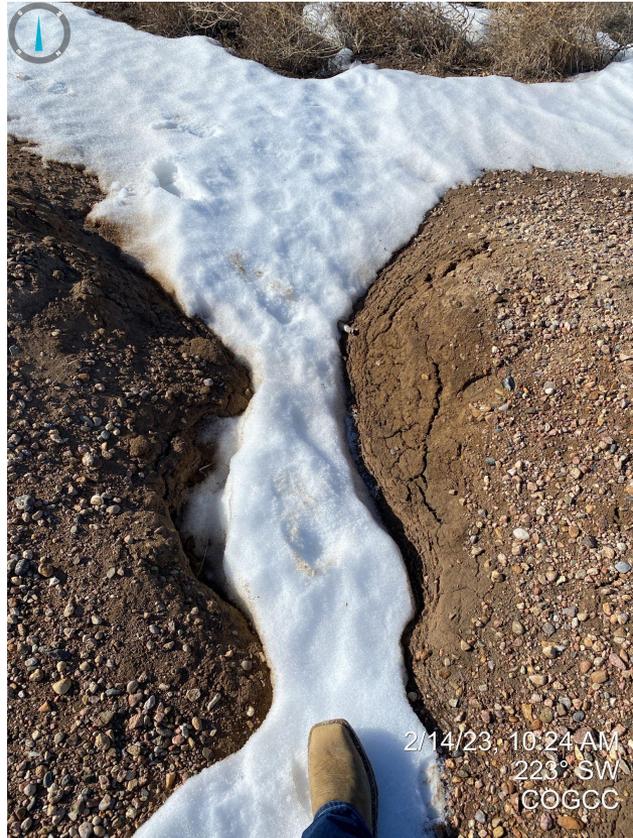
Photo 17. Close-up photo of gully erosion, boot for scale. See comments in Photos 15 & 16.
