**TEP Rocky Mountain LLC**  
**Specialty Restaurants SG 13-33**  
**Location #383331**

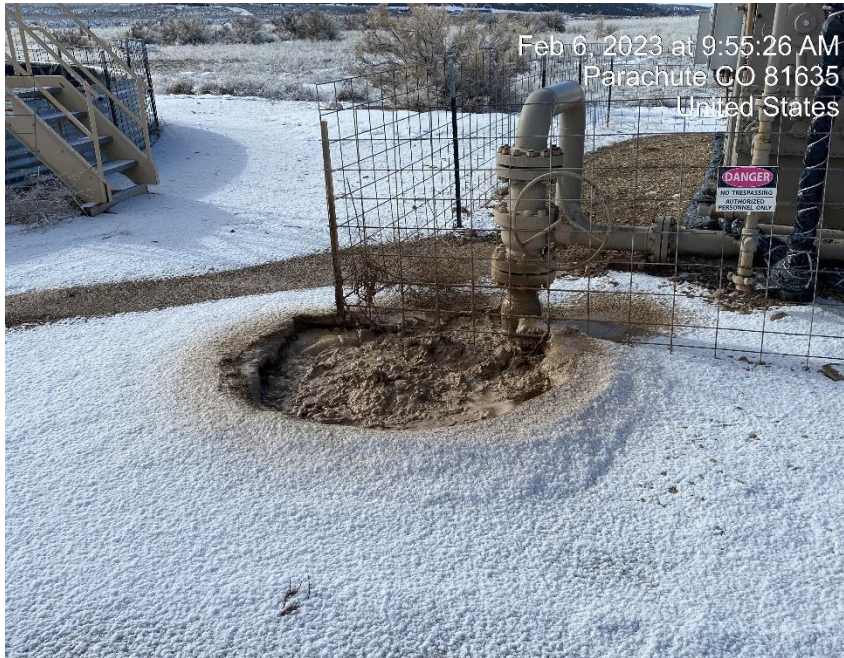
Line leak

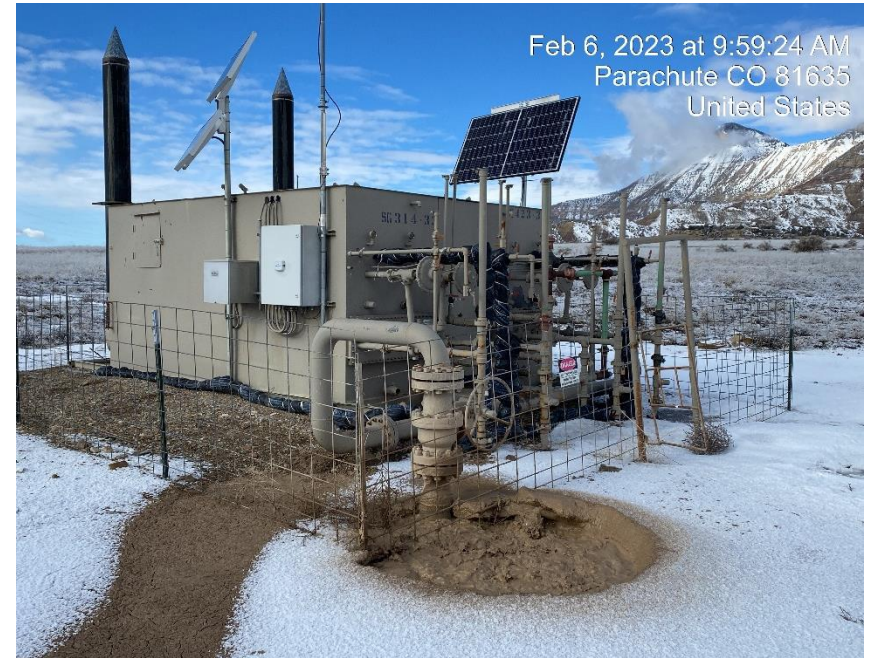
Line leak

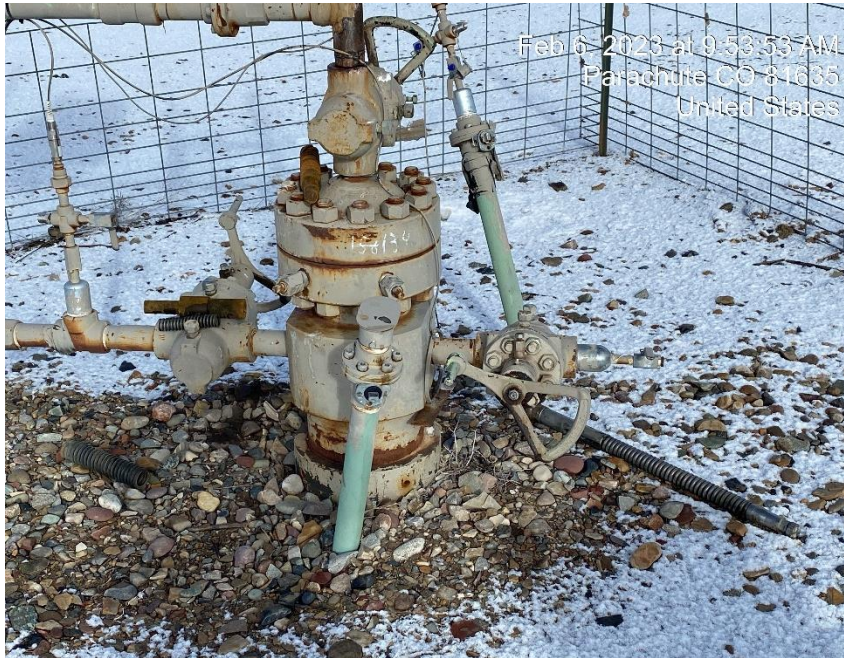
**Debris around wellhead**

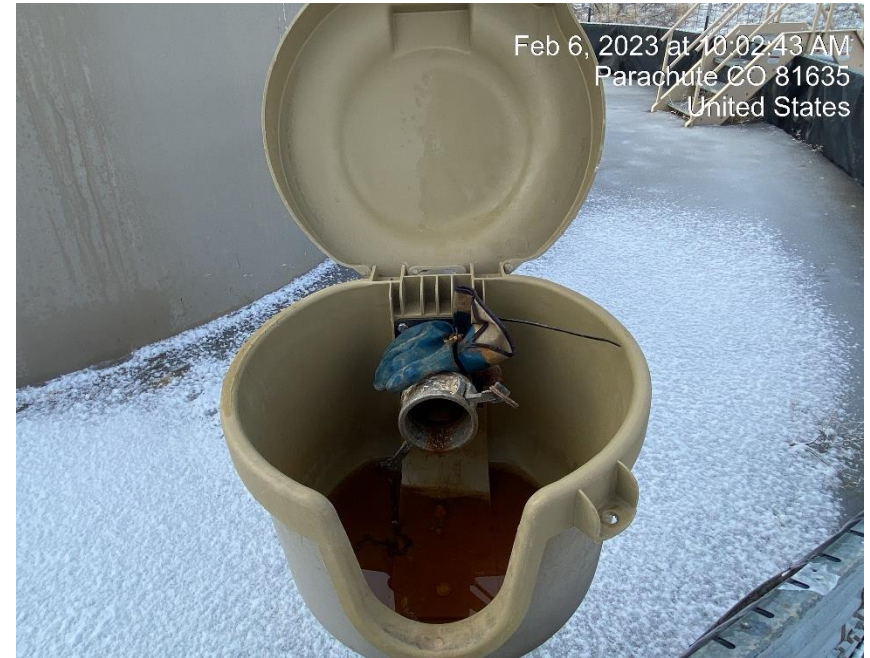
**Uncapped loadline on produced water tank**

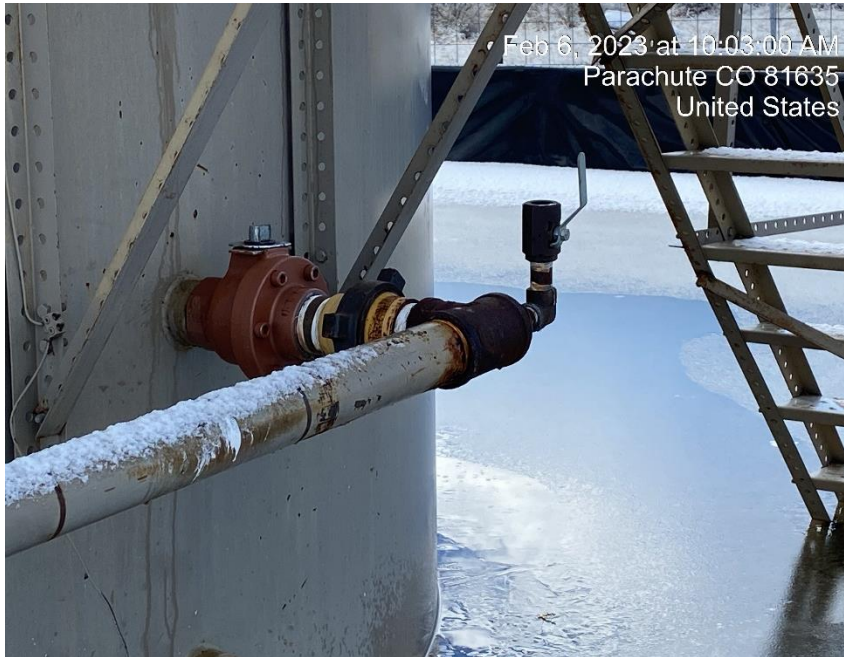
**Open valve on loadline**

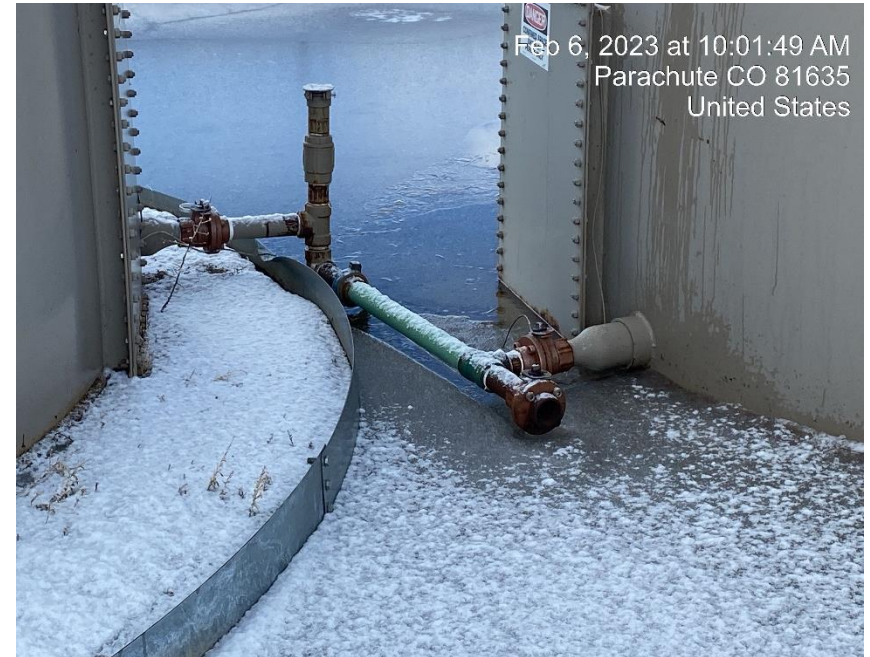
**Open end tank valve**

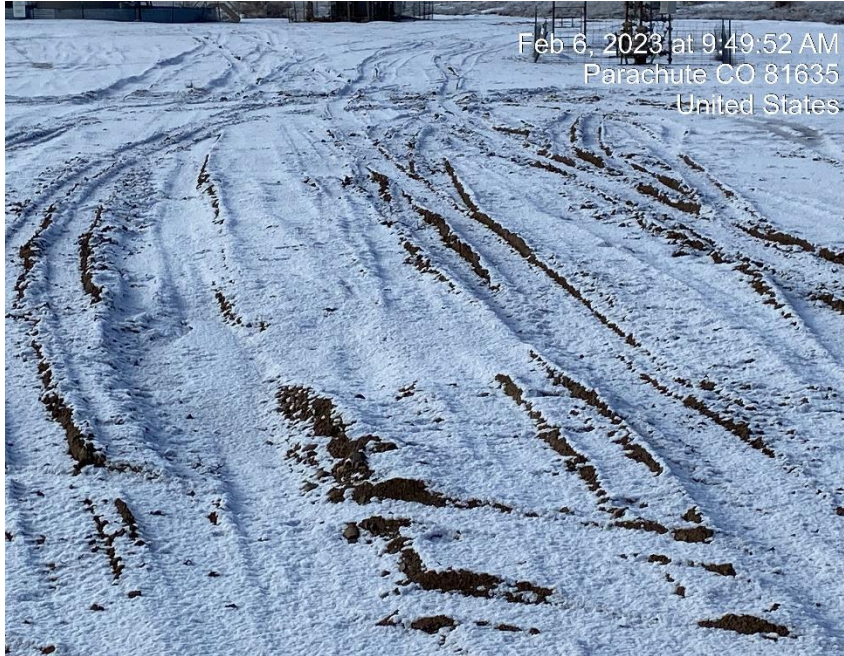
**Lack of stabilization**

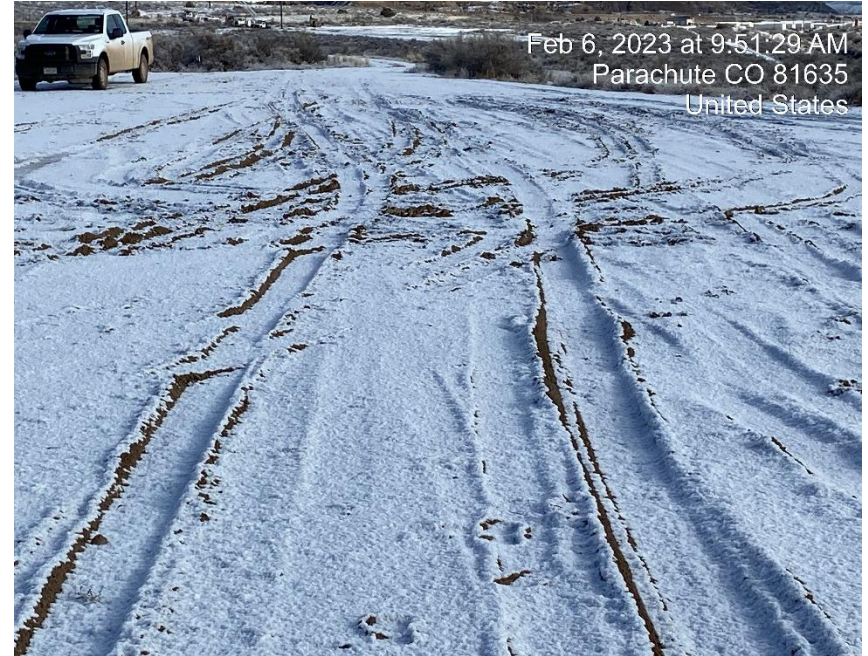
**Lack of stabilization**

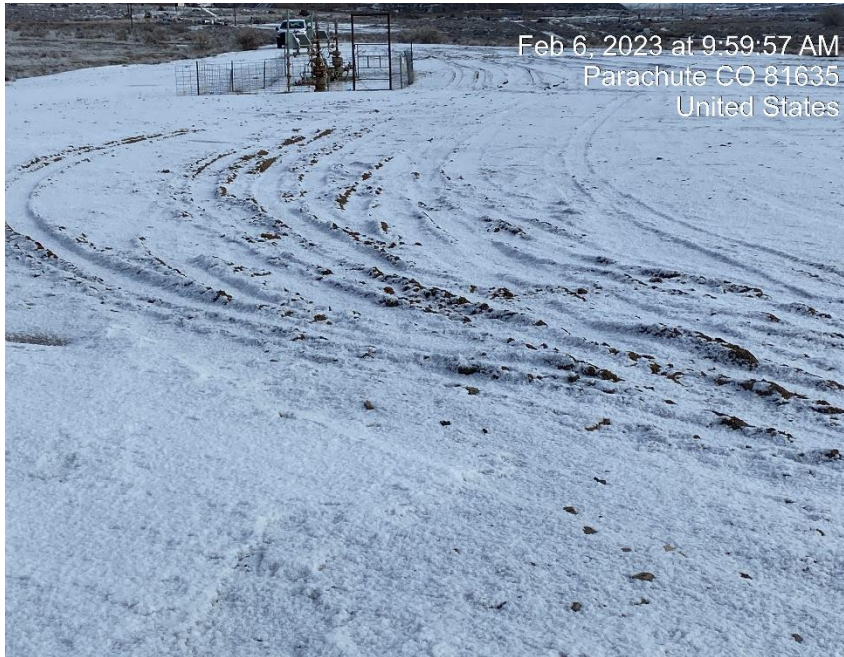
**Lack of stabilization**

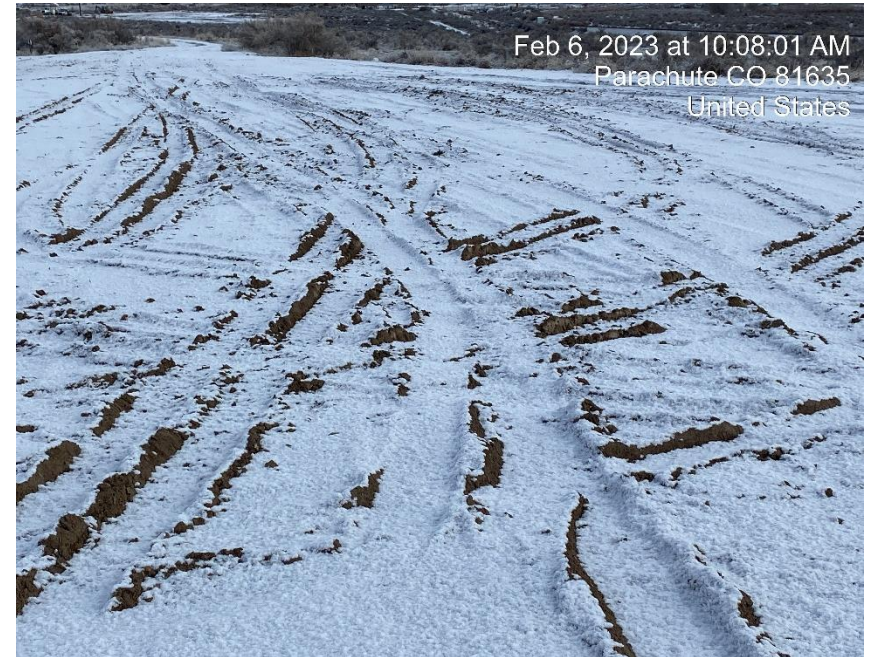
**Lack of stabilization**
