Caerus Piceance LLC
Nolte 14-796
Location #435806

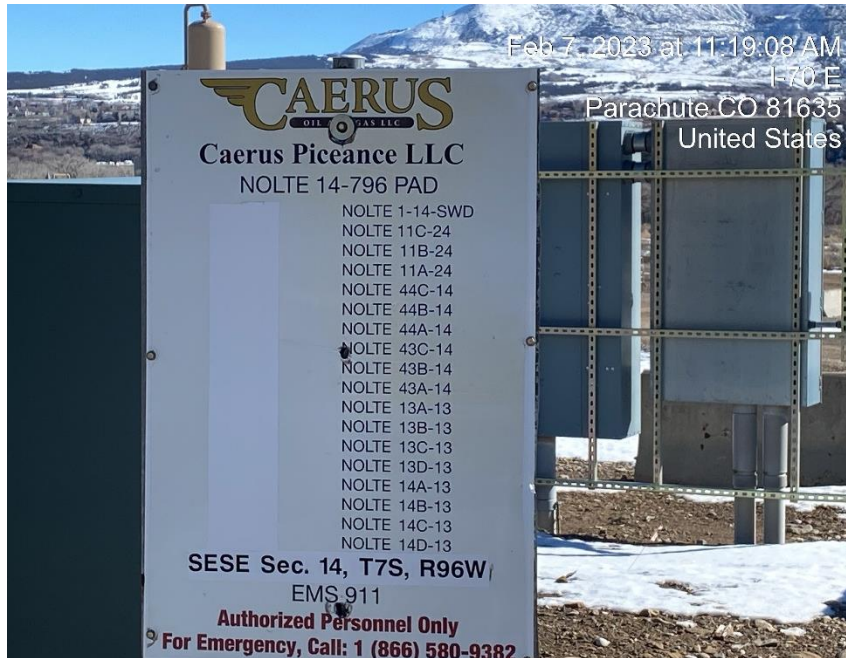
Sign at entrance to location

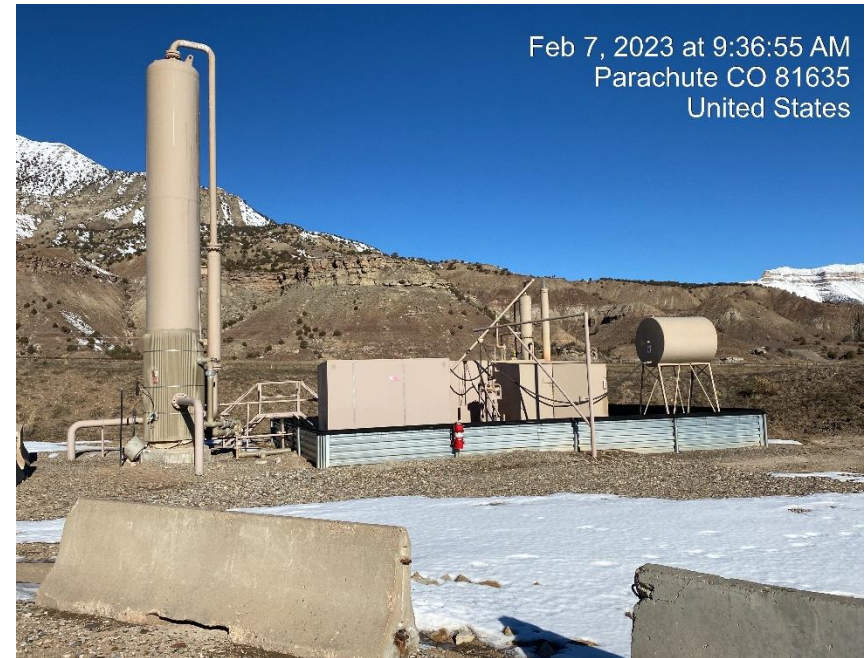
From entrance to location

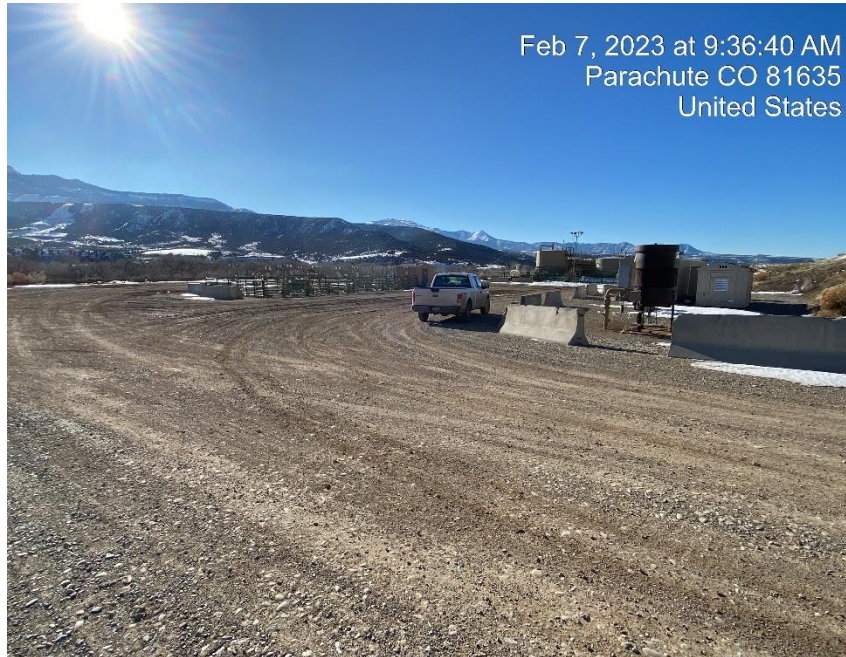
From entrance to location

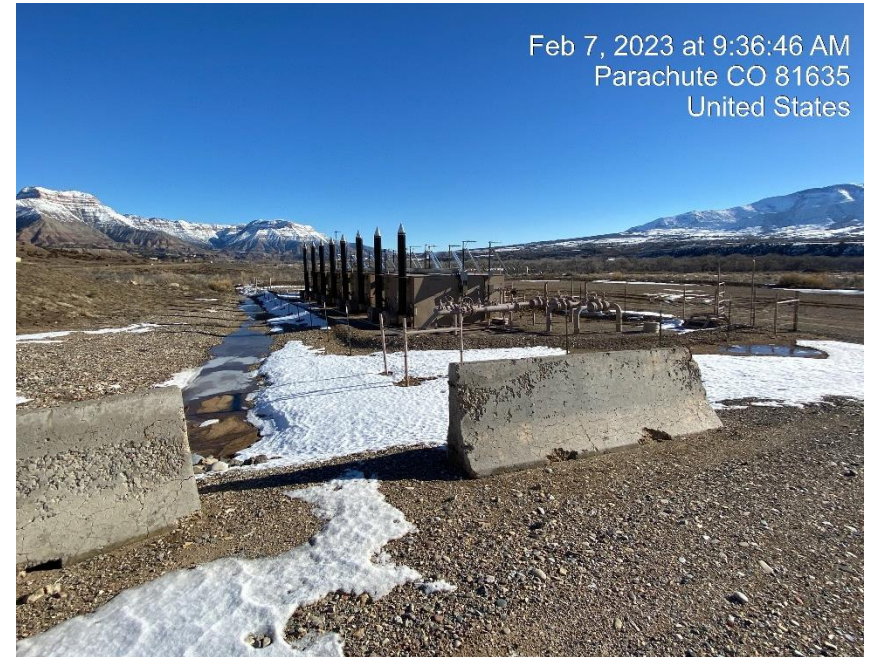
From entrance to location

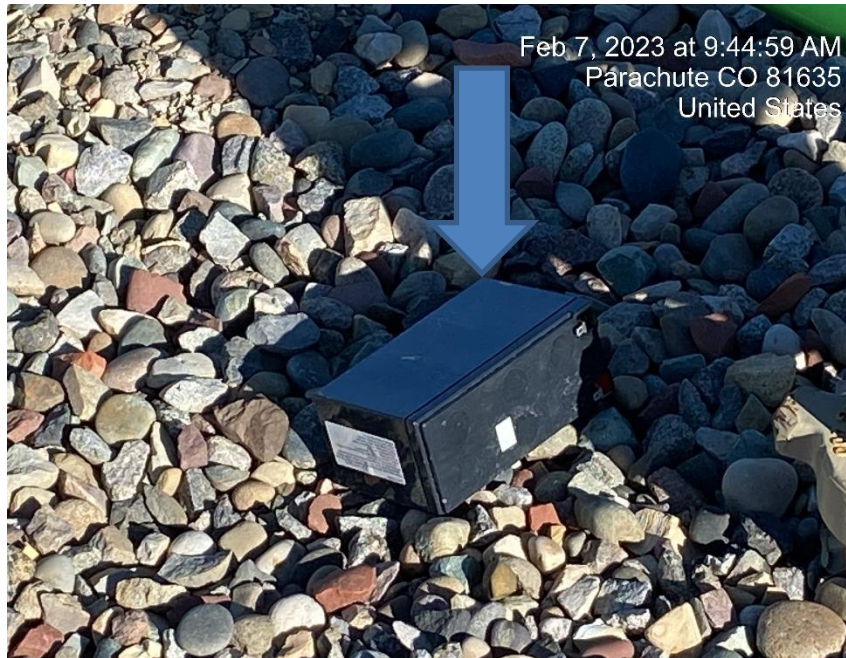
Debris around wellheads

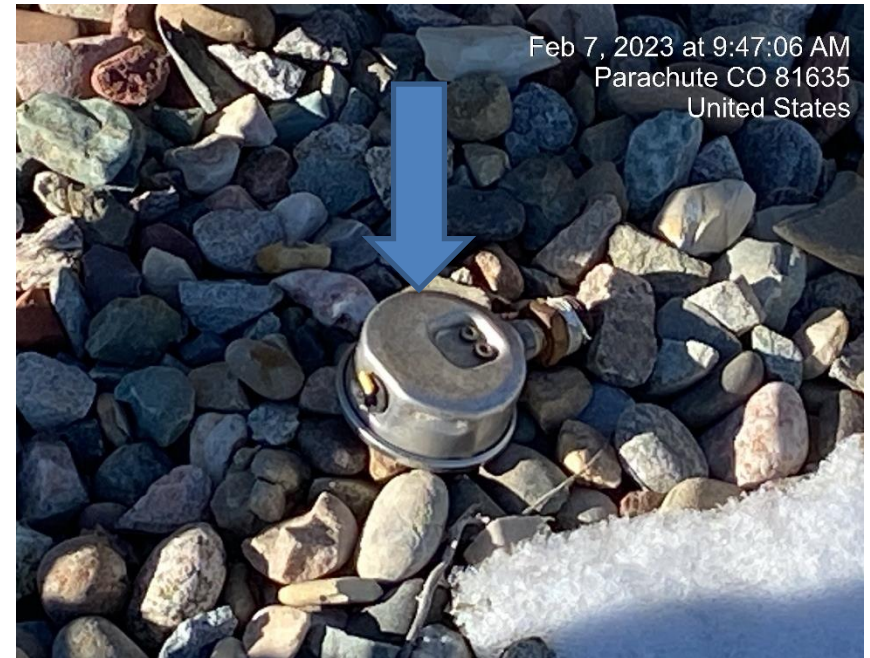
Debris around wellheads

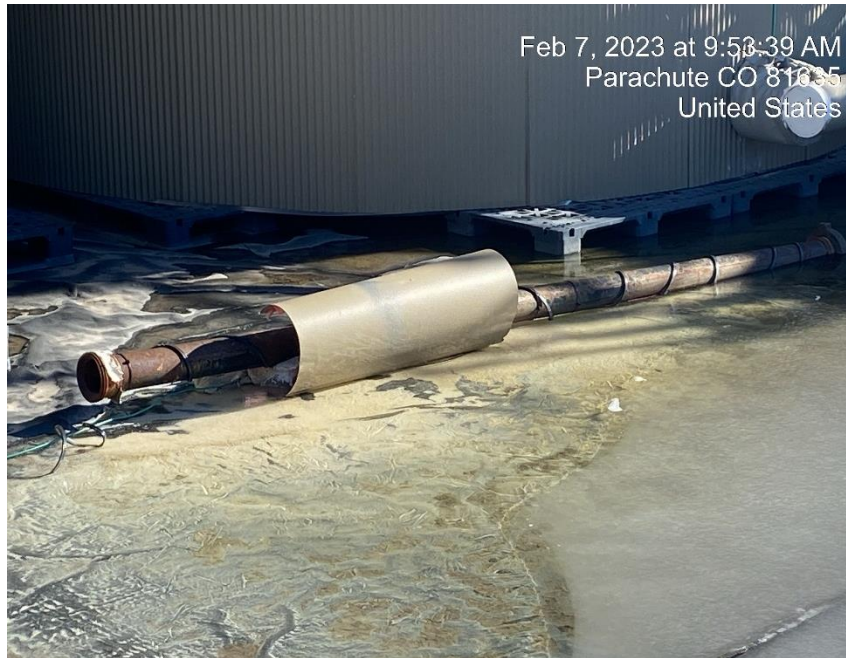
Debris inside tank battery

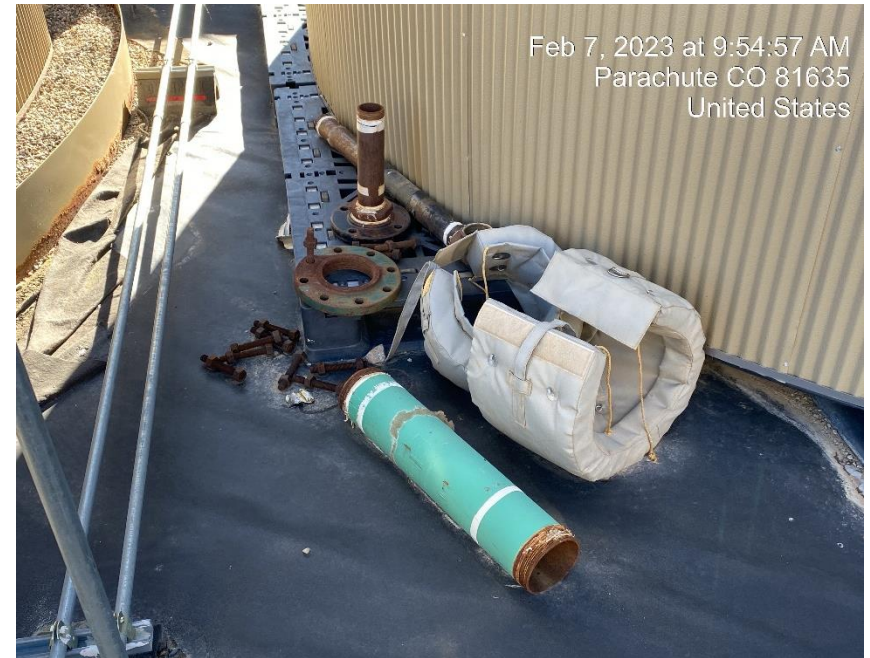
Debris inside tank battery

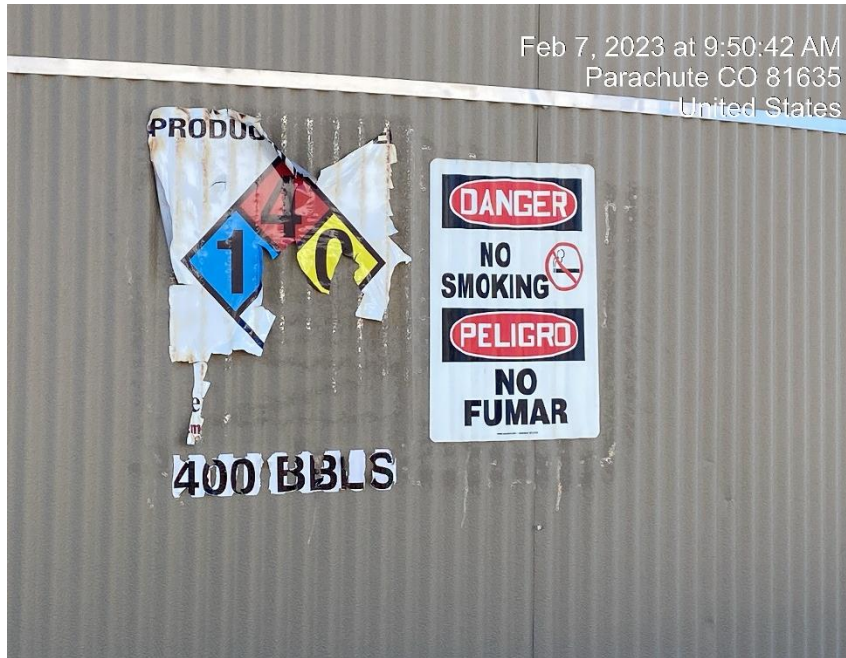
Label torn and illegible

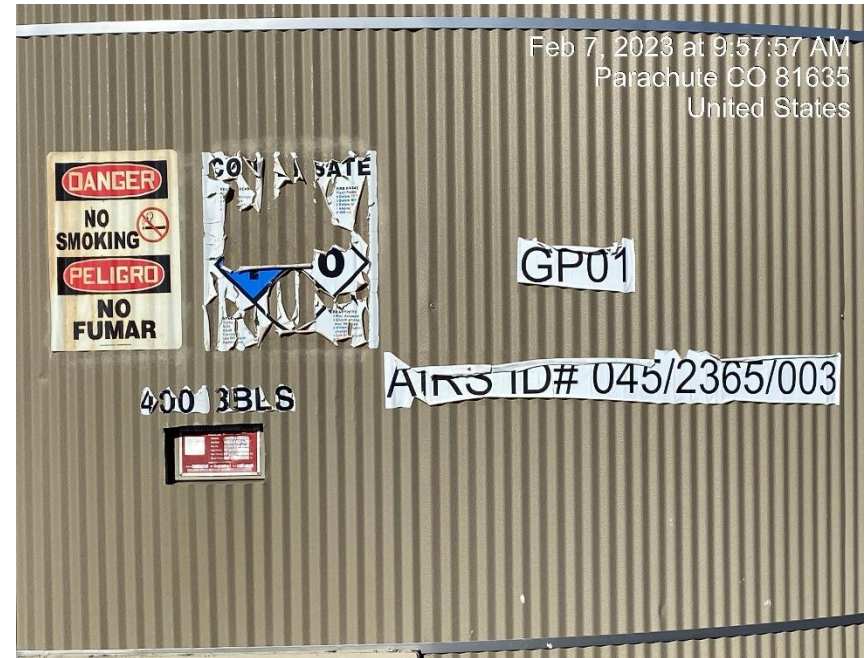
Label torn and illegible

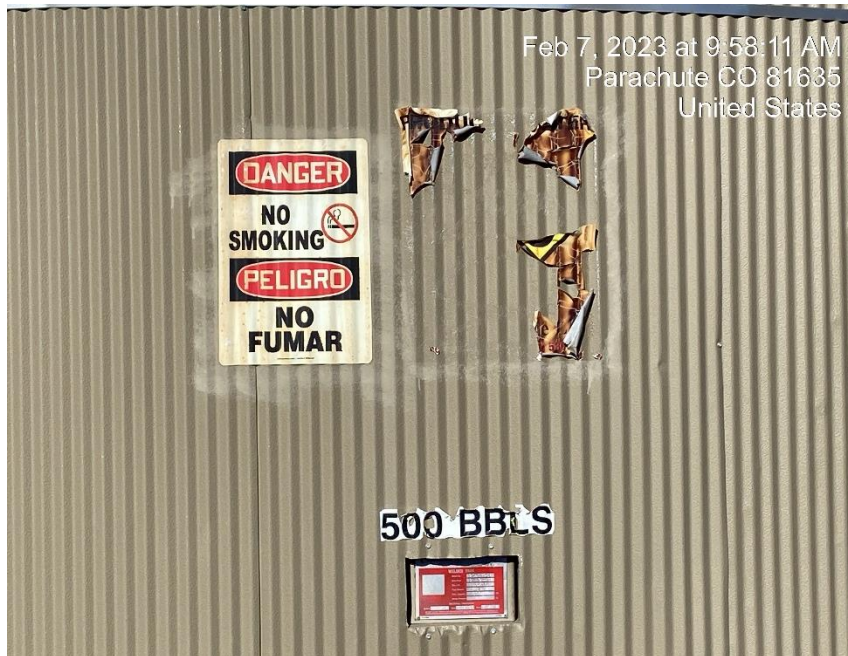
Missing tank label

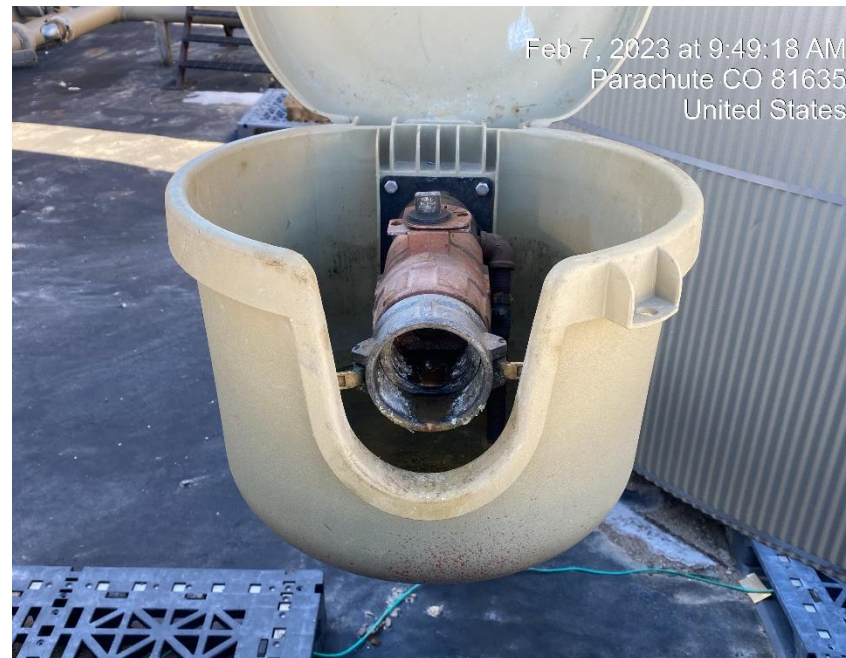
Uncapped loadline on produced water tank

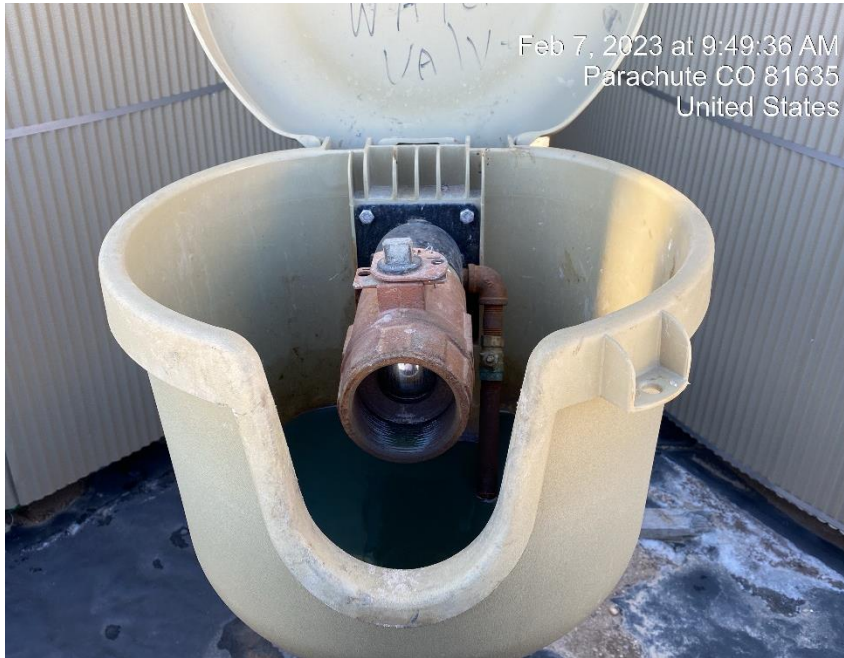
Open end loadline on condensate tank

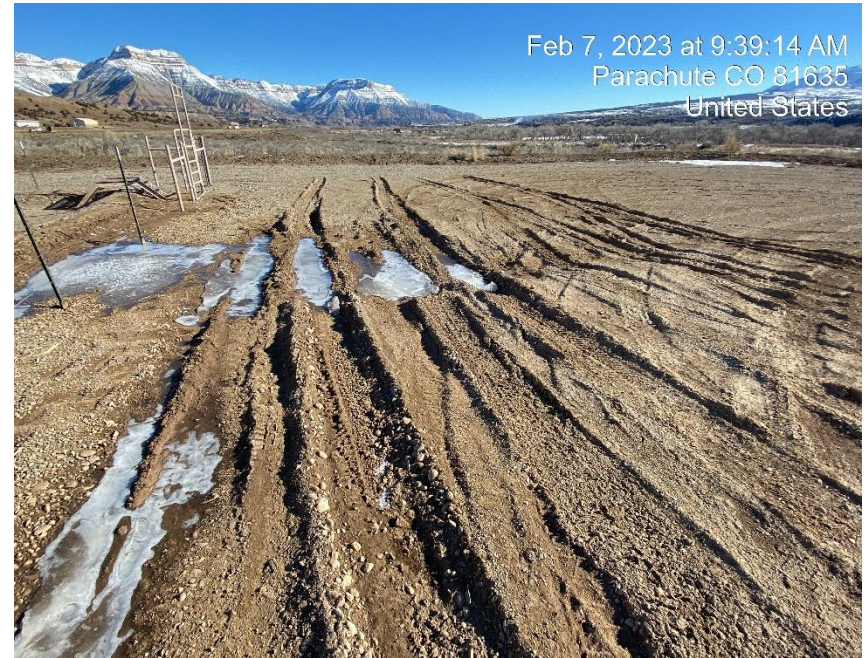
Lack of stabilization

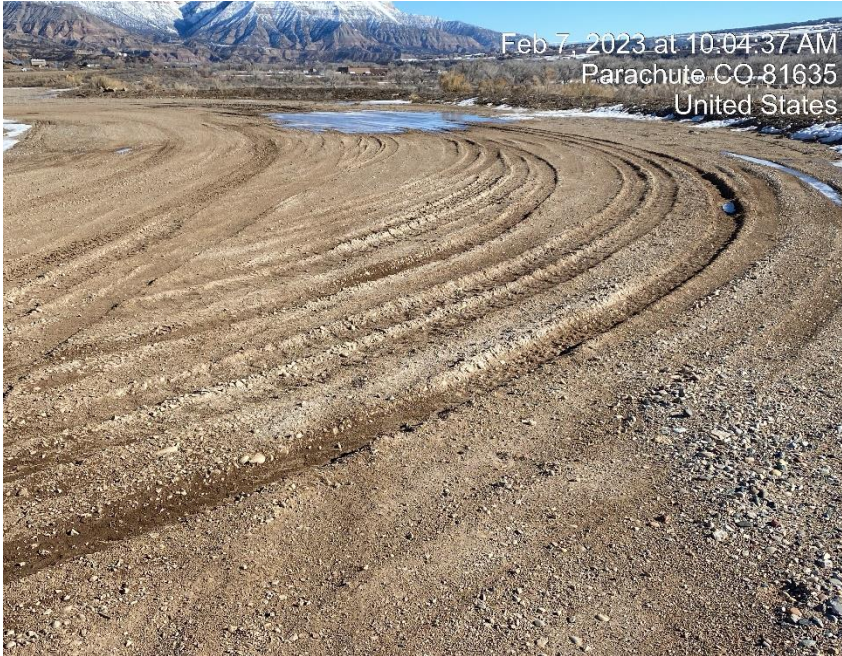
Lack of stabilization

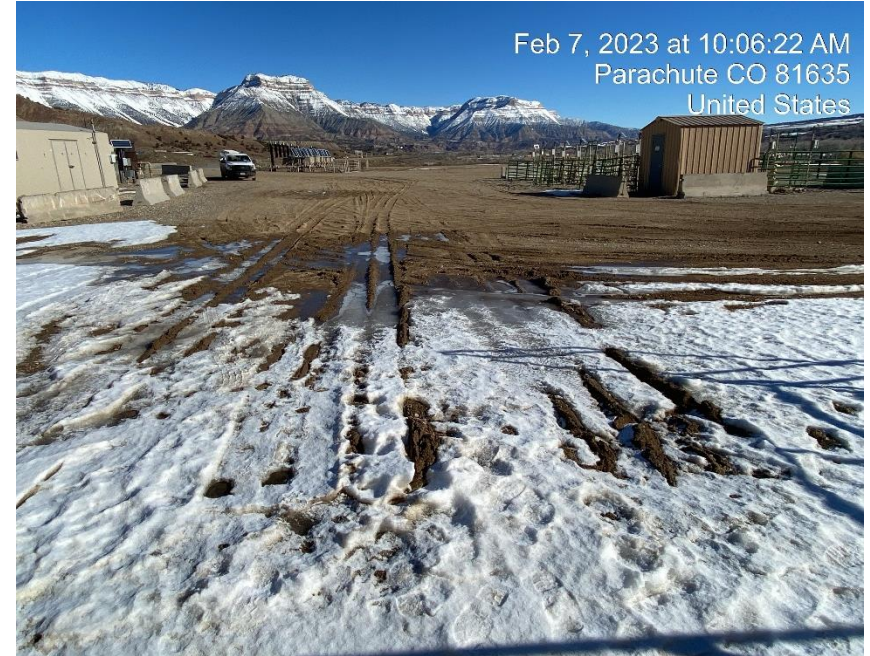
Lack of stabilization
