**TEP Rocky Mountain LLC
Mobil GM 24-27 Pad
Location #335397**

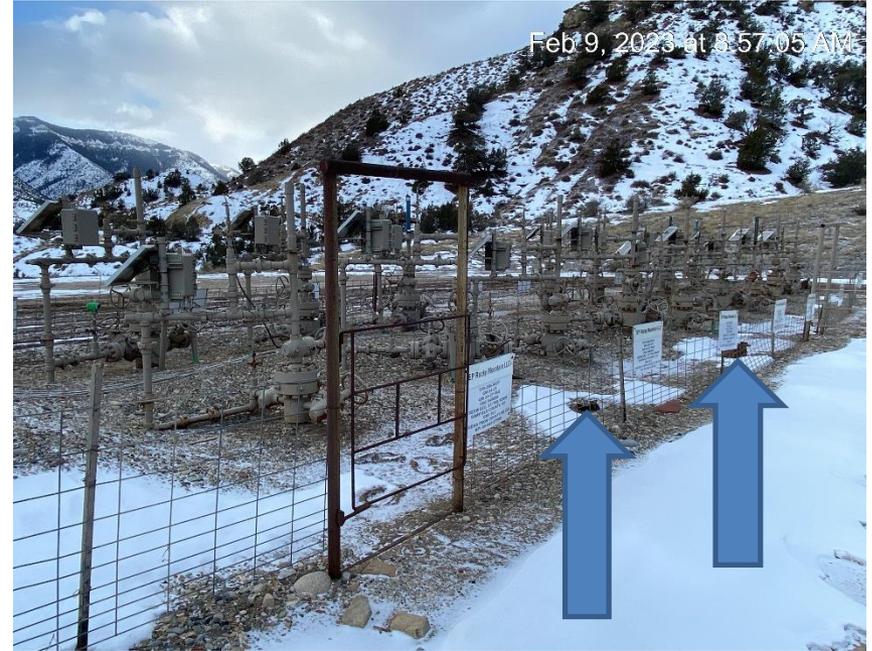
Exposed mouseholes

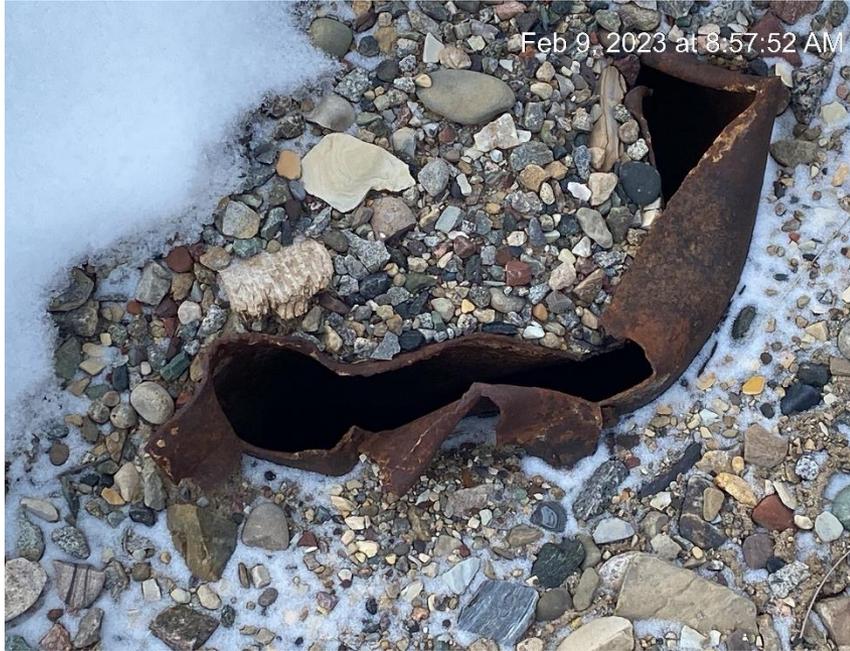
Southern exposed mousehole

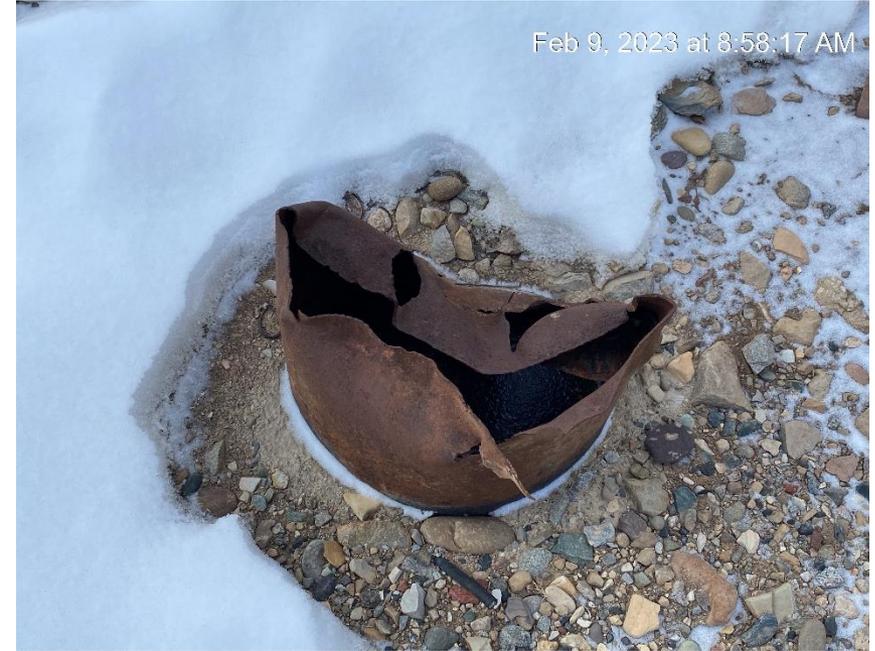
Northern exposed mousehole

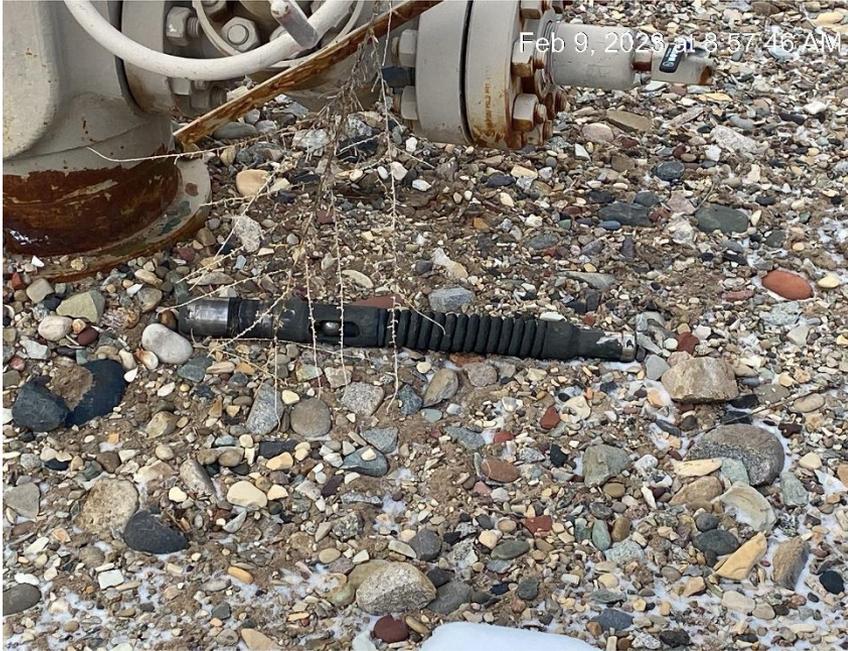
Random debris around several wellheads

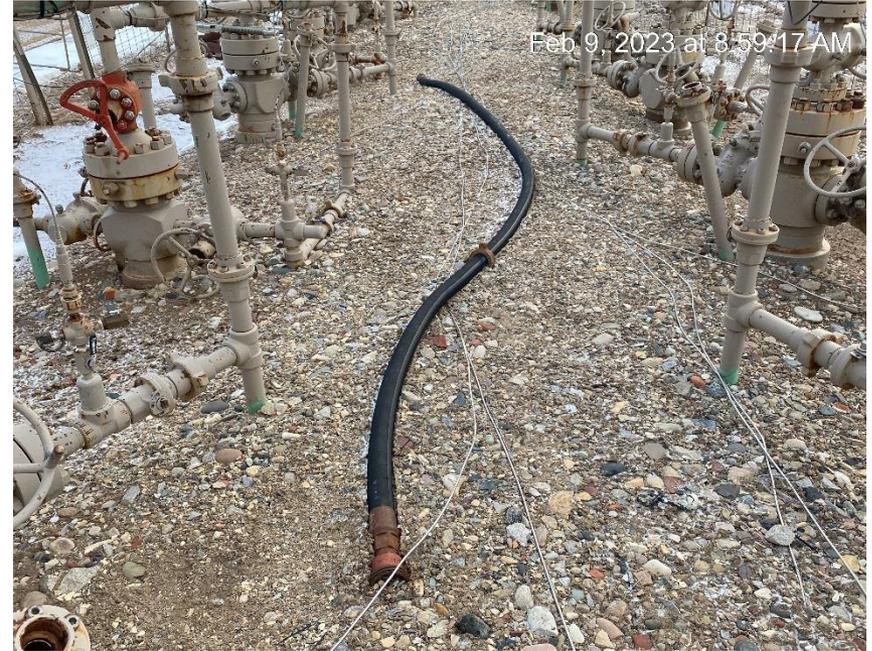
Random debris around wellheads including piping

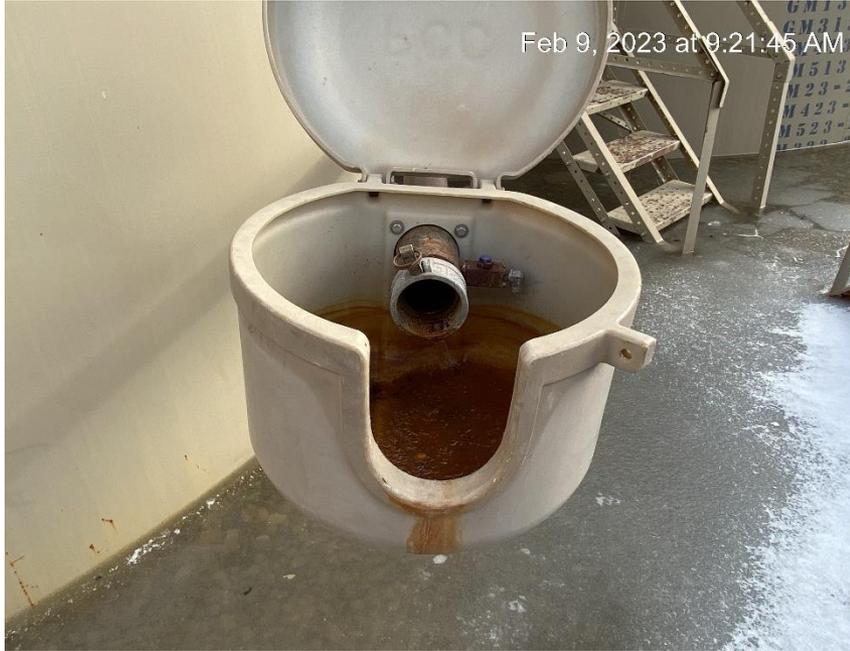
Open end loadlines on condensate and produced water tanks

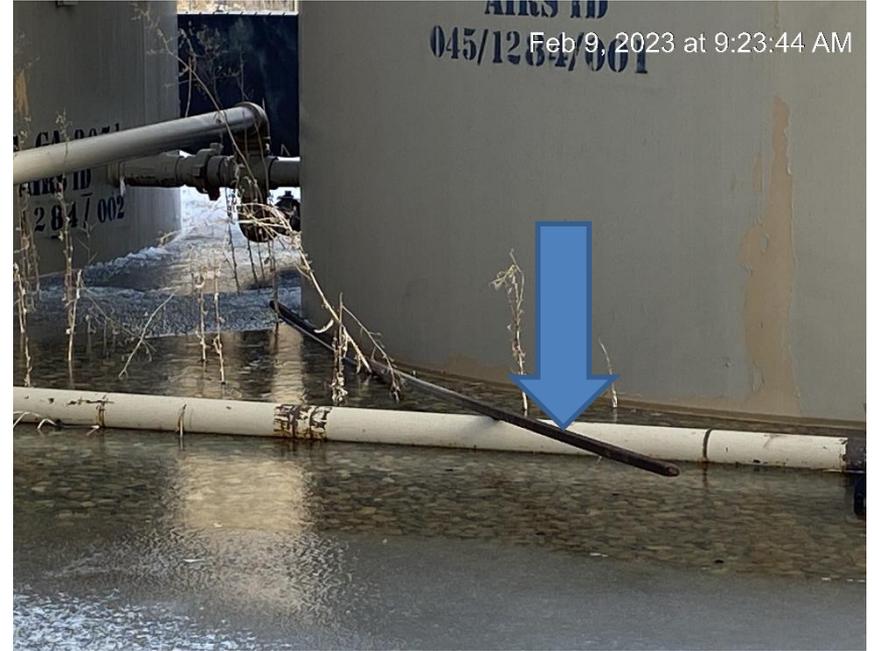
Debris inside tank battery containment

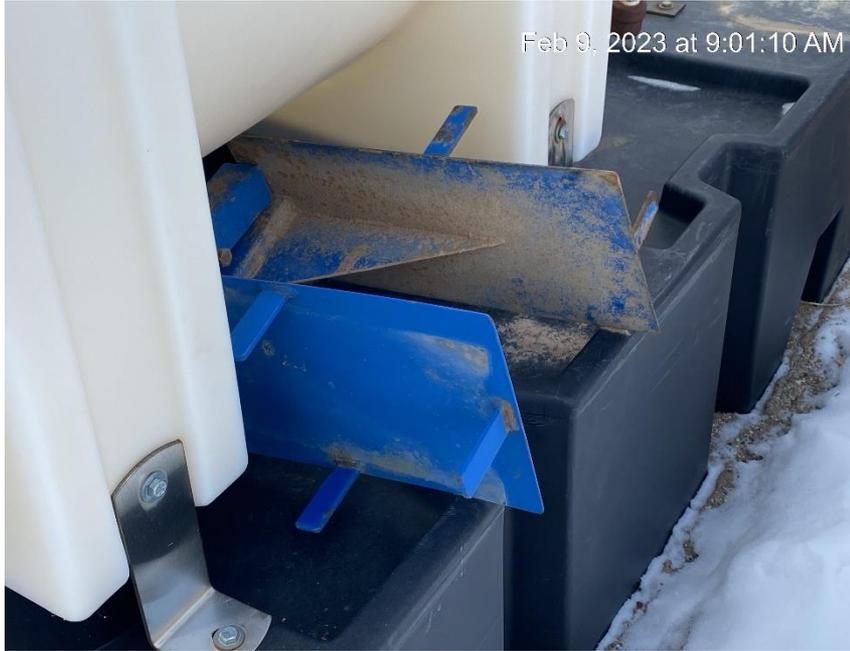
Random debris on chemical tank containments

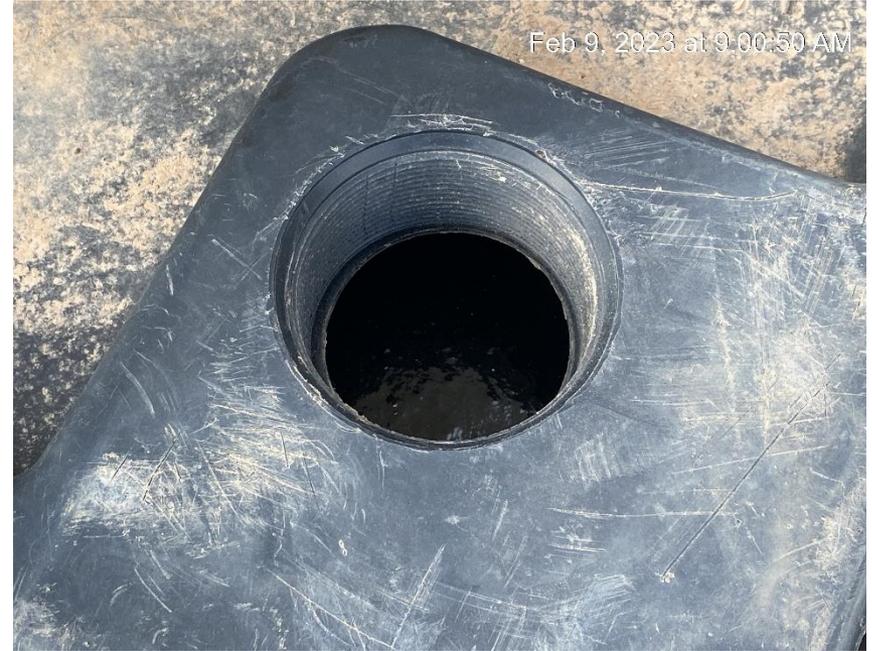
Chemical containment full of liquid

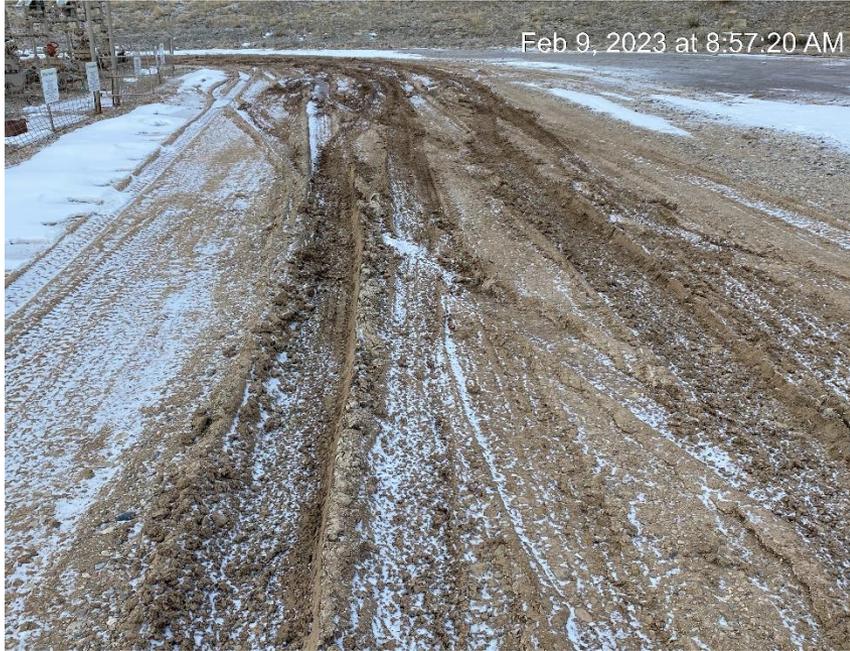
Feb 9, 2023 at 8:57:20 AM

Lack of stabilization

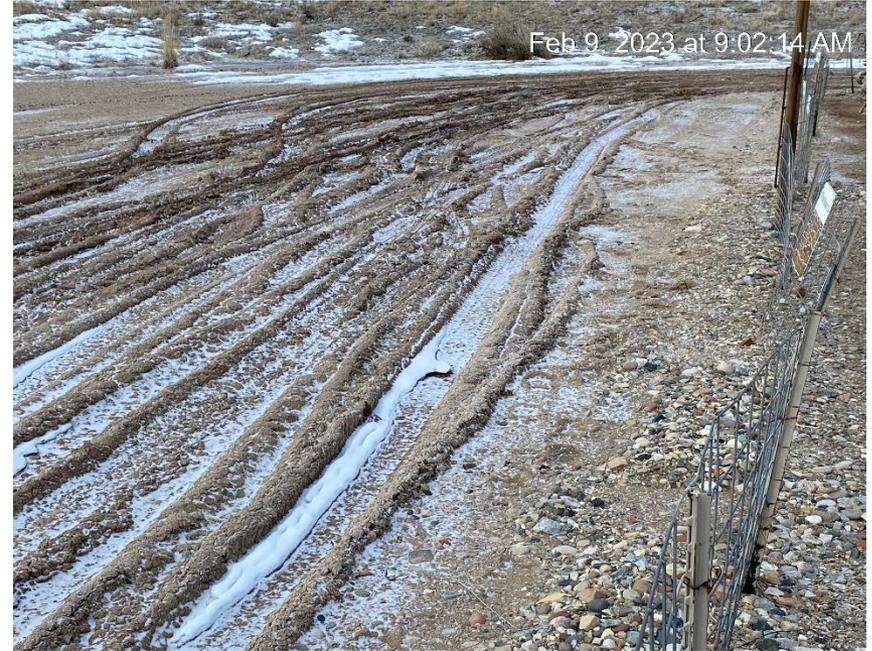
Feb 9, 2023 at 9:02:14 AM

Lack of stabilization
