# Interim Reclamation and Stormwater Inspection

Date: 02/14/2023

Operator: CIVITAS NORTH LLC - 10661

Inspection Photos  
Location Name: State 16-7-60 1H  
Location ID: 432352

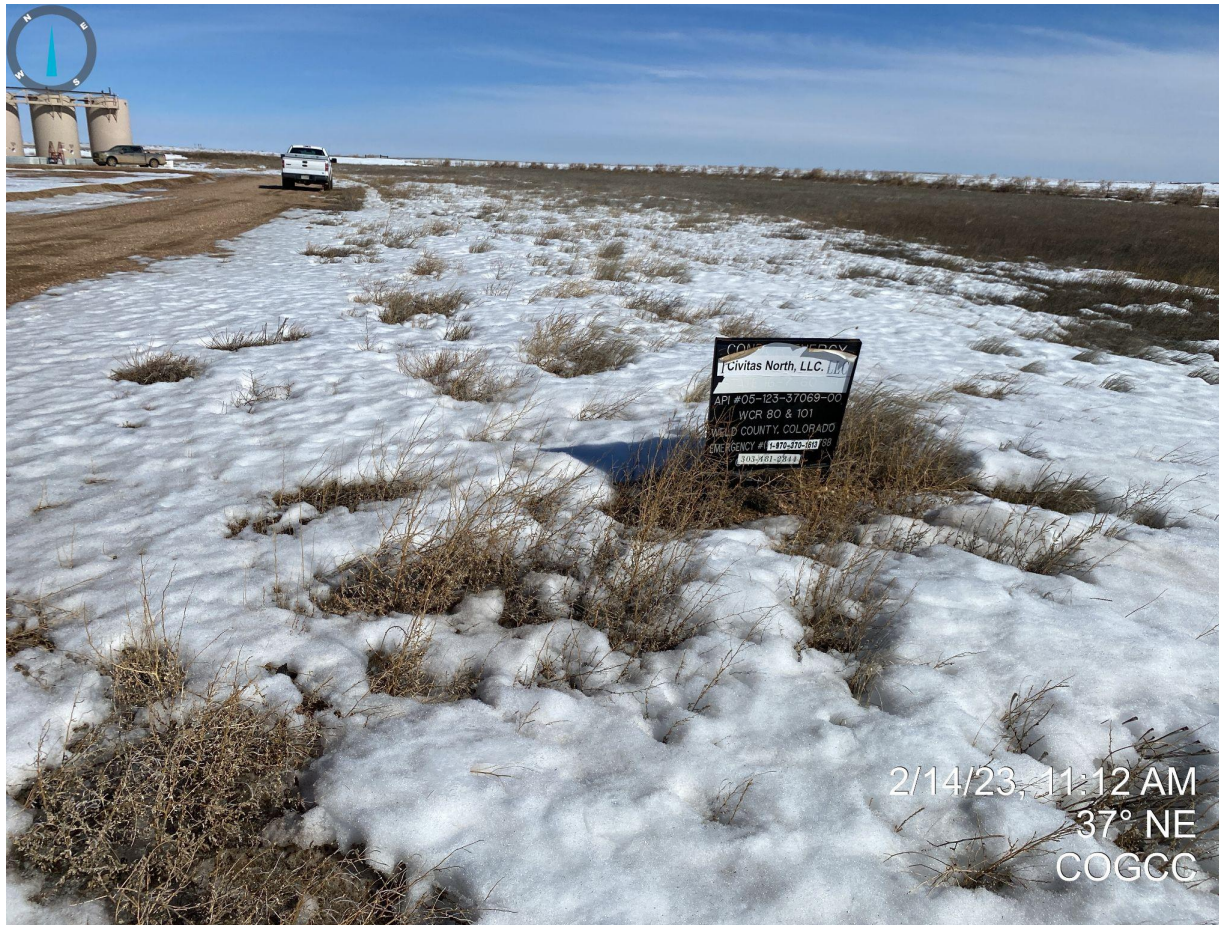
**Photo 1.** Facing northeast near the location's entrance. Photo illustrates that undesirable vegetation was observed throughout the interim reclamation areas. The operator will need to manage the location for undesirable vegetation during the next growing season to ensure compliance with Rule 1003.

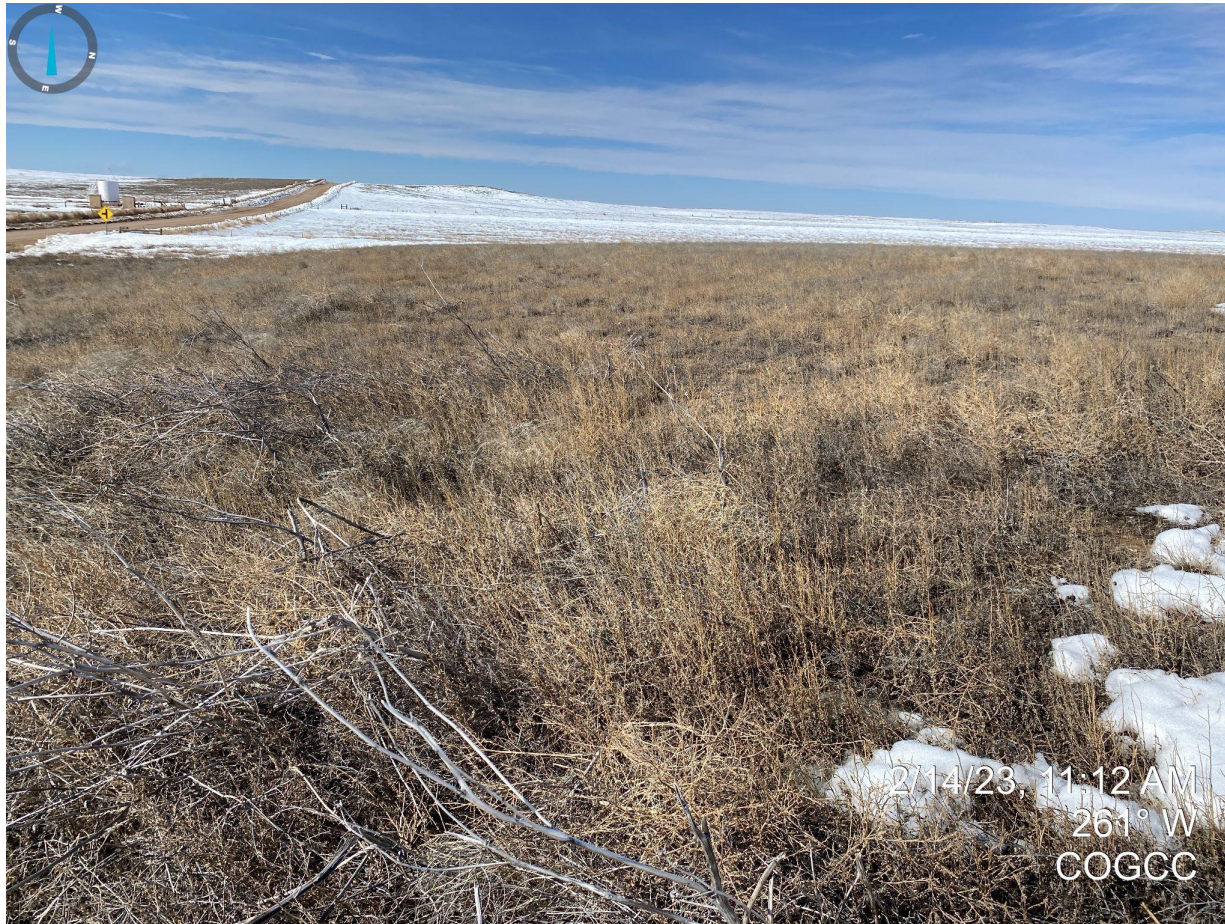
**Photo 2.** Facing west from the western portion of the location; see comments in Photo 1.

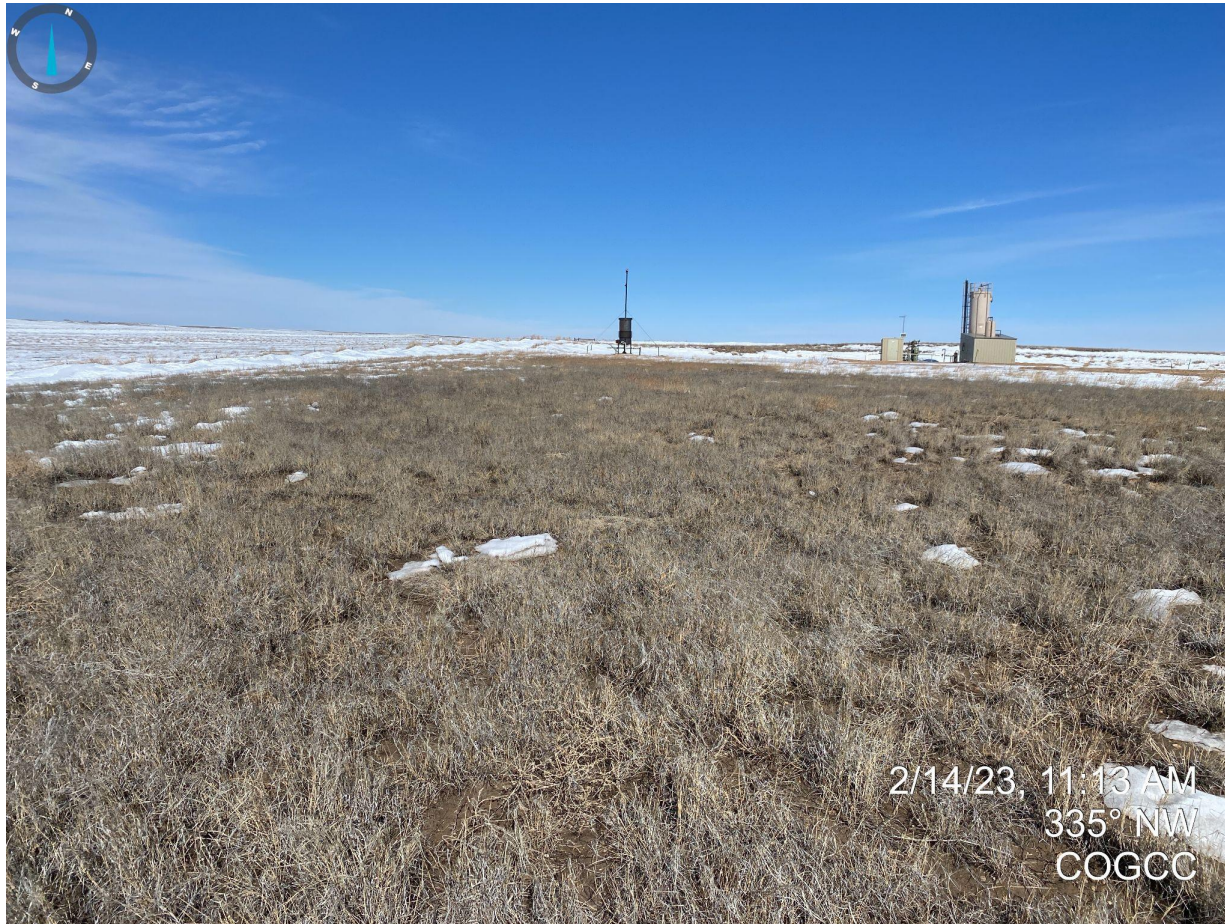
**Photo 3.** Facing northwest, from the western portion of location; see comments in Photo 1.

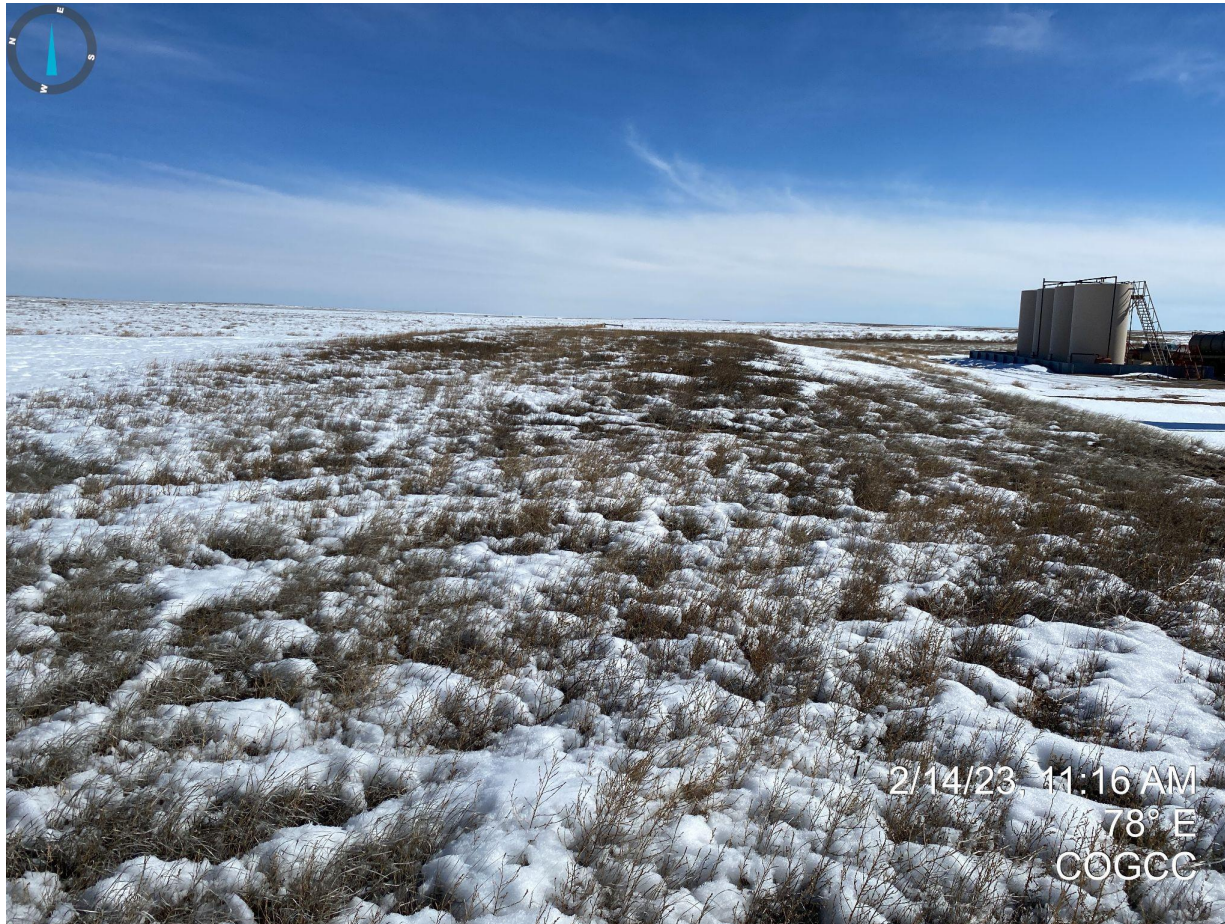
**Photo 4.** Facing east from the northern portion of location; see comments in Photo 1.

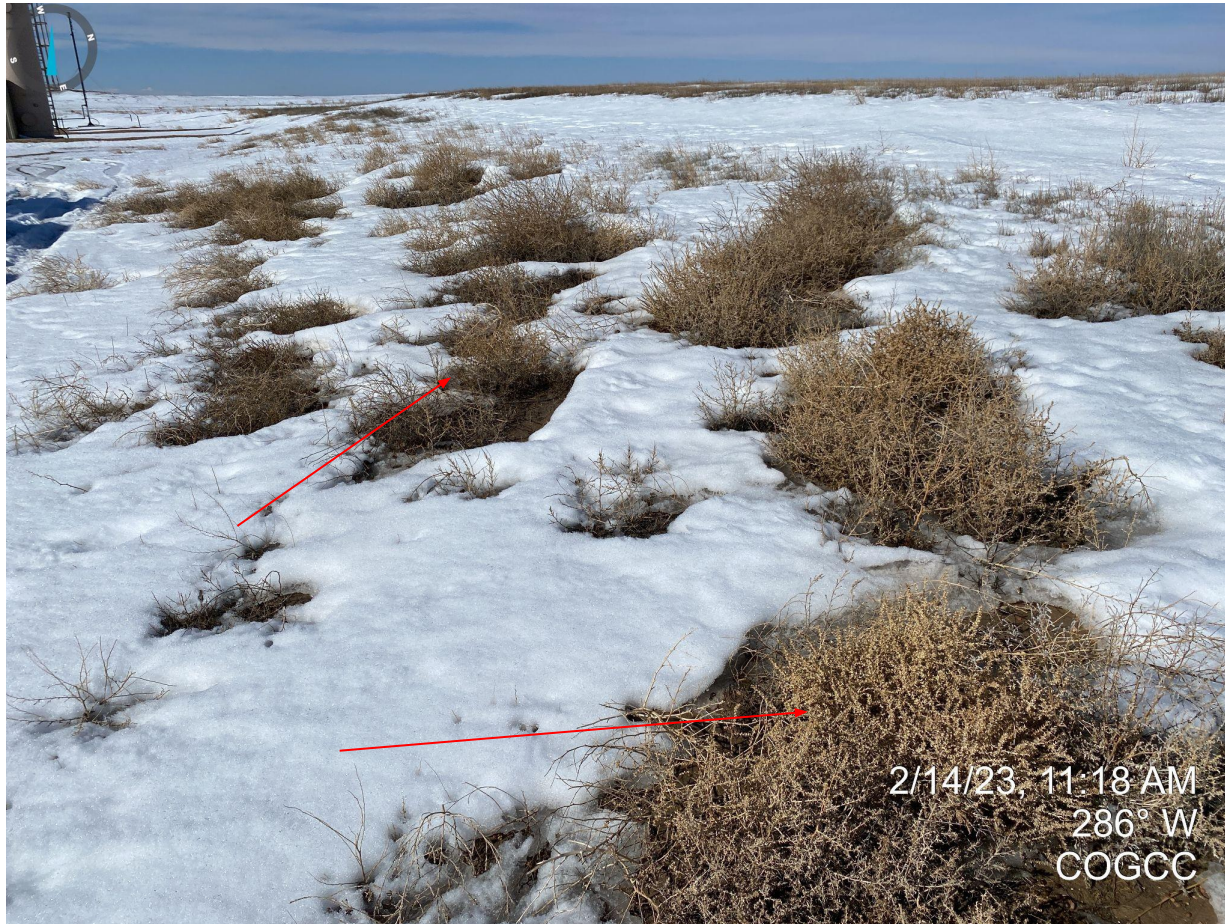
**Photo 5.** Facing west from the northern portion; russian thistle and kochia observed.

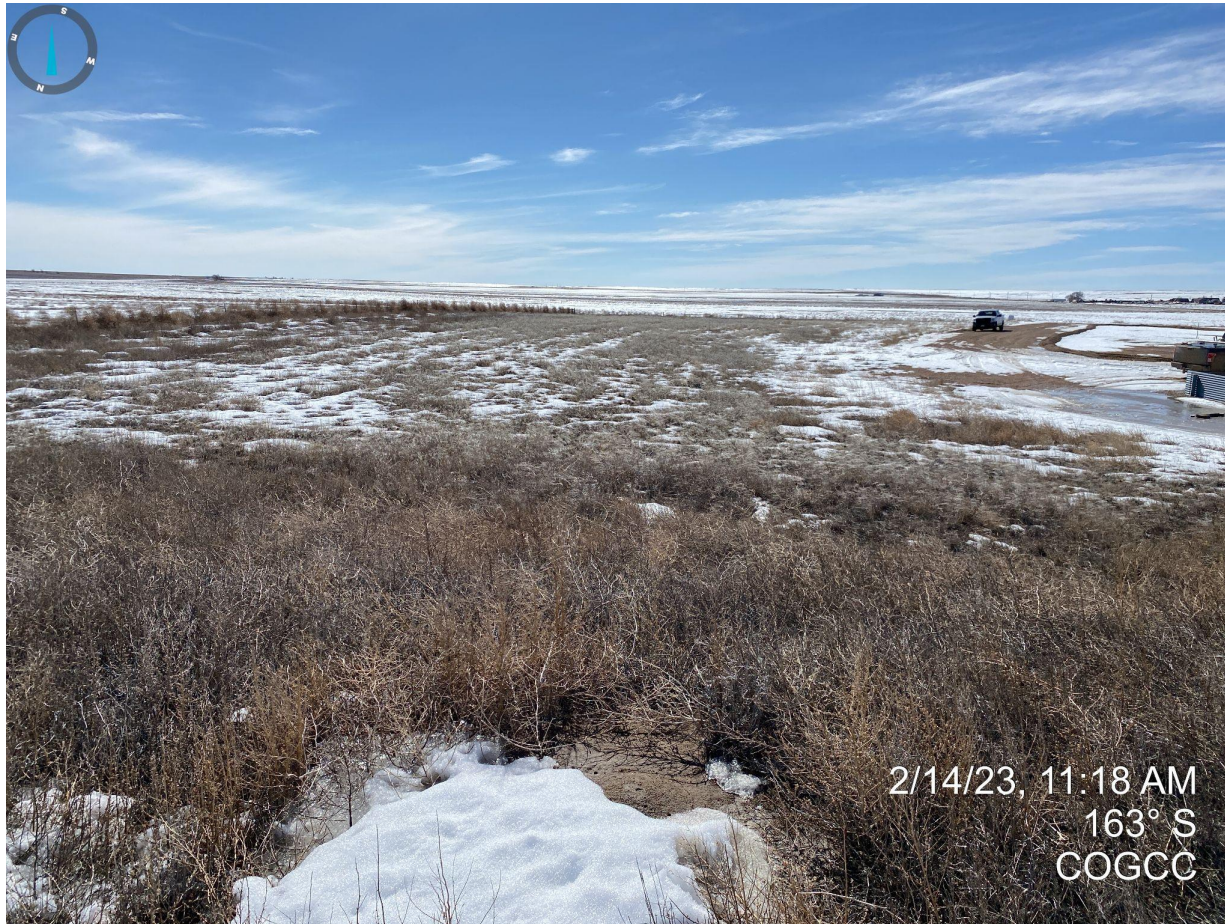
**Photo 6.** Facing south from the northeast corner of location; see comments in Photo 1.

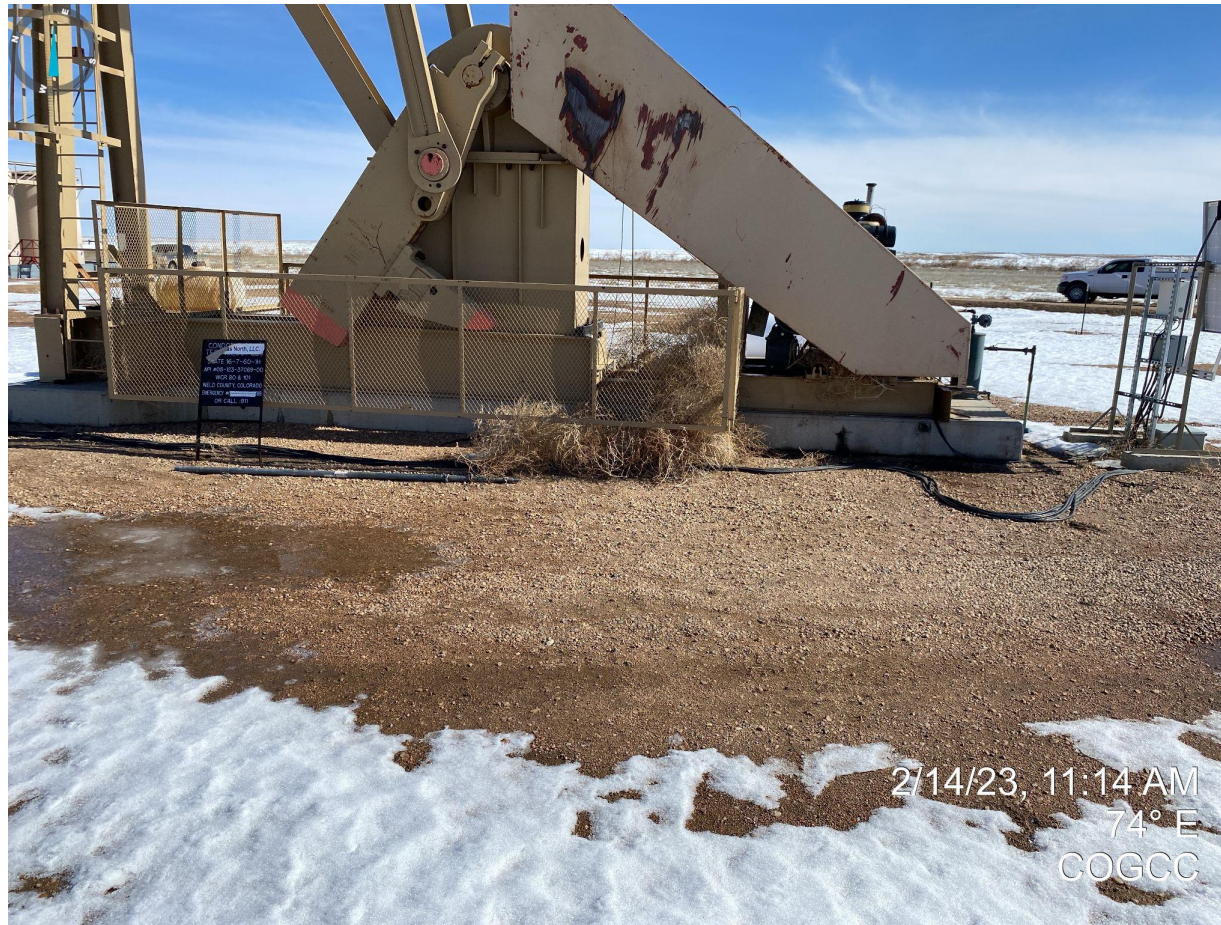
**Photo 7.** Facing east at pump jack; tumbleweed accumulations within equipment are considered debris and need to be removed as they are a potential fire hazard.

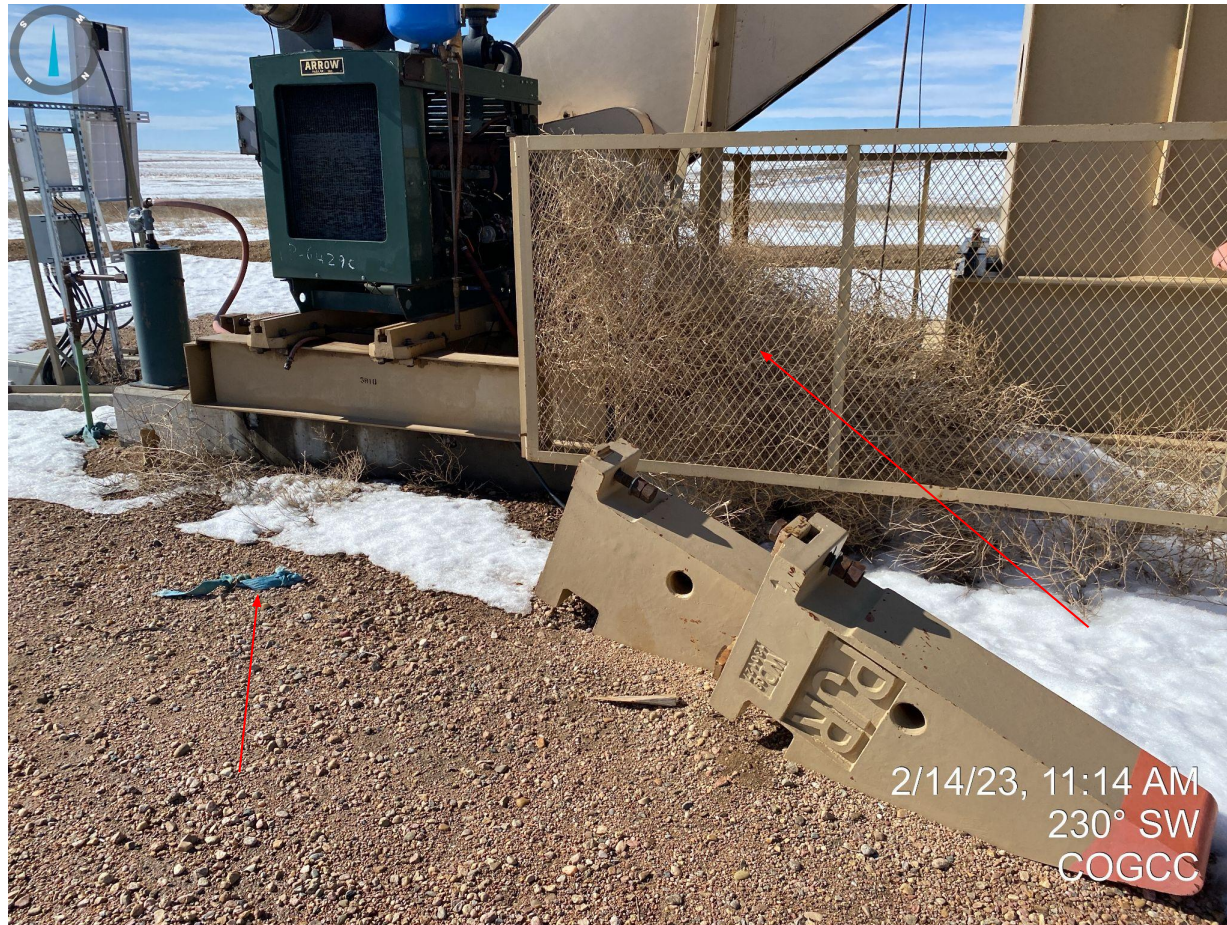
**Photo 8.** Facing southwest; see comments in Photo 7.

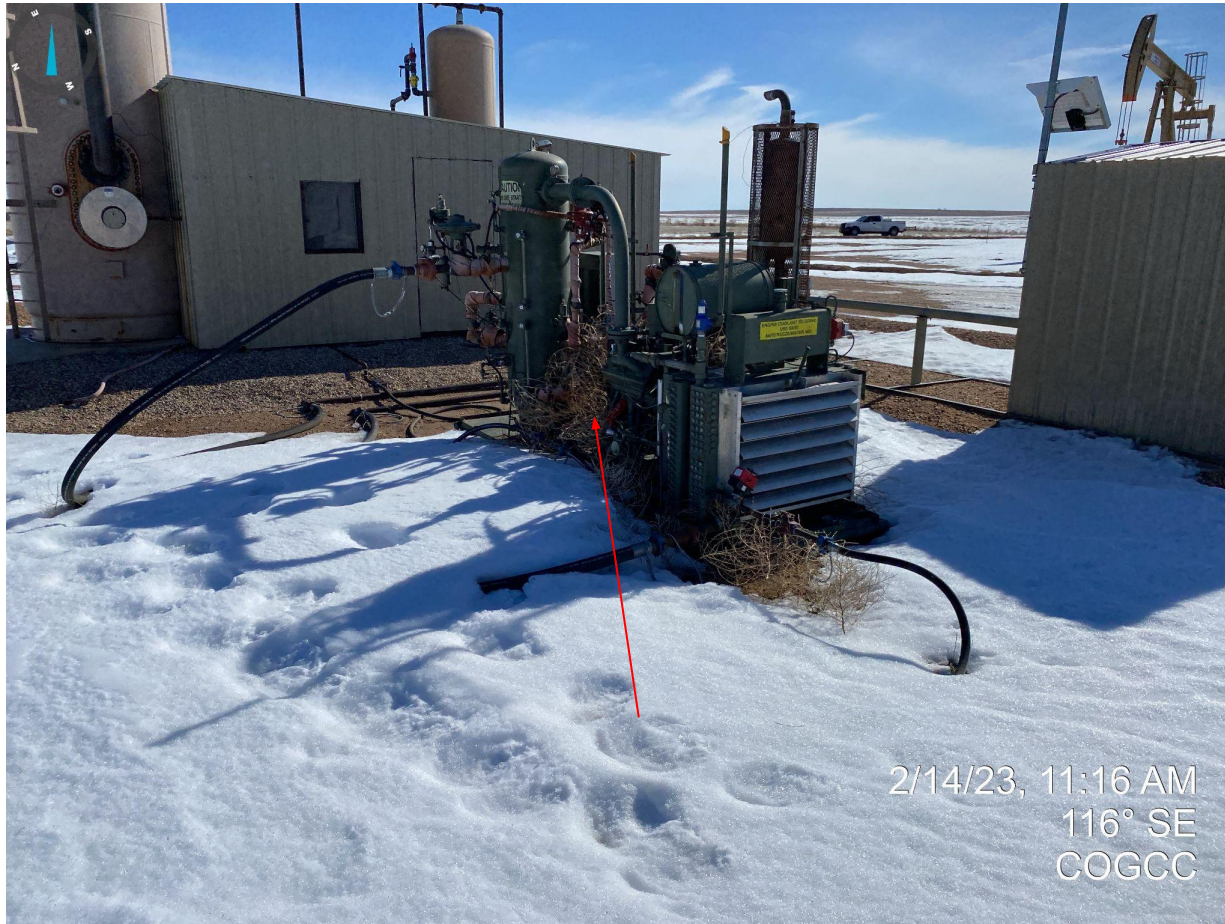
**Photo 9.** Facing southeast from the northwest corner of production area; see comments in Photo 7.

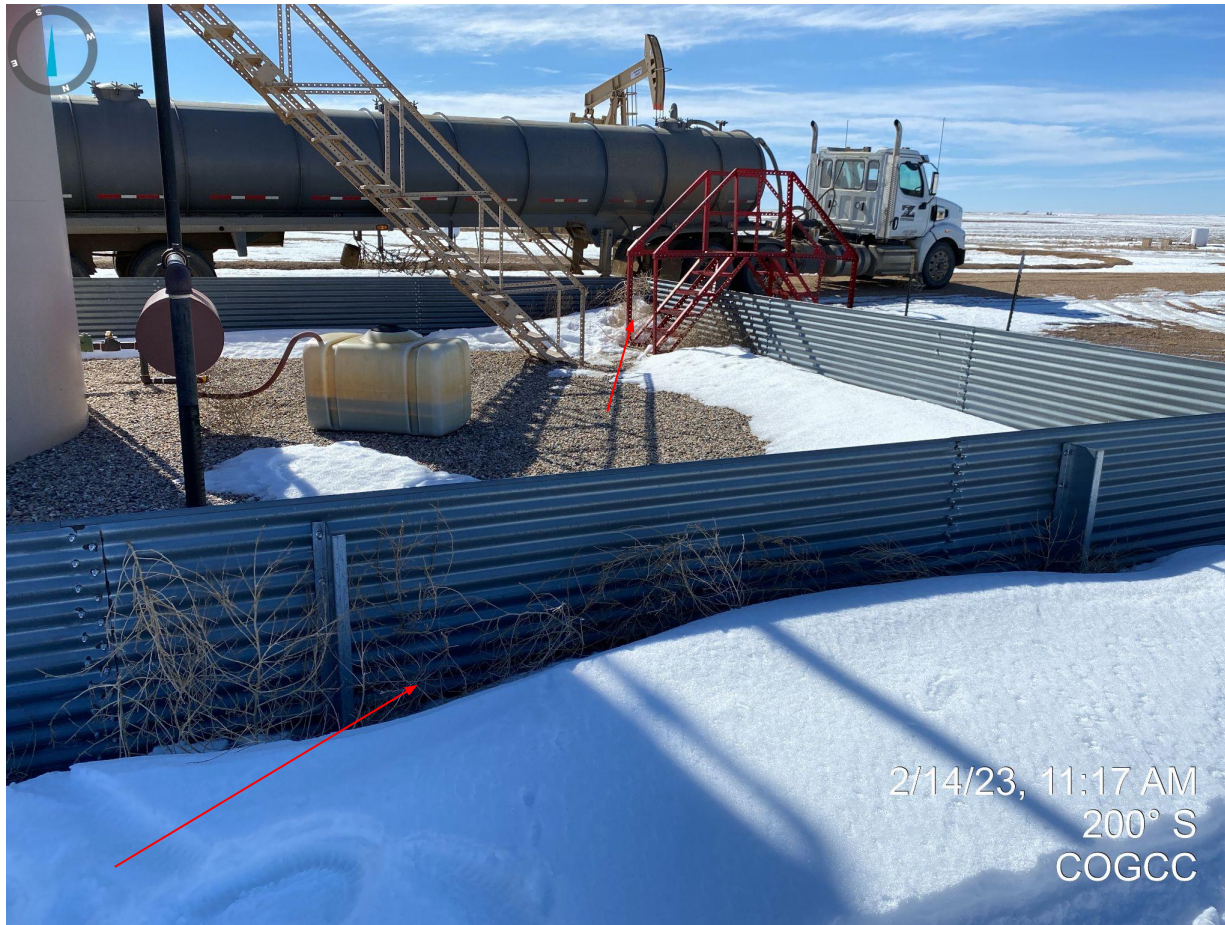
**Photo 10.** Facing south at tank battery; see comments in Photo 7.

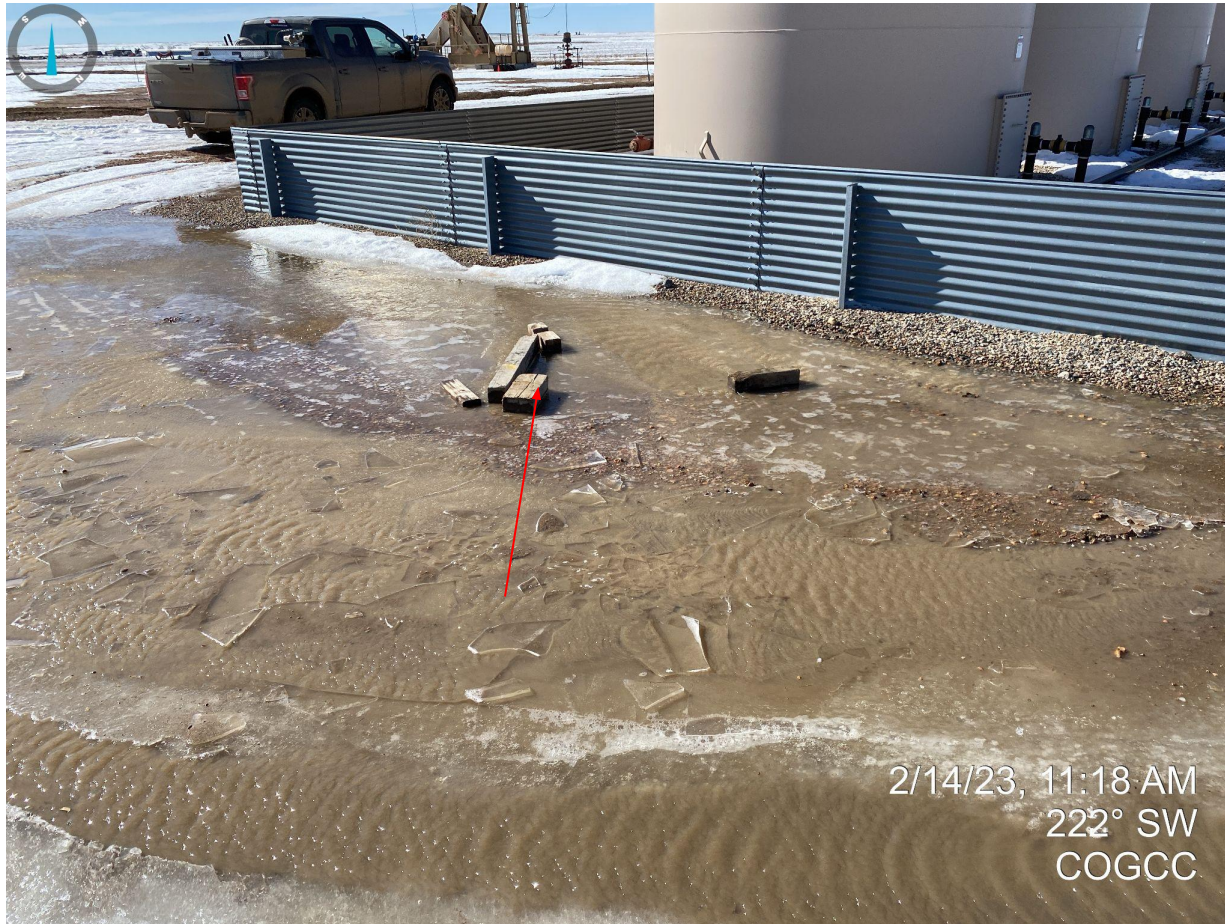
**Photo 11.** Facing southwest at tank battery; See comments in Photo 7.
