# Interim Reclamation and Stormwater Inspection

Operator: VERDAD RESOURCES LLC- 10651

Location ID: 424238

Inspection Photos  
Location Name: Pergamos 3-44-7-60  
Location ID: 424238

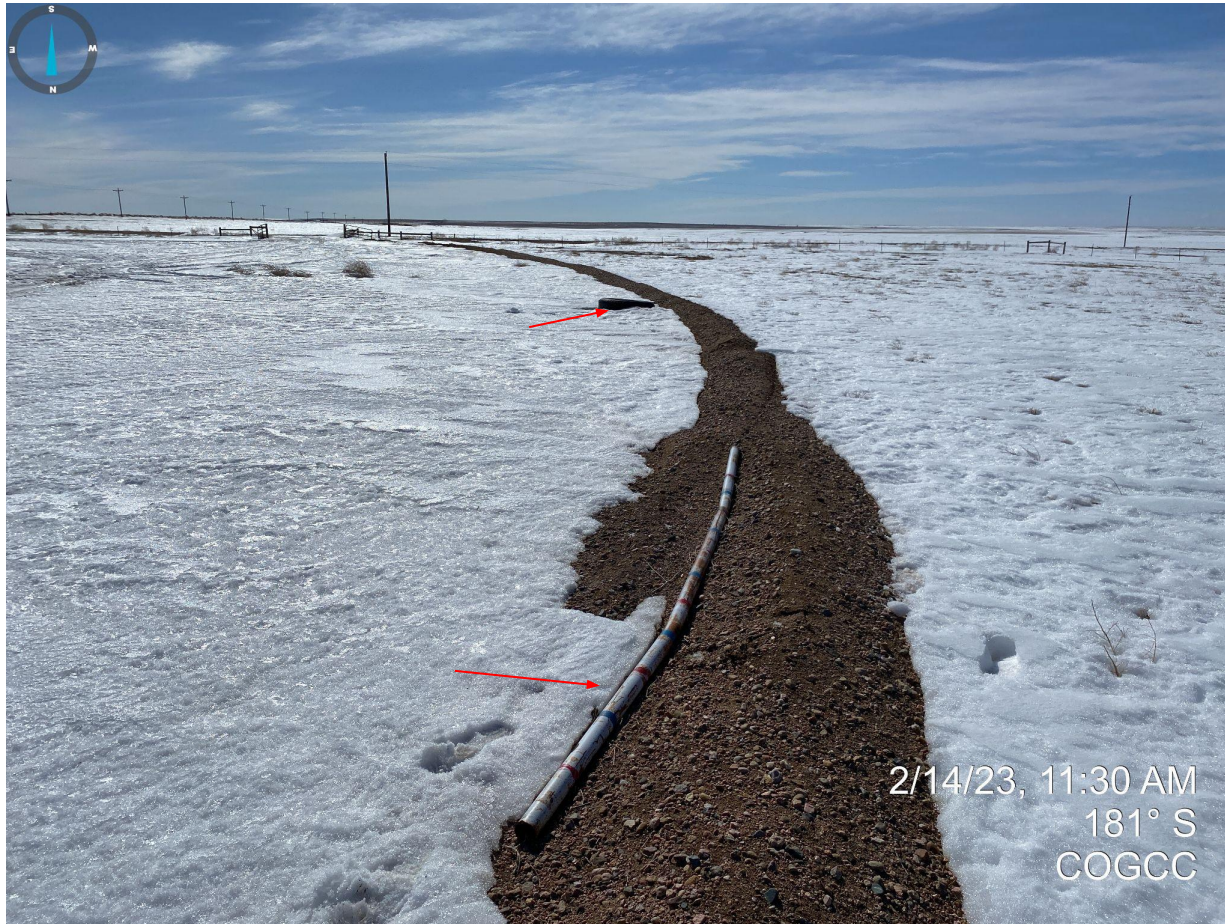
**Photo 1.** Facing south from the center of location; Debris was observed on location (e.g. tire and pipe) that will need to be removed.

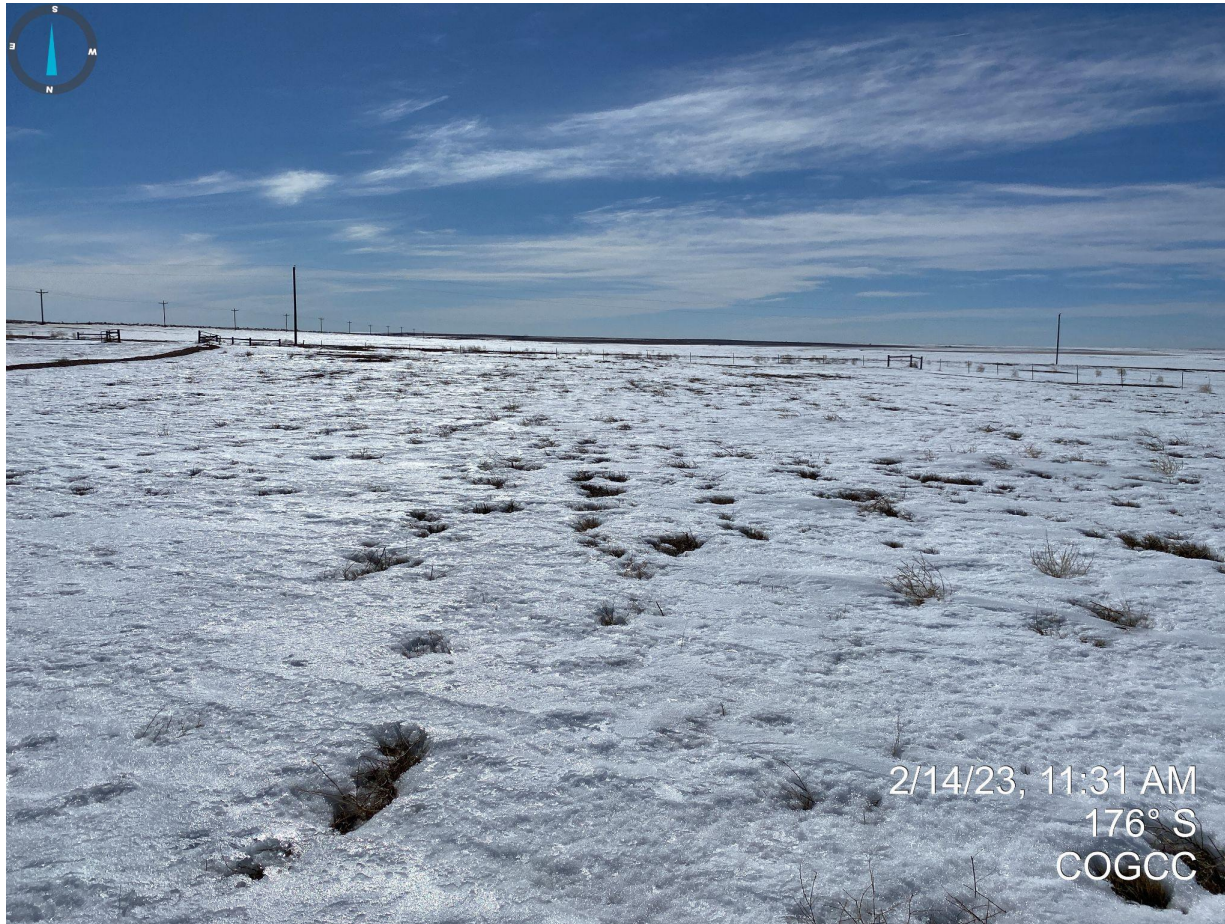
**Photo 2.** Facing south from the western interim reclamation area. Due to snow cover, Staff was unable to verify vegetation and the location will need to be inspected at a future date to ensure compliance with Rule 1003 standards.

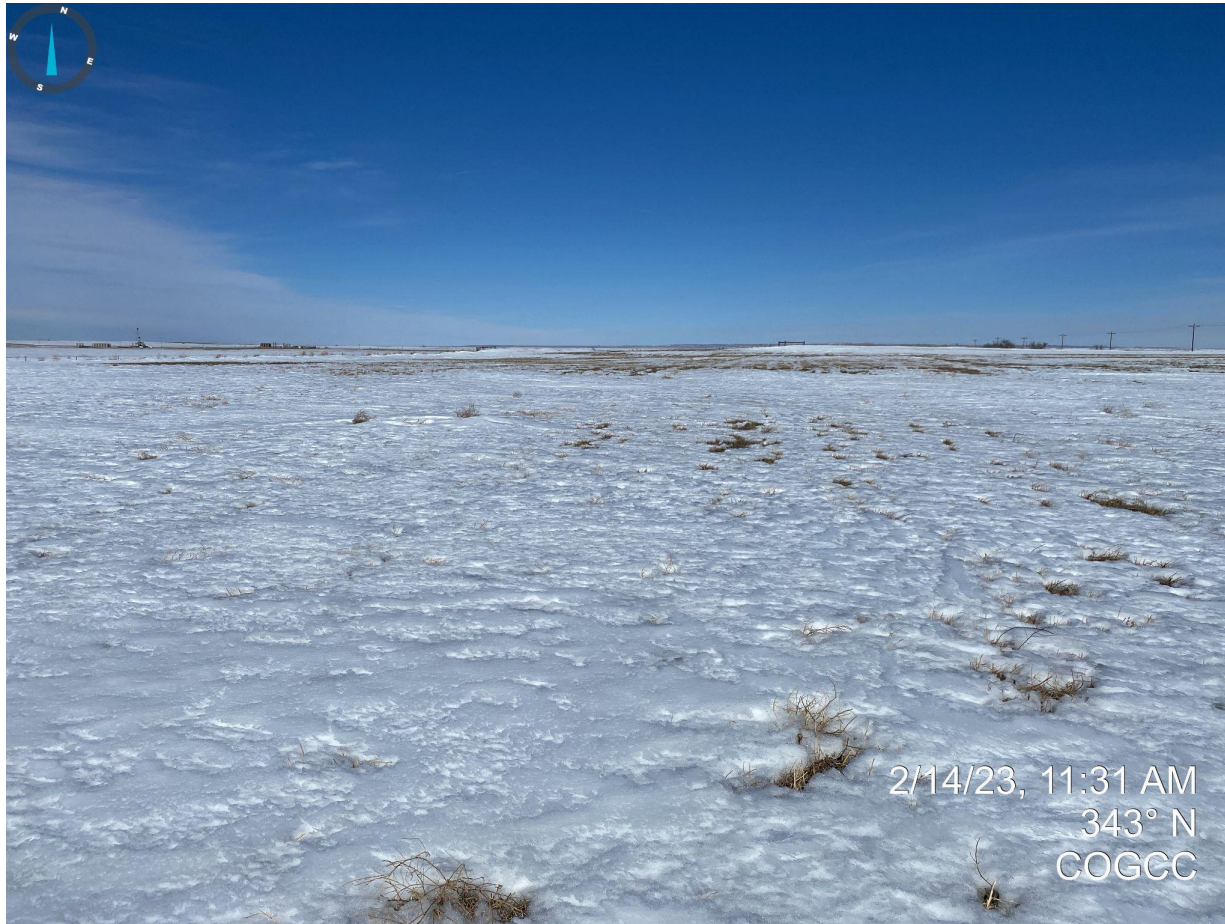
**Photo 3.** Facing north; see comments in Photo 2.

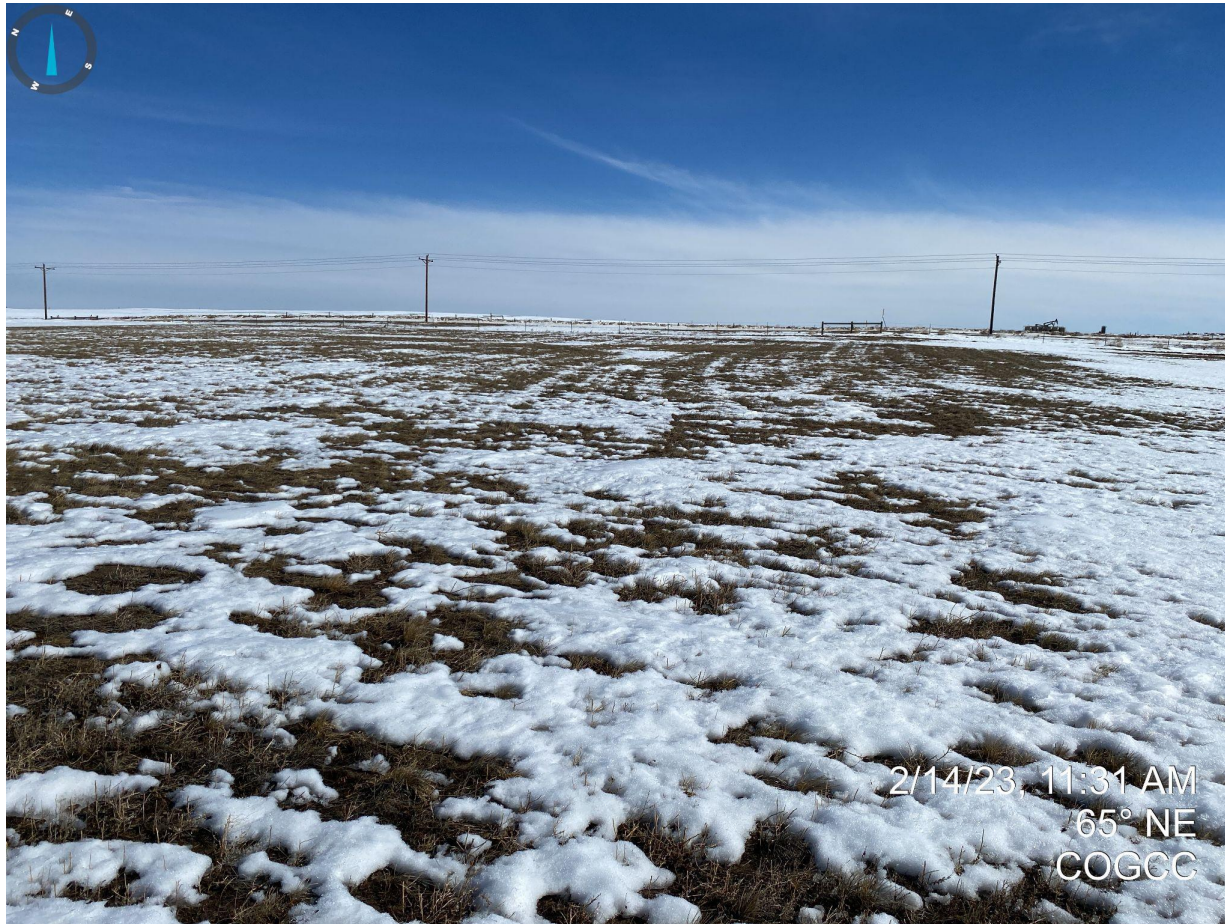
**Photo 4.** Facing northeast at the former/reclaimed pit; see comments in Photo 2.

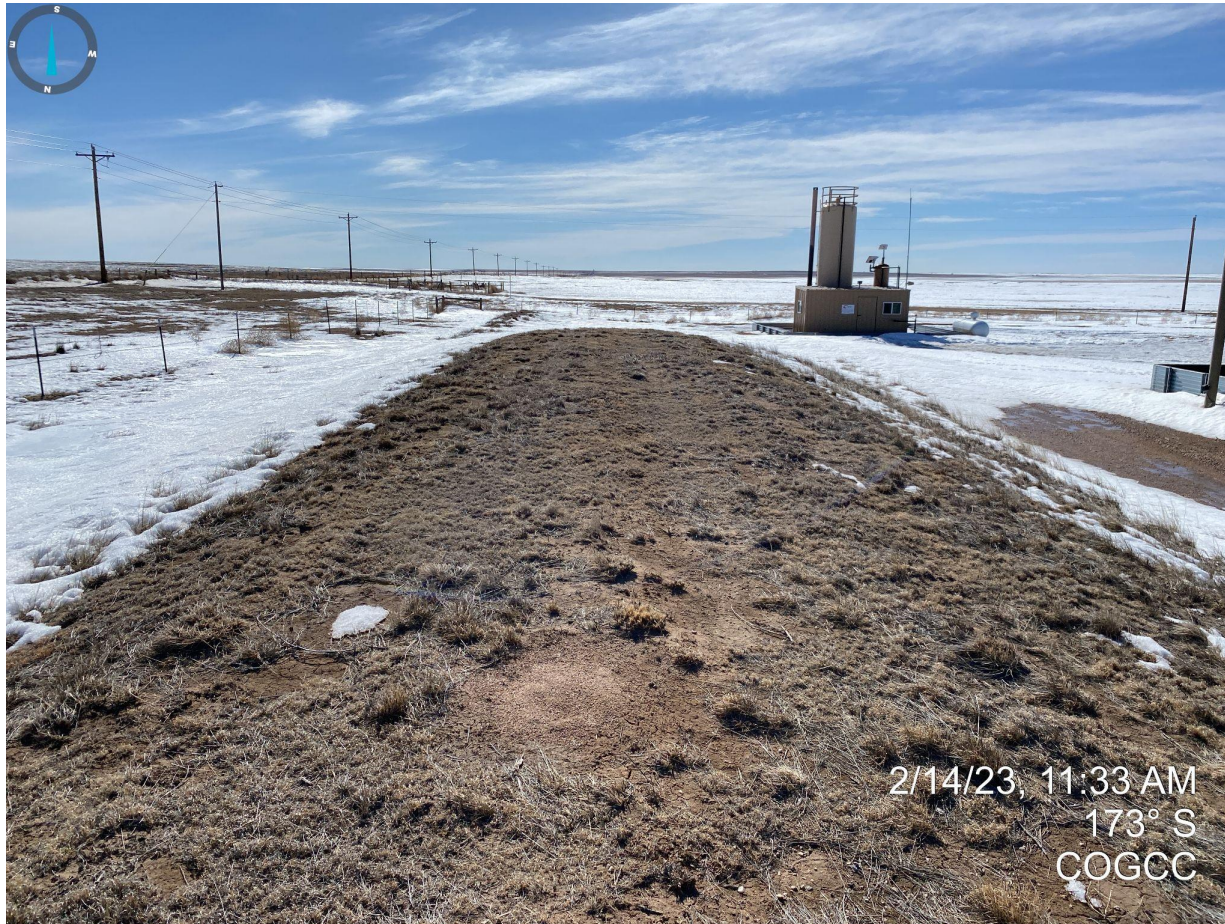
**Photo 5.** Facing south from on top of the topsoil stockpile. Photo illustrates some desirable vegetation (e.g. buffalo grass) was observed during this inspection and the location will be inspected at a future date to verify vegetation standards in accordance to Rule 1003.

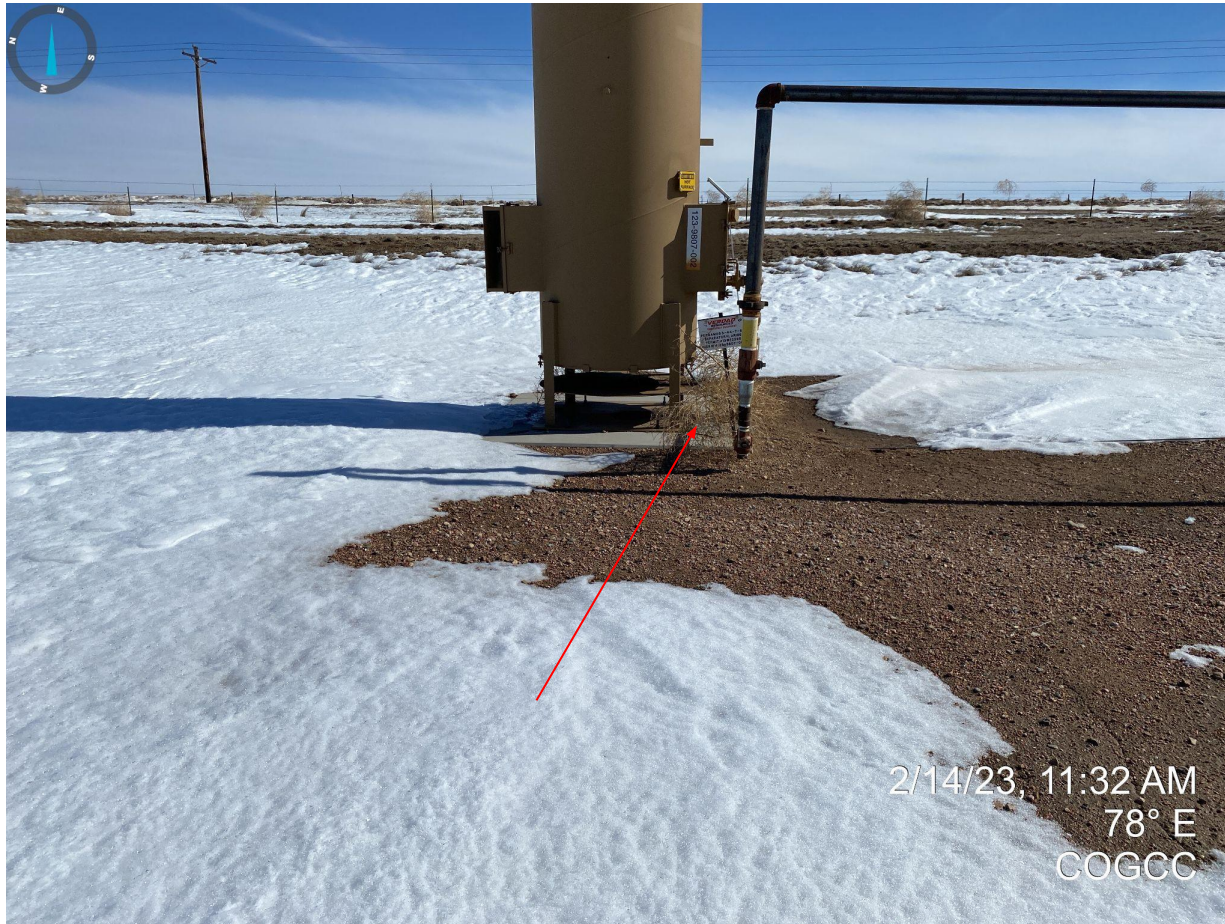
**Photo 6.** Facing east at combustor; tumbleweed accumulations were observed near and around equipment and are considered debris. The operator will need to remove this potential fire hazard.

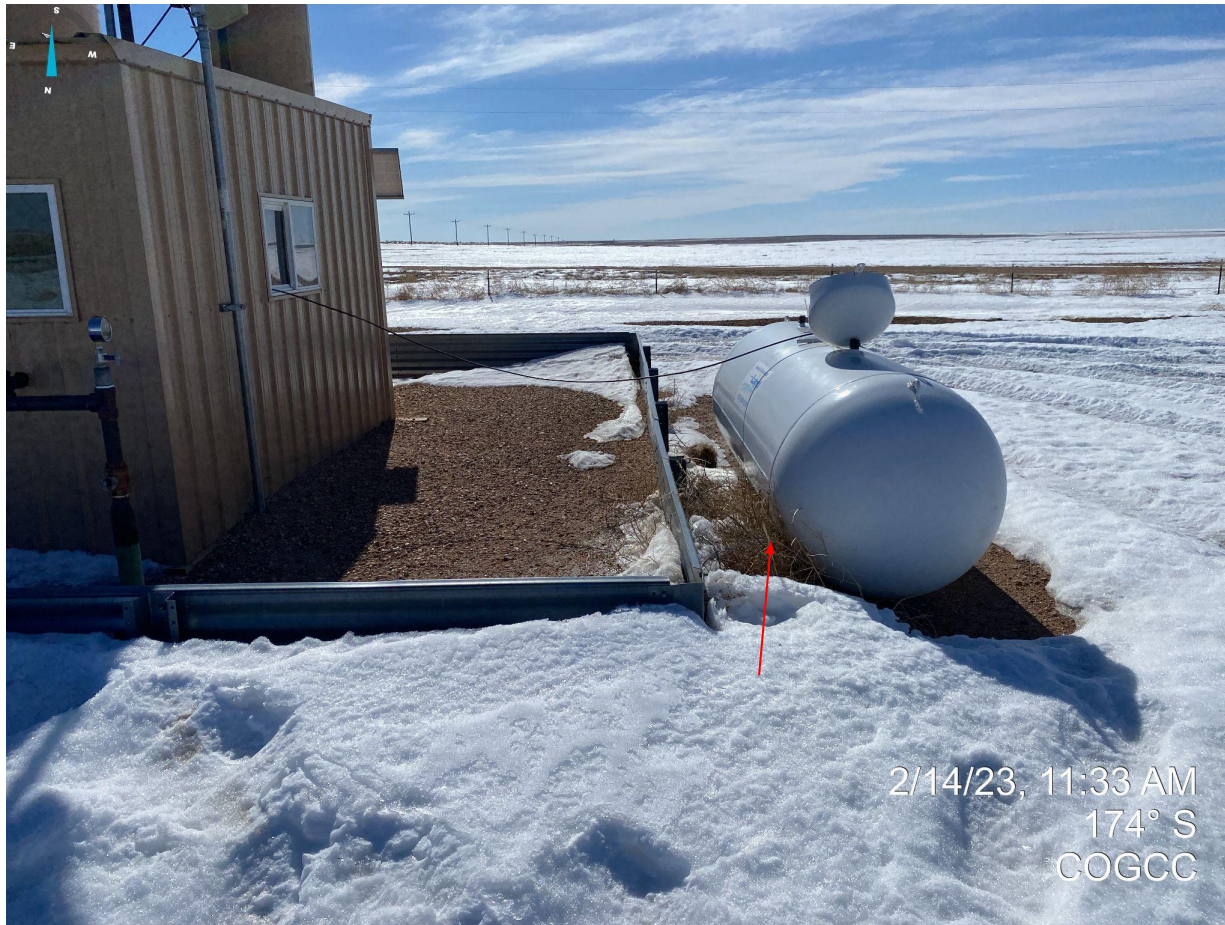
**Photo 7.** Facing south at treater/gauge station; see comments in Photo 6.

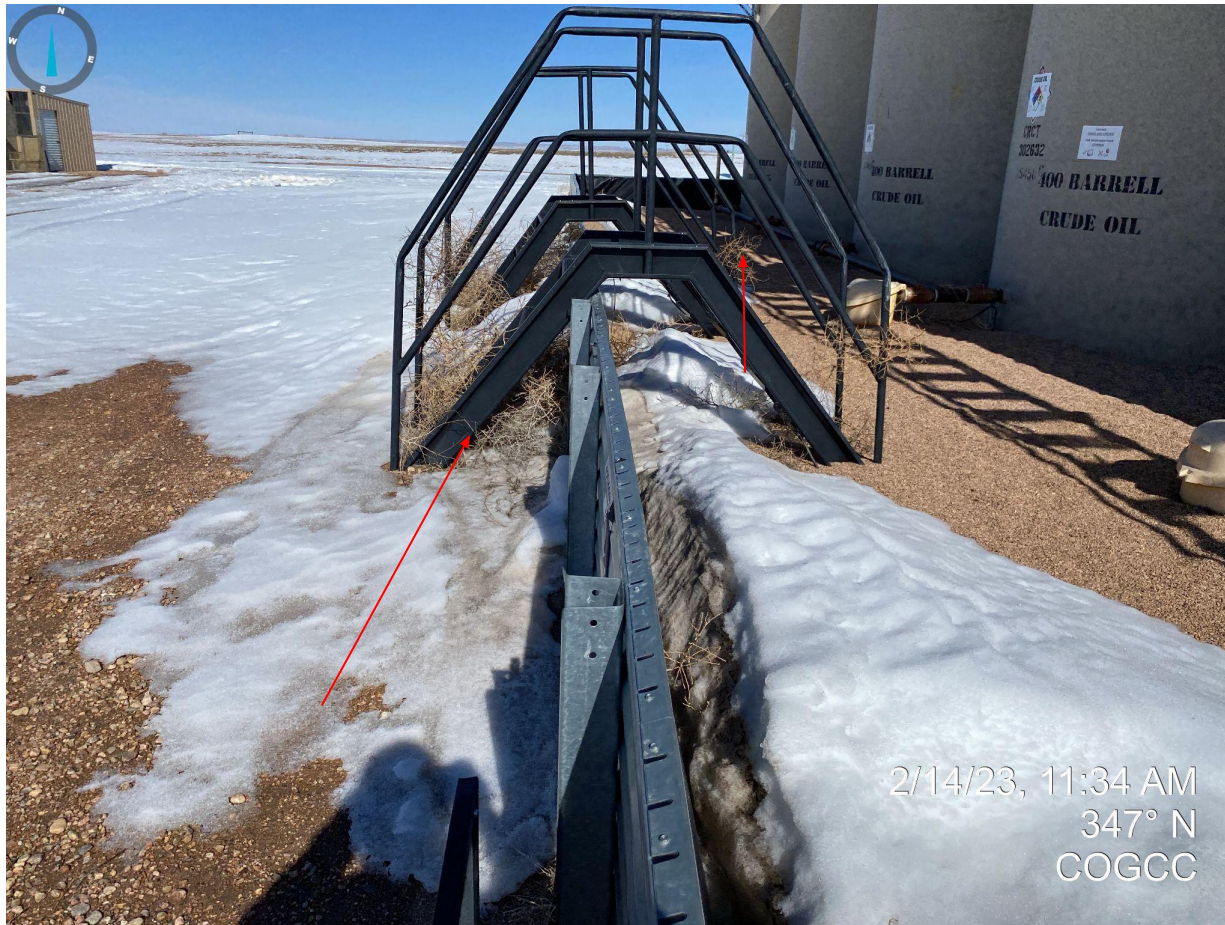
**Photo 8.** Facing north at the tank battery; see comments in Photo 6.

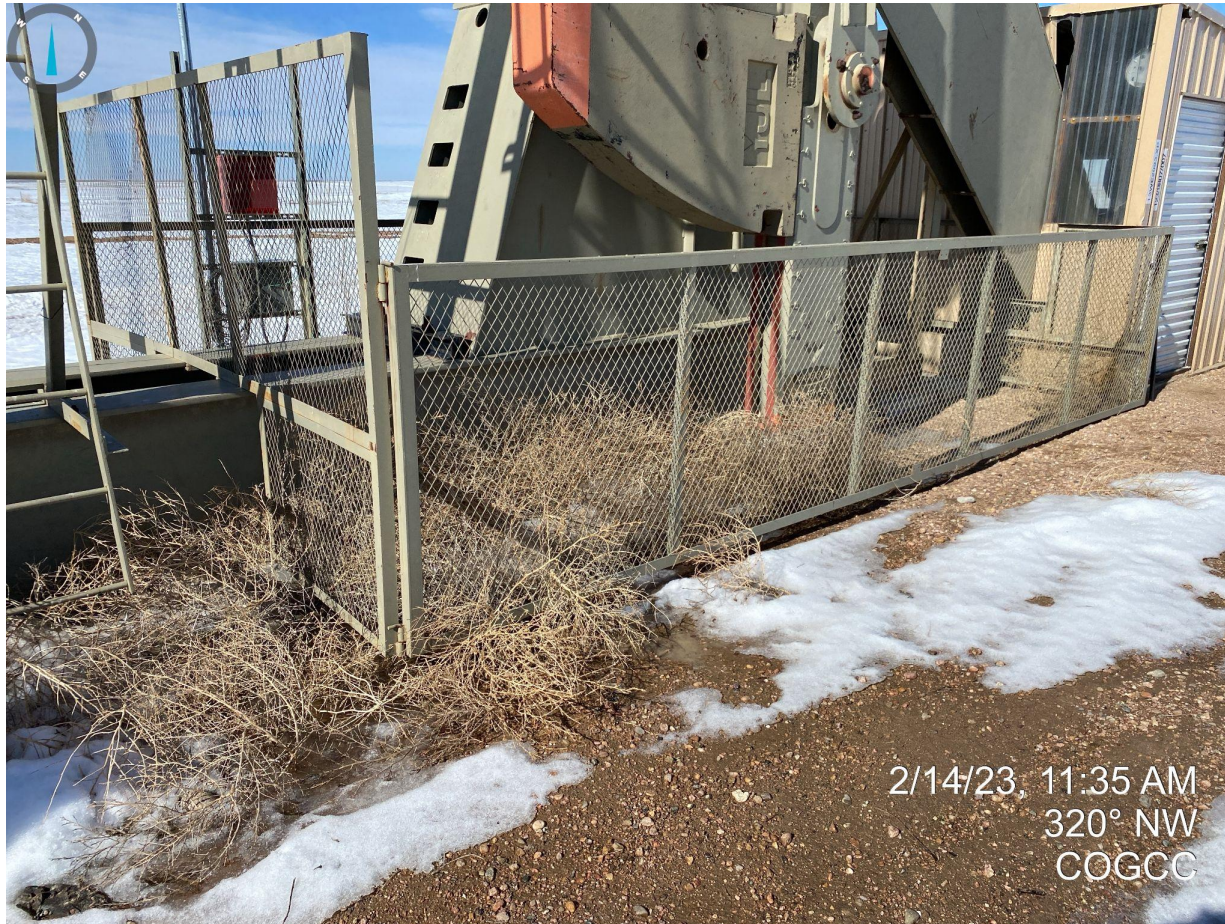
**Photo 9.** Facing northwest at the pump jack; see comments in Photo 6.

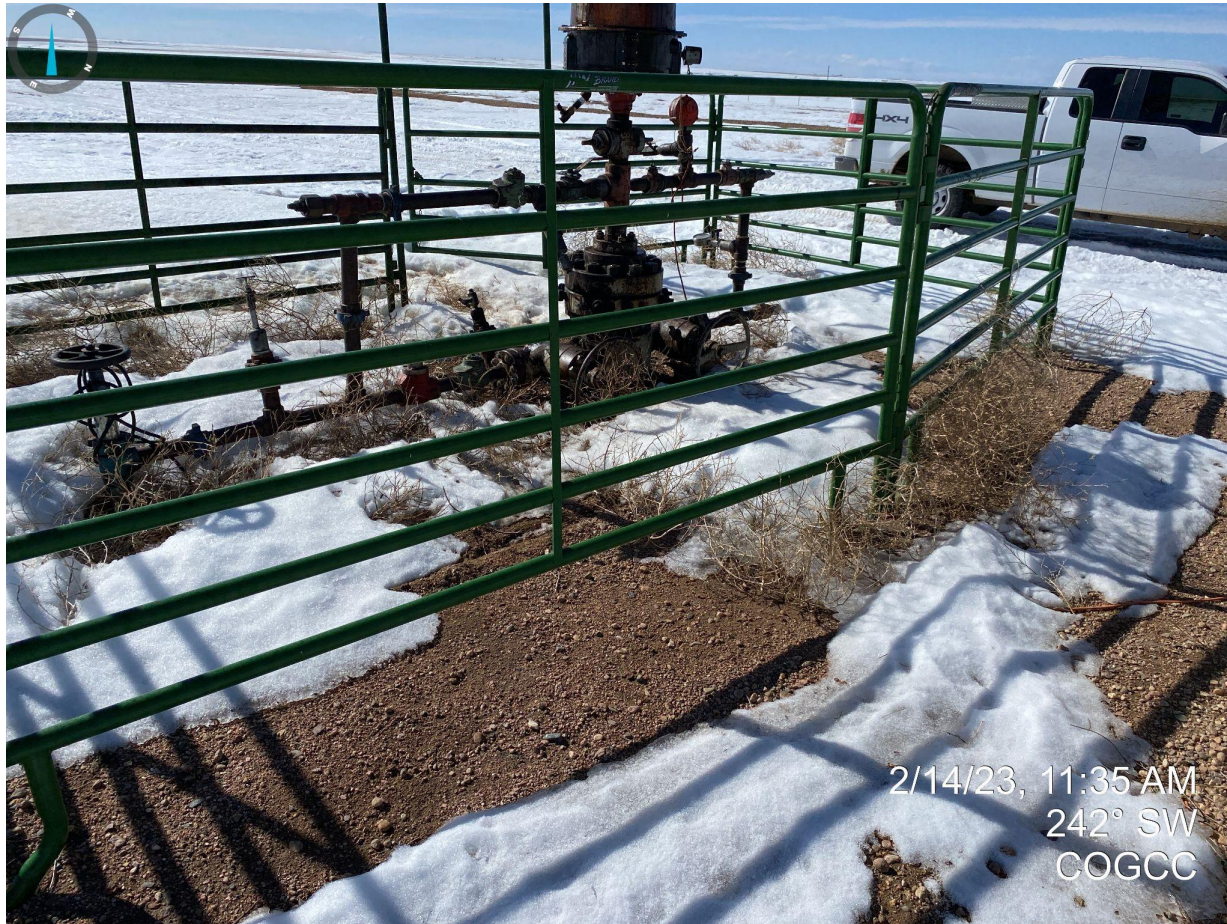
**Photo 10.** Facing southwest at the wellhead; see comments in Photo 6.

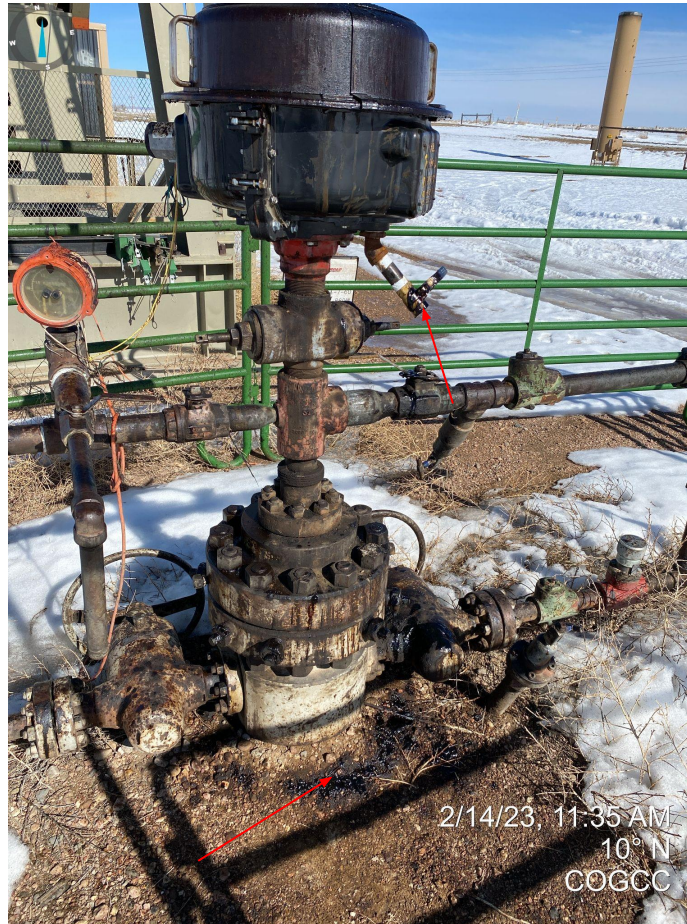
**Photo 11.** Facing north at the wellhead. Oil stained soil was observed during this inspection. The operator shall clean up the stained soil and perform maintenance on equipment to ensure leaks are addressed.
