# Interim Reclamation and Stormwater Inspection

Operator: RED HAWK PETROLEUM - 10503

Location ID: 438327

Inspection Photos  
Location Name: Loomis 2-1H  
Location ID: 438327

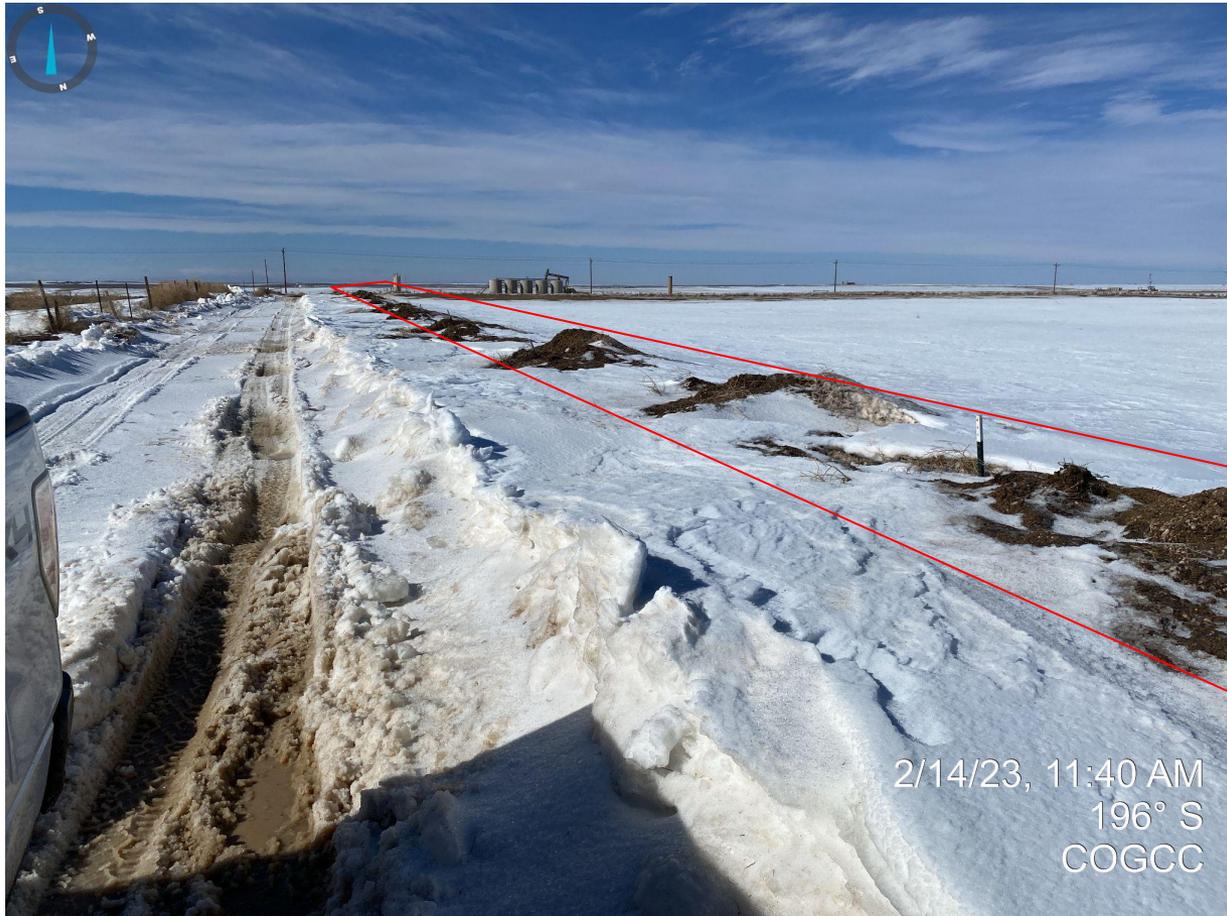
**Photo 1.** Facing south from the access road to the location. It appears the road has drifted in and been plowed. Any material inadvertently removed from the access road shall be placed back to its relative position once snow has melted to prevent off-site degradation to adjacent lands. No CA is being issued at this time.

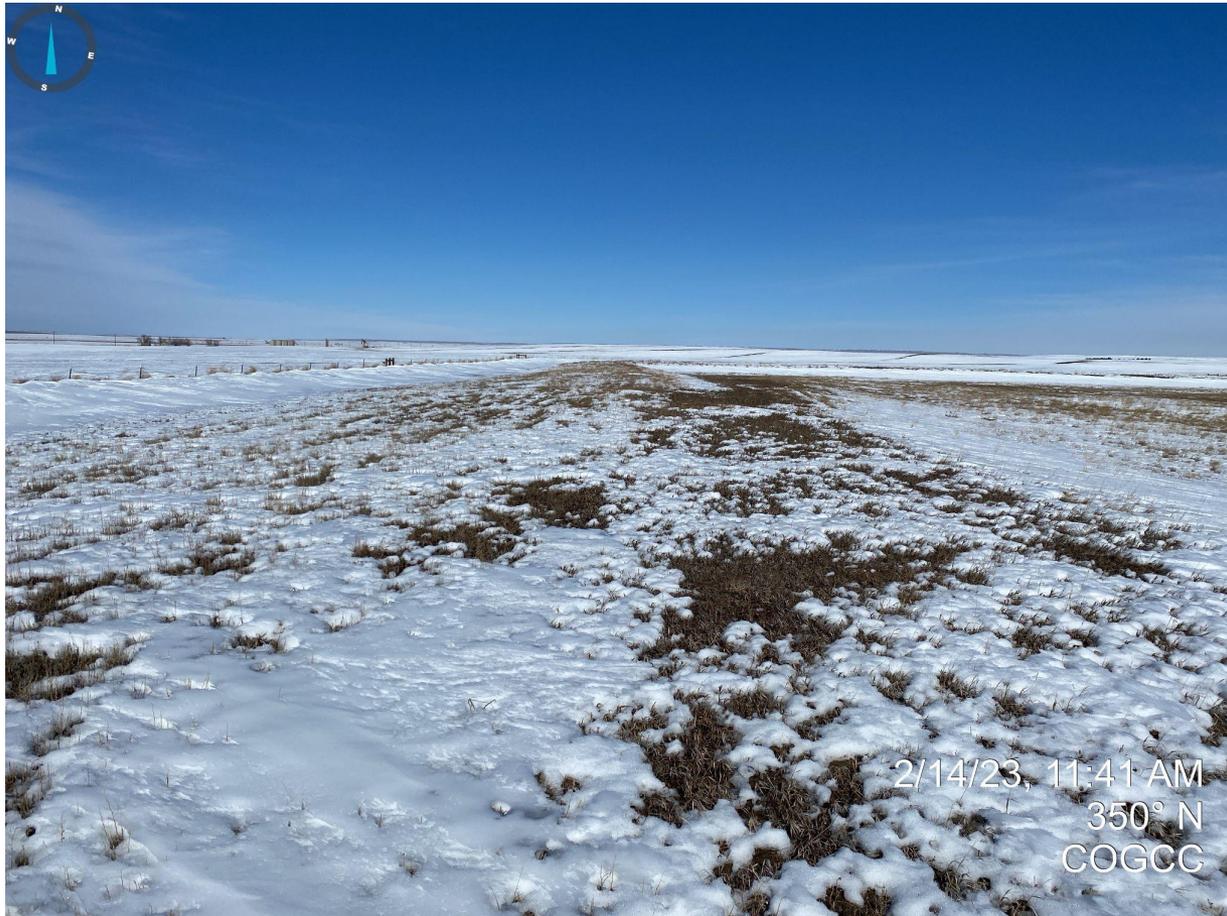
**Photo 2.** Facing north from the interim areas. Due to snow cover, this location will be inspected at a future date to ensure compliance with Rule 1003 standards.

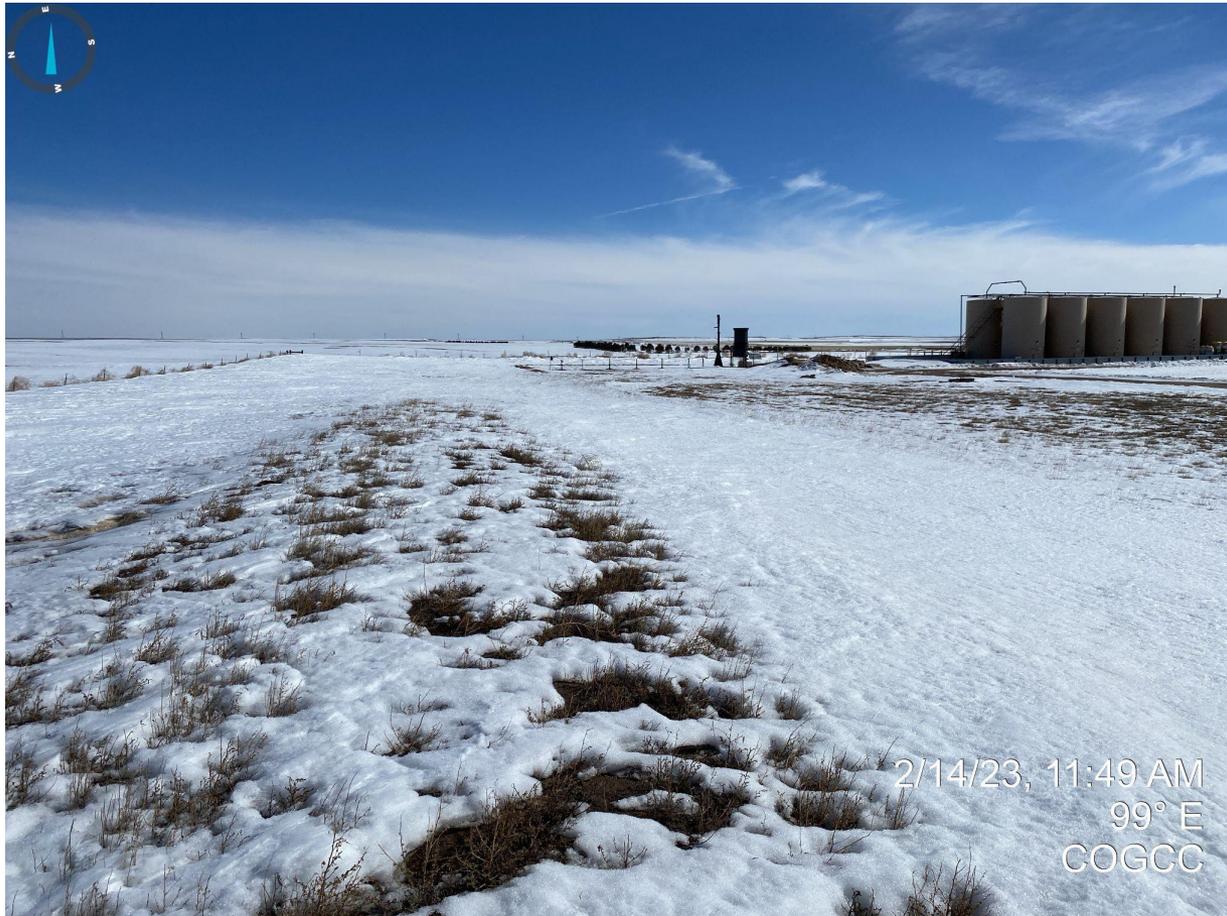
**Photo 3.** Facing east from the topsoil stockpile on the northern portion of the location; see comments in Photo 2.

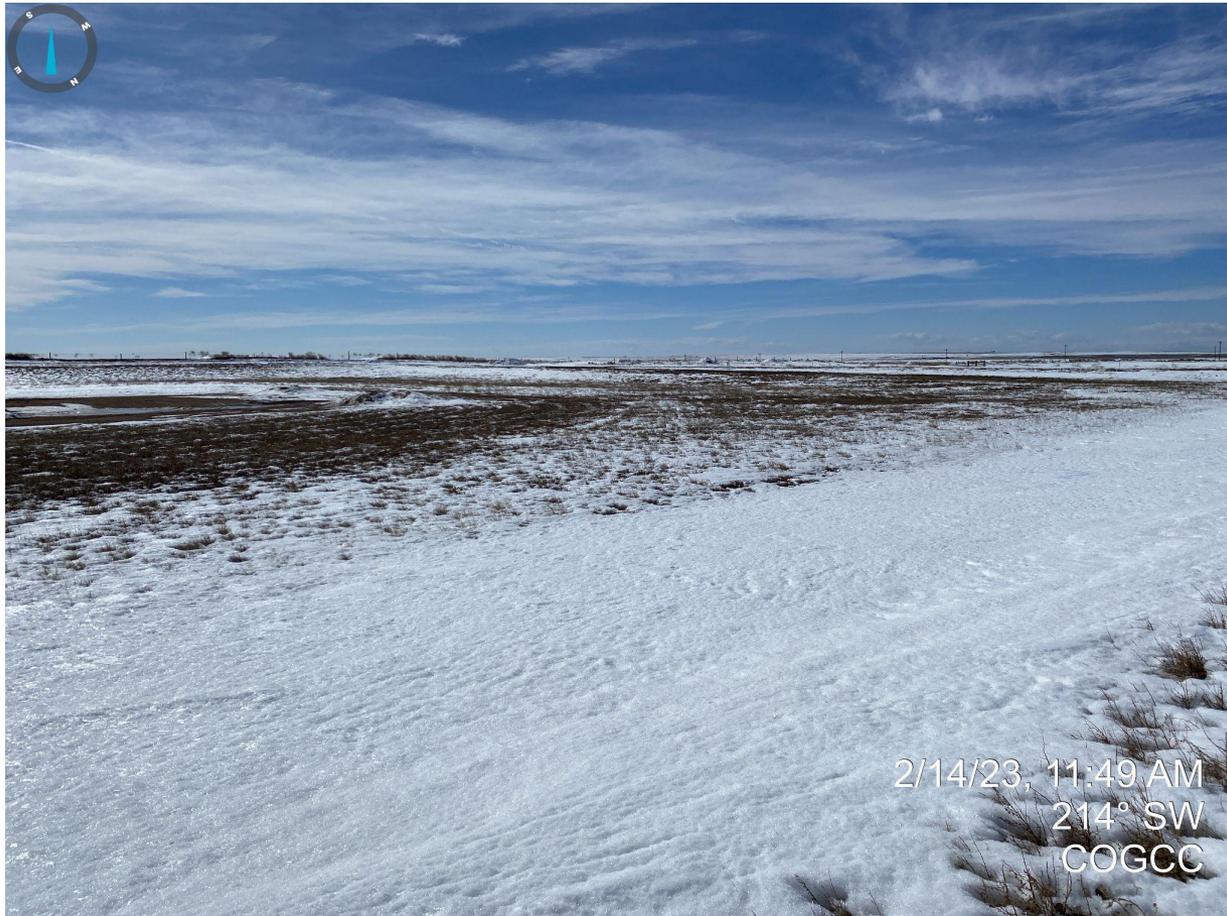
**Photo 4.** Facing southwest from topsoil stockpile area; see comments in Photo 2.

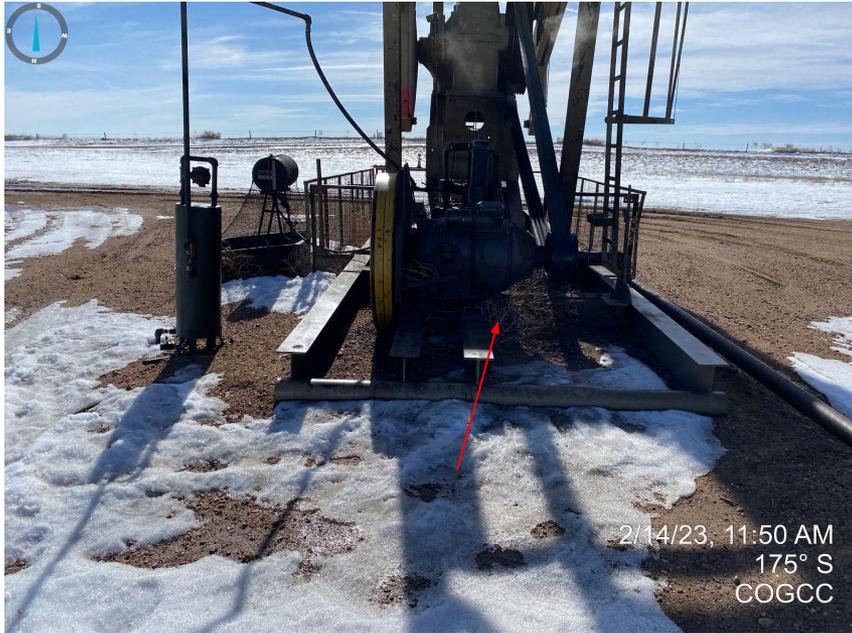
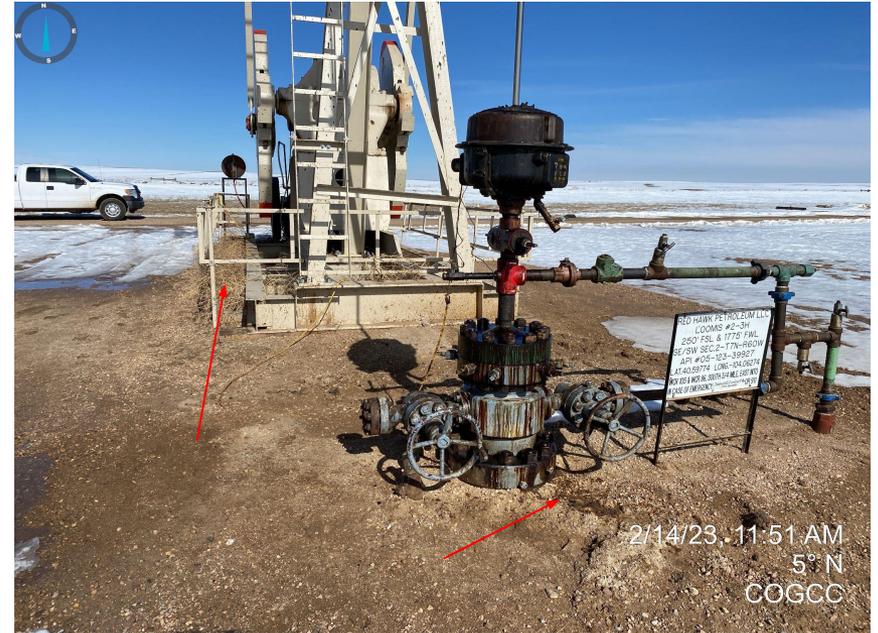
**Photos 5 & 6.** Facing south and north at the wellheads/pump jacks. Photos illustrate tumbleweed accumulations within equipment that needs to be removed as it is a potential fire hazard. Additionally, oil stained soil was observed near the wellheads that will need to be properly disposed of.

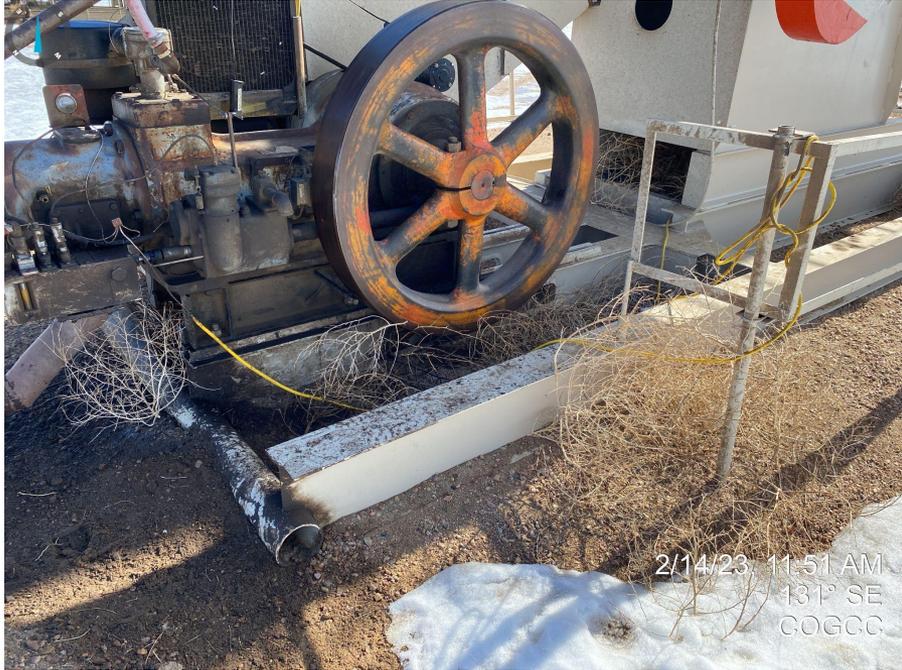
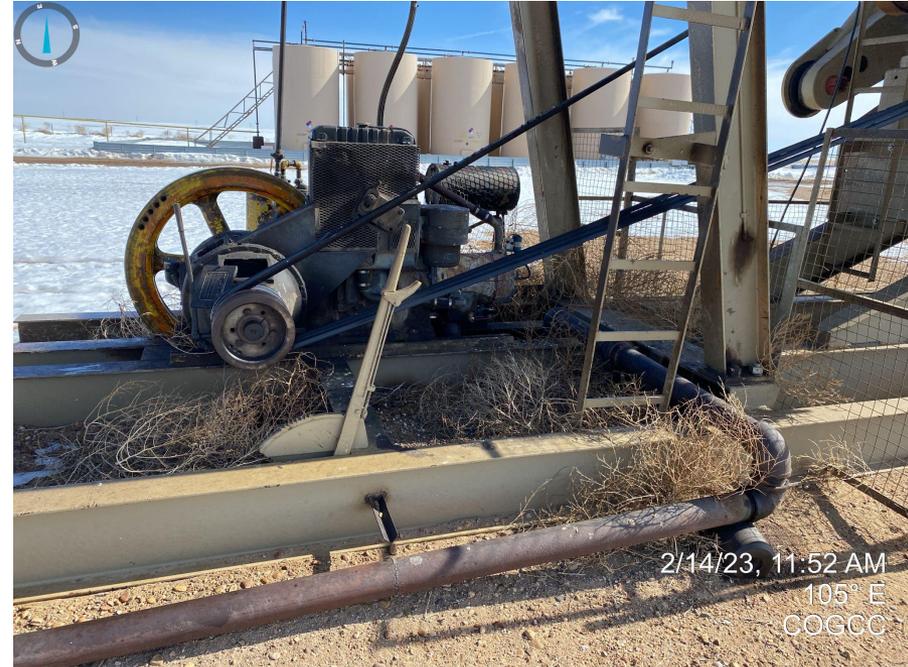
Photos 7 & 8. See comments in Photos 5 & 6.

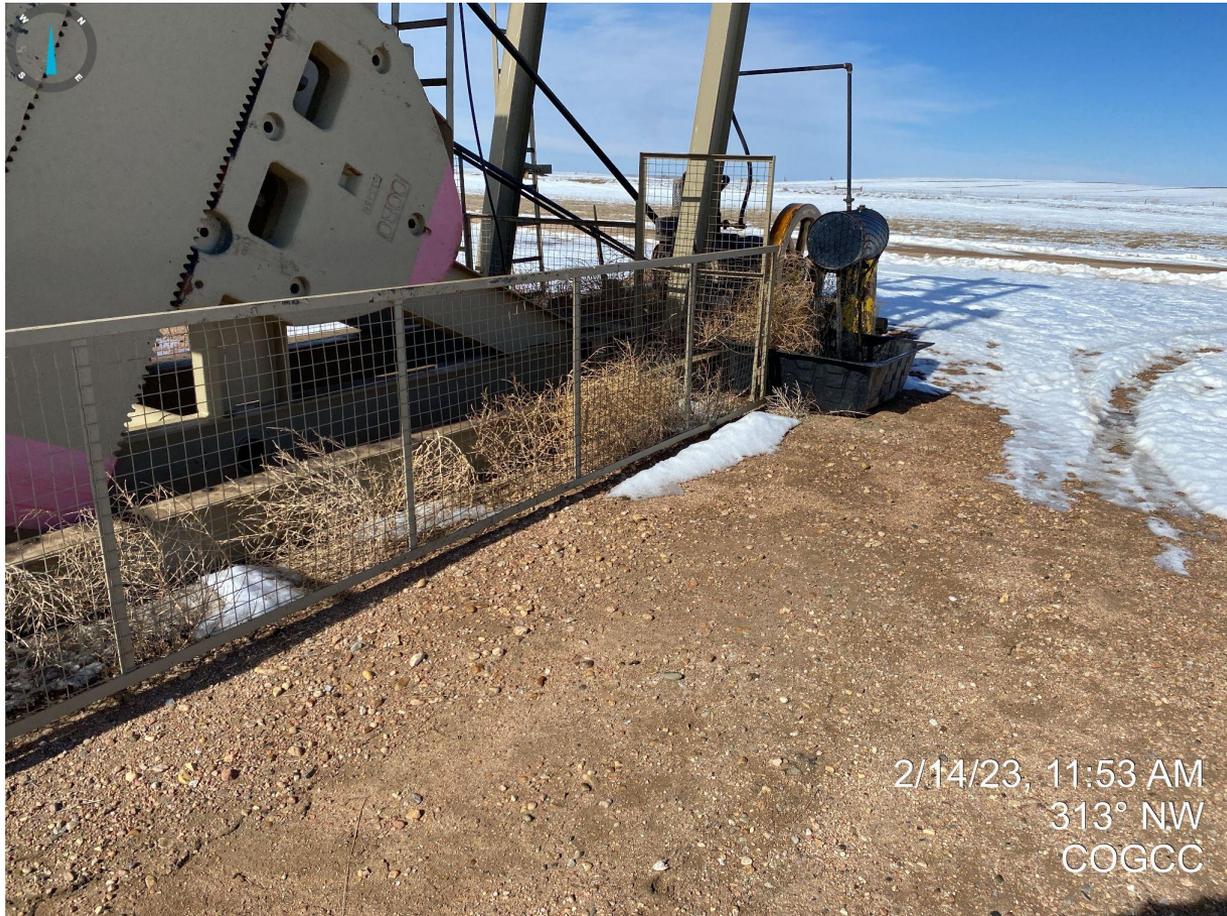
**Photo 9.** See comments in Photos 5 & 6.

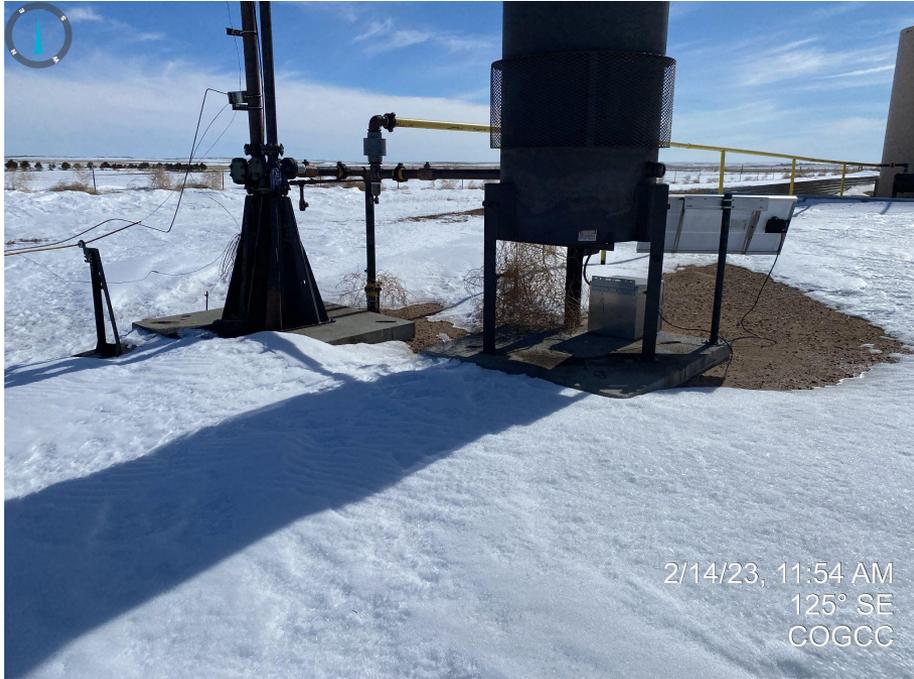
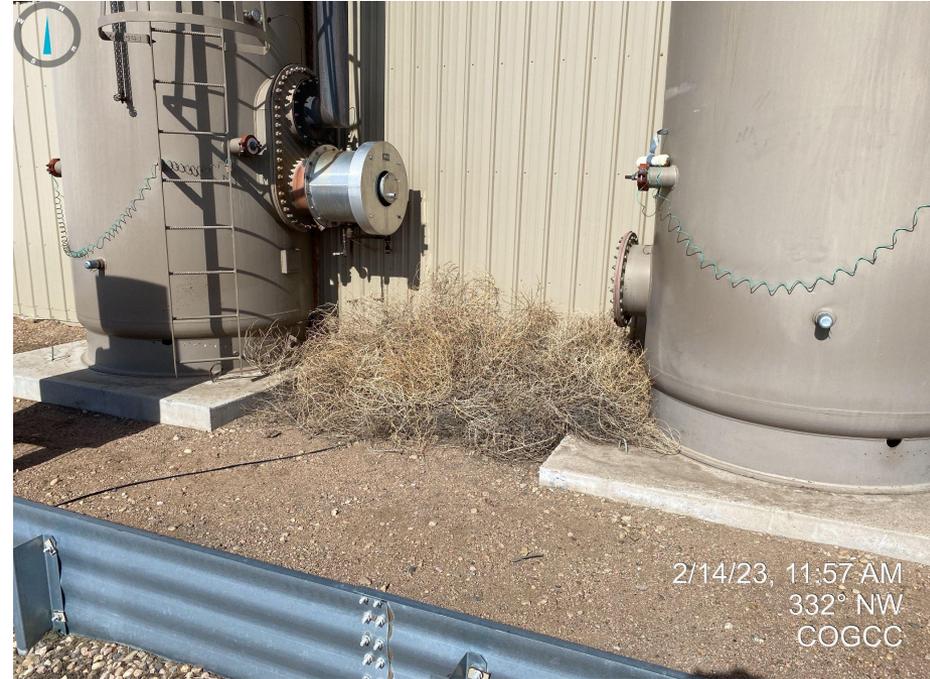
**Photos 10 & 11.** Facing southeast at combustor and northwest at treaters. See comments in Photos 5 & 6.

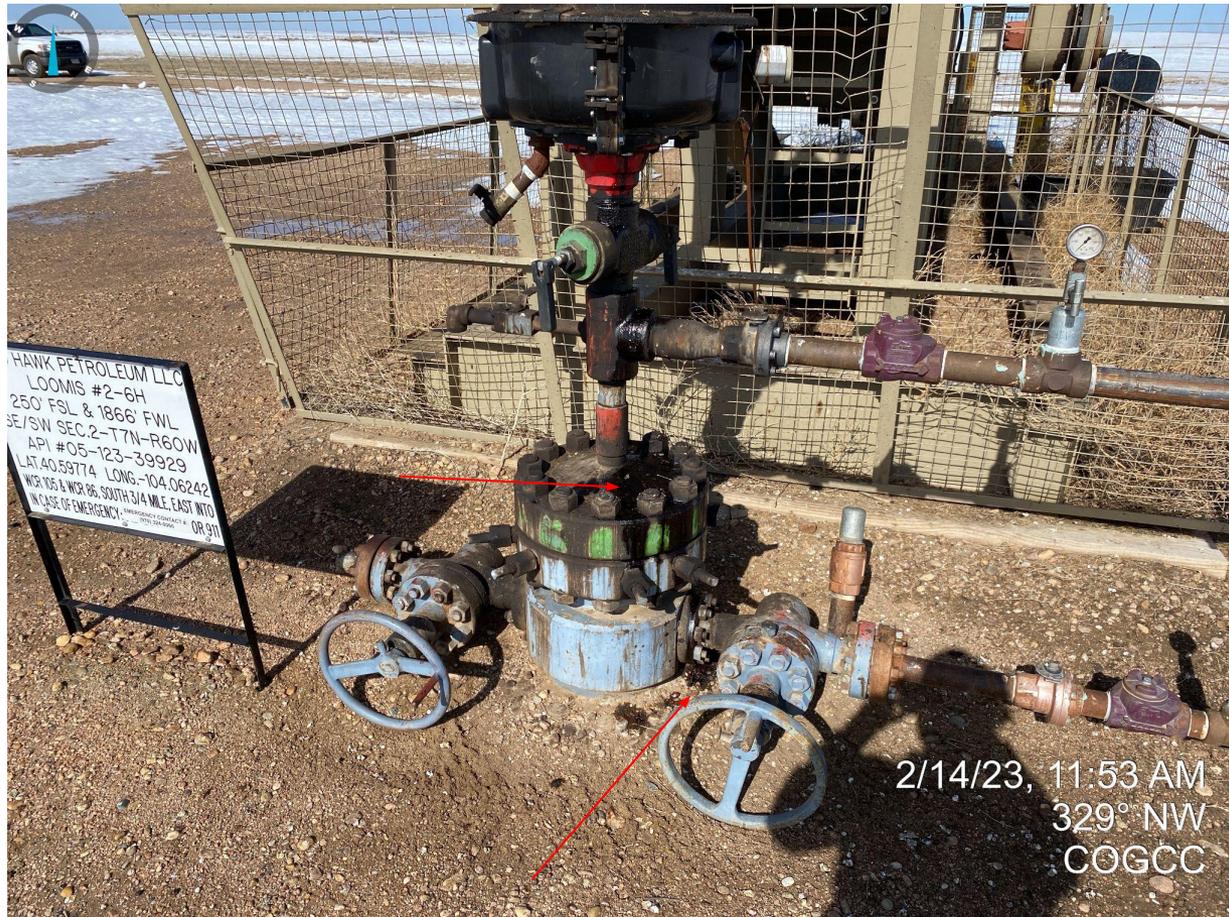
**Photo 12.** Facing northwest at wellhead. Oil stained soil was observed along with free fluid on equipment.

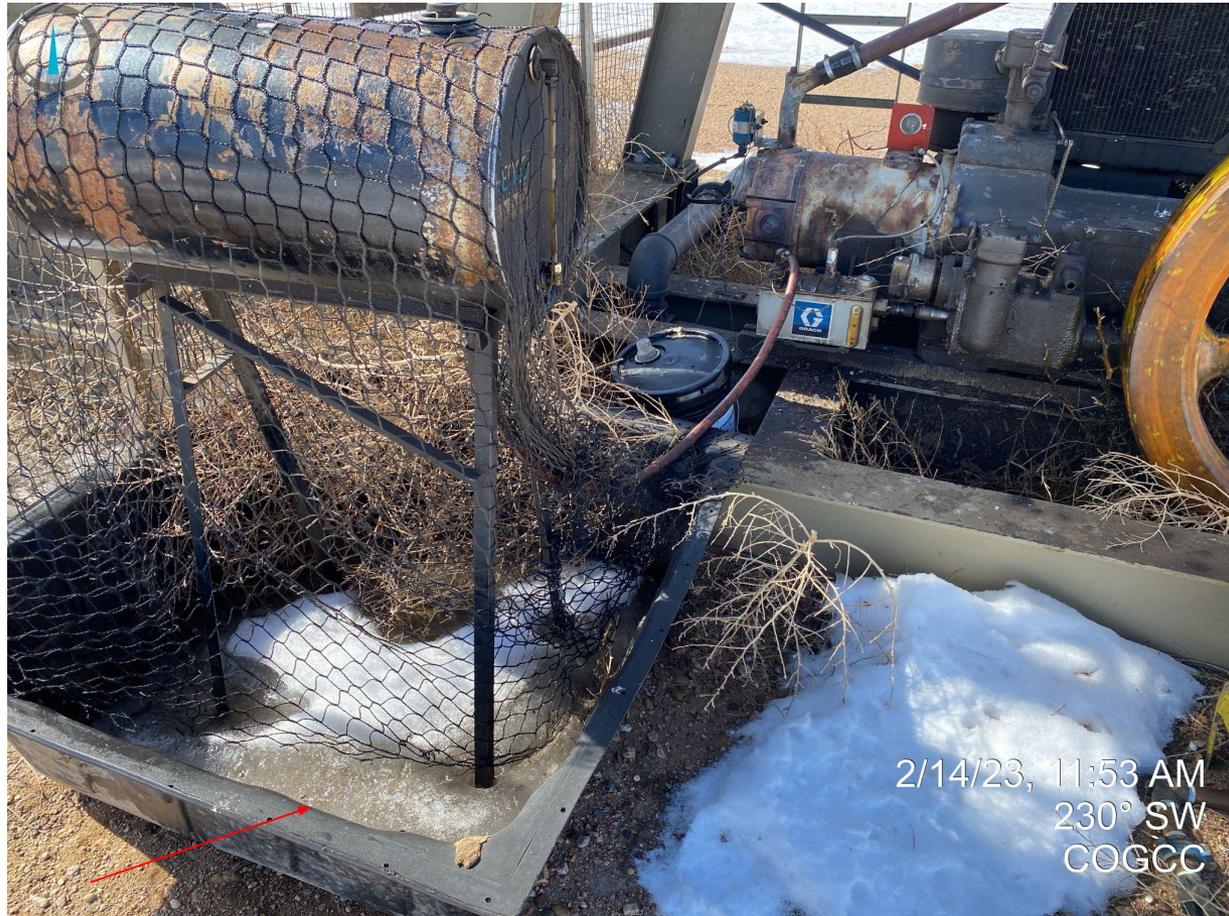
**Photo 13.** Facing southwest at one of the pump jacks. Wildlife netting is not adequate and/or properly installed.

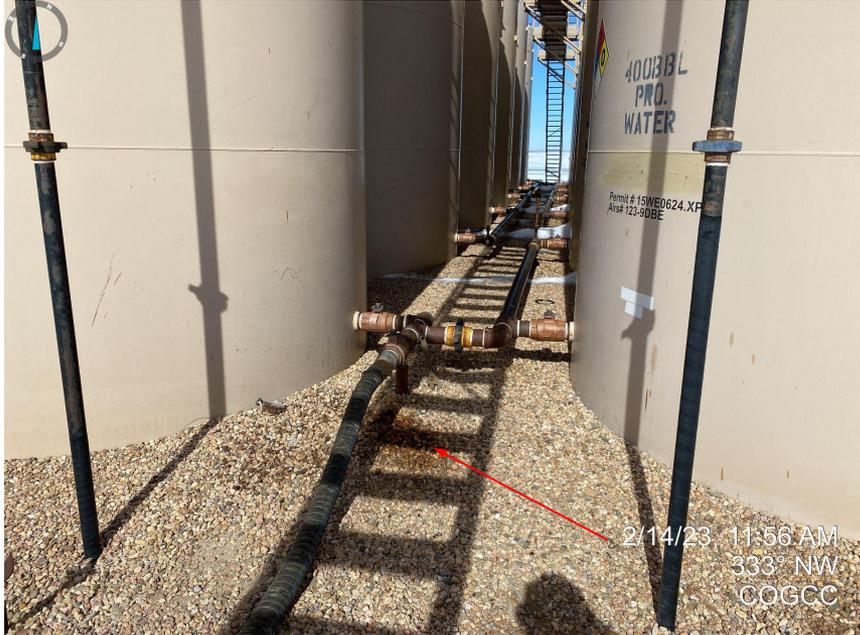
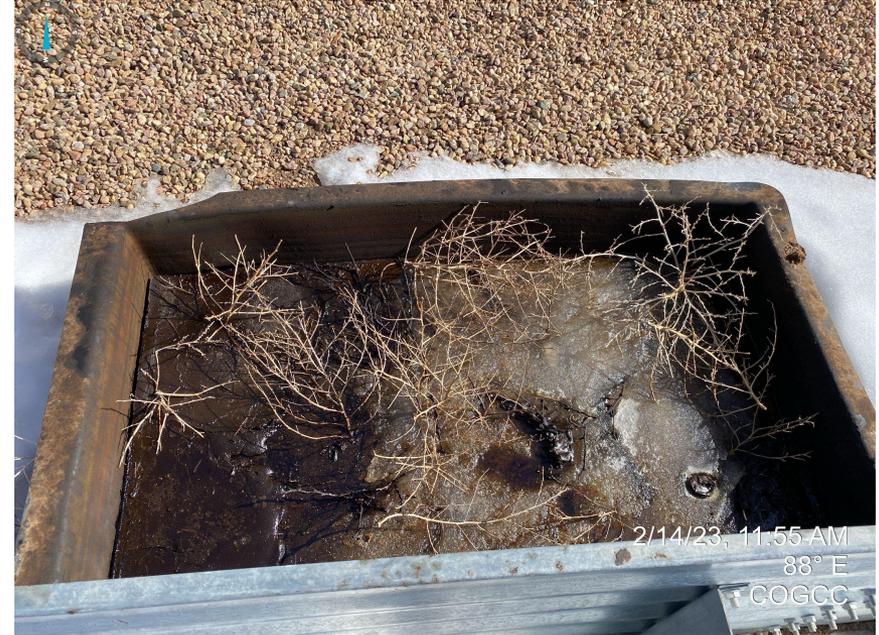
**Photos 14 & 15.** Facing northwest and east at the tank battery. Photos illustrates oil stained soil (left) and oily waste (right) that needs to be properly disposed of.

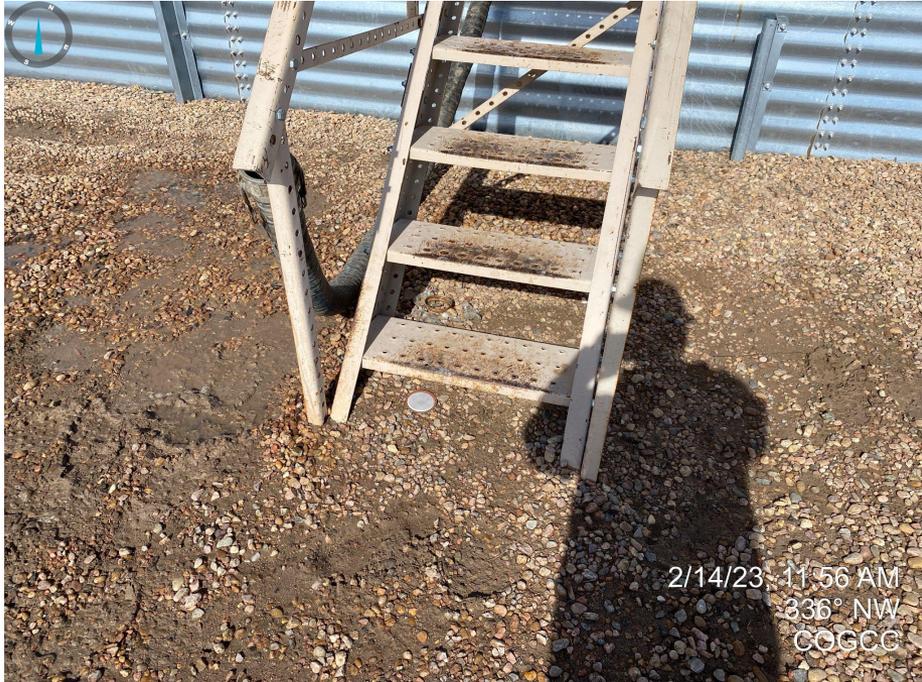
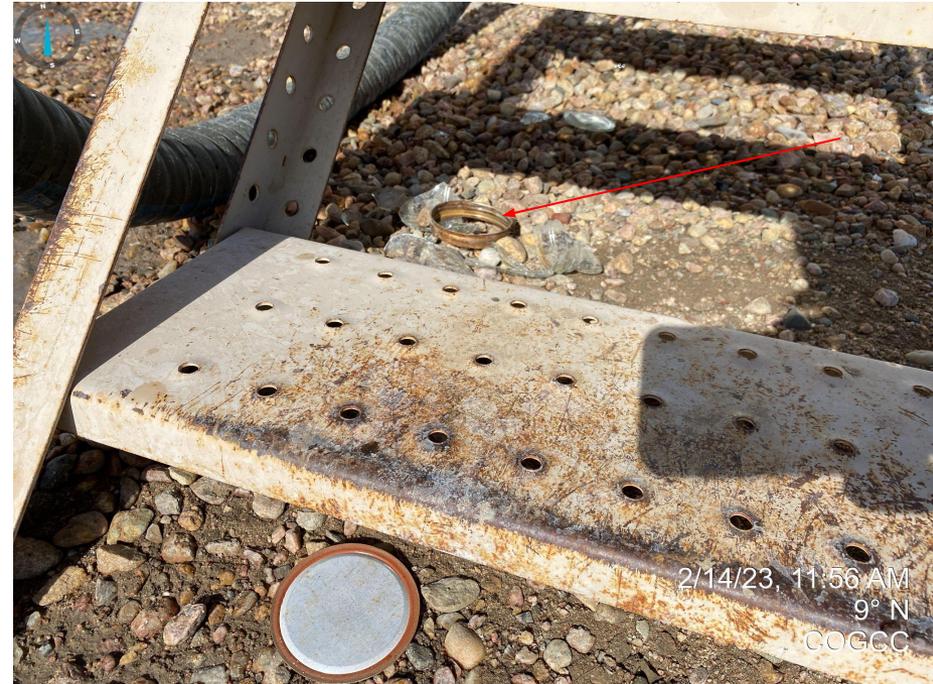
**Photos 16 & 17.** Facing north at the tank battery (south side). Debris (e.g. broken glass) was observed under ladder and will now need to be cleaned up as it's considered debris.

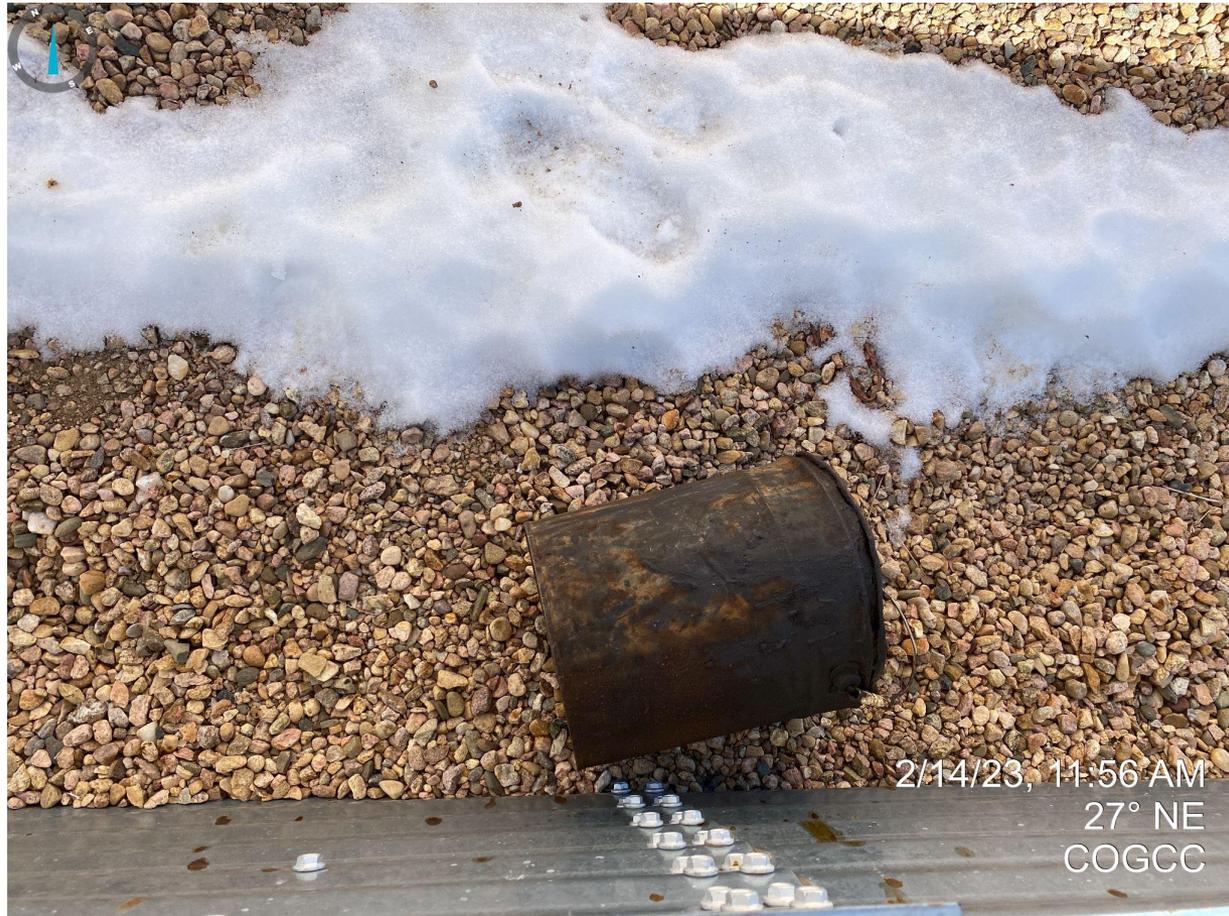
**Photo 18.** Debris observed within containment area of tank battery that will need to be removed.

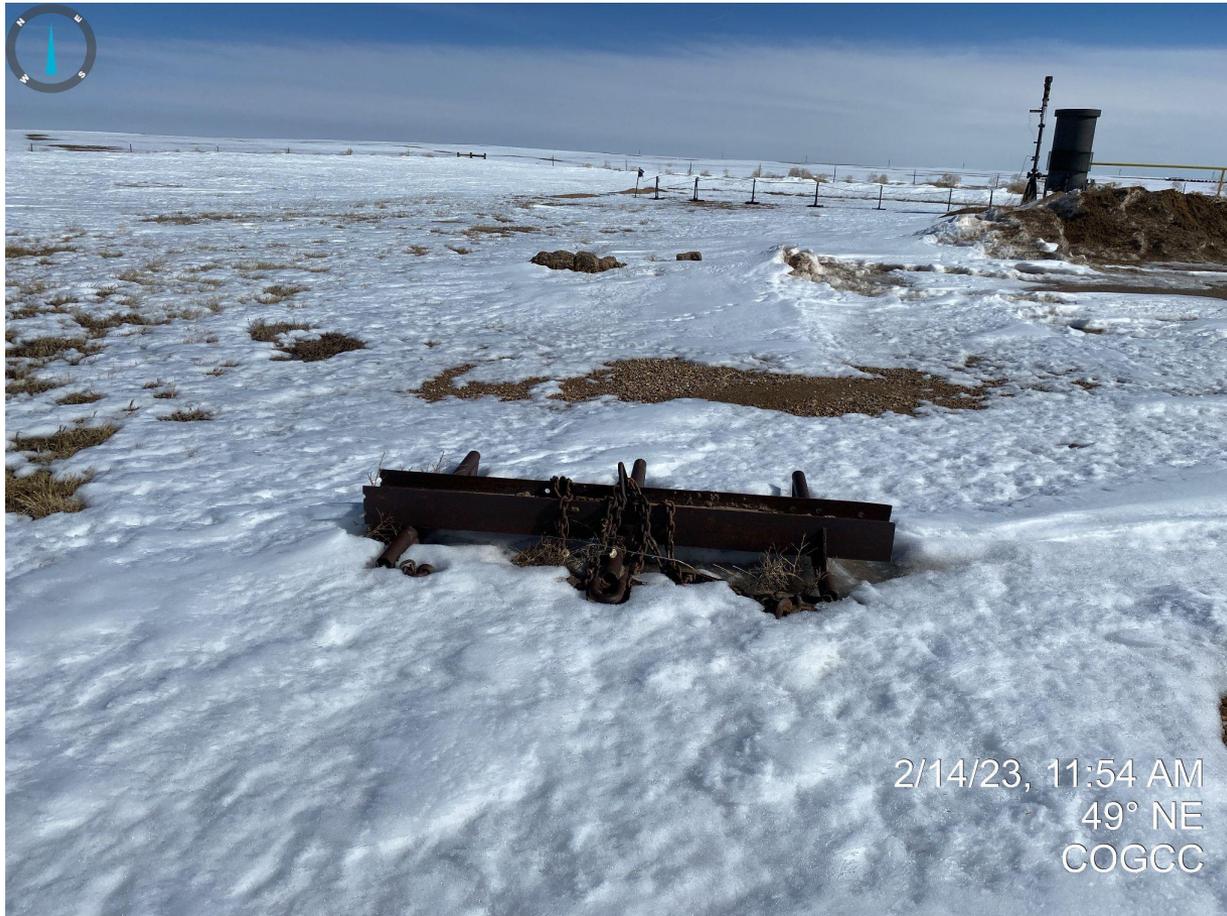
**Photo 19.** Facing northeast near combustor. Road maintainer being stored on location and will need to be removed. As a reminder, locations are not to be used as storage or lay-down yards.
