Inspection Photos

Location Name: TEP ROCKY MOUNTAIN LLC GENTRY-66S92W /17SESW

Location ID: 335547

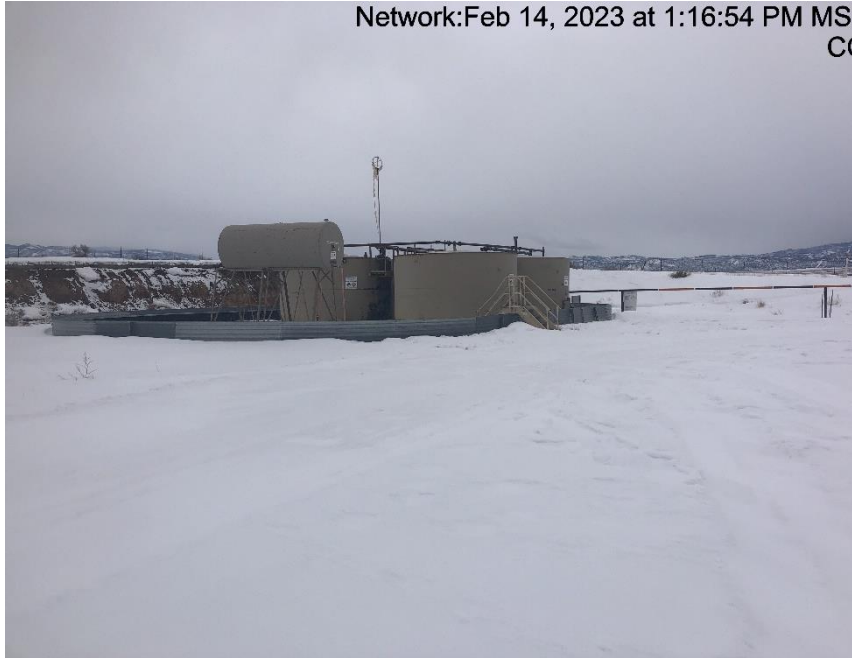
Photo #9003 From entrance to location.

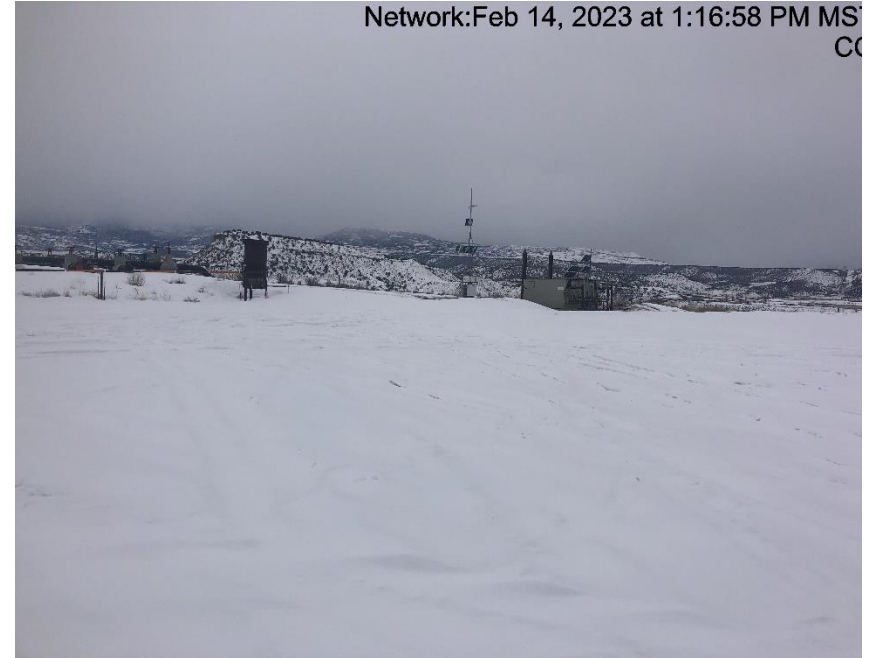
Photo #9004 From entrance to location

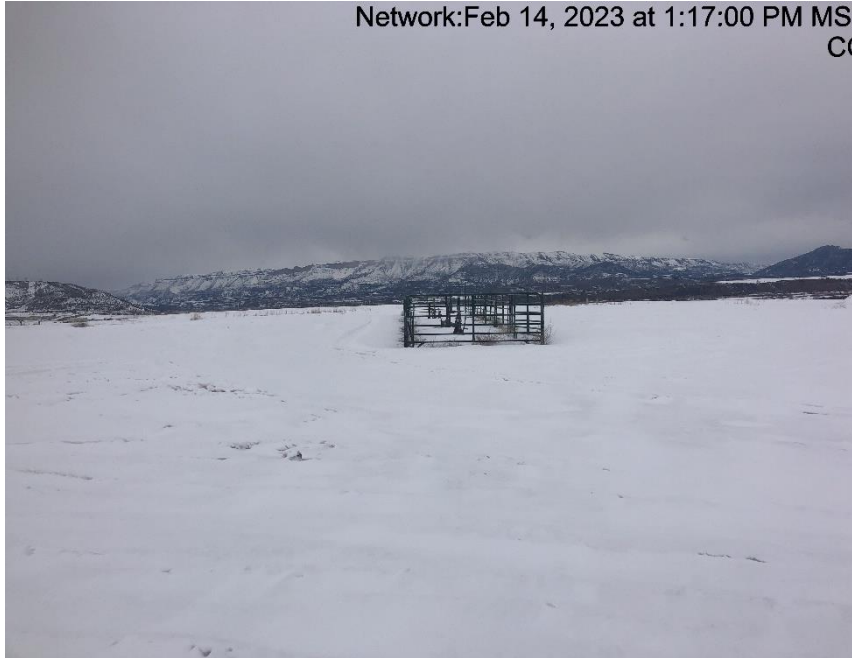
Photo #9005 From entrance to location.

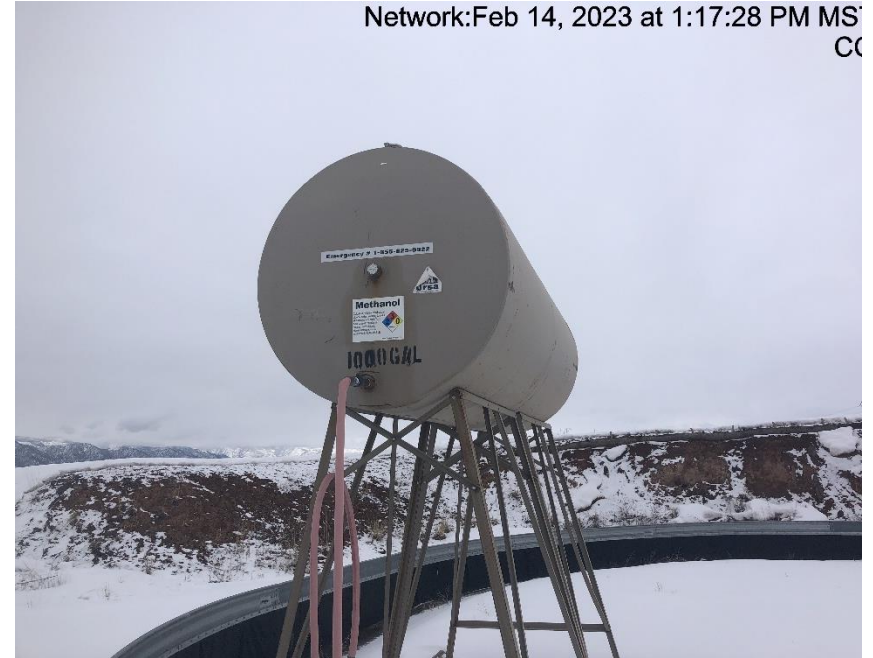
Photo #9006 Methanol tank information inaccurate.

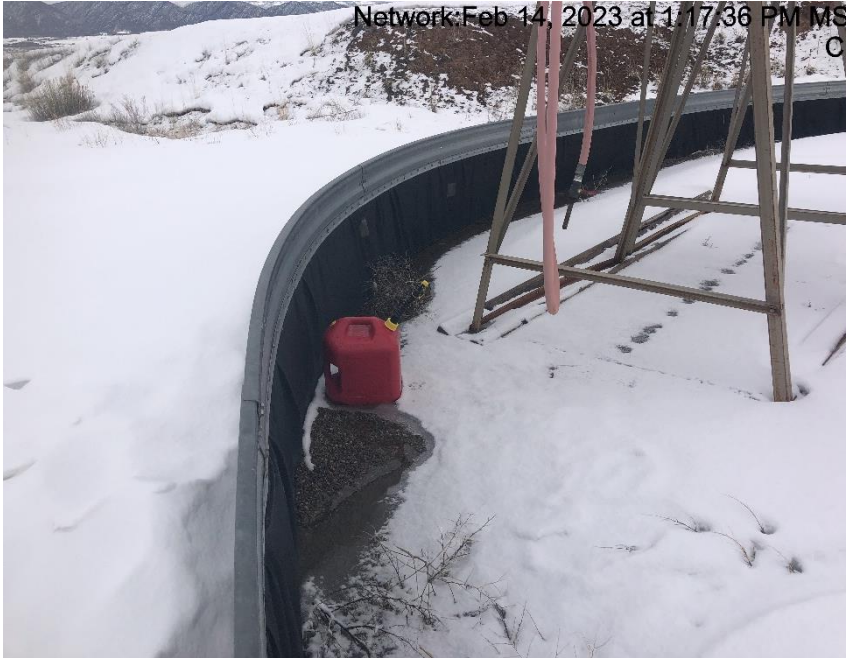
Photo #9007 Unused supplies.

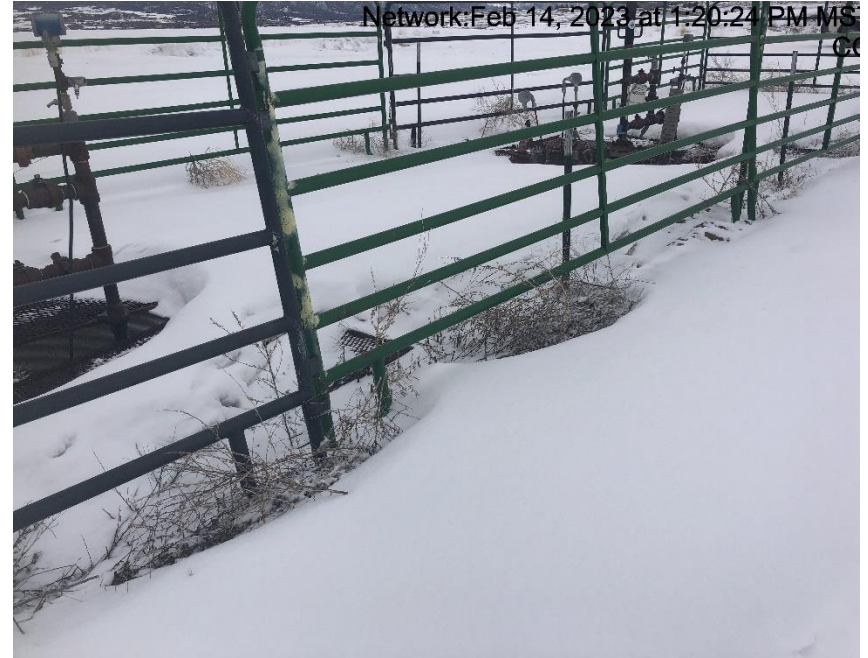
Photo #9015 Multiple places with debris on location.

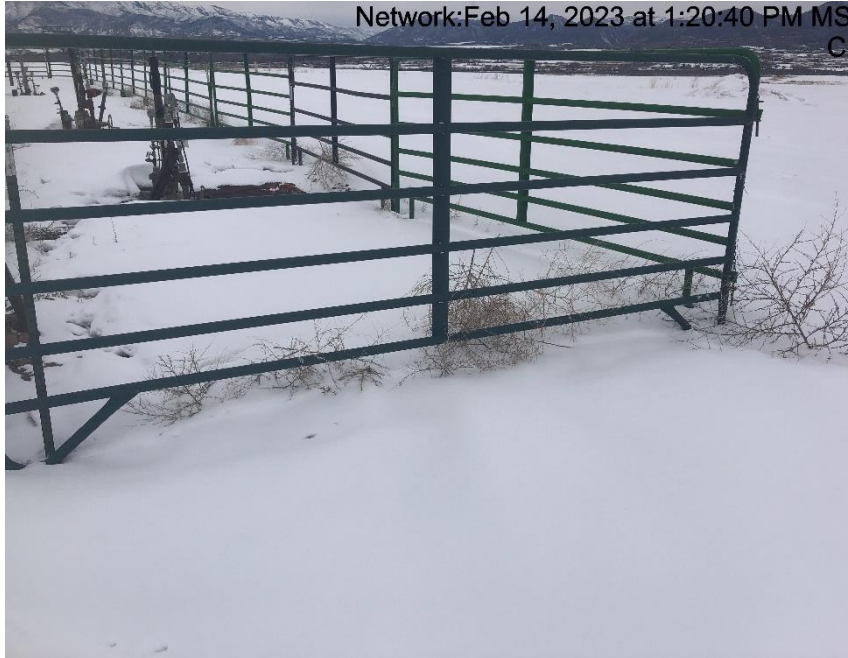
Photo #9016 Multiple places with debris on location.

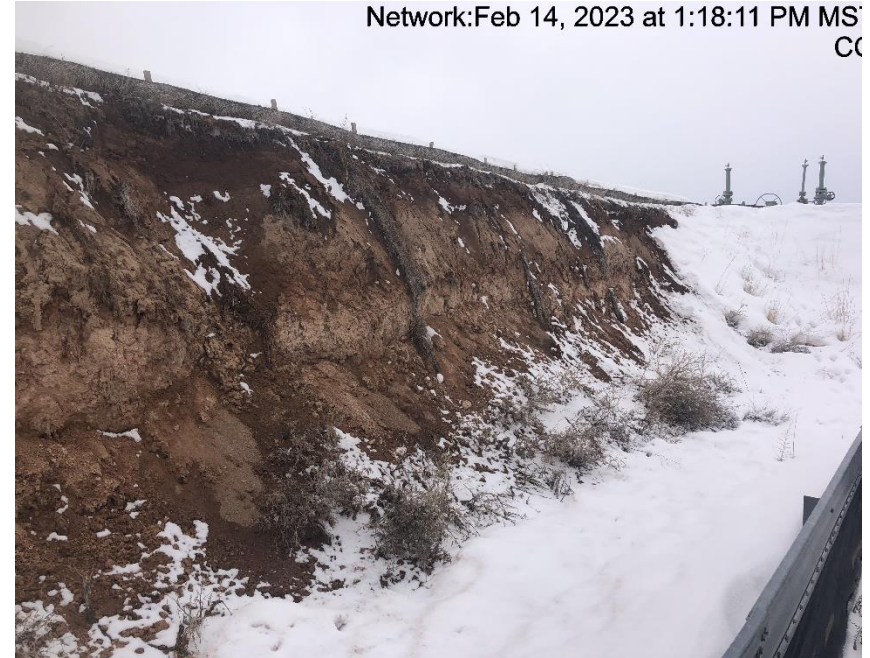
Photo # 9008 Slope stabilization BMP's insufficient.

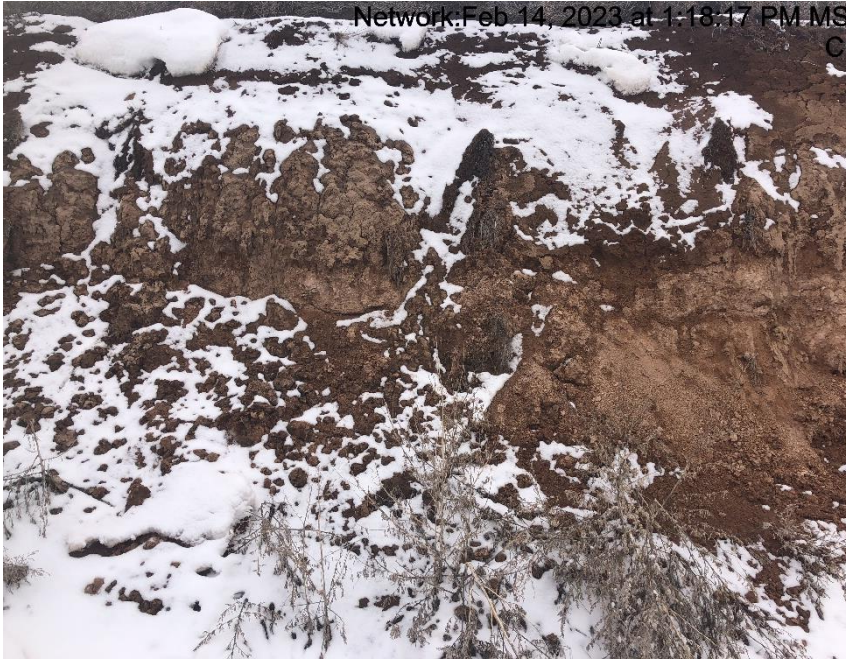
Photo #9009 Slope stabilization BMP's insufficient.

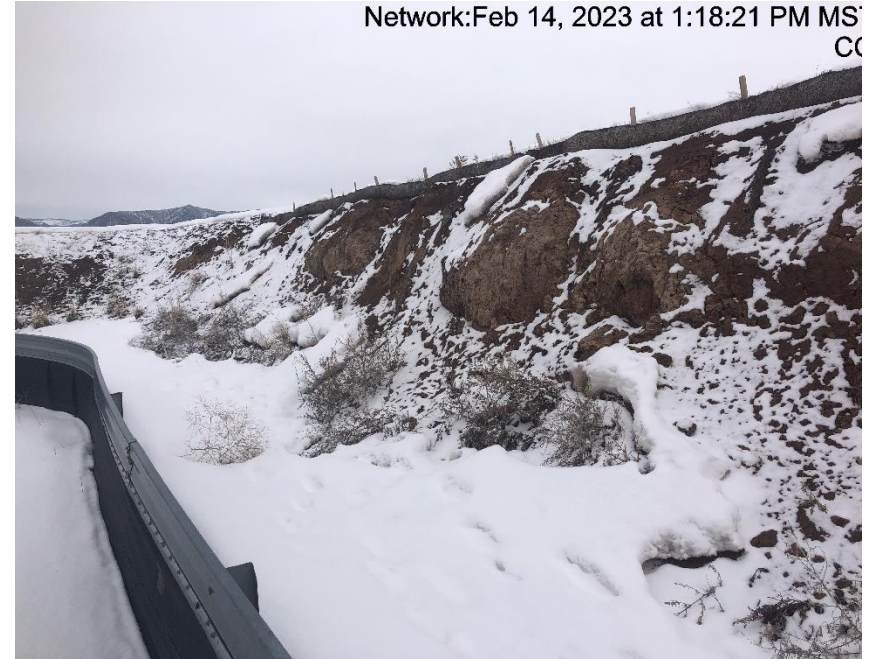
Photo #9010 Run on to location is not being controlled.

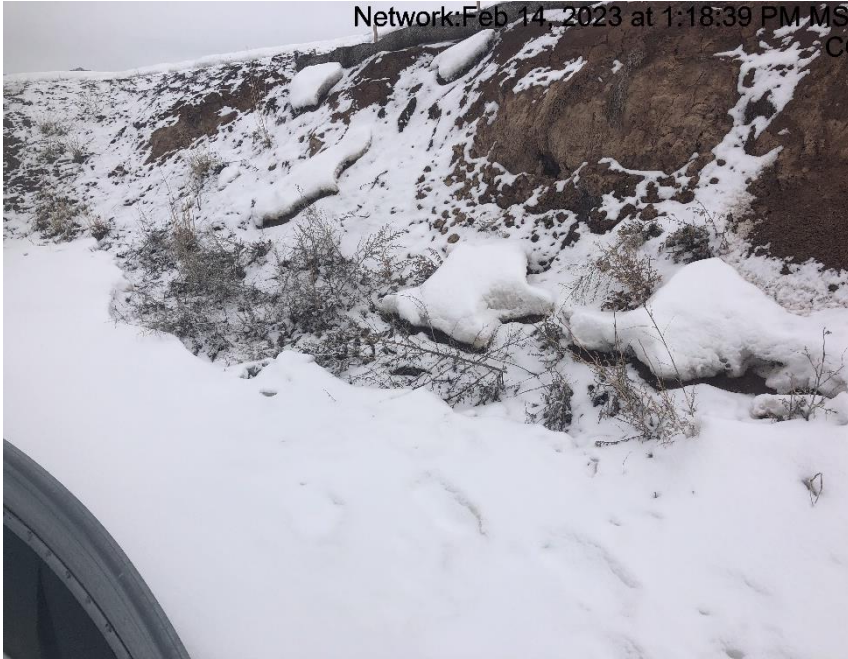
Photo #9009 Slope stabilization BMP's insufficient.
