## Inspection Photos

Location Name: TEP ROCKY MOUNTAIN LLC HERRERA-66S92W /20NESE

Location ID: 335445

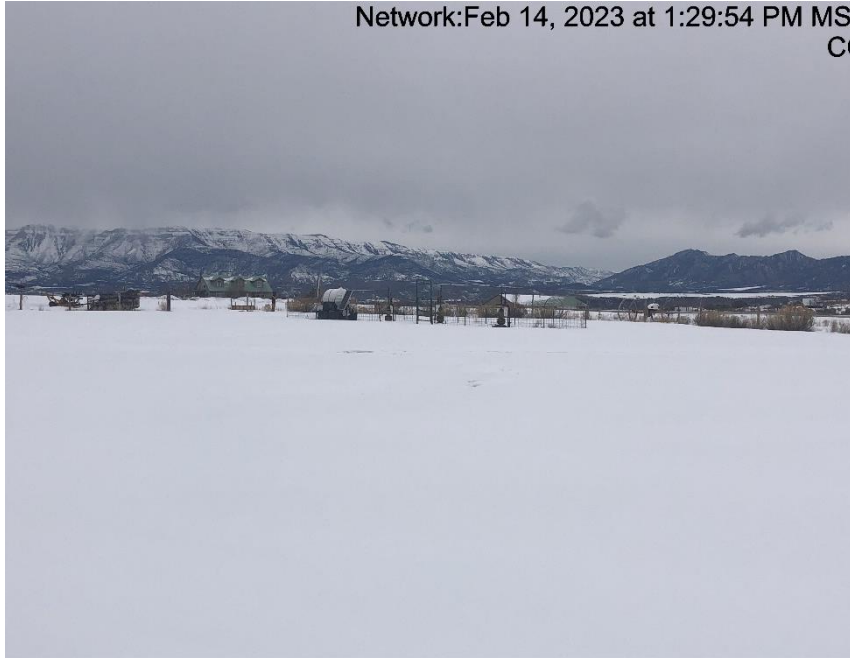
**Photo #9017 From entrance to location.**

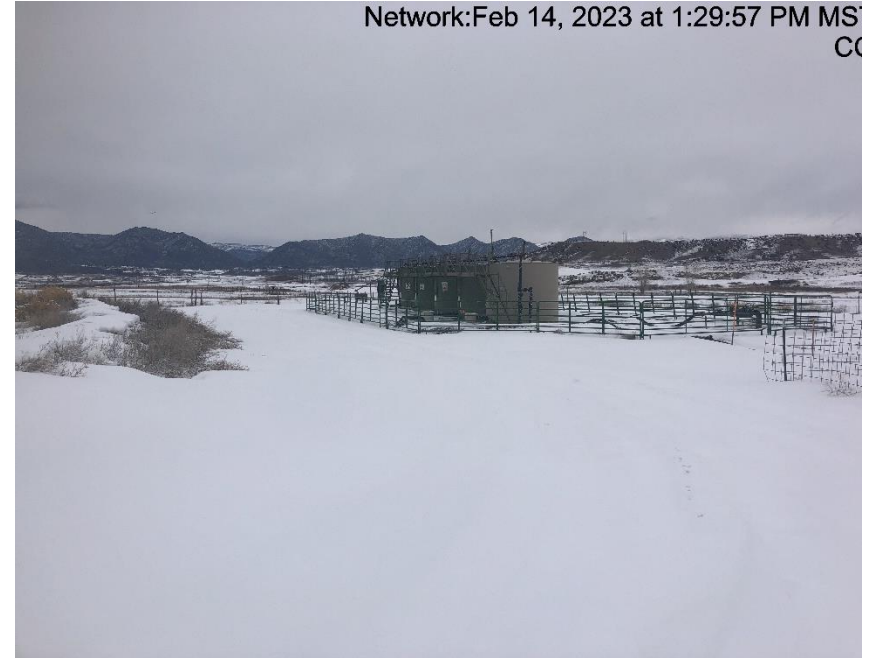
**Photo #9018 From entrance to location**

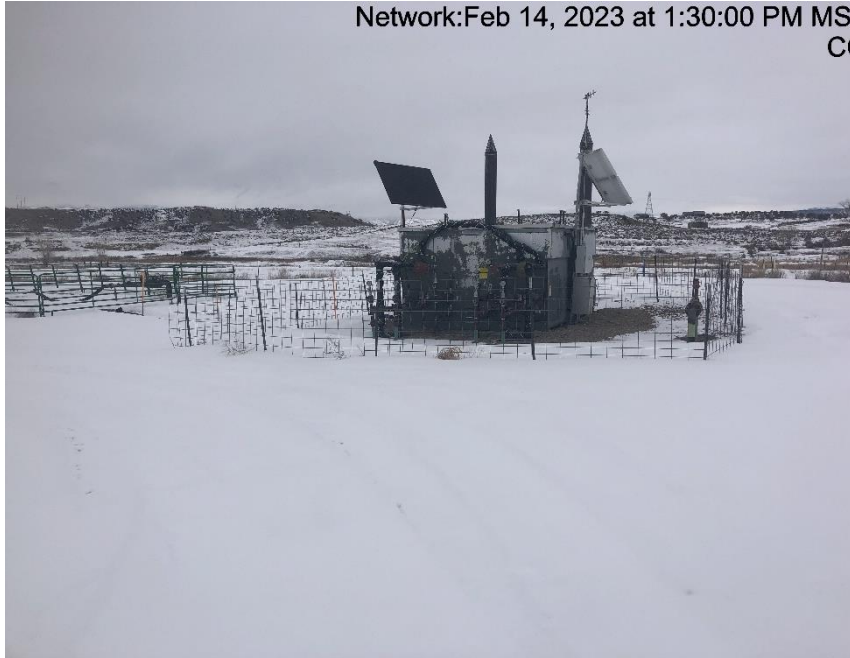
Photo #9019 From entrance to location.

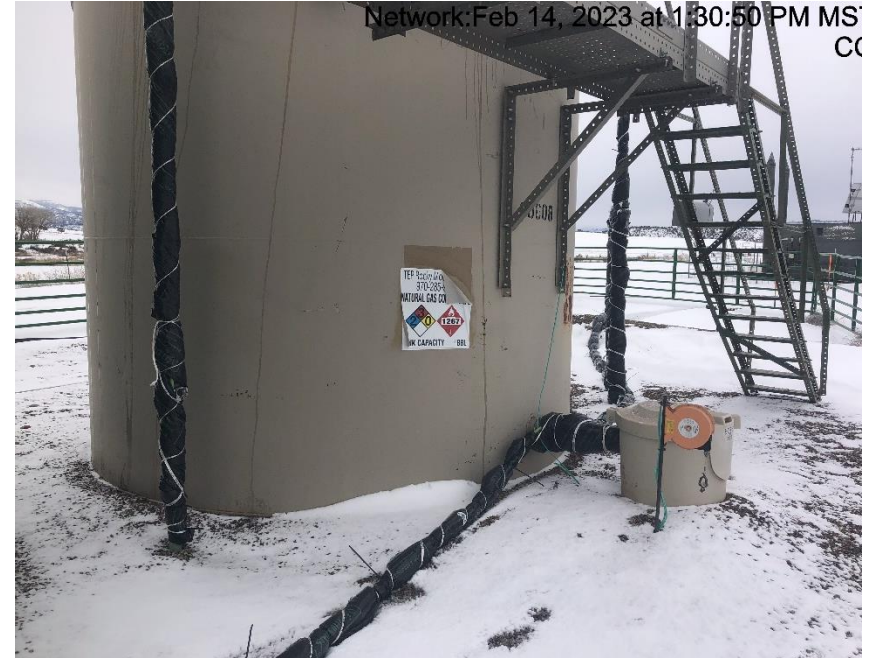
Photo #9020 Multiple tank labels weathered and not legible.

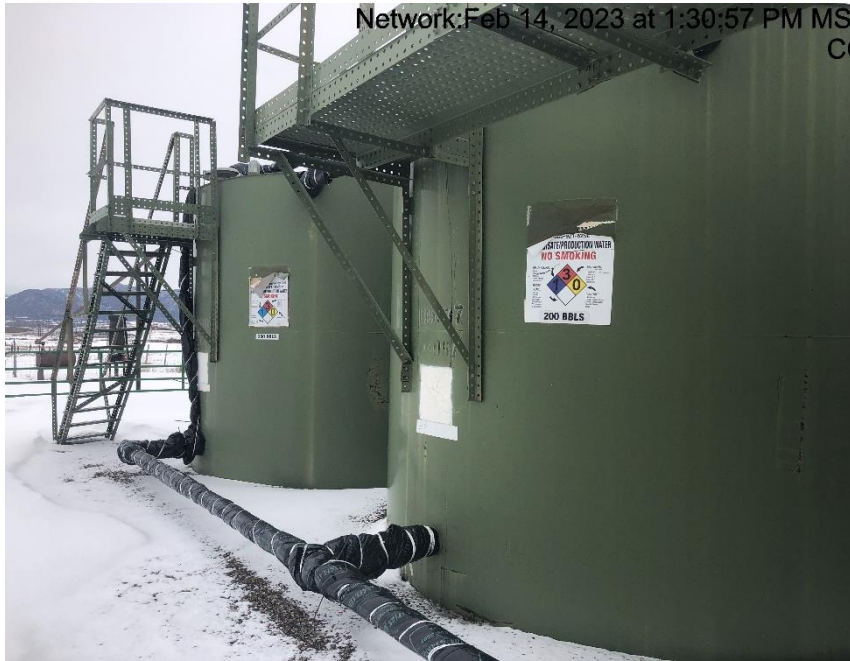
Photo #9021 Multiple tank labels weathered and not legible.

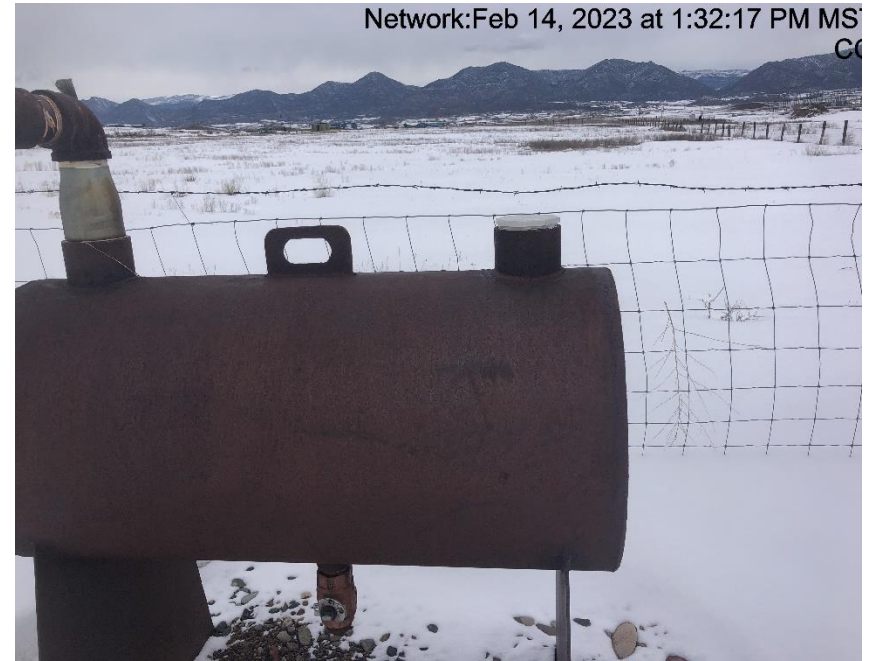
Photo #9022 unused equipment.

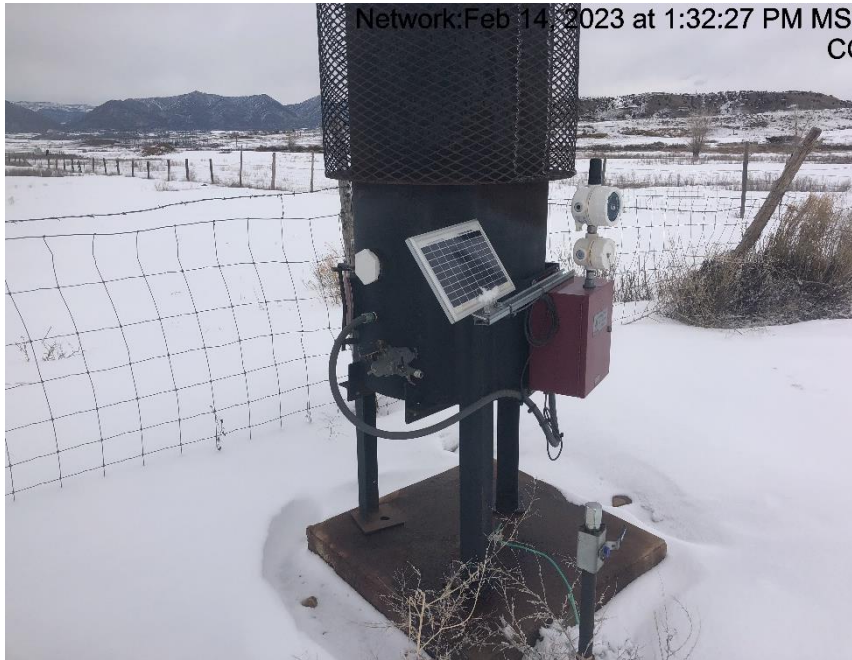
Photo #9023 Unused equipment.

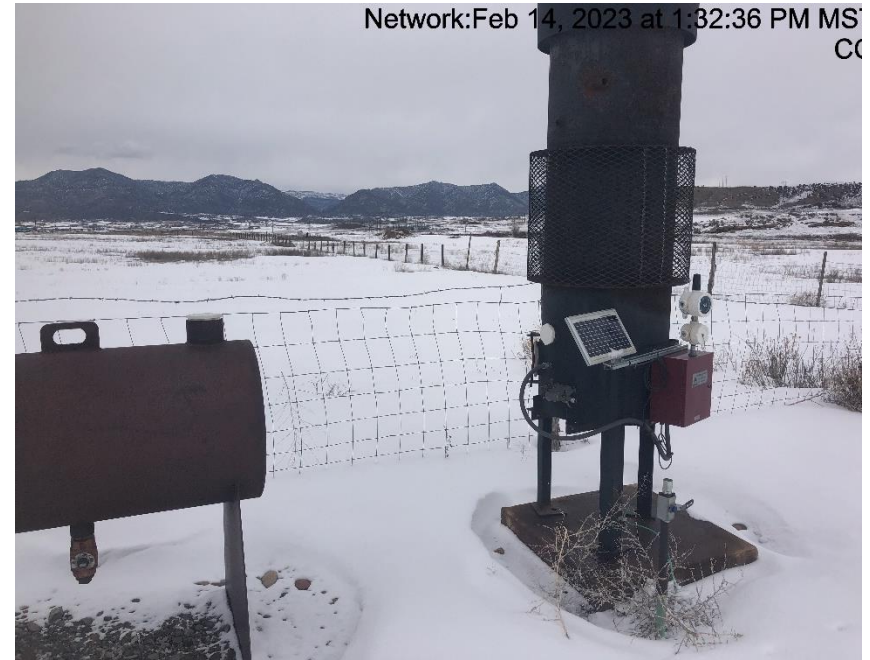
Photo #9024 Unused equipment.
