Inspection Photos

API: 071-09919

Operator: DESERT EAGLE OPERATING LLC

Inspection Date: 2/24/2023

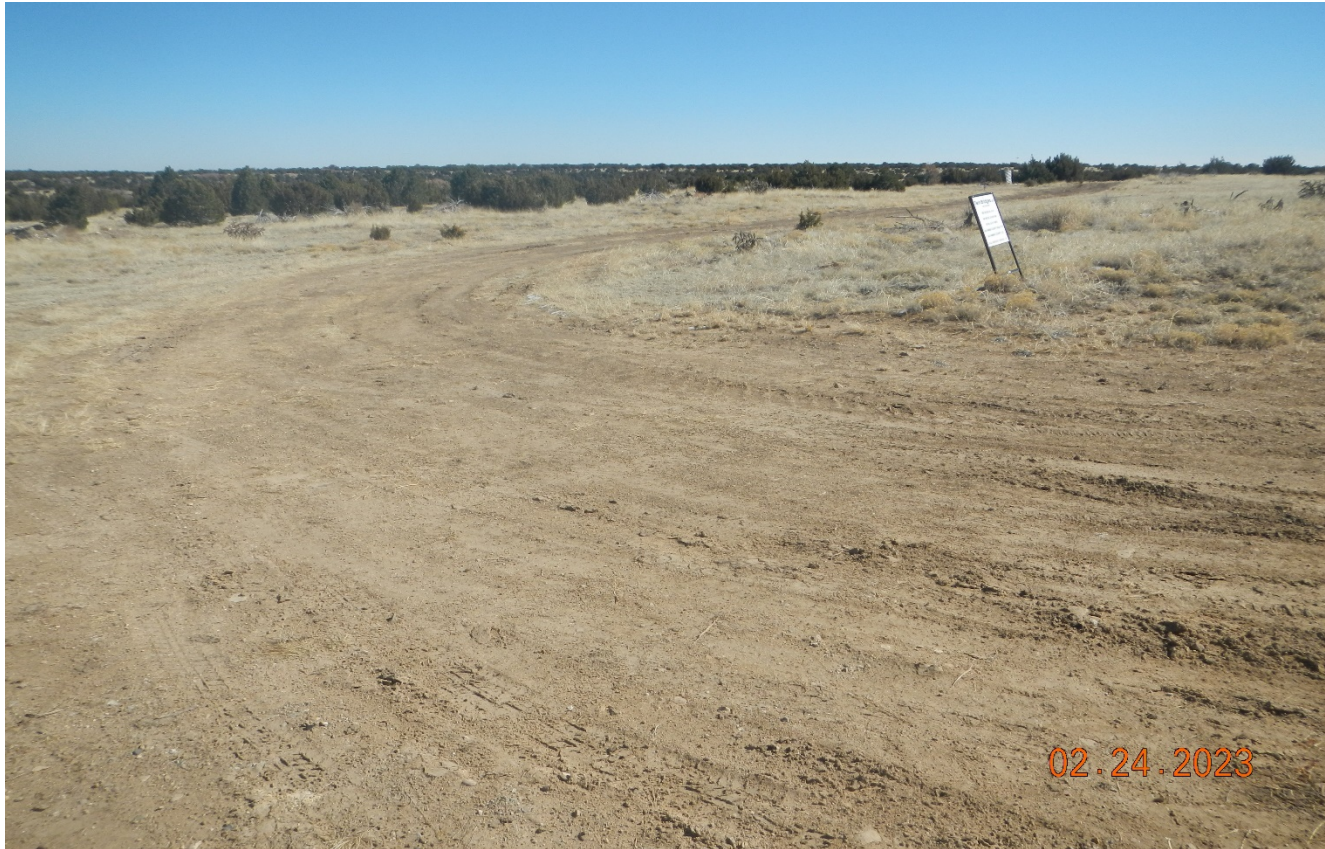
Photo 1. Facing southeast toward the access road. Sign posted at road does not reflect current operator.

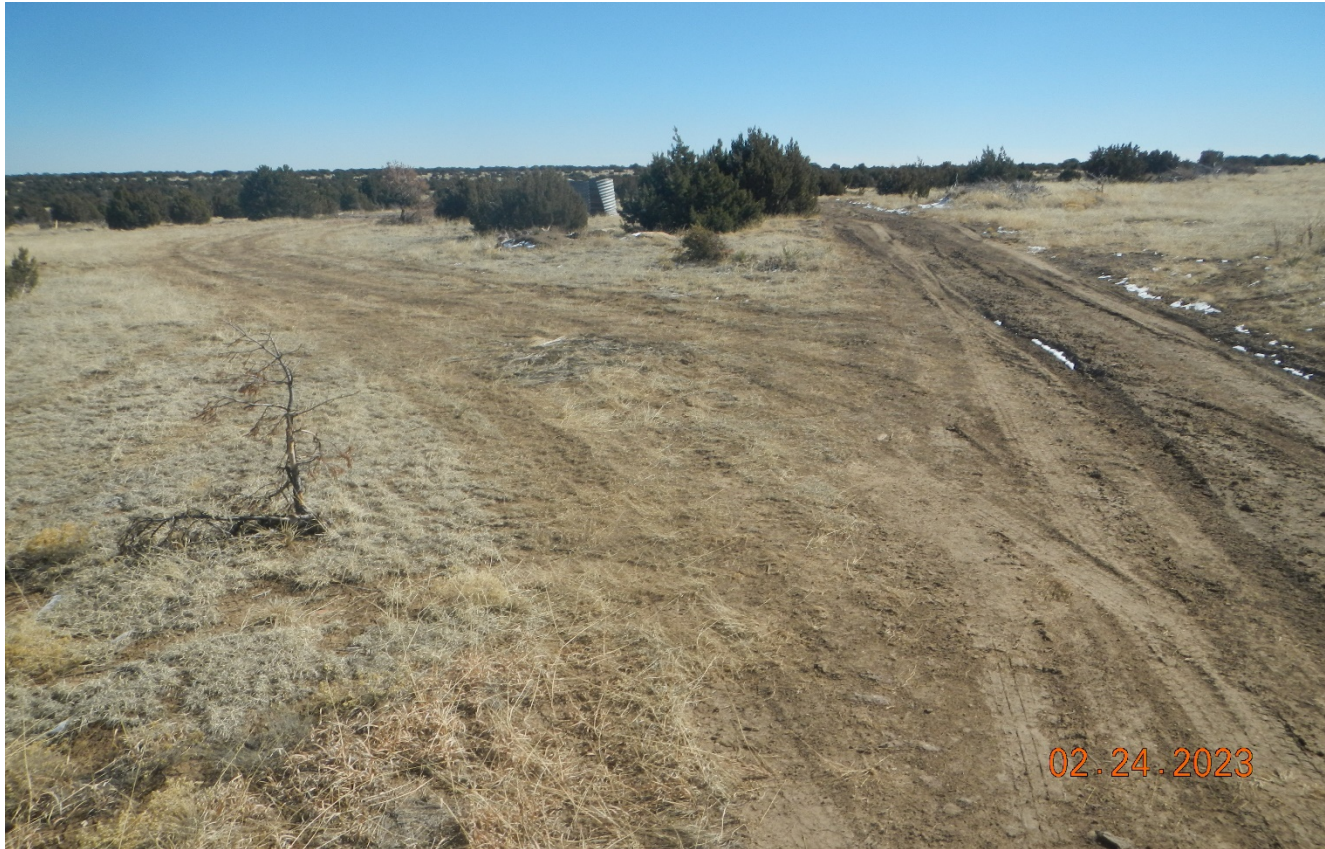
Photo 2. Facing southeast along the access road. Vehicles are not staying on the access road and causing additional disturbance. Vehicle traffic must be limited to the access road only.

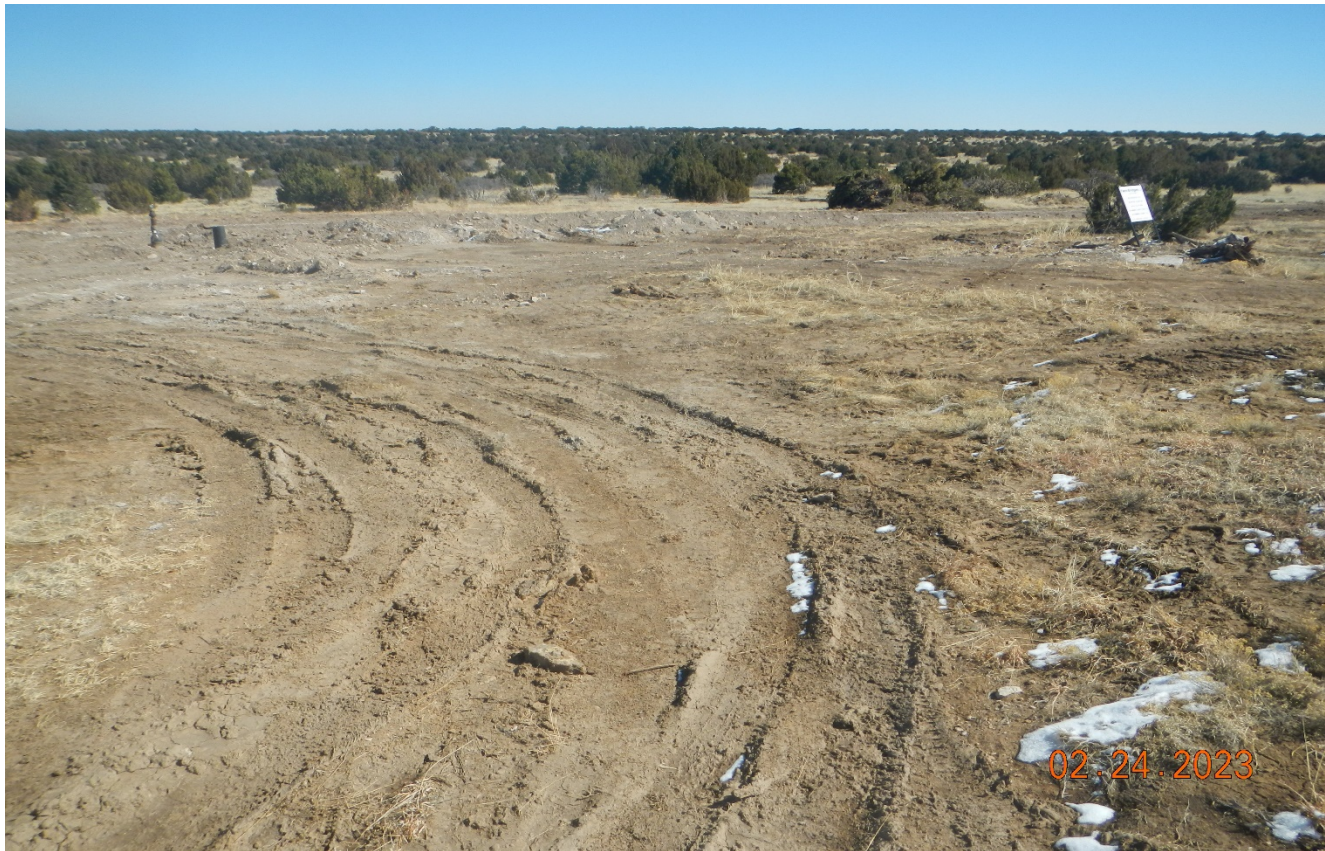
Photo 3. Facing southeast toward the location.

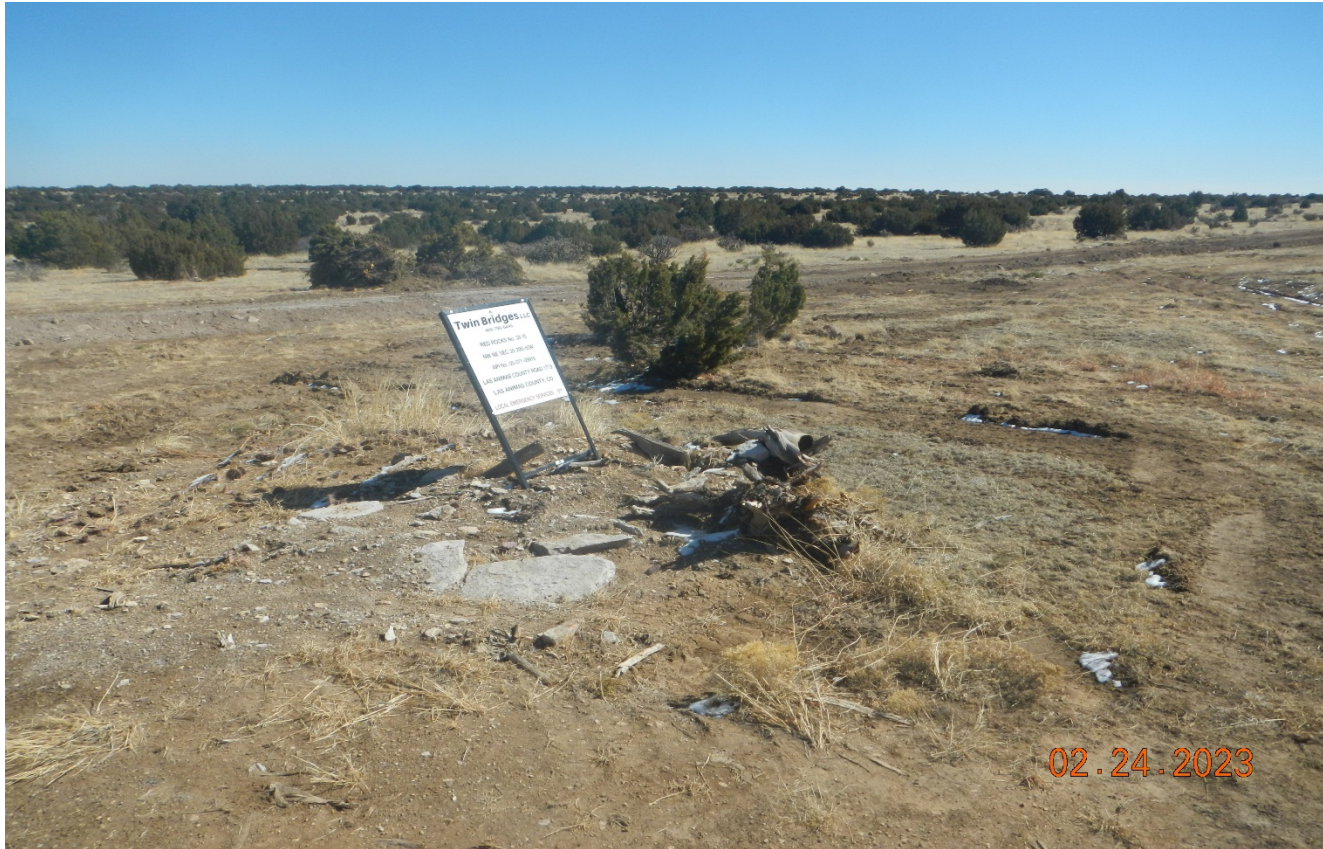
Photo 4. Sign posted at the location does not reflect the current operator. No emergency operator contact number posted.

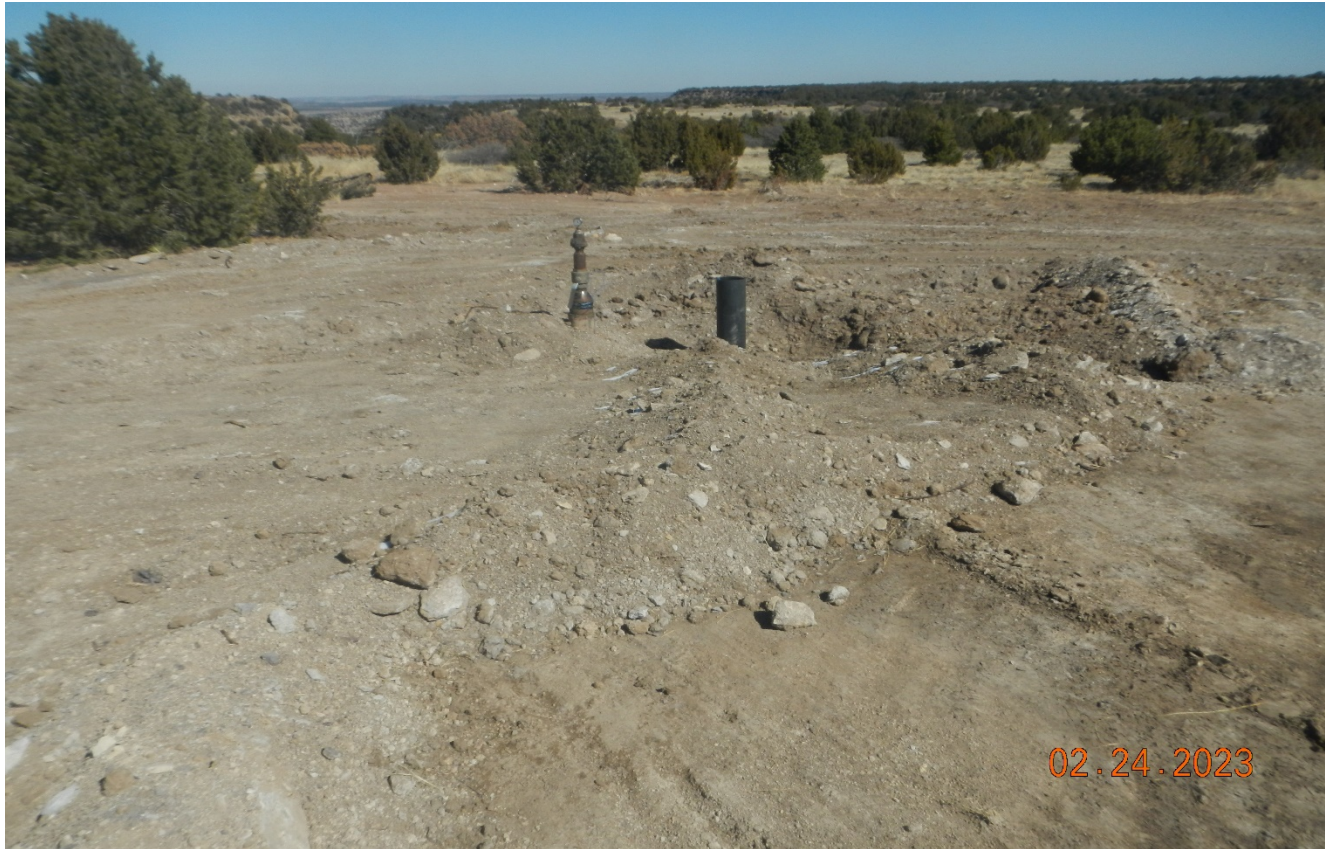
Photo 5. Facing east toward the wellsite. There is soil mixing throughout this area and soils are not salvage and protected from degradation and compaction.

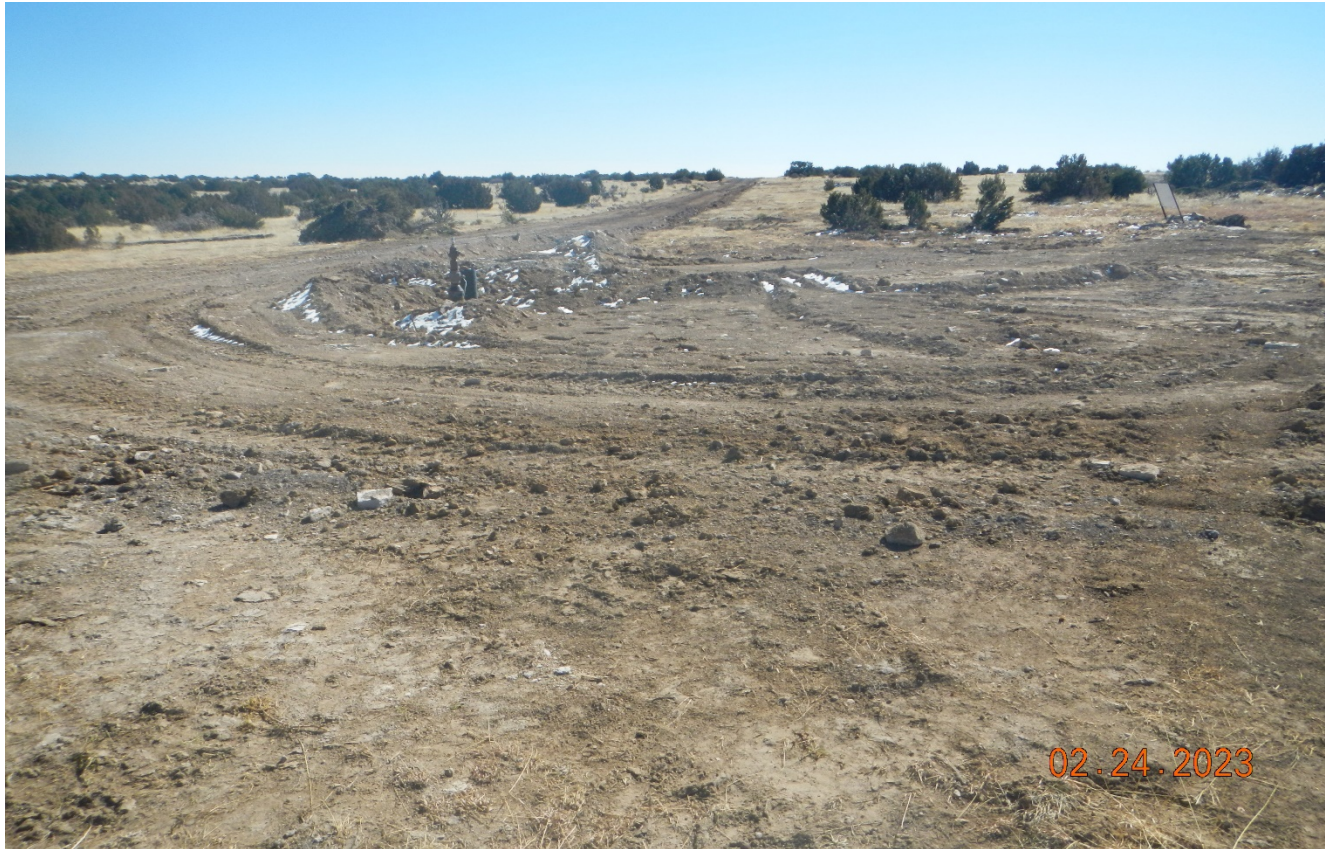
Photo 6. Facing southeast at the wellsite. Flowline trenching was performed from the well to the processing plant located approx. 1 mile southeast.

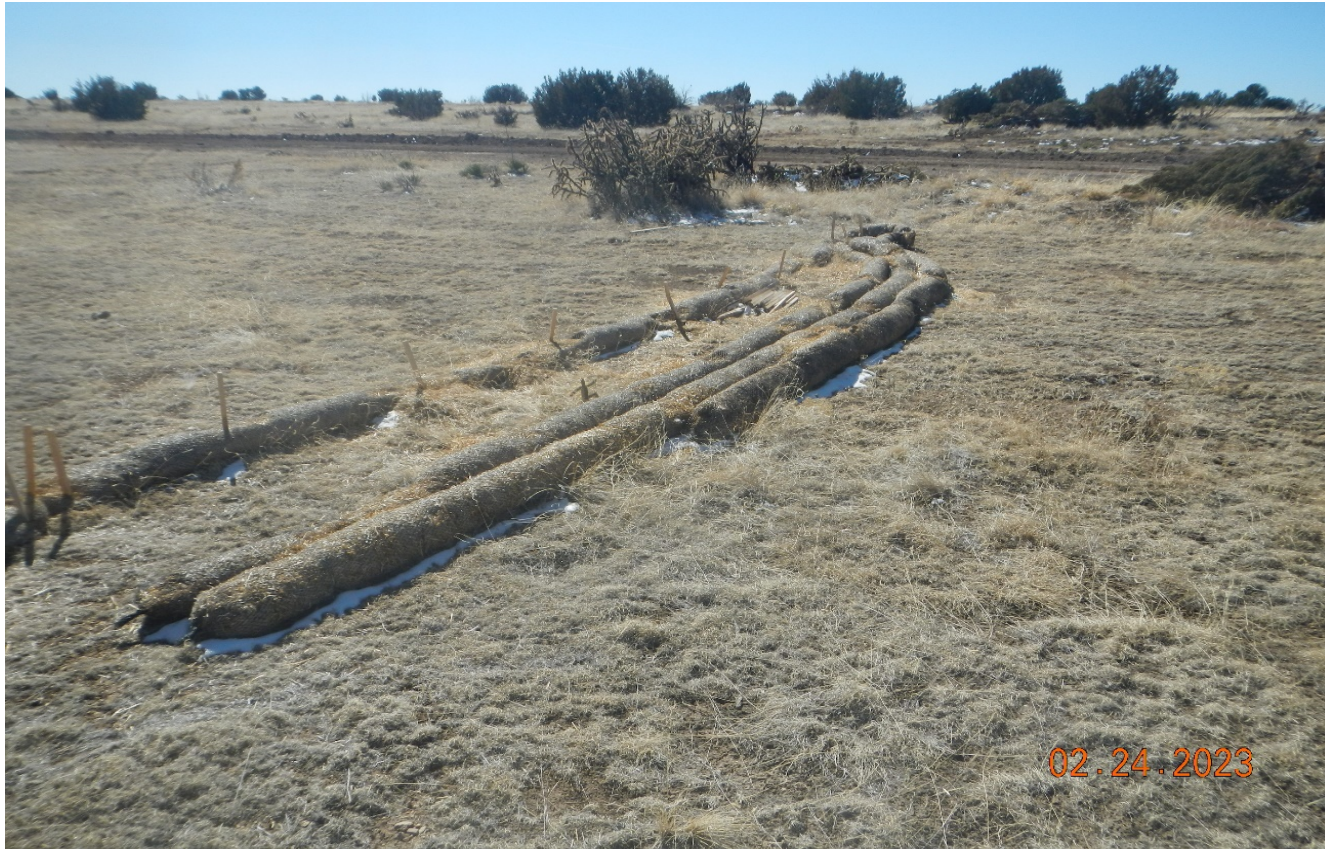
Photo 7. Stormwater BMP's at the location are not maintained or installed.

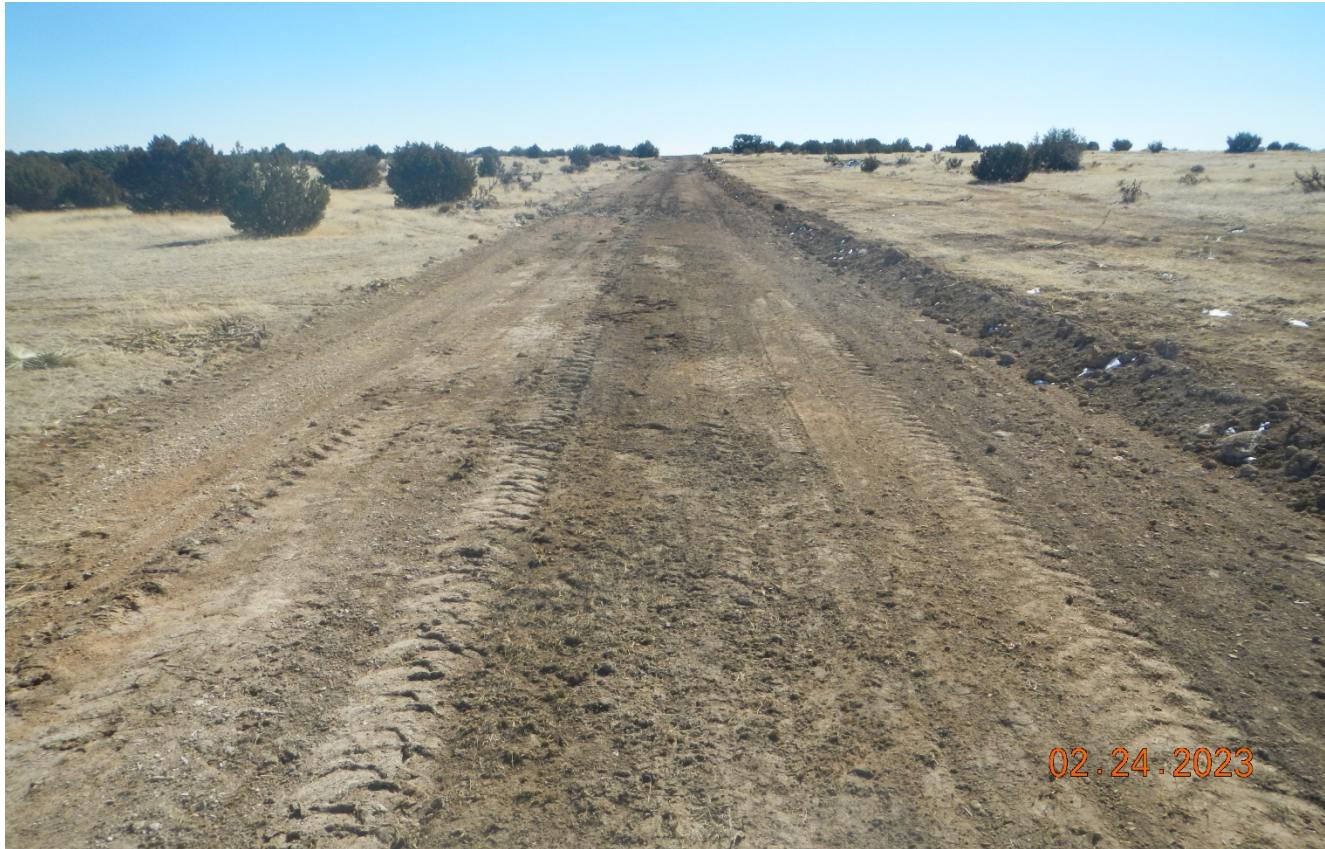
Photo 8. Facing southeast toward the flowline trenching disturbance.

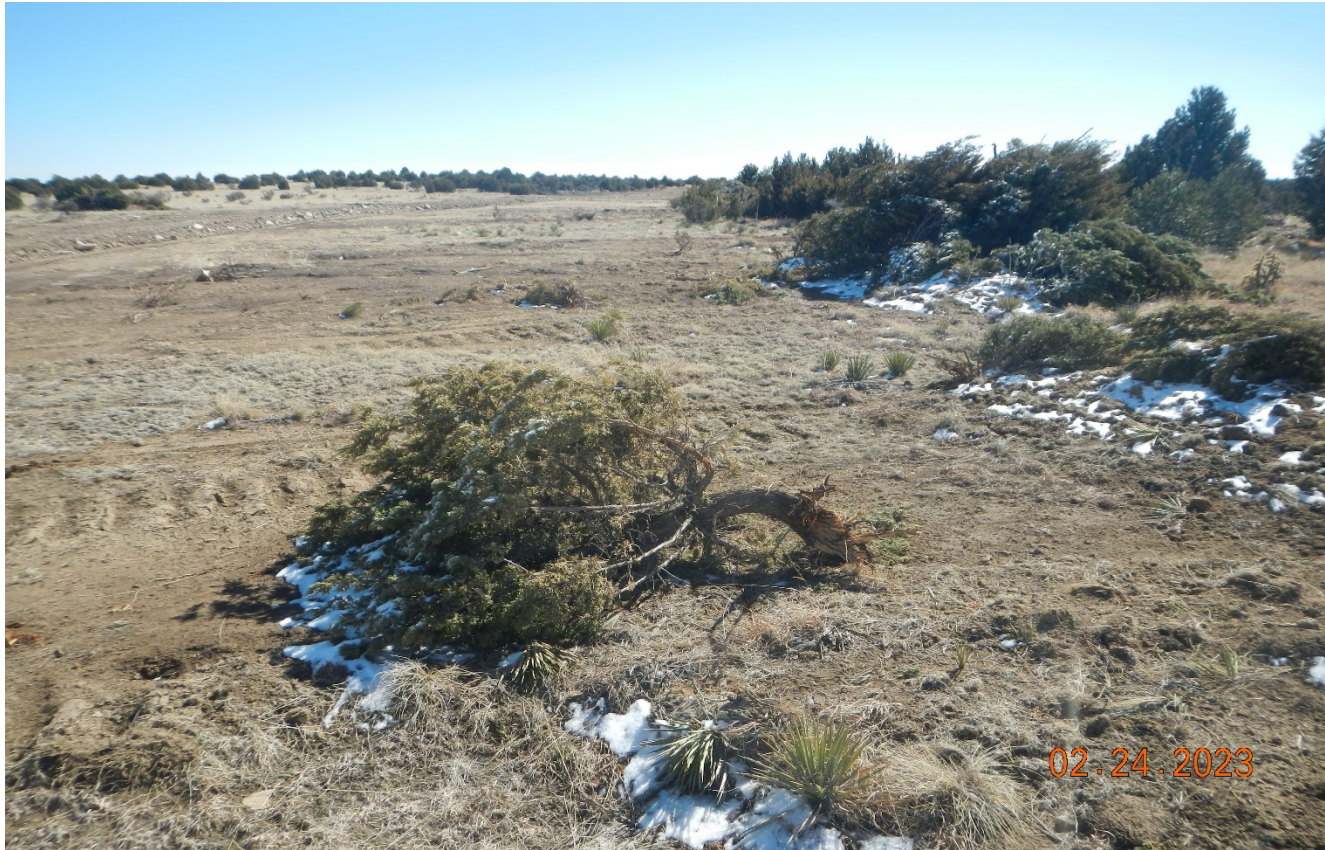
Photo 9. There are trees and soil pushed out along the area of trenching. All tree debris will need to be removed. Soil pushed out will need to be replaced.

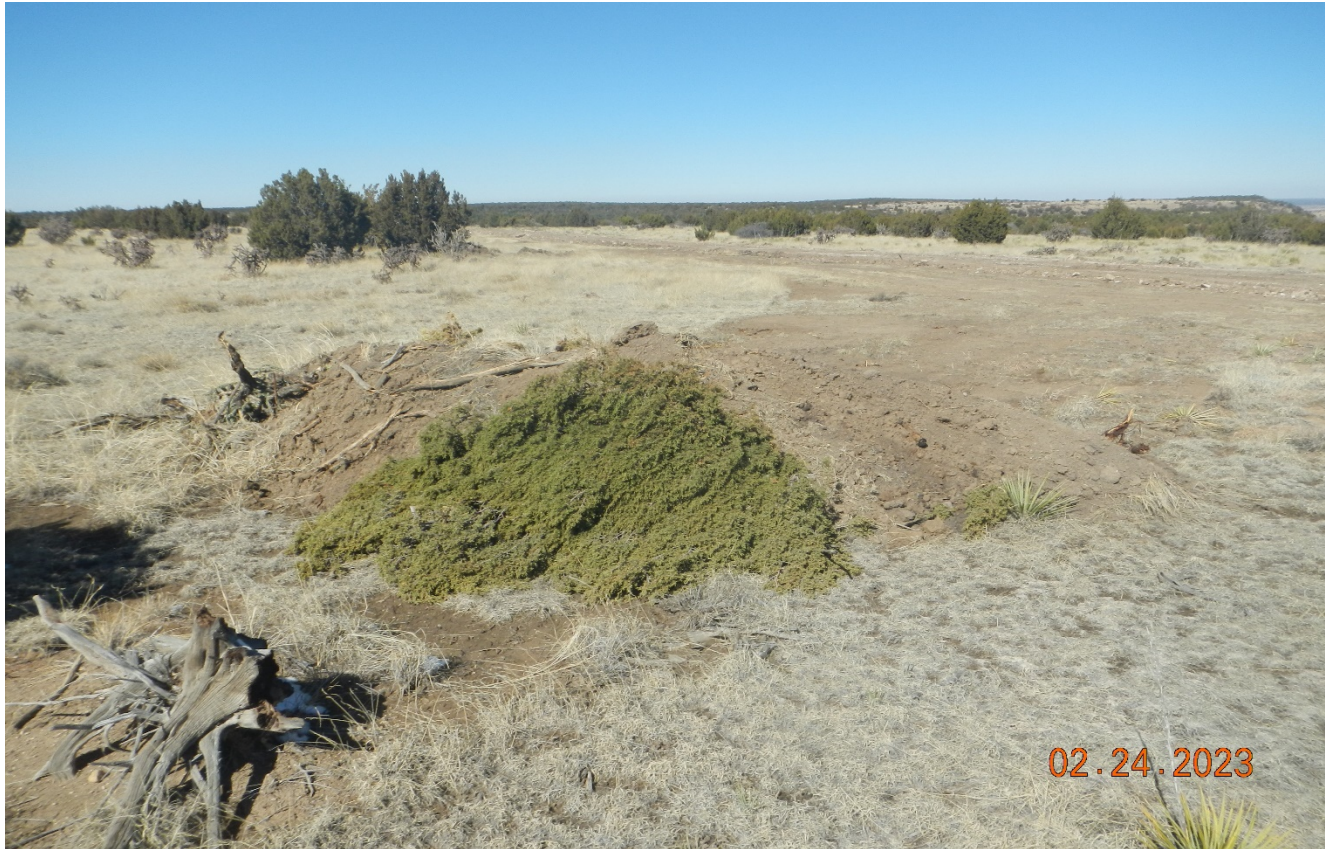
Photo 10. There are trees and soil pushed out along the area of trenching. All tree debris will need to be removed. Soil pushed out will need to be replaced.

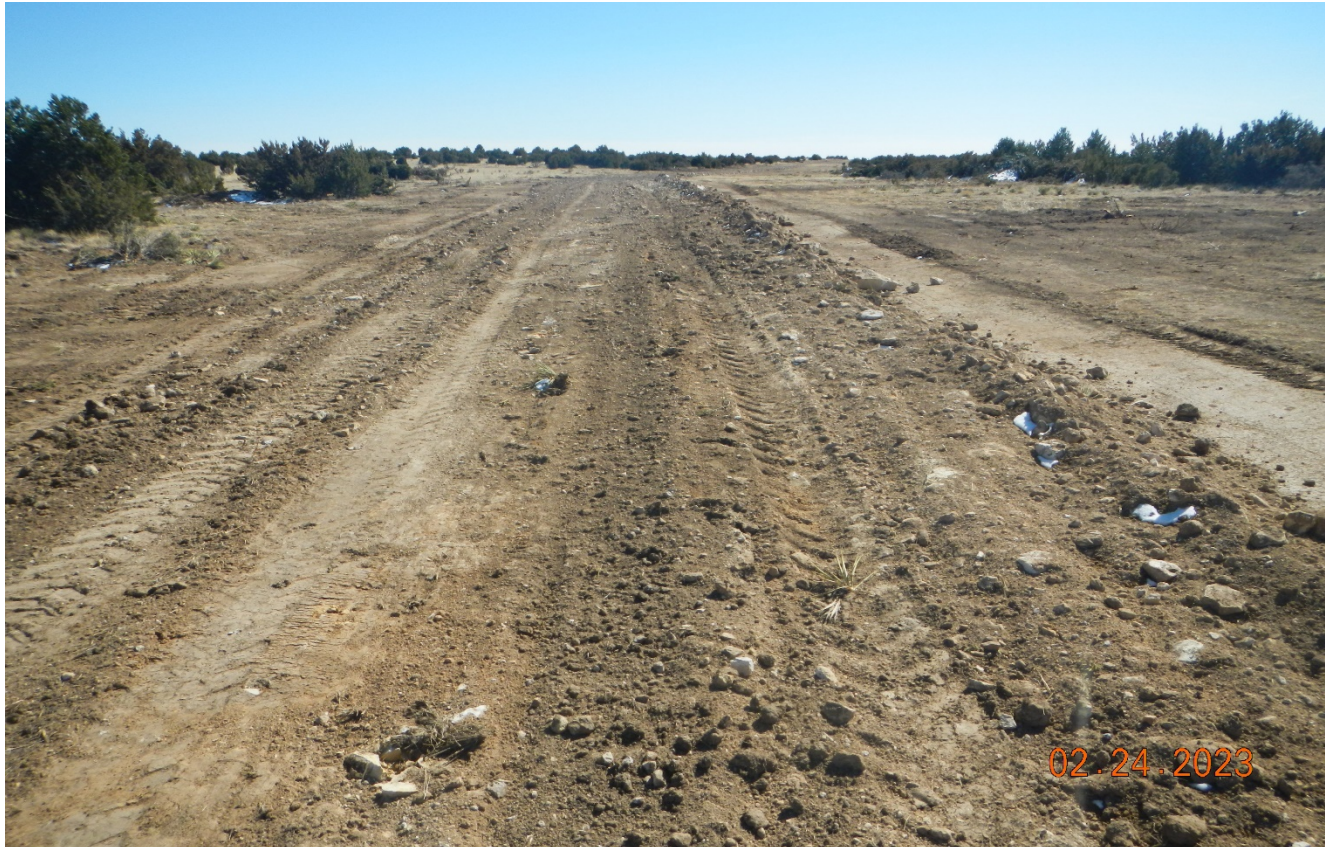
Photo 11. Facing southeast toward the flowline trenching disturbance. There were scattered rocks along the disturbance and it does not appear topsoil was separated along the flowline.

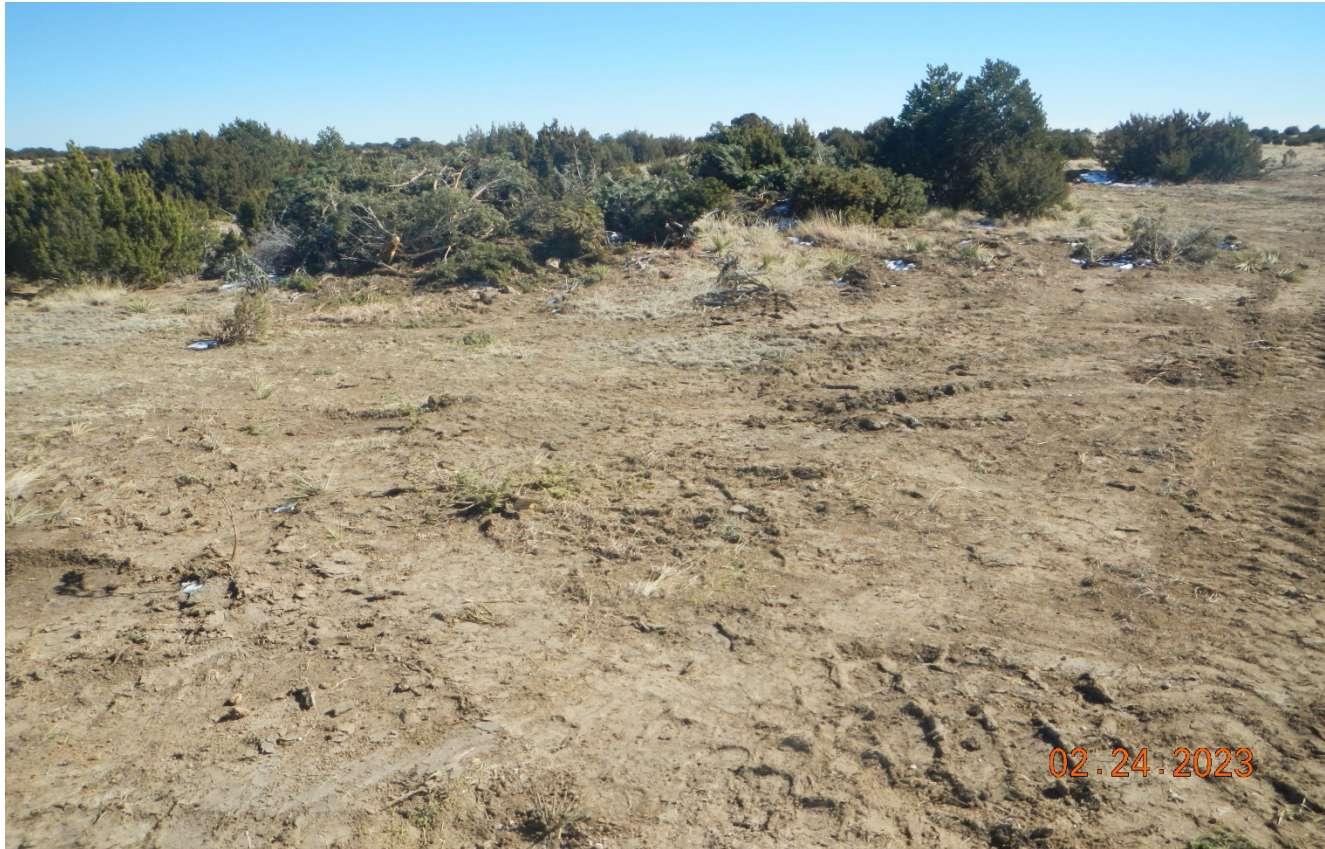
Photo 12. There are trees pushed out about 100 ft. from the flowline. Unnecessary disturbance has been created.
