Inspection Photos

2/27/2023

Operator: CAERUS PICEANCE LLC - 10456

Location #423081

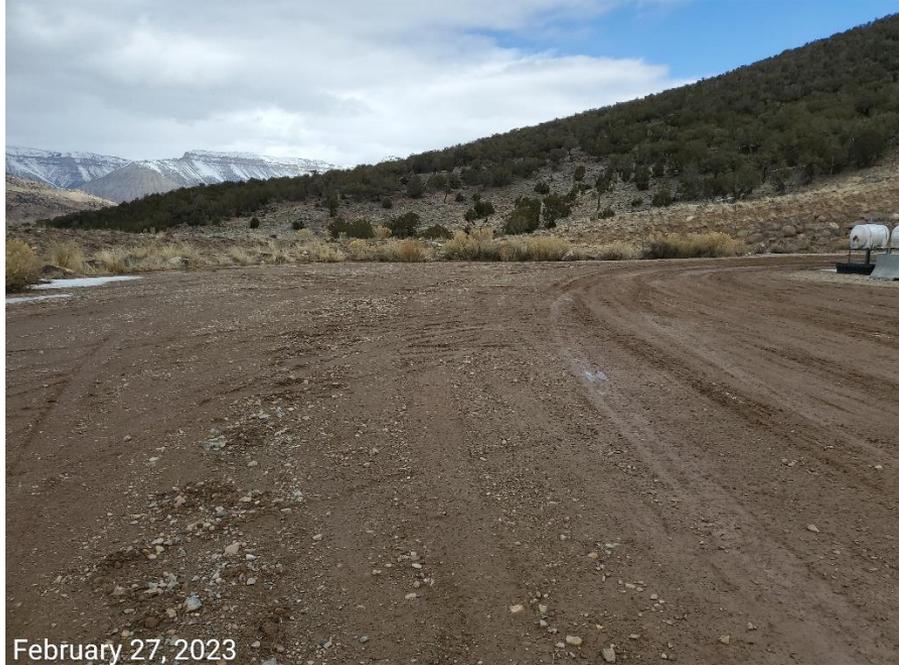
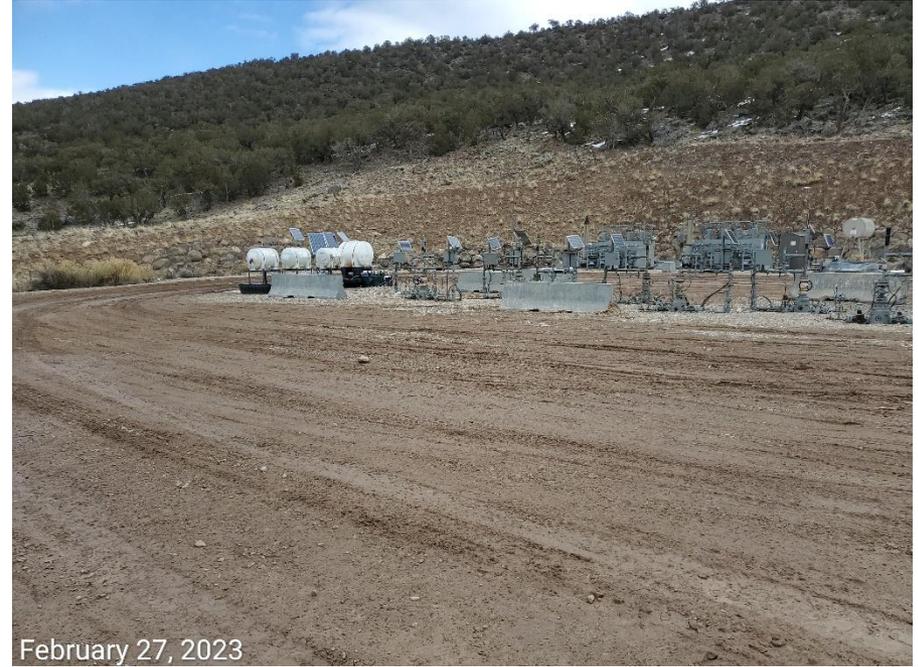
Photo 1: Photos 1-2 taken from the west end of the Location. Photos provide an overview of the Location from north, northeast, southeast to south.

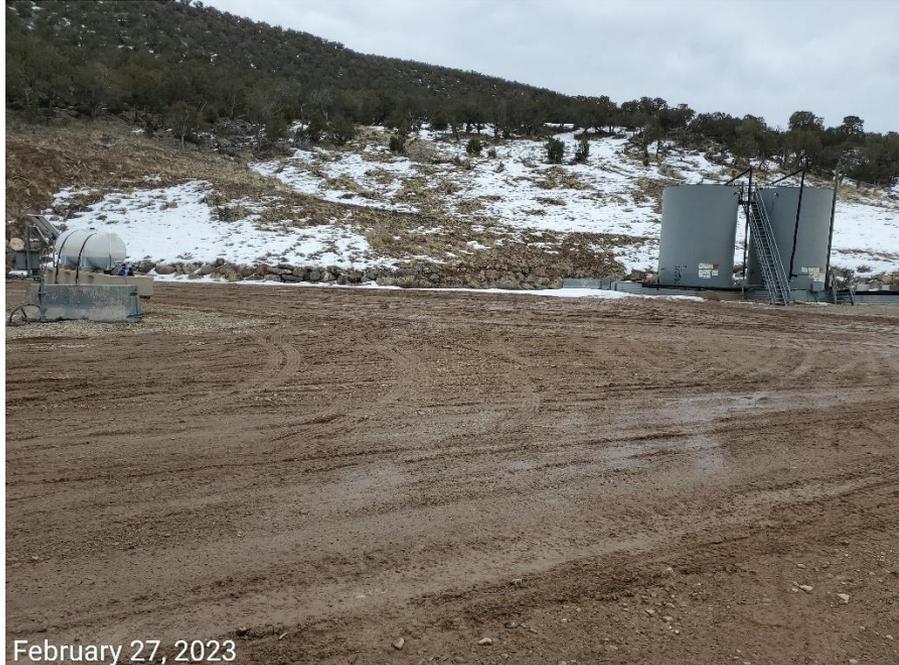
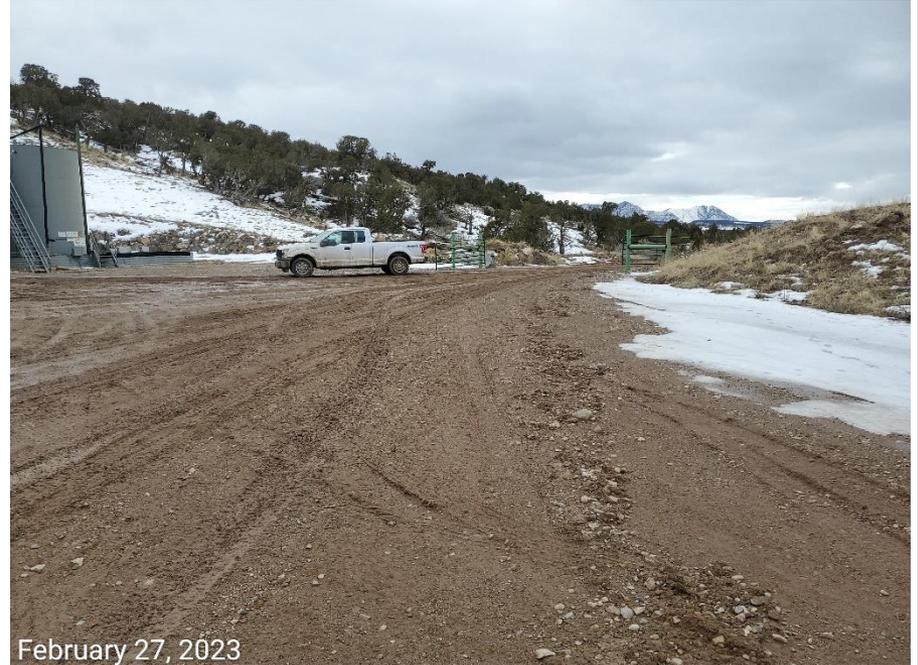
Photo 2: See comments under photo 1.

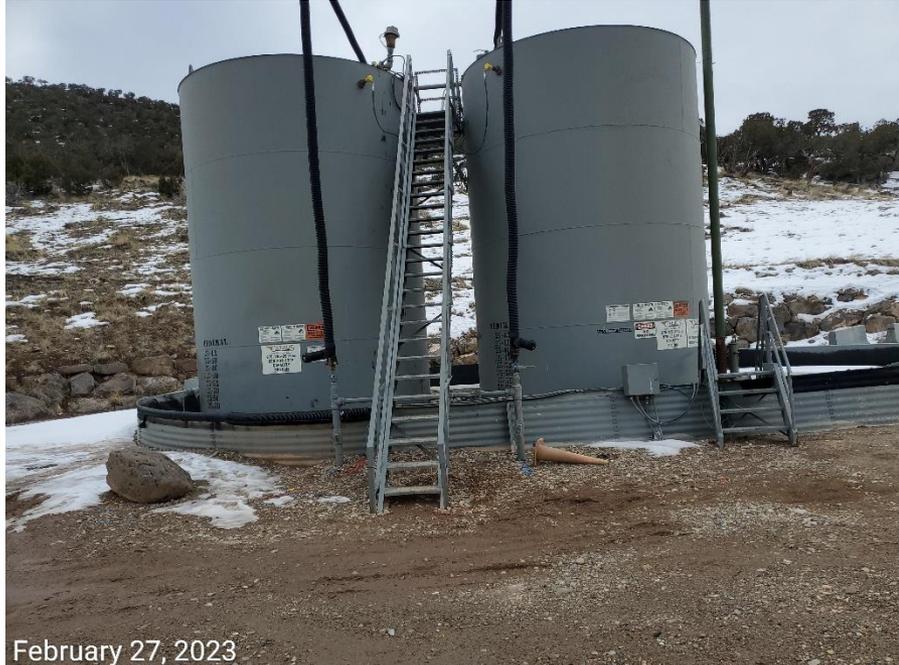
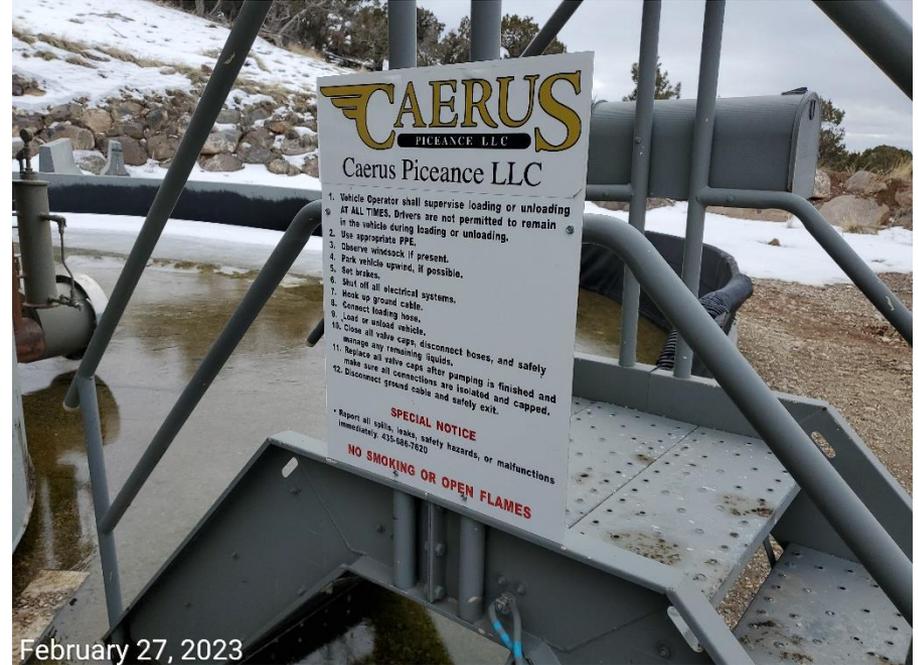
Photo 3: Photo of tank battery facility. Sign not posted or information pursuant to Rule 605.e. is missing or inaccurate at the tank battery.

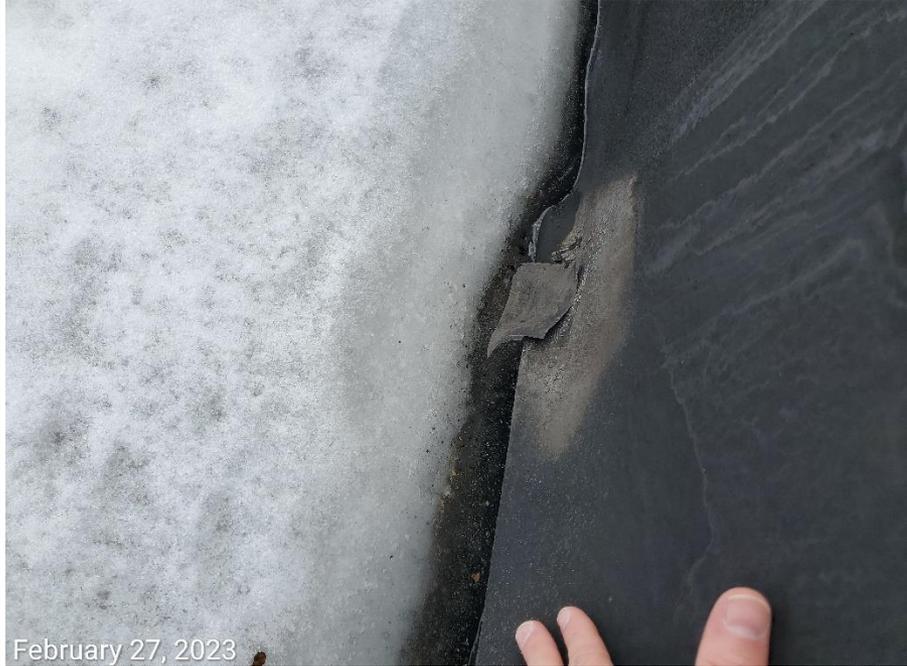
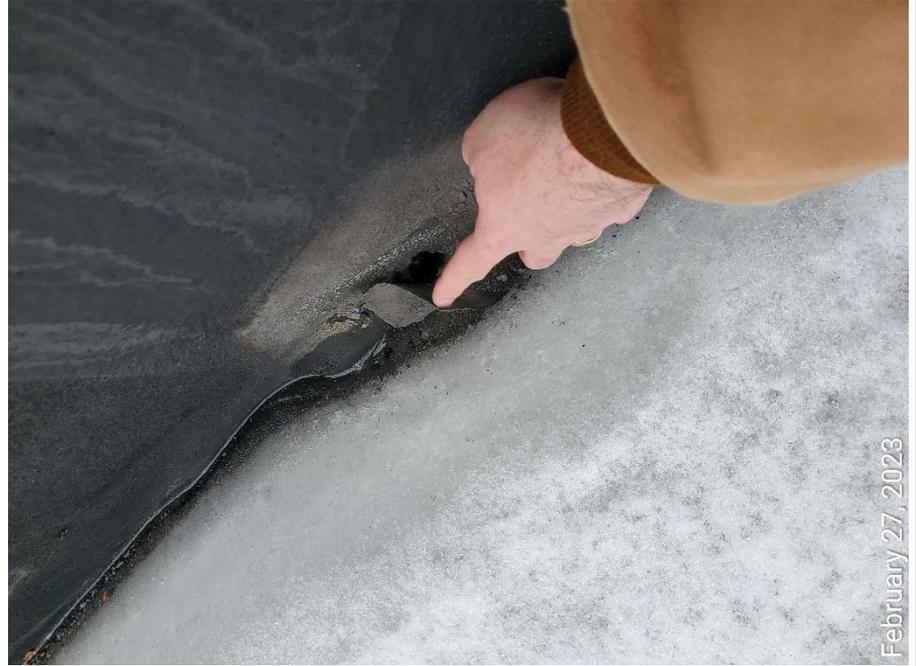
Photo 4: Photo example showing holes observed within secondary containment liner at the tank battery facility. Patch previously applied to hole has peeled off.

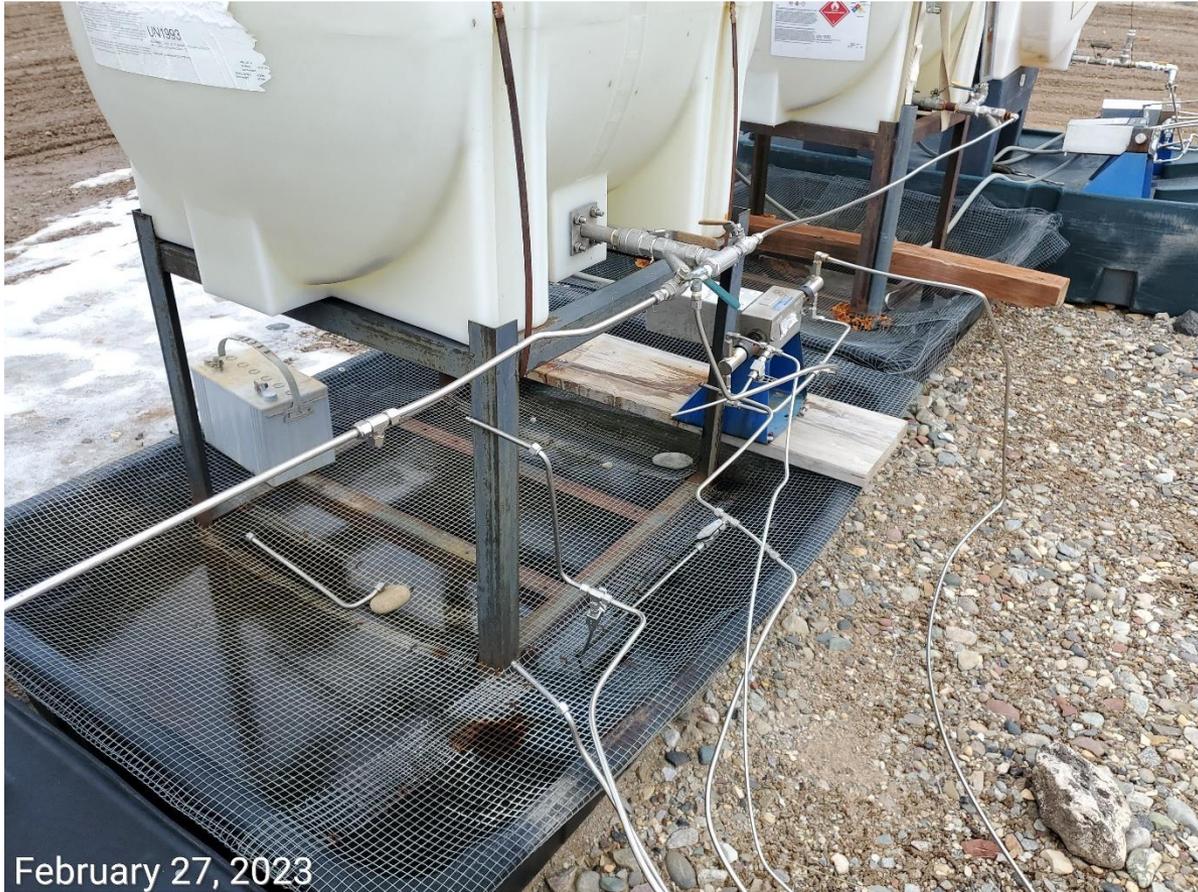
Photo 5: Methanol tanks- containment BMPs partially filled with fluids. Advise removal of fluids to ensure containment BMP remains in proper functioning condition.

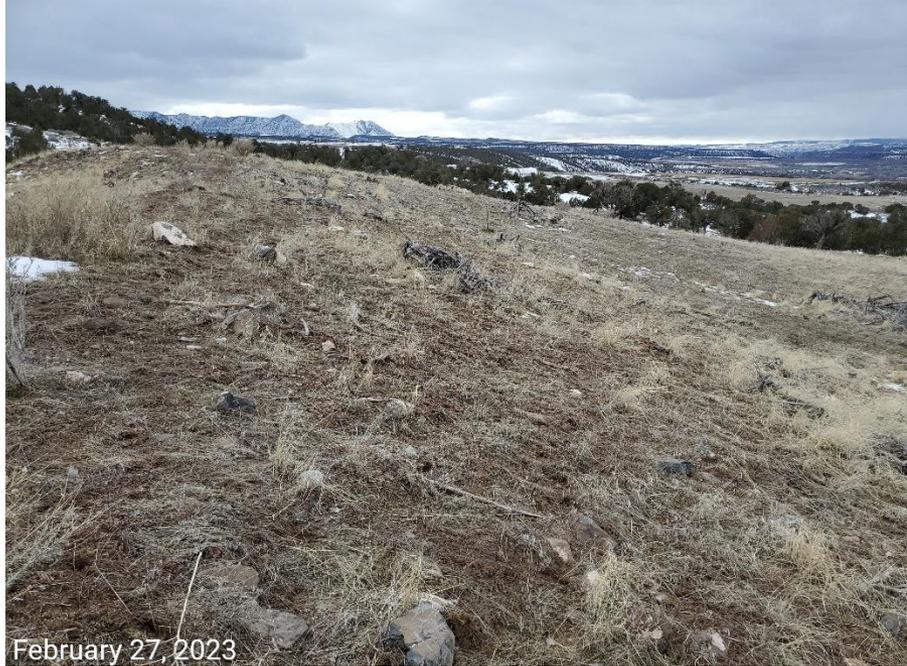
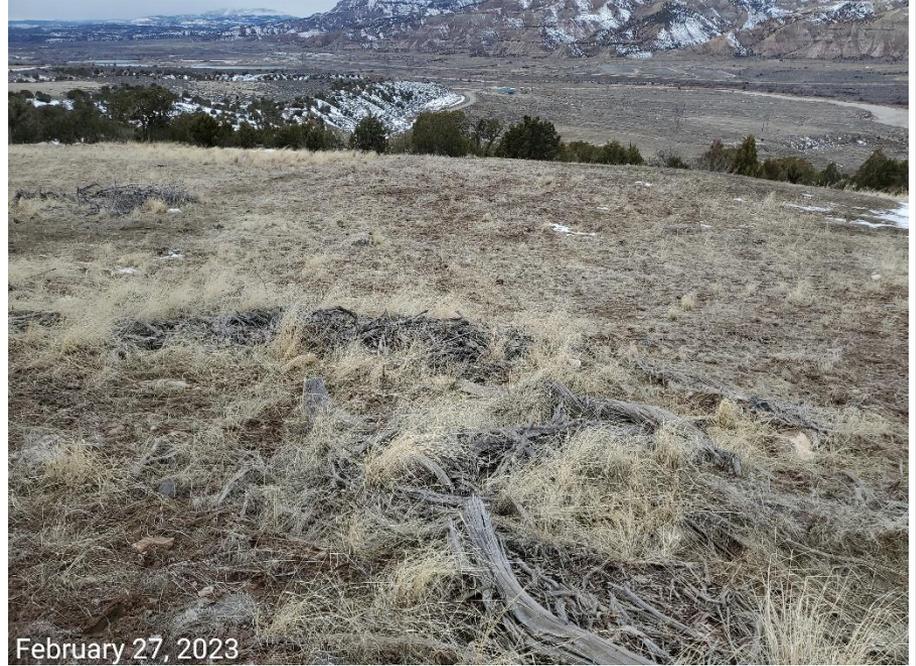
Photo 6: Photos 6-8 provide overview of the Interim areas of the Location. Limited reclamation inspection due to winter conditions; areas appear to be progressing towards 1003 standards.

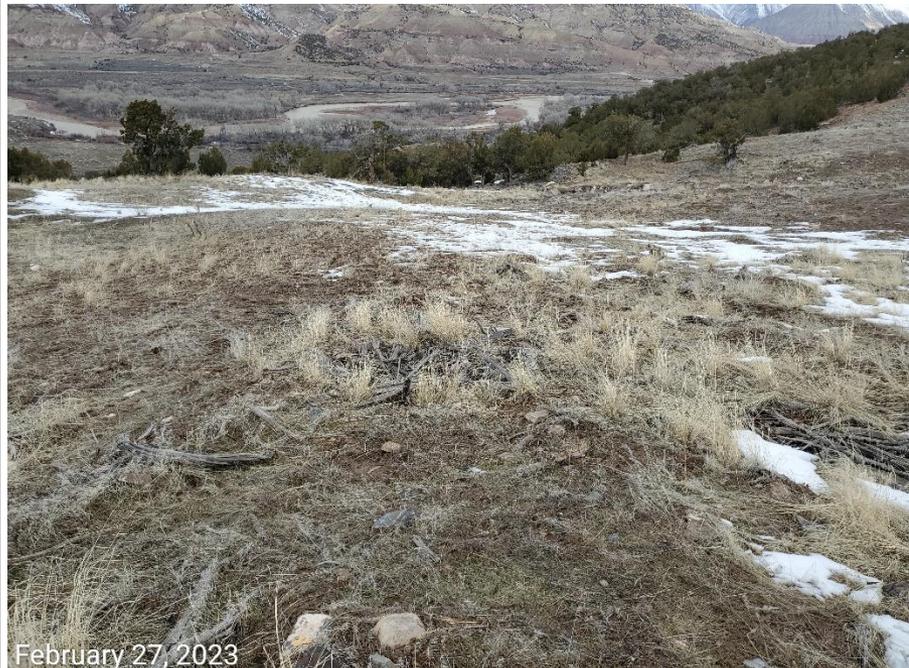
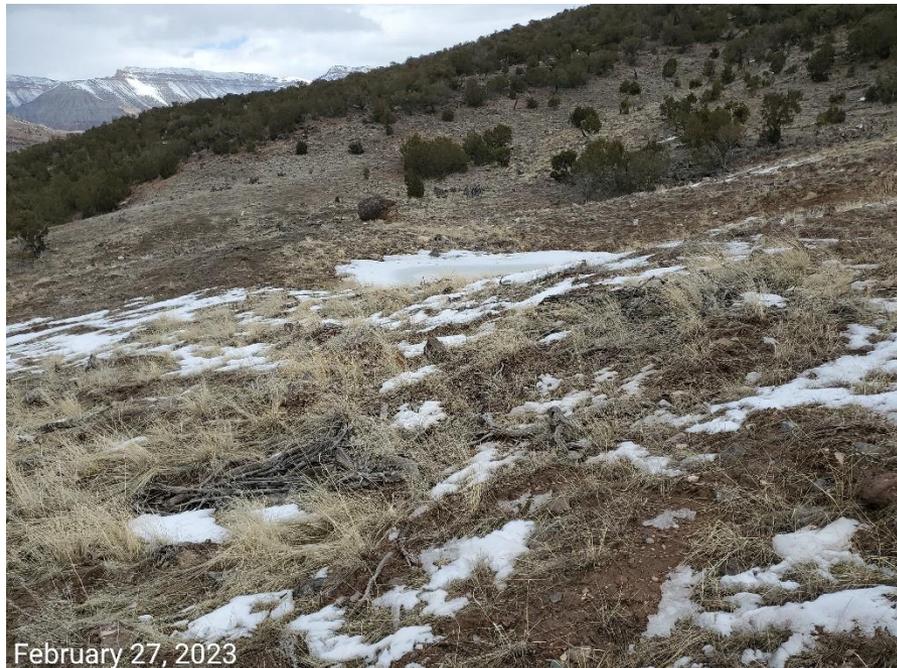
Photo 7: See comments under photo 6.

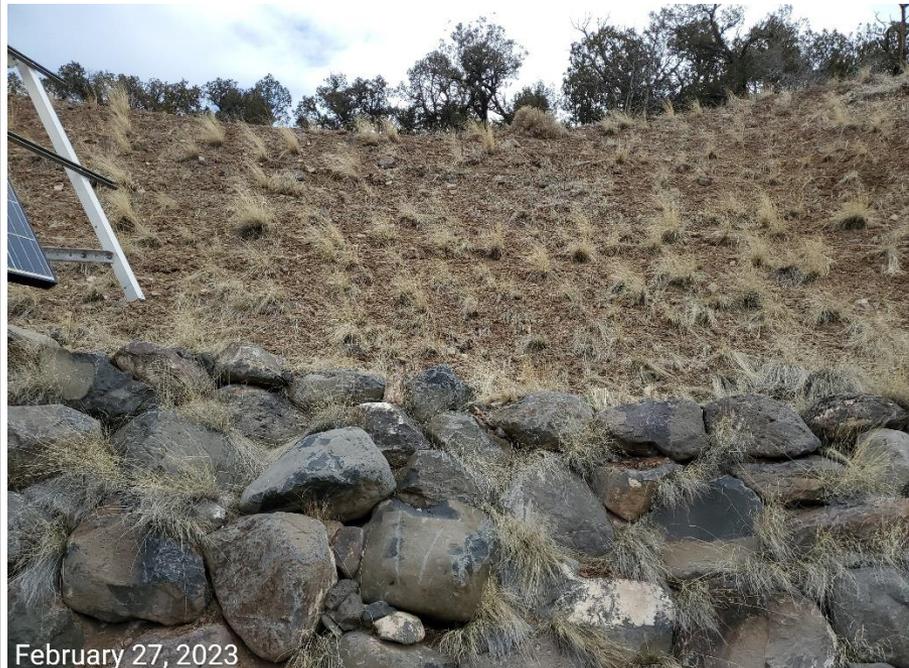
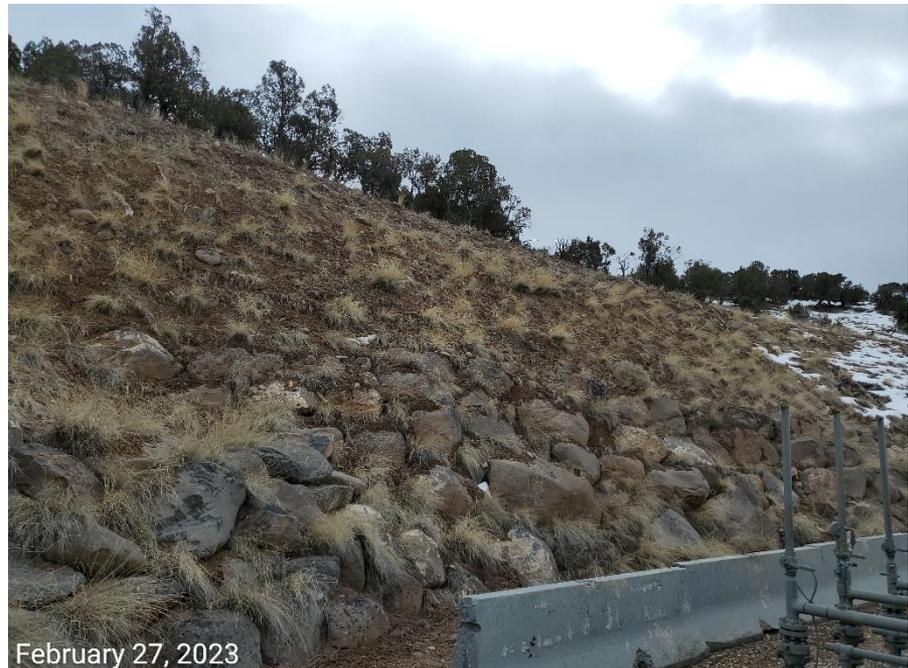
Photo 8: See comments under photo 6.

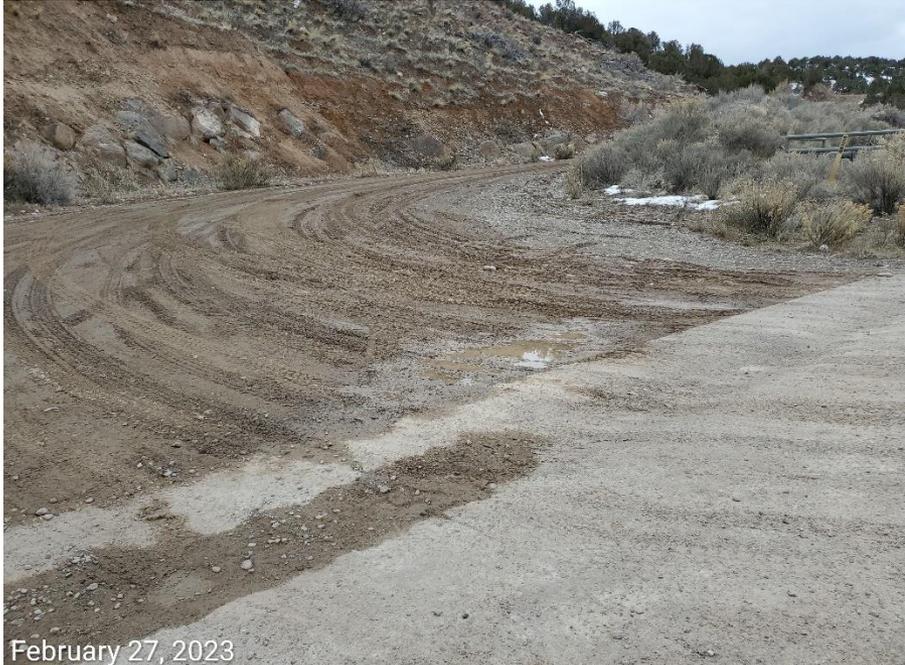
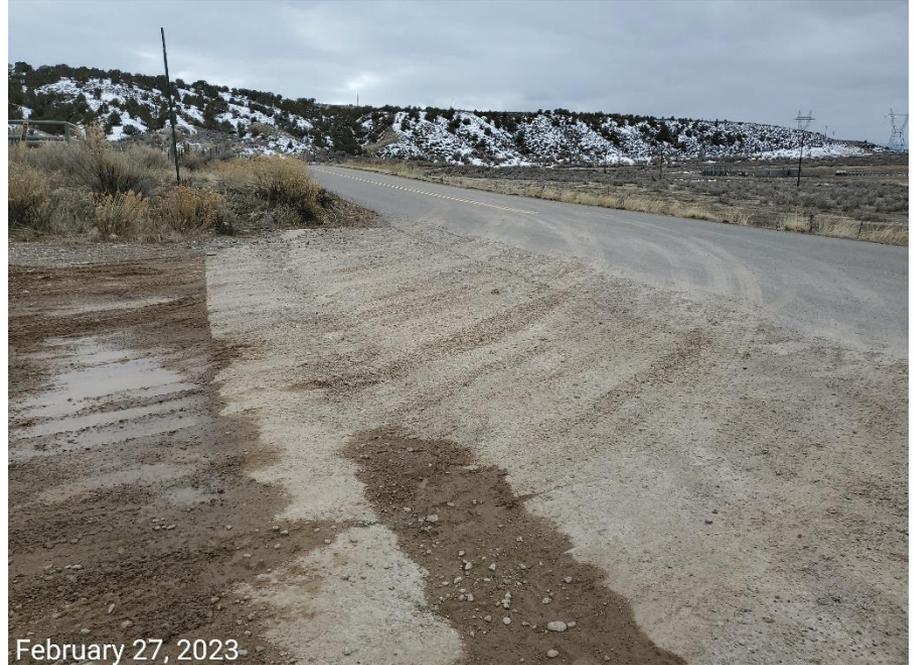
Photo 9: Photo taken from the access road entrance, from the County Road (Stone Quarry Rd). Photos show BMPs to minimize tracking and sediment transport are missing or insufficient; tracking/sediment transport from the access road onto the County Road observed.
