Final Reclamation and Stormwater Inspection

Operator: ST CROIX OPERATING INC - 81490

Location ID: 482780

Inspection Document #: 708200024

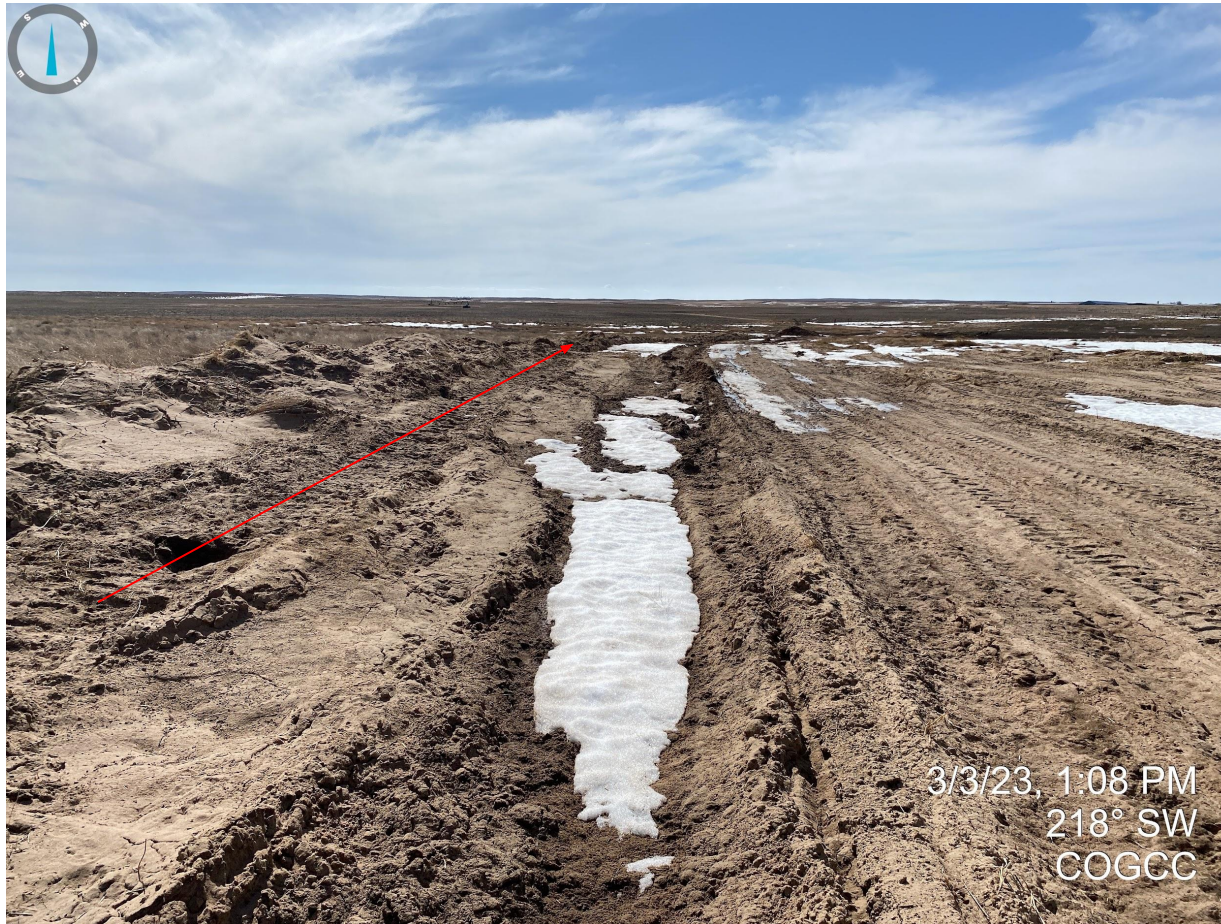
Photo 1. Facing southwest along the access road to the location. Photo illustrates that the topsoil stockpiles salvaged for the access road remain unconsolidated and not stabilized against wind or water erosion. BMPs will need to be implemented.

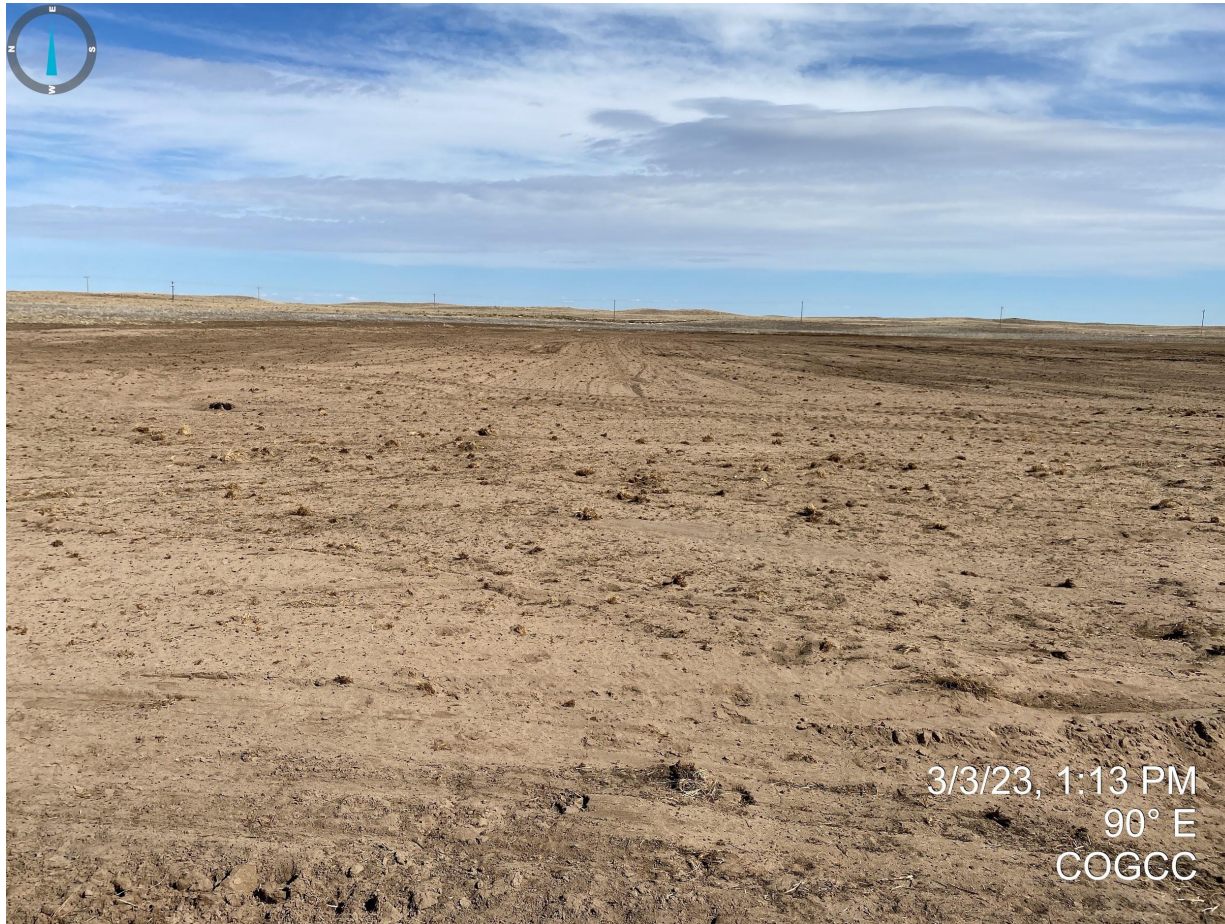
Photo 2. Facing east from the western portion of the location. Final reclamation activities have started with evidence of grading and contouring observed during this inspection. Operator shall continue to comply with 1004 Rules for final reclamation activities and timing requirements.

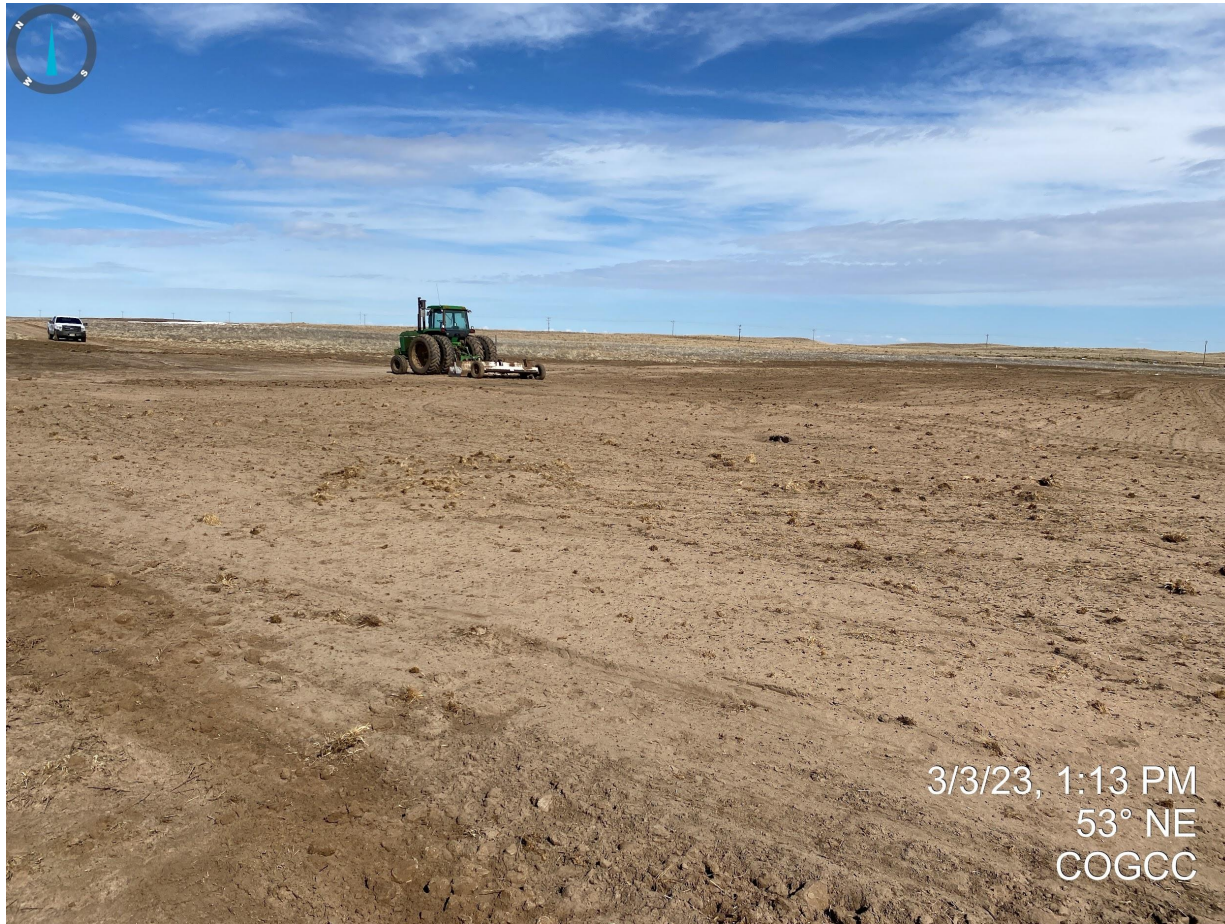
Photo 3. Facing northeast, see comments in Photo 2.

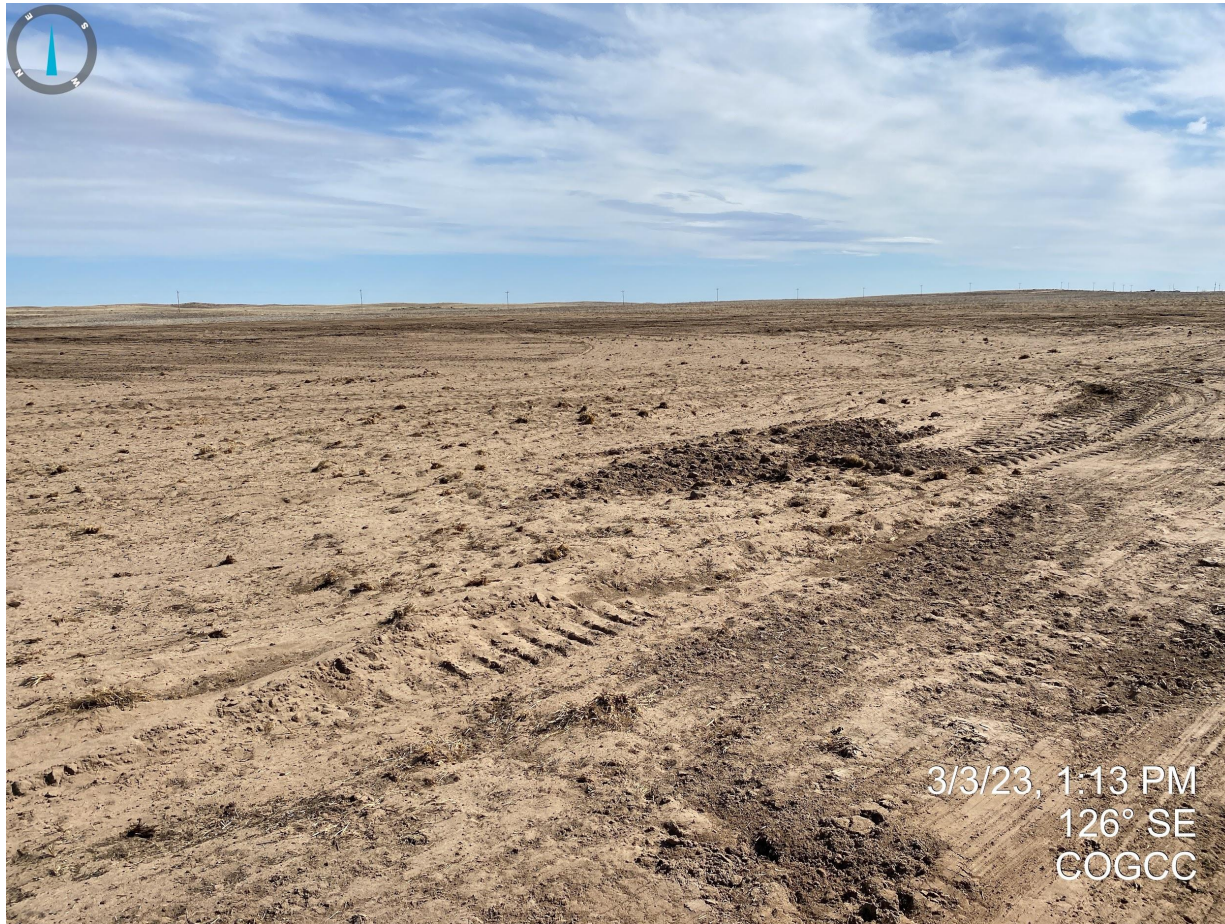
Photo 4. Facing southeast, see comments in Photo 2.

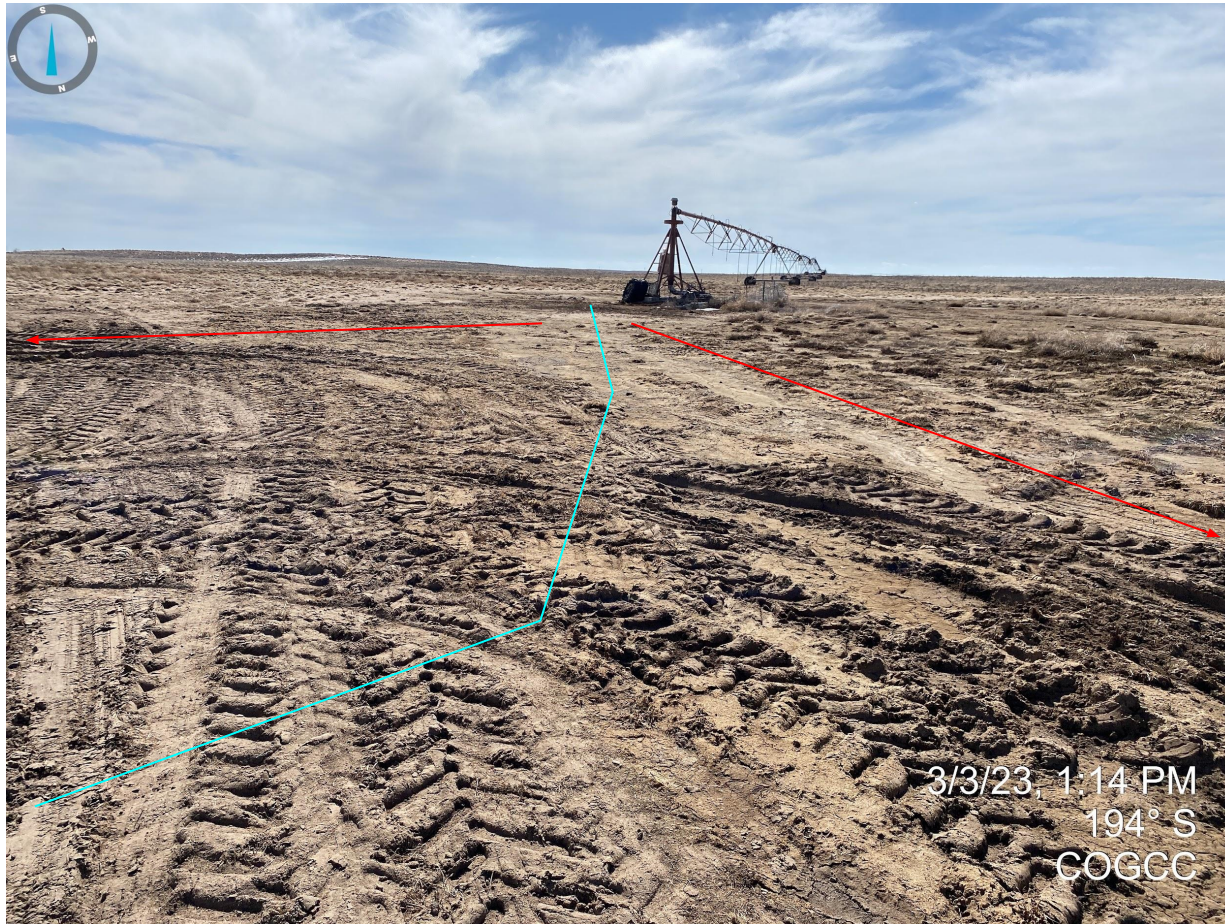
Photo 5. Facing south from the western portion of the location. No stormwater BMPs (e.g. perimeter berm, etc) observed to prevent and manage run on and run off, illustrated by red arrows. Blue line illustrates estimated path of water from broken irrigation line.

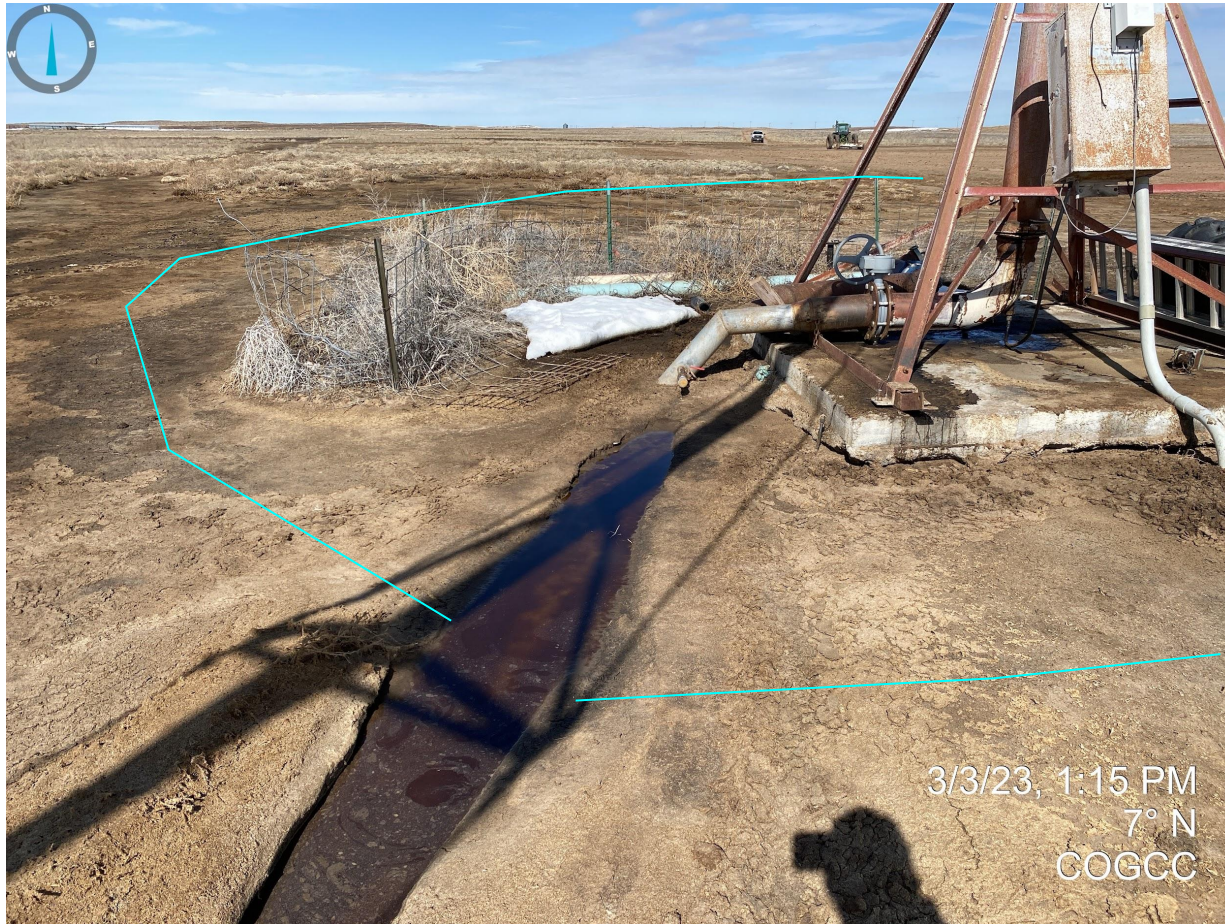
Photo 6. Facing north at center pivot. Blue lines illustrate approximate path of water. No BMPs observed around location to prevent water from coming onto location (e.g. run on)

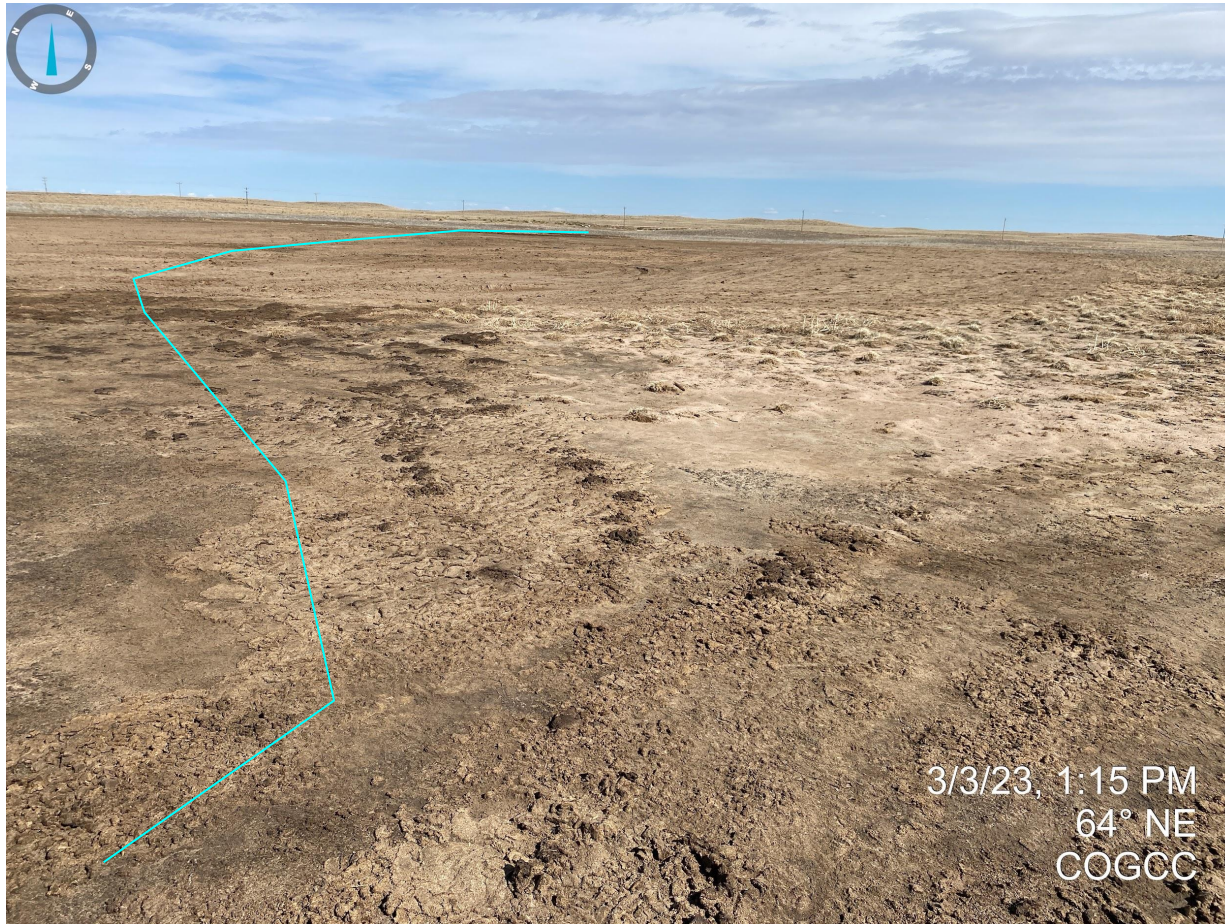
Photo 7. Facing northeast from the center pivot, see comments in Photo 6.

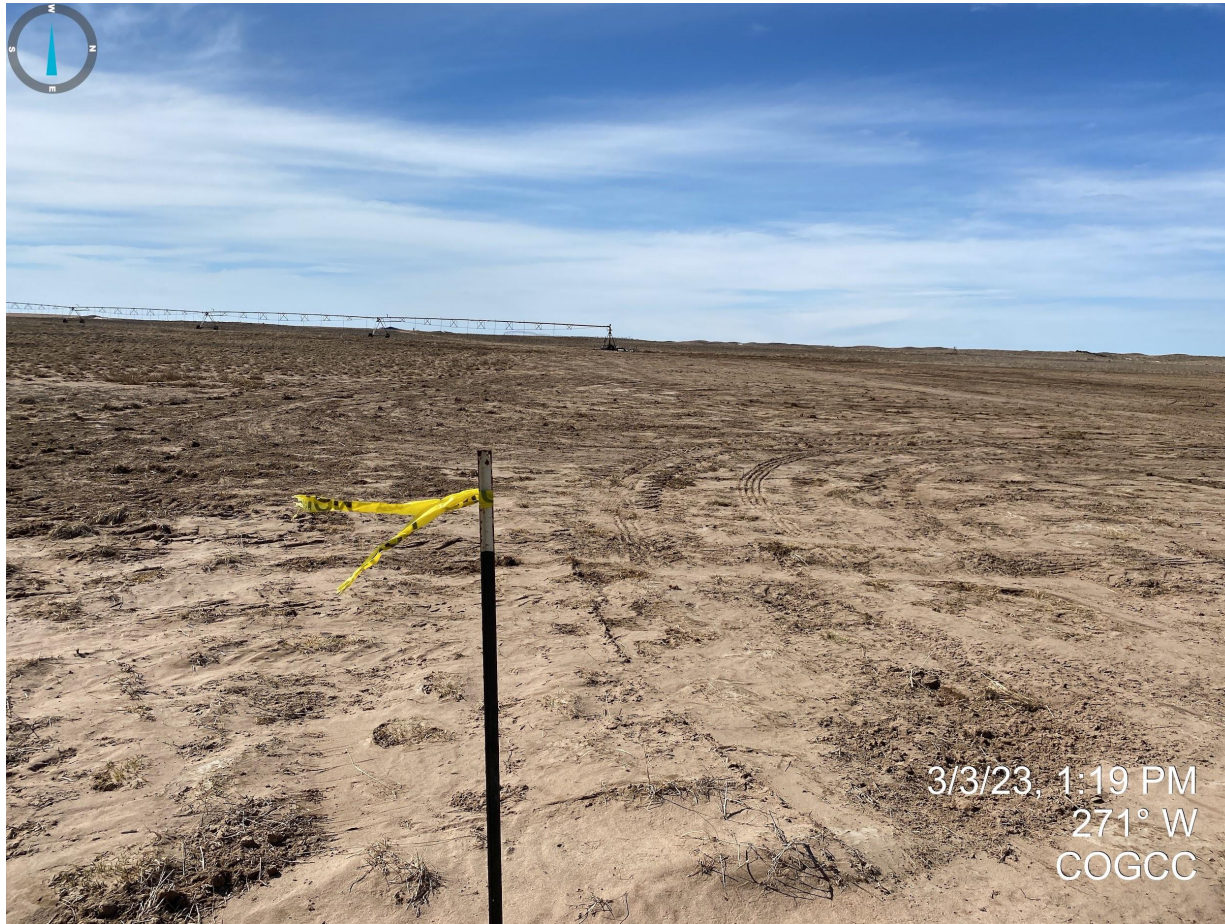
Photo 8. Facing west from the southeast corner of the location, see comments in Photo 5.

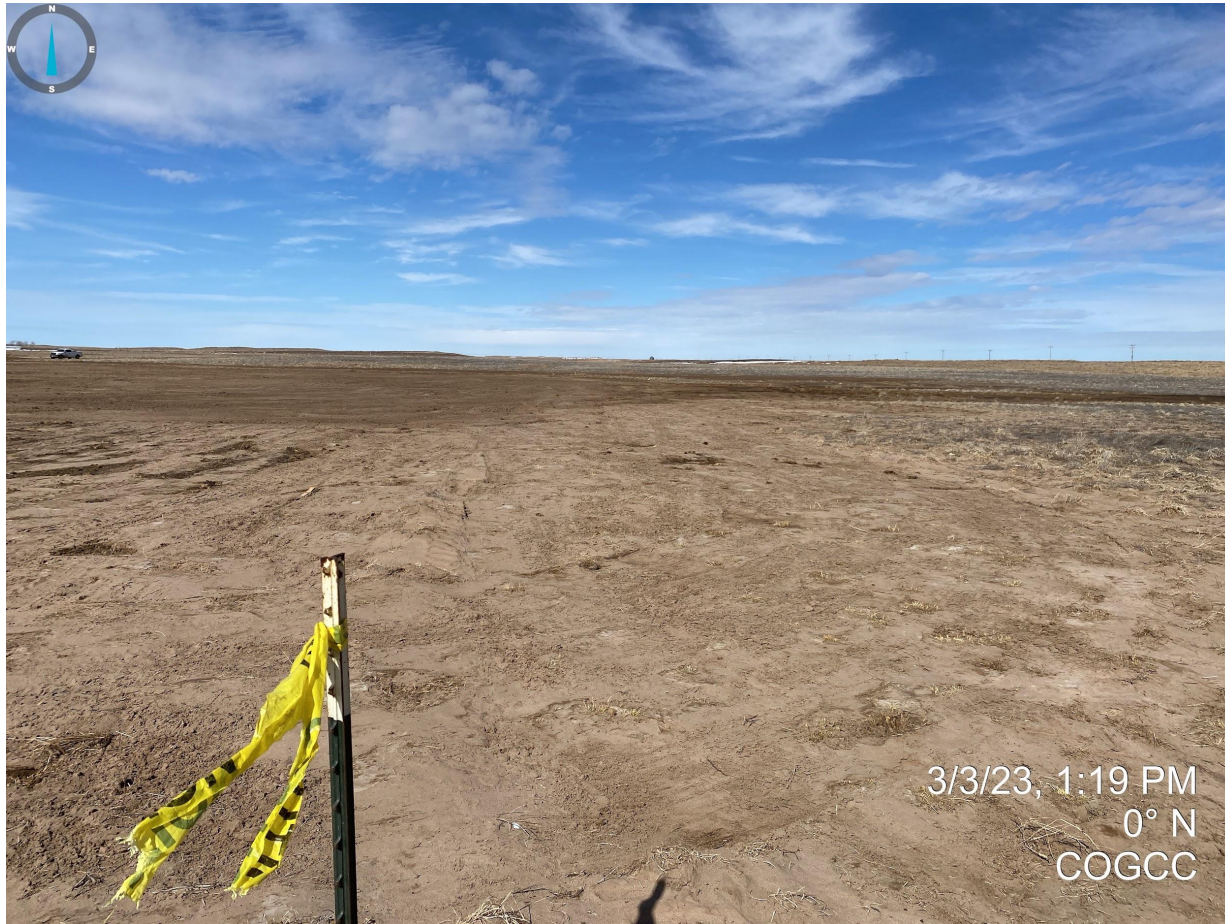
Photo 9. Facing north from the southeast corner of the location, see comments in Photo 5.

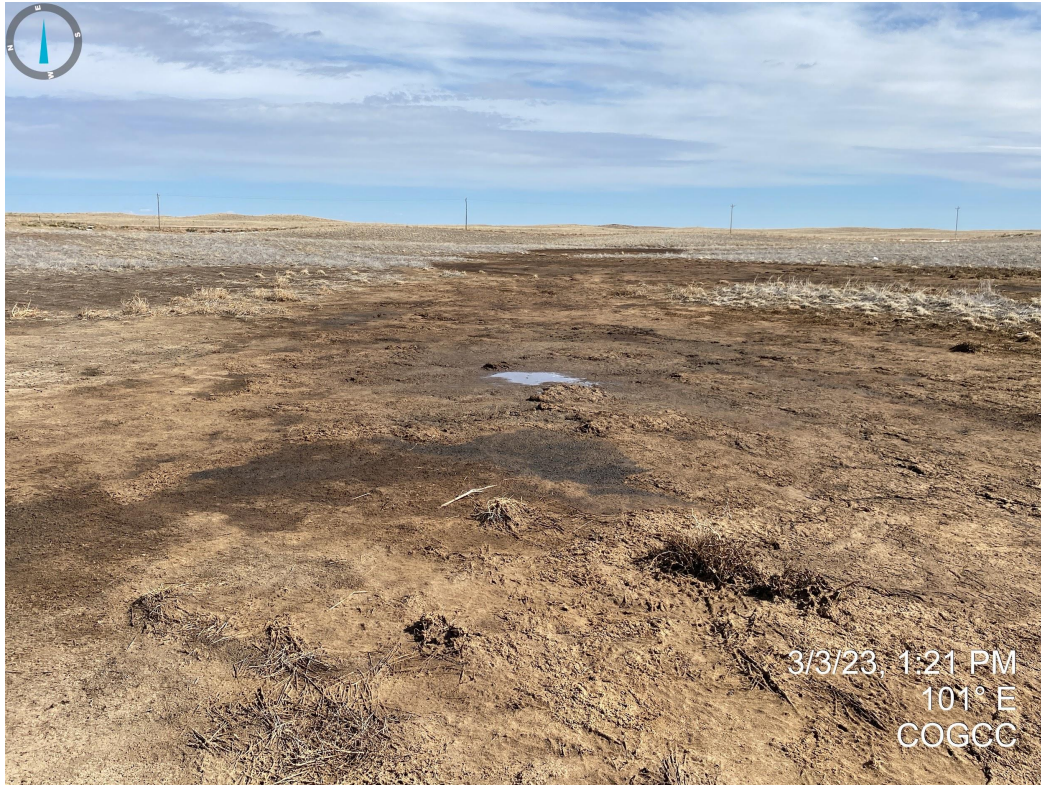
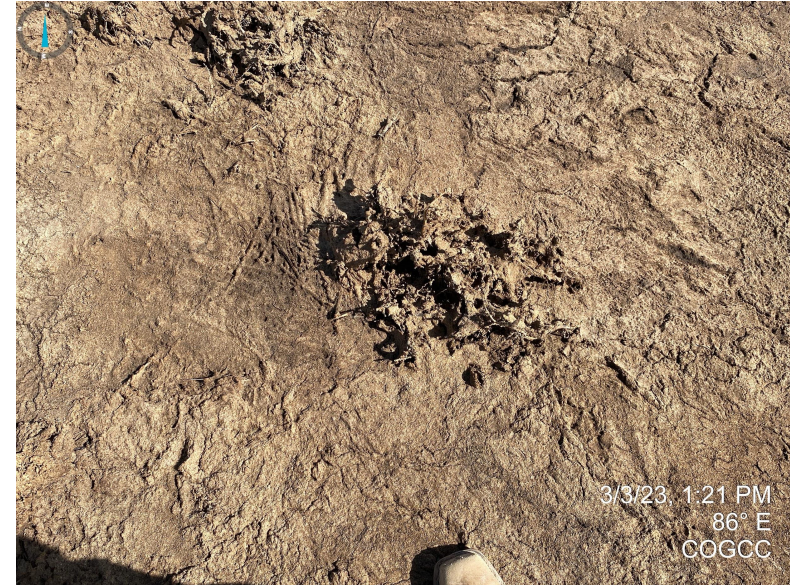
Photos 10 and 11. Facing east from the eastern boundary of the location. Photo illustrates saturated soils, ponding, and evidence of manure (right) from the broken water line at center pivot.

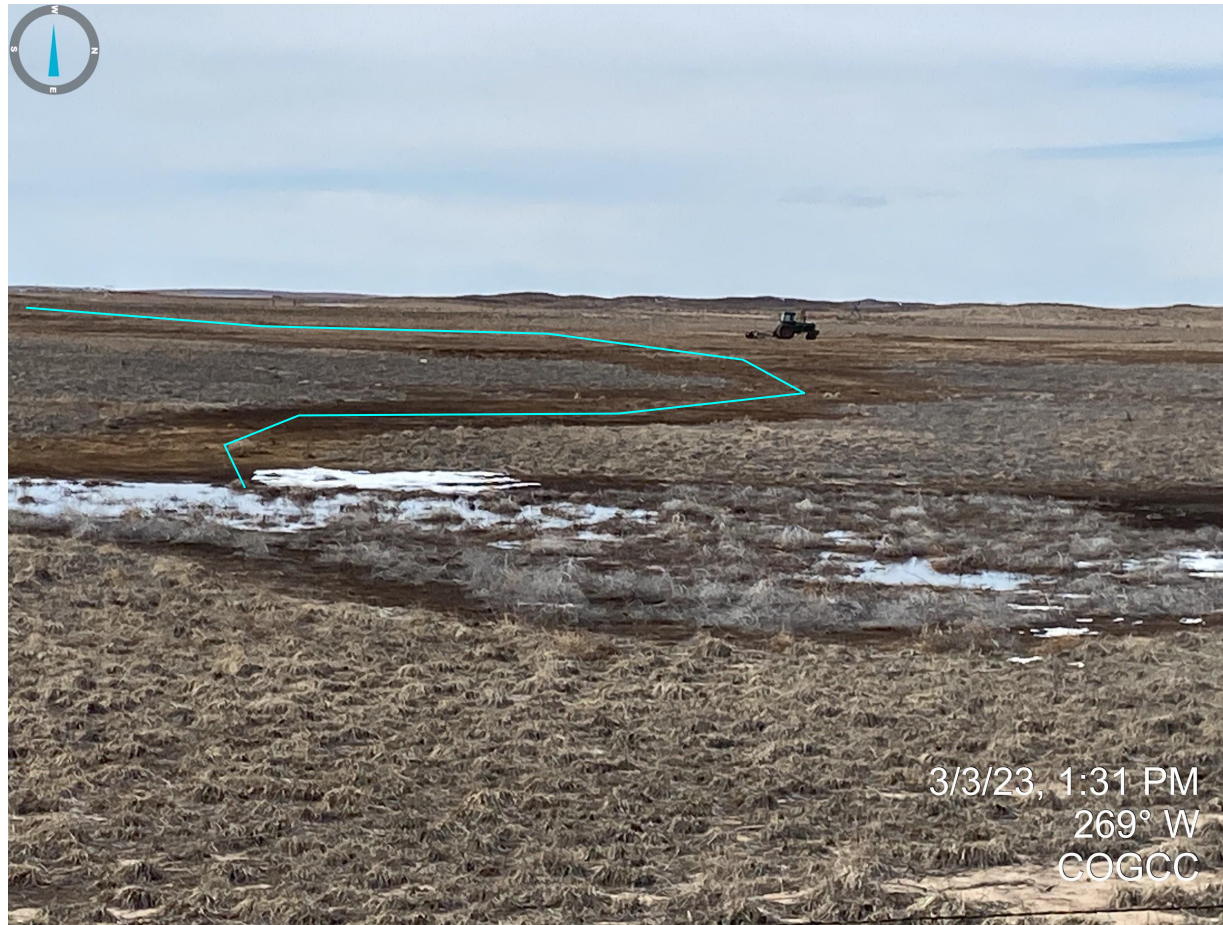
Photo 12. Facing west from CR YY, Blue line illustrates approximate path of water from broken pipe. Note: ponding water is likely a combination of water from the broken irrigation system and snow melt.

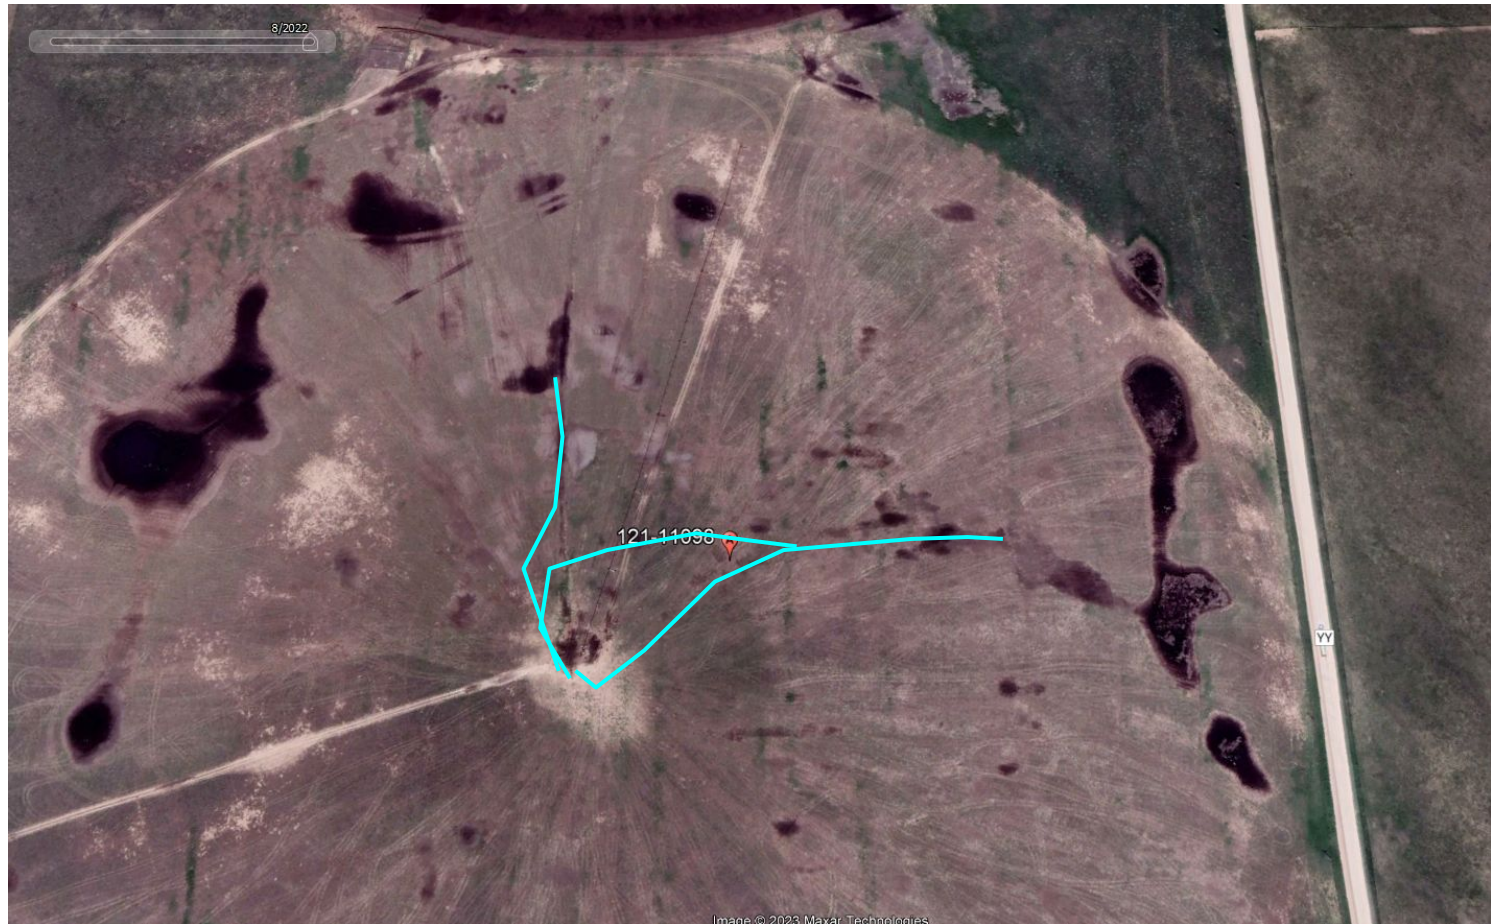
Photo 13. Google Earth aerial imagery taken circa 08/2022. Blue line illustrate approximate path of water from broken water line. The absence of any stormwater BMPs to control run on and run off allowed the water from the broken water line to pass through and off location. Staff acknowledges the broken line happened independent of oil and gas activities.
