Construction and Stormwater Inspection

Operator: DENOVE SEQUESTRATION LLC - 10790

Location ID: 483817

Inspection Document #: 708200035

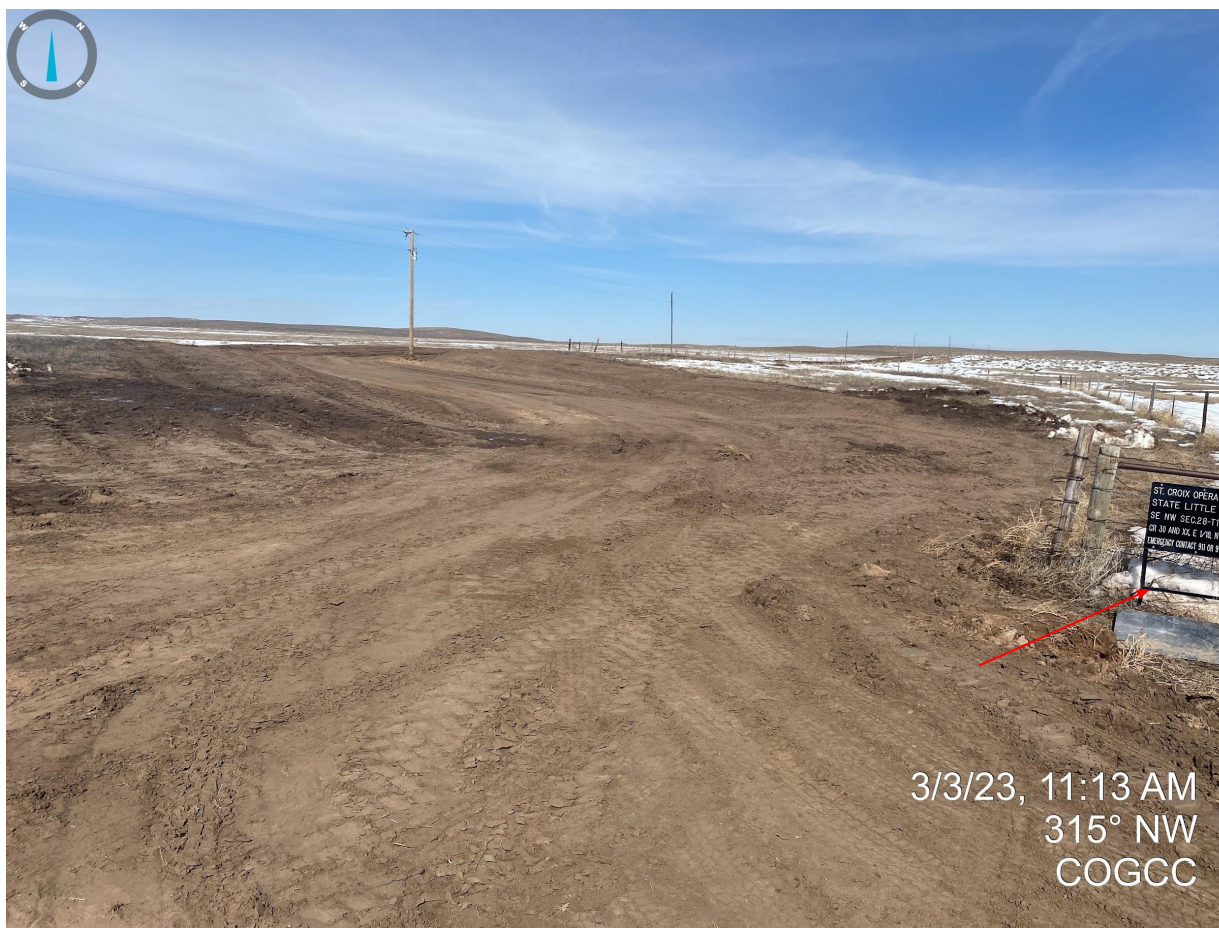
Photo 1. Facing northwest from the location's entrance at the county road. A copy of the approved Form 2A and a posted sign with location information was not posted in a conspicuous location. A sign for a different location and a JSA sign-in board was observed, highlighted in red.

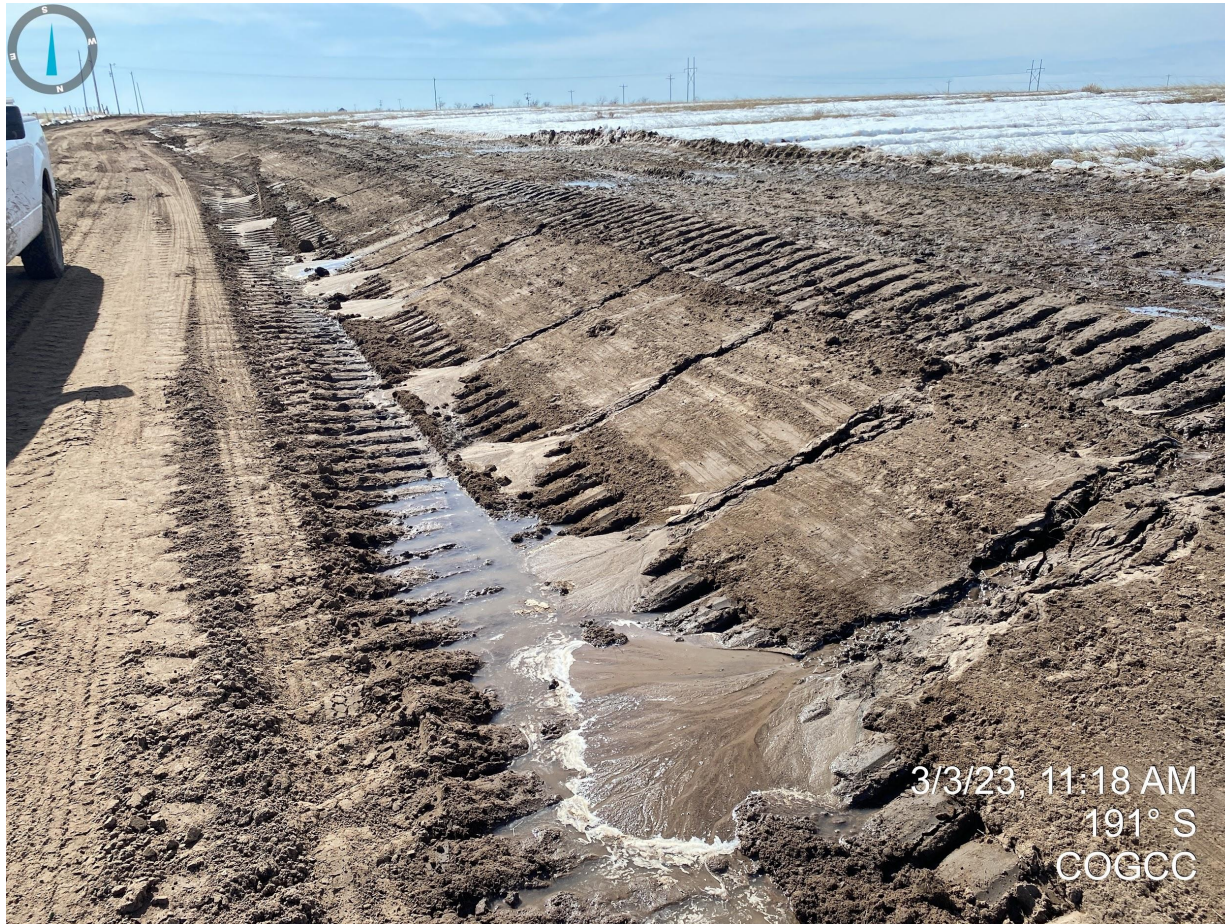
Photo 2. Facing south, approximately ¼ mile from the location's entrance, west side of road. Photo illustrates rill erosion on side of stormwater ditch and berm. This BMP will need to be repaired and maintained in accordance with Rule 1002.f.

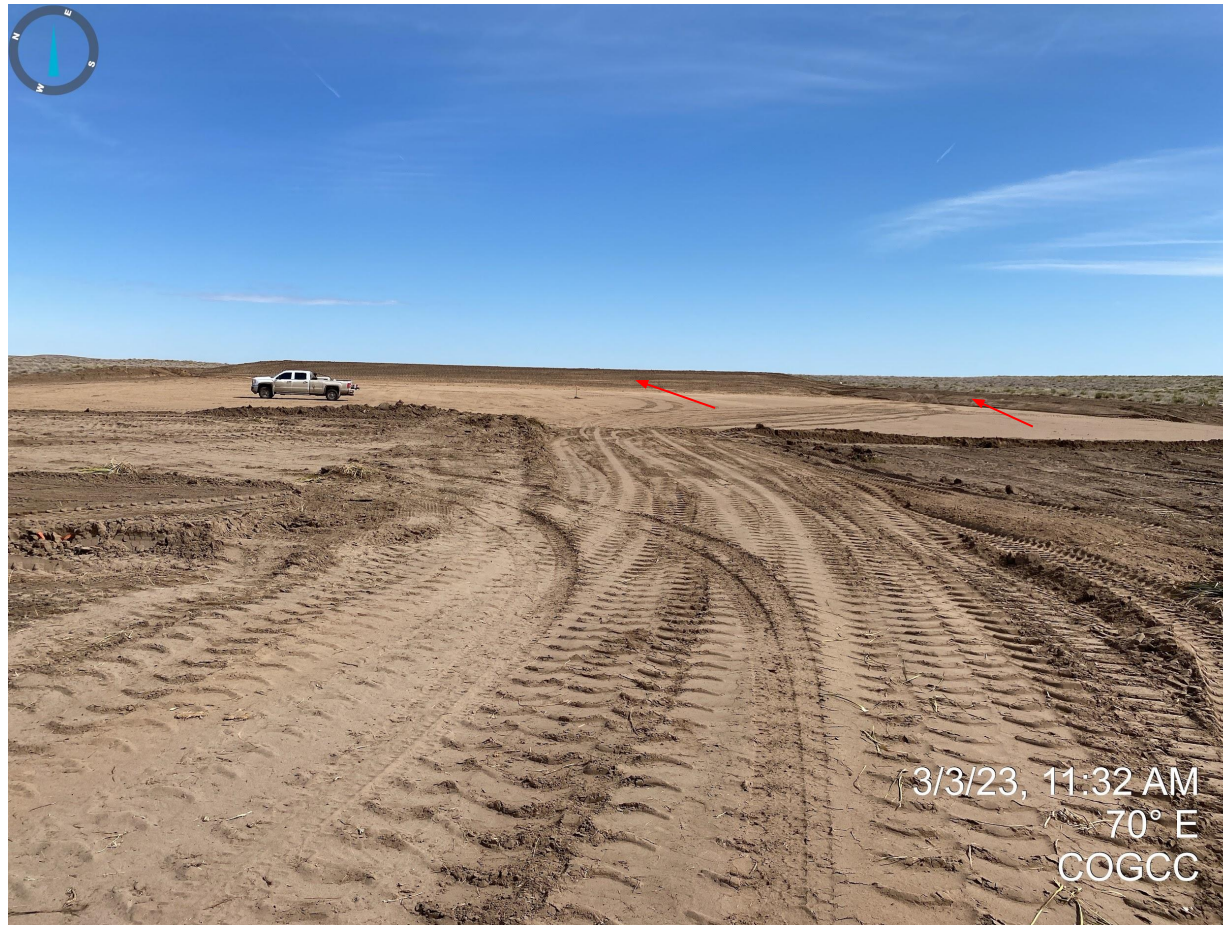
Photo 3. Facing east towards well location/pad. It appears the operator has removed all topsoil and stockpiled on the eastern and southern portions of the pad, pictured in background.

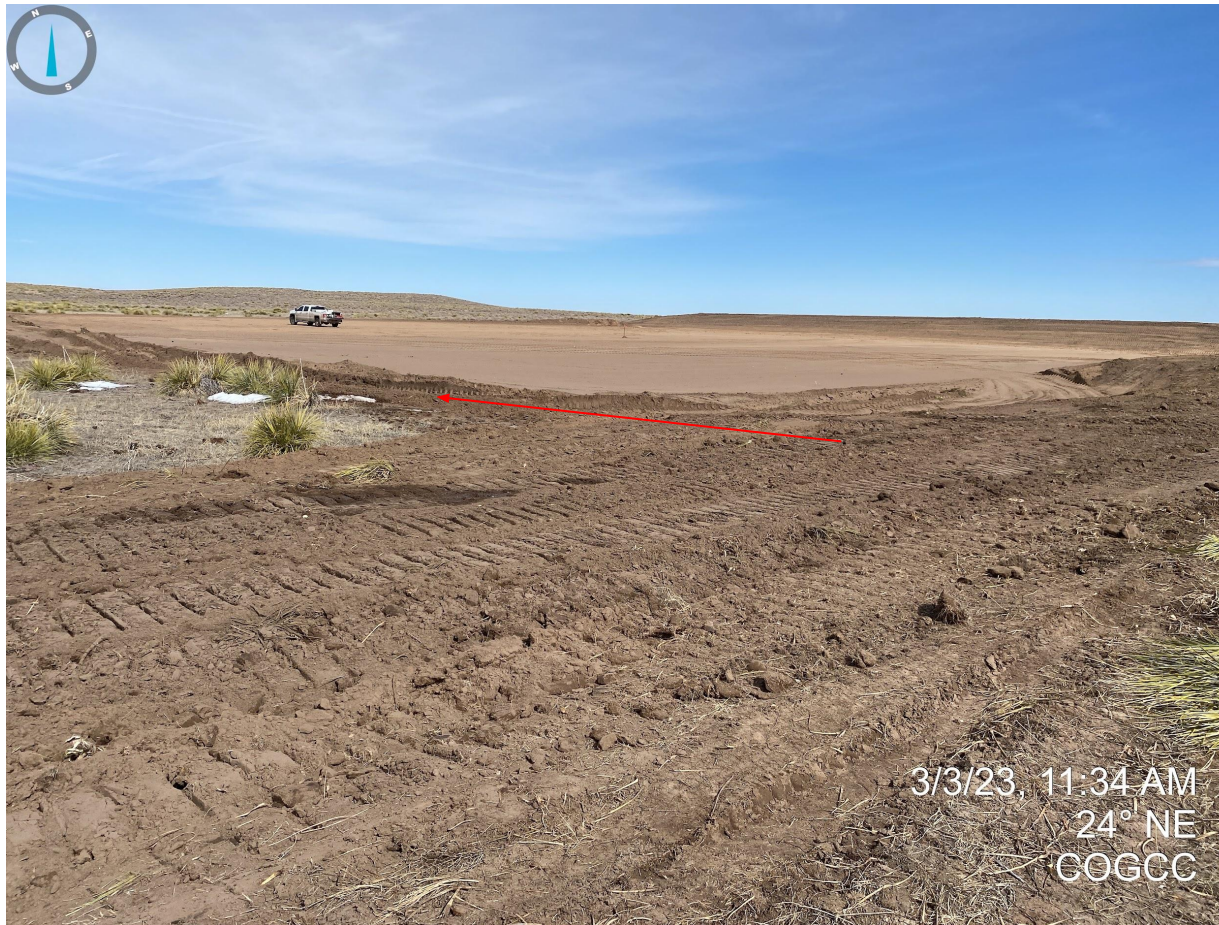
Photo 4. Facing northeast from the southwest corner of the disturbance area. Perimeter ditch and berm pictured in foreground. At this time, dirt contractors were still in the process of building the sediment trap, highlighted in red.

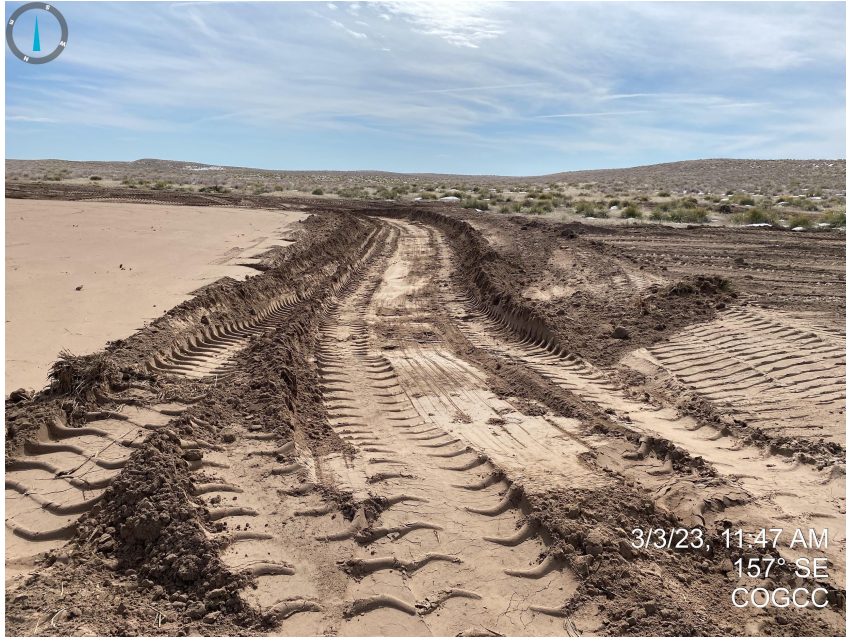
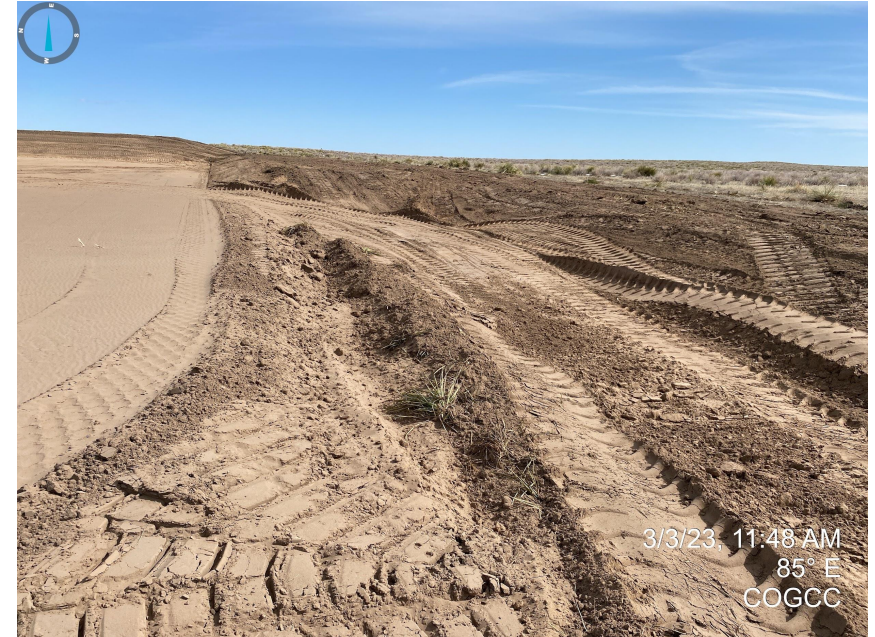
Photo 5. Continued from Photo 4. Facing southeast near the pad's entrance. The sediment trap was still in process of being built. A follow-up inspection will be conducted to ensure compliance with Rule 1002.f.

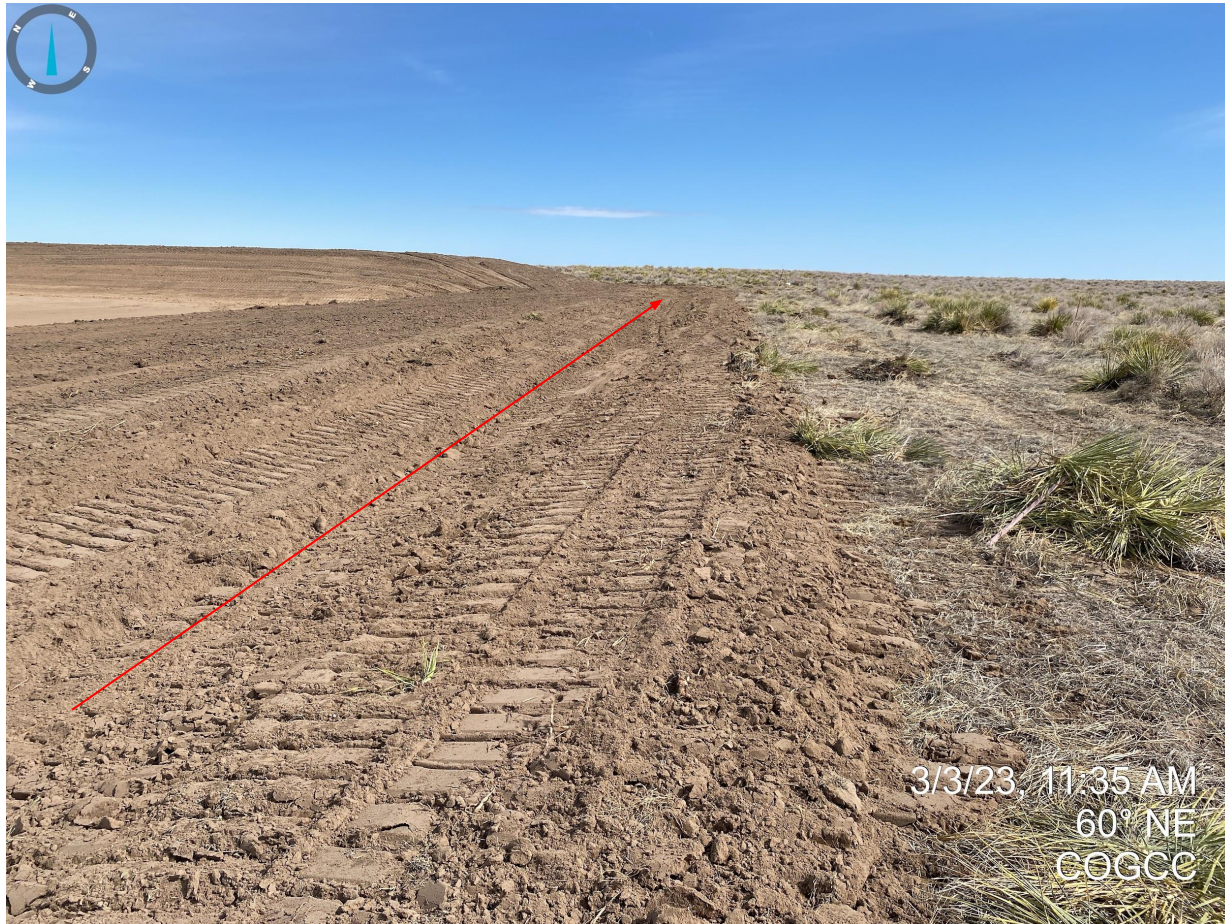
Photo 6. Facing northeast from the southwest corner of the disturbance are. Perimeter ditch and berm highlighted in red.

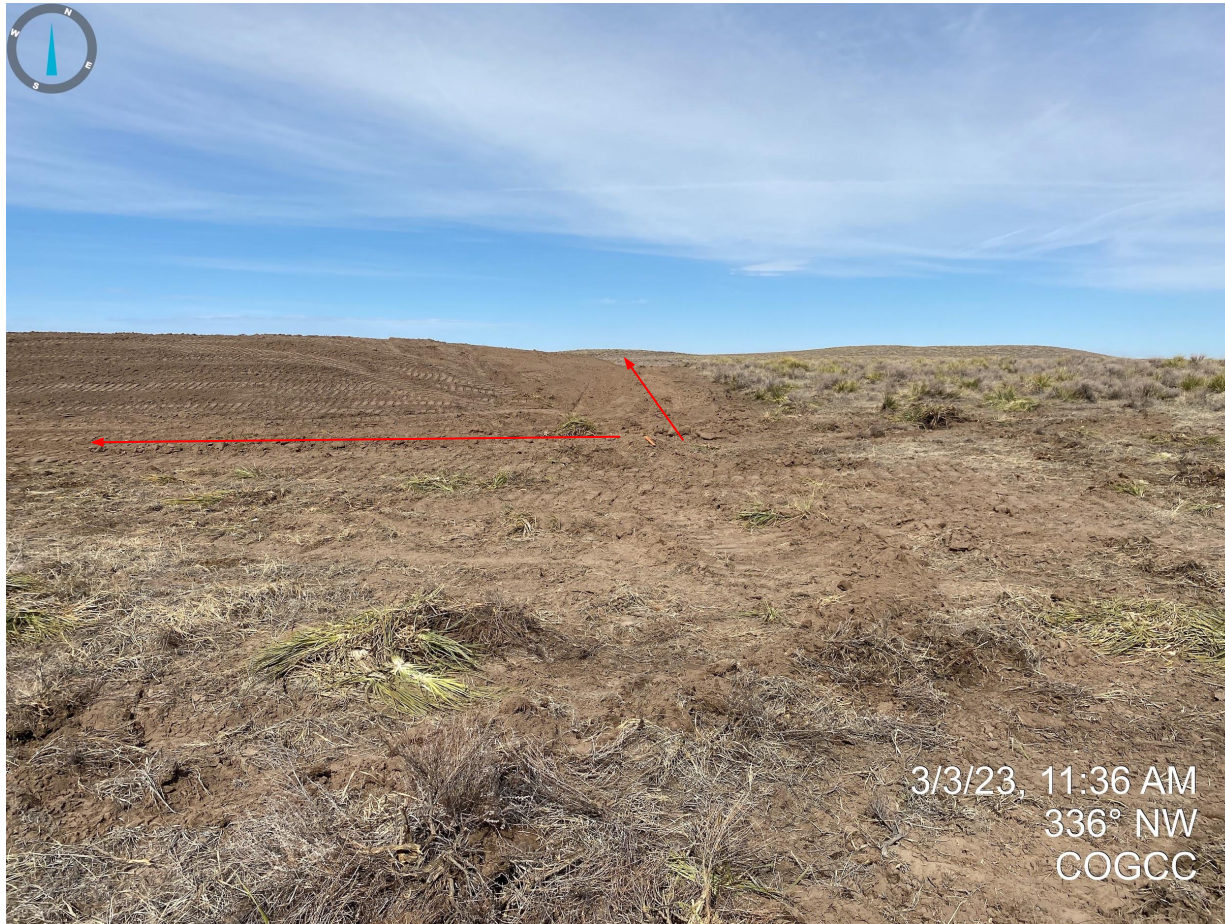
Photo 7. Facing northwest from the southeast corner of the disturbance area. A perimeter ditch and berm BMP (highlighted in red) was observed around the topsoil stockpile.

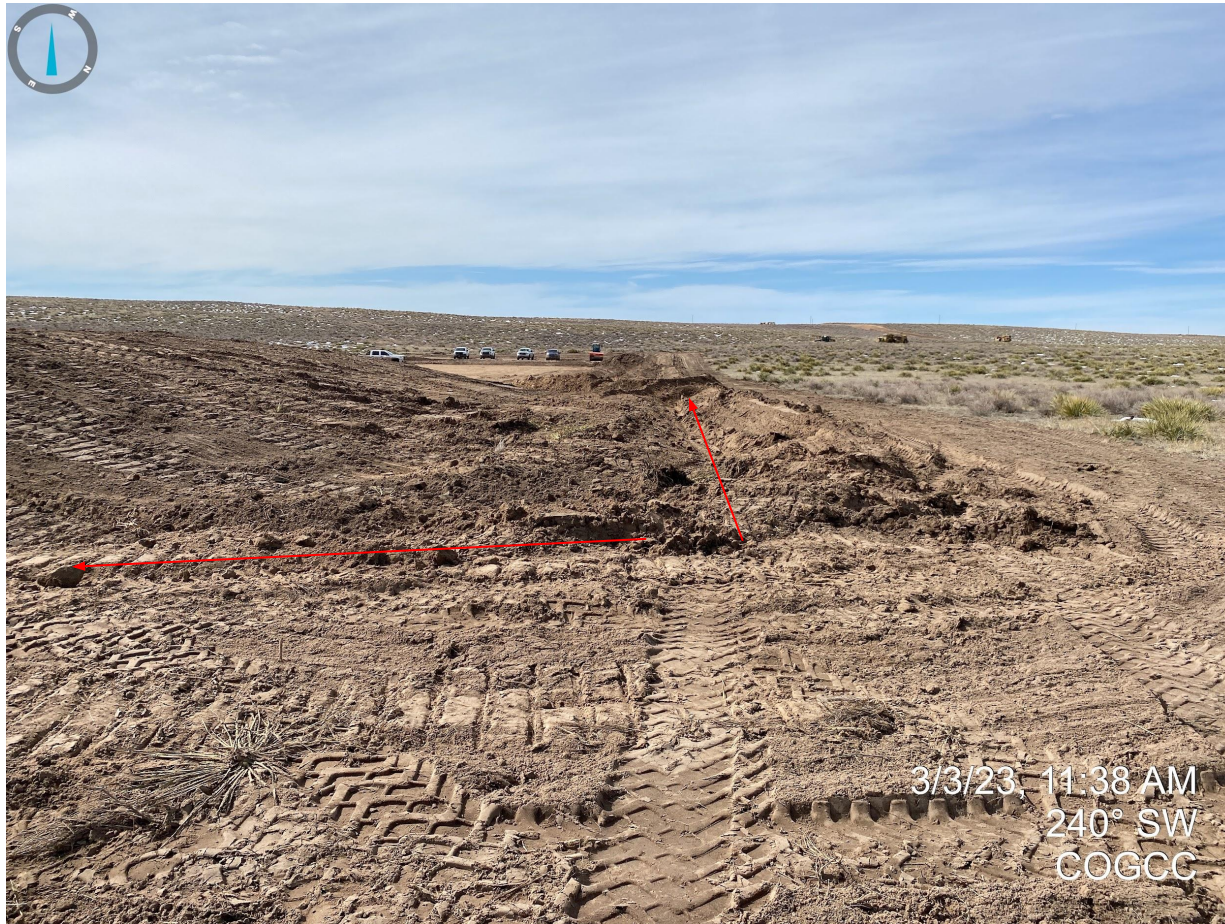
Photo 8. Facing southwest from the northeast corner of the disturbance area. See comments in Photo 7.

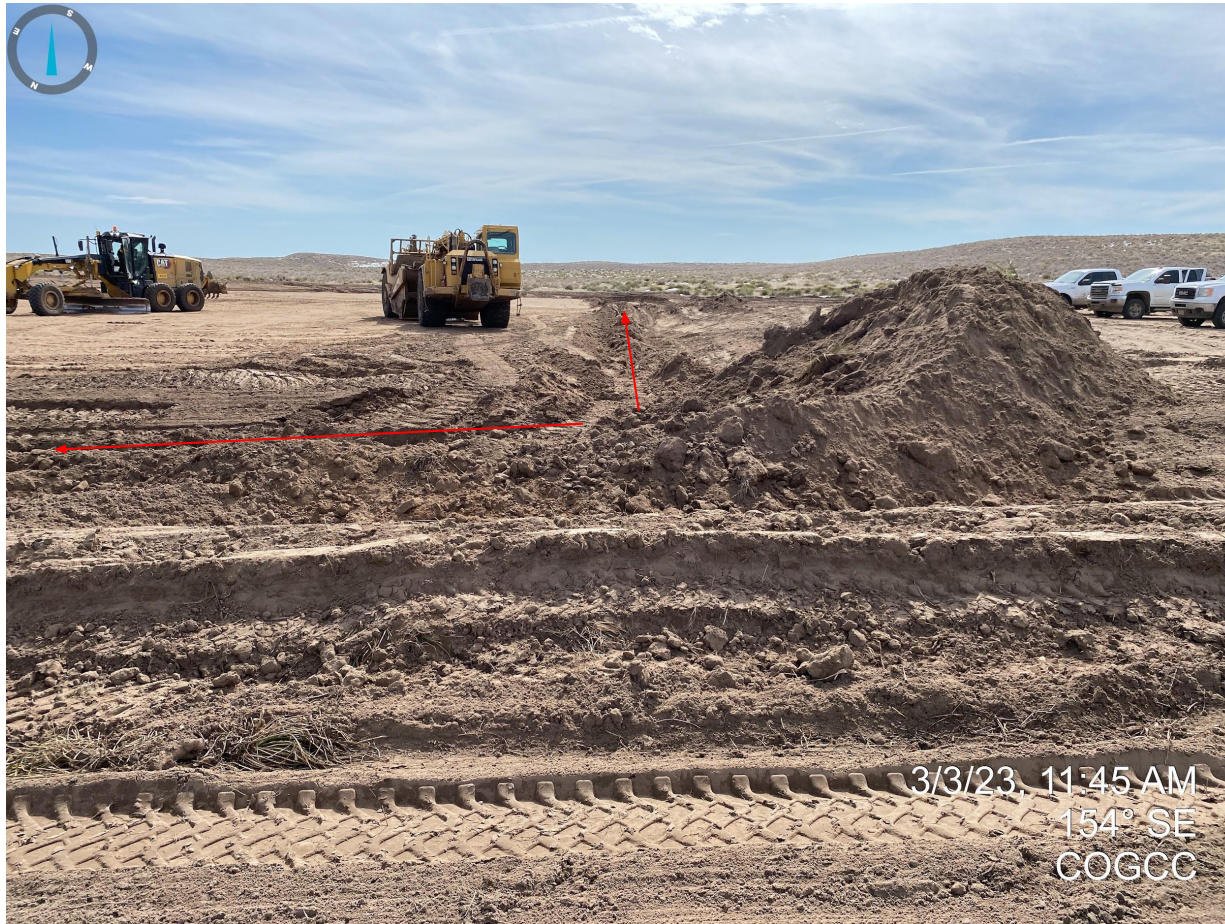
Photo 9. Facing southeast from the northwest corner of the location. See comments in Photo 7.

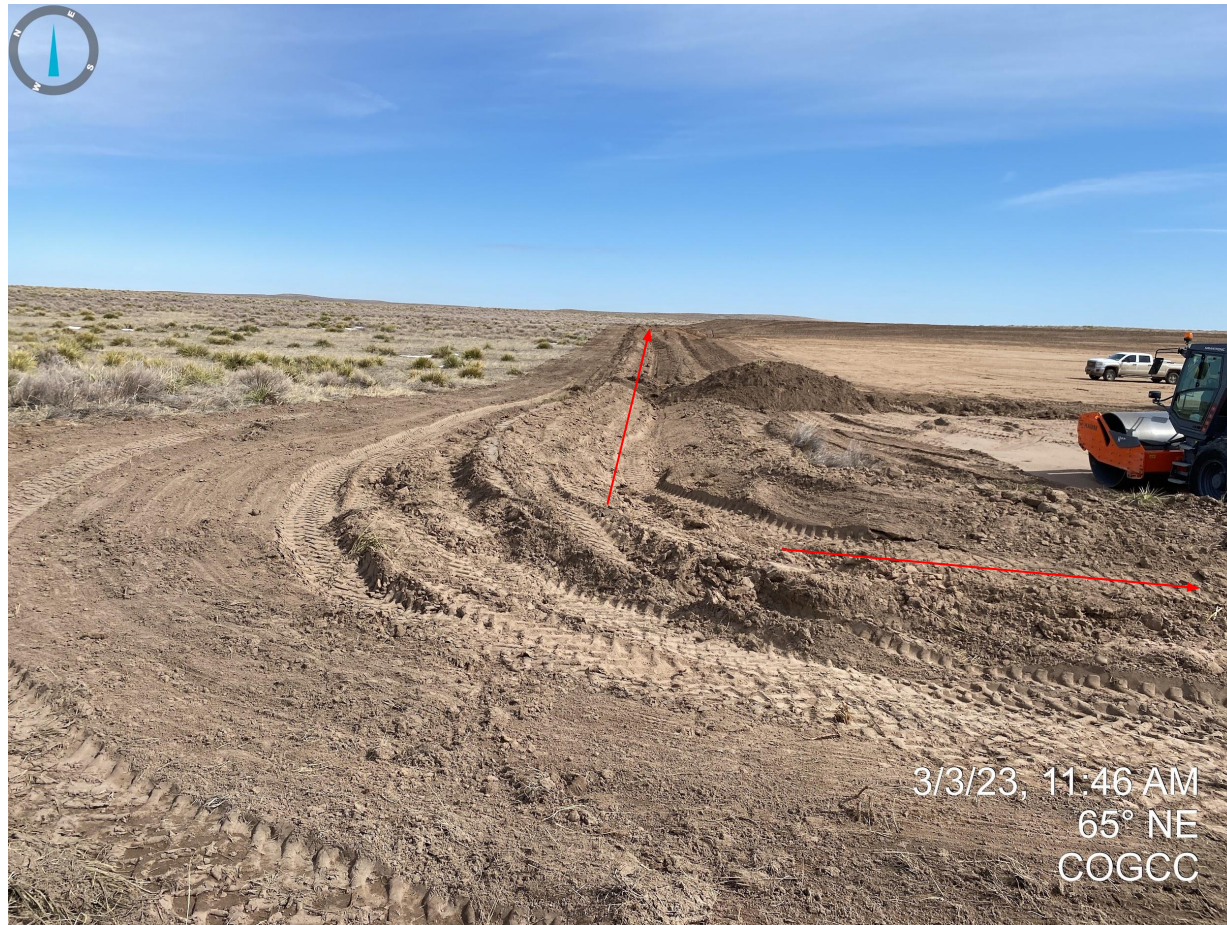
Photo 10. Facing northeast from the northwest corner of the location. See comments in Photo 7.

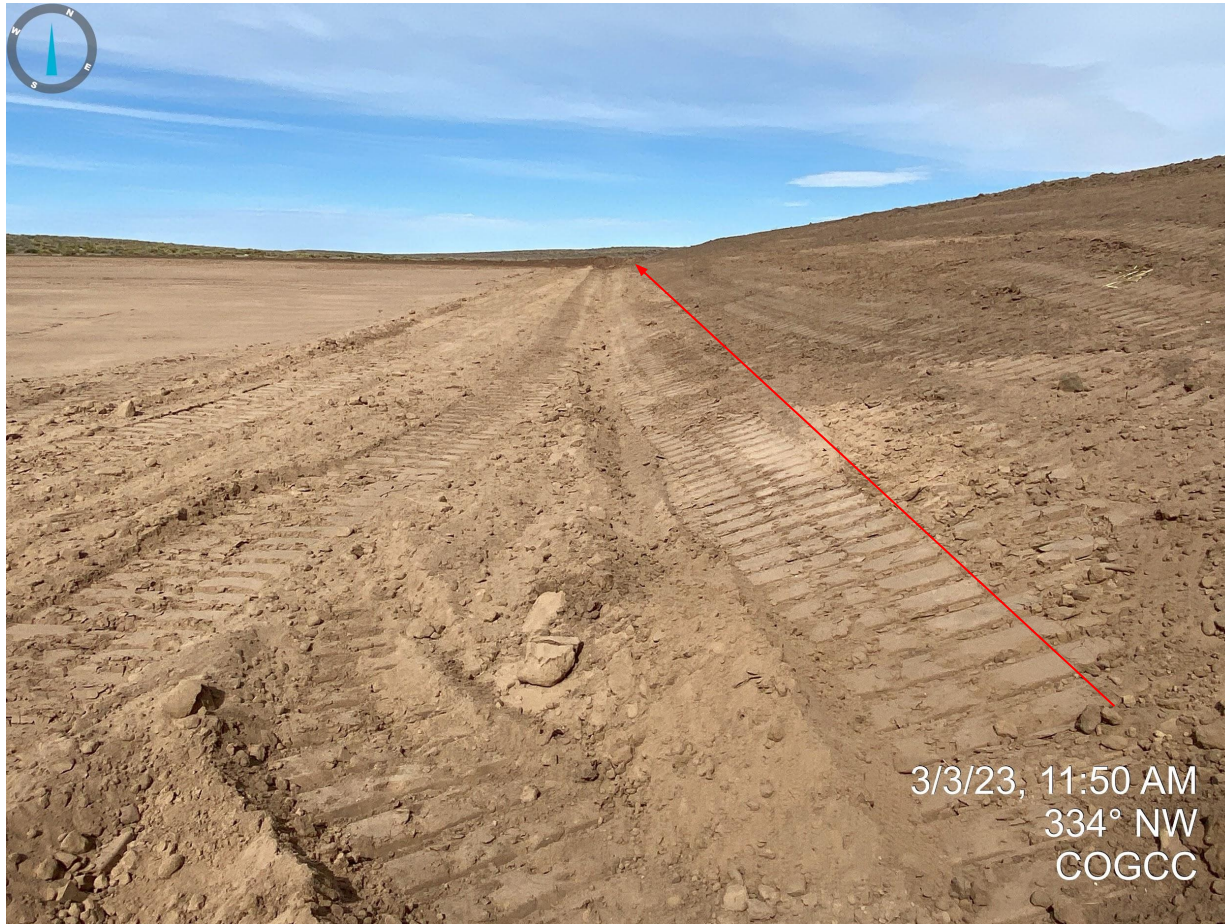
Photo 11. Facing northwest from the southern end of the topsoil stockpile. It appears the operator has salvaged all topsoil from the location with a noticeable change in soil layers observed, highlighted in red.

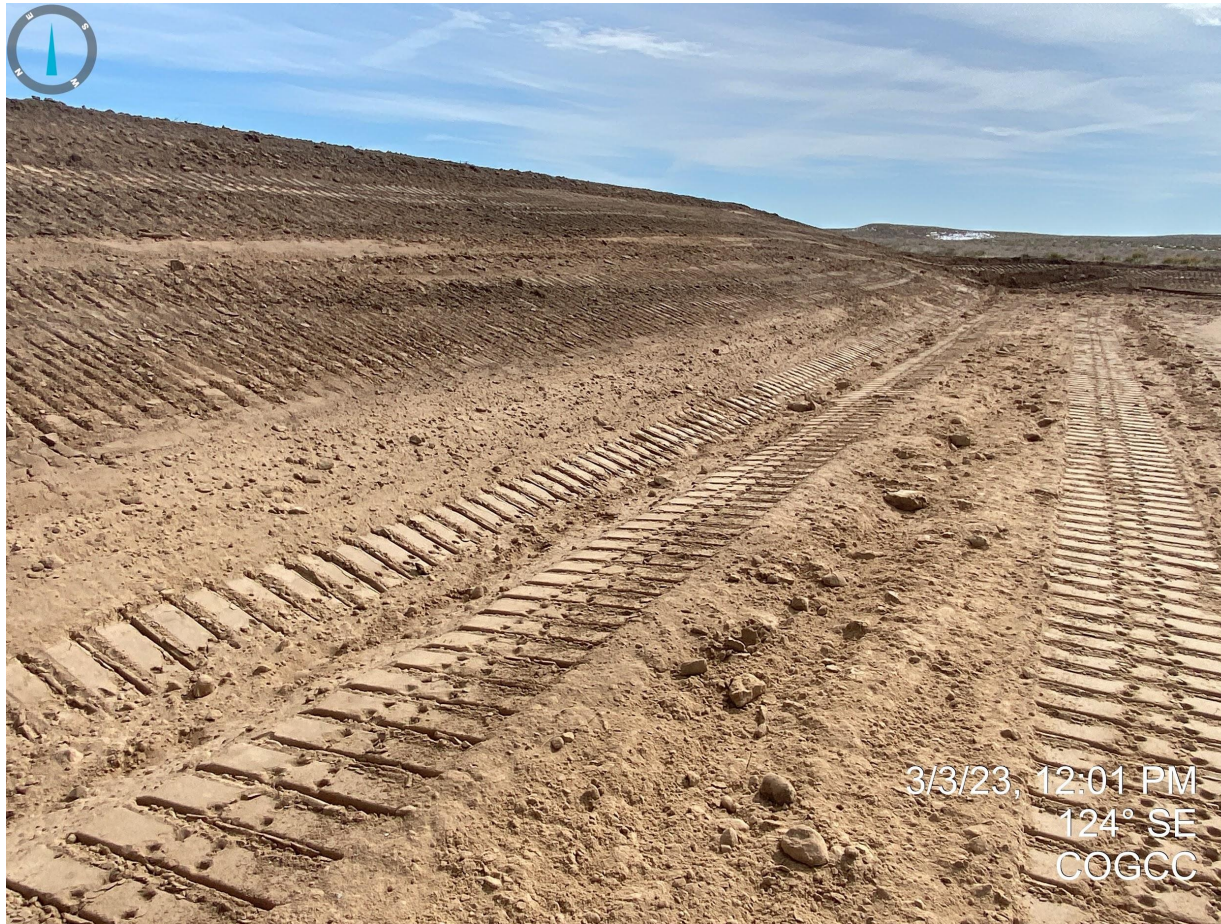
Photo 12. Facing southeast from the center (western side) of the topsoil stockpile. The stockpile has been temporarily stabilized with equipment tracking. The topsoil stockpile will need more permanent stabilization as equipment tracking is only a temporary solution. Note: equipment tracking should be perpendicular to grade to prevent soil migration from stormwater events.

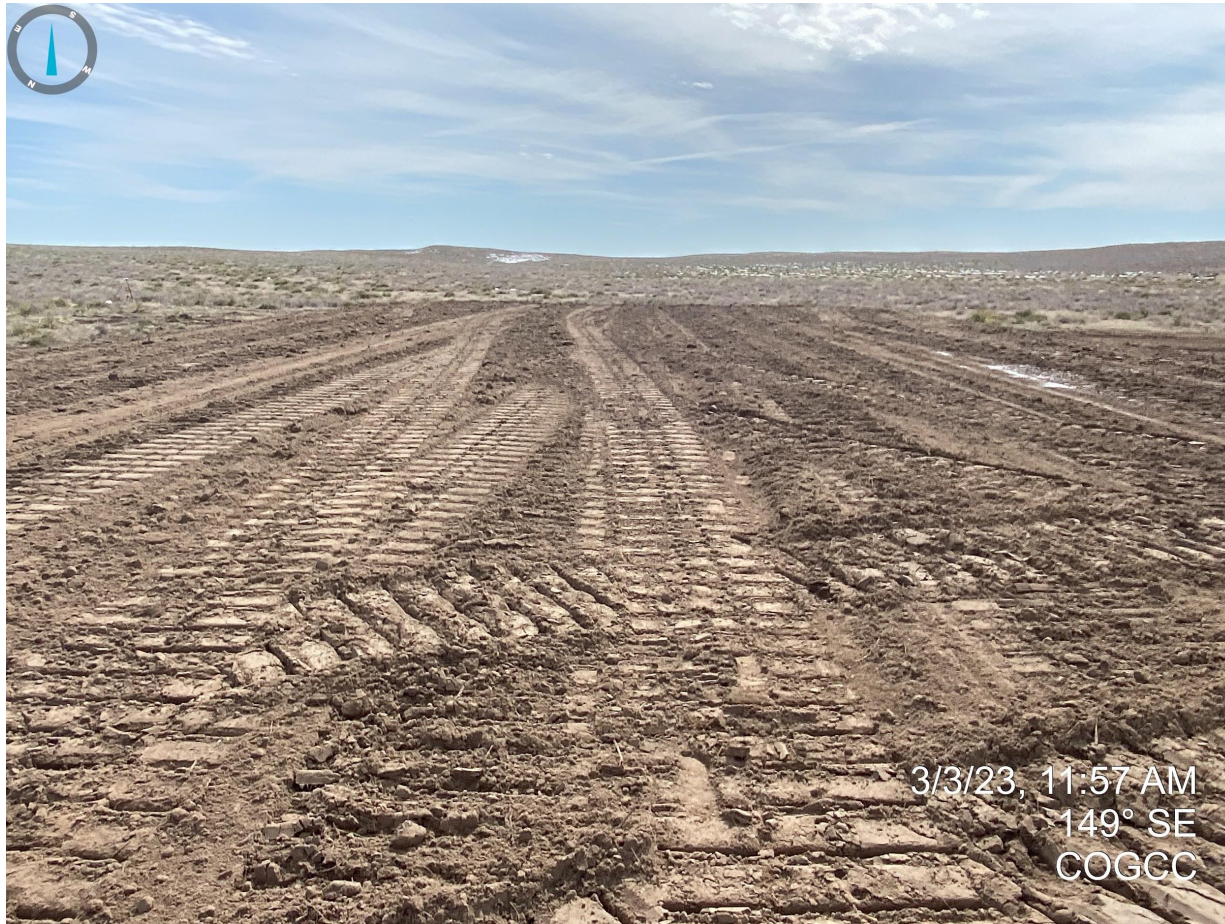
Photo 13. Facing southeast from the top of the topsoil stockpile; See comments in Photo 12.

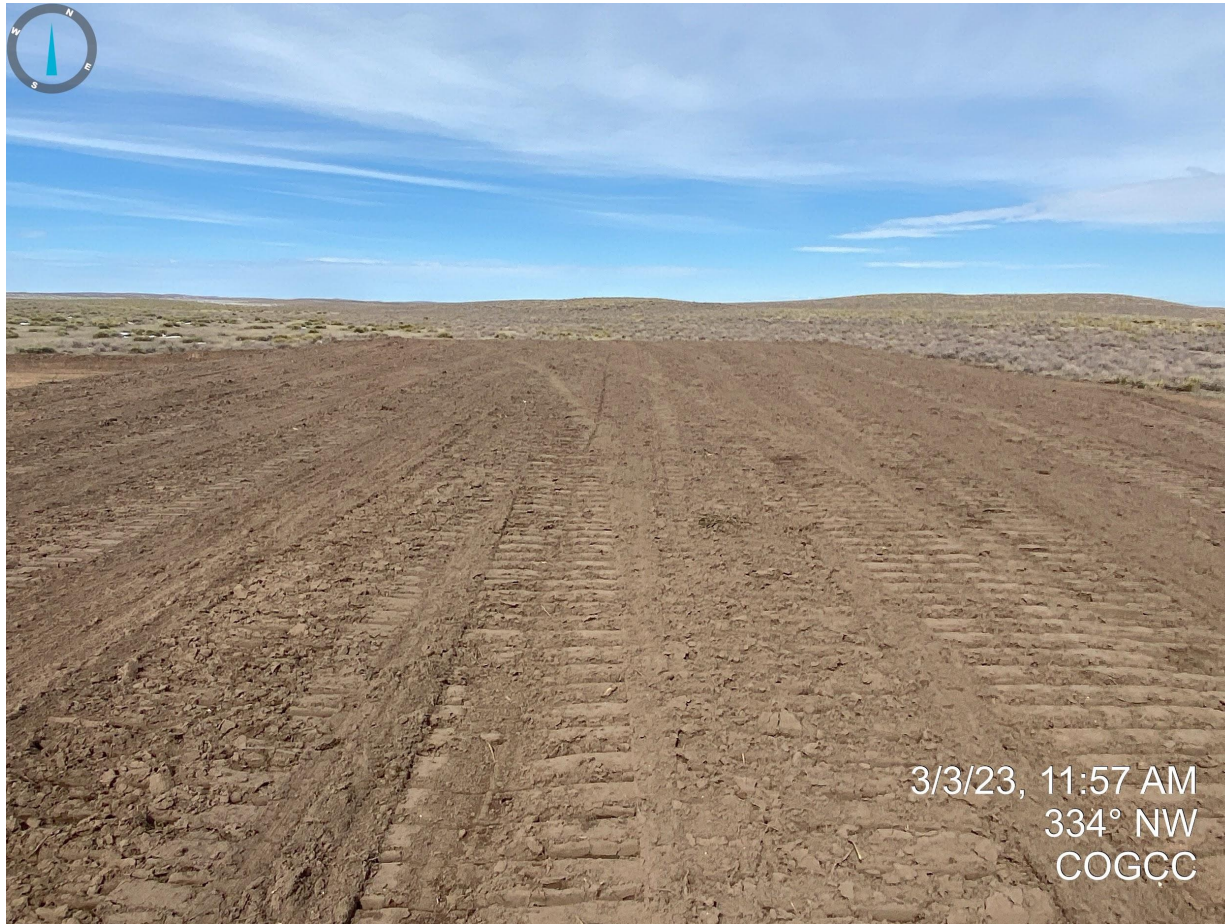
Photo 14. Facing northwest from the top of the topsoil stockpile; See comments in Photo 12.

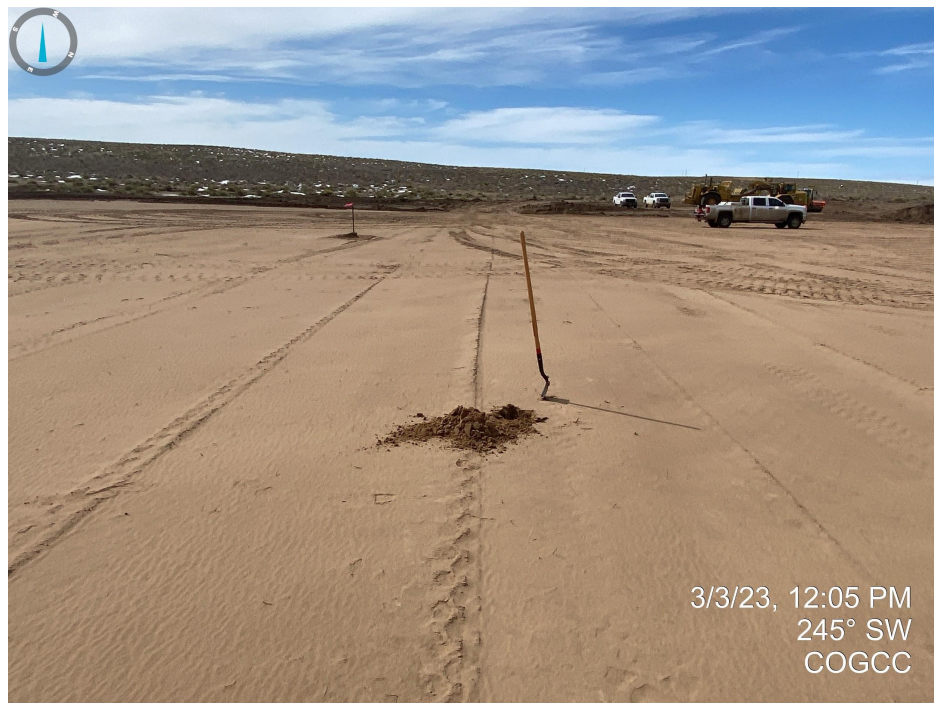
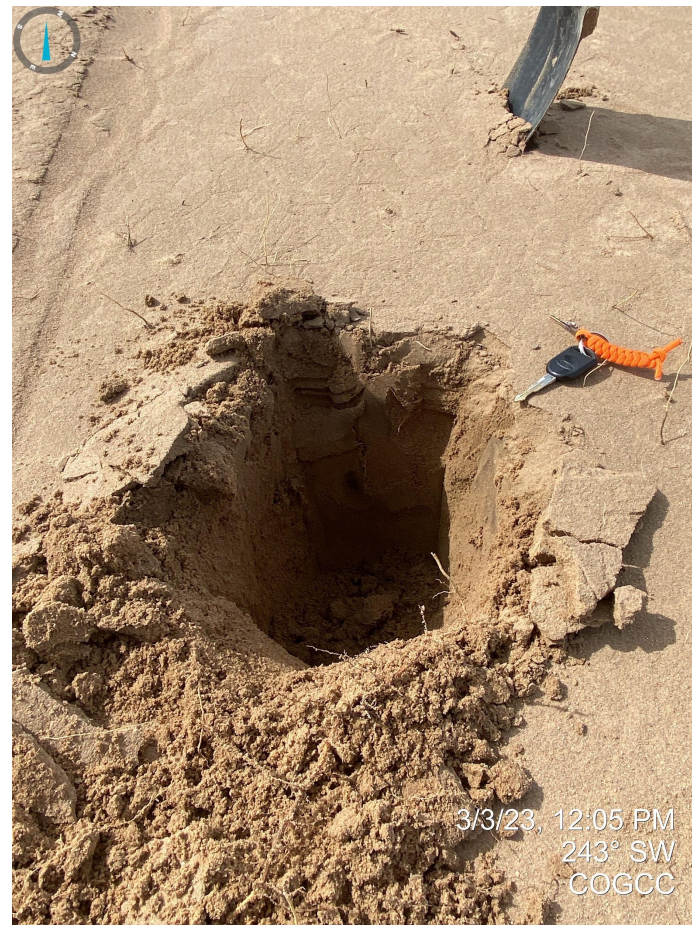
Photo 14. Facing southwest near the approximate center of the location. Soil pit dug by Staff to view soil profile; it appears the operator has salvaged all topsoil from the location.
