# Stormwater Inspection

Date: 03/15/2023

Operator: SCHNEIDER ENERGY SERVICES INC - 76840

Location ID: 317498

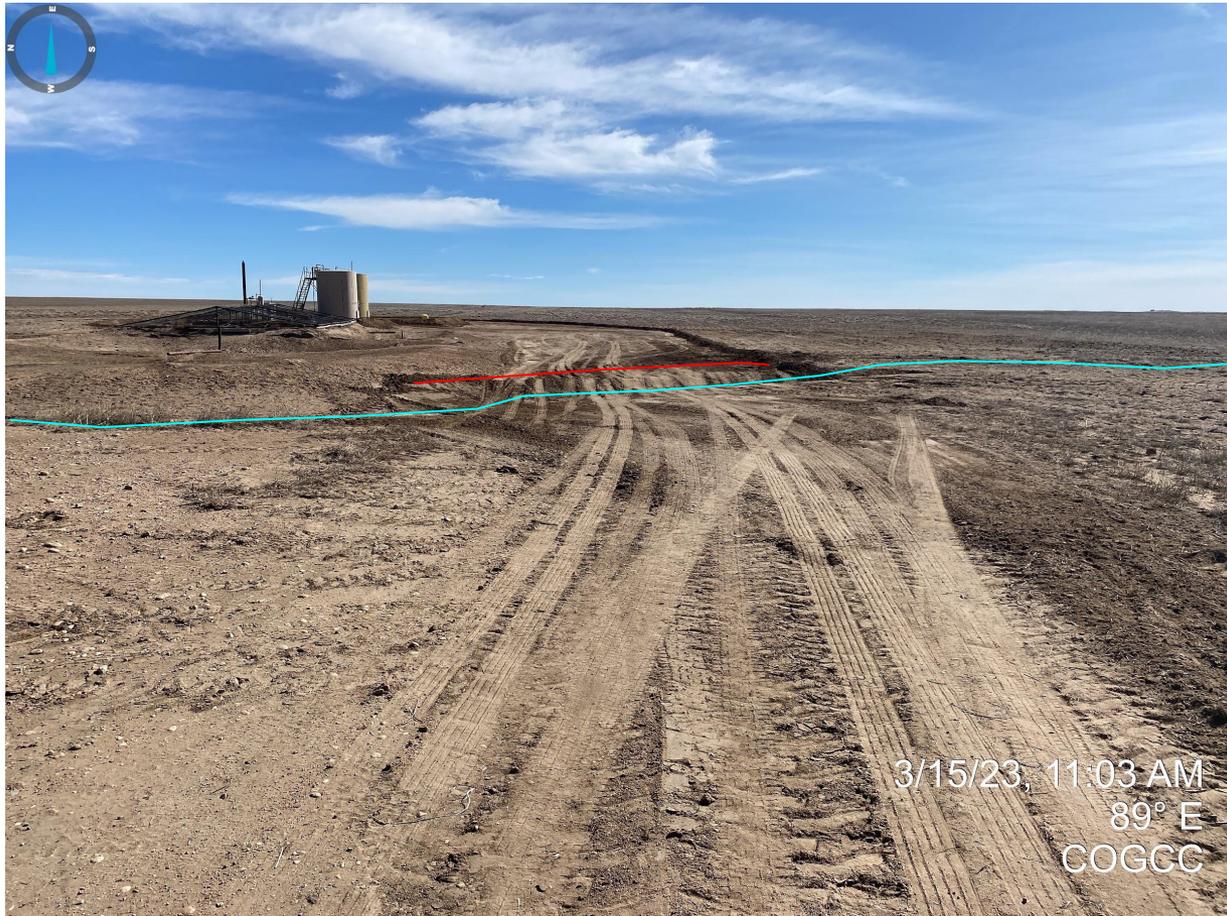
**Photo 1.** Facing east towards location. A water bar (red line) was constructed that appears will divert any stormwater run on/off through the location and towards the eroded area. Blue line illustrates the potential path of stormwater travel with current BMP in place.

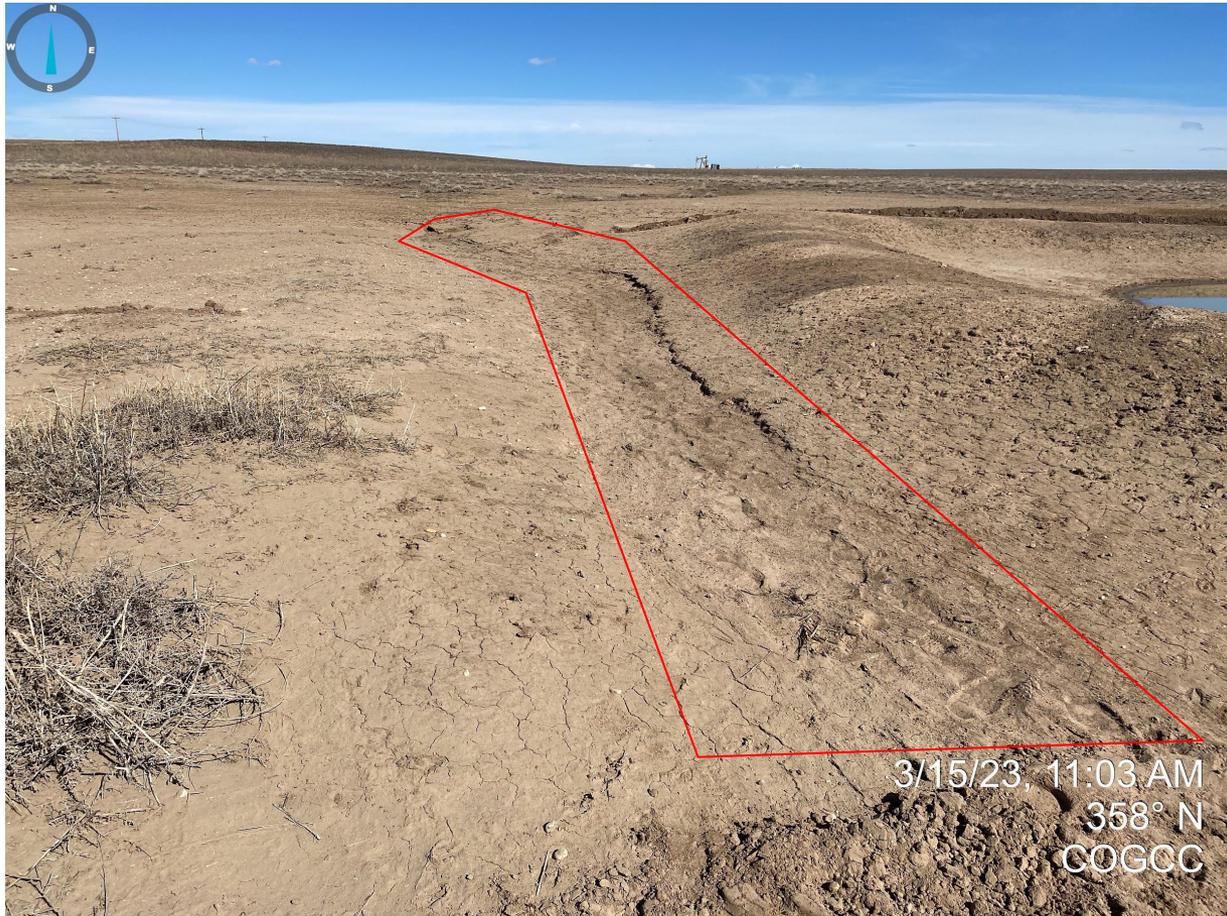
**Photo 2.** Facing north near the eroded area next to pit. No BMPs were observed to prevent or manage stormwater run on and run off with evidence of rill erosion occurring on pit walls (red outline). This area will need to be properly stabilized to prevent further erosion from occurring.

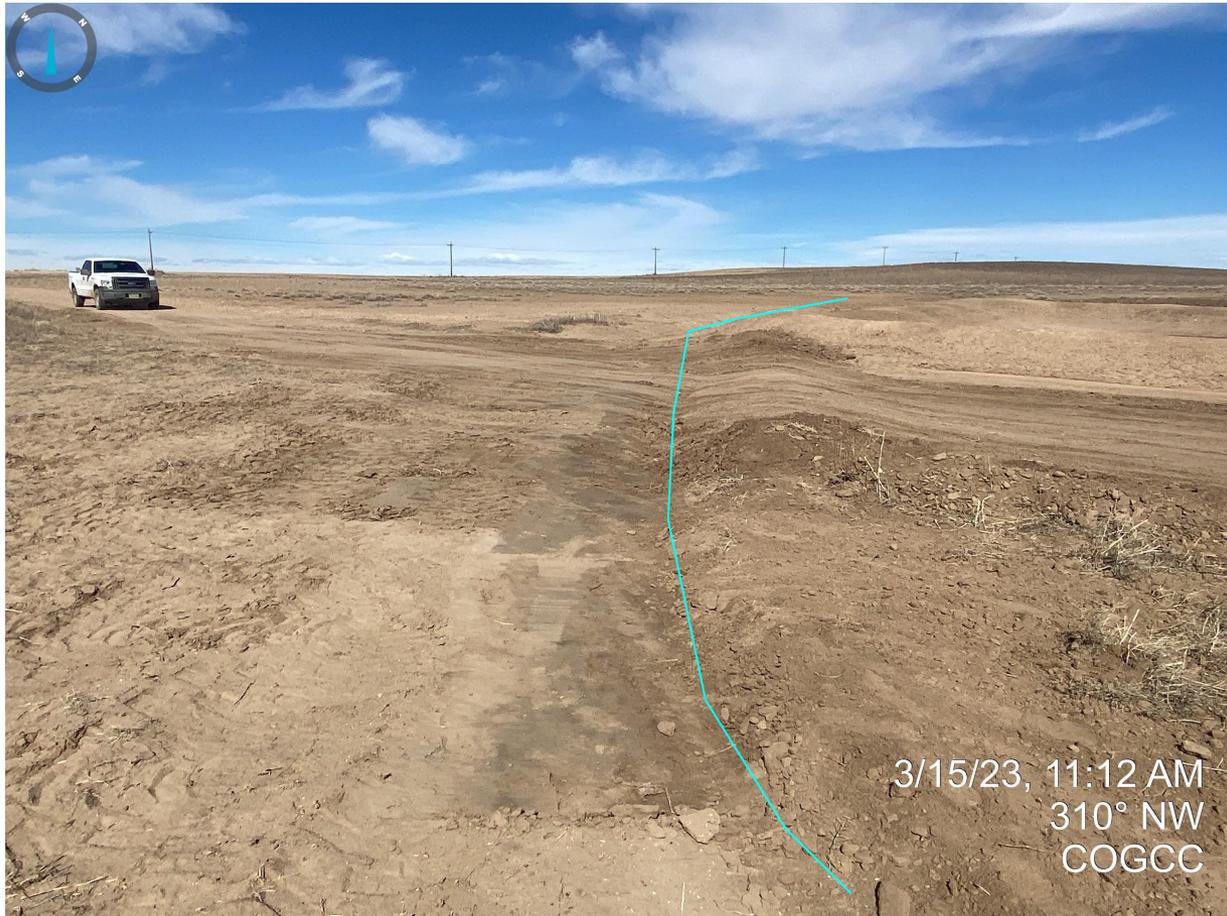
**Photo 3.** Facing northwest next to water bar/ditch. Blue line illustrates the potential path of stormwater; see comments in Photos 1 and 2 for additional detail.

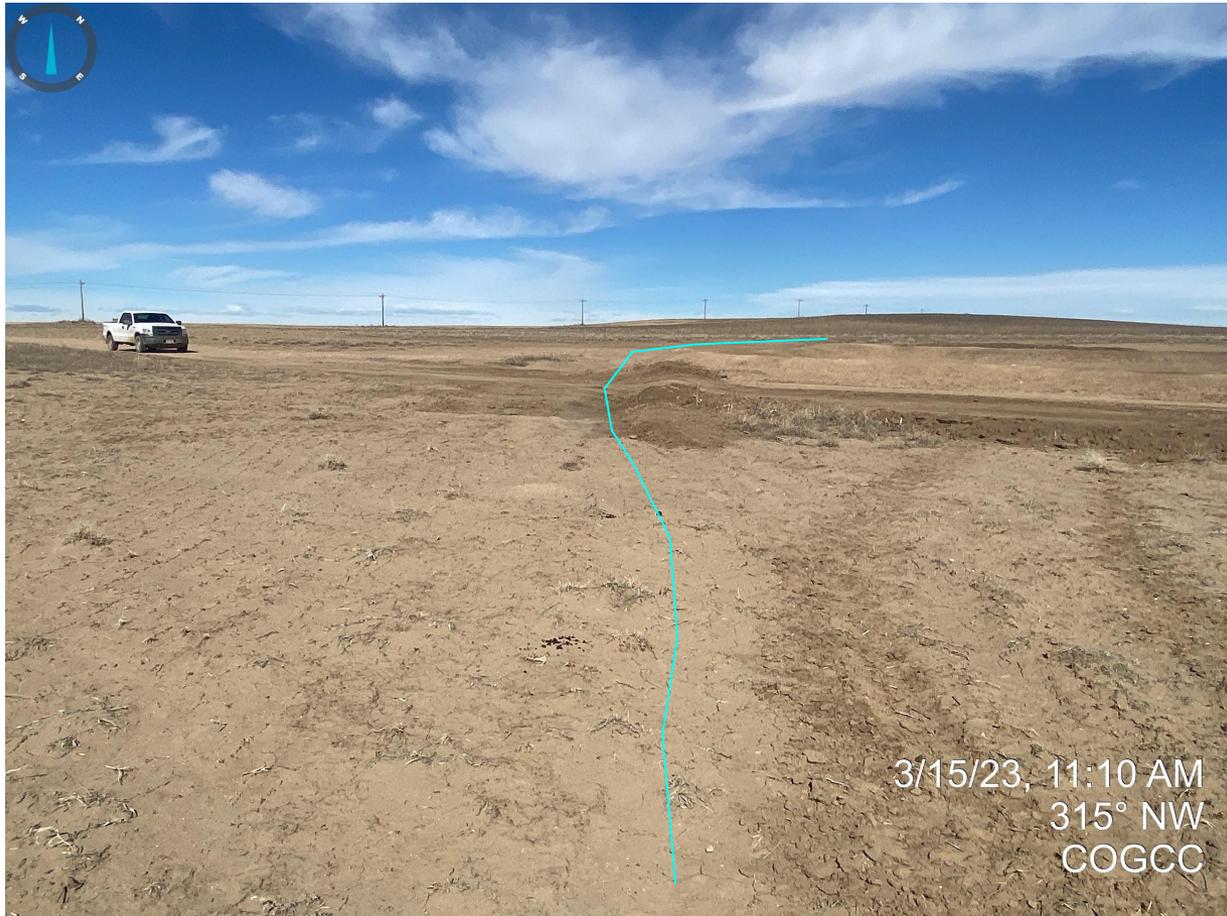
**Photo 4.** Facing northwest; see comments in Photos 1-3.

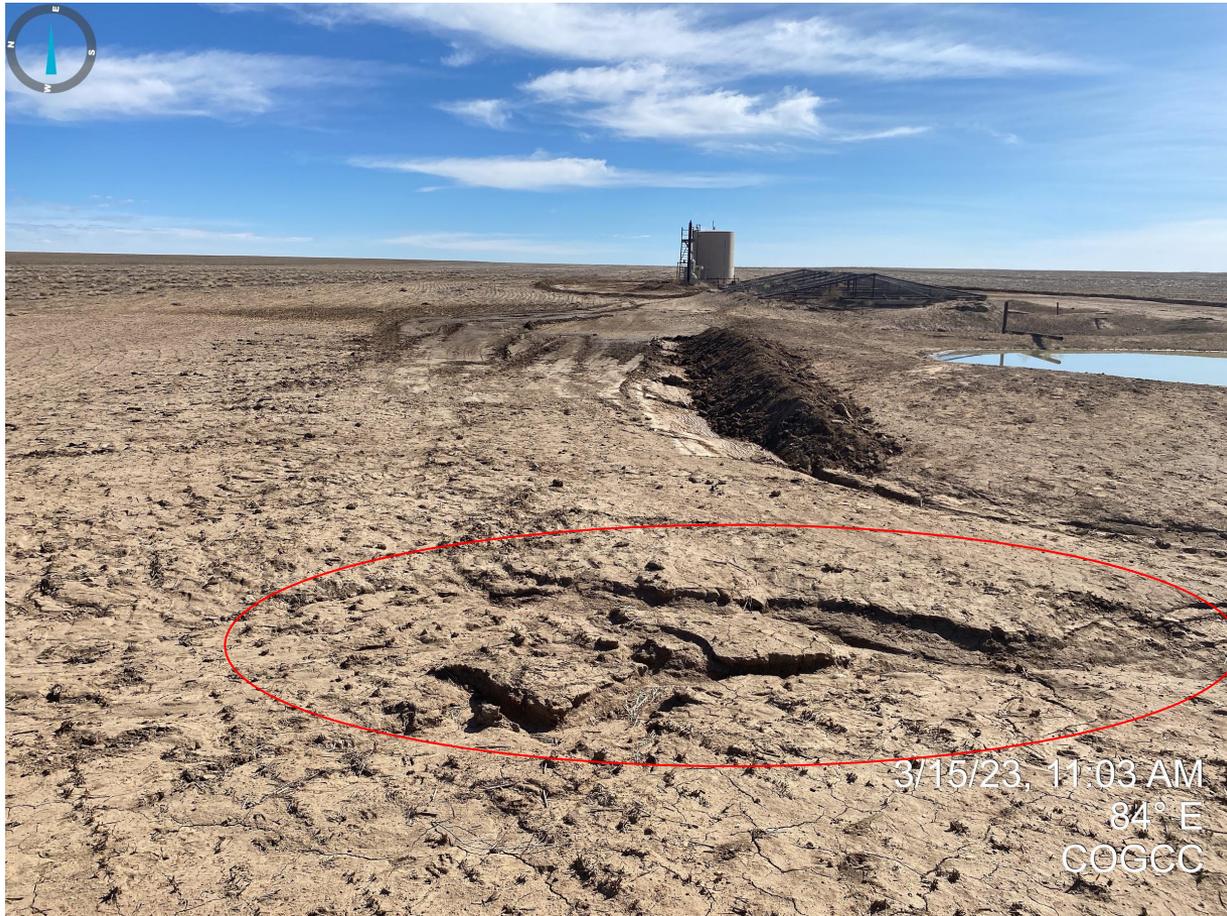
**Photo 5.** Facing east from the northwest corner of the location. Photo illustrates the eroded areas have not been stabilized and no BMPs were observed to prevent further stormwater erosion from occurring.

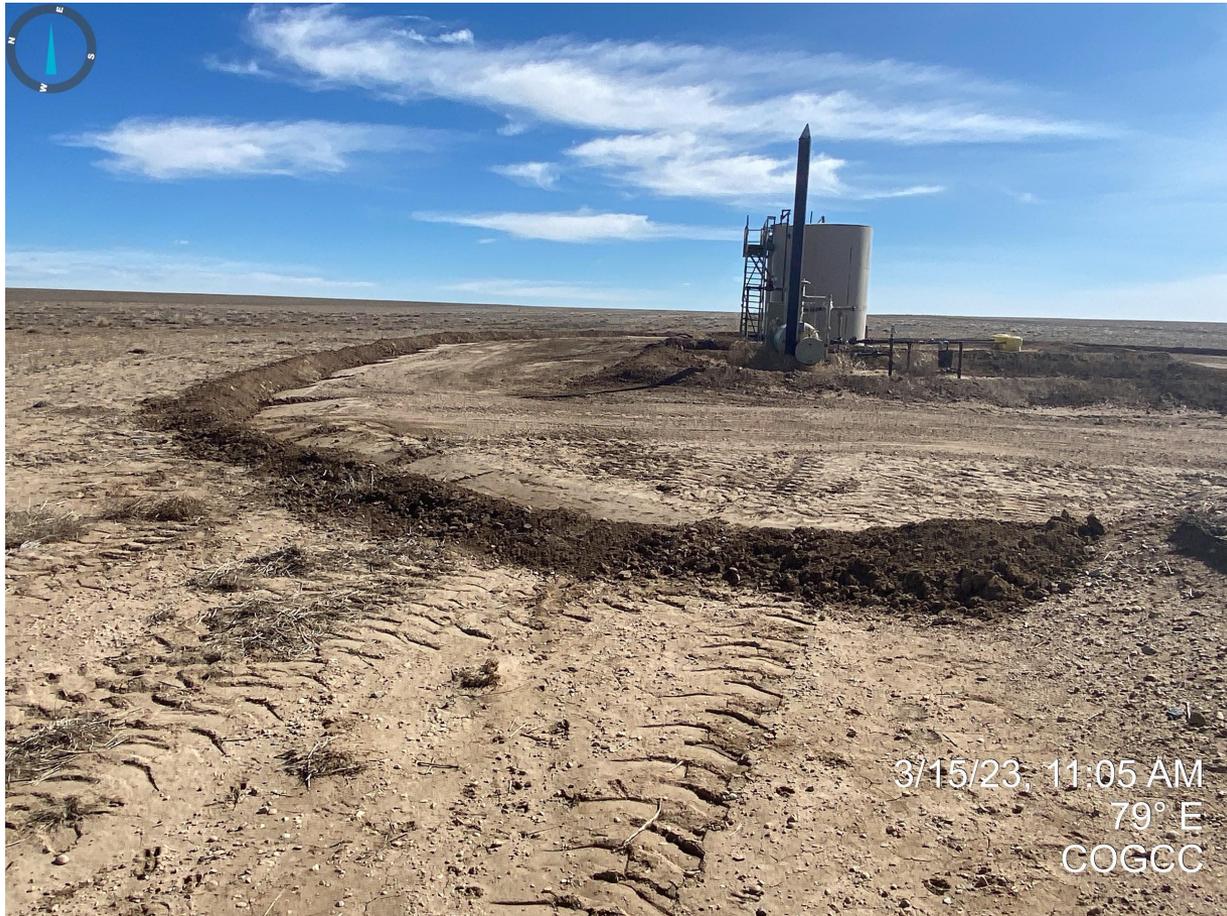
**Photo 6.** Facing east from the northern portion of the location. A perimeter ditch and berm was constructed around the production area; these BMPs are not sufficient as the berm material is not stabilized and is comprised of loose/unconsolidated material that can become a potential source of pollution itself.

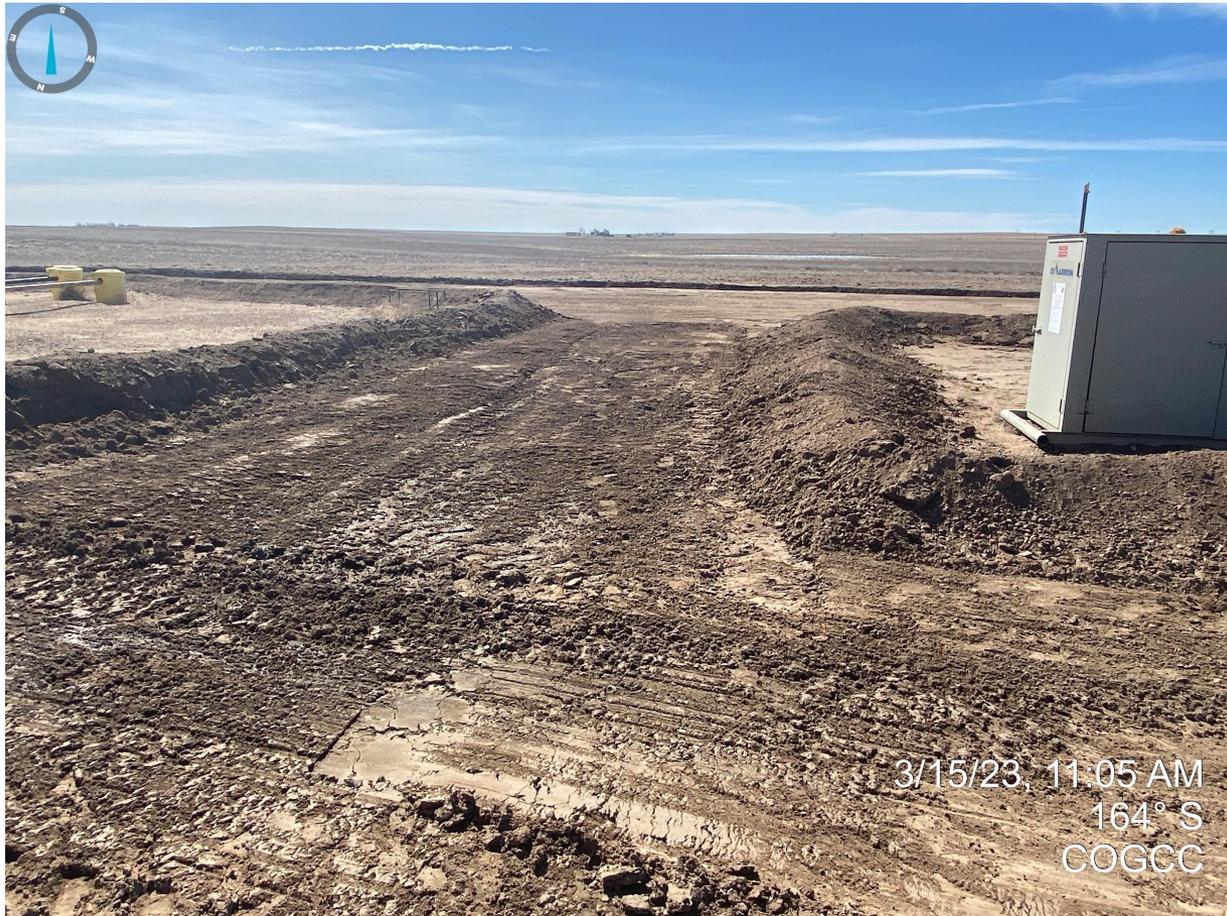
**Photo 7.** Facing south near battery; see comments in Photo 6.

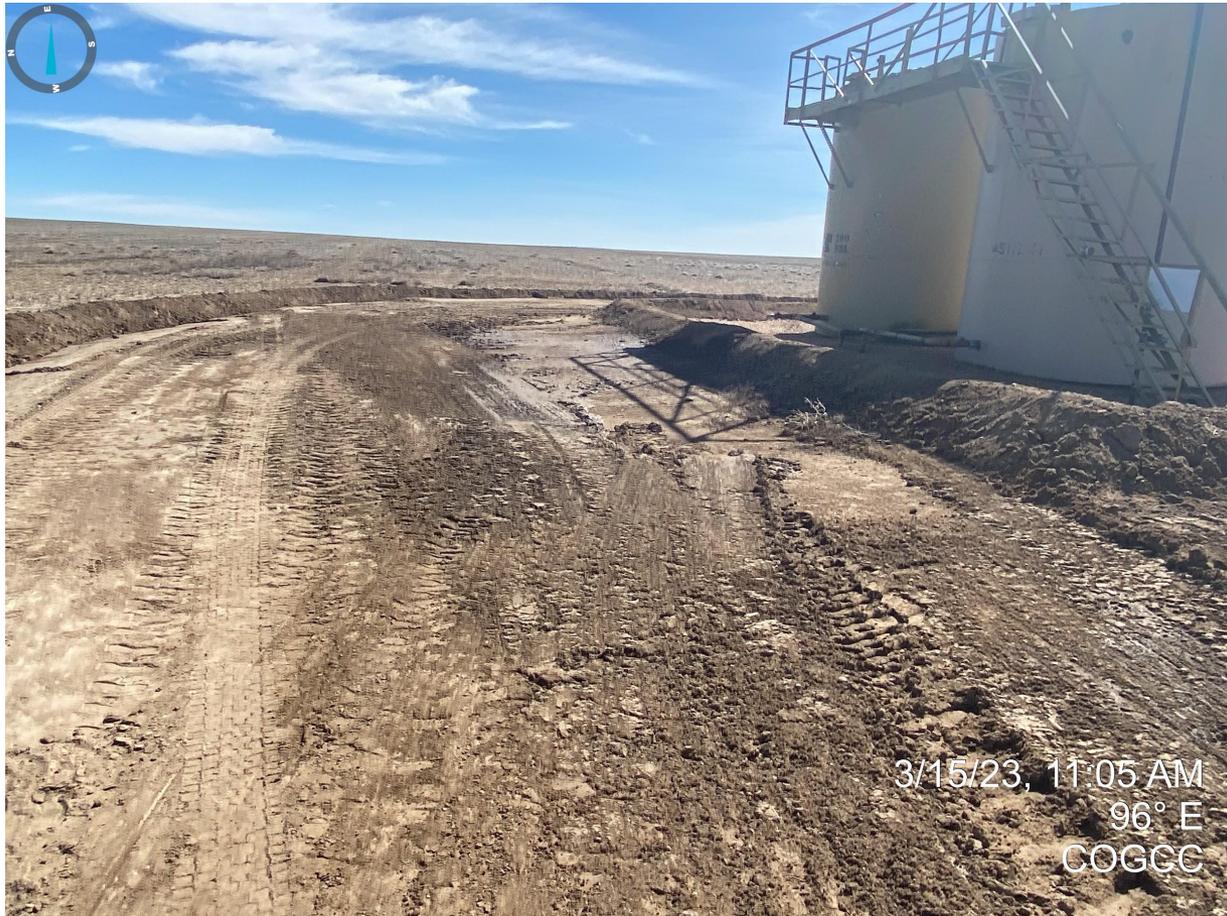
**Photo 8.** Facing east near battery; see comments in Photo 6.

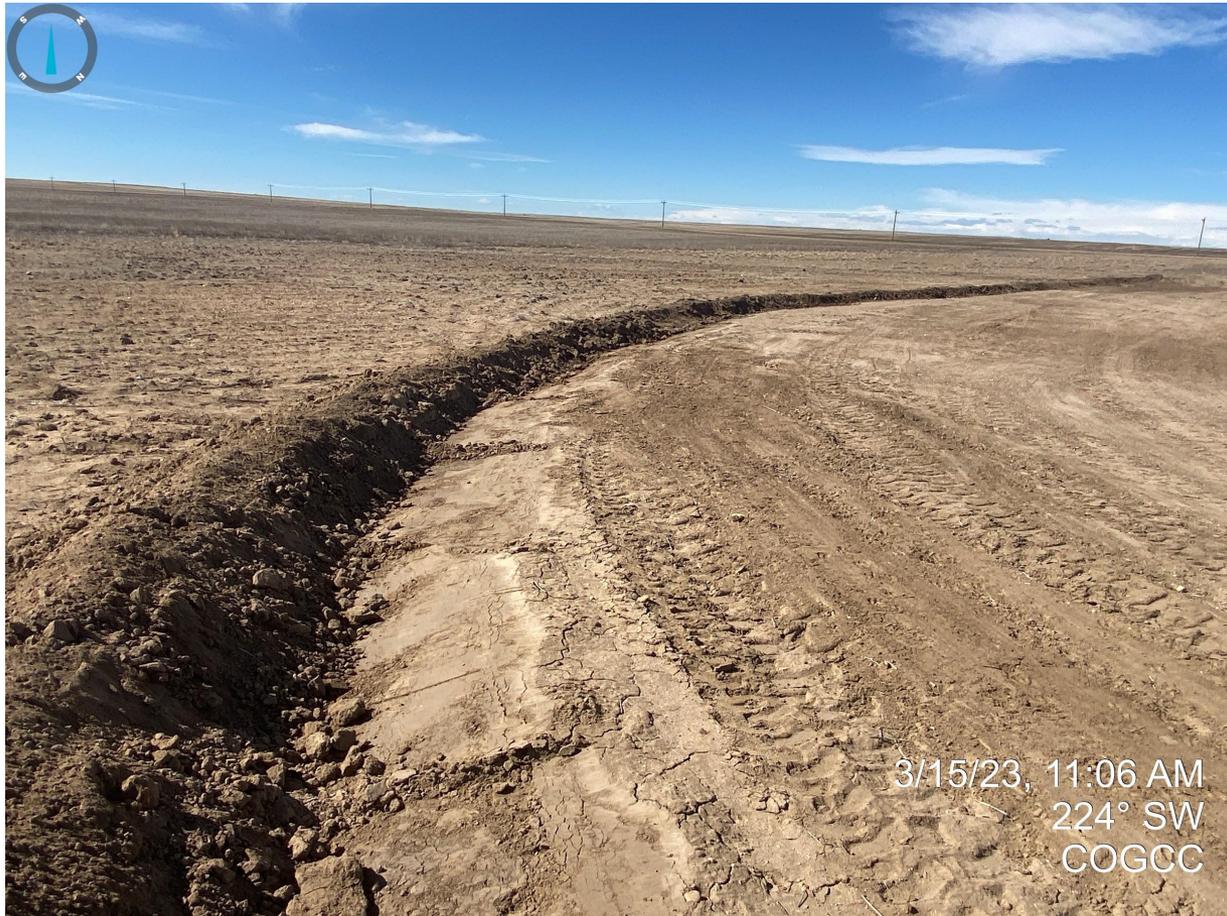
**Photo 9.** Facing southwest from the eastern portion of the location; see comments in Photo 6.

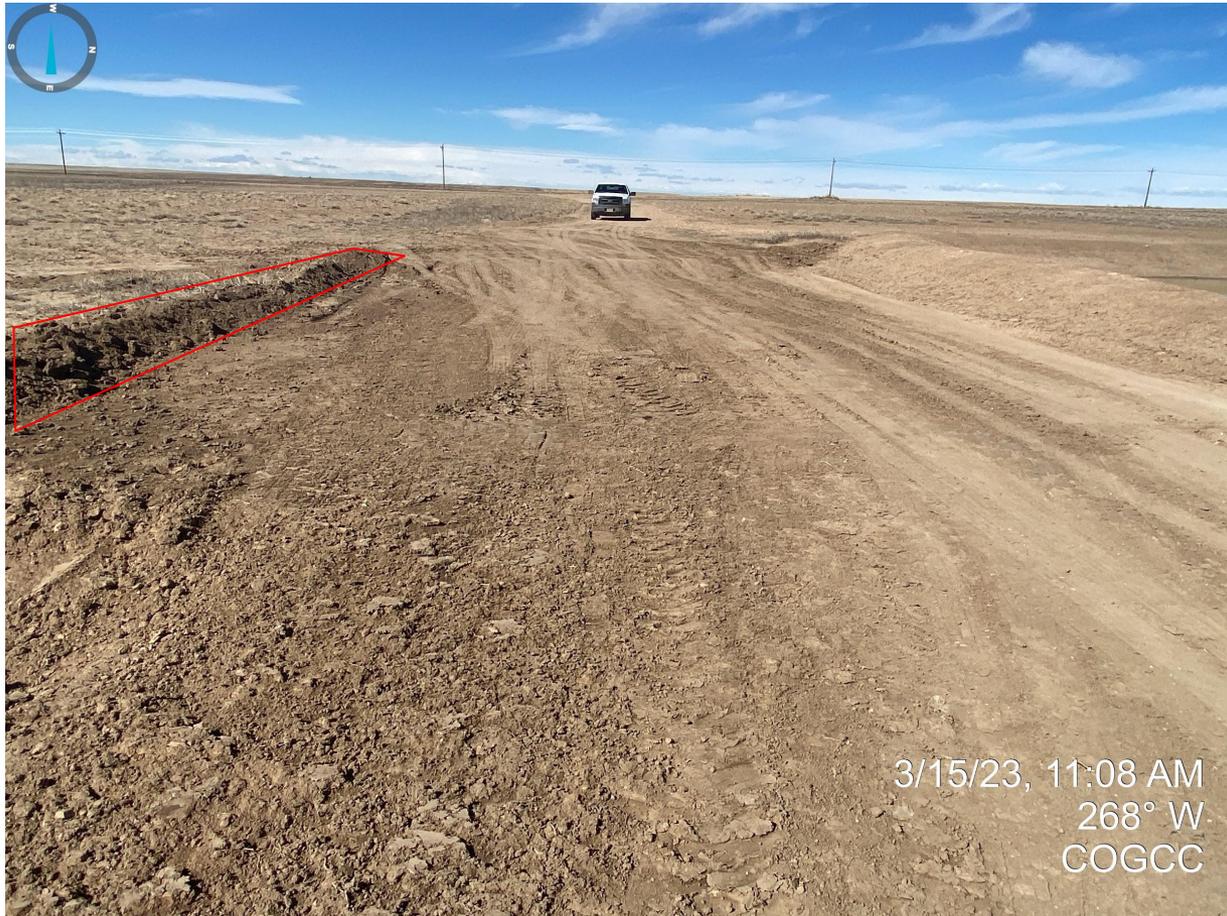
**Photo 10.** Facing west near the sediment trap; see comments in Photo 6.

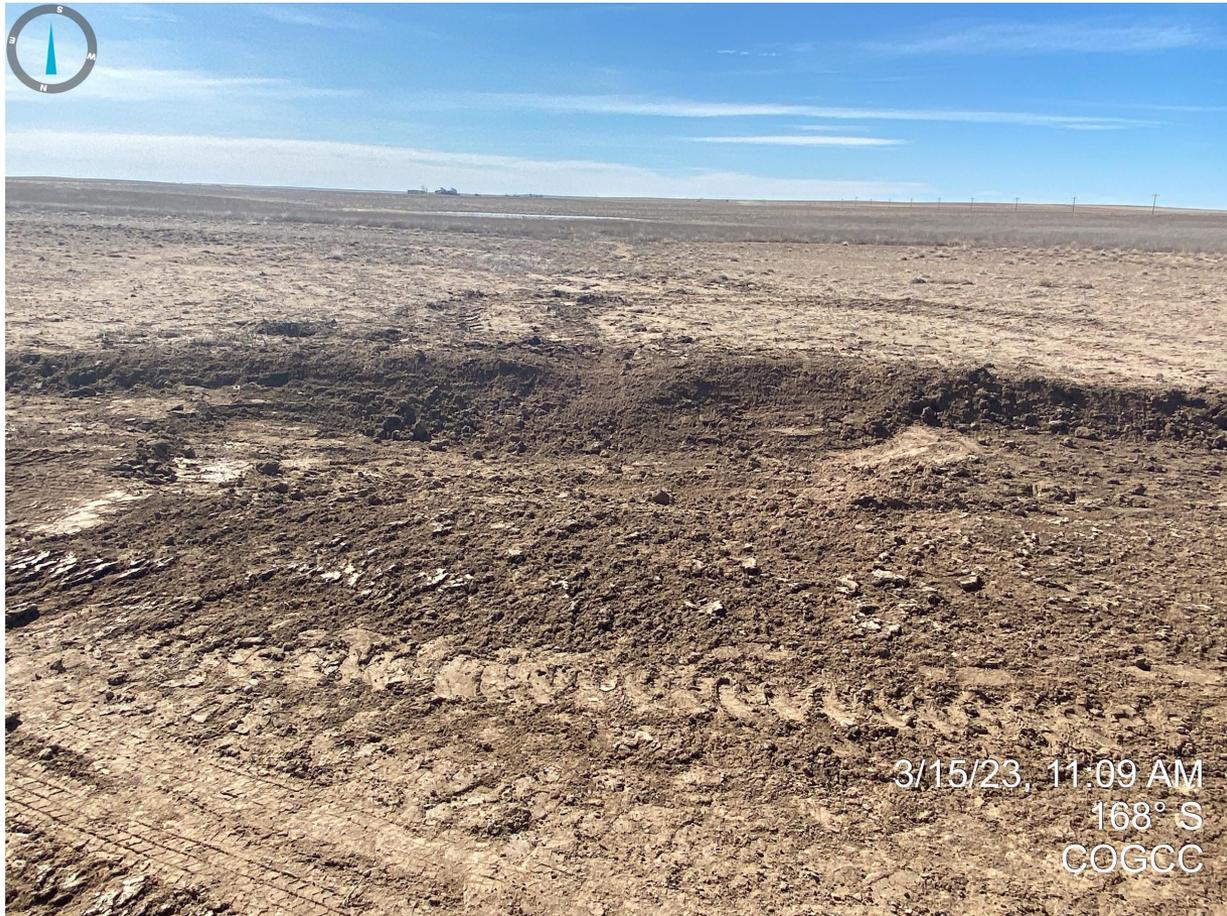
**Photo 11.** Facing south at sediment trap. The sediment trap does not appear stabilized at the inlet/outlets with the absence of rip-rap, erosion control blanket, etc. Additionally, the berms are comprised of loose/unconsolidated material and need to be properly stabilized to prevent further off-site sediment transport.

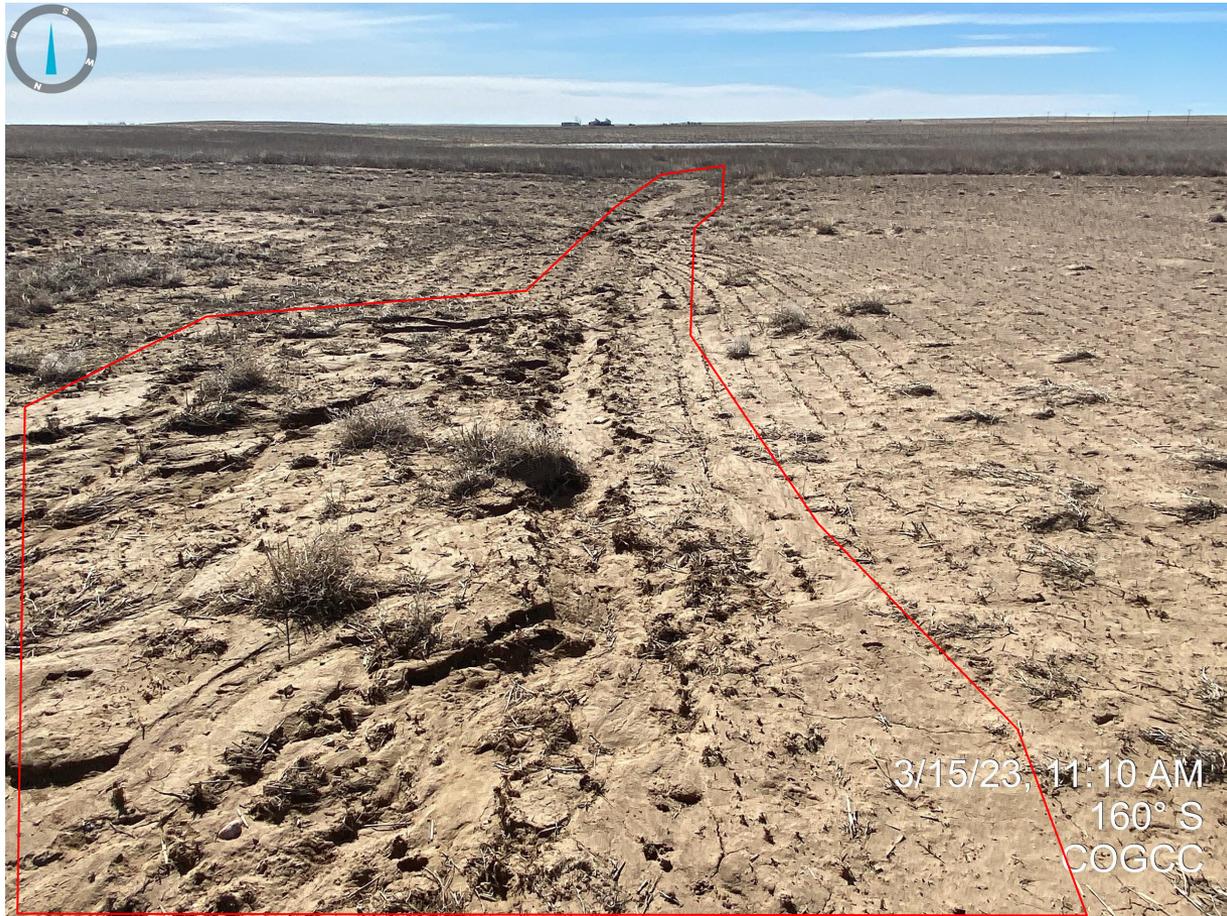
**Photo 12.** Facing south within recently reclaimed portion. Outline illustrates that the eroded areas have not been repaired/stabilized and no evidence of stormwater BMPs observed to prevent further off-location sediment transport. The impacted areas will need to be reclaimed, including any off-location disturbances.

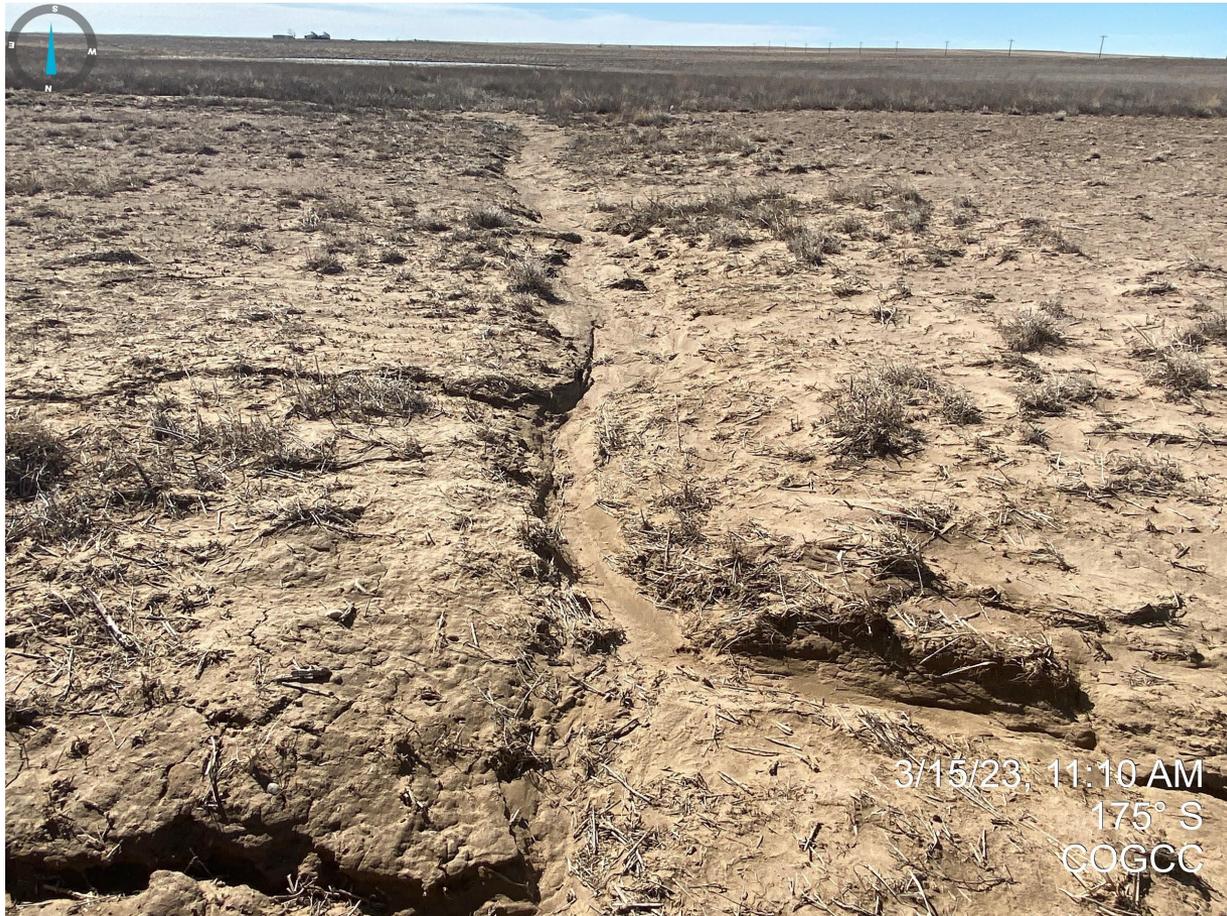
**Photo 13.** Facing south; see comments in Photo 12.

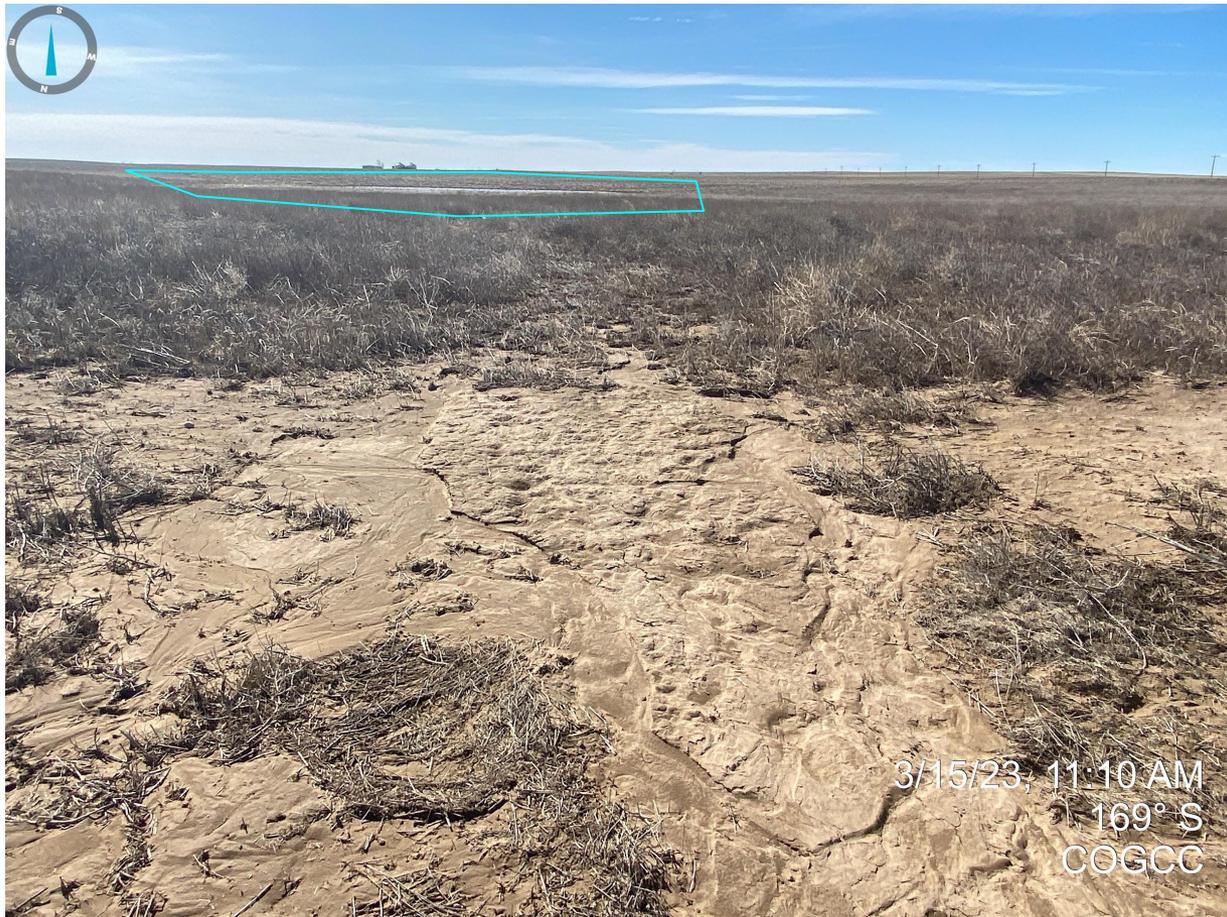
**Photo 14.** Facing south at adjacent land. No stormwater BMPs were identified at the time of this inspection that would prevent sediment laden stormwater from continuing to exit off location. Blue polygon illustrates freshwater emergent wetland approximately 600' south and down gradient of location. This portion of disturbance will need to be reclaimed per Rule 1004.
