Interim Reclamation and Stormwater Inspection

Date: 03/15/2023

Location ID: 455365

Inspection Document #: 708200060

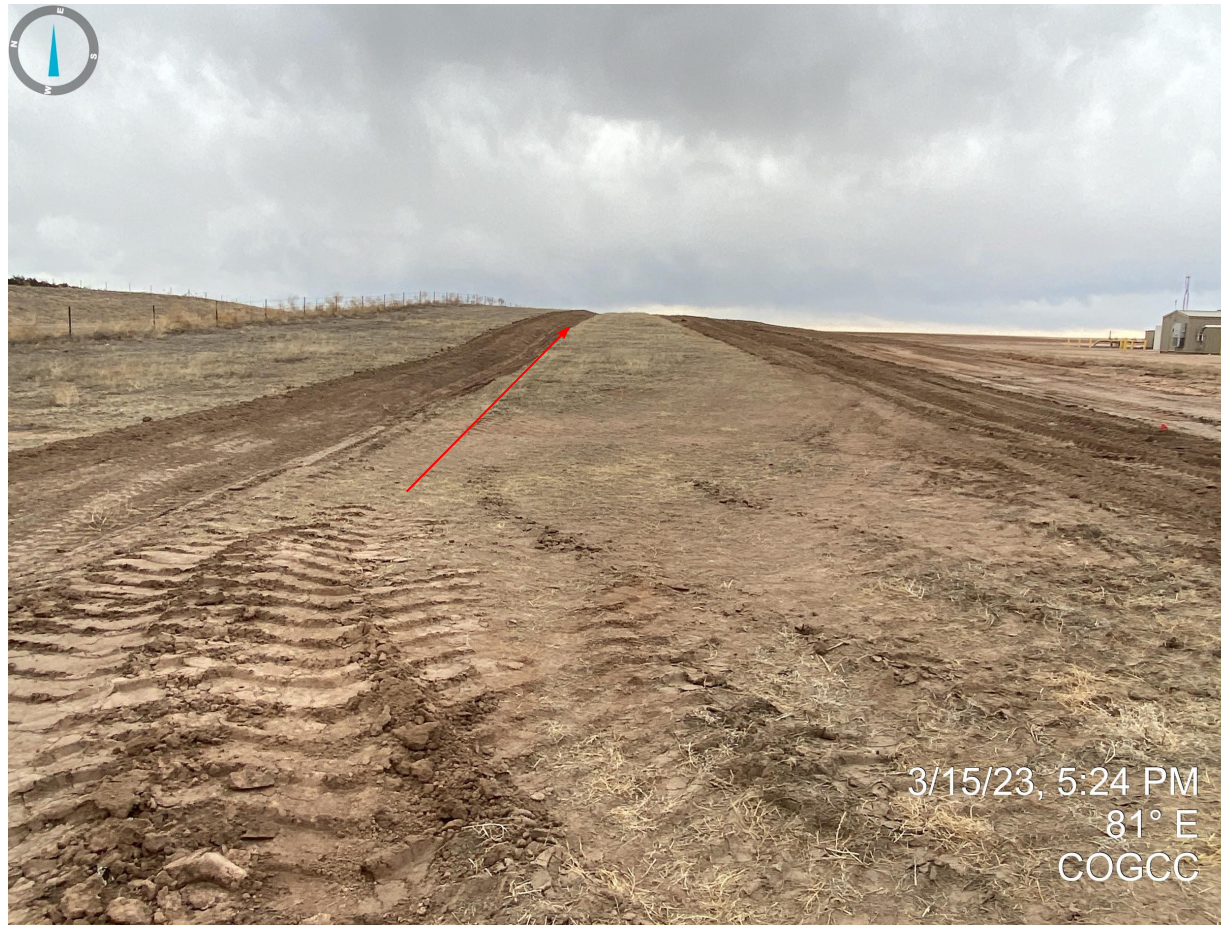
Photo 1. Facing east from the location entrance. Temporary BMPs have been installed (ditch and berm) around the entire perimeter during the construction phase of the location. More permanent BMPs should be installed upon the completion of pad expansion.

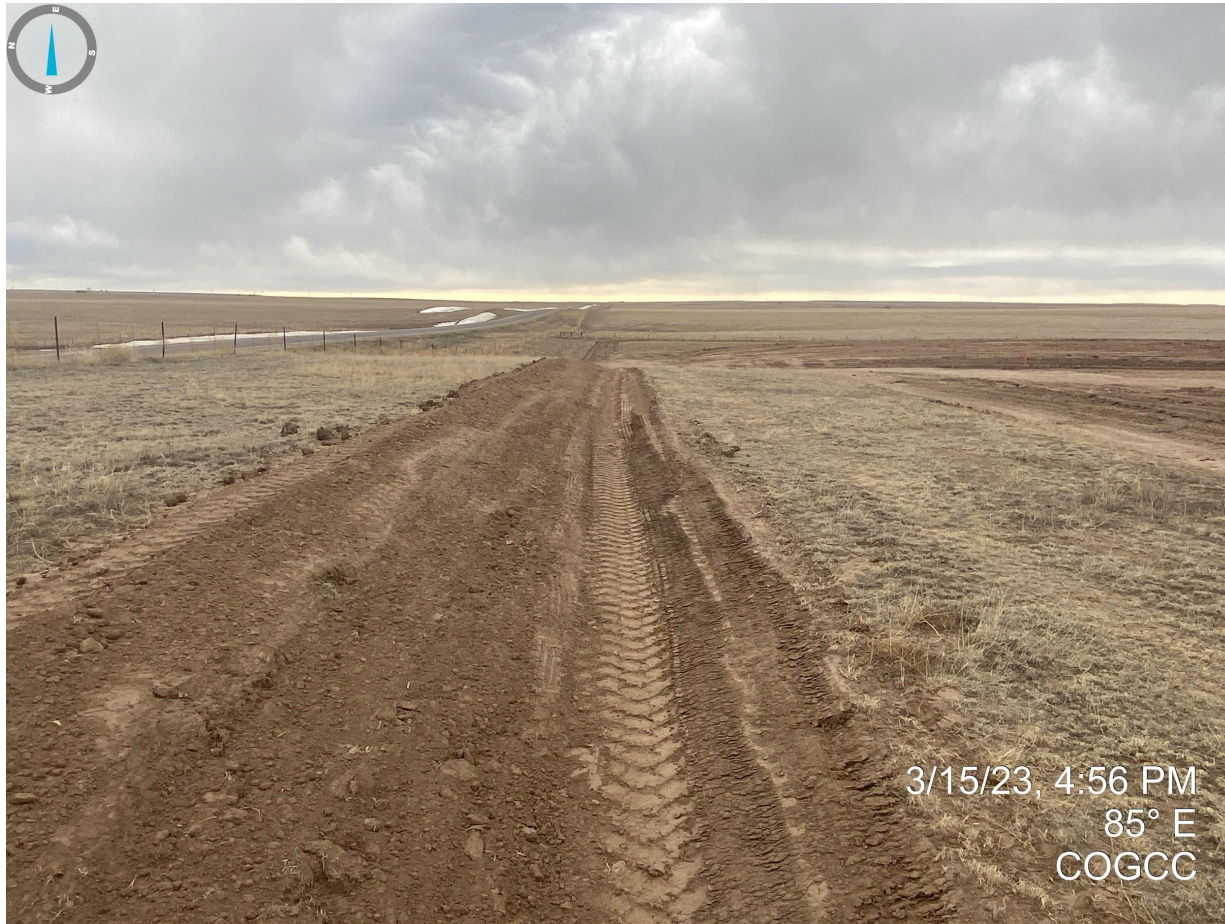
Photo 2. Facing east from the northern portion of the location; see comments in Photo 1.

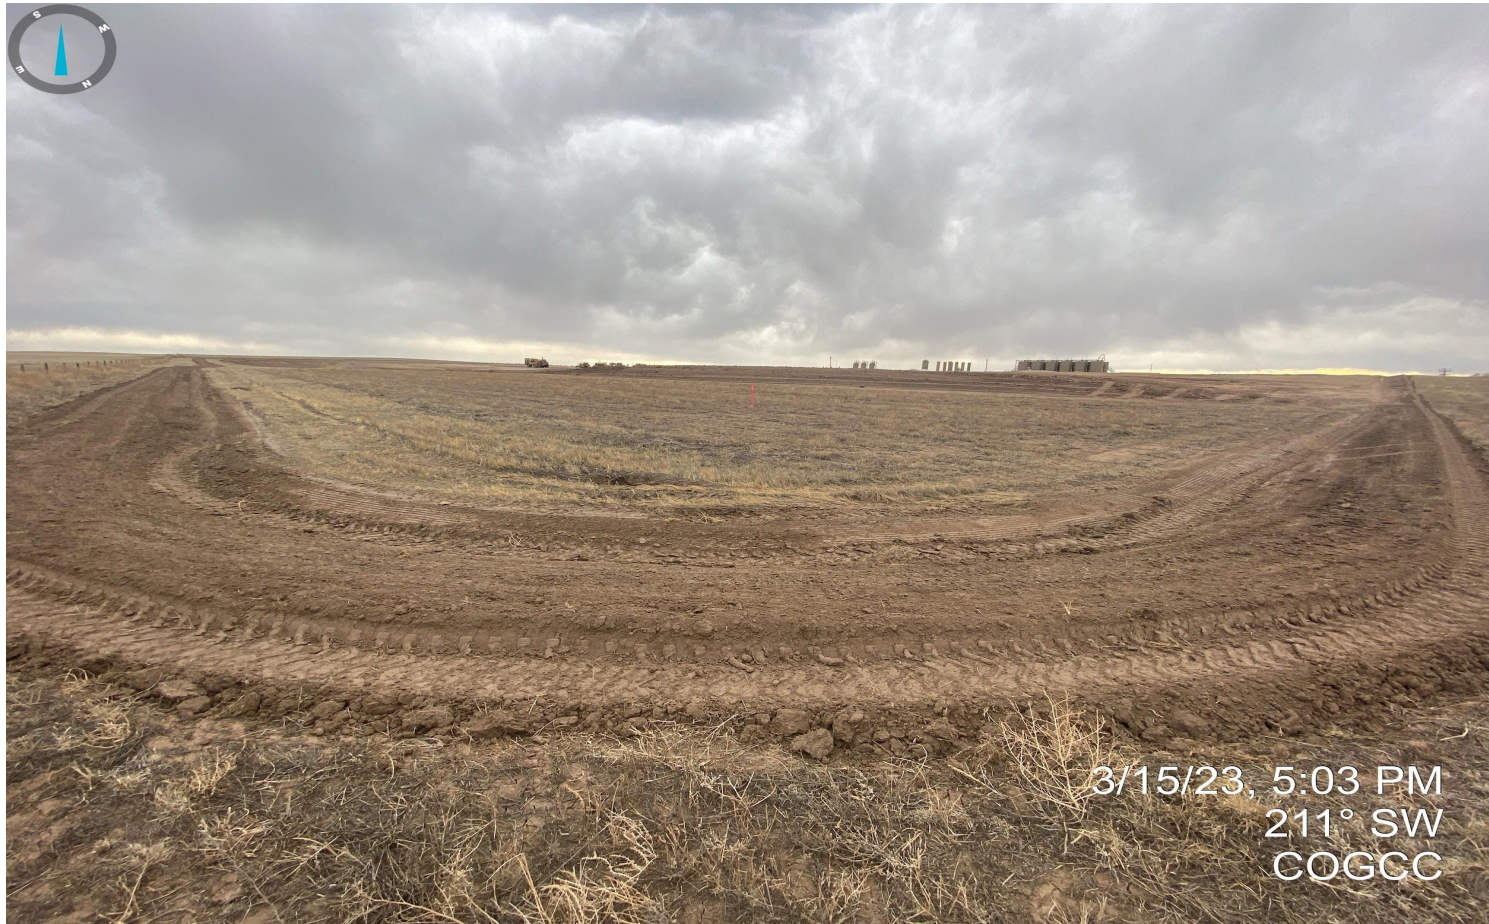
Photo 3. Facing southwest from the northeast corner of the location; see comments in Photo 1.

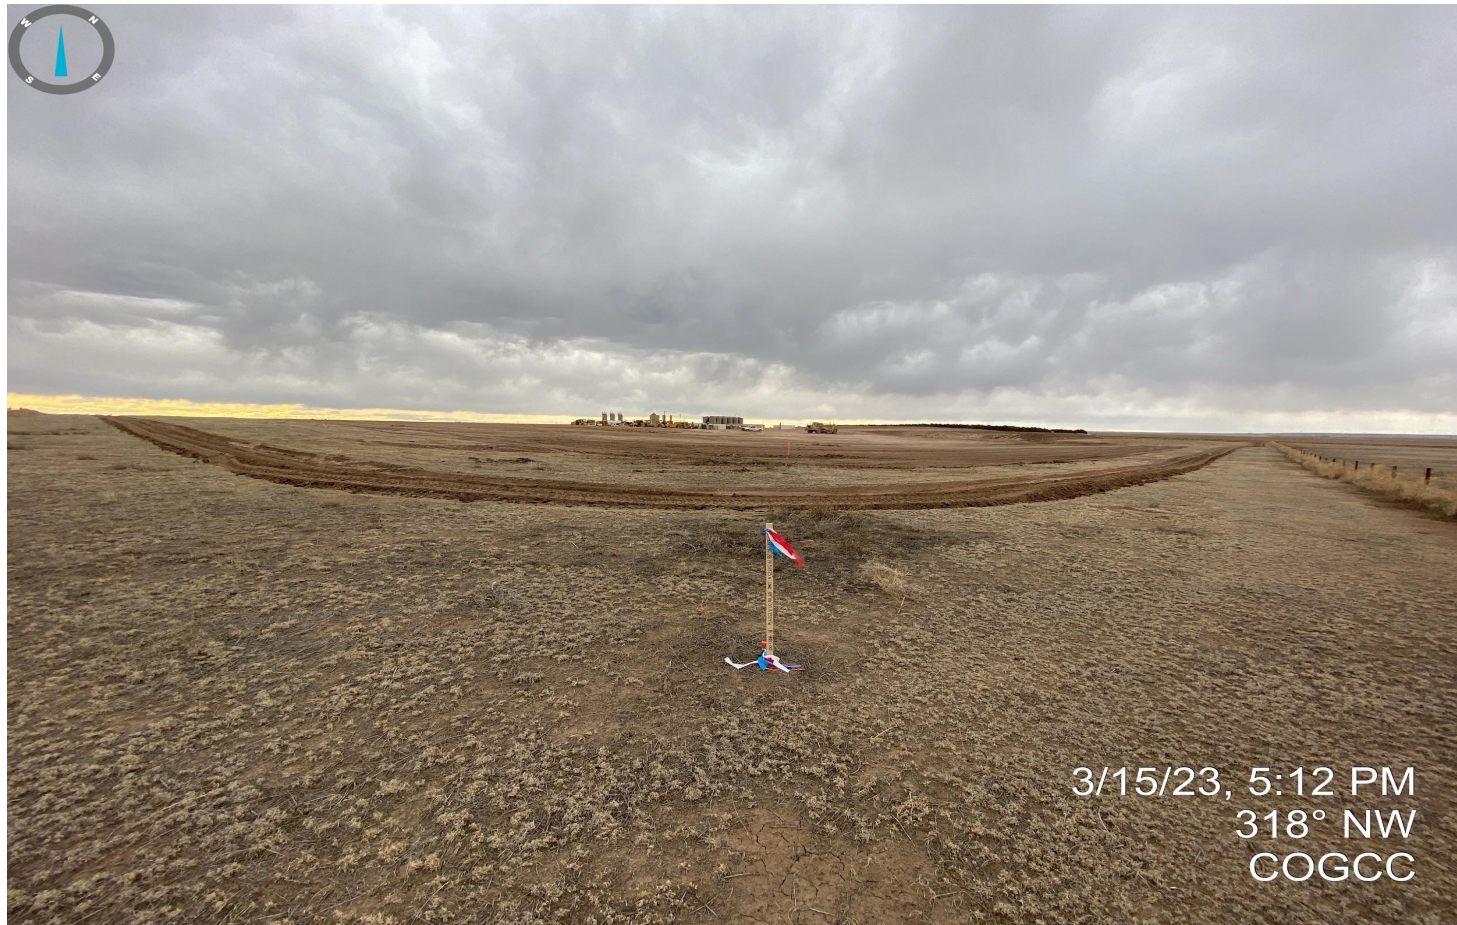
Photo 4. Facing northwest from the southeast corner of the location; see comments in Photo 1.

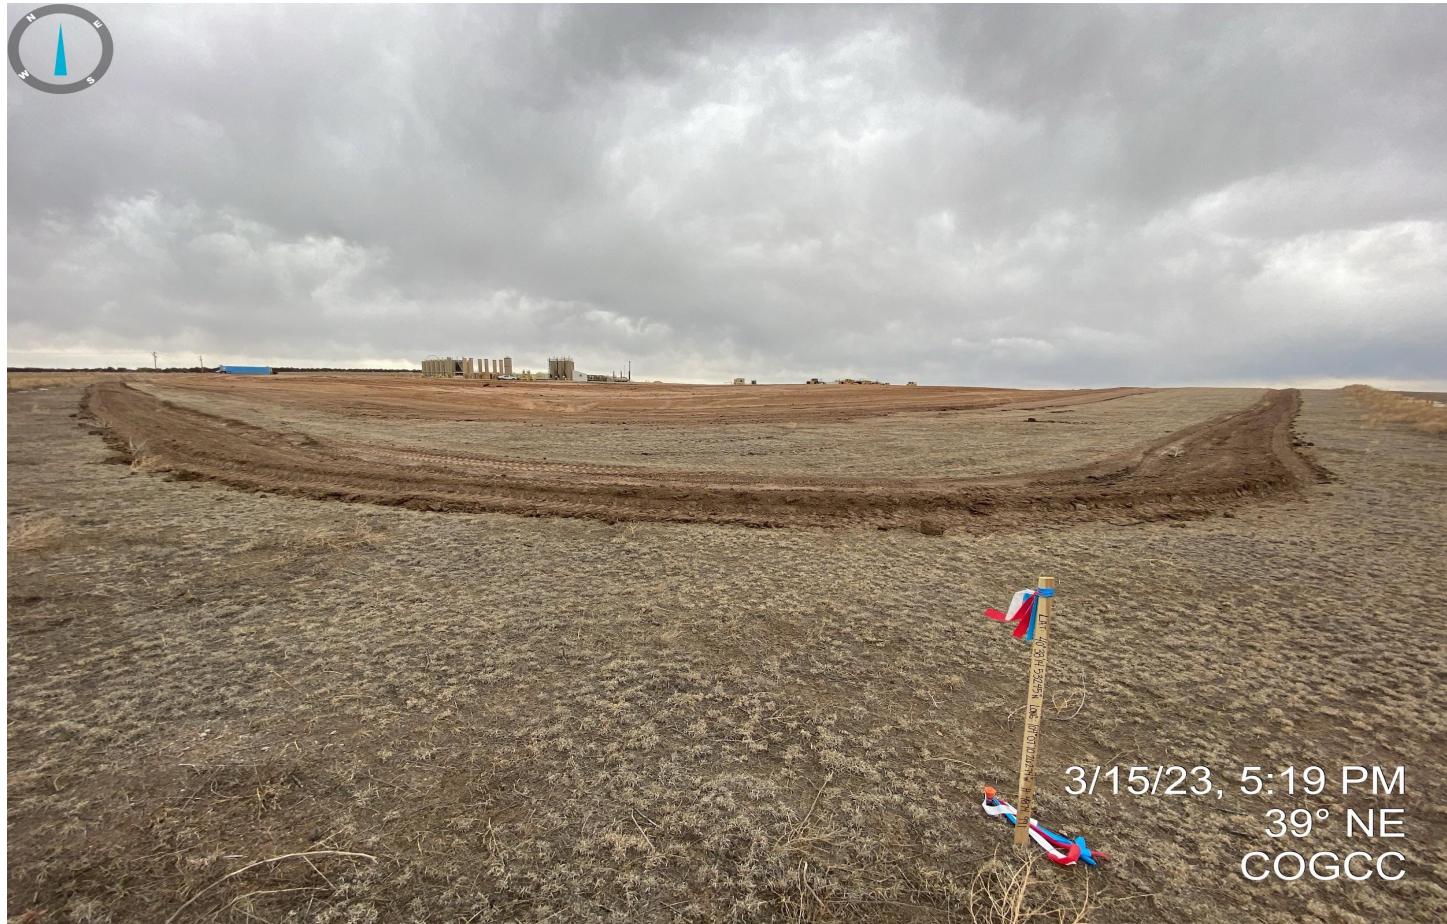
Photo 5. Facing northeast from the southwest corner of the location; see comments in Photo 1.

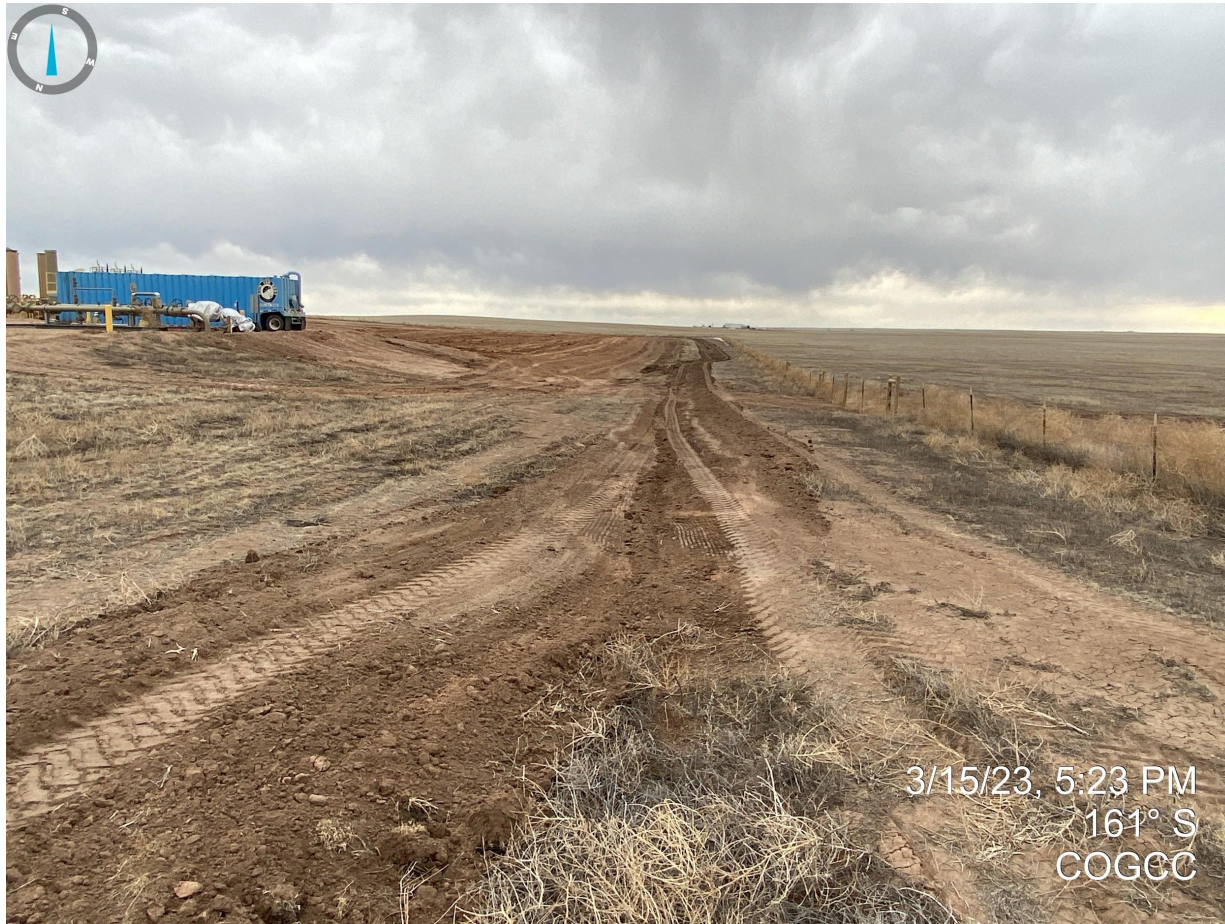
Photo 6. Facing south from the location's entrance; see comments in Photo 1.

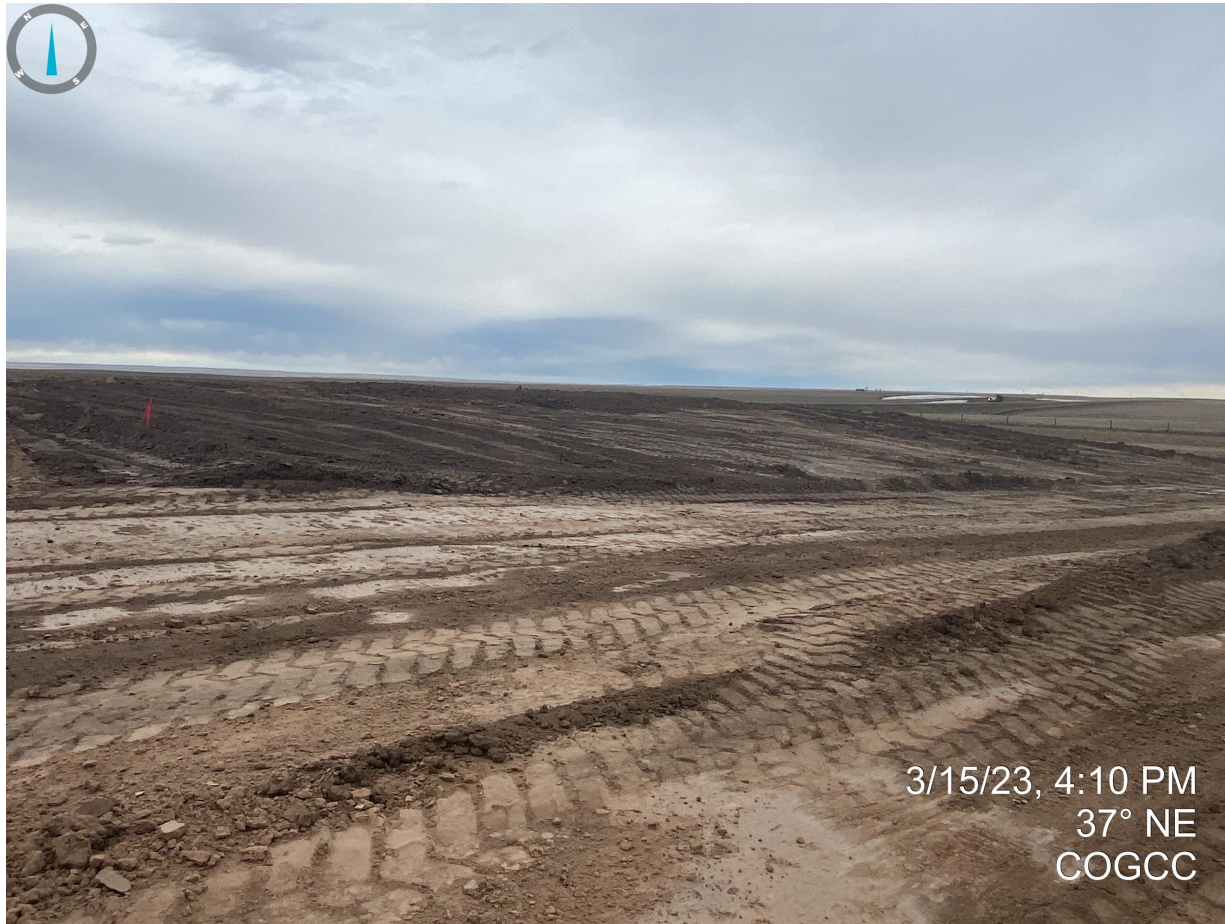
Photo 7. Facing northeast towards the new topsoil stockpile. Construction activities were occurring at the time of this inspection; topsoil salvage operations are still ongoing and the material is being segregated on the northeastern portion of the location.

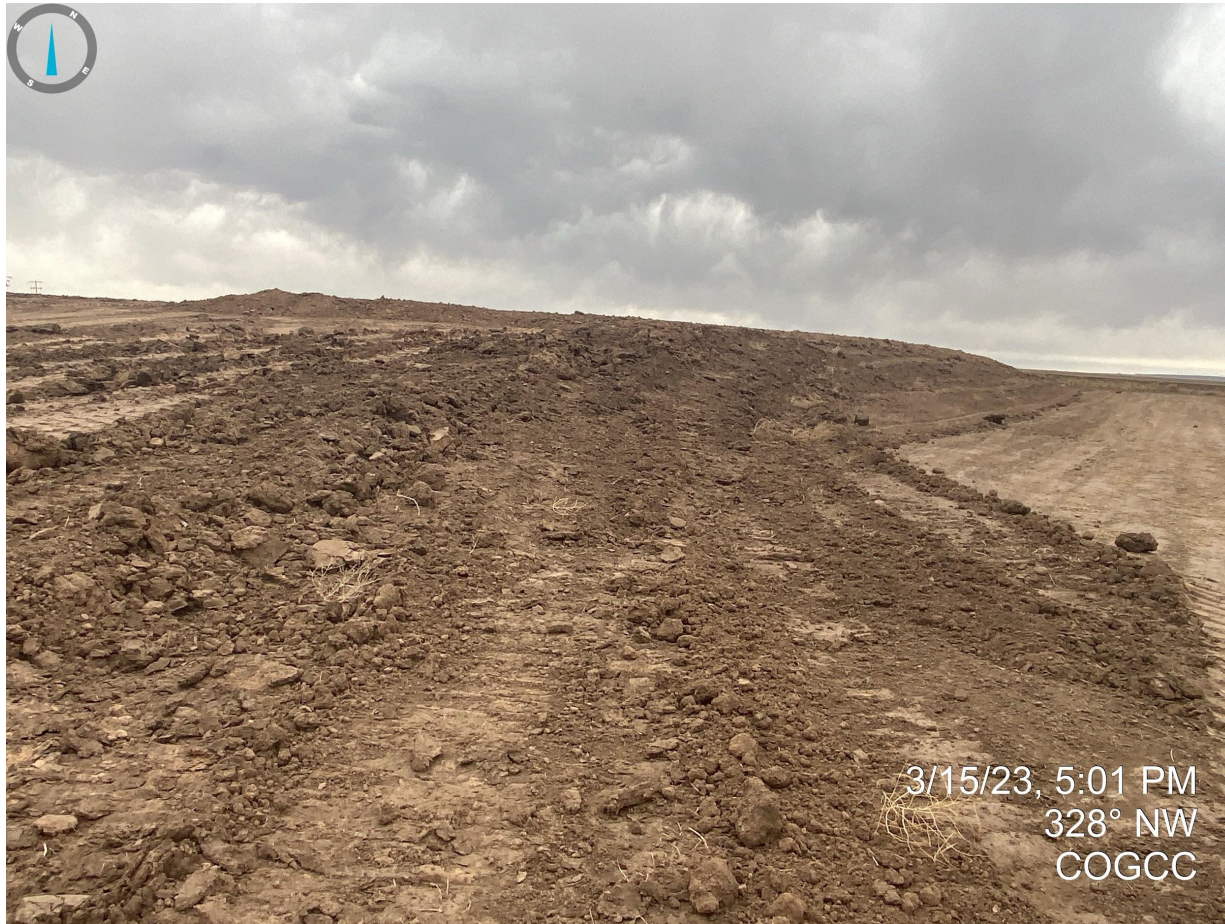
Photo 8. Facing northwest at the topsoil stockpile; see comments in Photo 7.

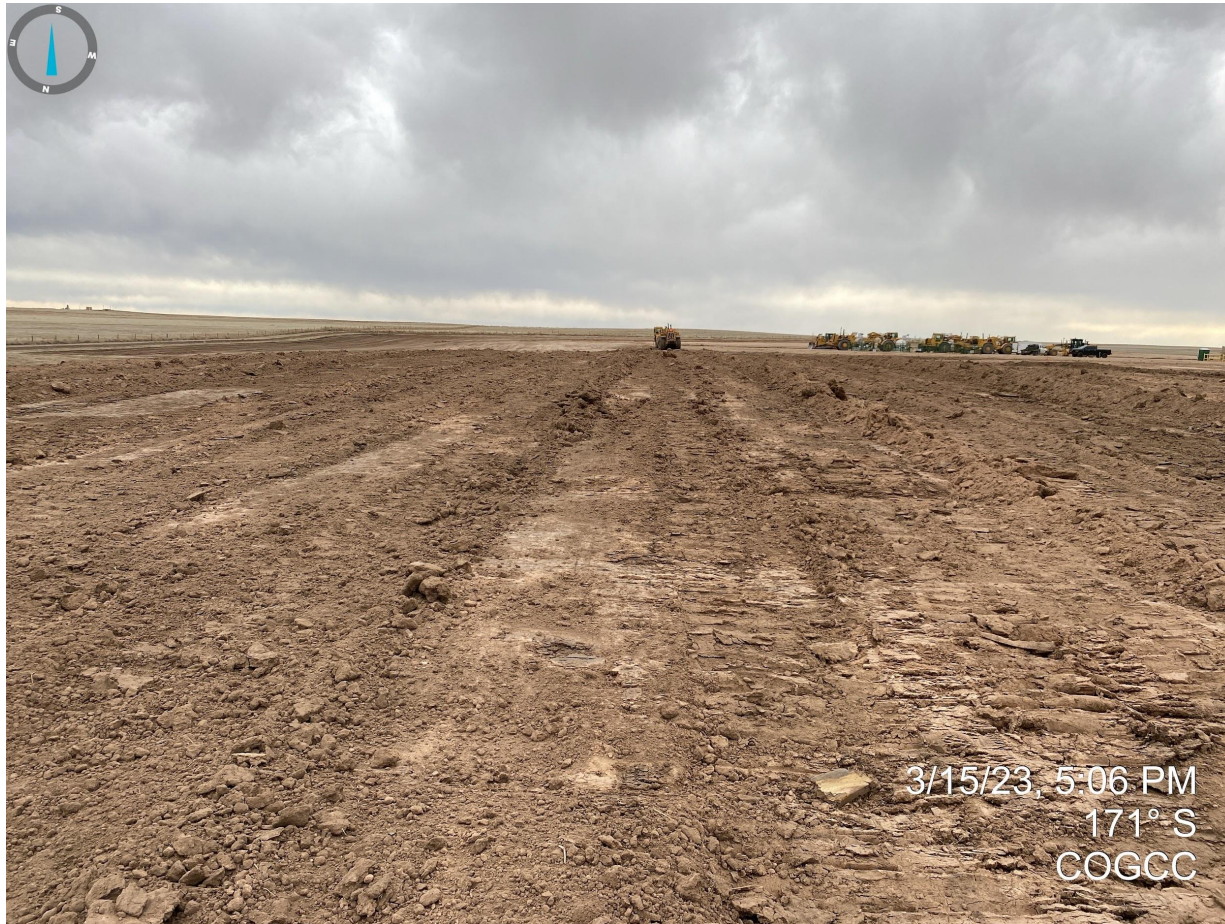
Photo 9. Facing south from topsoil stockpile; salvage operations were still on-going. Staff observed some evidence of equipment tracking on the stockpile and it is required by Rule 1002.c that the entire topsoil stockpile is temporarily stabilized prior to long term stabilization efforts occur.

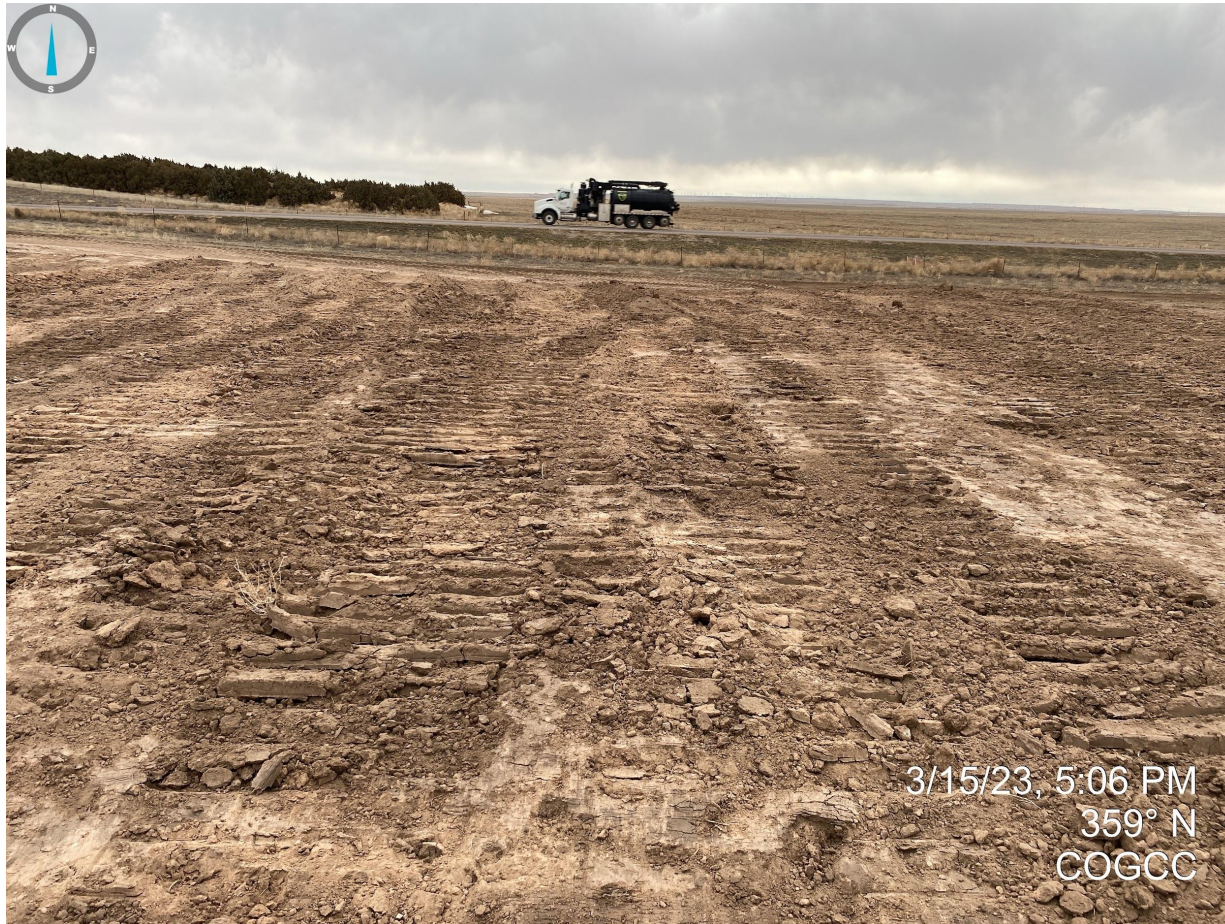
Photo 10. Facing north from topsoil; see comments in Photo 9.

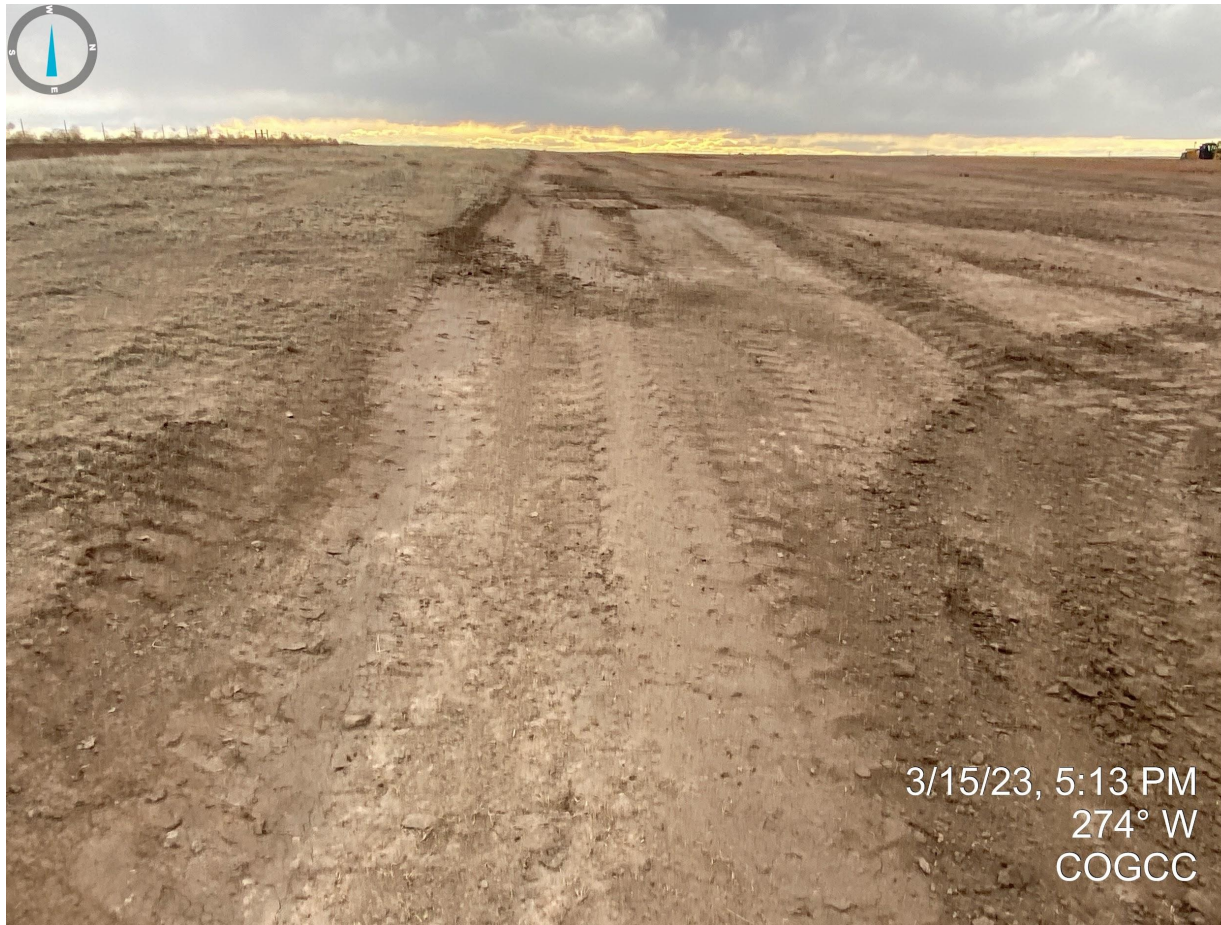
Photo 11. Facing west from the southern portion of the location. Topsoil salvage operations were still occurring during this inspection. The Operator shall ensure that all topsoil is properly salvaged and segregated.

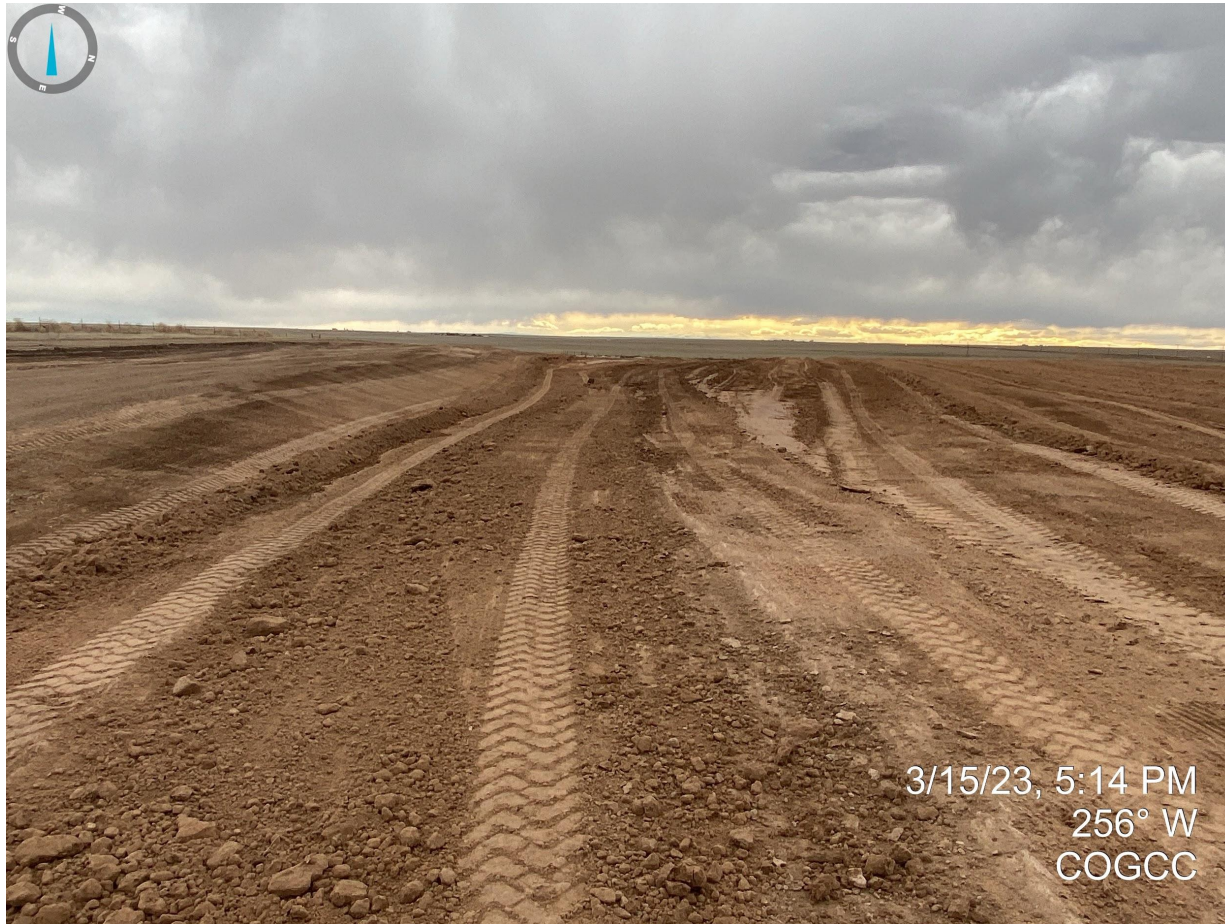
Photo 12. Facing west from the southern portion of the location; photo illustrates cut and fill areas during the pad expansion/construction activities.

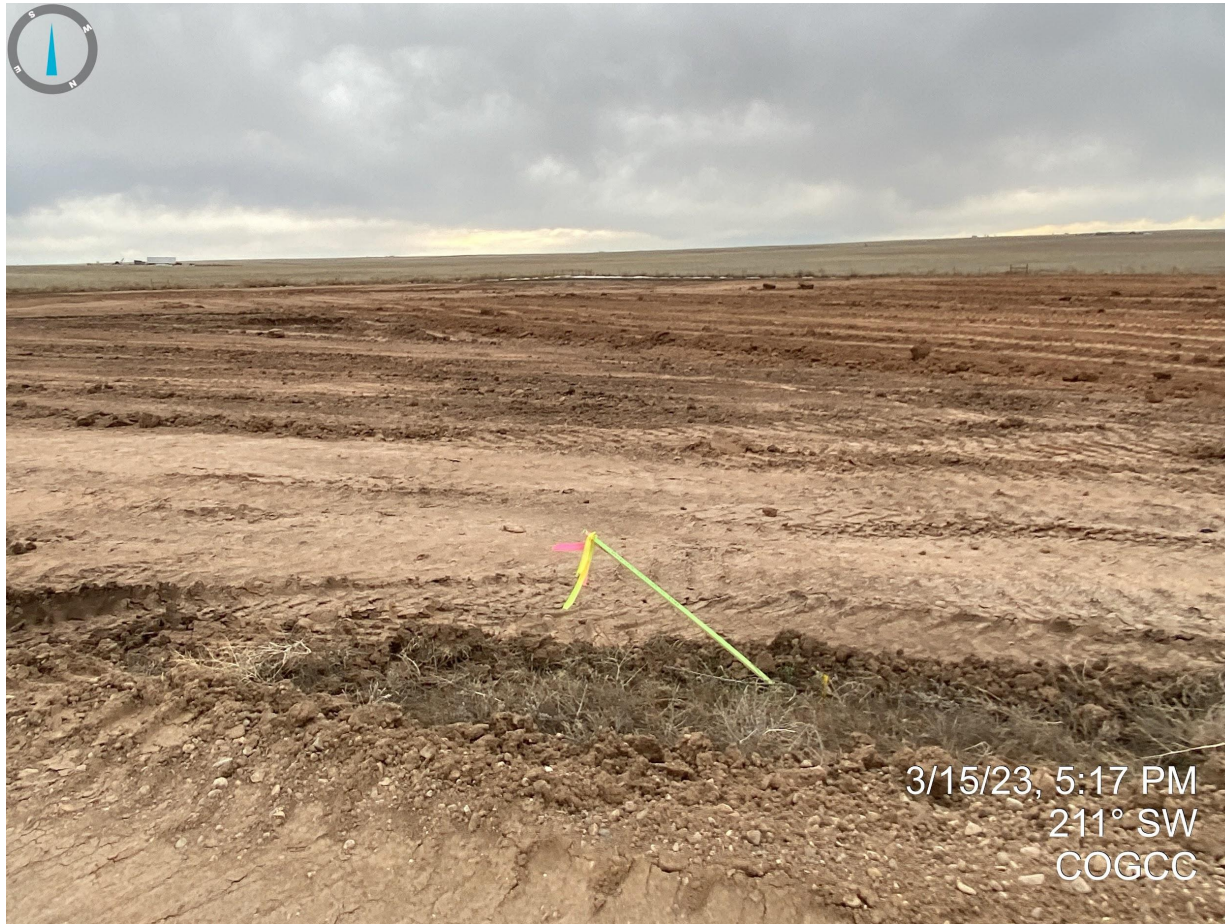
Photo 13. Facing southwest near one of the new well locations; see comments in Photo 12.

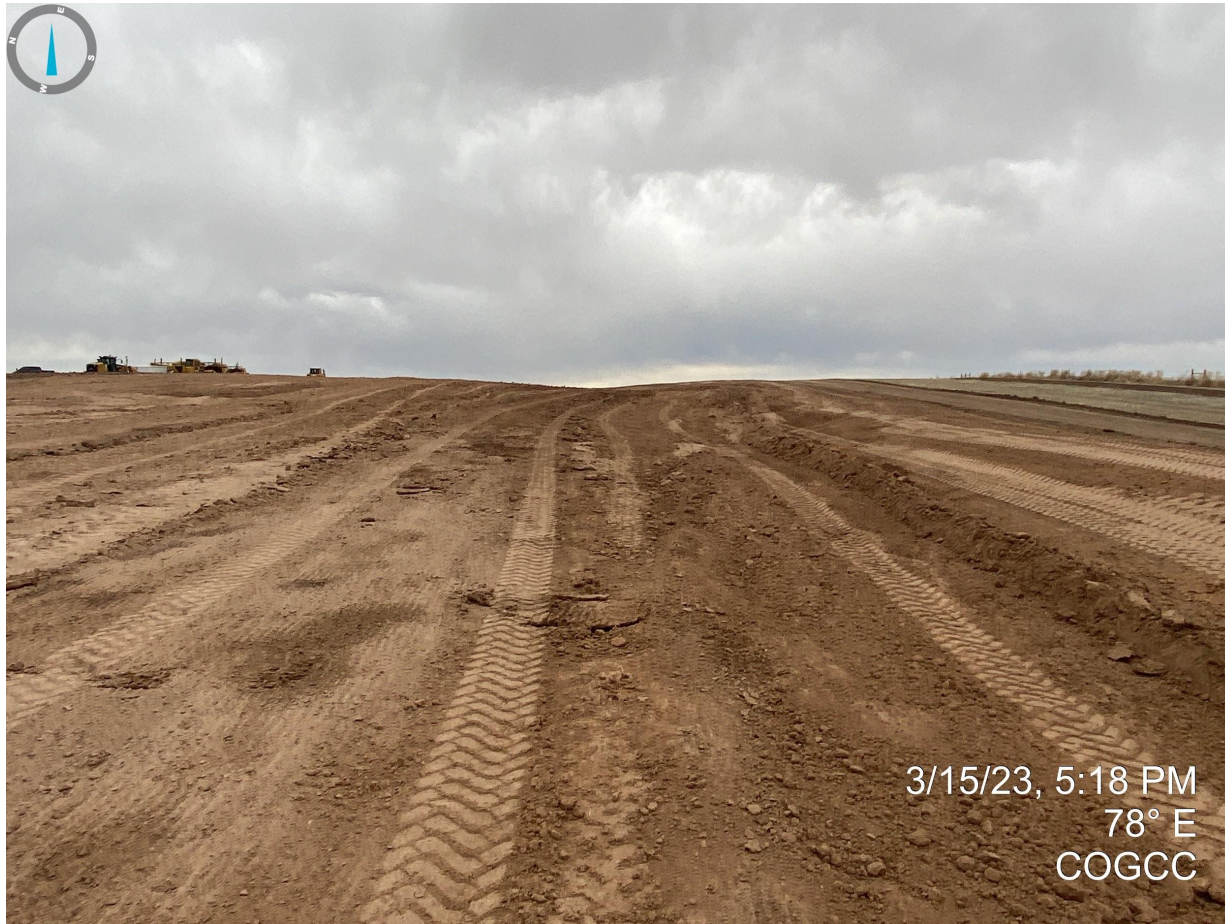
Photo 14. Facing east from southern portion of location; see comments in Photo 12.

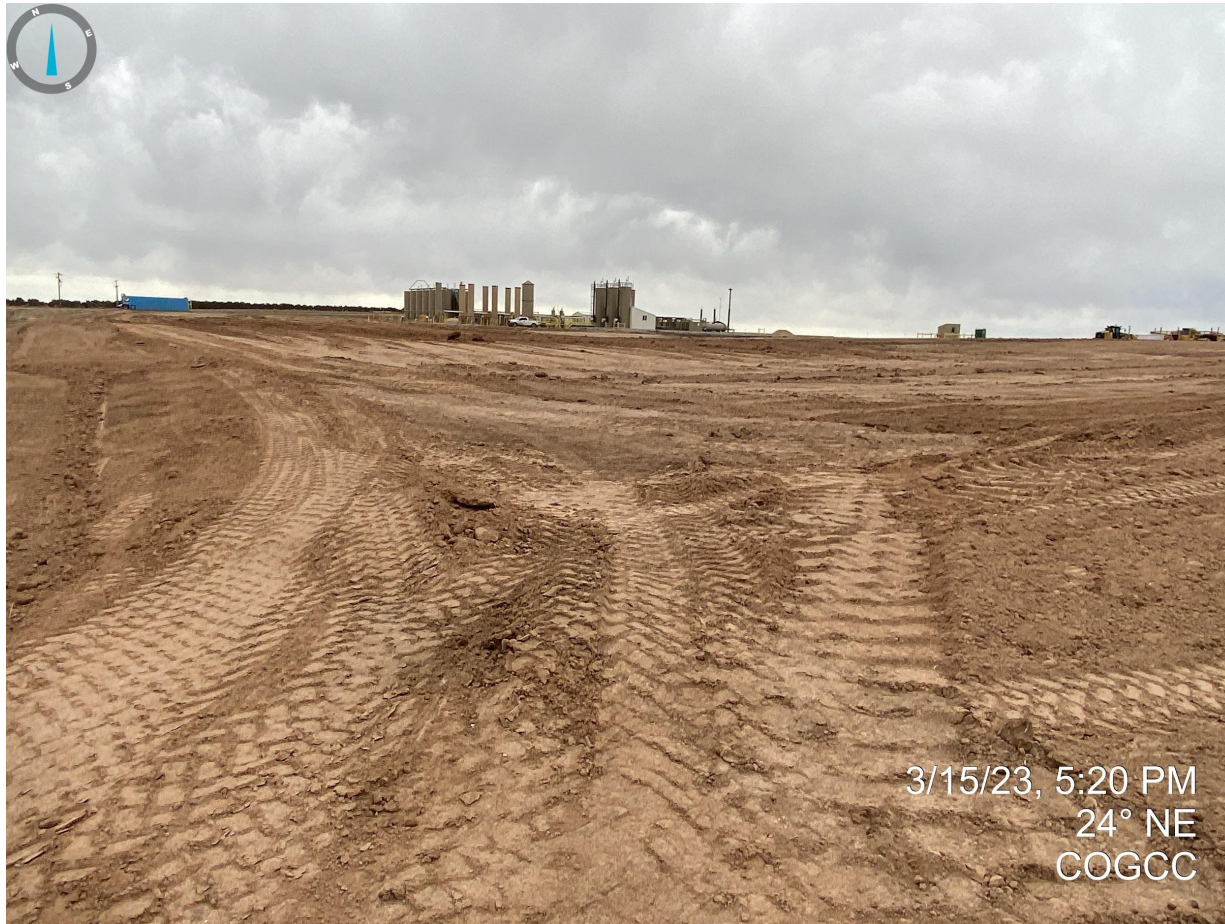
Photo 15. Facing northeast from the southwest corner of the location; see comments in Photo 12.

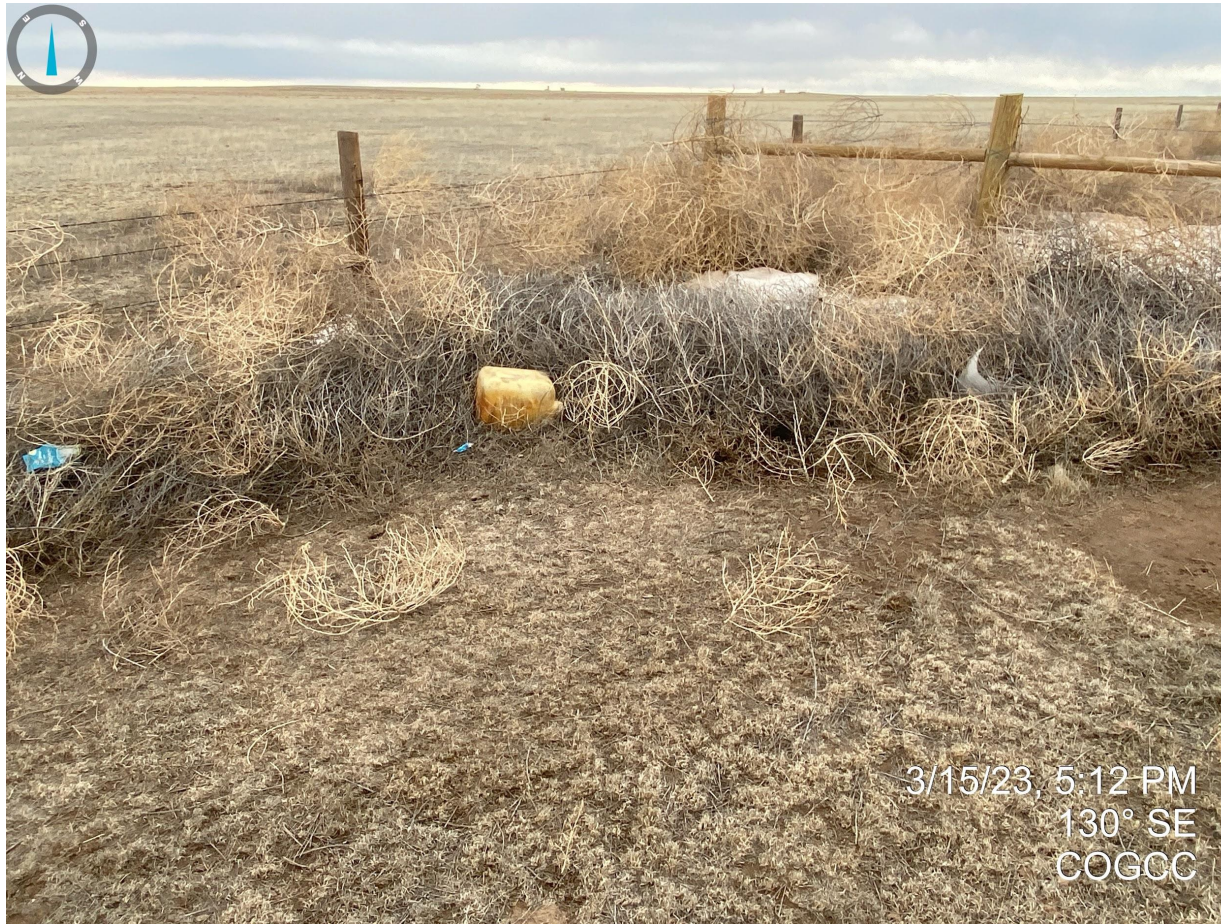
Photo 16. Taken from southeast corner of the location. Trash and debris accumulations observed on location; all trash and debris will need to be cleaned up and disposed of in compliance with Rule 606.
