Inspection Photos

Location Name: TEP ROCKY MOUNTAIN LLC UNOCAL GM 11-2 Pad

Location ID: 334771

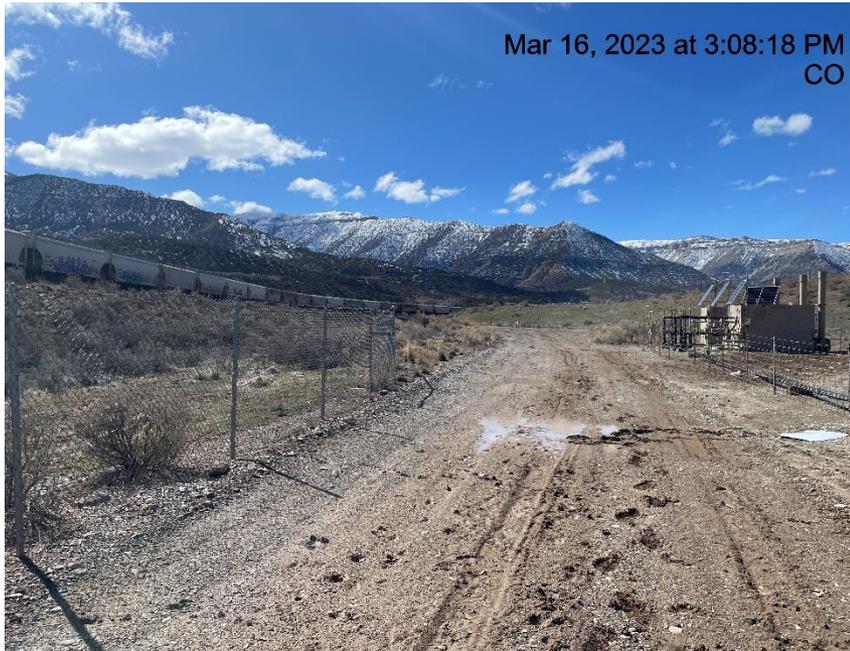
Photo # 2509 From entrance to location

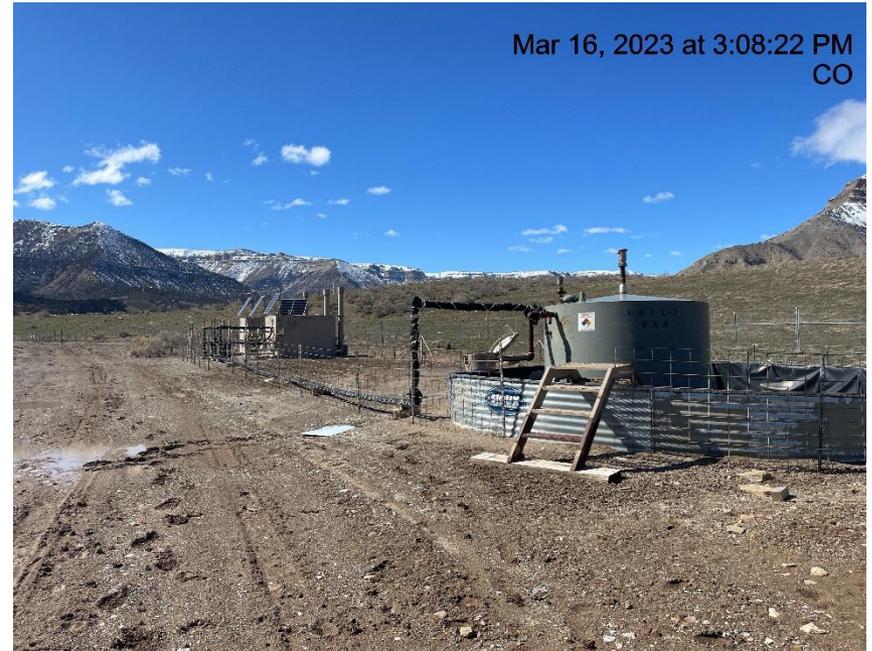
Photo # 2510 From entrance to location

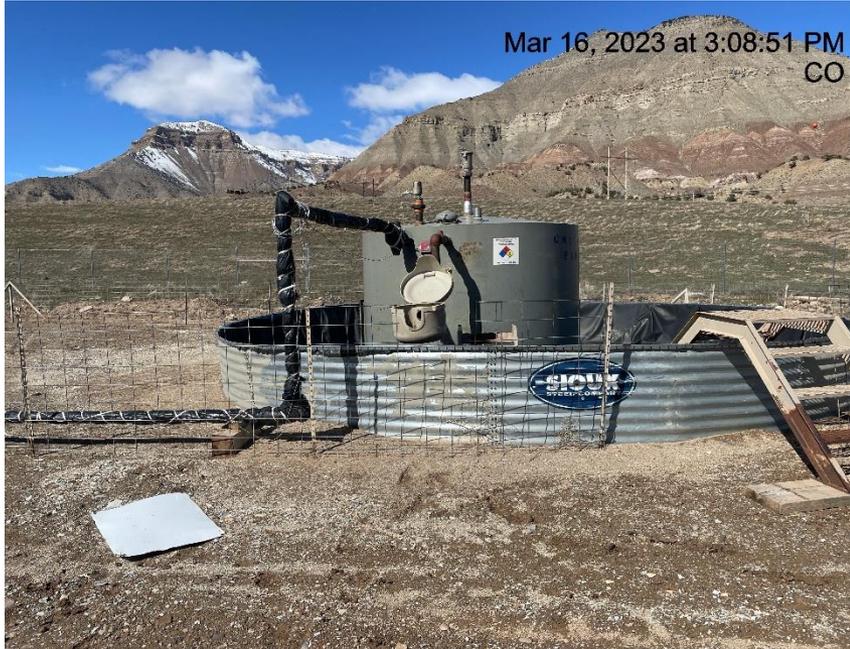
Photo # 2511 Location

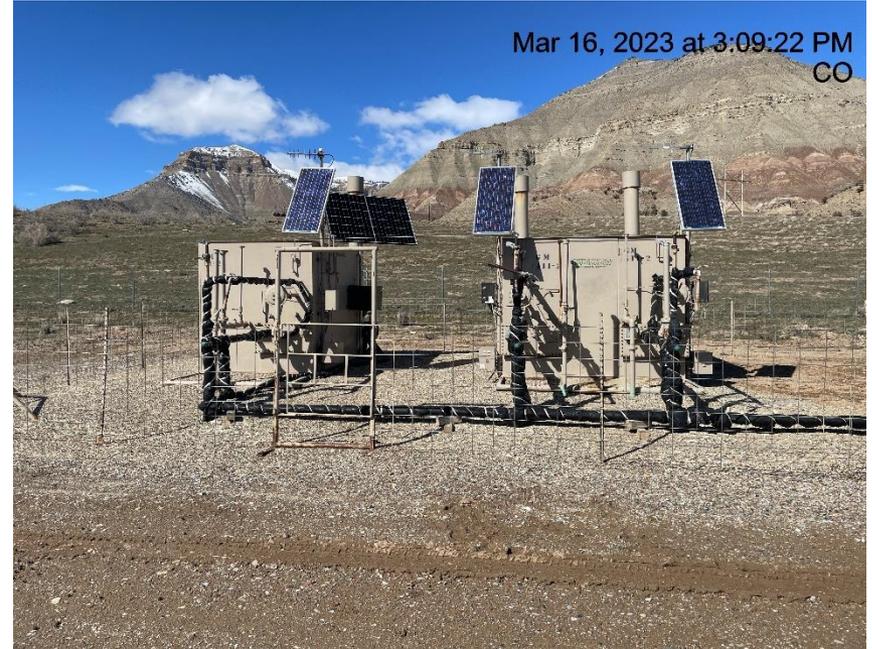
Photo # 2512 Location

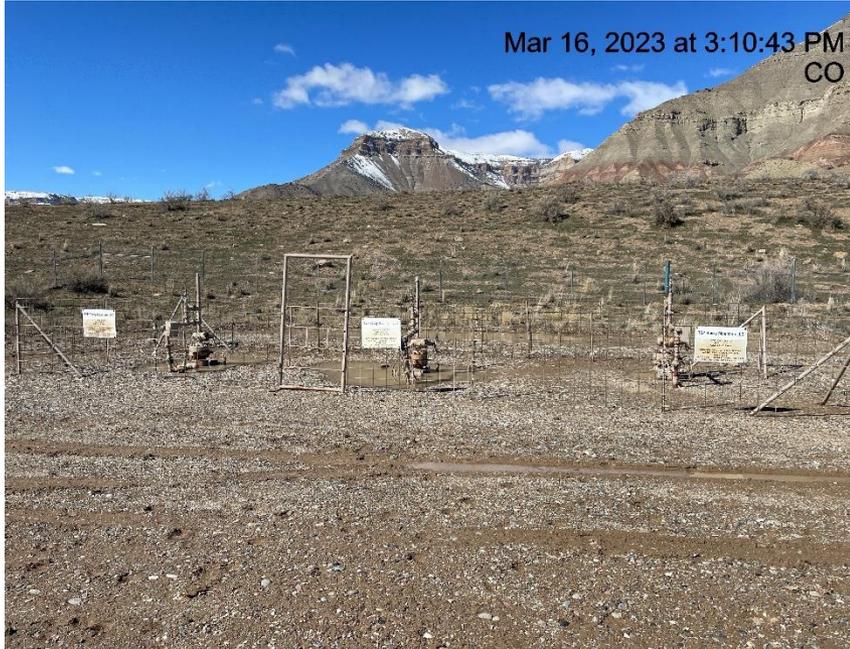
Photo # 2513 Location

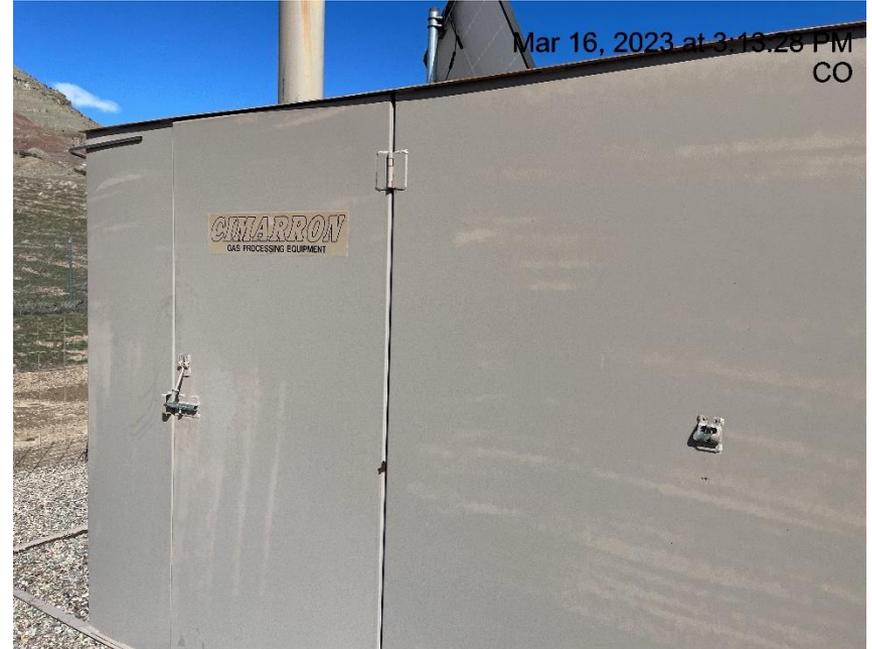
Photo # 2517 Meter calibration info not conspicuously posted

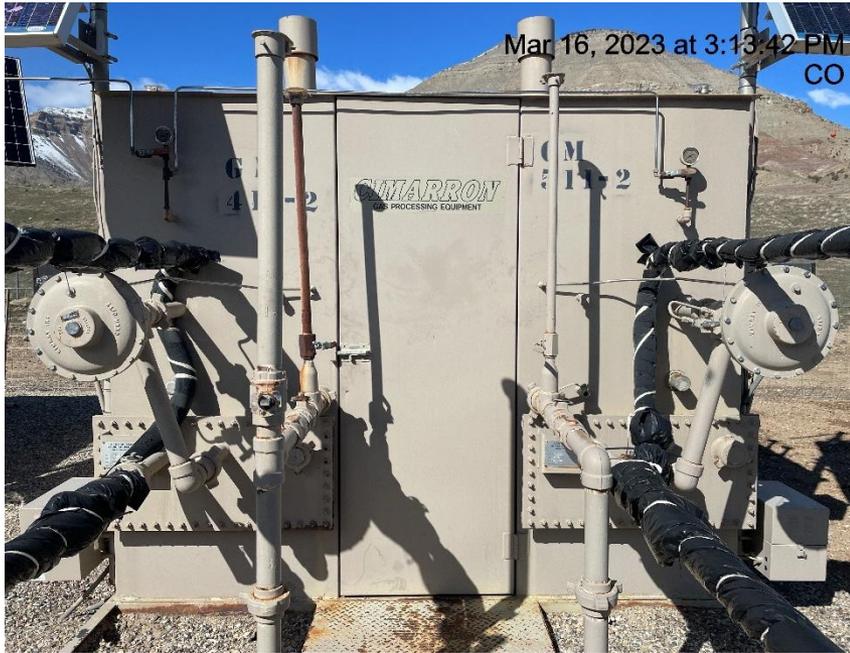
Photo # 2518 Meter calibration info not conspicuously posted

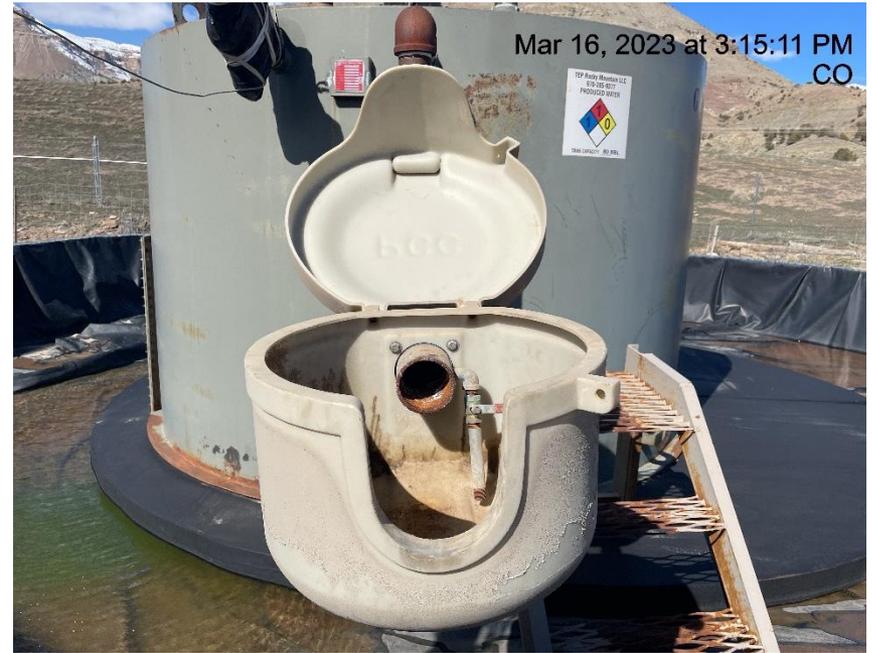
Photo # 2519 Open ended load line

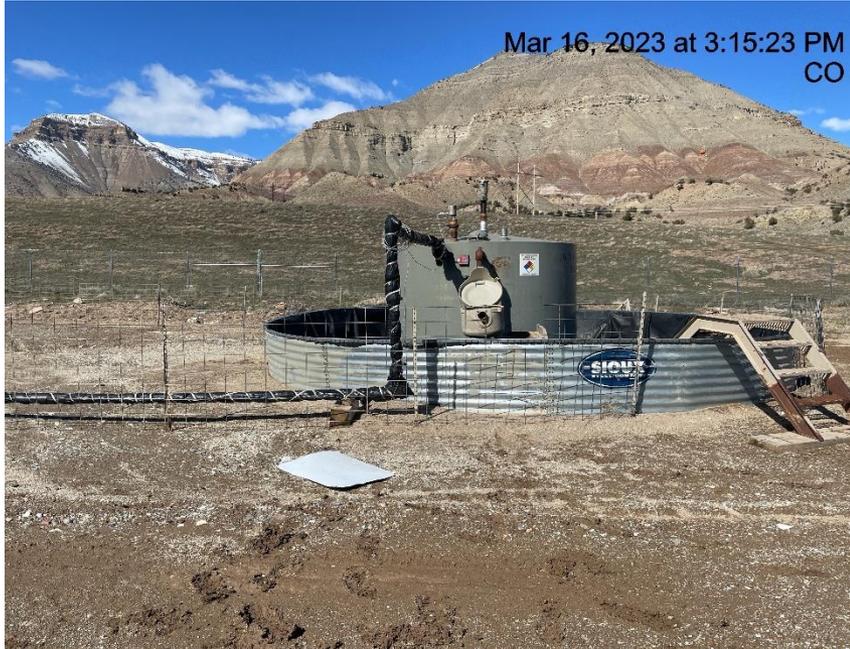
Photo # 2520 Battery sign not maintained/properly posted

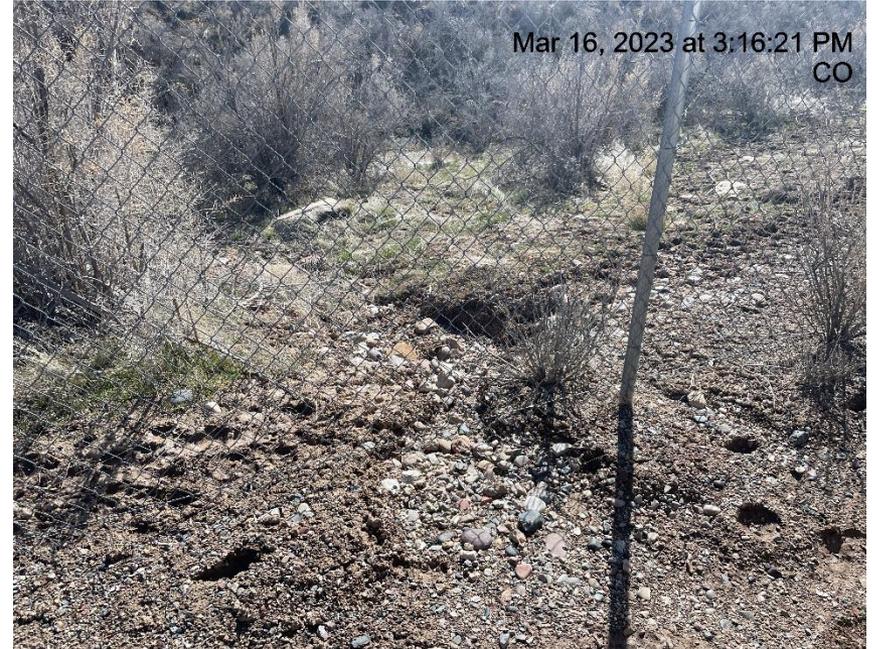
Photo # 2522 Gulley erosion along lease road

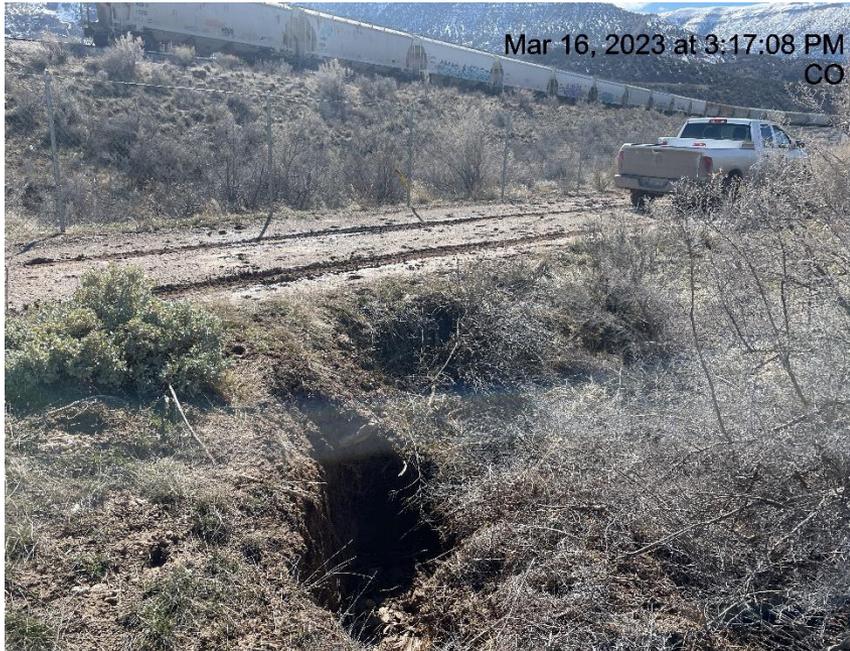
Photo # 2523 Culvert needs maintenance (lease road)

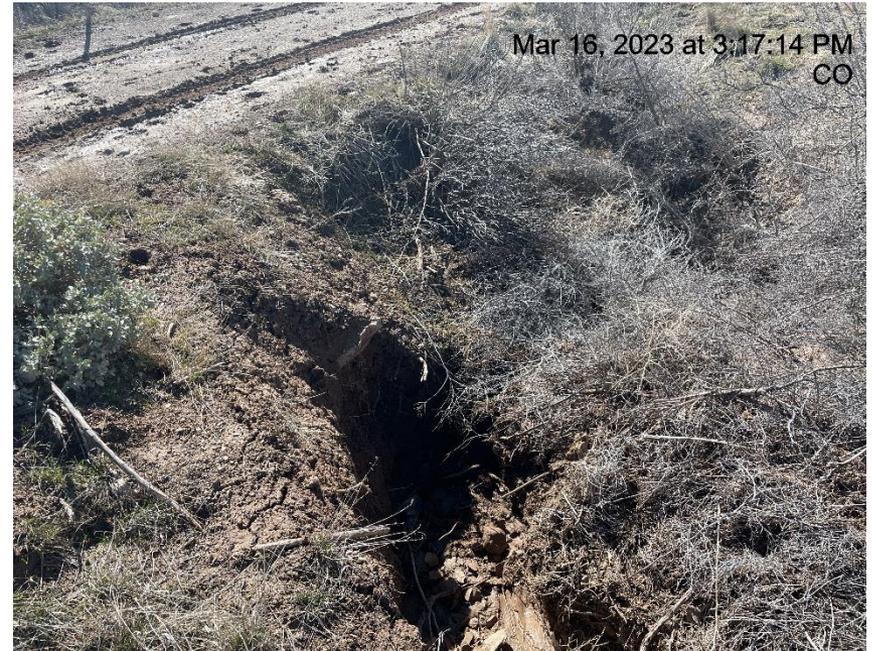
Photo # 2524 Culvert needs maintenance (lease road)

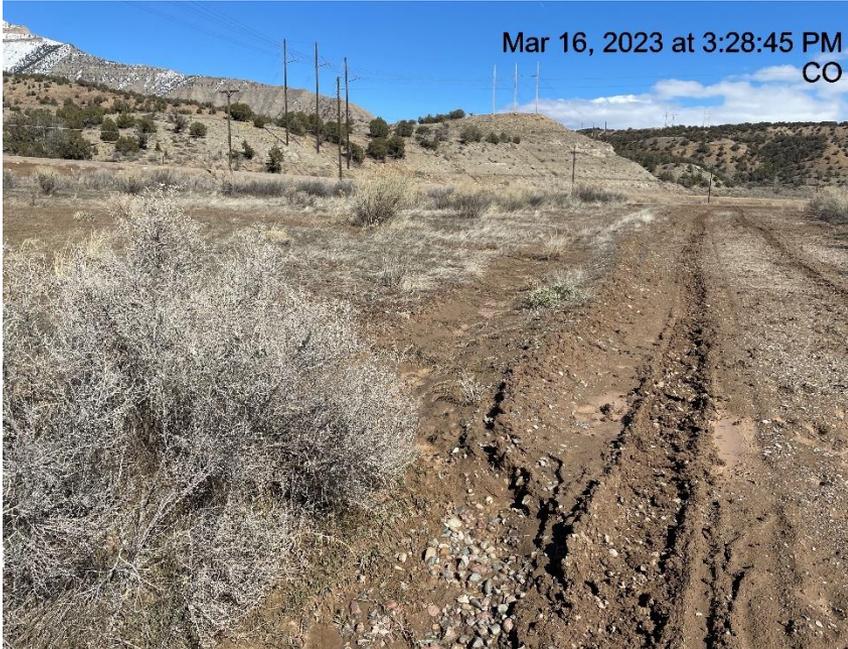
Photo # 2530 Gulley erosion on lease road

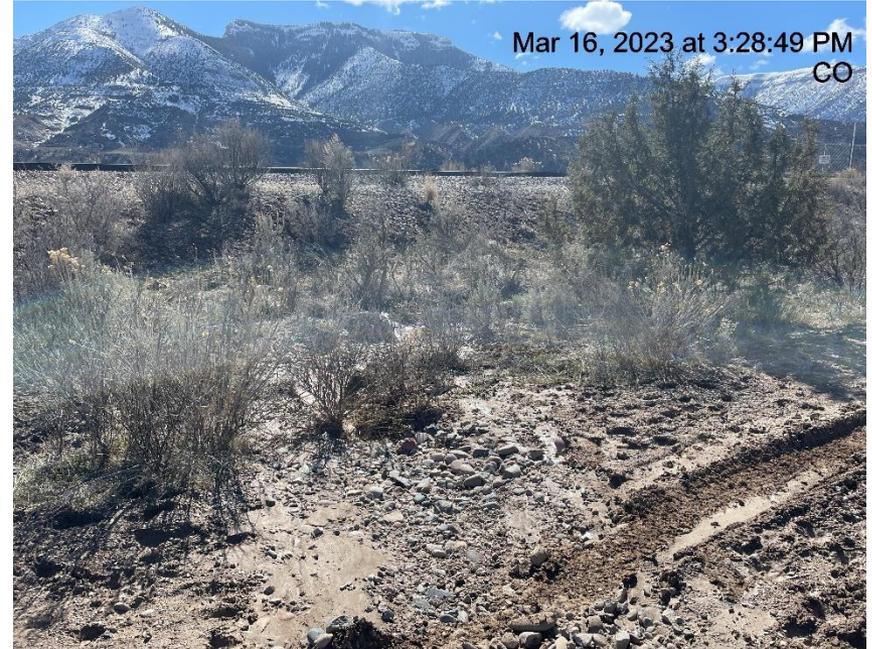
Photo # 2531 Erosion & sediment migration off lease road

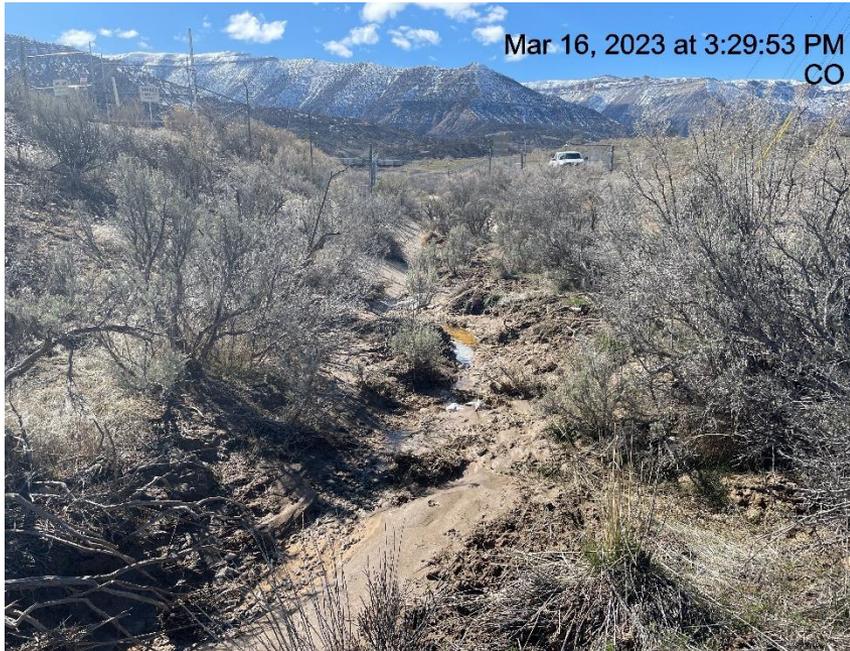
Photo # 2534 Ditch along lease road needs maintenance

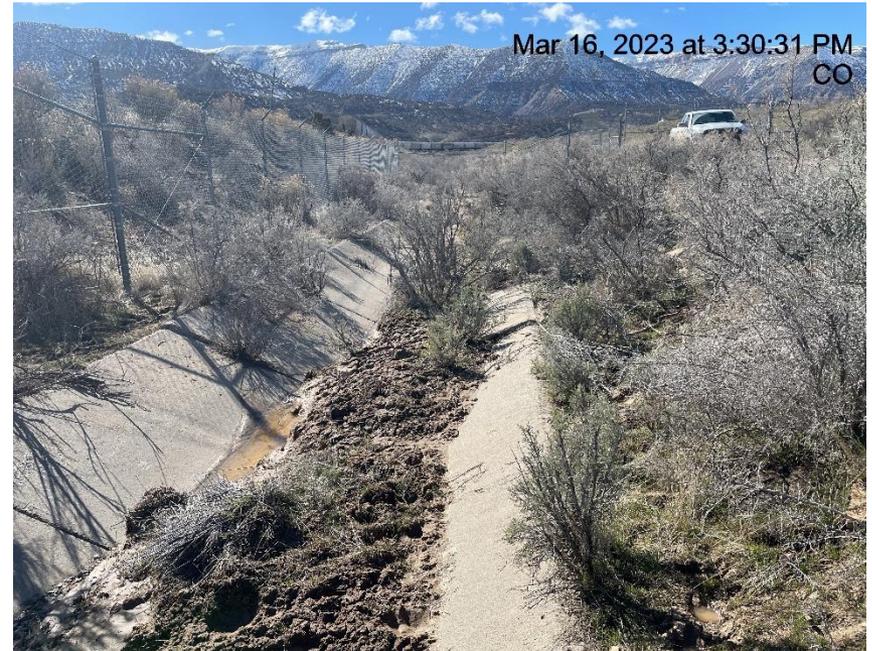
Photo # 2535 Ditch along lease road needs maintenance

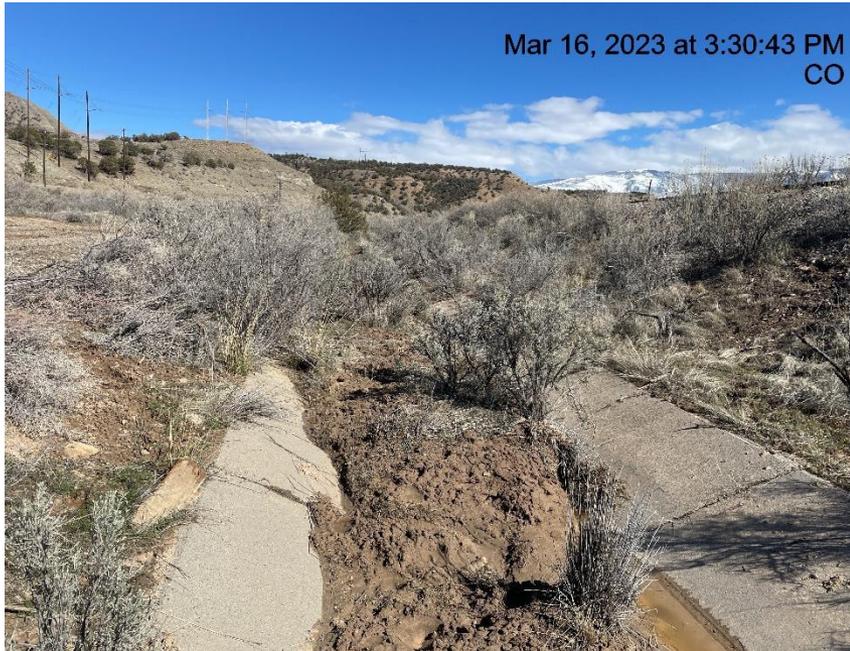
Photo # 2536 Ditch along lease road needs maintenance

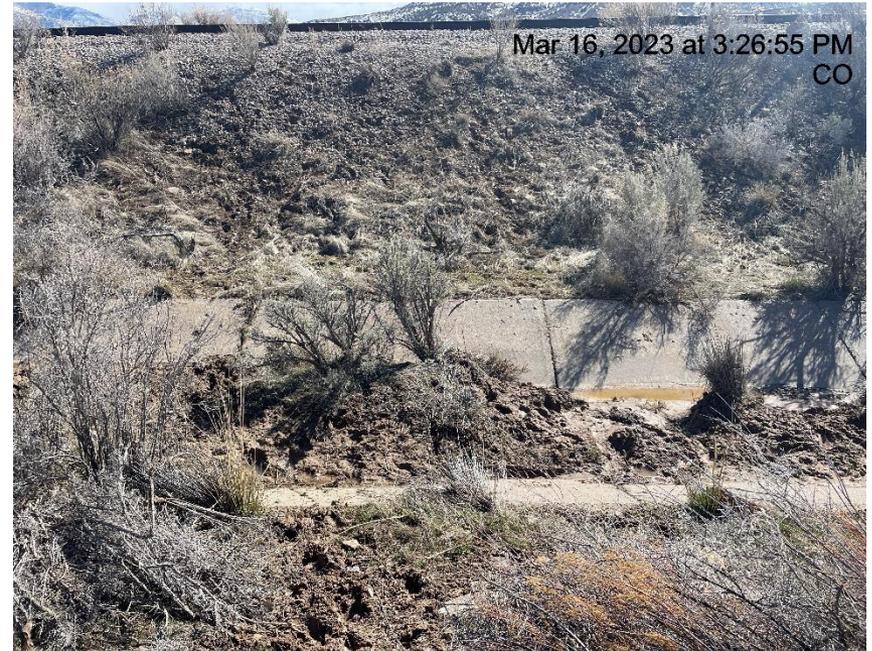
Photo # 2527 Ditch along lease road needs maintenance
