Inspection Photos

Location Name: TEP ROCKY MOUNTAIN LLC WRIGHT, CASTEEL AND SMALLWOOD SG 24-28

Location ID: 334397

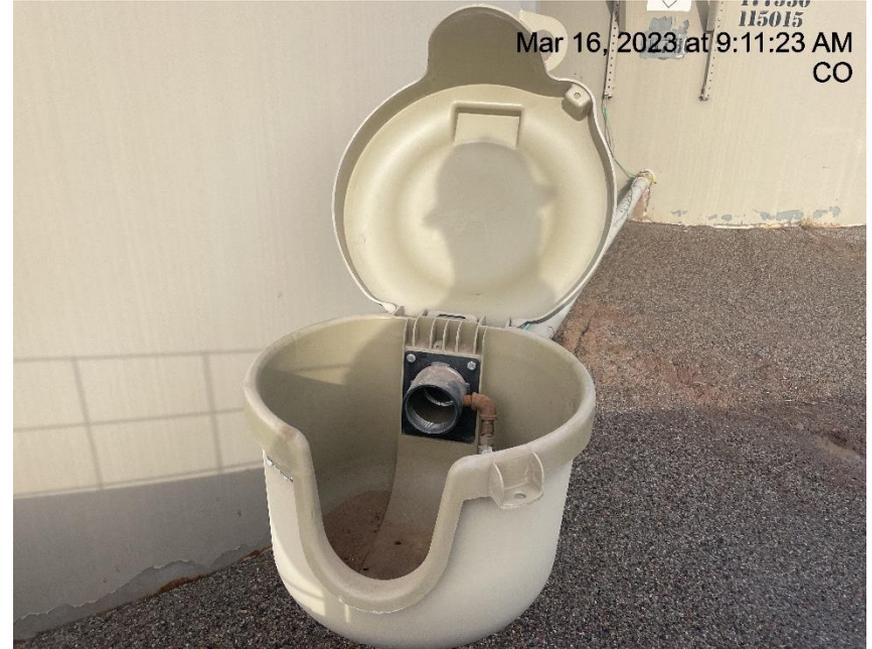
Photo # 2423 Open ended load line

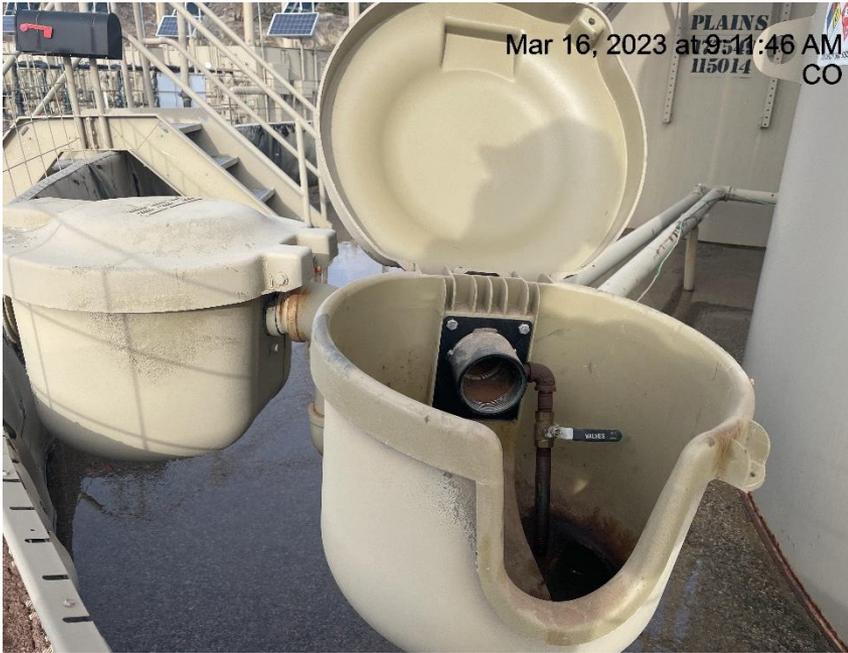
Photo # 2424 Open ended load line

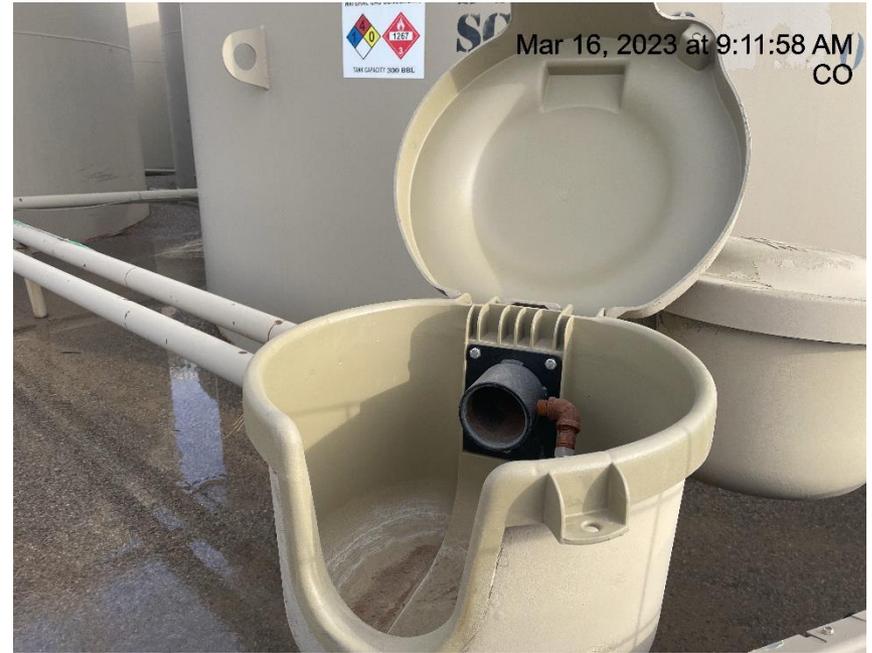
Photo # 2425 Open ended load line

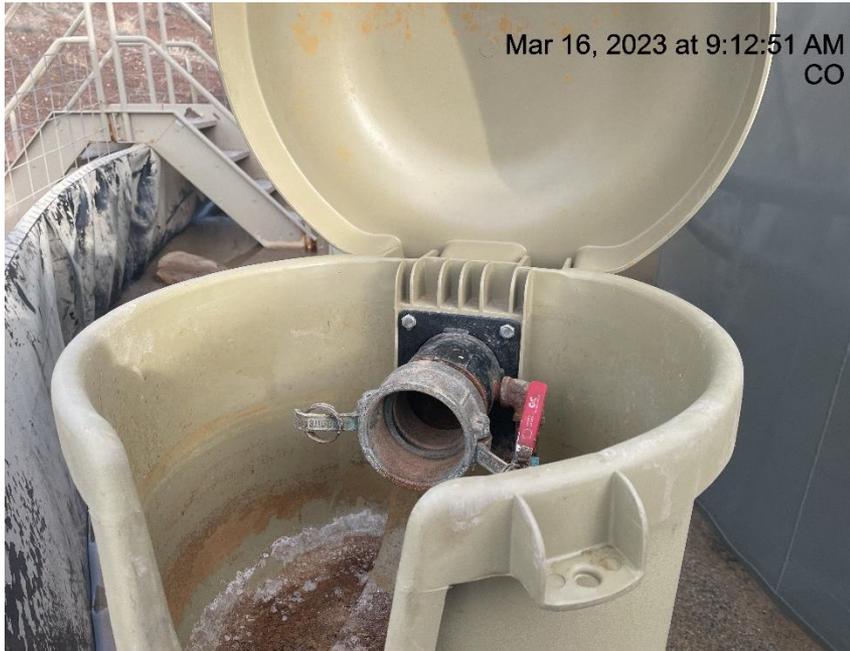
Photo # 2426 Open ended load line

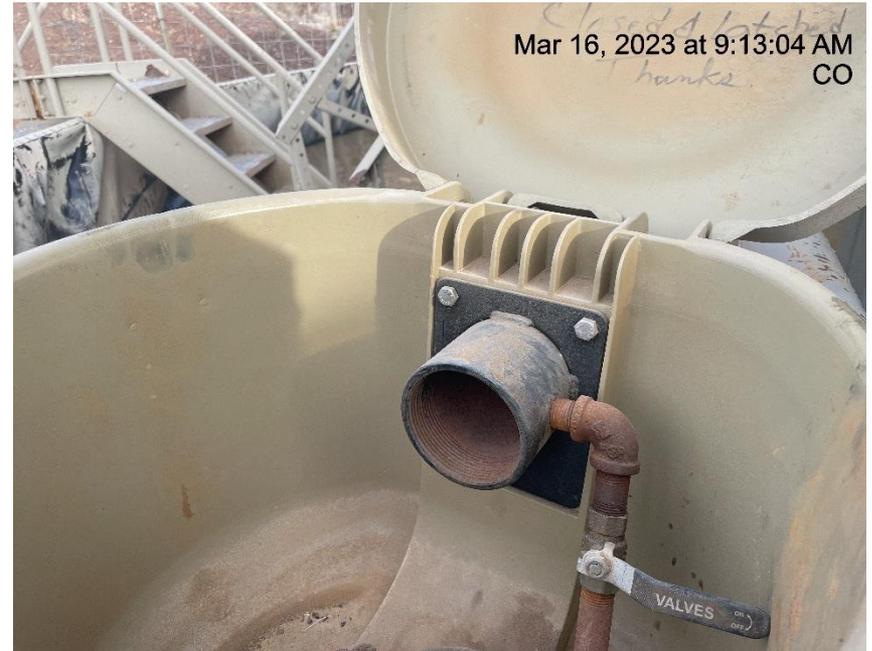
Photo # 2427 Open ended load line

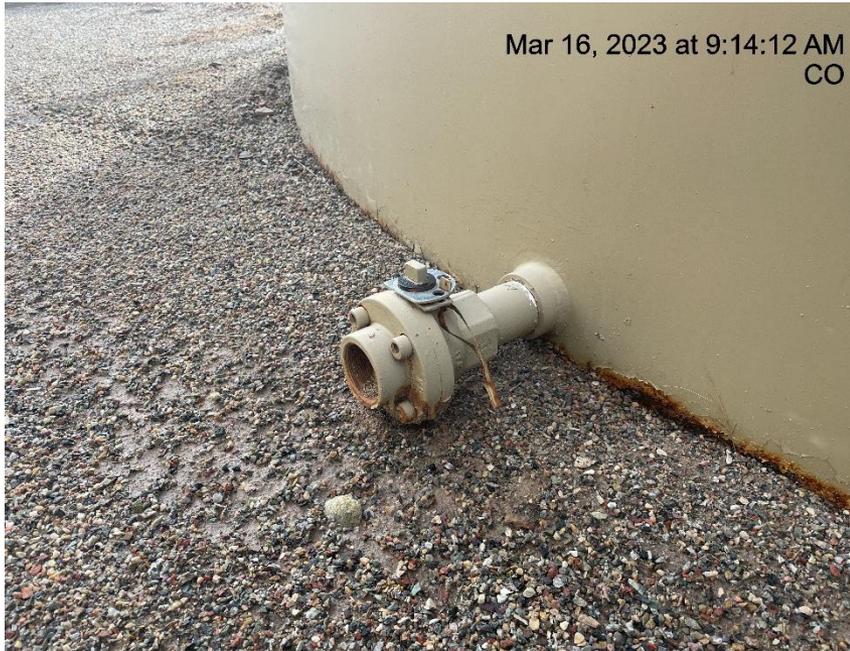
Photo # 2430 Open ended load line

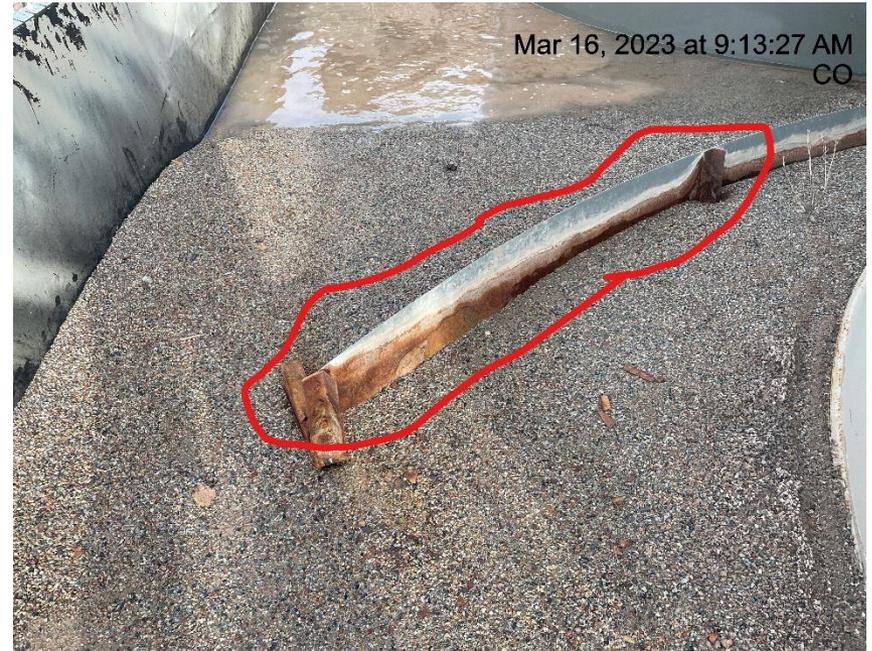
Photo # 2428 Debris

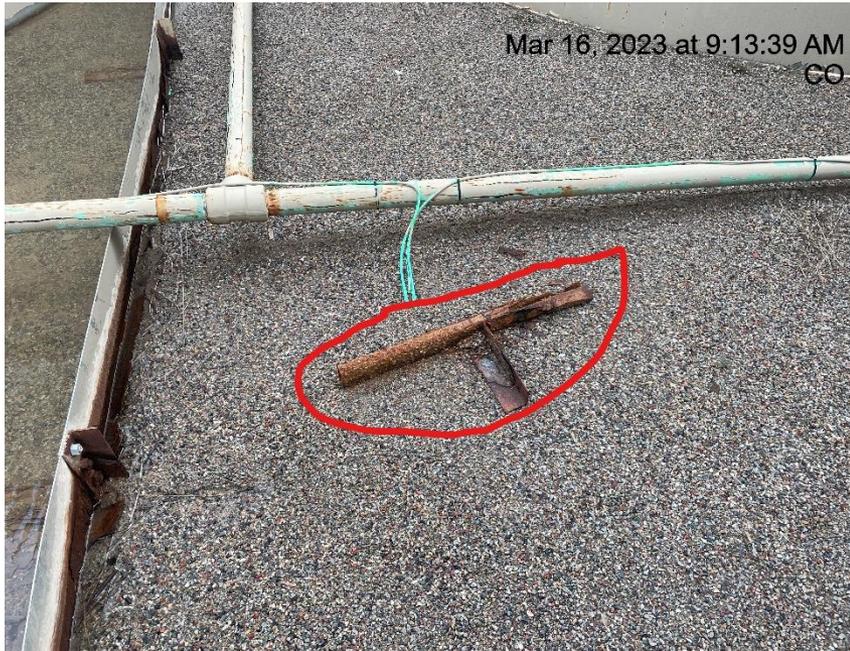
Photo # 2429 Debris

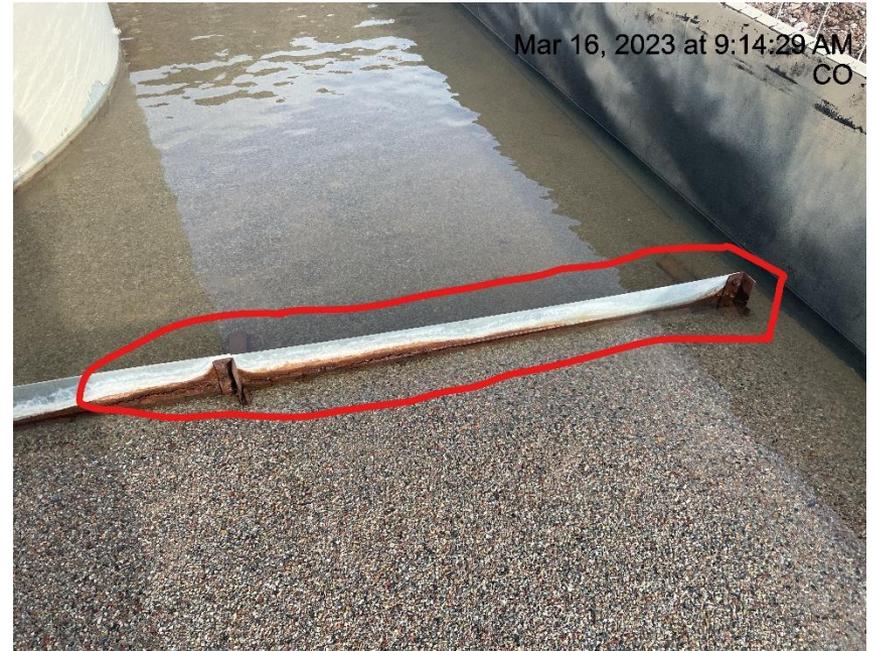
Photo # 2431 Debris

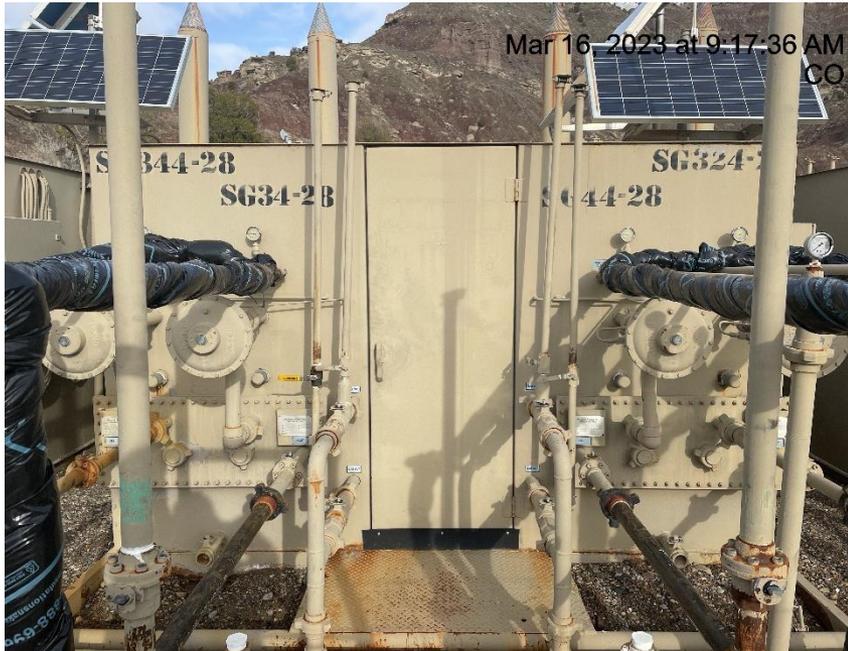
Photo # 2432 Meter calibration info not conspicuously posted

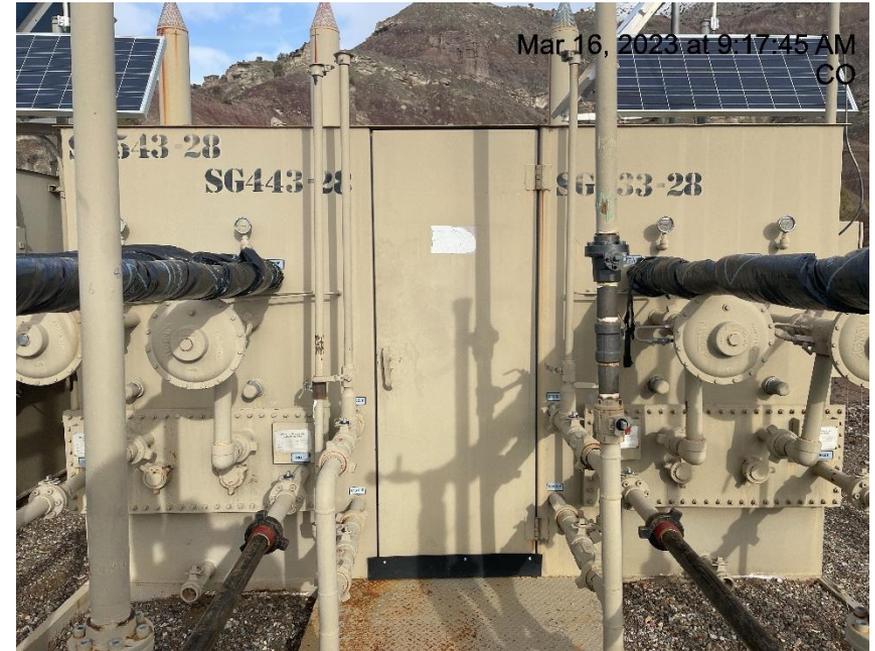
Photo # 2433 Meter calibration info not conspicuously posted

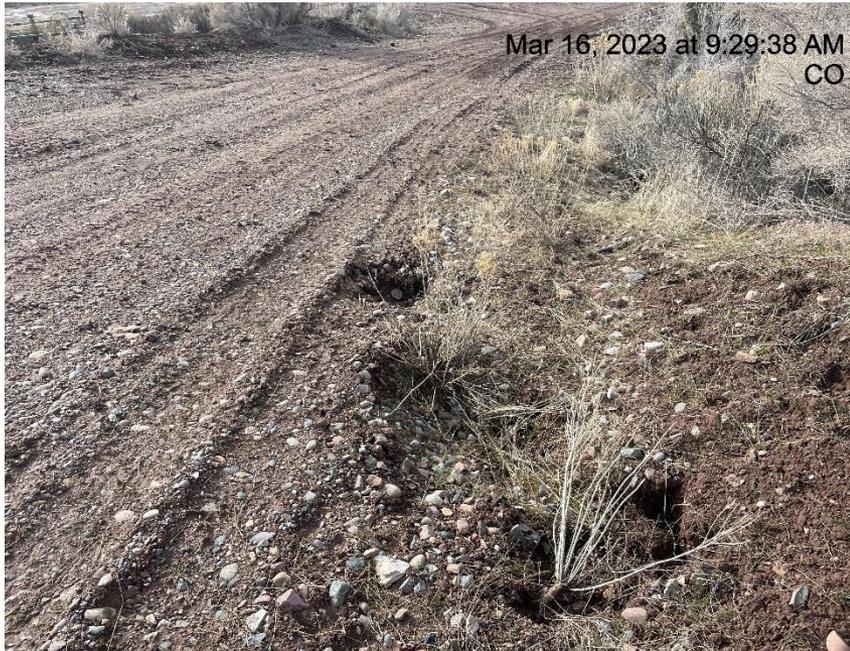
Photo # 2434 Gully erosion on spur road into pad

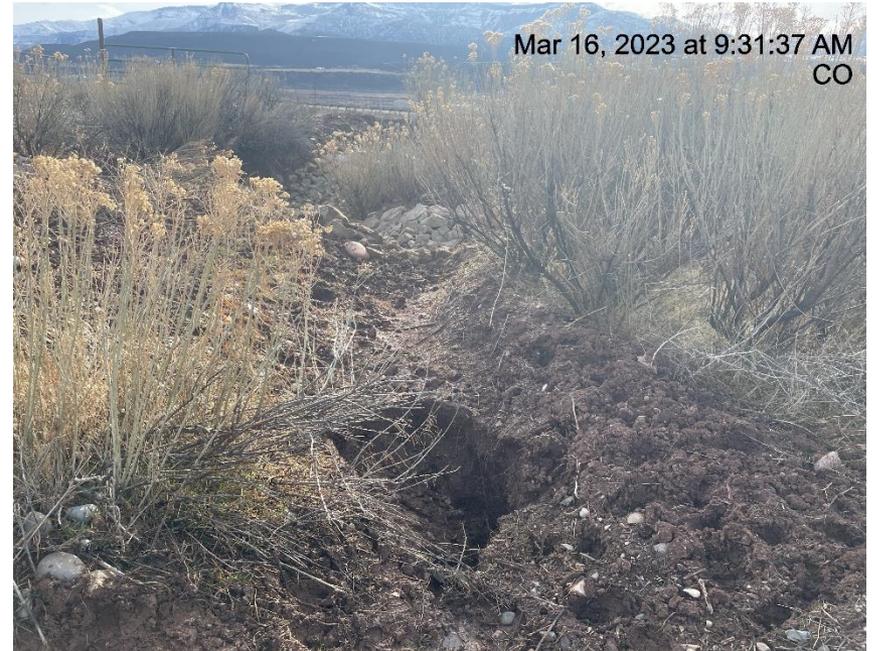
Photo # 2435 Ditch needs maintenance (Towards SW corner of pad 6-10 ft from sediment trap)

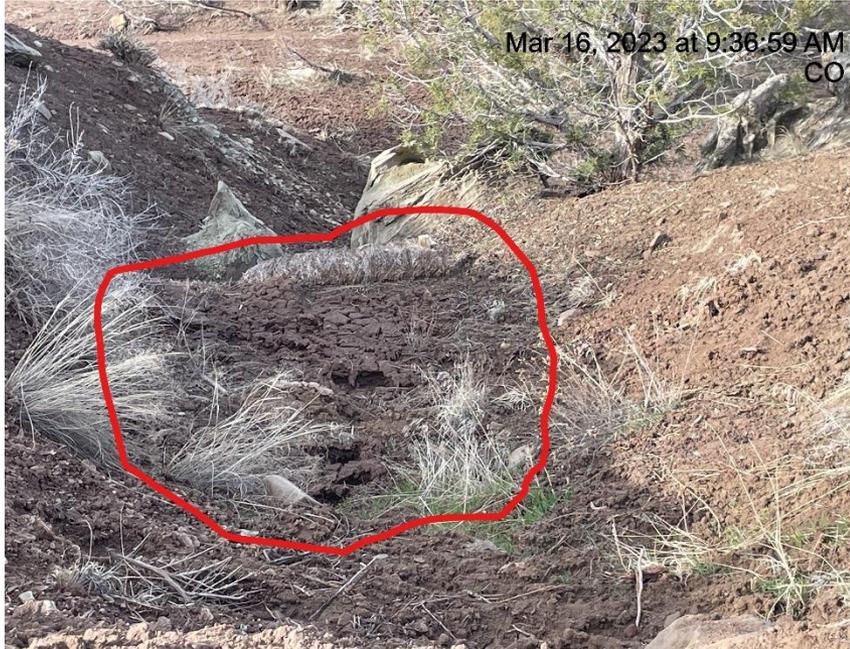
Photo # 2437 Hay bales/BMP needs maintenance (NW corner just off location near separators)

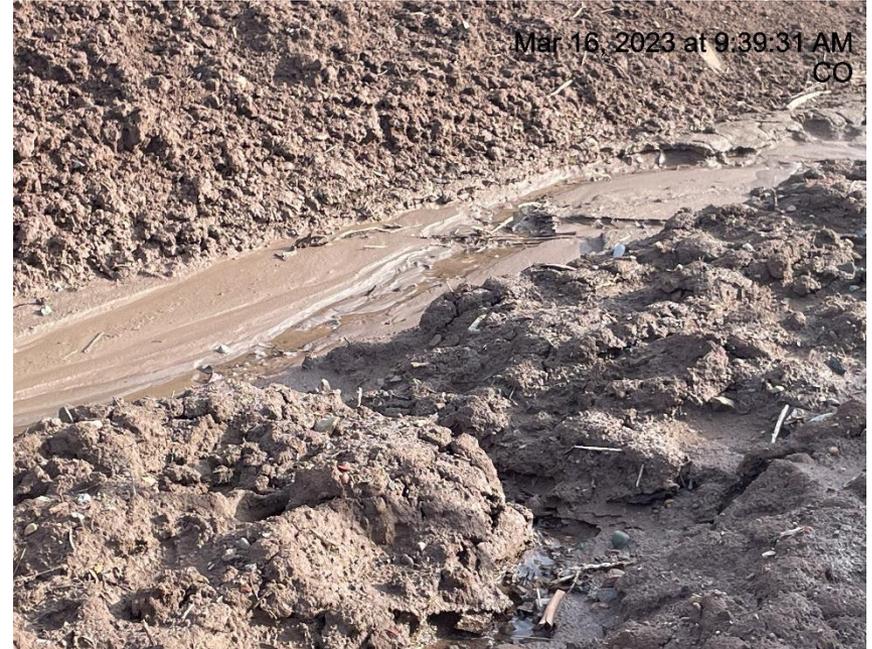
Photo # 2438 Gulley erosion into ditch (NE corner near tank battery)

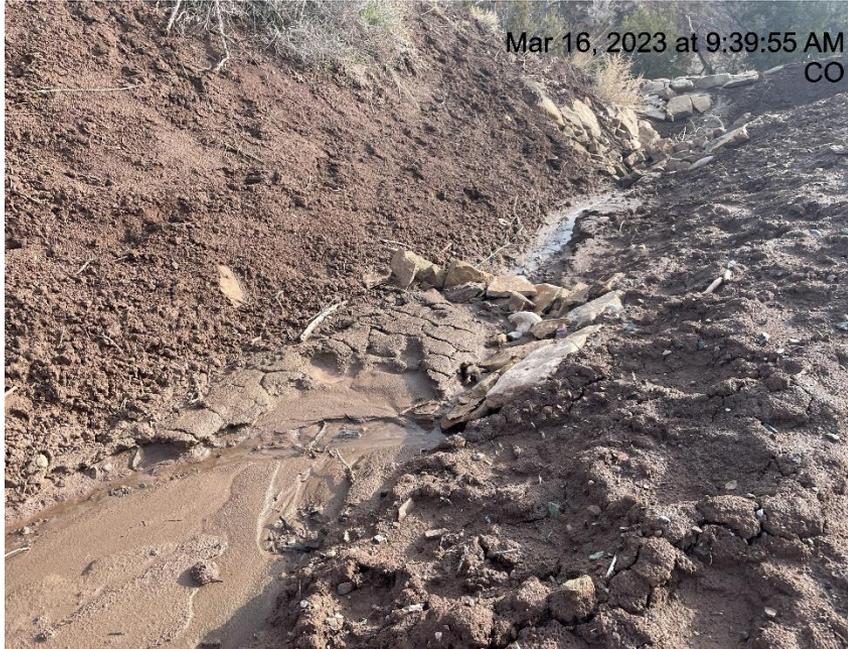
Photo # 2439 Check Dam needs maintenance (NE corner of location near tank battery)

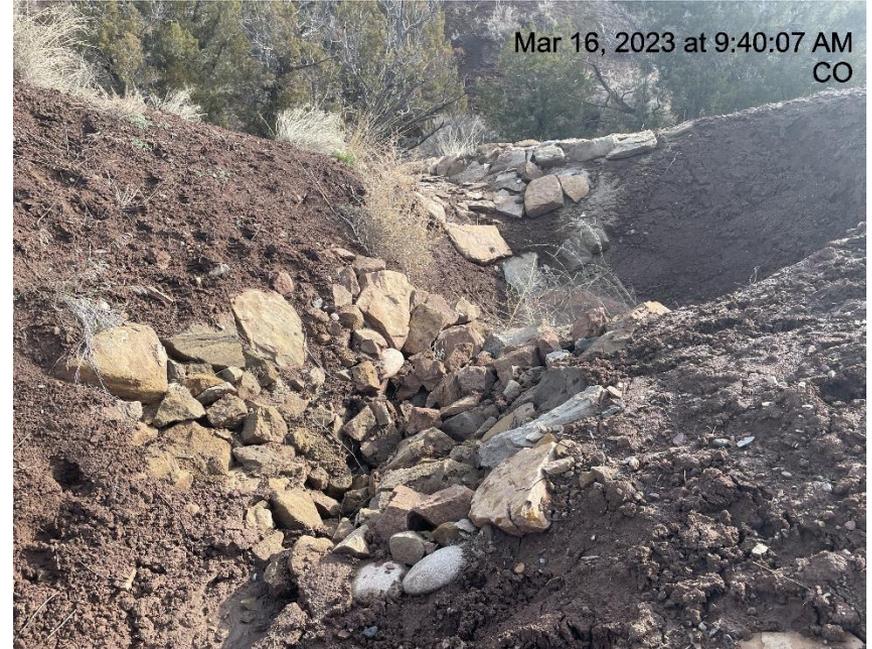
Photo # 2440 Sediment Trap needs maintenance (NE corner of location near tank battery)

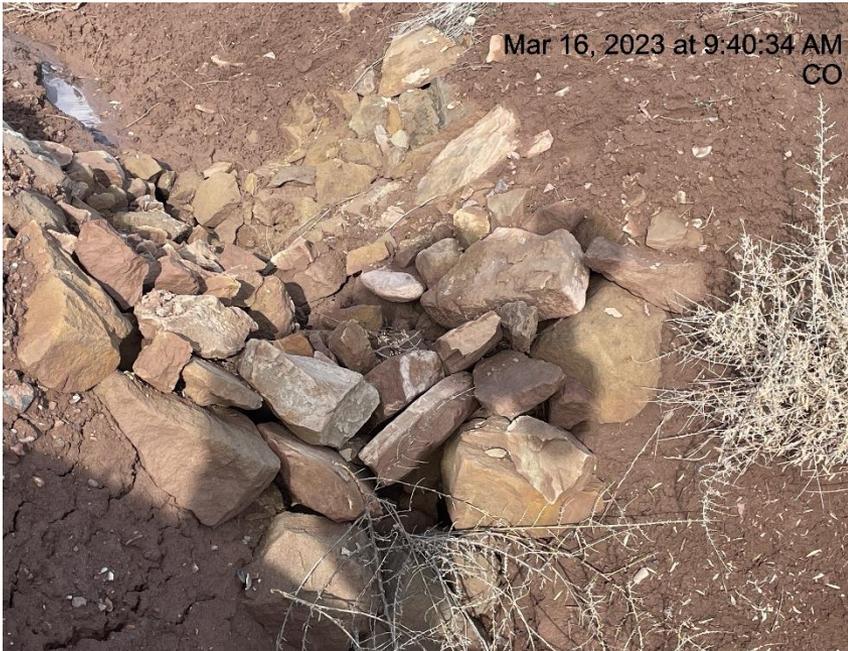
Photo # 2441 Sediment Trap needs maintenance (NE corner of location near tank battery)

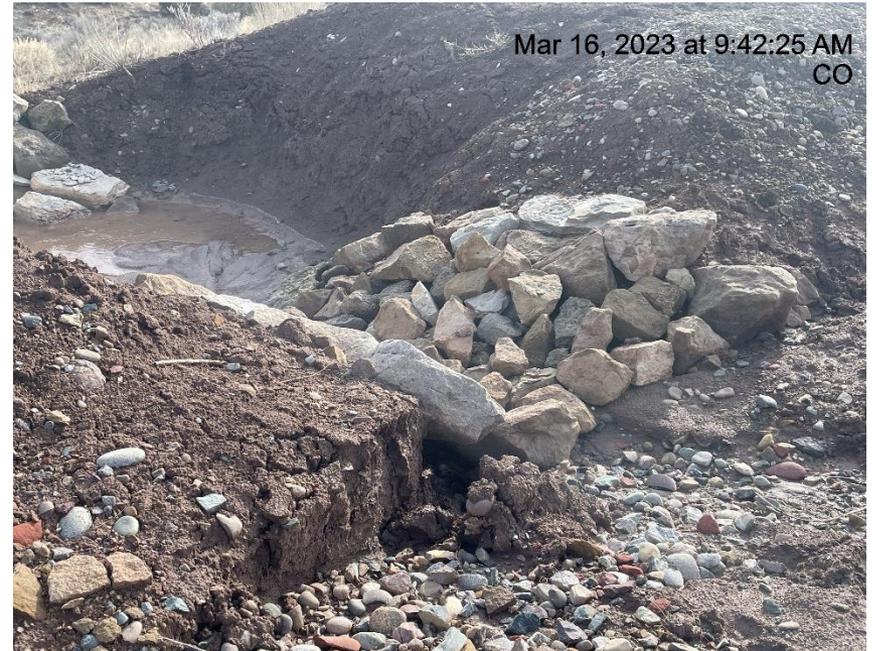
Photo # 2442 Sediment Trap needs maintenance (East side of location across from wellheads)

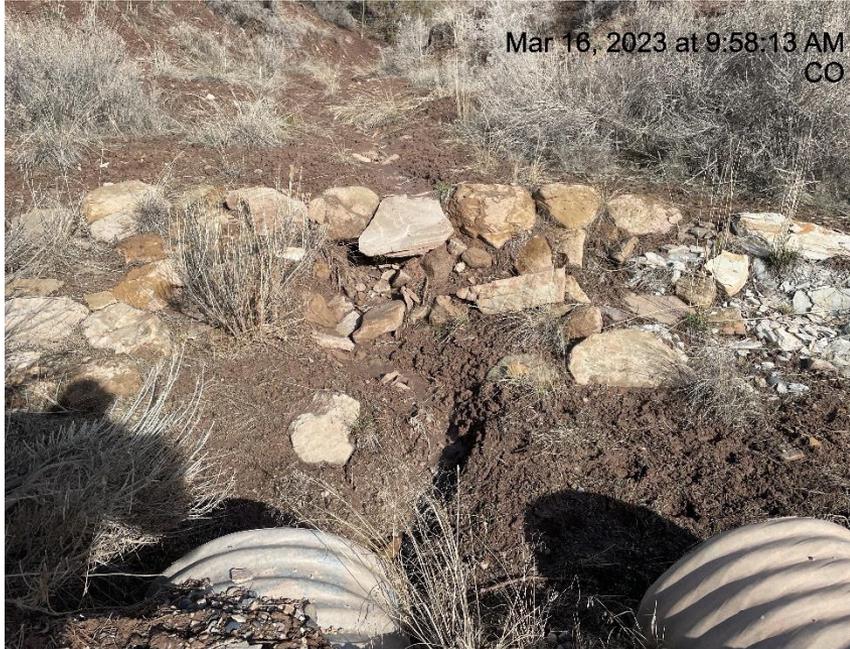
Photo # 2447 Rip Rap needs maintenance (on lease road approximately 600 yards past the I-70 underpass)

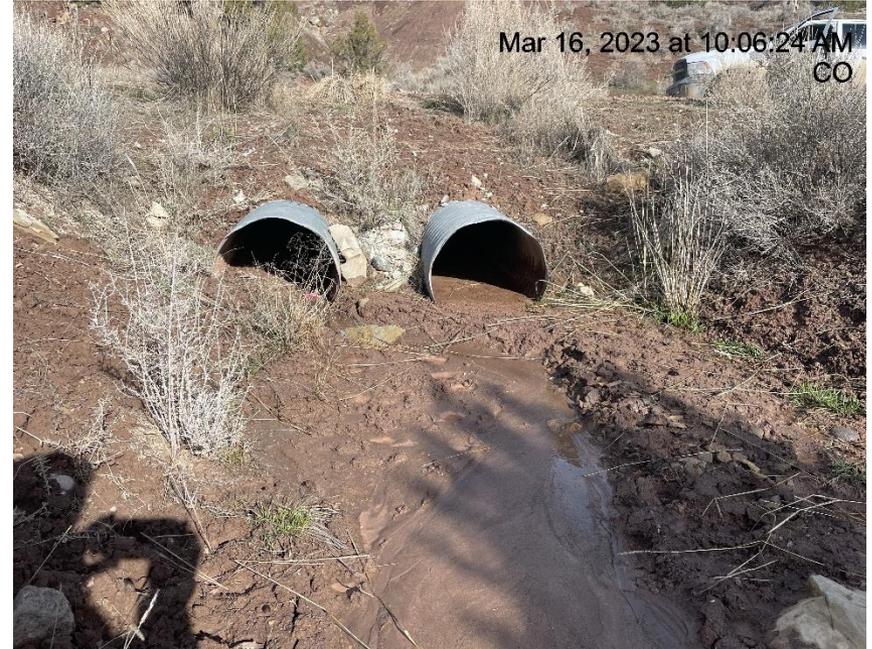
Photo # 2448 Culverts need maintenance (on lease road approximately 600 yards past the I-70 underpass)
