Inspection Photos
Location Name: Rollie J Vincent A #1
Location ID:332911

COLORADO
Oil & Gas Conservation
Commission
Department of Natural Resources

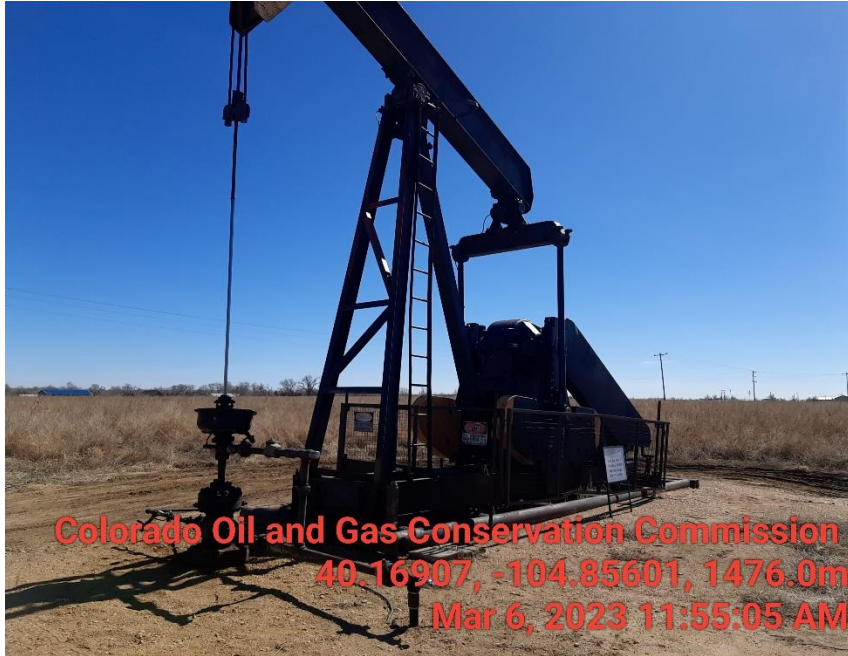
Photo 1 Well head

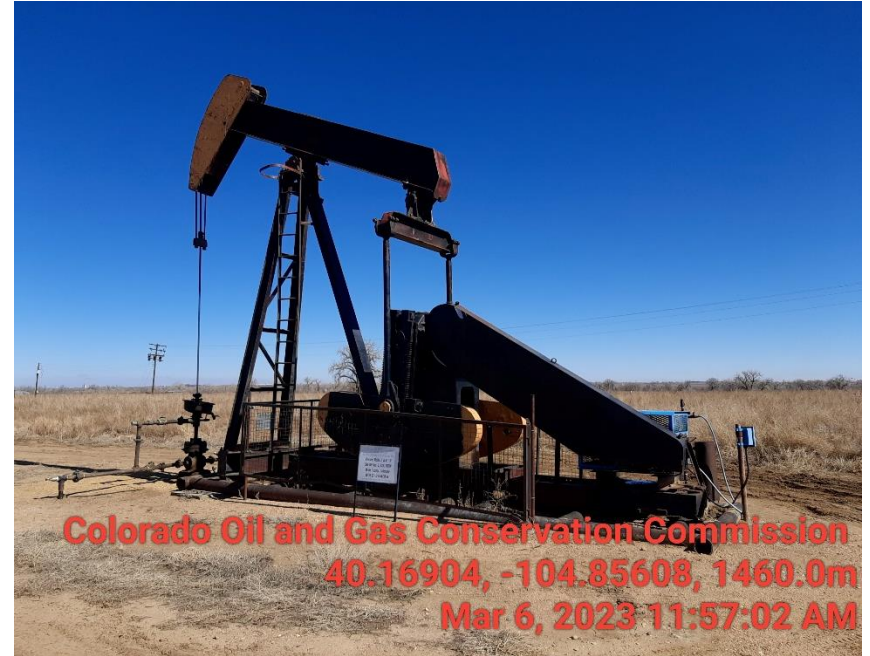
Photo 2 PU

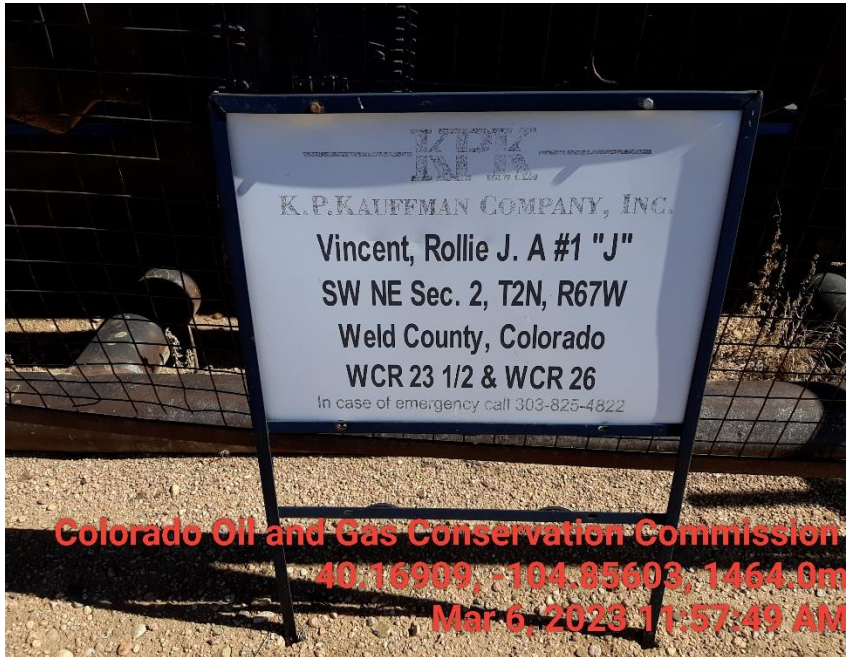
Photo 3 Well head sign

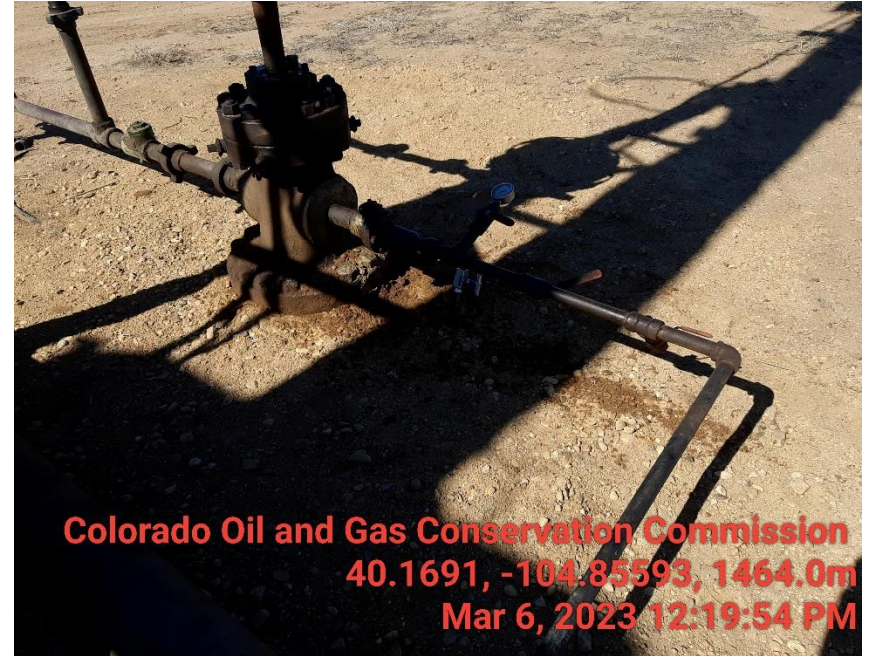
Photo 4 Stained soil and mechanical issue 1" Flow line

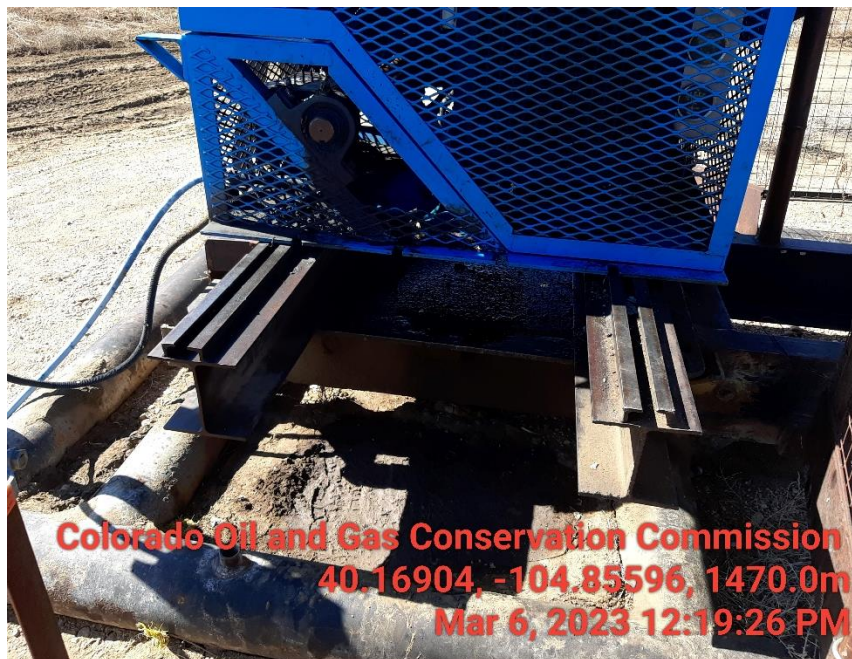
Photo 5 Stained soil under gas powered motor

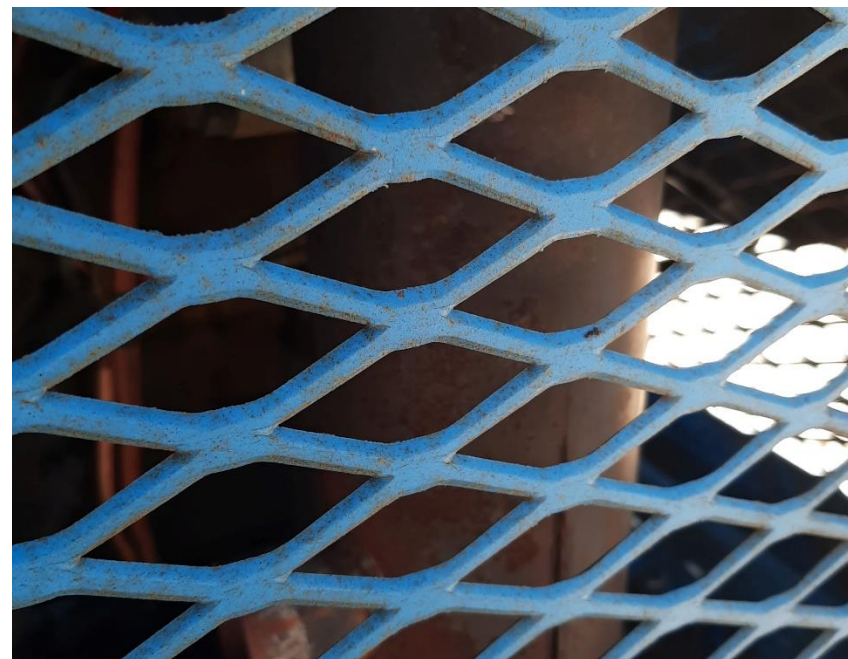
Photo 6 Gas powered motor muffler appears to be rusted out, rust cracks are visible.

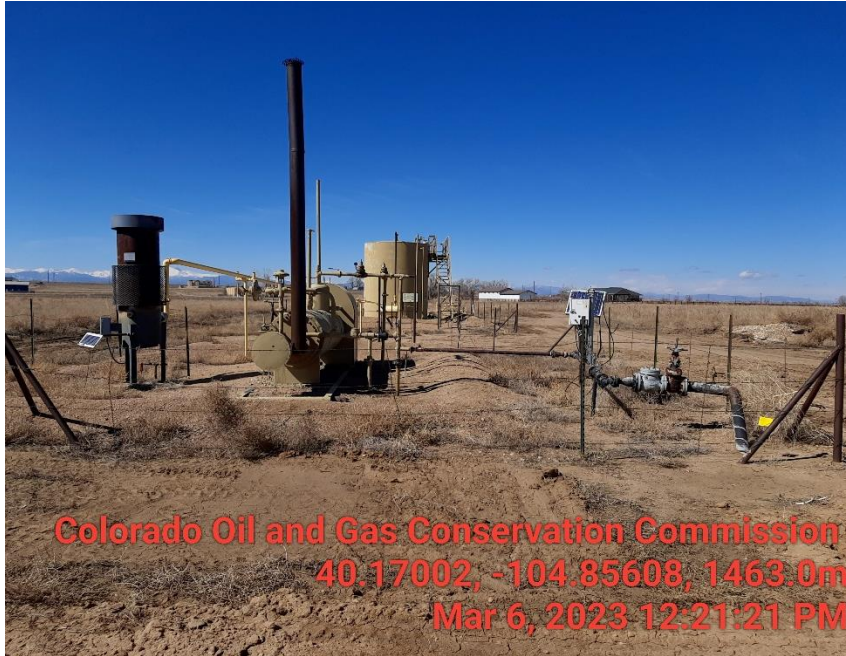
Photo 7 production equipment: ECD and Hoz separator were in operation at time of inspection. DEBRIS (dead weeds around equipment).

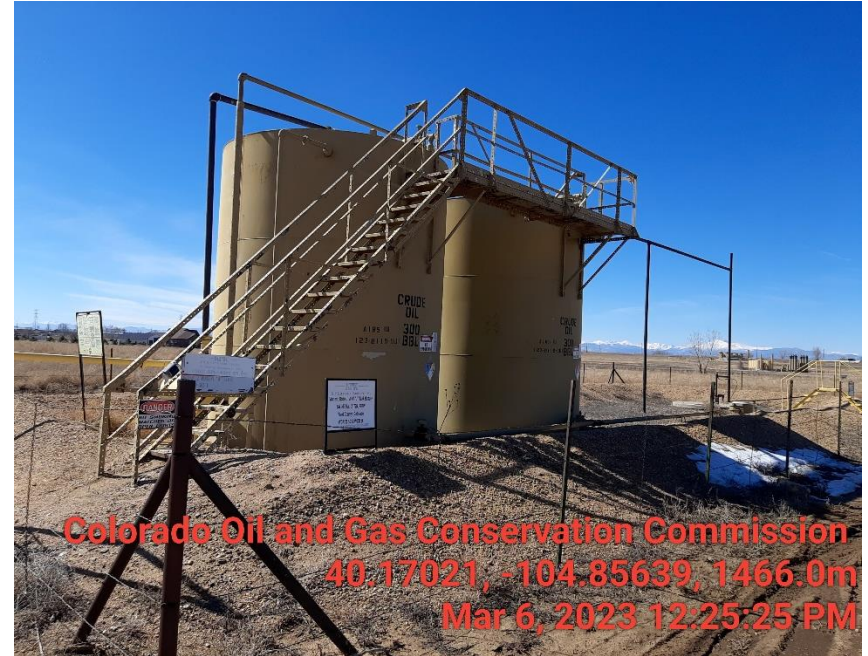
Photo 8 TNK BTRY DEBRIS (dead weeds in and around containment).

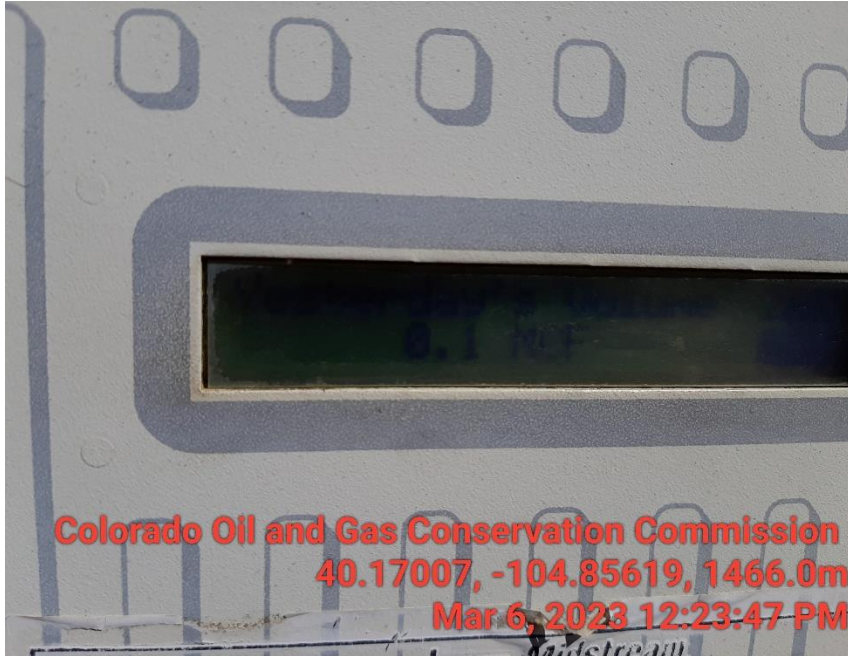
Photo 9 Mete show .1 MCF production

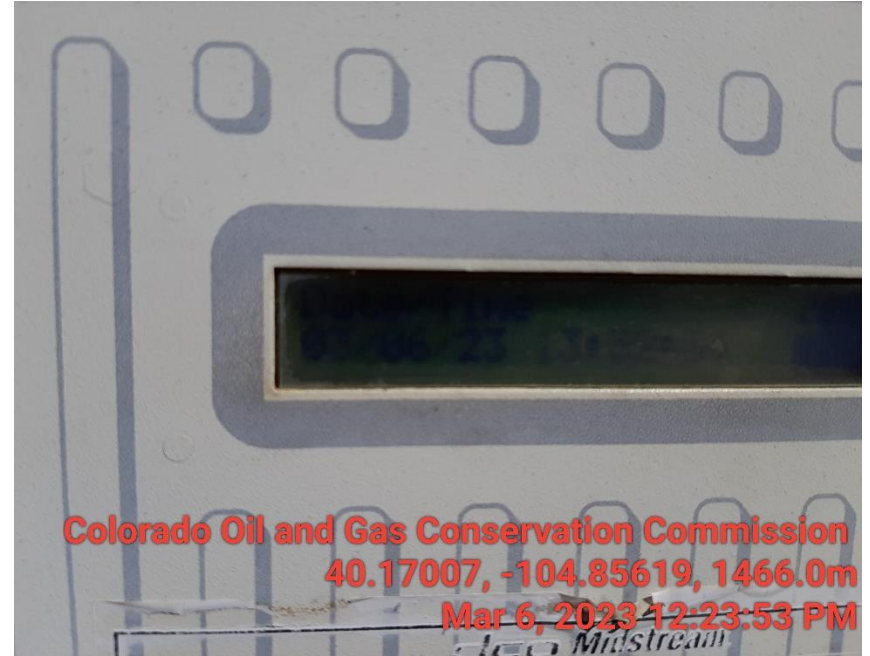
Photo 10 Shows production date of 3-6-23
