Inspection Photos

Location Name: TEP ROCKY MOUNTAIN LLC SPECIALTY RESTAURANTS SG 334-32

Location ID: 413524

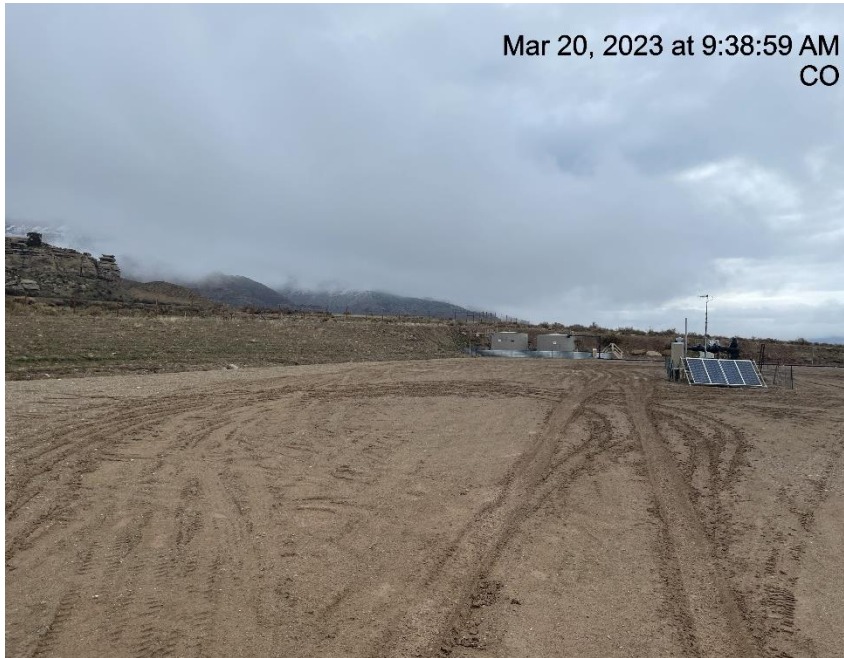
Photo # 2571 From entrance to location

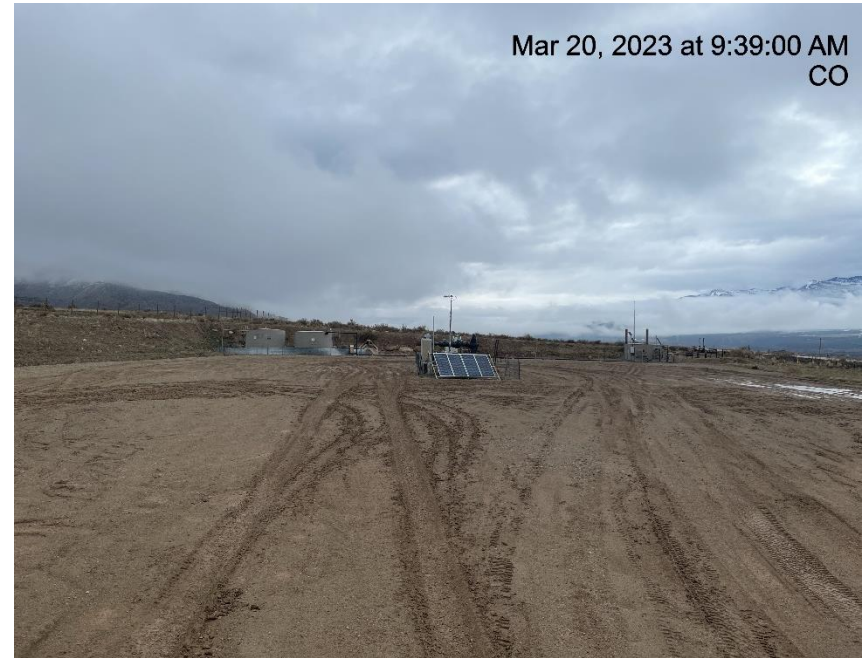
Photo # 2572 From entrance to location

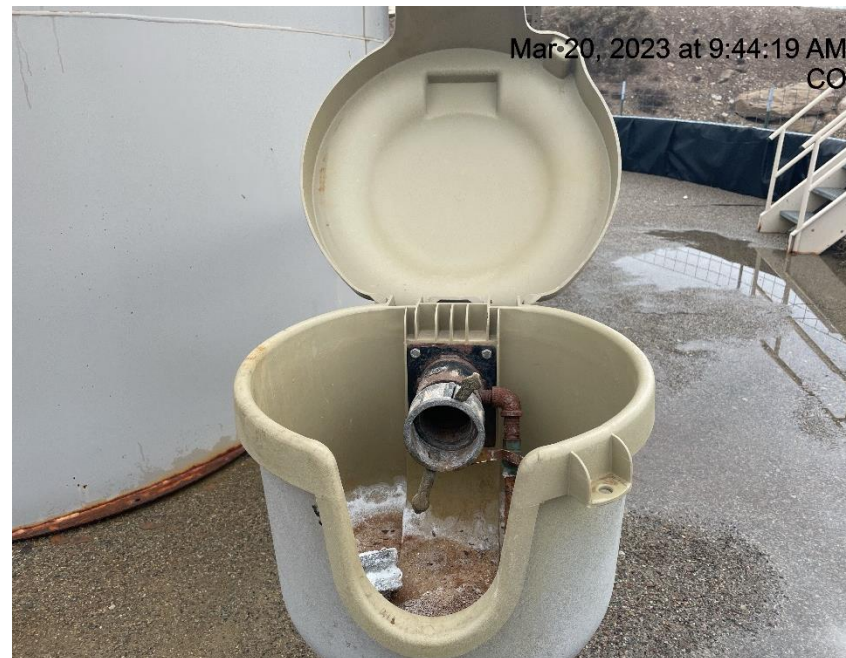
Photo # 2578 Open ended load line

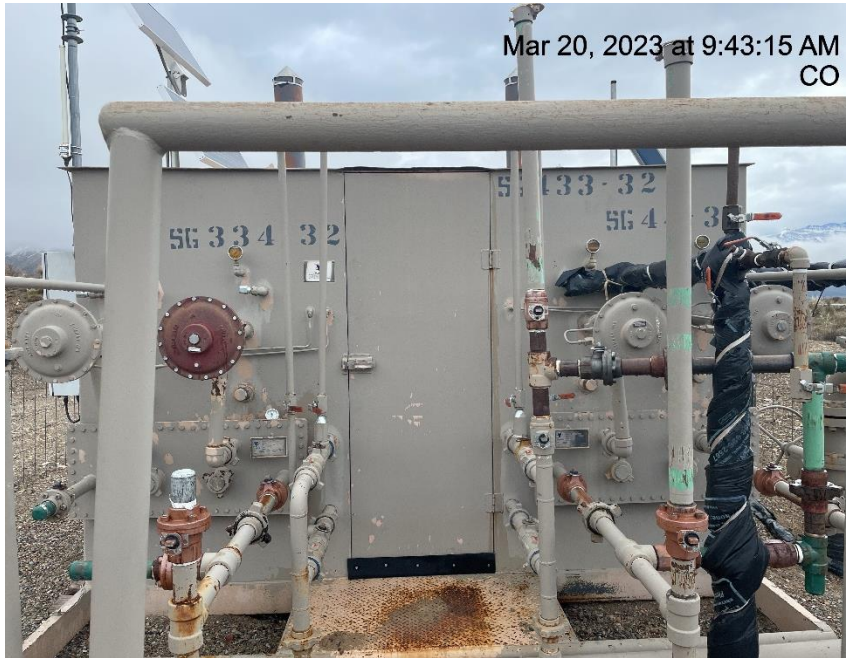
Photo # 2577 Meter calibration info not conspicuously posted

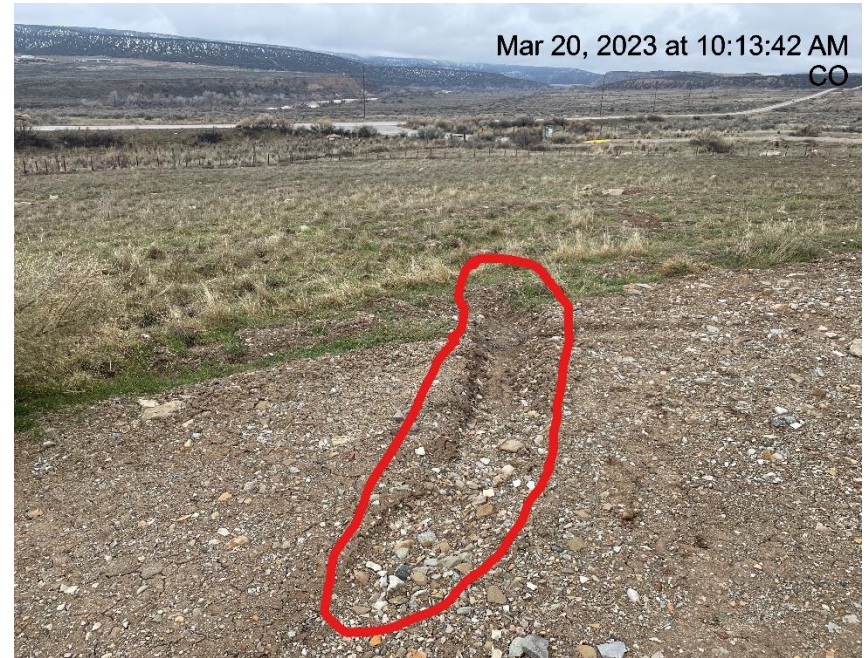
Photo # 2584 Gulley erosion on location, 40 yards SW of solar panels

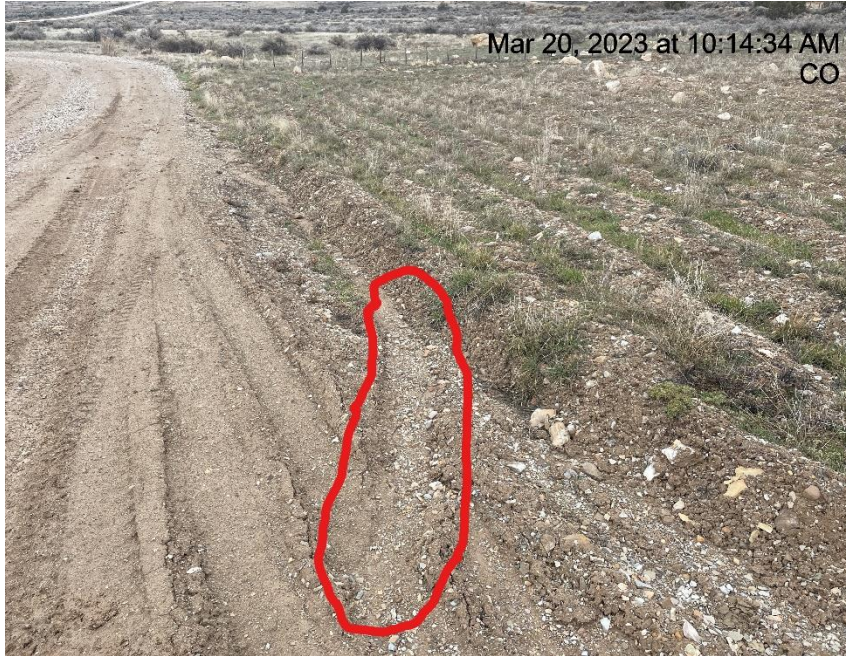
Photo # 2585 Gulley erosion at entrance to location north side

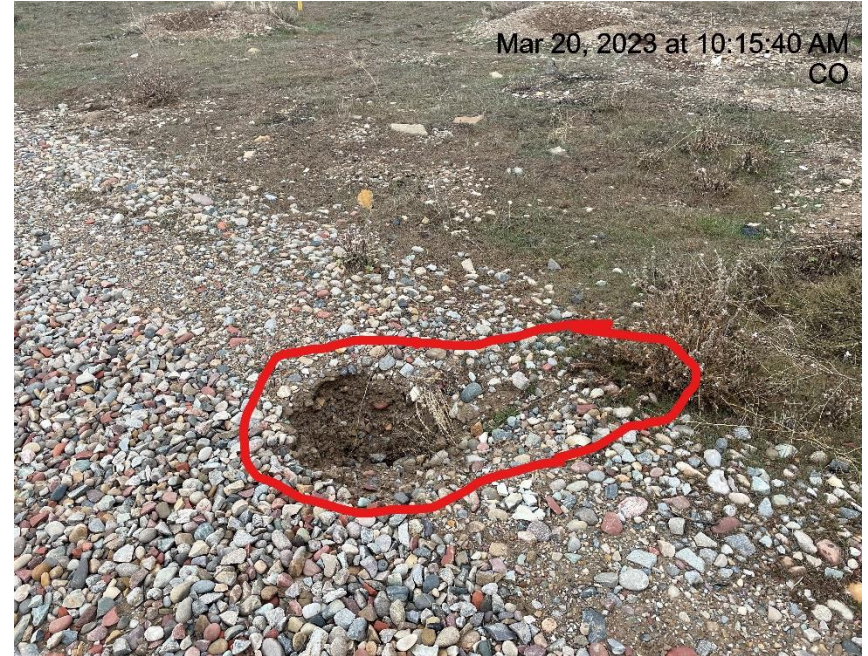
Photo # 2586 Gulley erosion on lease road 40 yards from tracking pad on the west side
