Inspection Photos

Location Name: TEP ROCKY MOUNTAIN LLC BORUCH GM 24-12 pad

Location ID: 334722

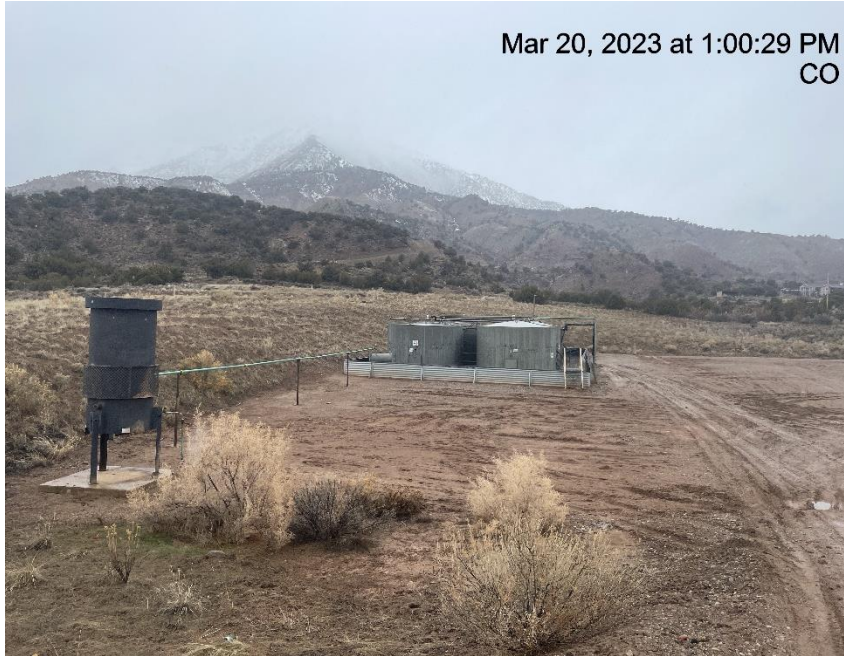
Photo # 2703 From entrance to location

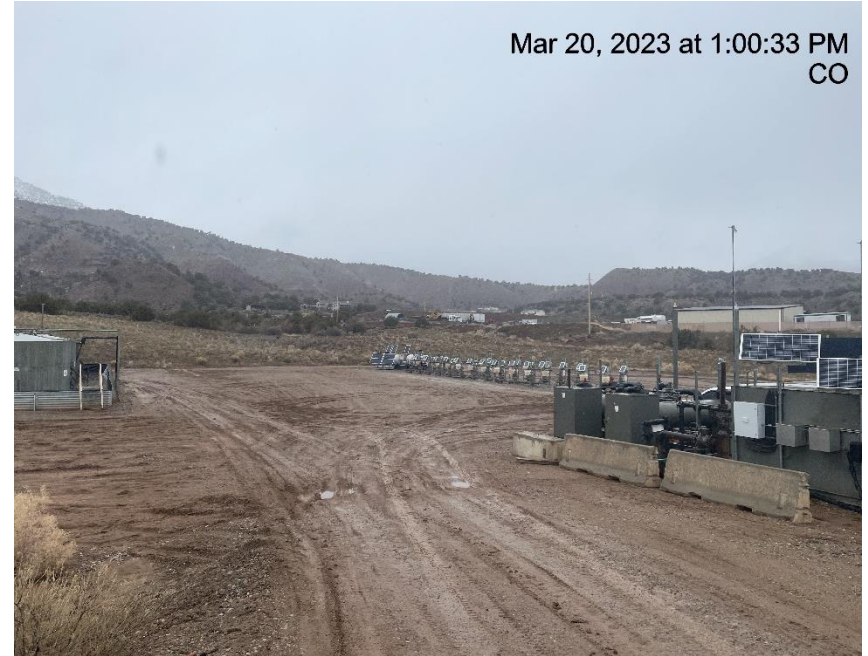
Photo # 2704 From entrance to location

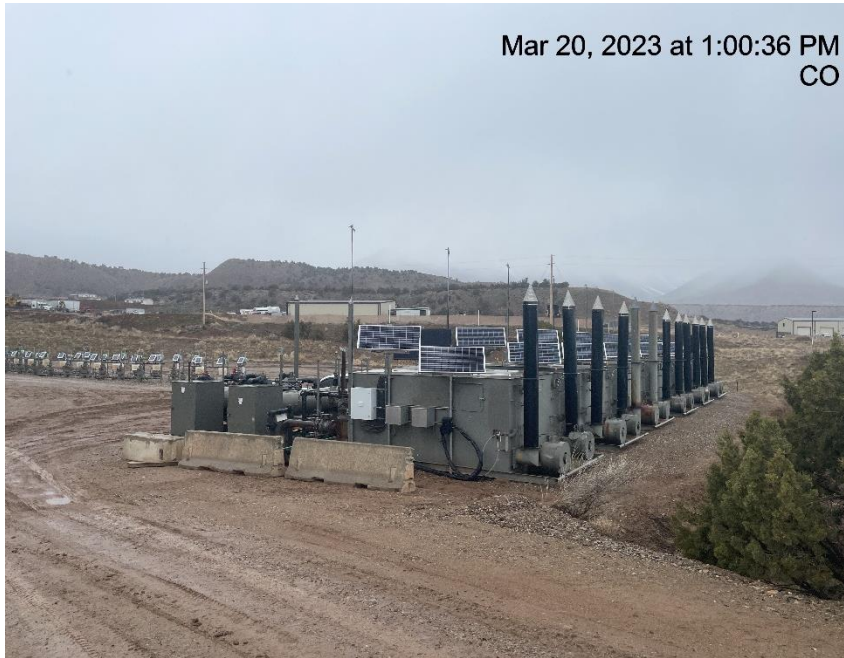
Photo # 2705 From entrance to location

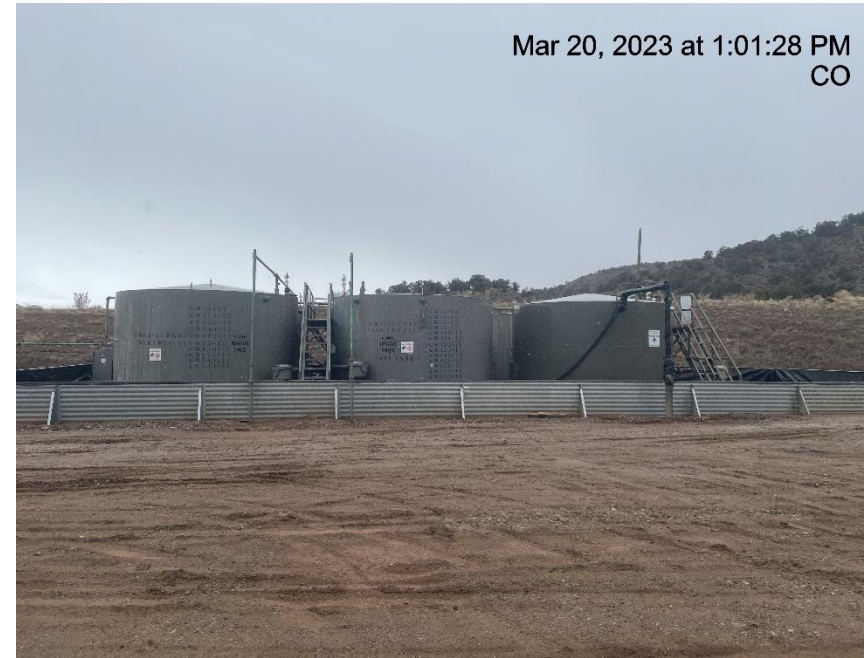
Photo # 2706 Location

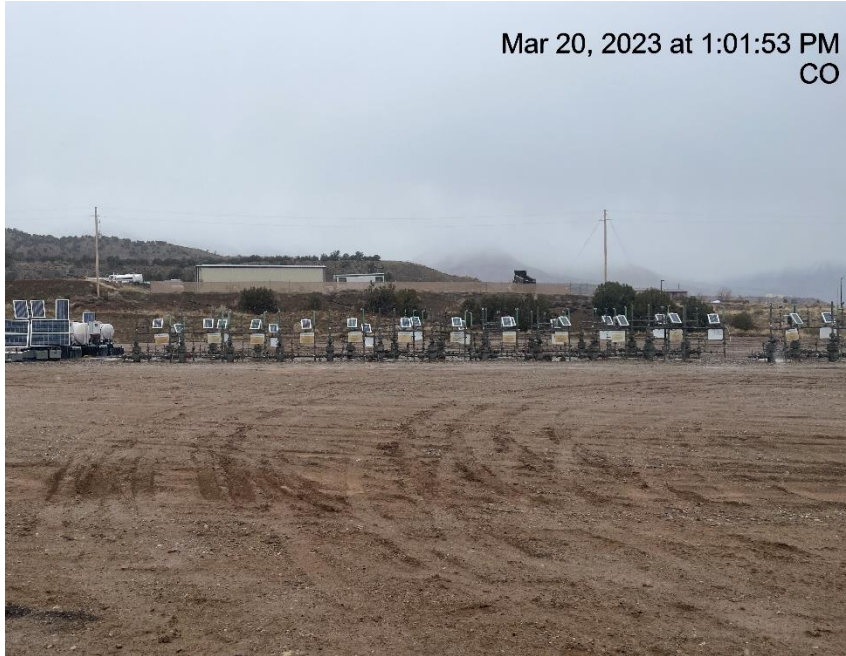
Photo # 2707 Location

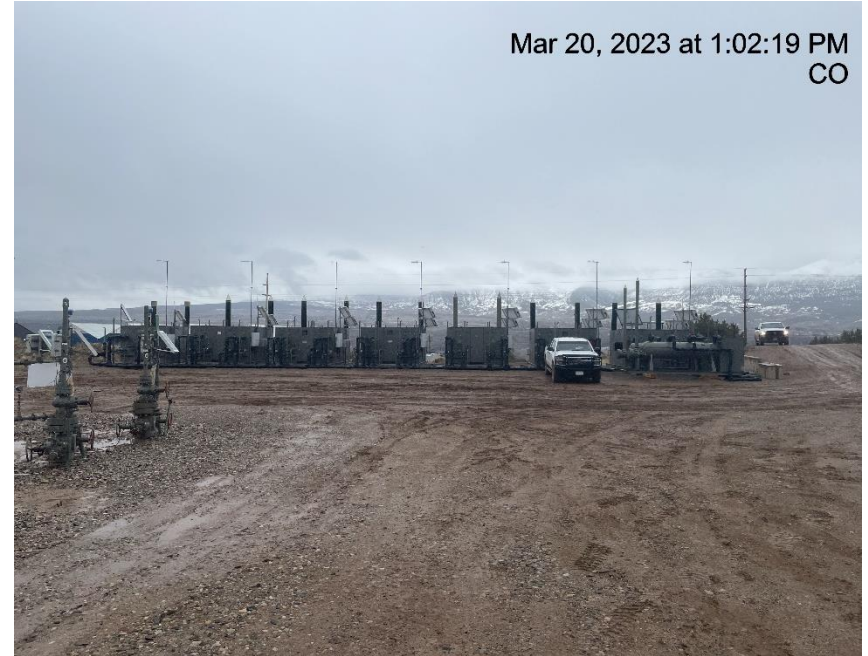
Photo # 2708 Location

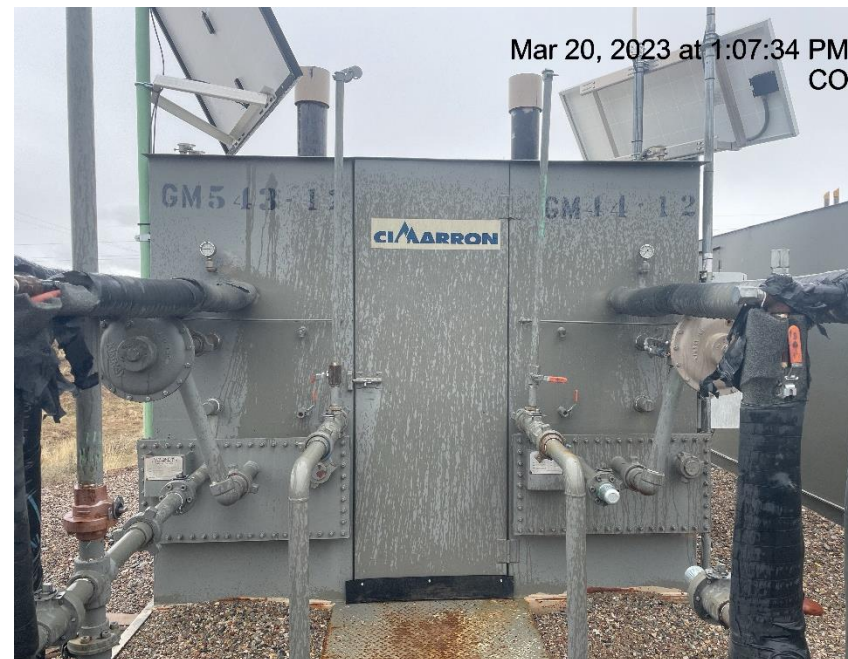
Photo # 2711 Meter calibration info not conspicuously posted

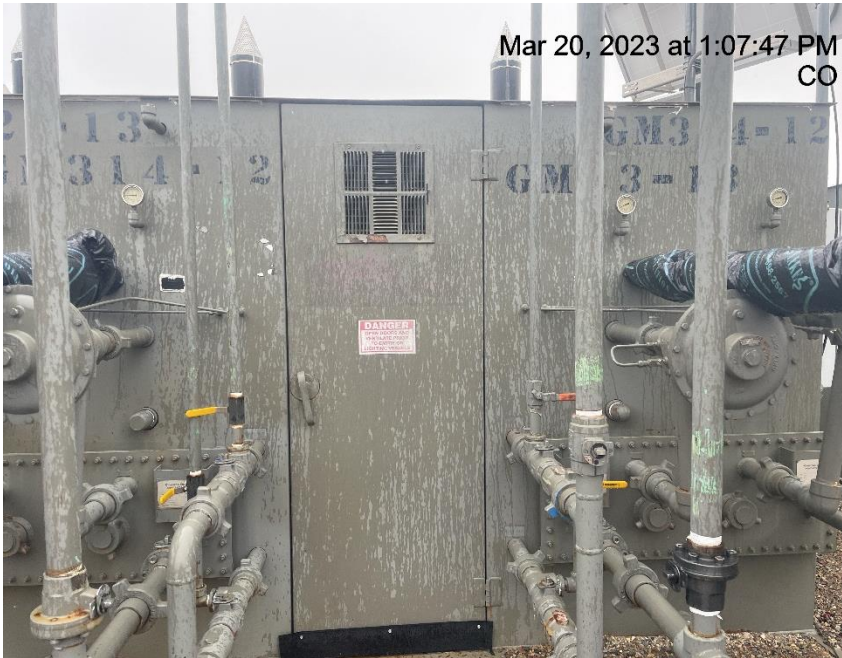
Photo # 2712 Meter calibration info not conspicuously posted

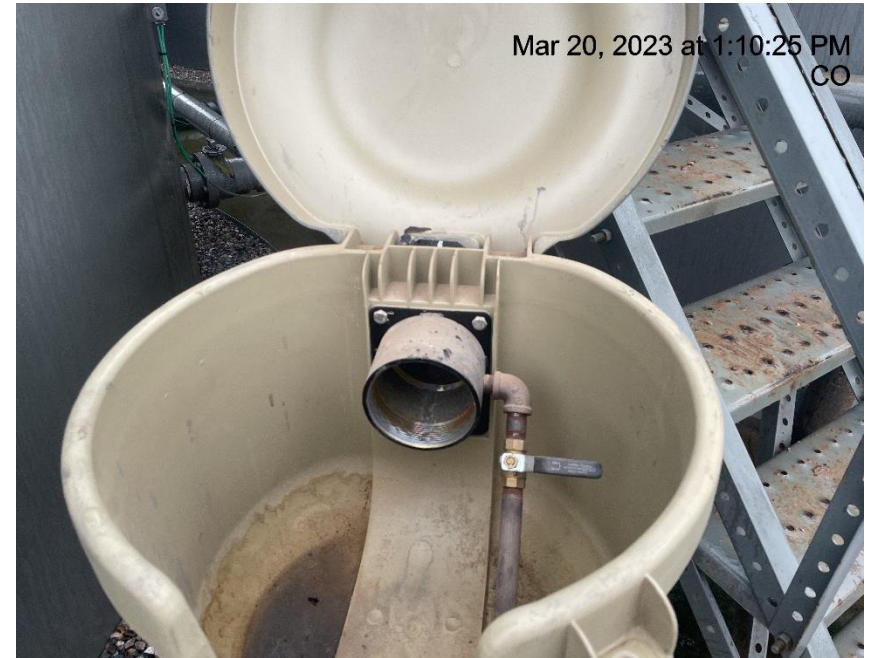
Photo # 2715 Open ended load line

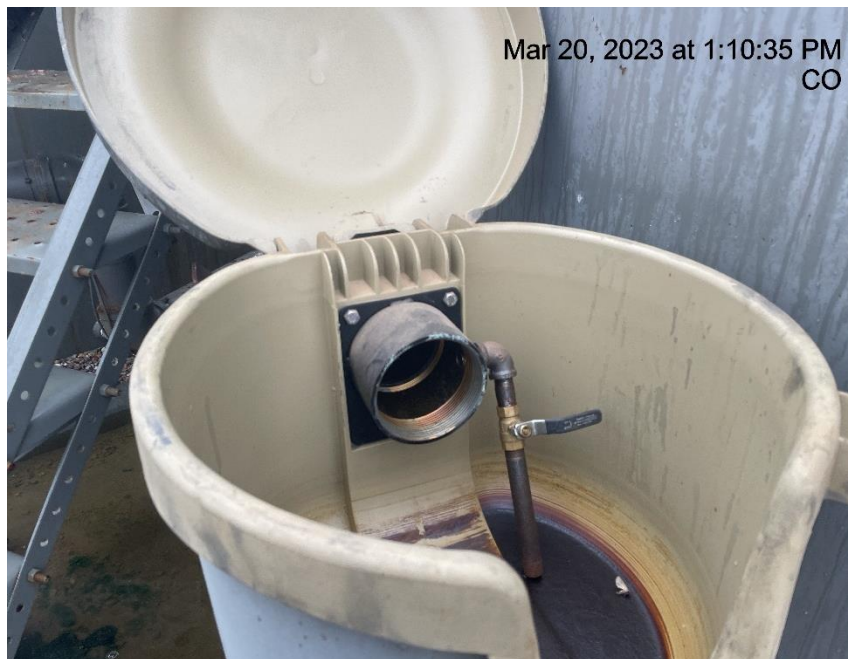
Photo # 2716 Open ended load line

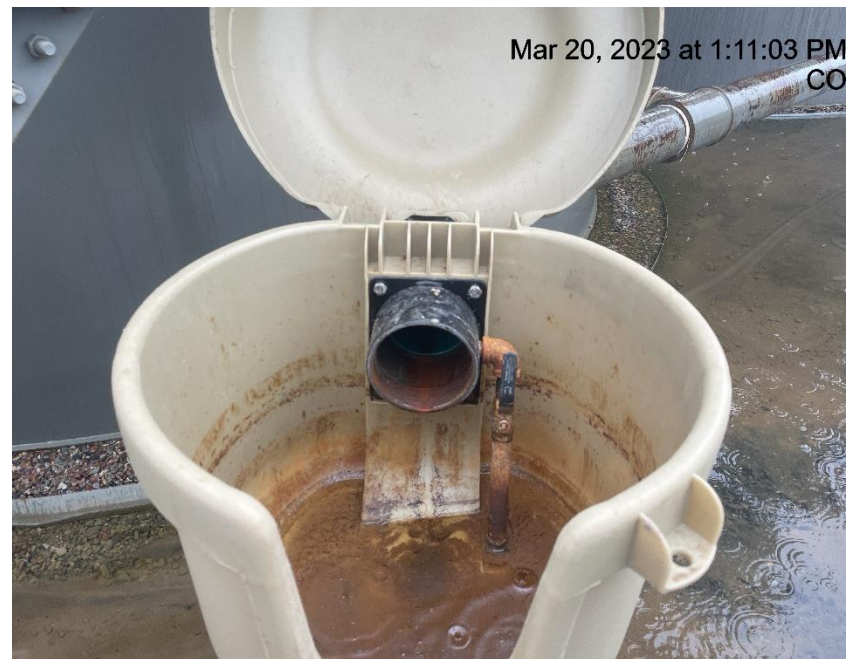
Photo # 2717 Open ended load line

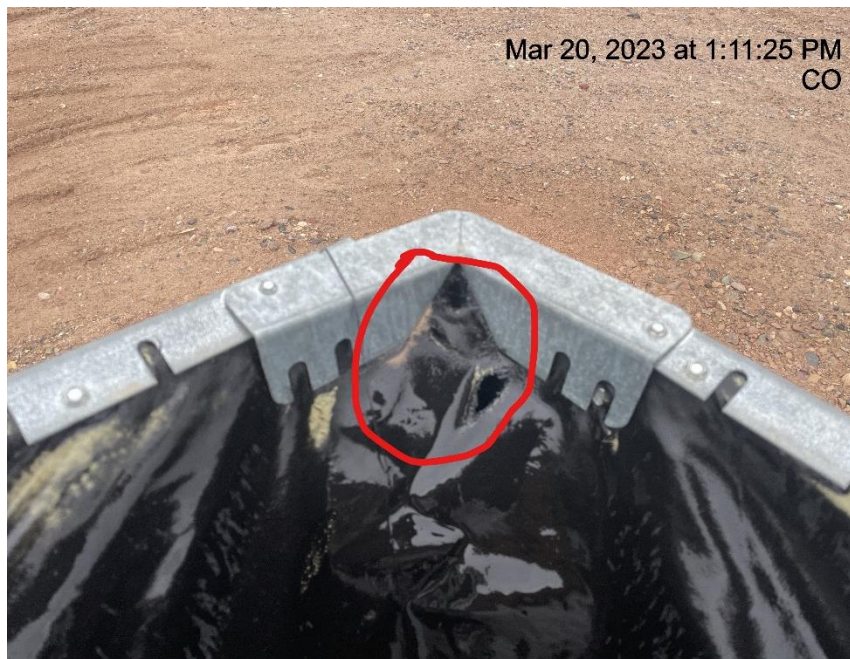
Photo # 2718 Containment liner needs maintenance

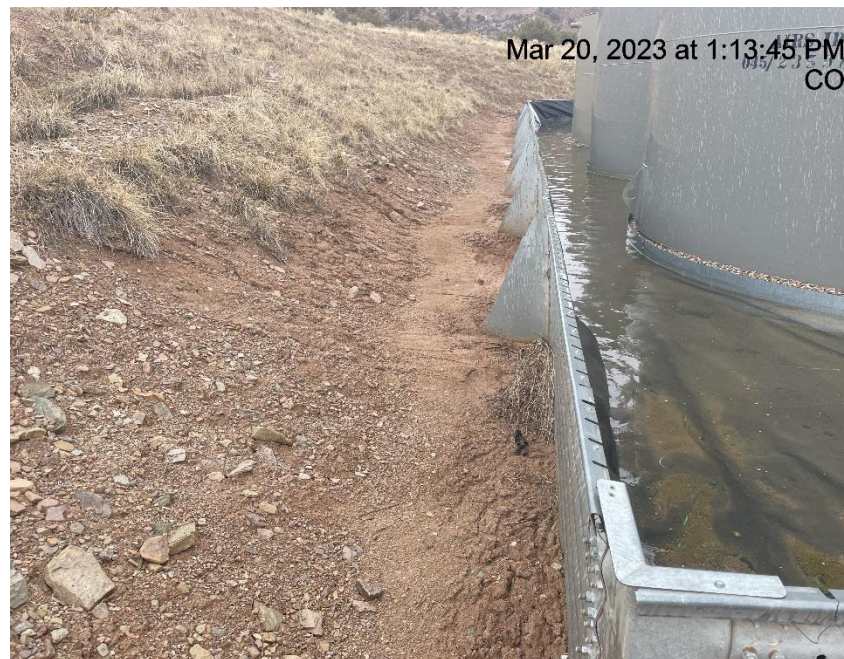
Photo # 2719 Rill erosion/insufficient run on control (BMP)/sediment encroaching on equipment

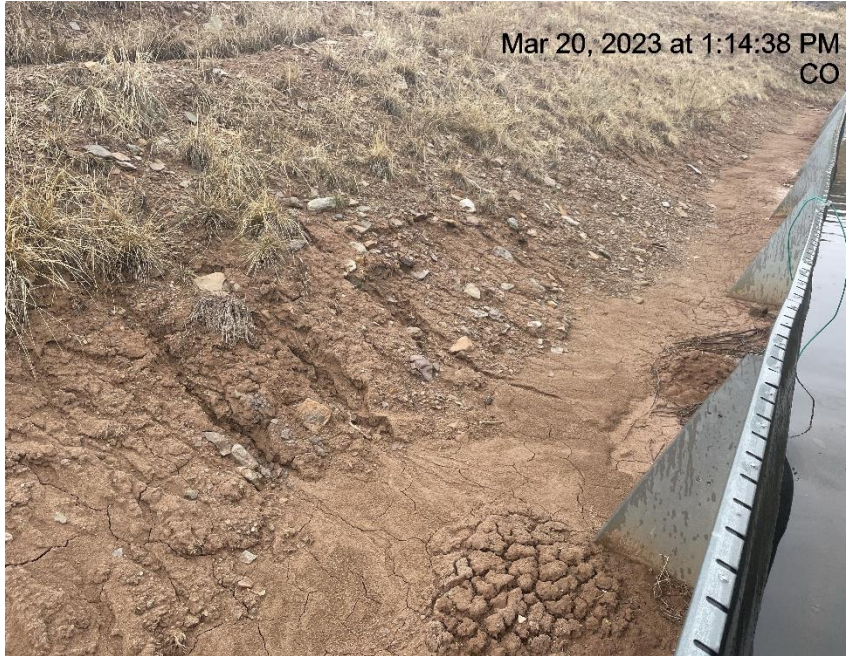
Photo # 2720 Rill erosion/insufficient run on control (BMP)/sediment encroaching on equipment

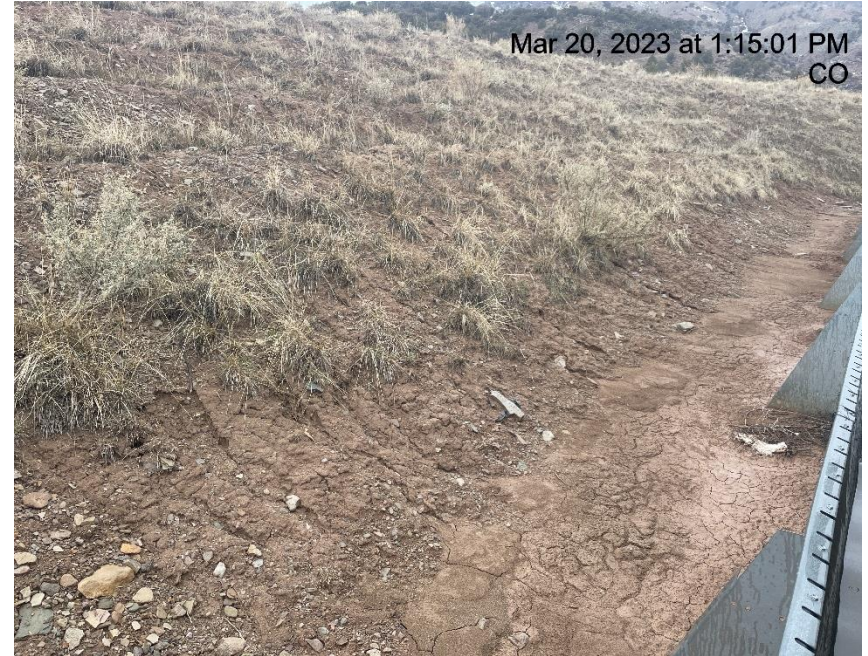
Photo # 2722 Rill erosion/insufficient run on control (BMP)/sediment encroaching on equipment

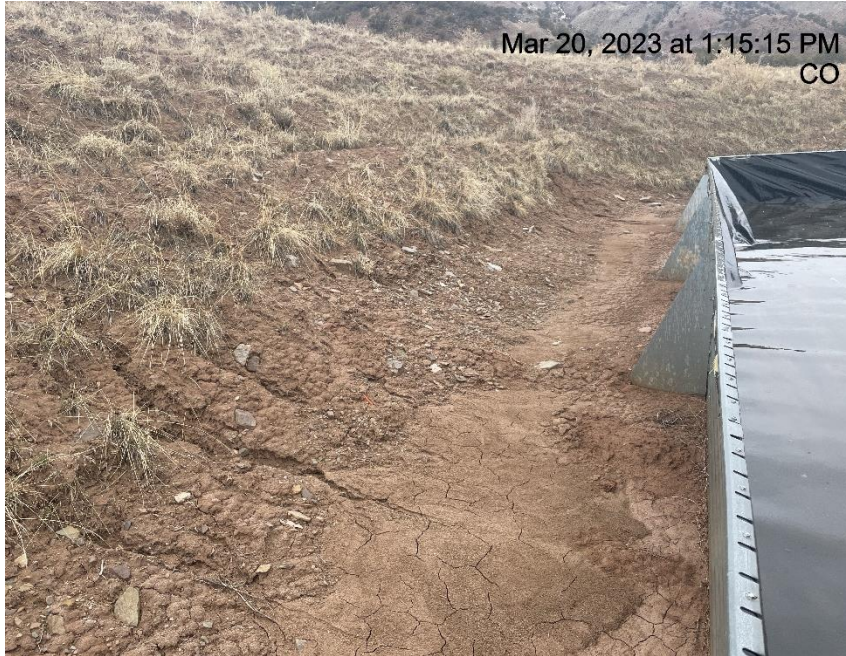
Photo # 2723 Rill erosion/insufficient run on control (BMP)/sediment encroaching on equipment

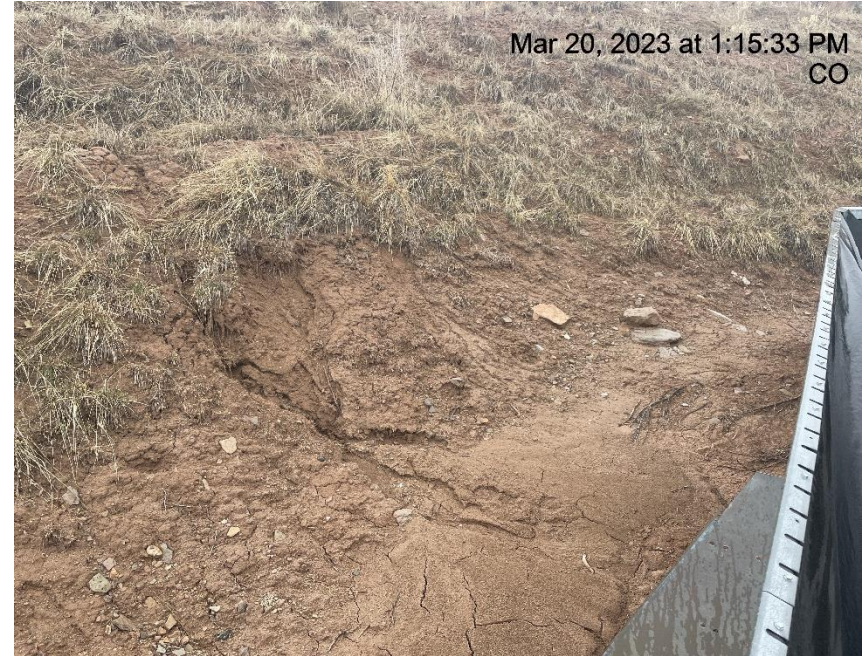
Photo # 2724 Rill erosion/insufficient run on control (BMP)/sediment encroaching on equipment

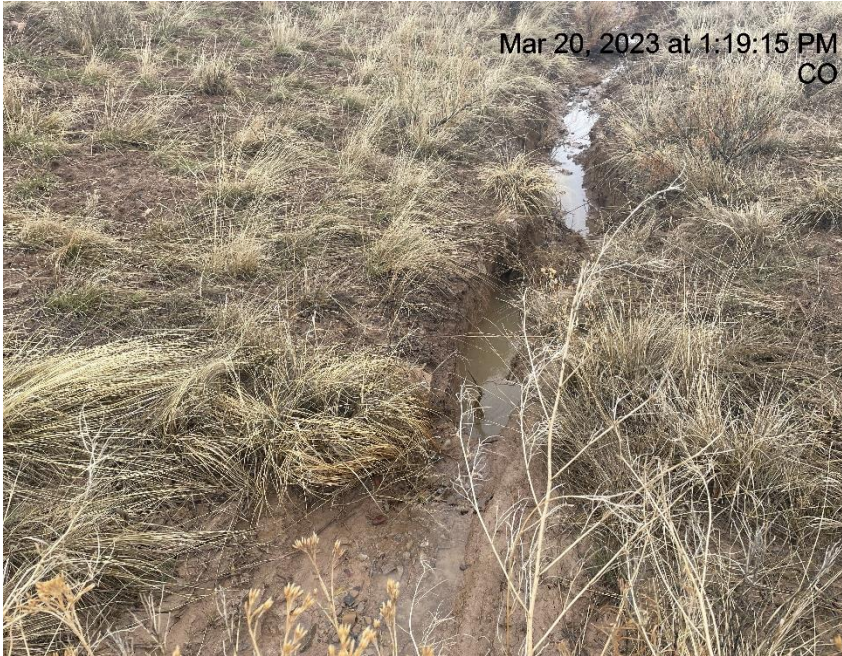
Photo # 2726 Channel erosion/insufficient BMP

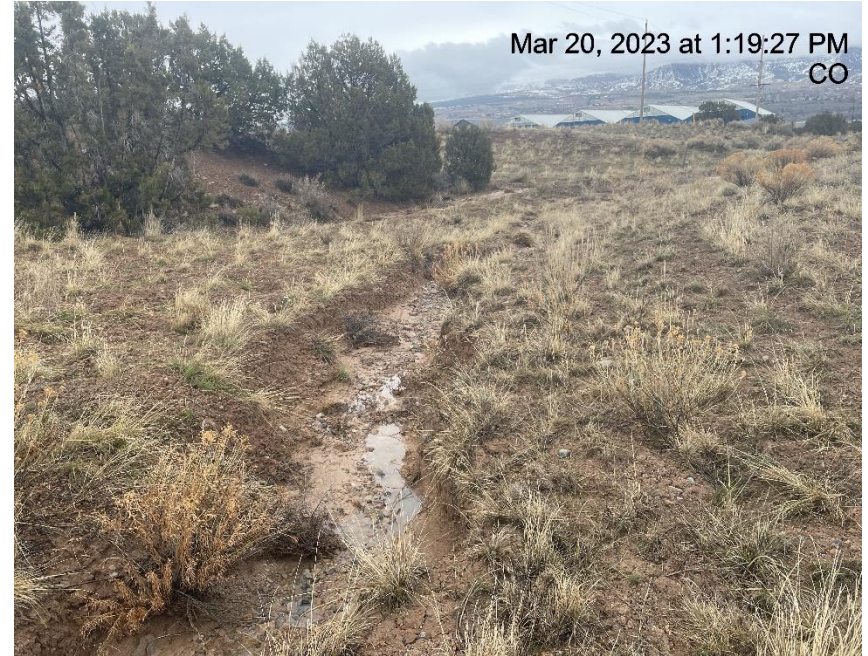
Photo # 2727 Channel erosion/insufficient BMP

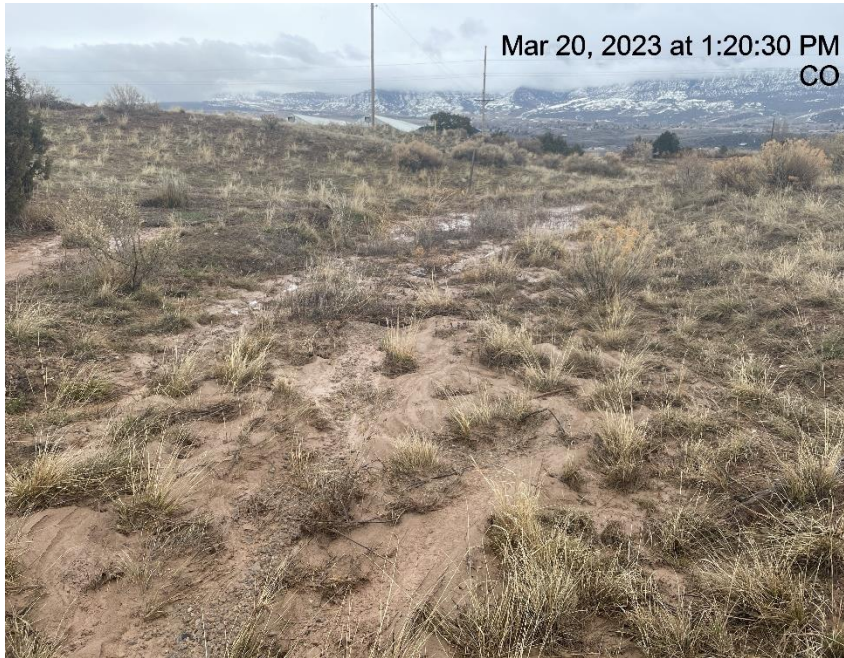
Photo # 2731 Sediment choking off vegetation

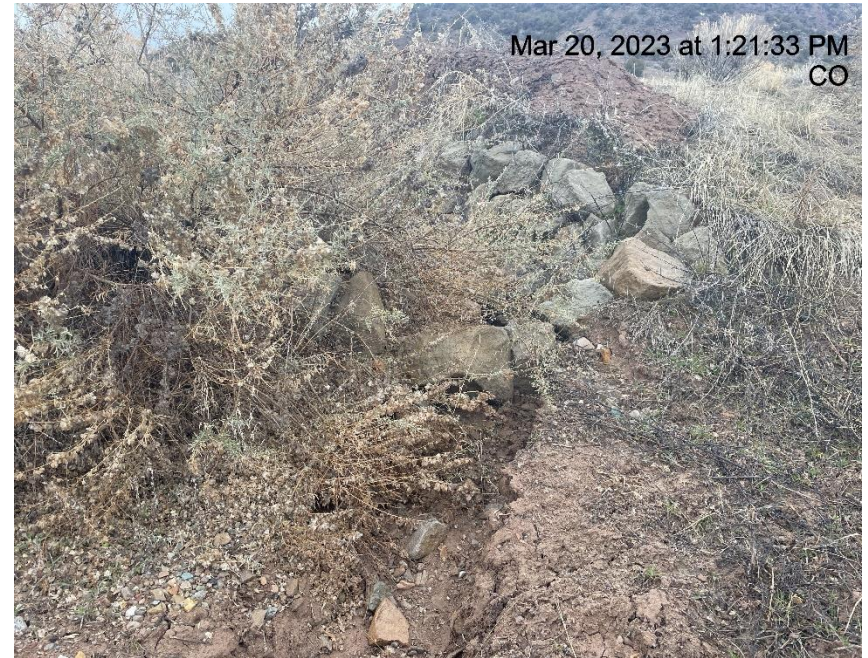
Photo # 2732 Sediment Trap needs maintenance

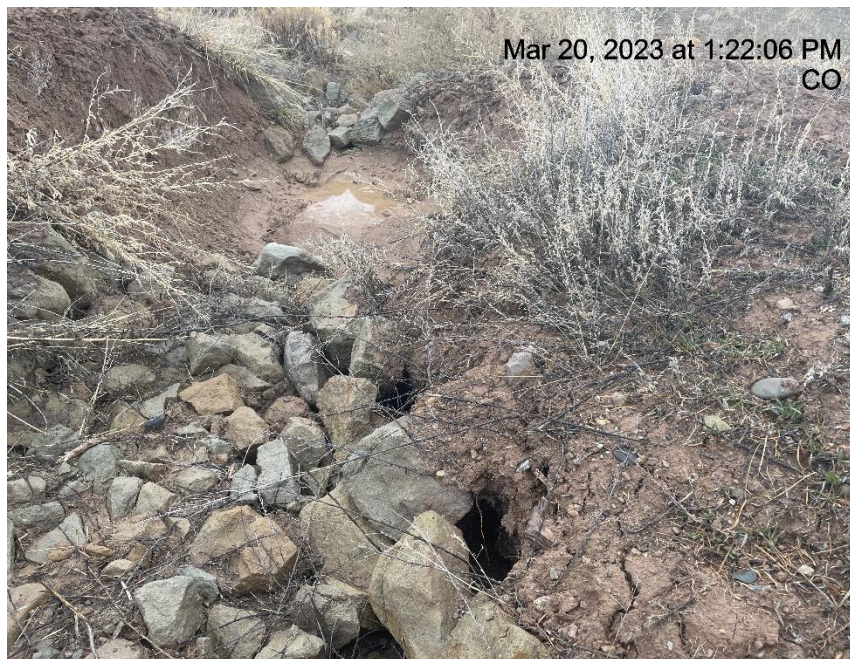
Photo # 2733 Sediment Trap needs maintenance

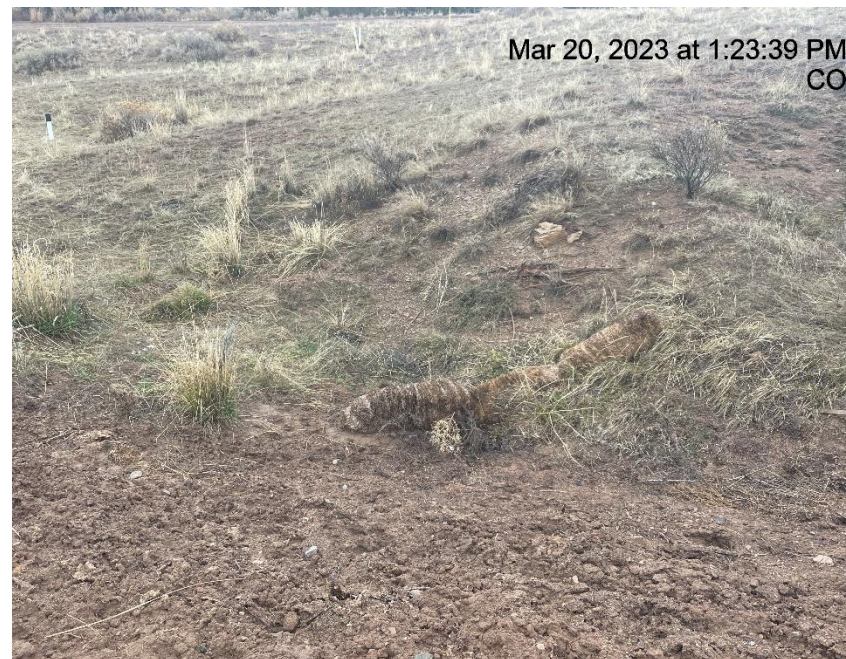
Photo # 2736 Hay bales need maintenance

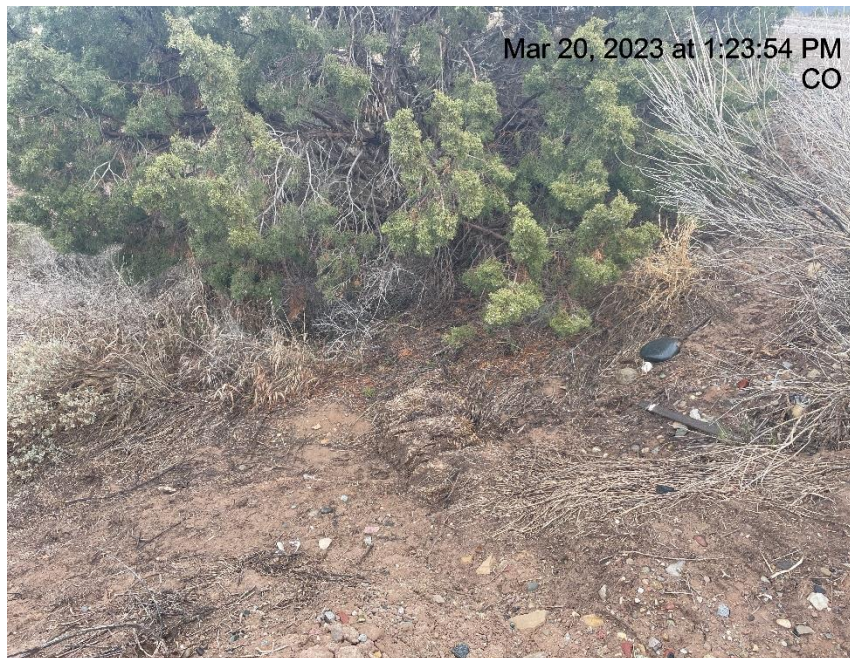
Photo # 2737 Hay bales need maintenance

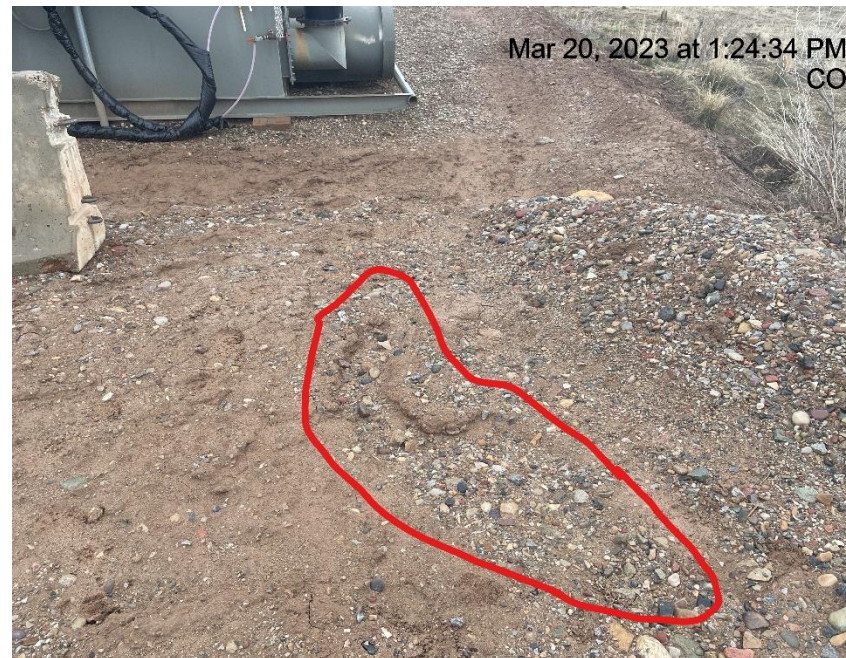
Photo # 2738 Gulley erosion near entrance to location
