Inspection Photos

Location Name: TEP ROCKY MOUNTAIN LLC WILLIAMS SG 431-32 pad

Location ID: 334395

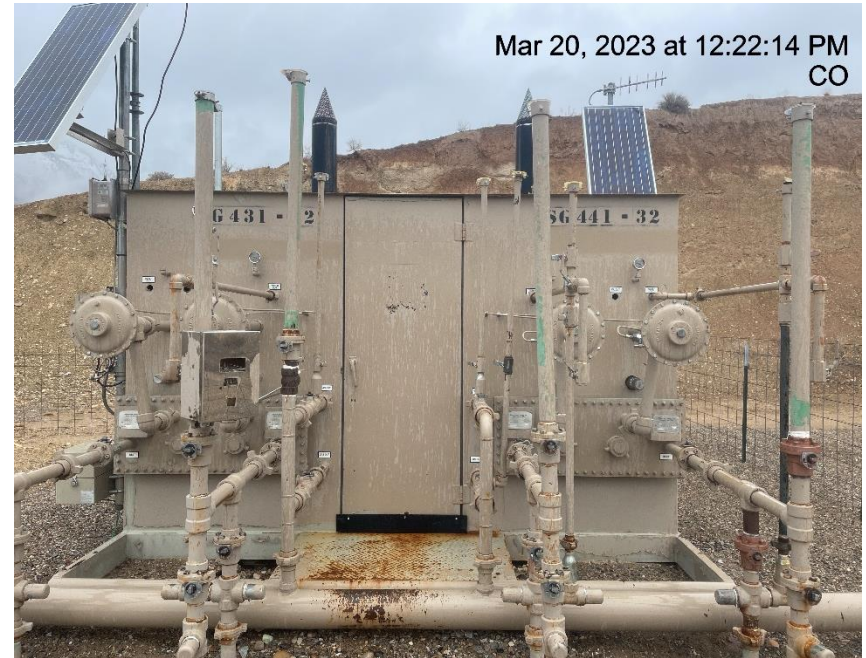
Photo # 2679 Meter calibration info not conspicuously posted

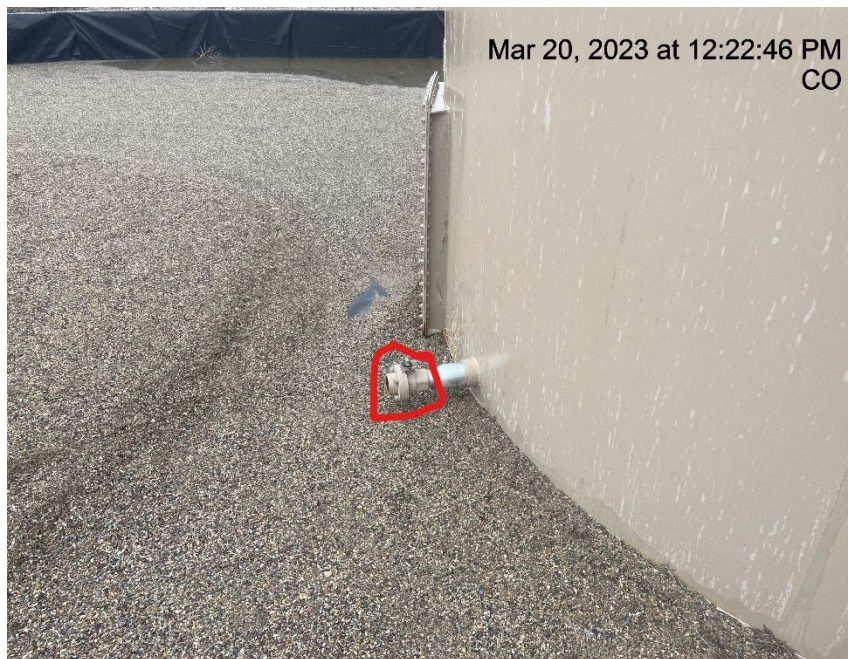
Photo # 2680 Open ended load line

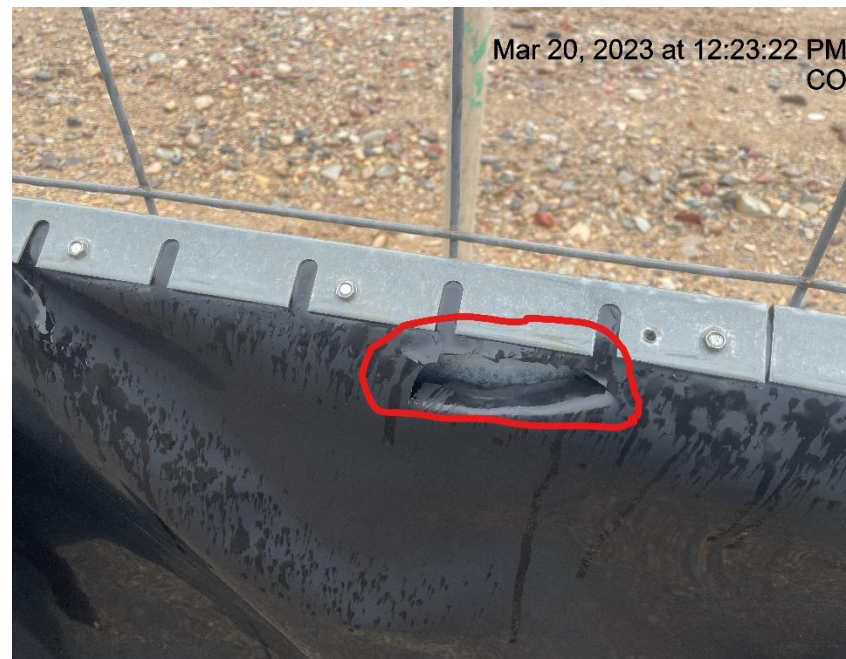
Photo # 2682 Containment needs maintenance

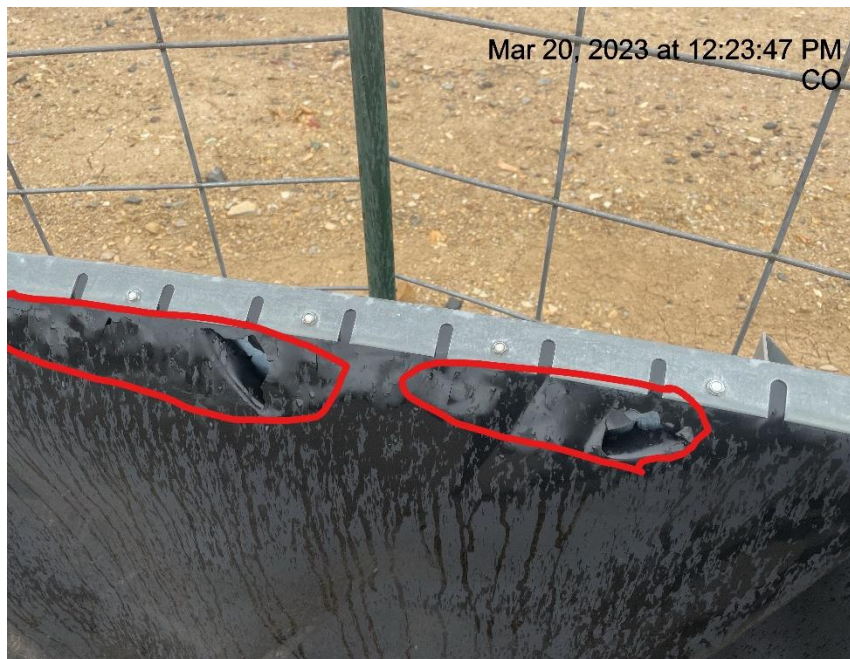
Photo # 2683 Containment needs maintenance

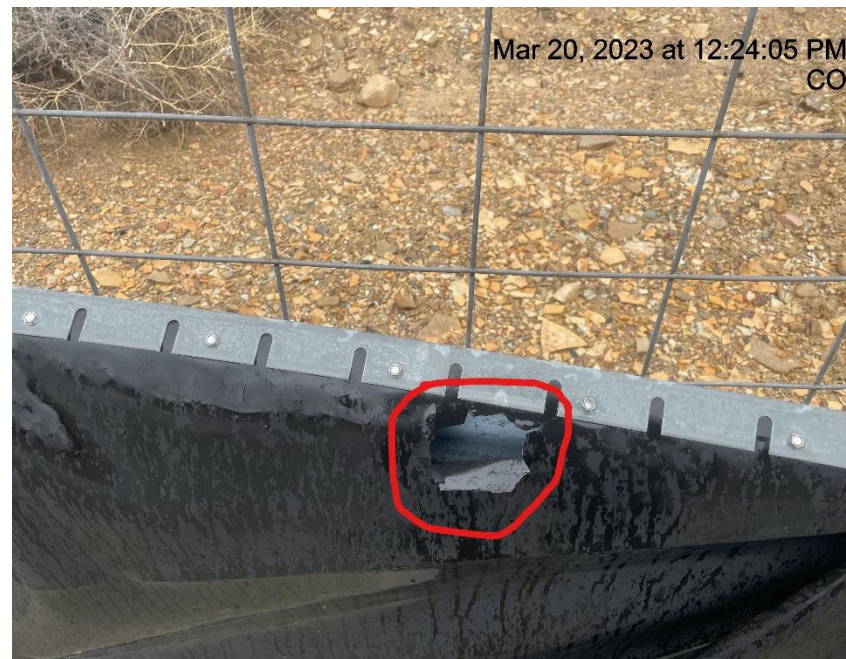
Photo # 2684 Containment needs maintenance

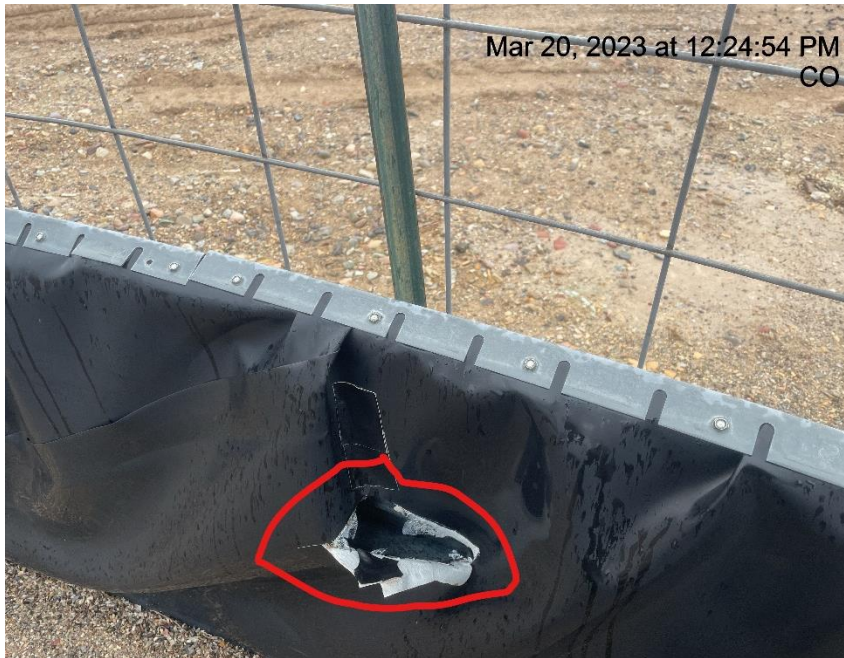
Photo # 2686 Containment needs maintenance

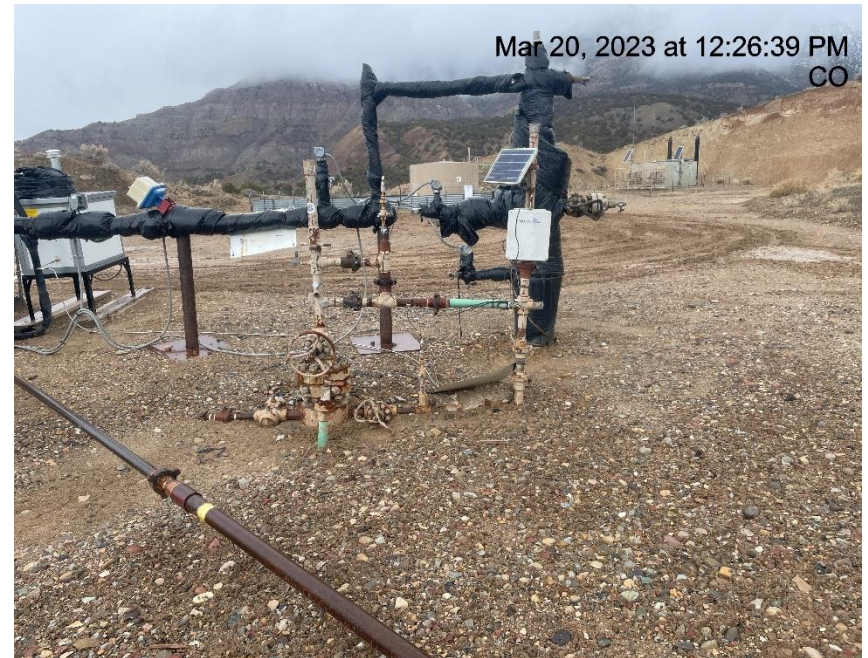
Photo # 2688 SG 431-32 wellhead sign missing

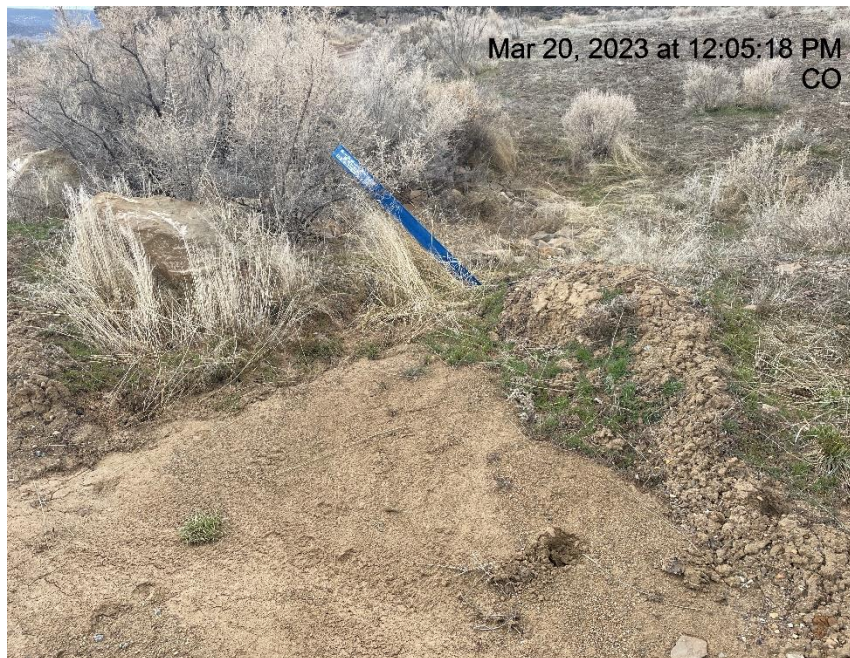
Photo # 2660 Erosion & Transport of sediment off spur road

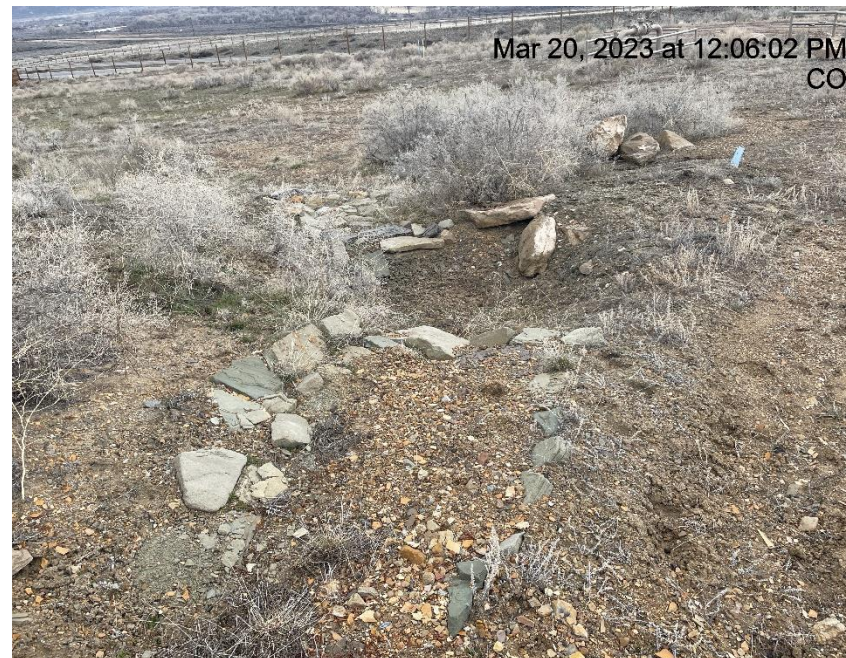
Photo # 2662 Sediment trap needs maintenance

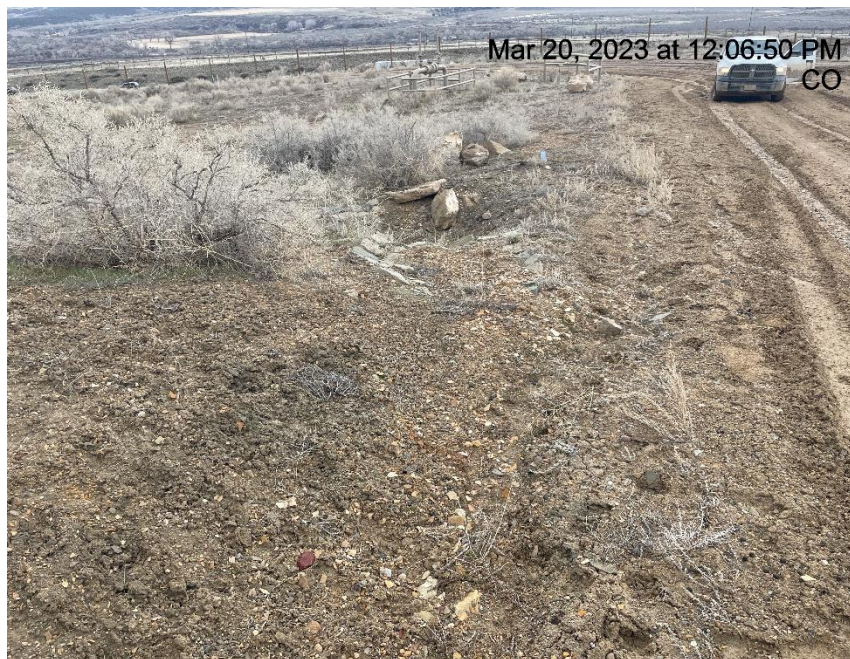
Photo # 2664 Sediment trap & ditch need maintenance

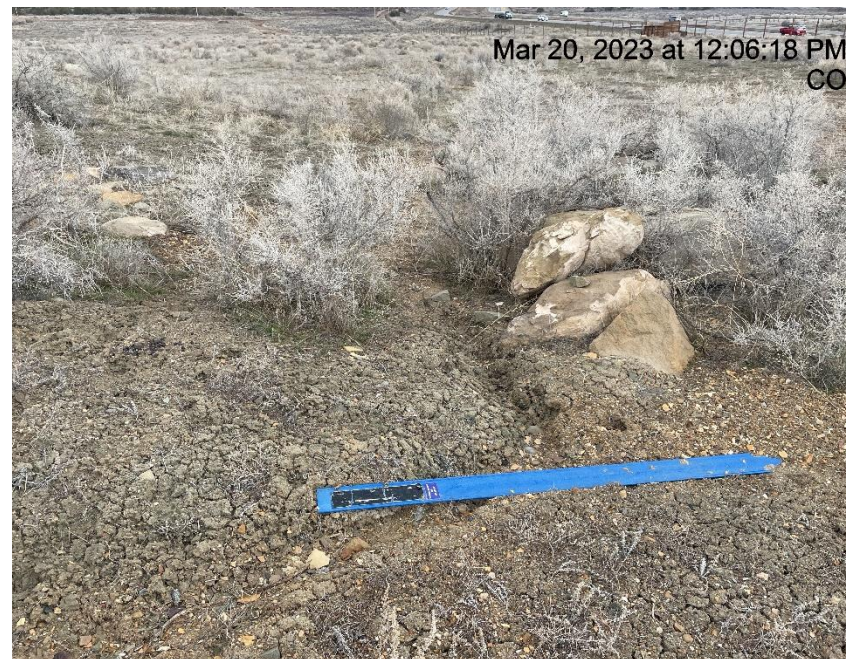
Photo # 2663 Rill erosion on spur road

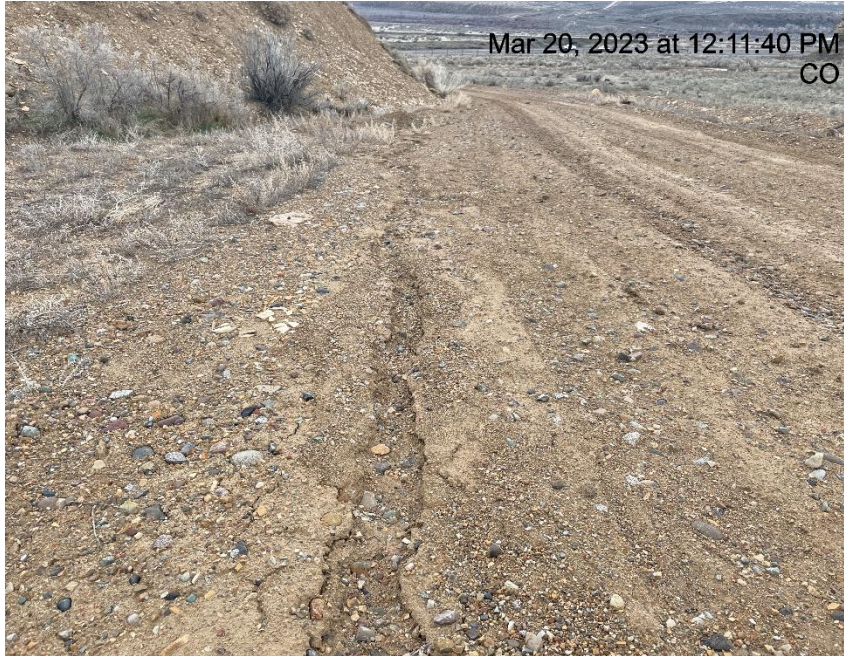
Photo # 2665 Rill erosion on spur road

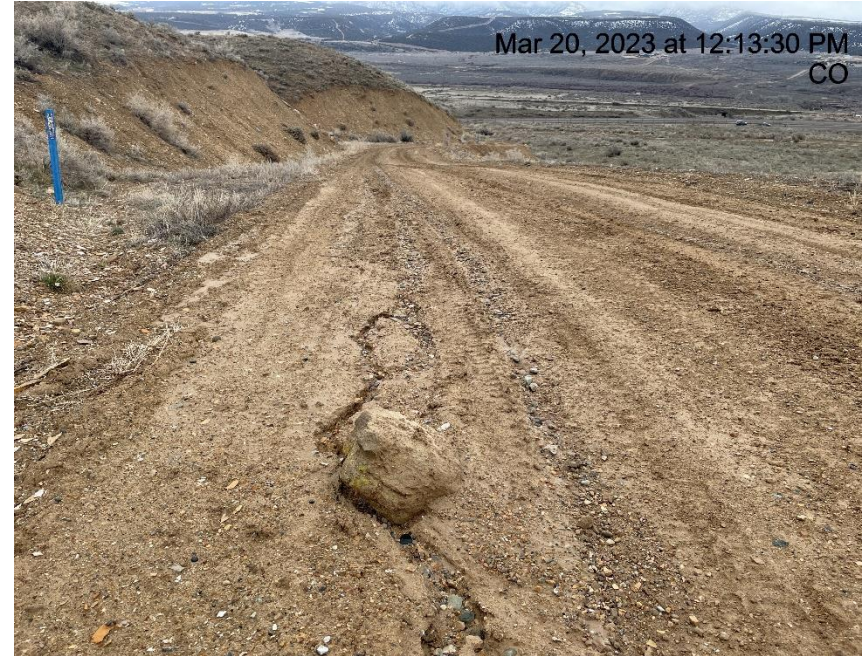
Photo # 2667 Rill erosion on spur road

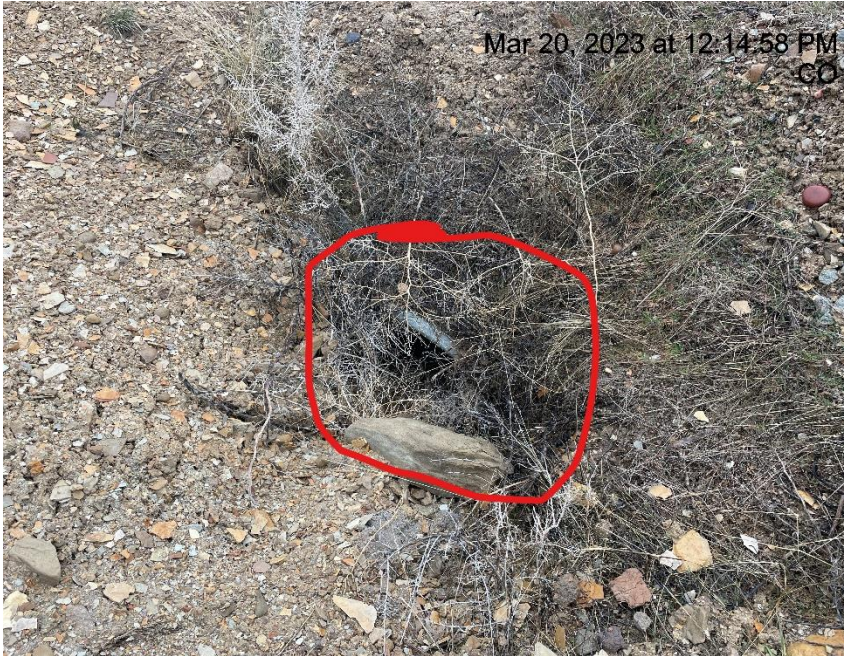
Photo # 2668 Culvert needs maintenance

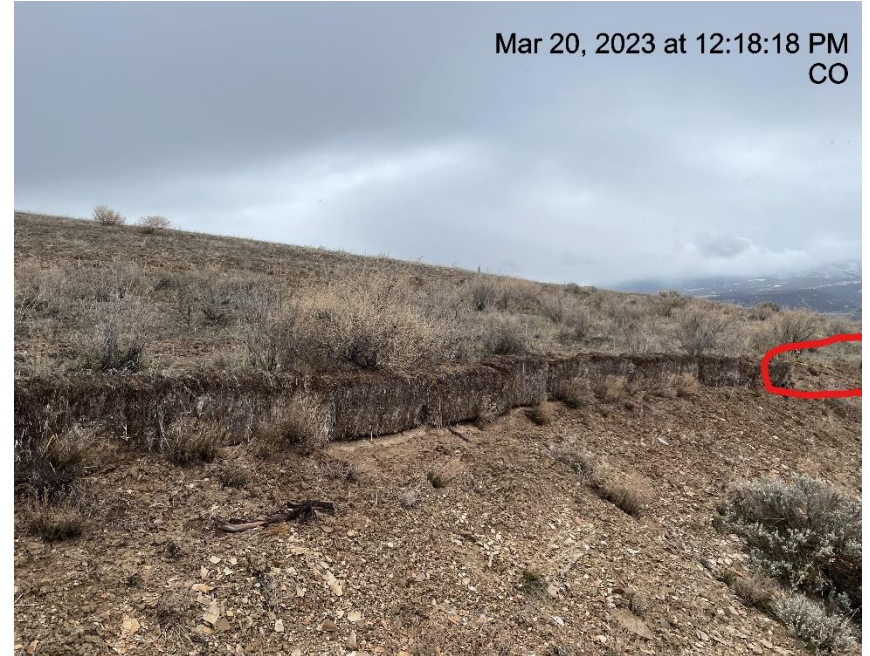
Photo # 2671 Hay bales need maintenance

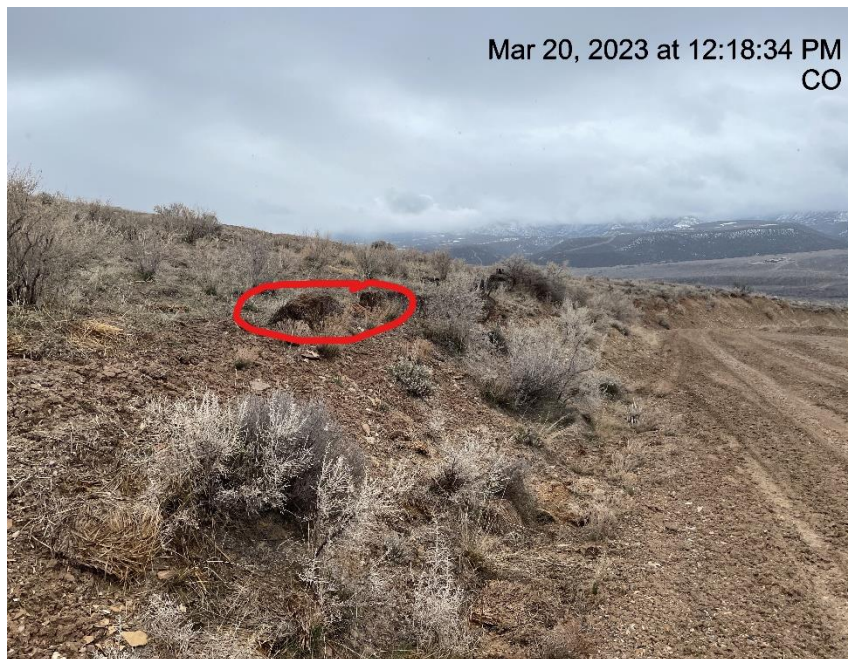
Photo # 2672 Hay bales need maintenance

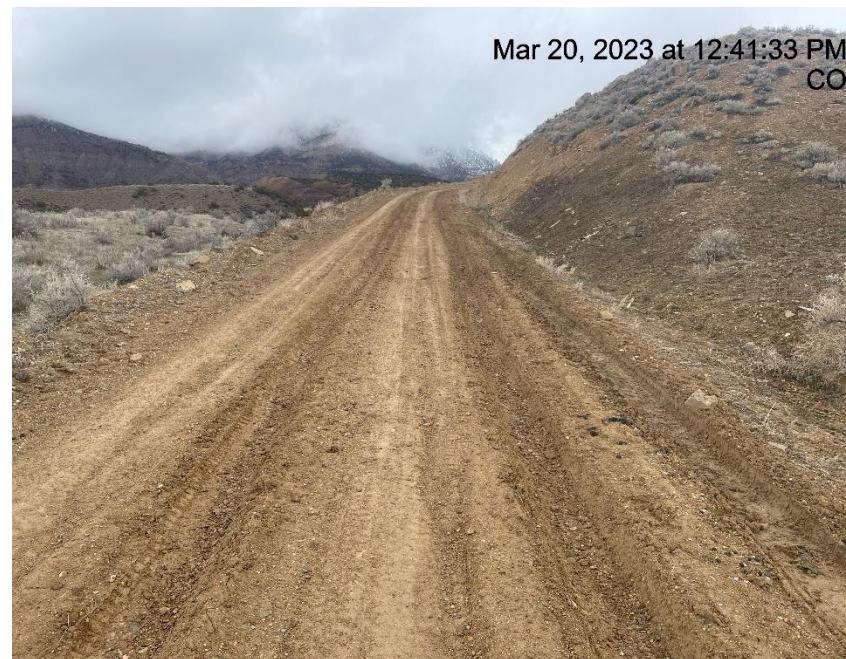
Photo # 2694 Lack of stabilization

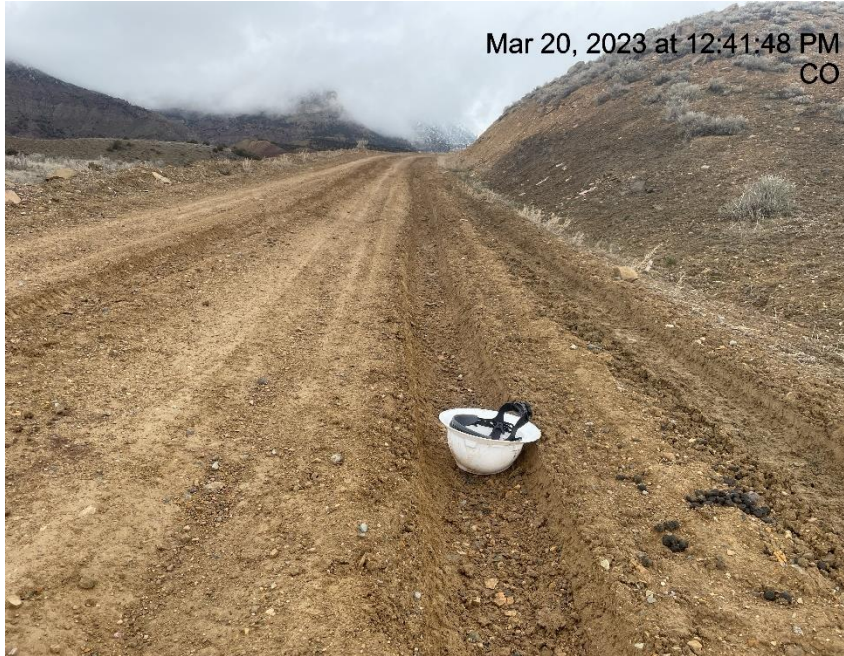
Photo # 2695 Lack of stabilization

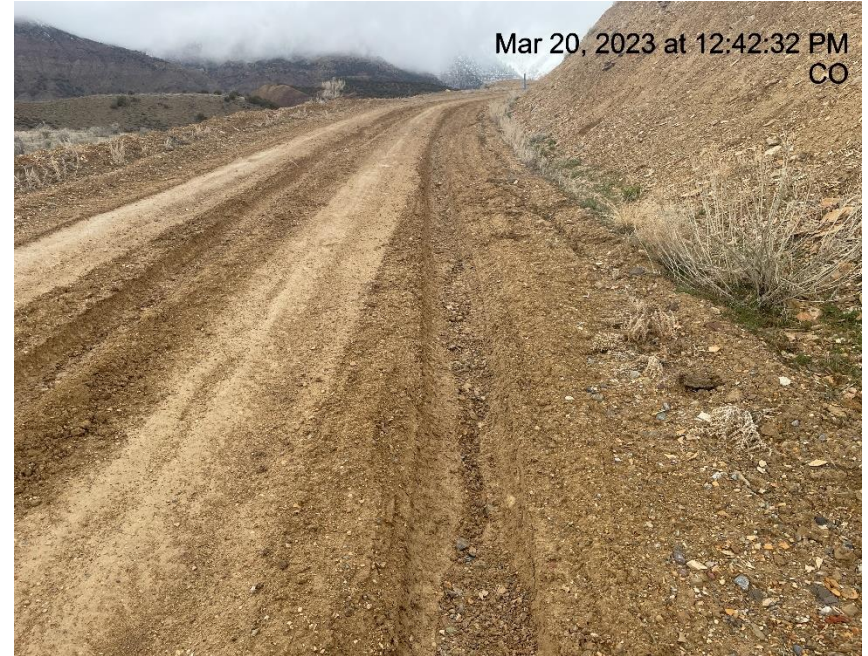
Photo # 2696 Lack of stabilization

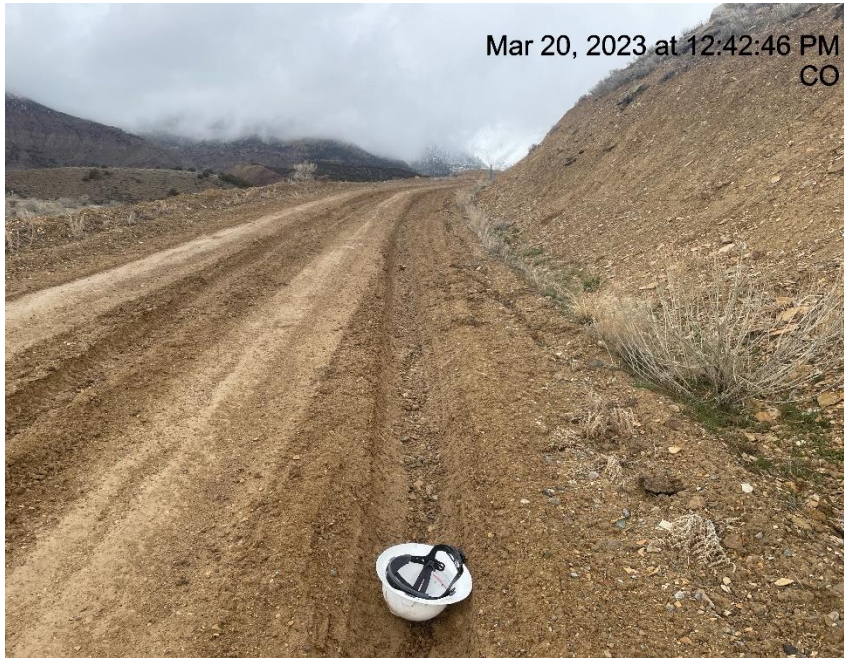
Photo # 2697 Lack of stabilization
