## Inspection Photos

Location Name: TEP ROCKY MOUNTAIN LLC WILLIAMS SG 522-32 pad

Location ID: 334401

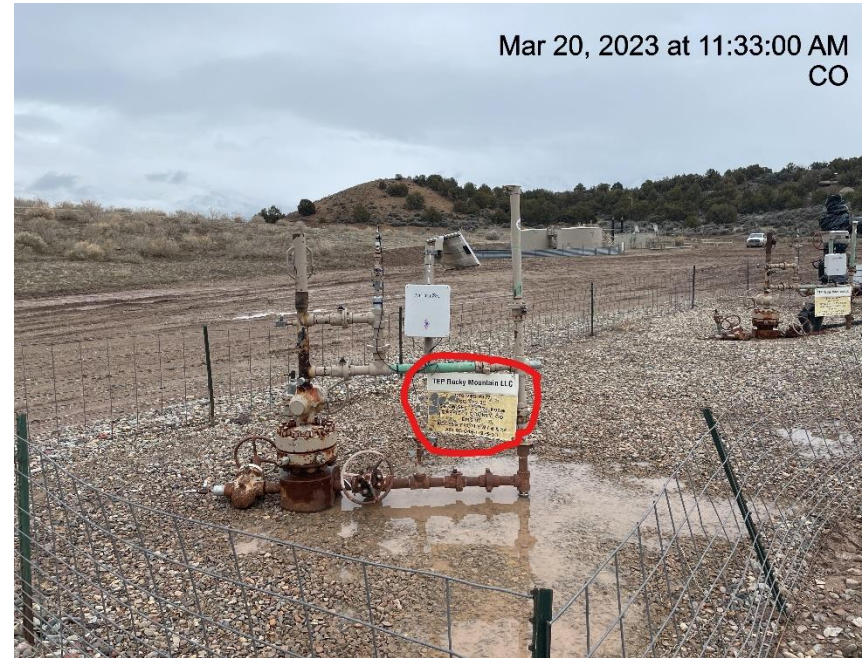
Photo # 2626 Wellhead sign peeling & illegible

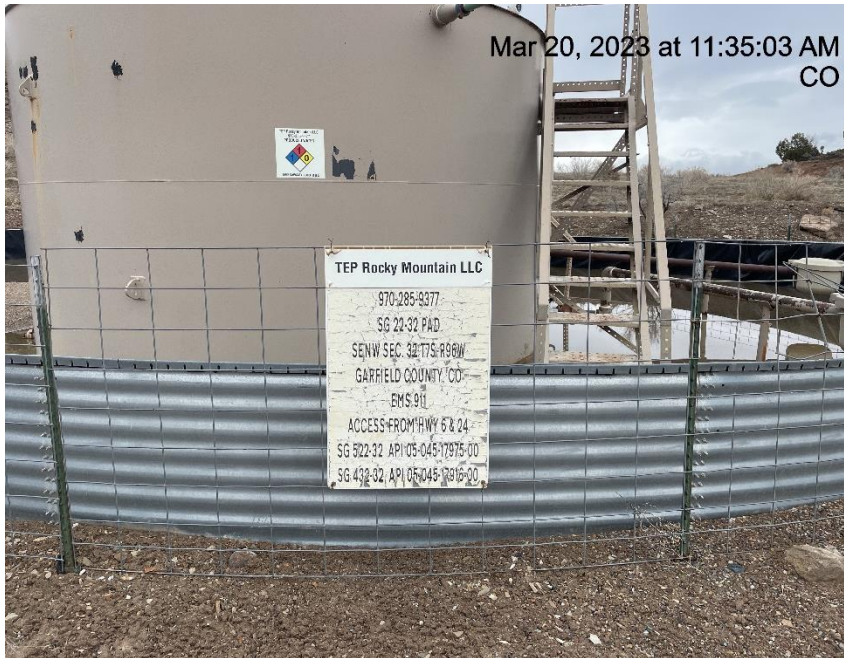
Photo # 2629 Battery sign peeling & illegible

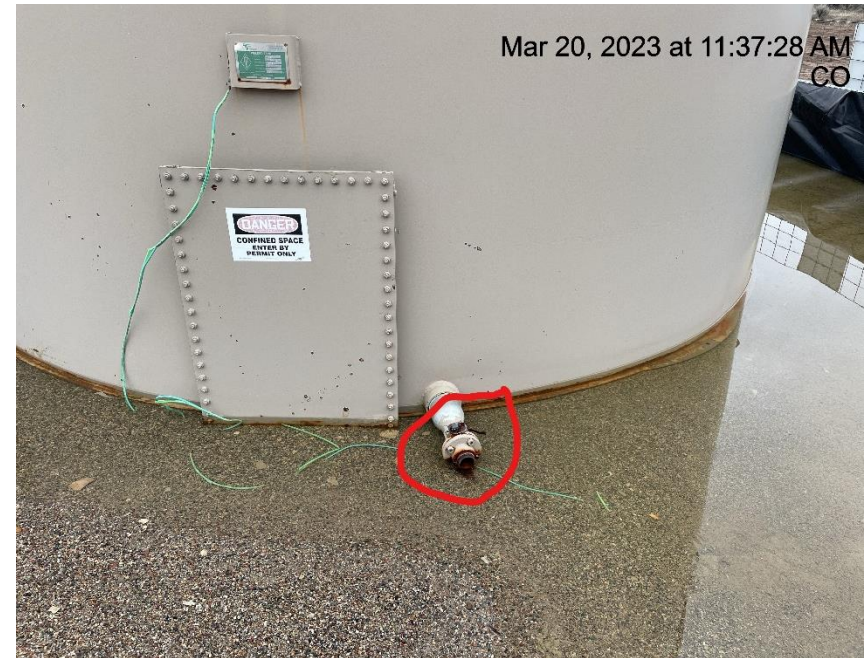
Photo # 2632 Open ended load line

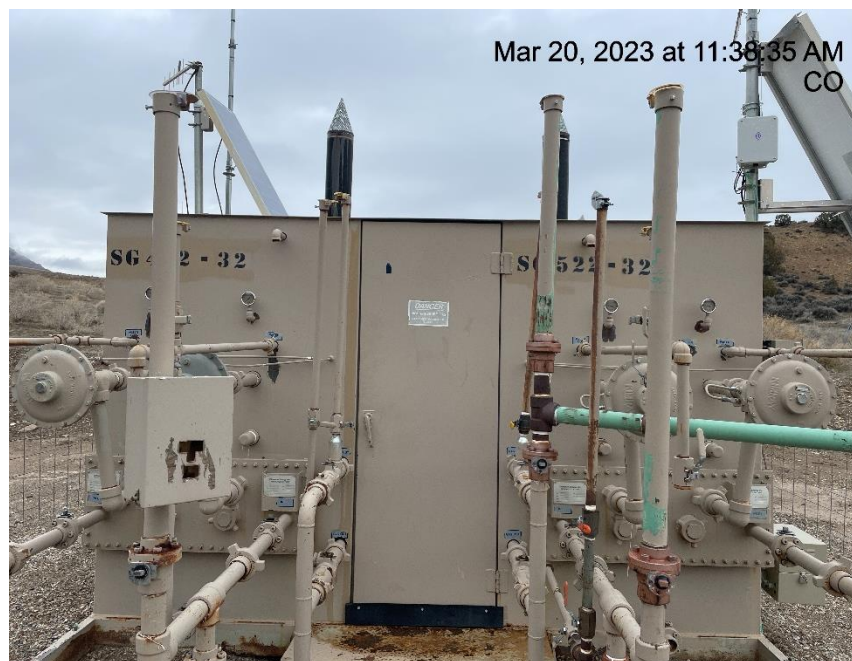
**Photo # 2633 Meter calibration info not conspicuously posted**

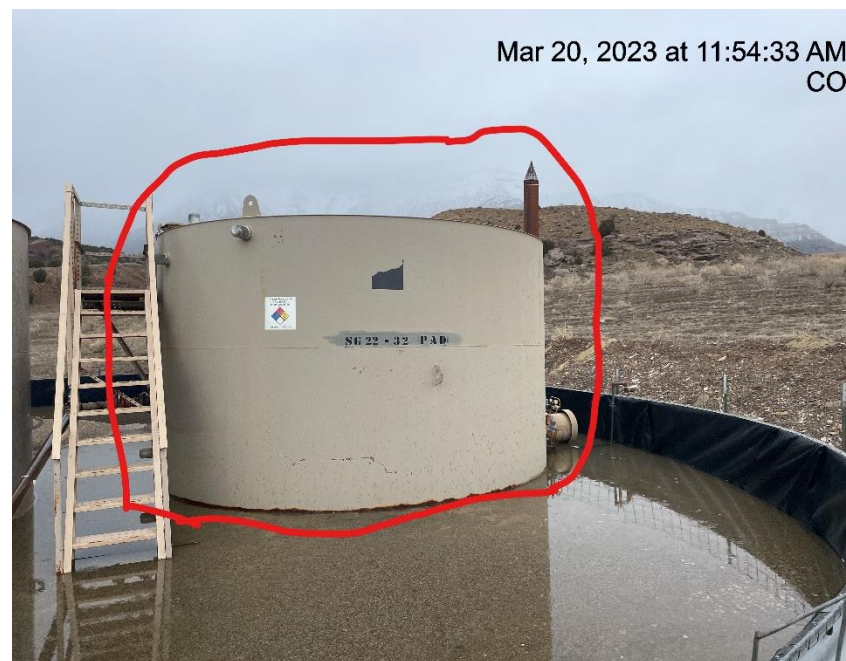
**Photo # 2647 Unused equipment**

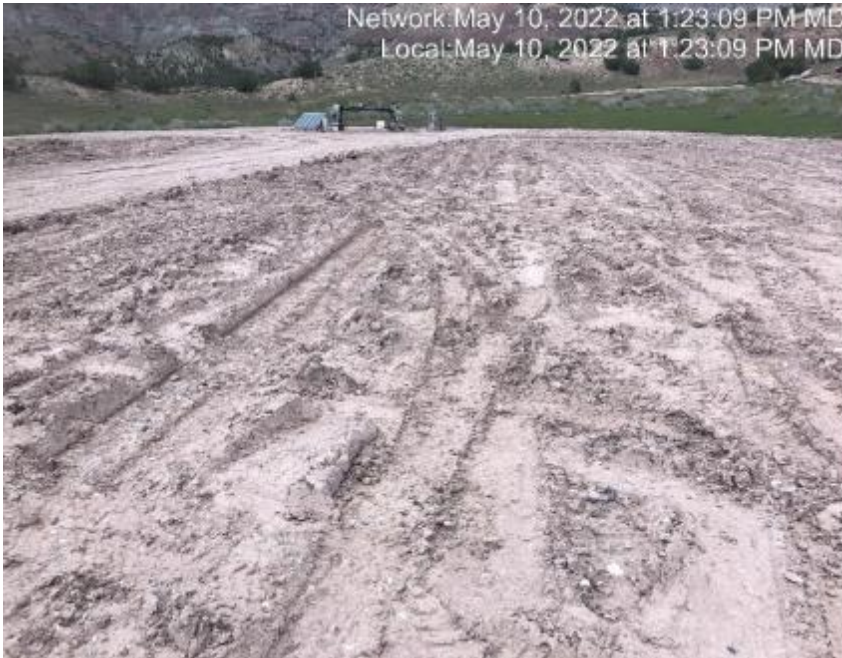
**Photo # 6668 – 05/10/2022 Location lacks stabilization**

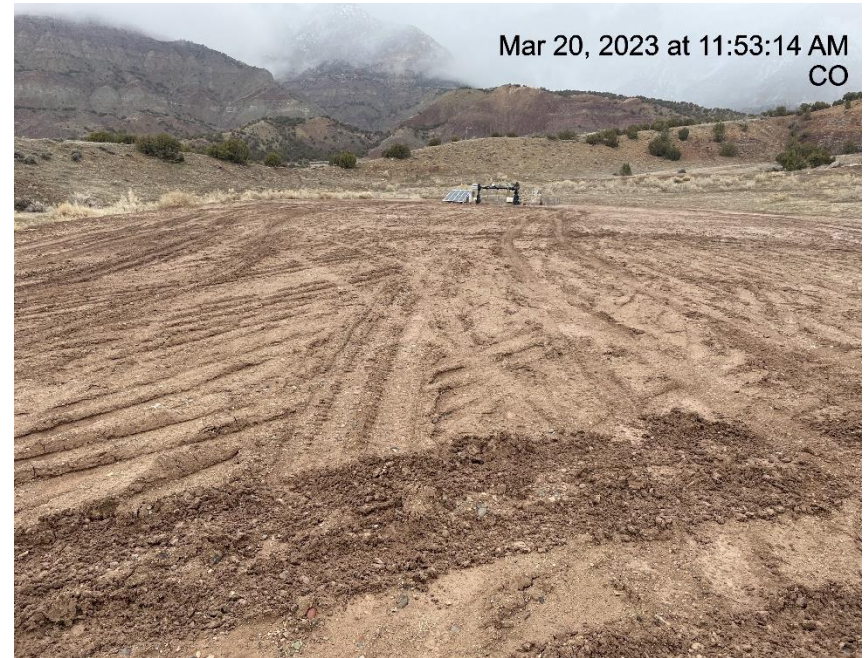
**Photo # 2645 Lack of stabilization**

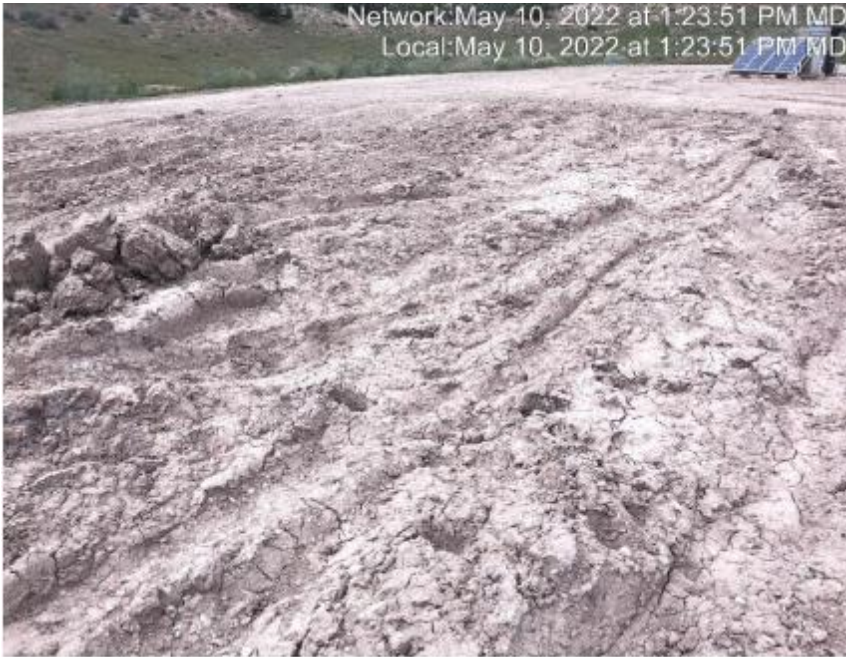
**Photo # 6669 – 05/10/2022 Location lacks stabilization**

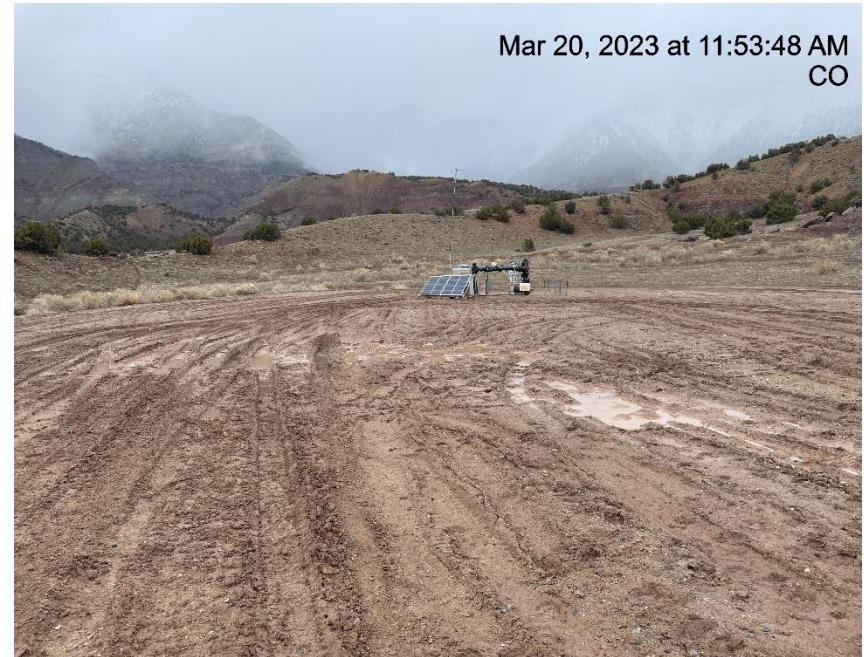
**Photo # 2646 Lack of stabilization**

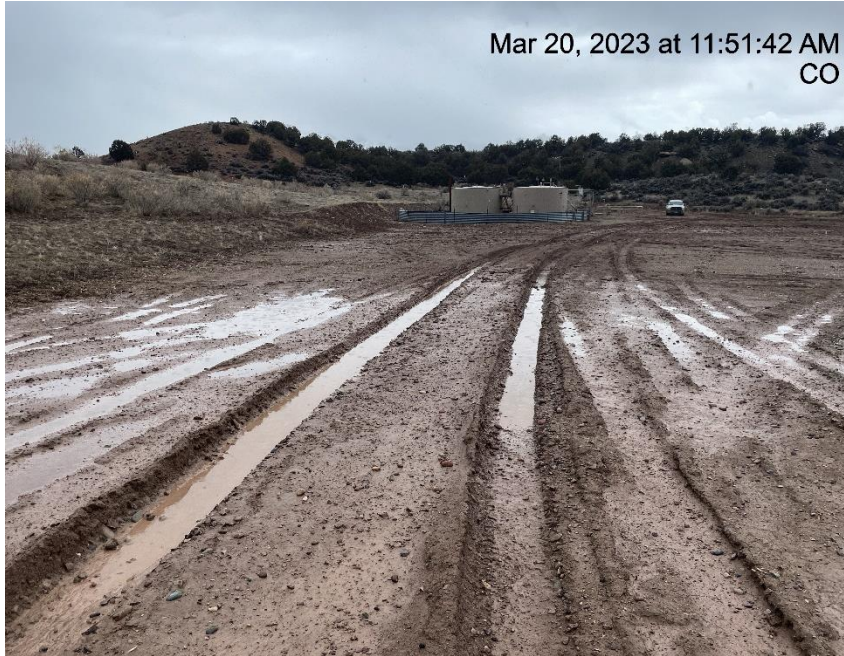
**Photo # 2643 Lack of stabilization**

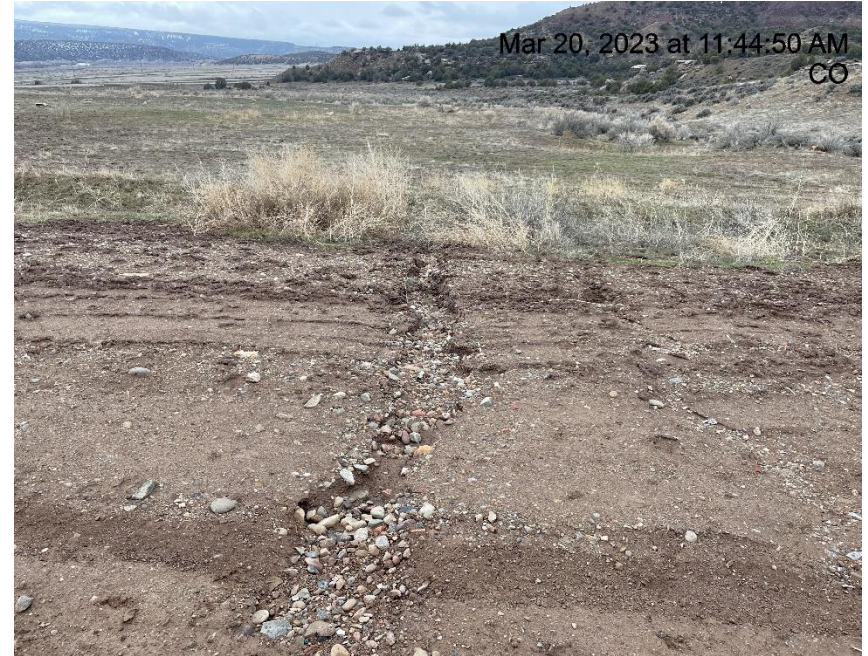
**Photo # 2636 Rill erosion west side of location**

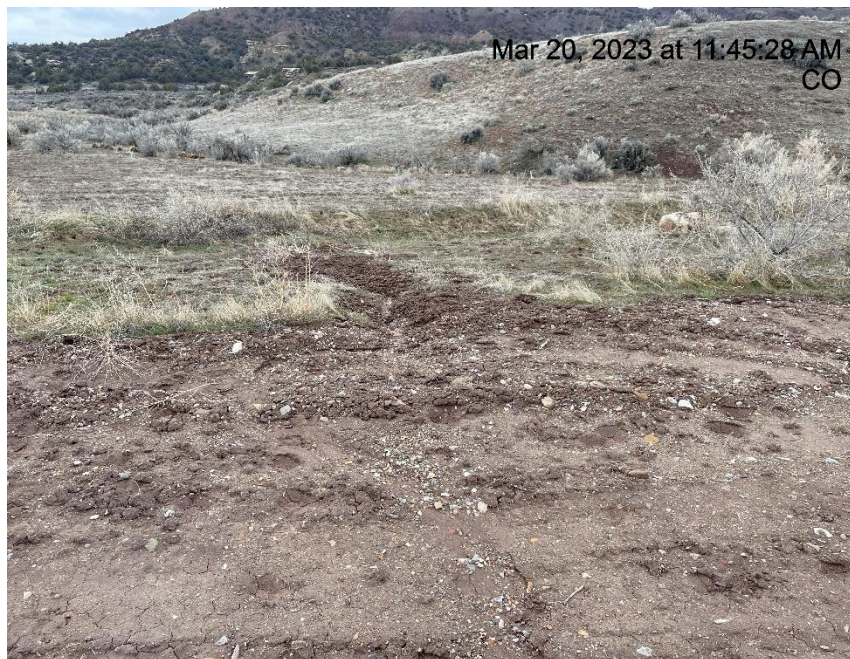
**Photo # 2637 Rill erosion & transport of sediment off location (west side)**

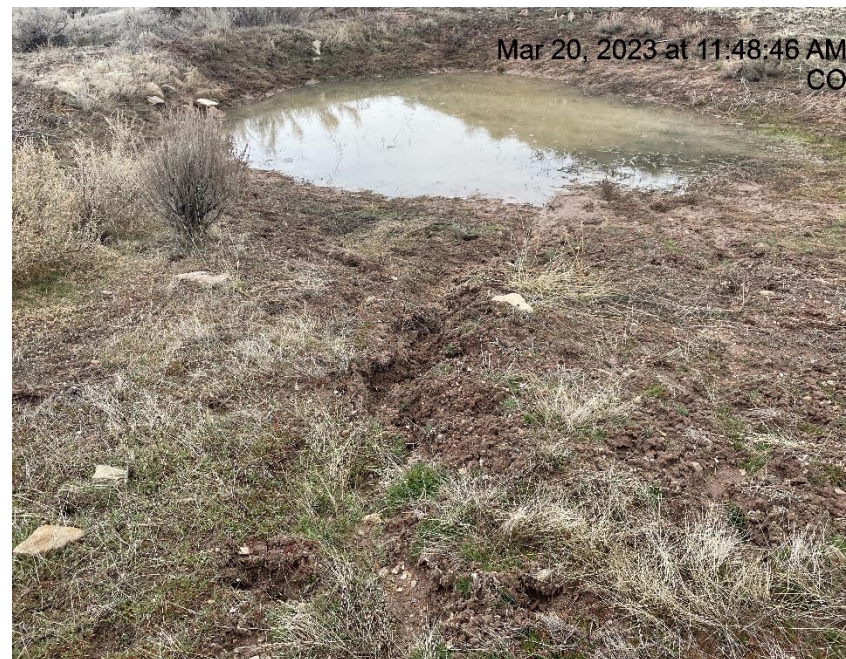
**Photo # 2640 Rill erosion near settling pond NW corner**

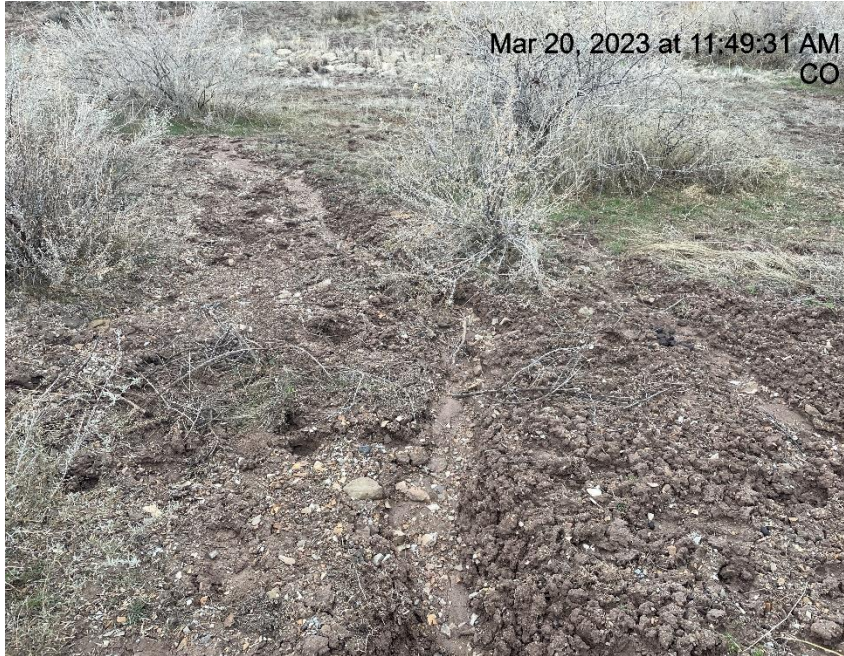
**Photo # 2641 Rill erosion**

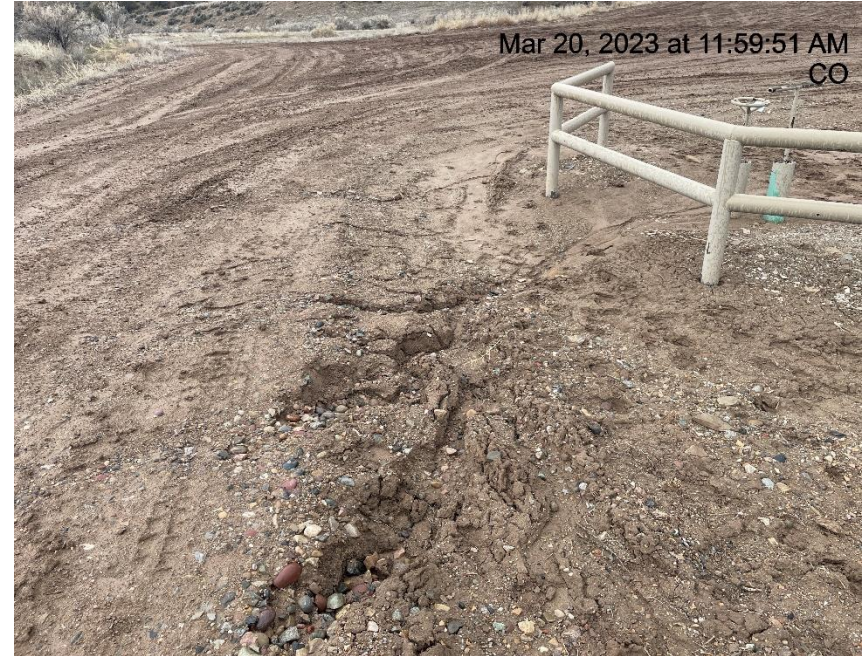
**Photo # 2651 Gully erosion near bollards at entrance to location**

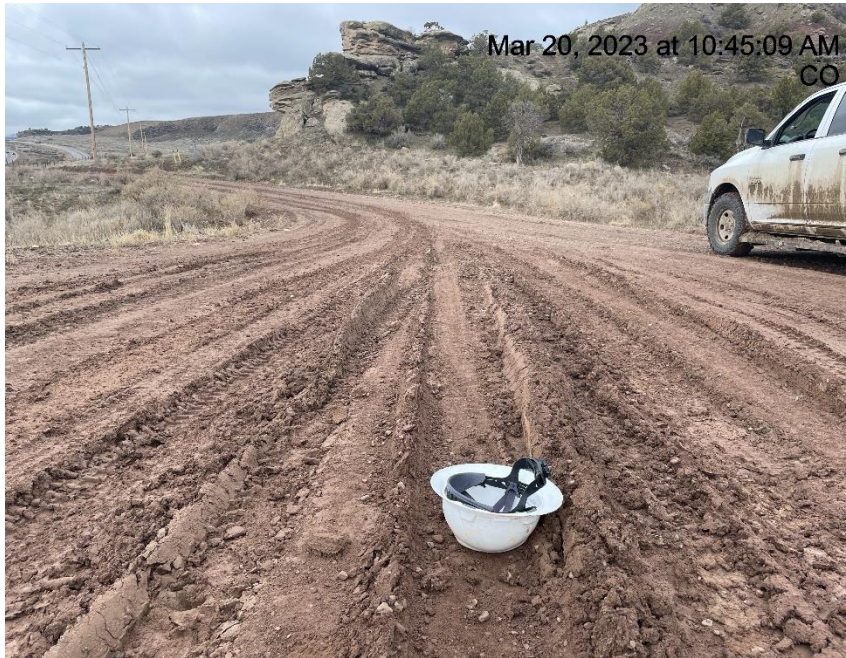
Photo # 2593 Lack of stabilization on lease road

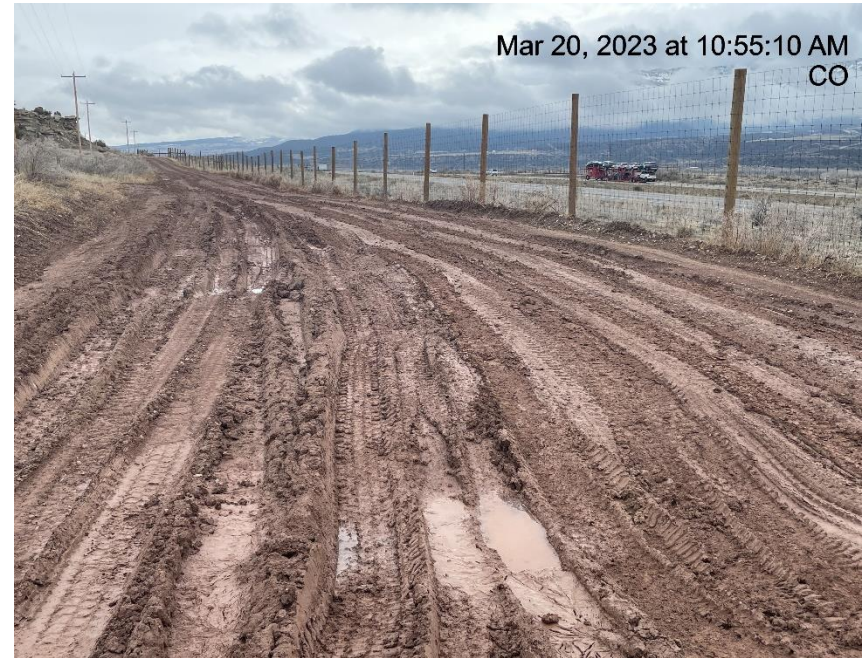
Photo # 2599 Lack of stabilization on lease road

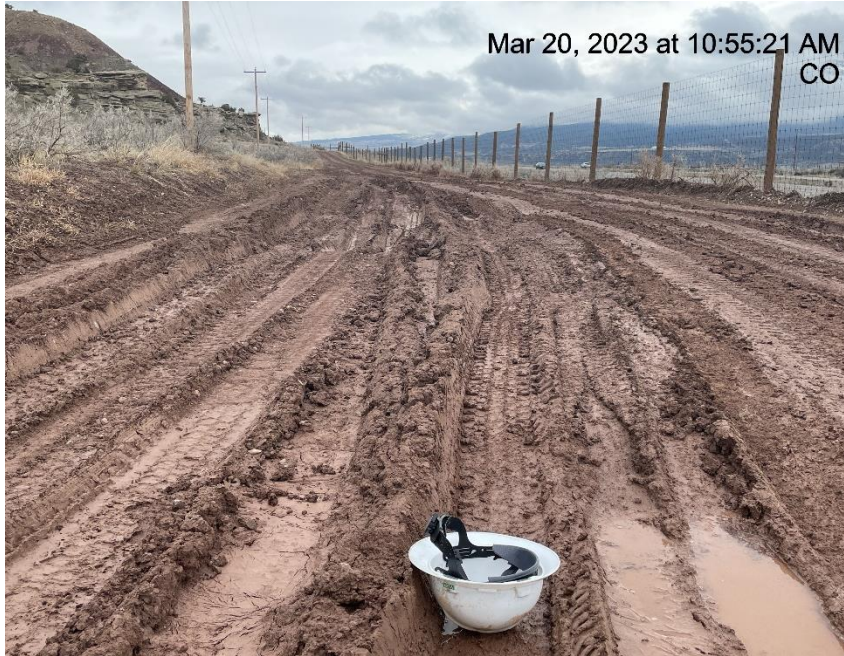
**Photo # 2600 Lack of stabilization on lease road**

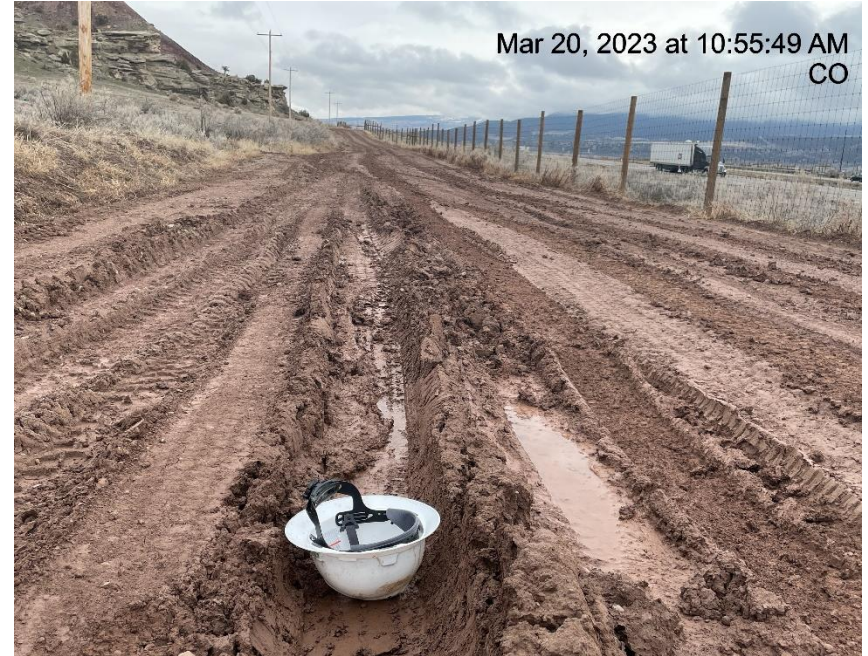
**Photo # 2602 Lack of stabilization on lease road**

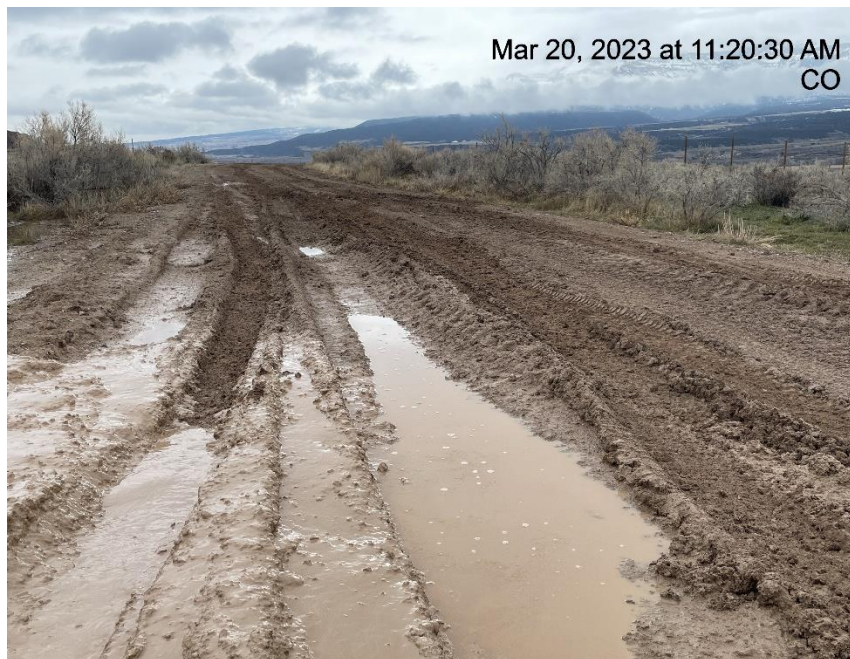
**Photo # 2612 Lack of stabilization on lease road**

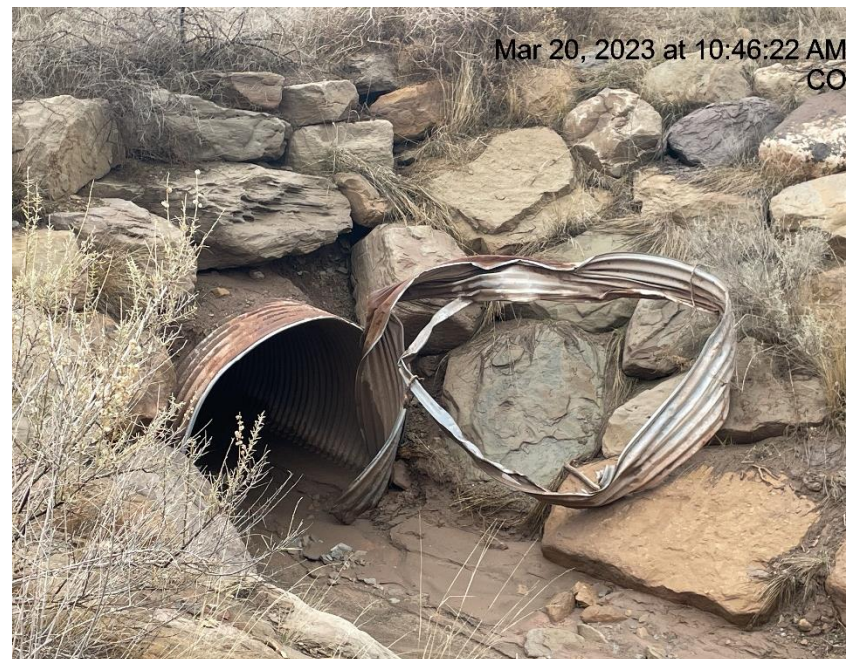
**Photo # 2594 Culvert needs maintenance**

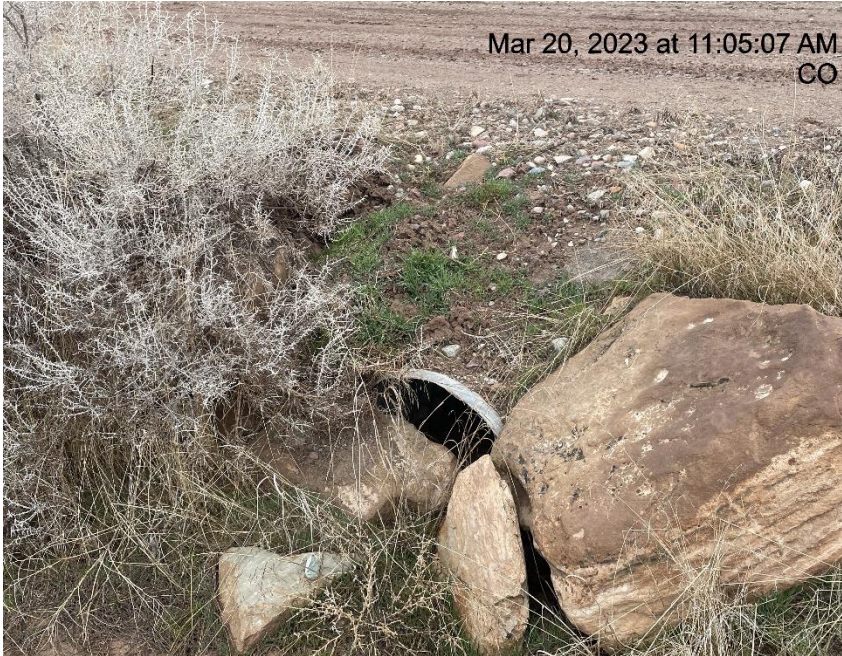
**Photo # 2606 Culvert needs maintenance**

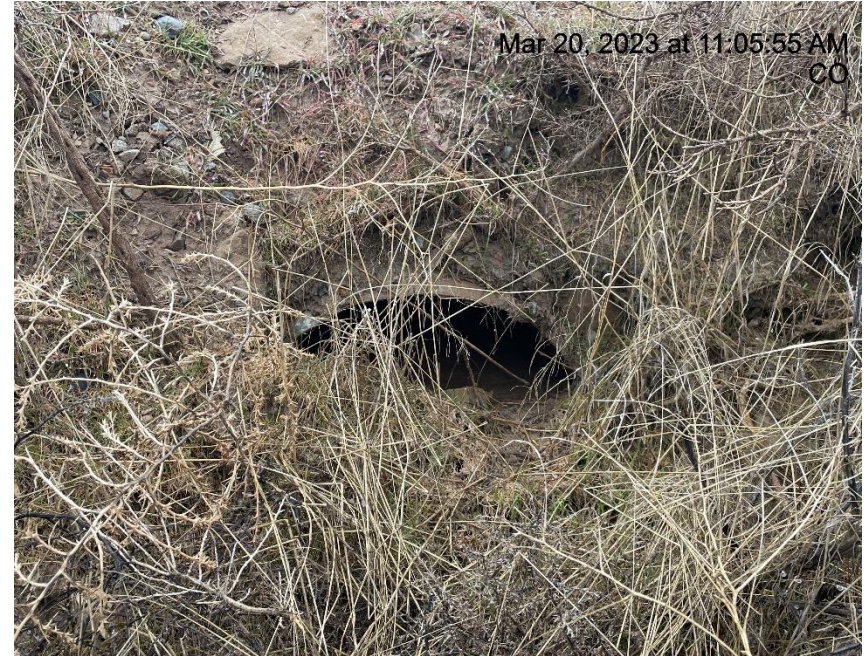
**Photo # 2607 Culvert needs maintenance**

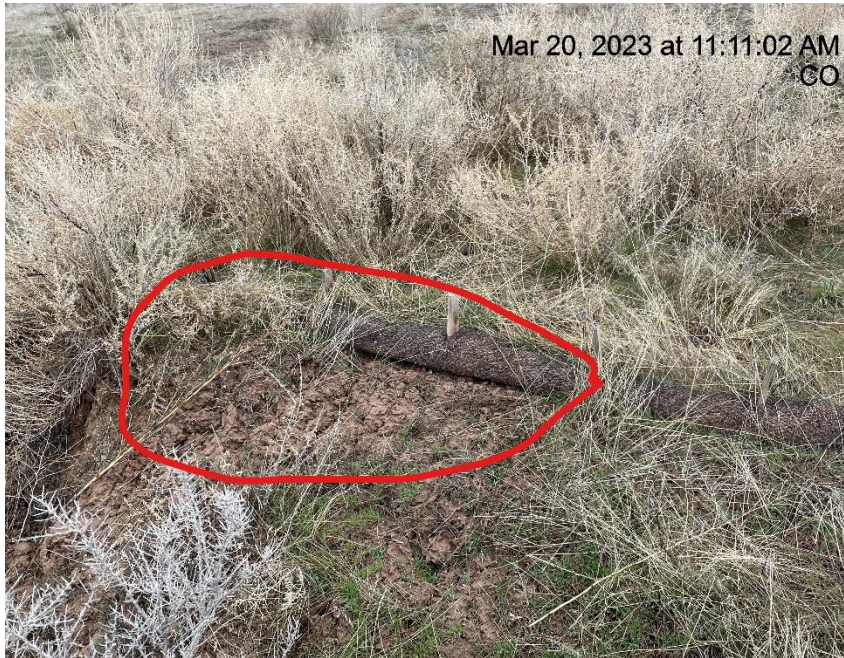
Photo # 2609 Waddles around culvert need maintenance

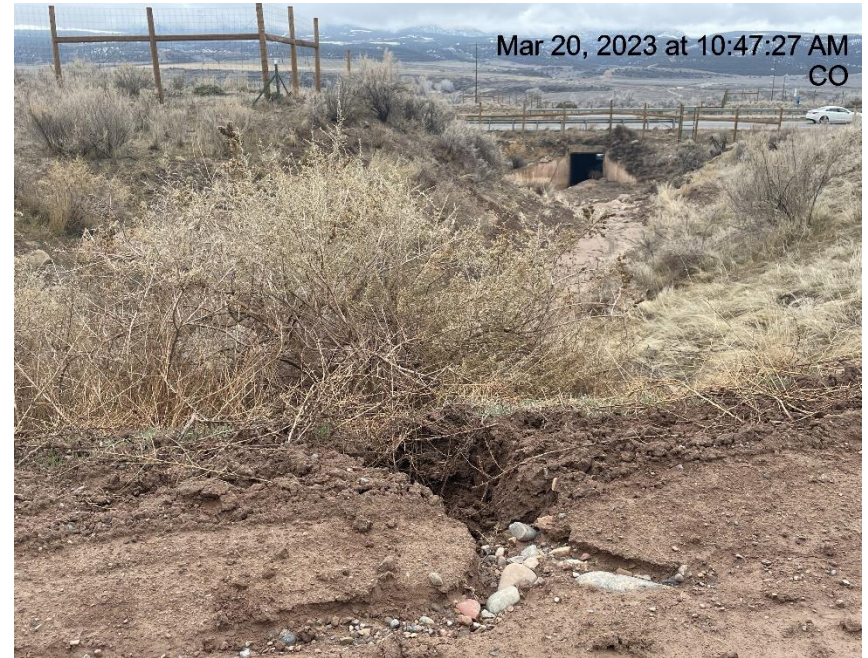
Photo # 2595 Gully erosion

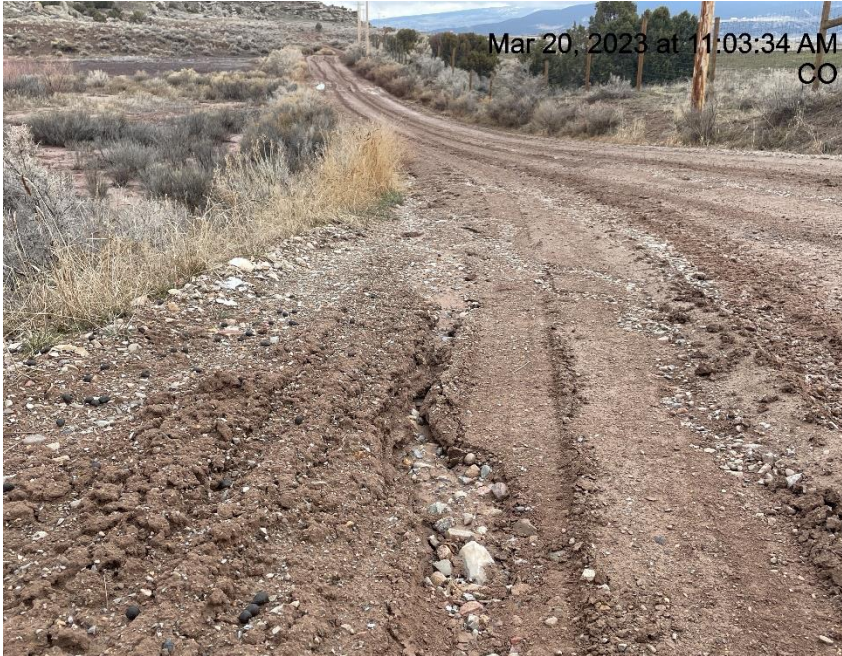
**Photo # 2603 Rill erosion on lease road**

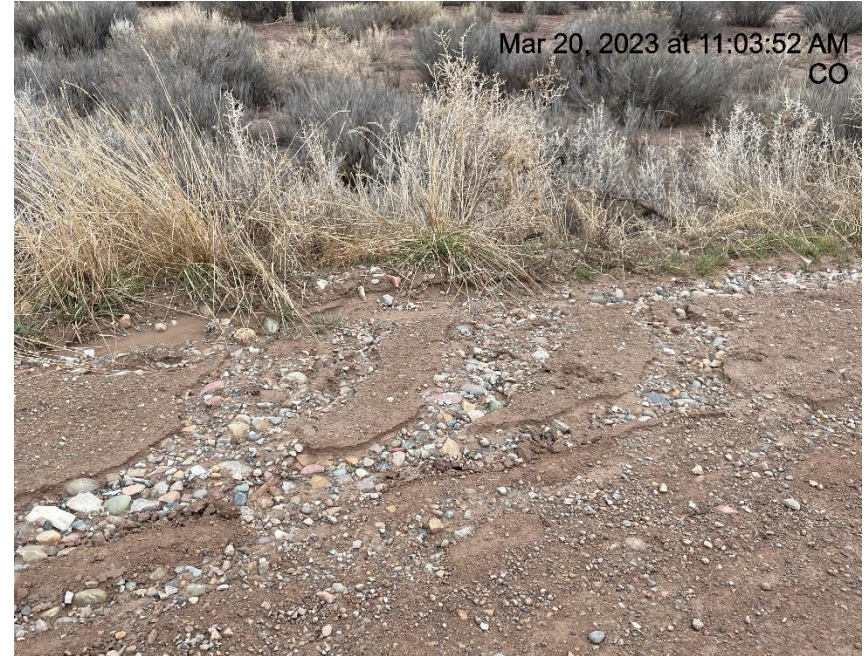
**Photo # 2605 Rill erosion on lease road**

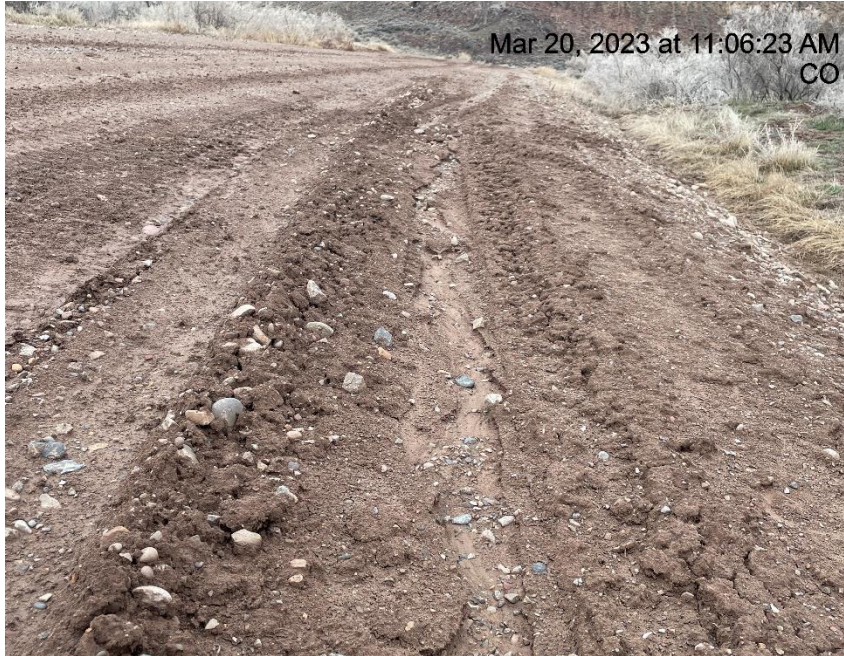
**Photo # 2608 Rill erosion on lease road**

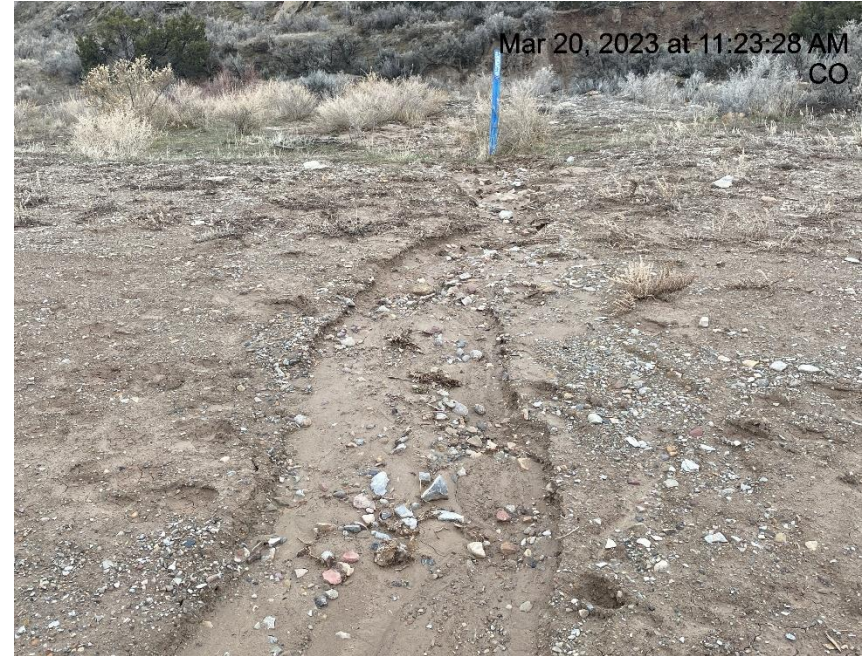
**Photo # 2614 Erosion on lease road**

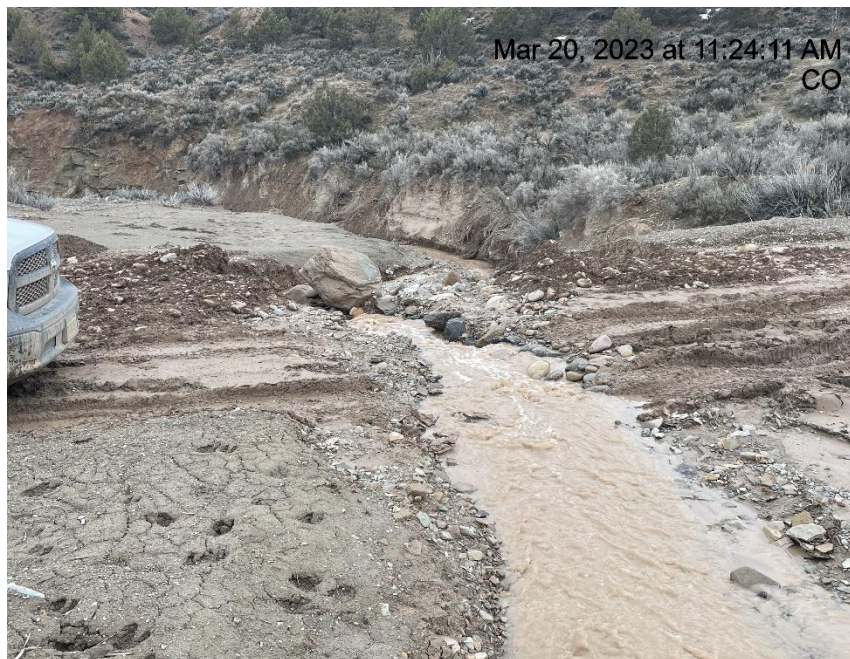
**Photo # 2616 Degradation of roadway/insufficient BMP's**

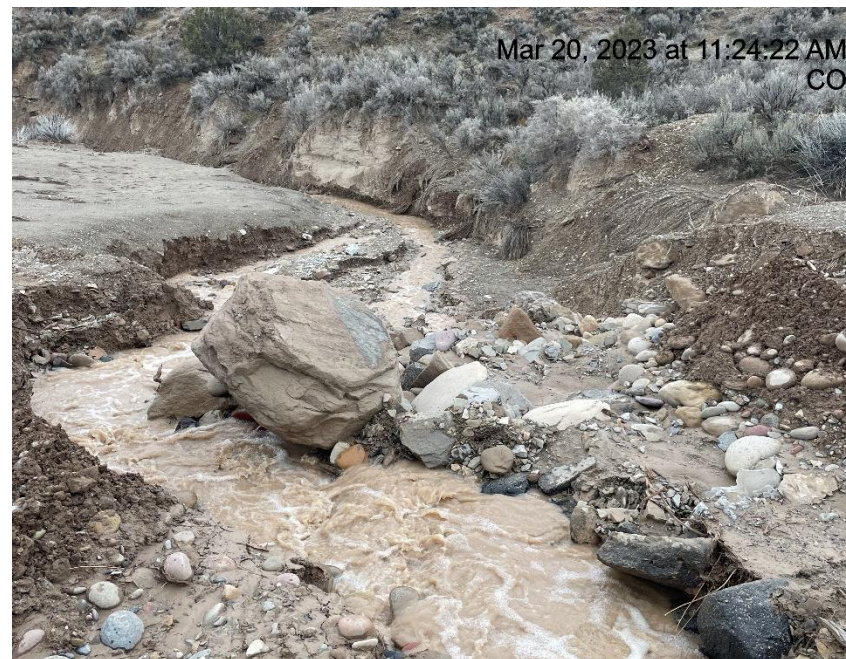
**Photo # 2617 Degradation of roadway/insufficient BMP's**

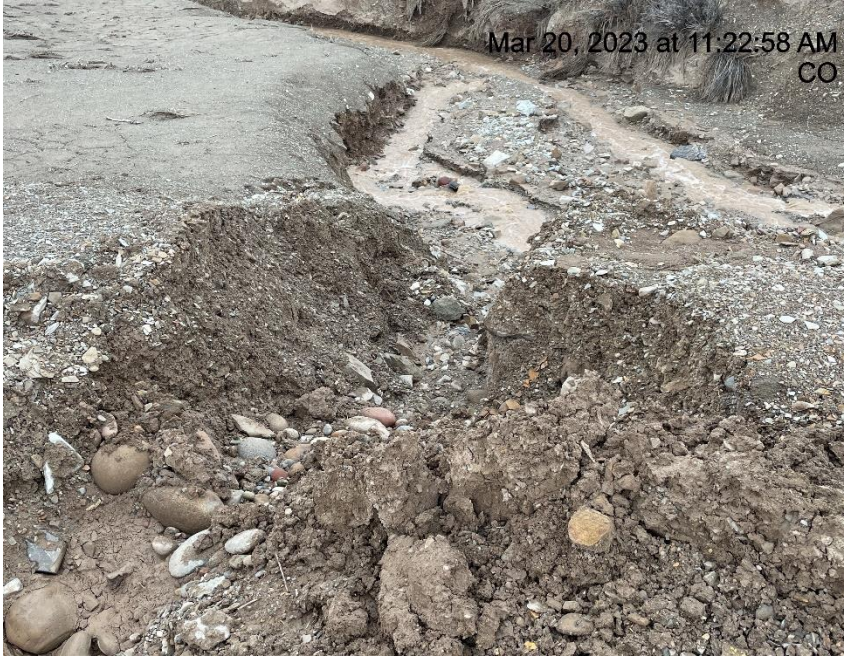
**Photo # 2613 Degradation of roadway/insufficient BMP's/erosion of area near road**

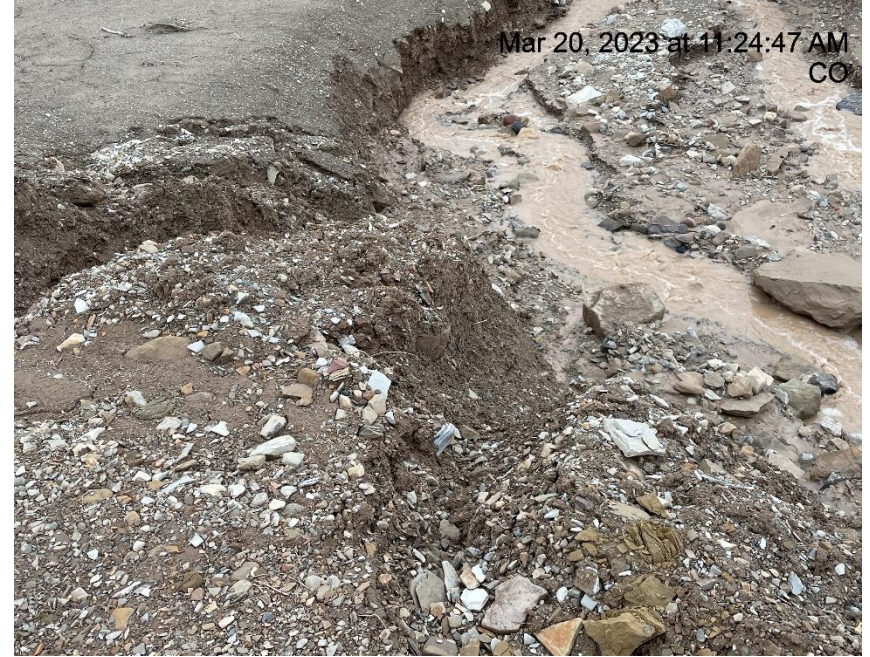
**Photo # 2618 Degradation of roadway/insufficient BMP's/erosion of area near road**

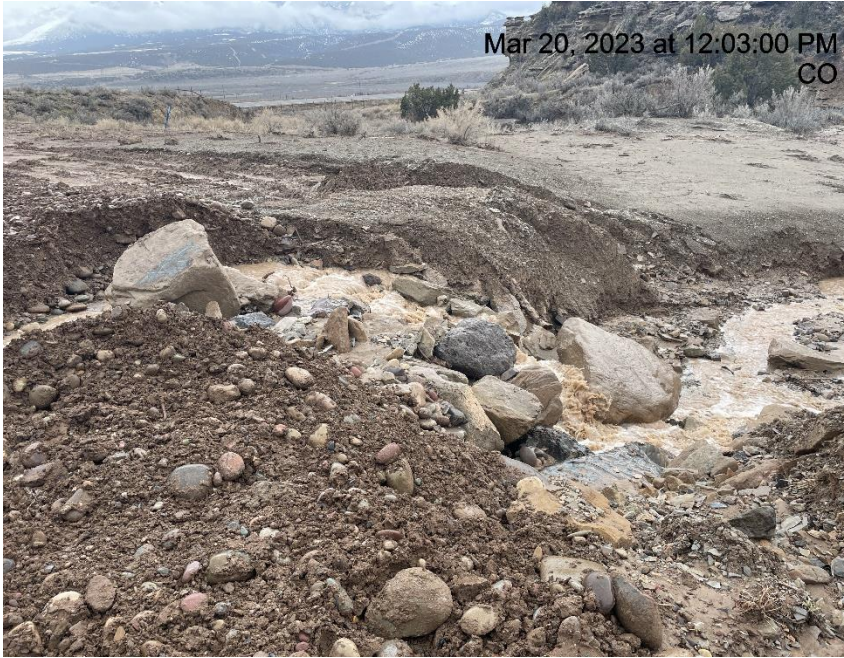
**Photo # 2657 Degradation of roadway/insufficient BMP's/erosion of area near road**

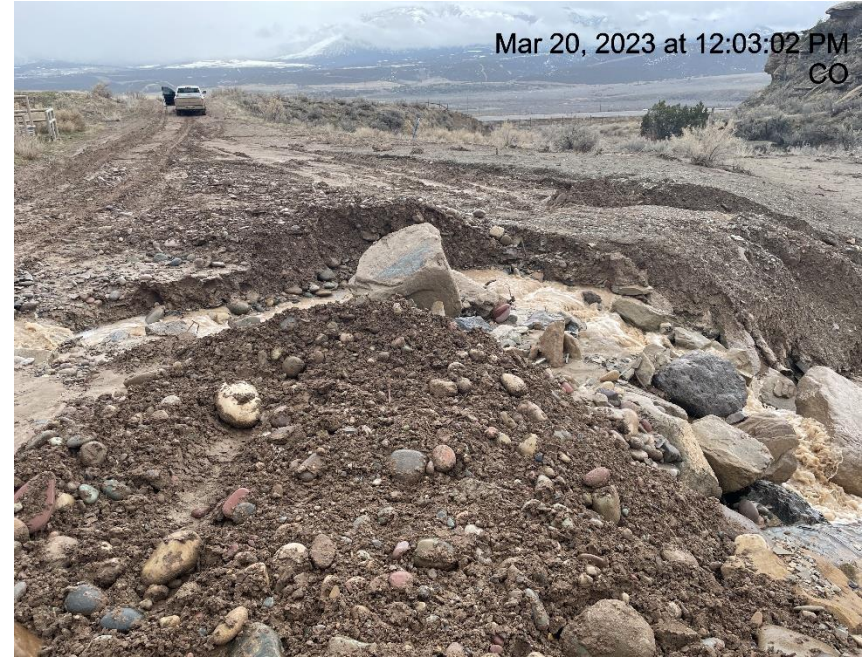
**Photo # 2658 Degradation of roadway/insufficient BMP's/erosion of area near road**
