Inspection Photos
Location Name: Genesis #9-2 and #3
Location ID: 319579

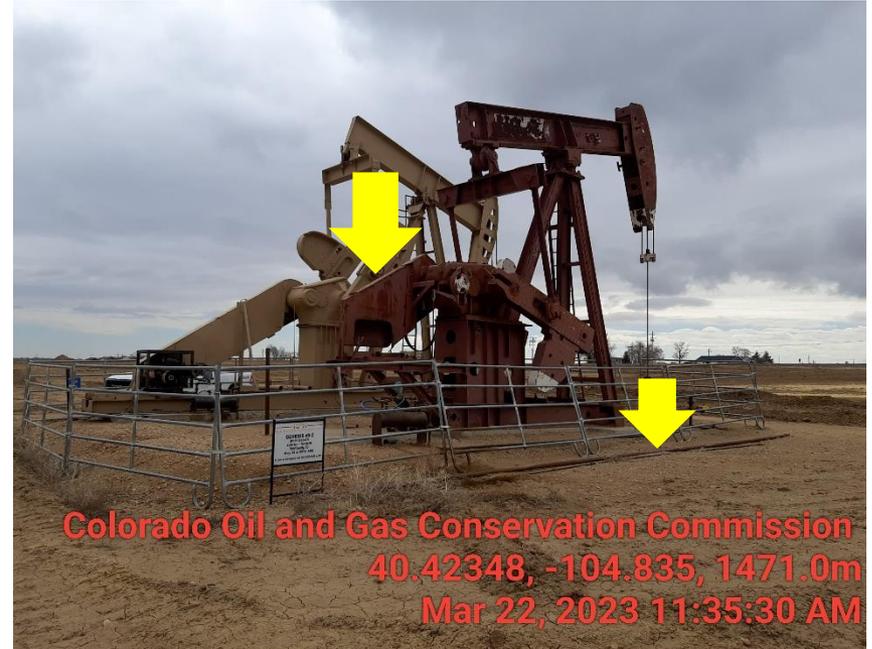
Photo 2 Genesis #9-2 PU has no motor, tubing and rod on ground.
PU is considered unused equipment due to not having a motor.

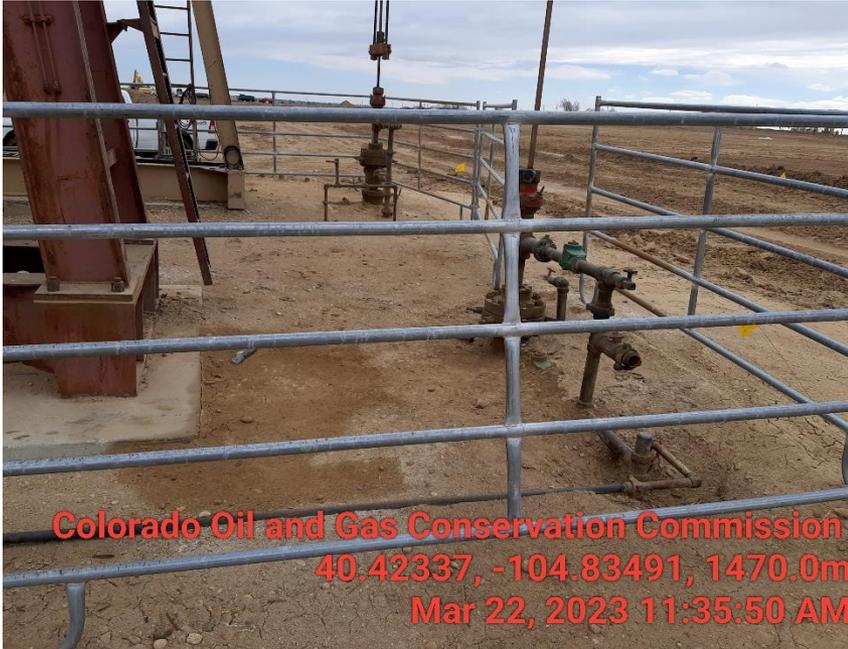
Photo 3 stained soil on Genesis 9-2

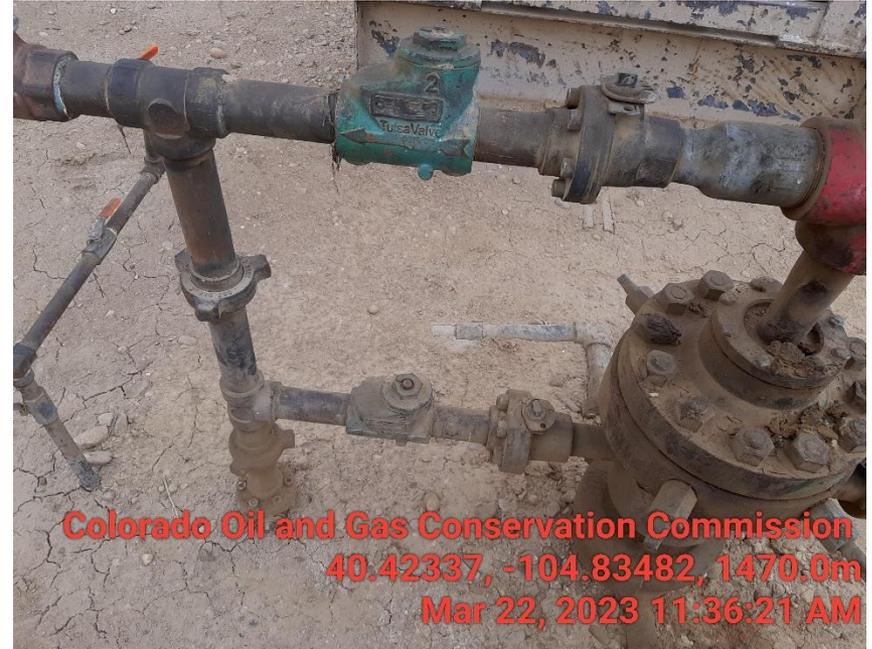
Photo 4 flow line appear to be in the open position on Genesis #3

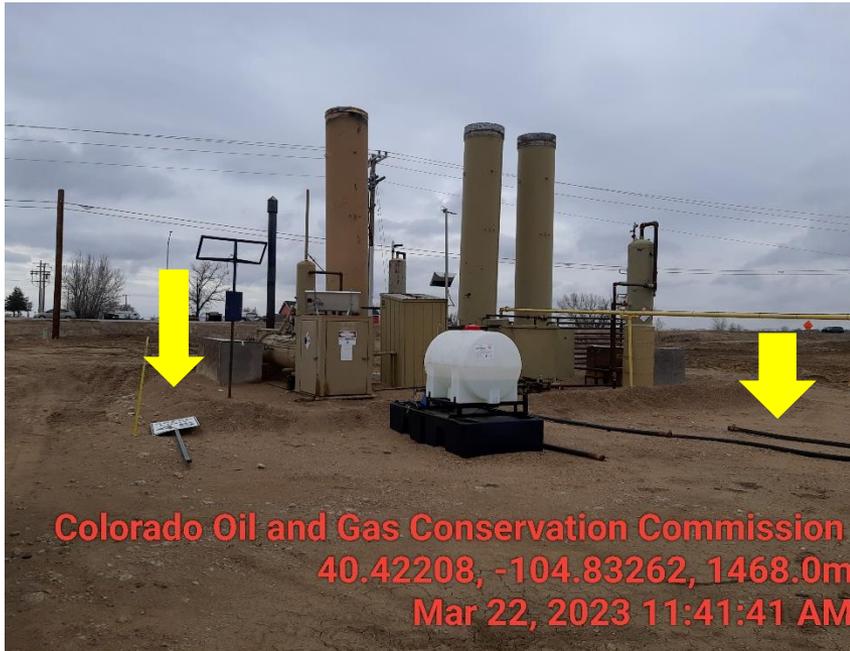
Photo 5 unused equipment sign and 2' hose.

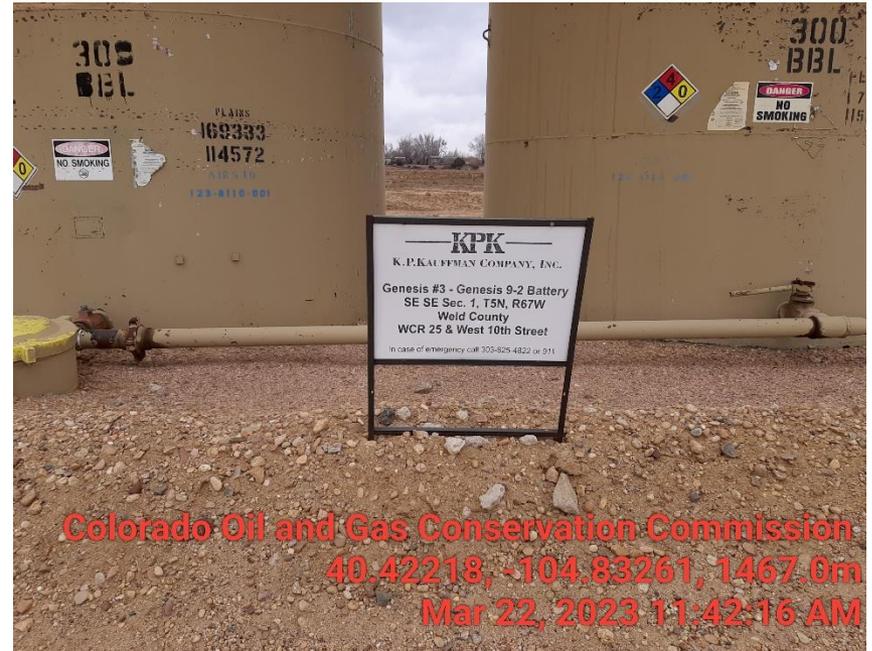
Photo 6 TNK BTRY sign

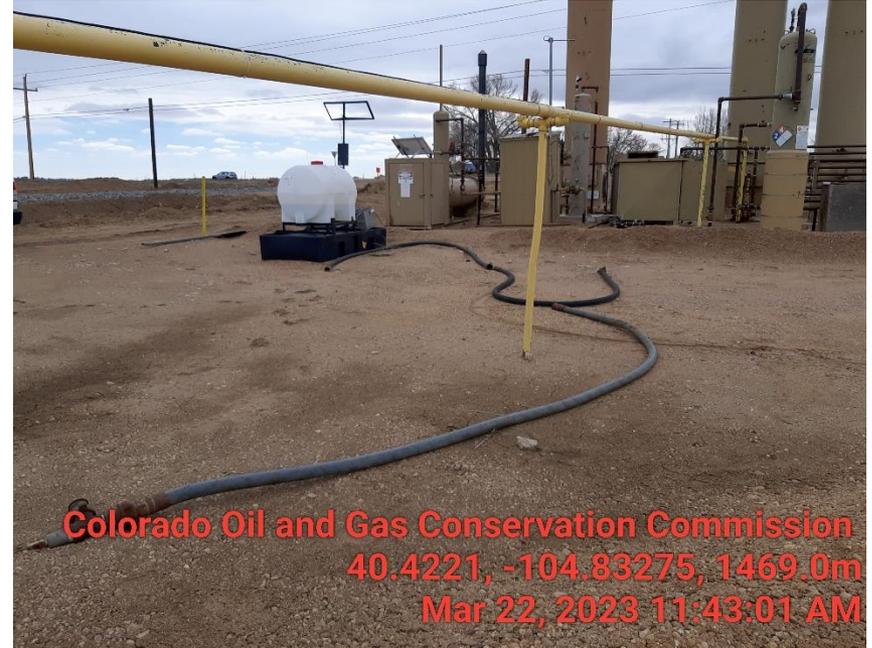
Photo 8 unused equipment 2" hose

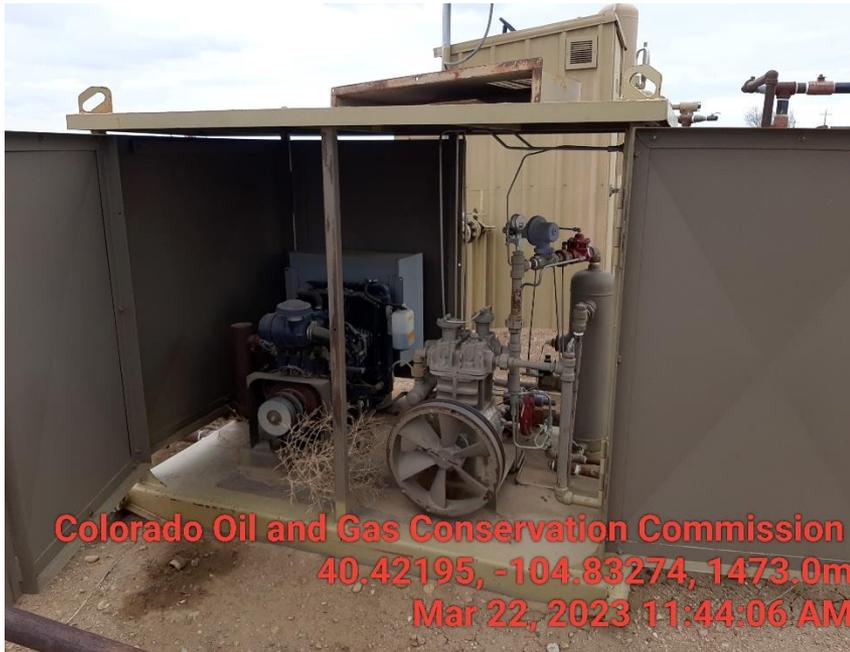
Photo 9 Unused equipment/Mechanical issue, pump and motor have no belts and piping has been removed not operational. Stained soil

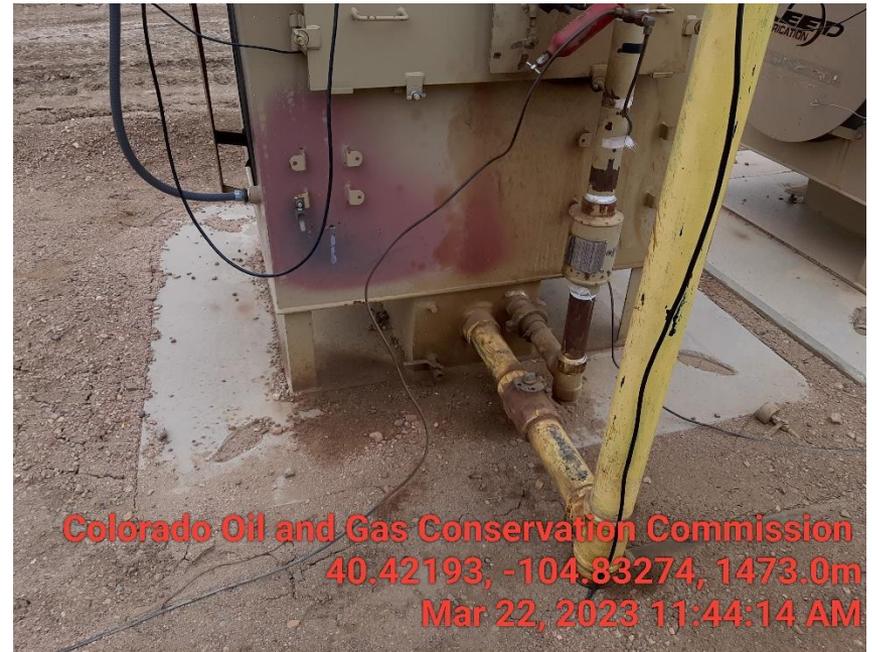
Photo 10 Stained soil/Mechanical issue piping on ECD

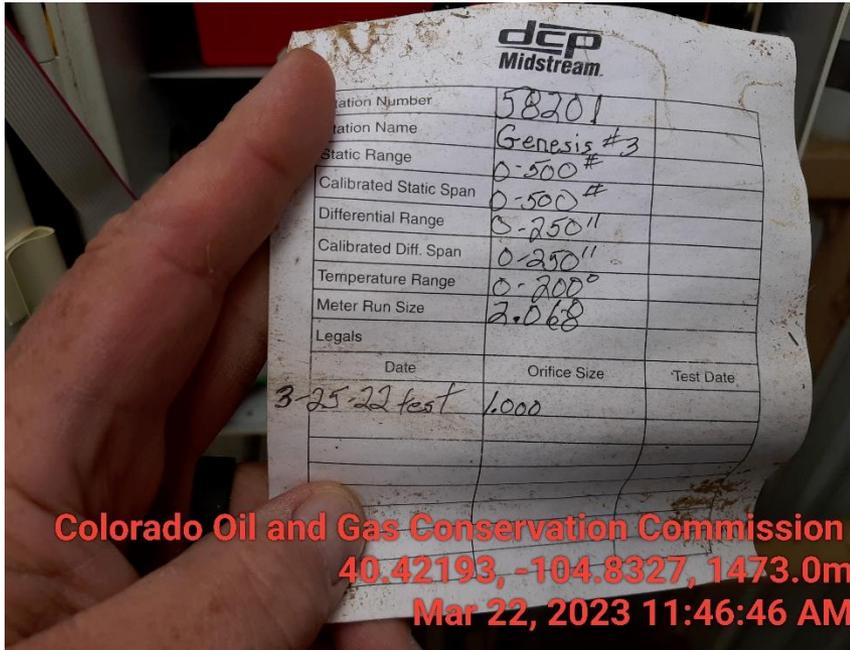
Photo 11 sales meter out of calibration.

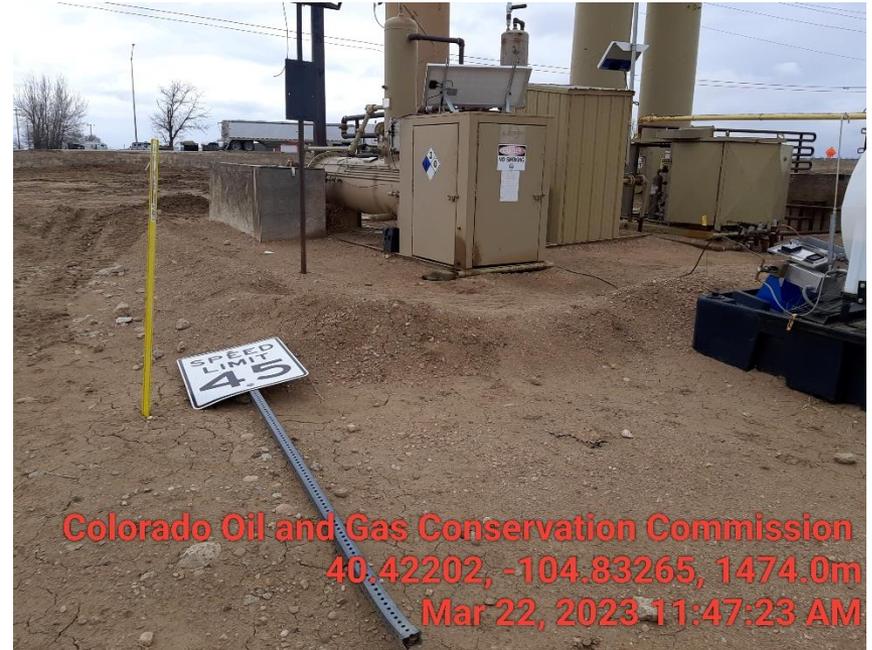
Photo 12 unused equipment (sign)
