Inspection Photos

Location Name: TEP ROCKY MOUNTAIN LLC BARRETT-66S96W /36SESW.

Location ID: 334947

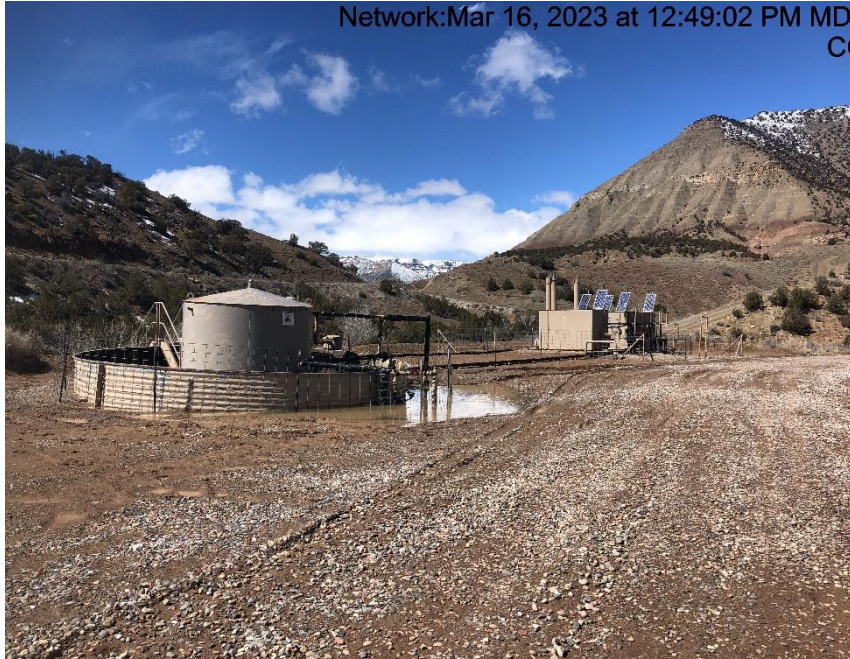
Photo #9252 From entrance to location.

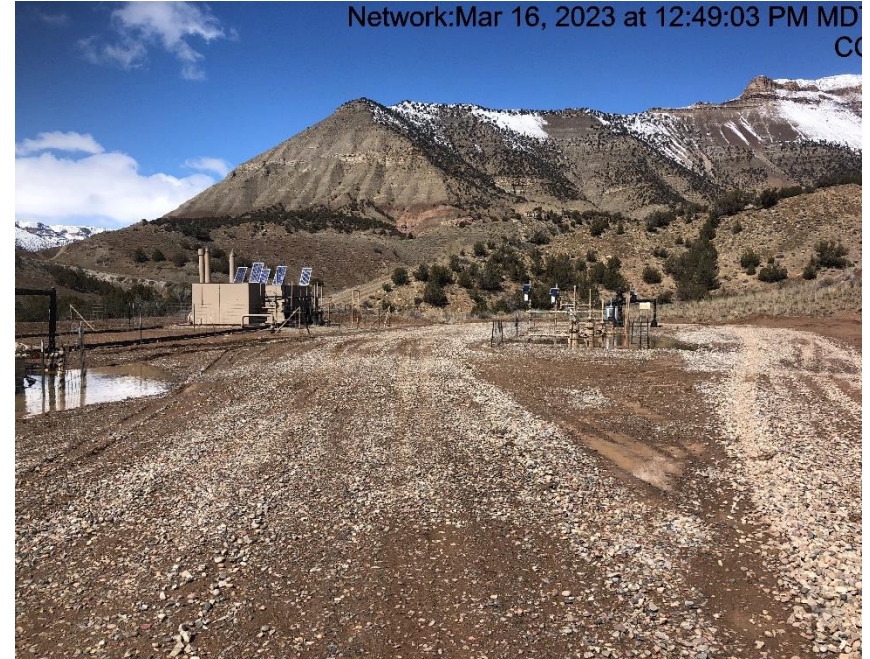
Photo #9253 From entrance to location

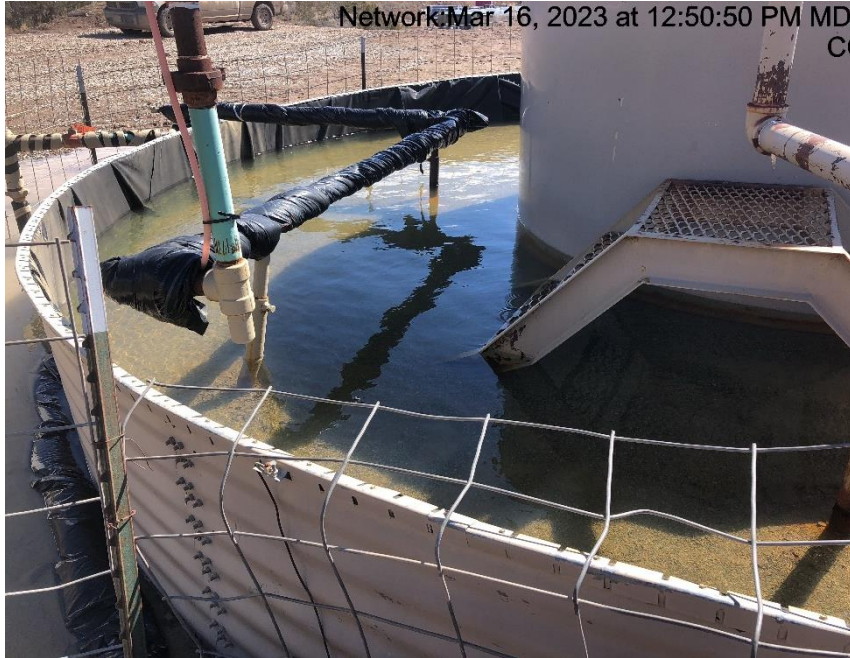
Photo #9254 Secondary containment capacity reduced due to storm water.

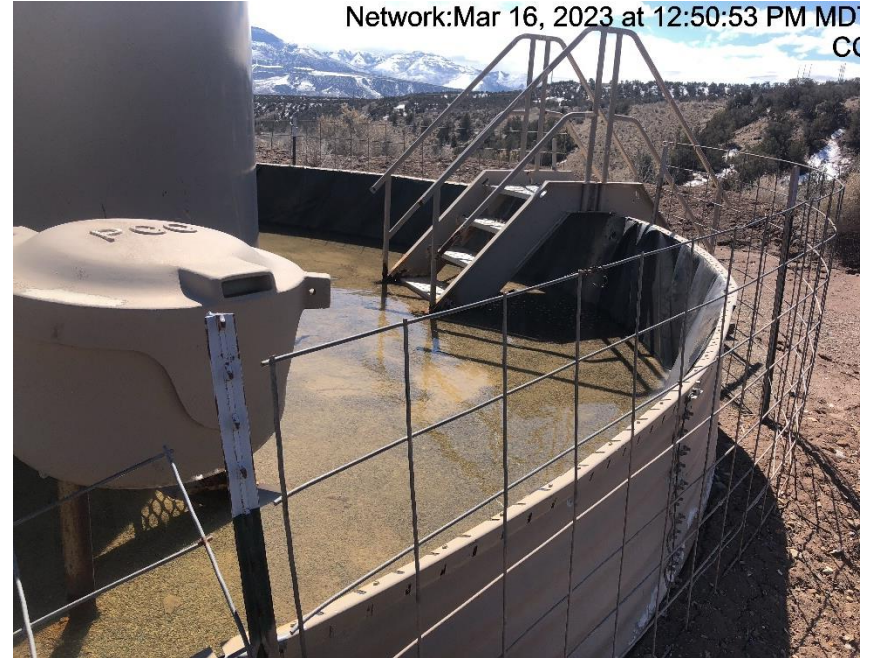
Photo #9254 Secondary containment capacity reduced due to storm water.

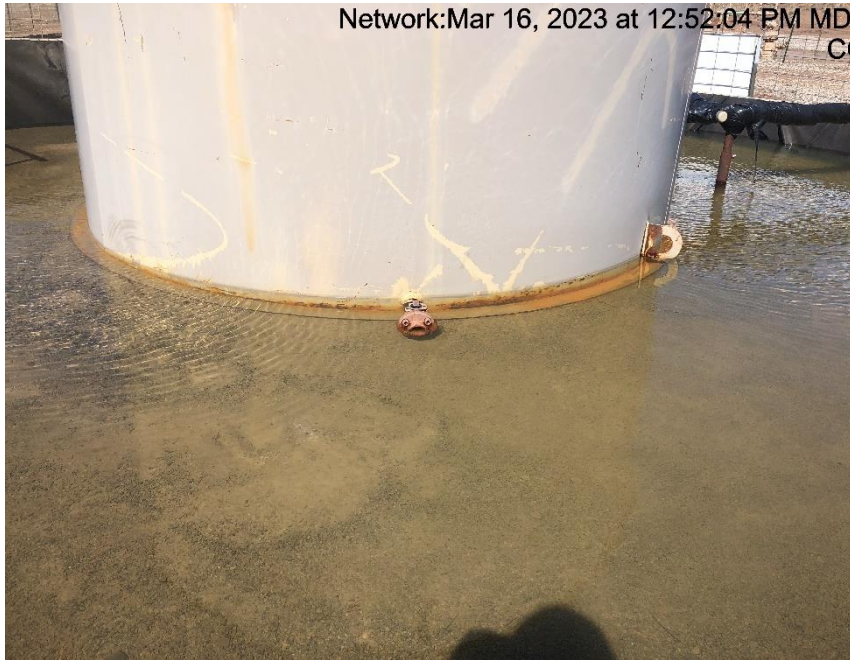
Photo #9257 Loadline open ended.

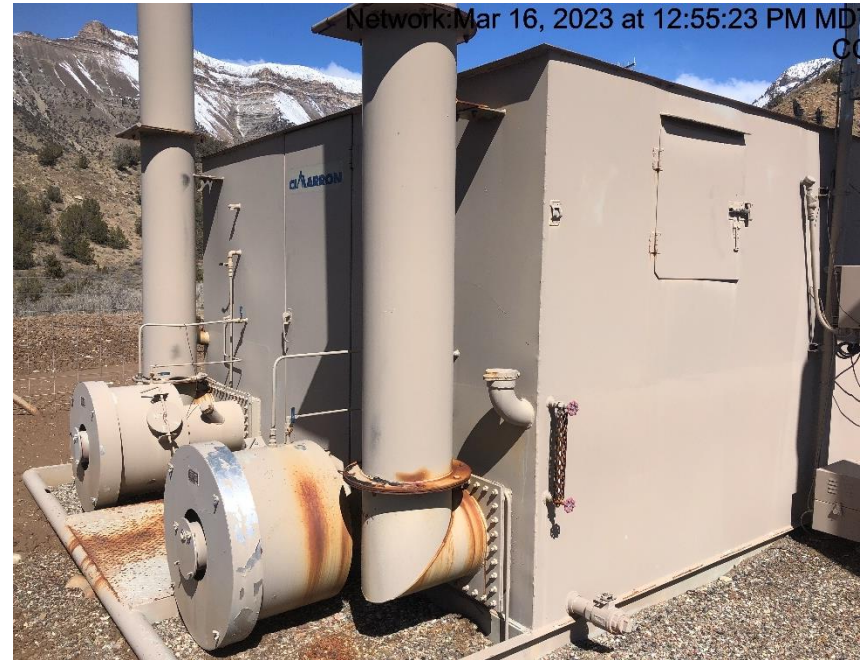
Photo #9259 Calibration cards not conspicuously posted

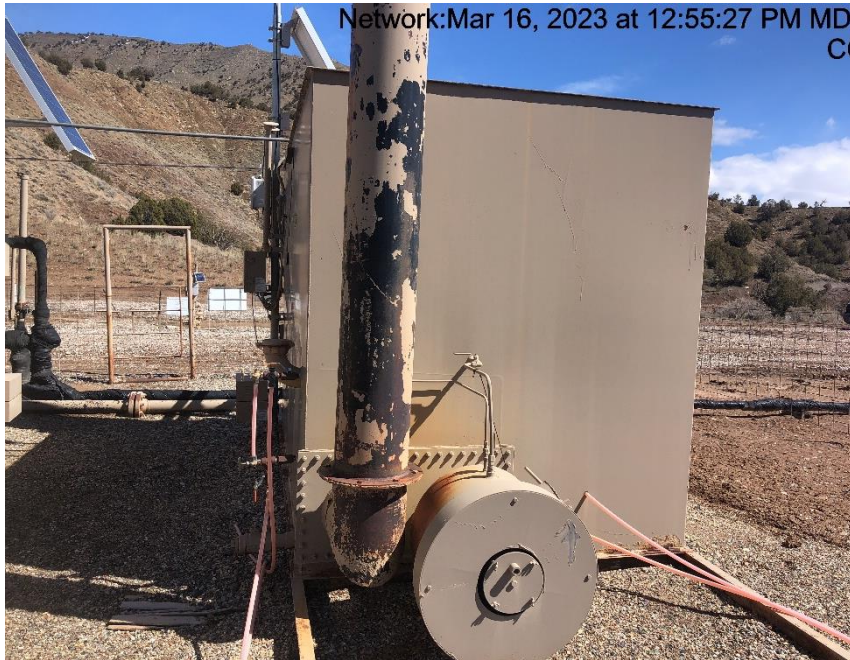
Photo #9260 Calibration cards not conspicuously posted.
