# Inspection Photos

3/21/2023

Operator: CAERUS PICEANCE LLC #10456

Location #335781

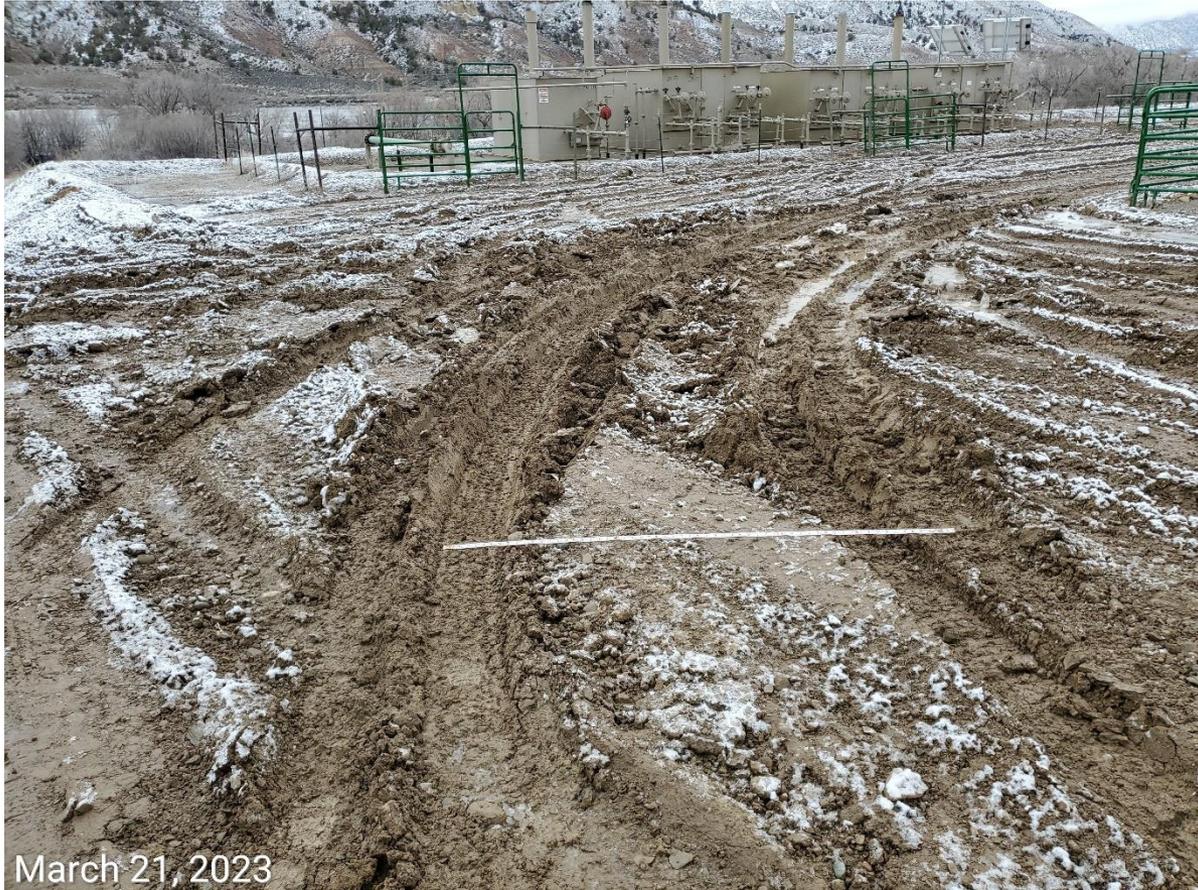
**Photo 1:** Photos 1-16 taken from throughout the working pad areas of the Location. Photos examples showing BMPs, including vehicle tracking control measures, remain missing or insufficient to stabilize, as well as to minimize erosion, degradation, tracking and sediment transport during wet conditions. Degradation of the working pad has persisted since the 1/25/2023 inspection. Regrading alone will be inadequate to address tracking and stabilization issues. 6 foot measuring stick in photos for reference.

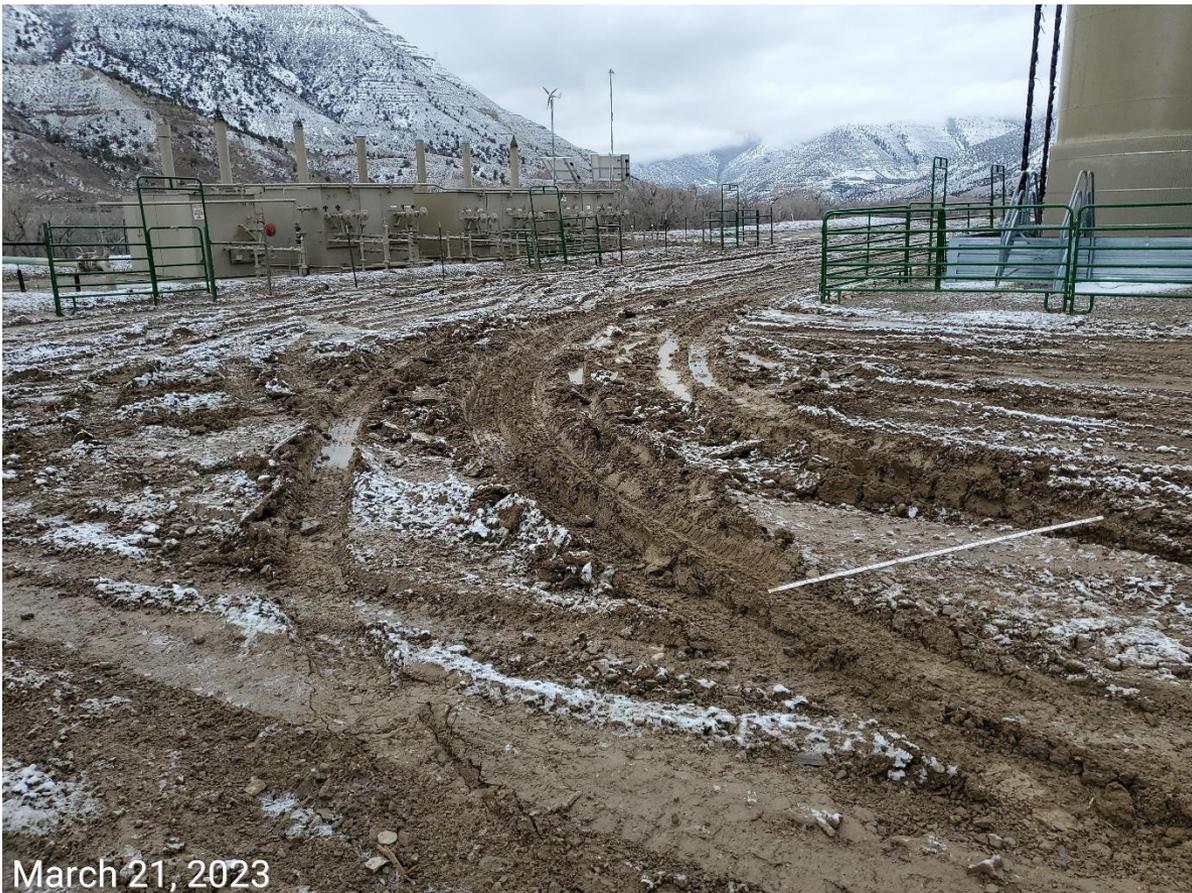
**Photo 2:** See comments under photo 1.

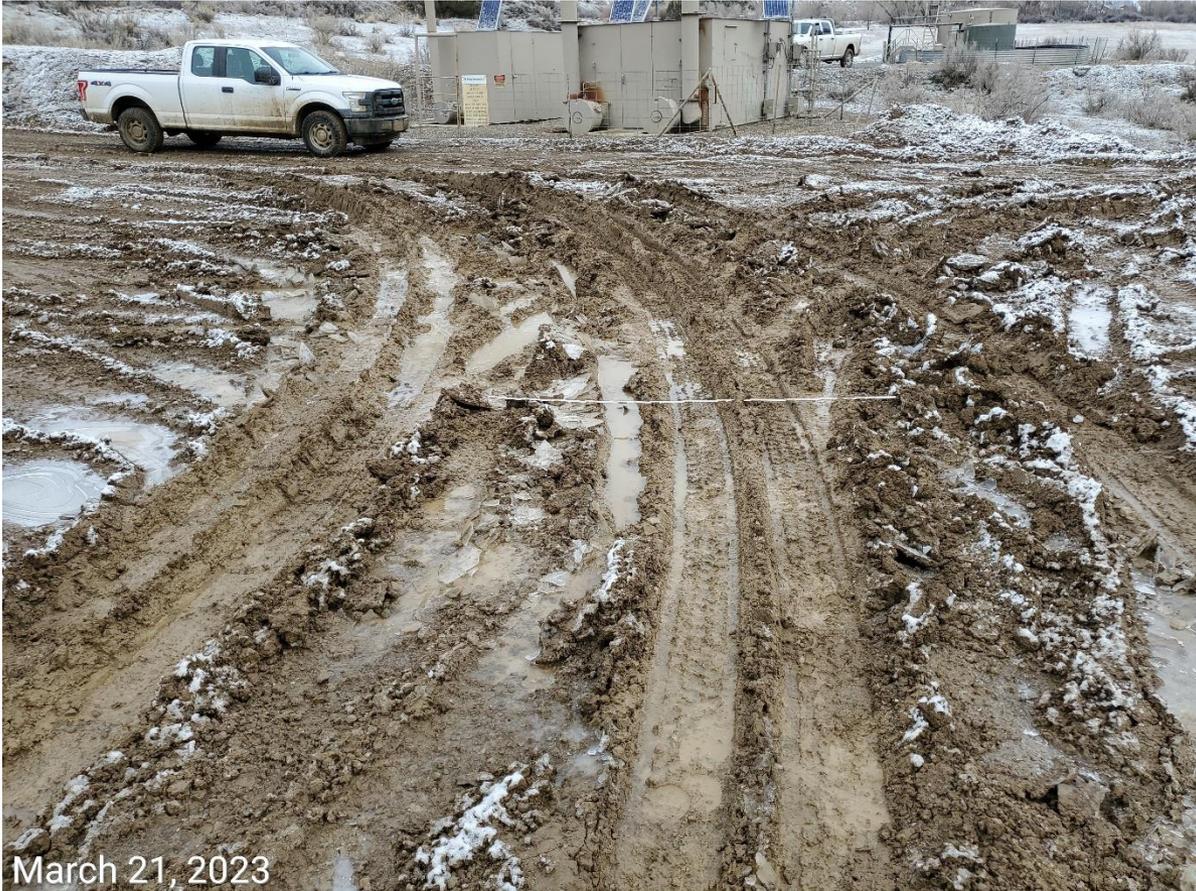
**Photo 3:** See comments under photo 1.

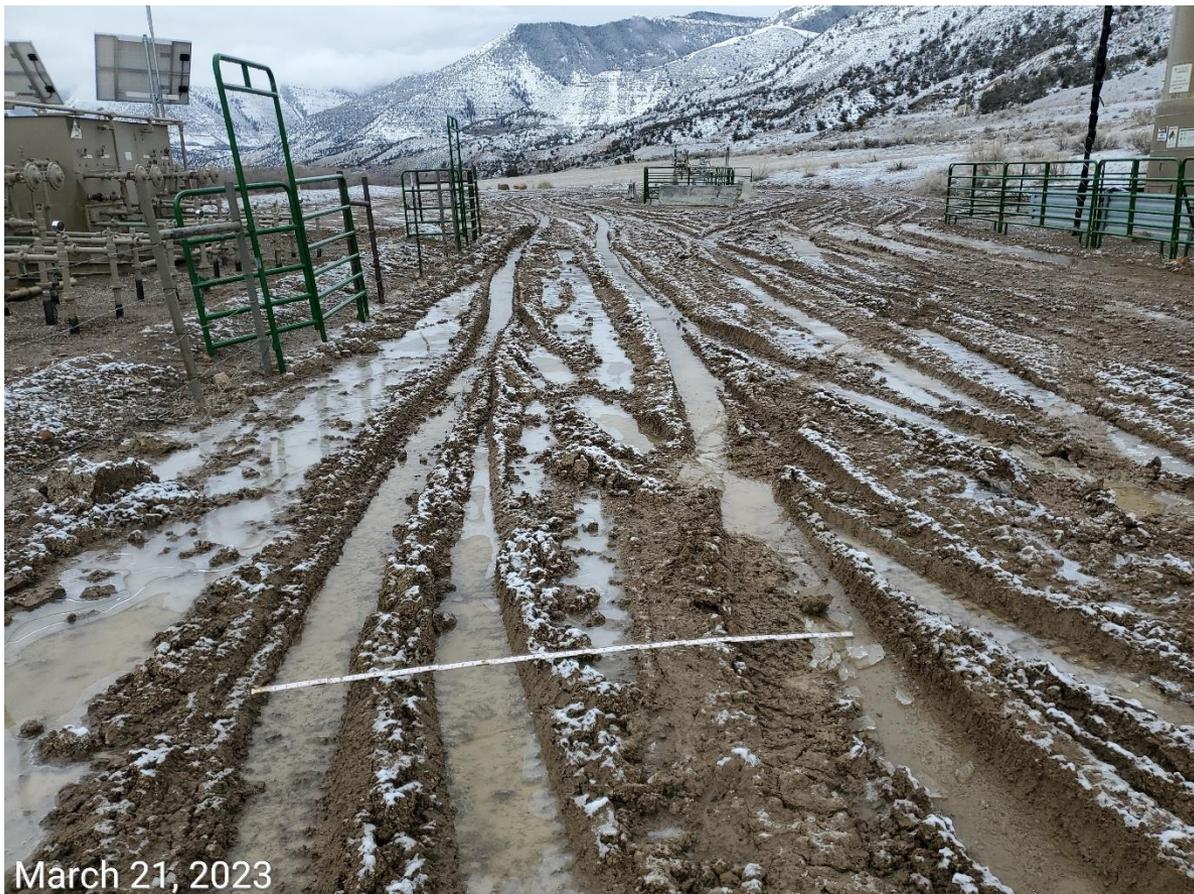
**Photo 4:** See comments under photo 1.

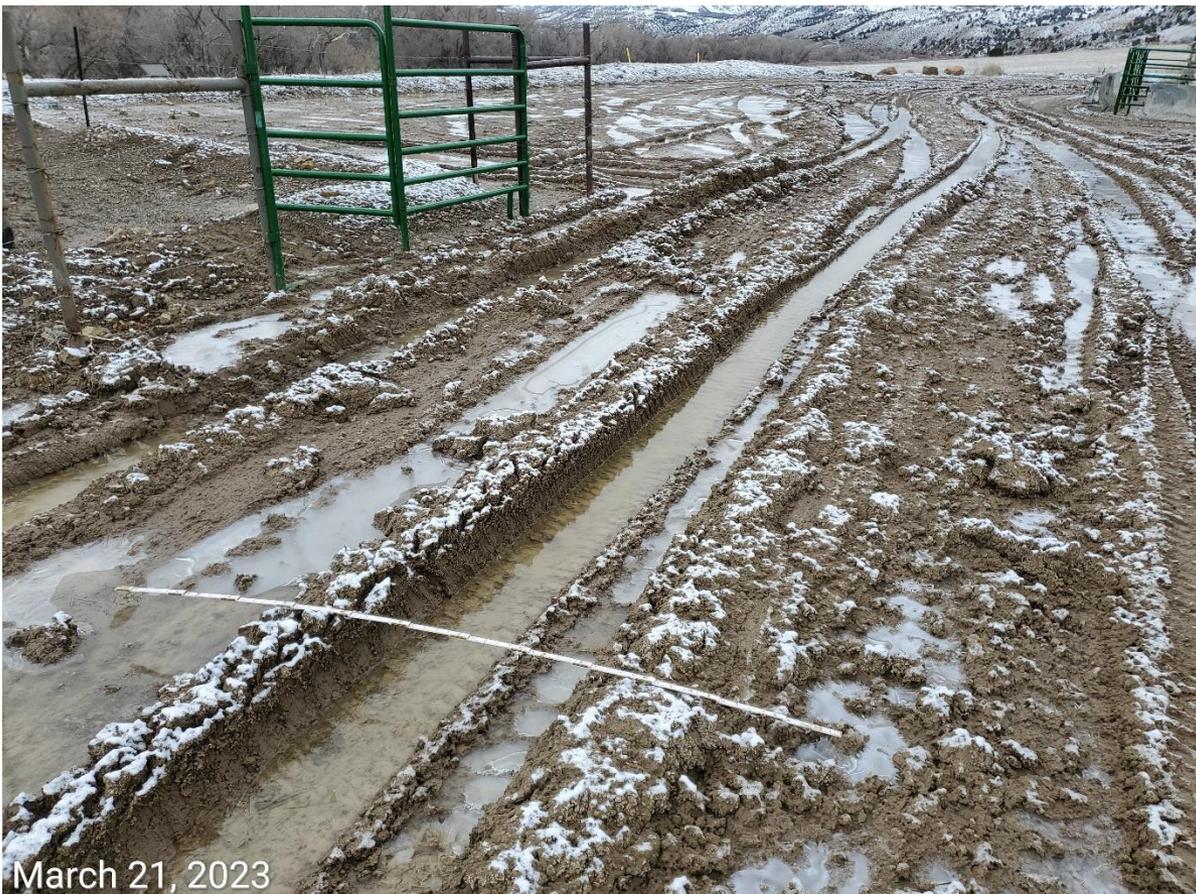
**Photo 5:** See comments under photo 1.

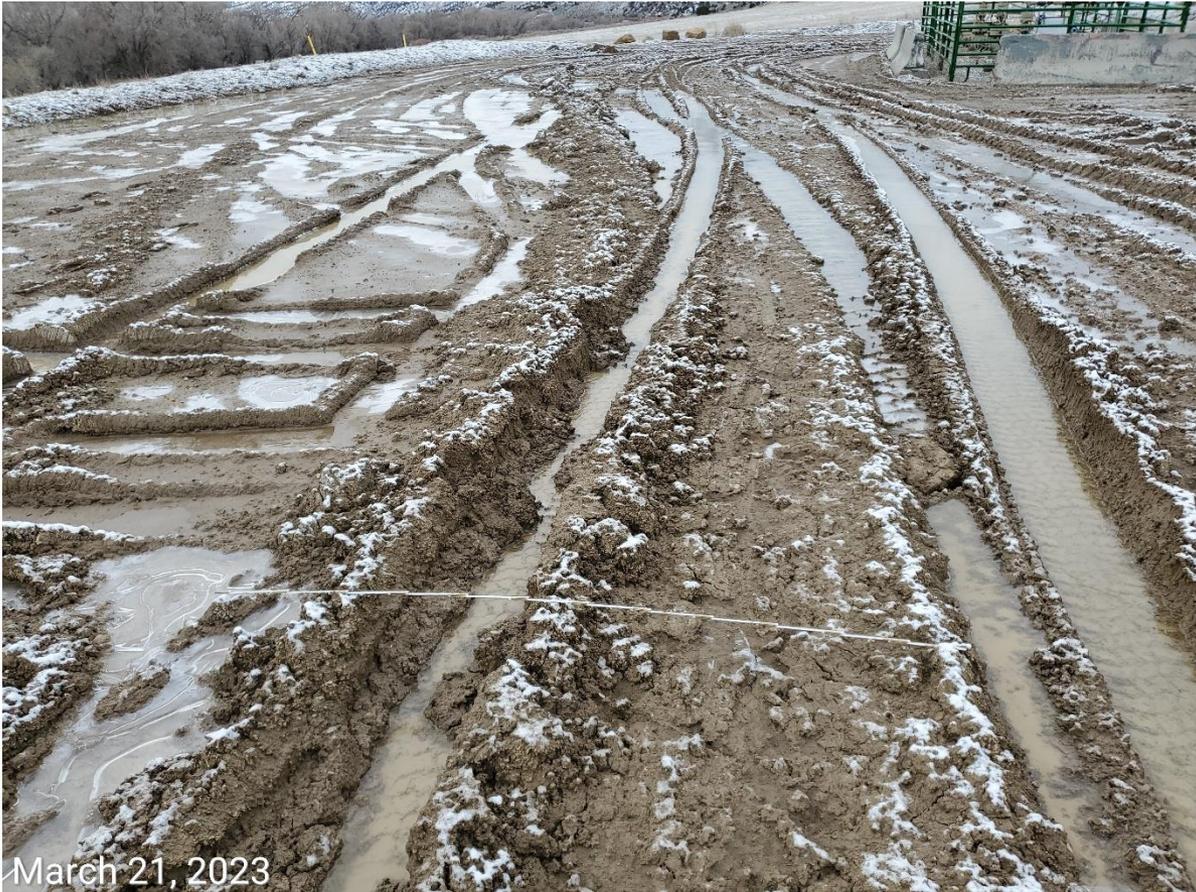
**Photo 6:** See comments under photo 1.

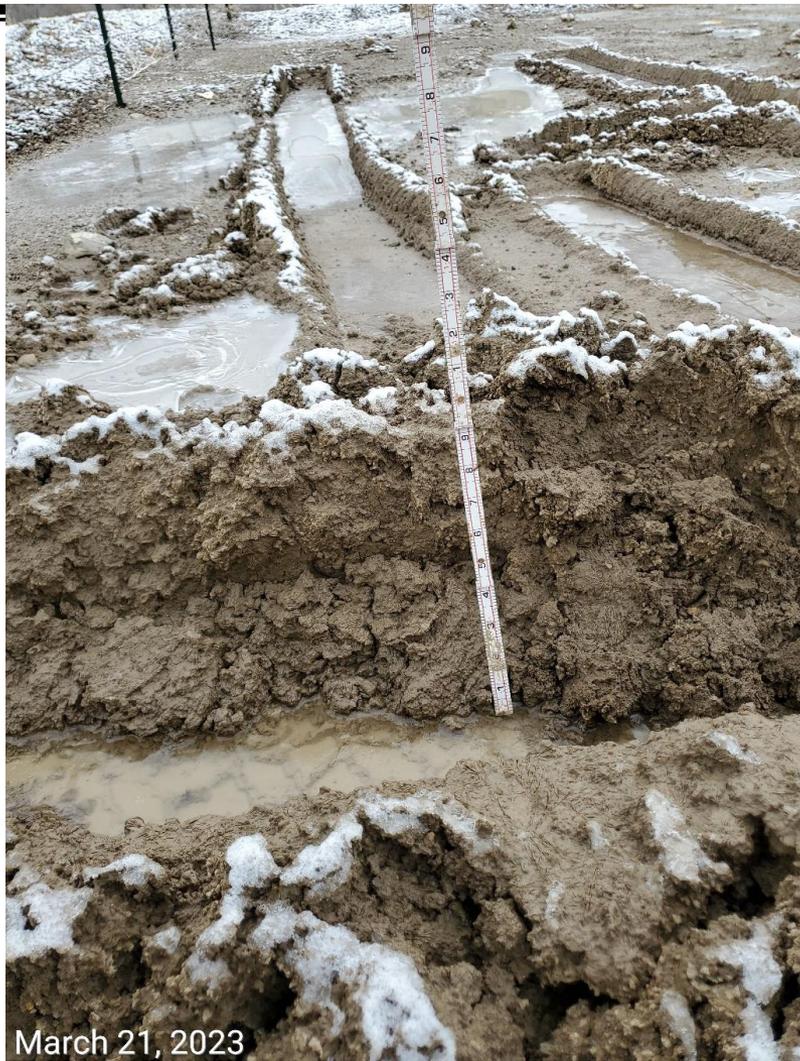
**Photo 7:** See comments under photo 1. Rutting observed to be close to 1 foot in depth at certain areas of the working pad.

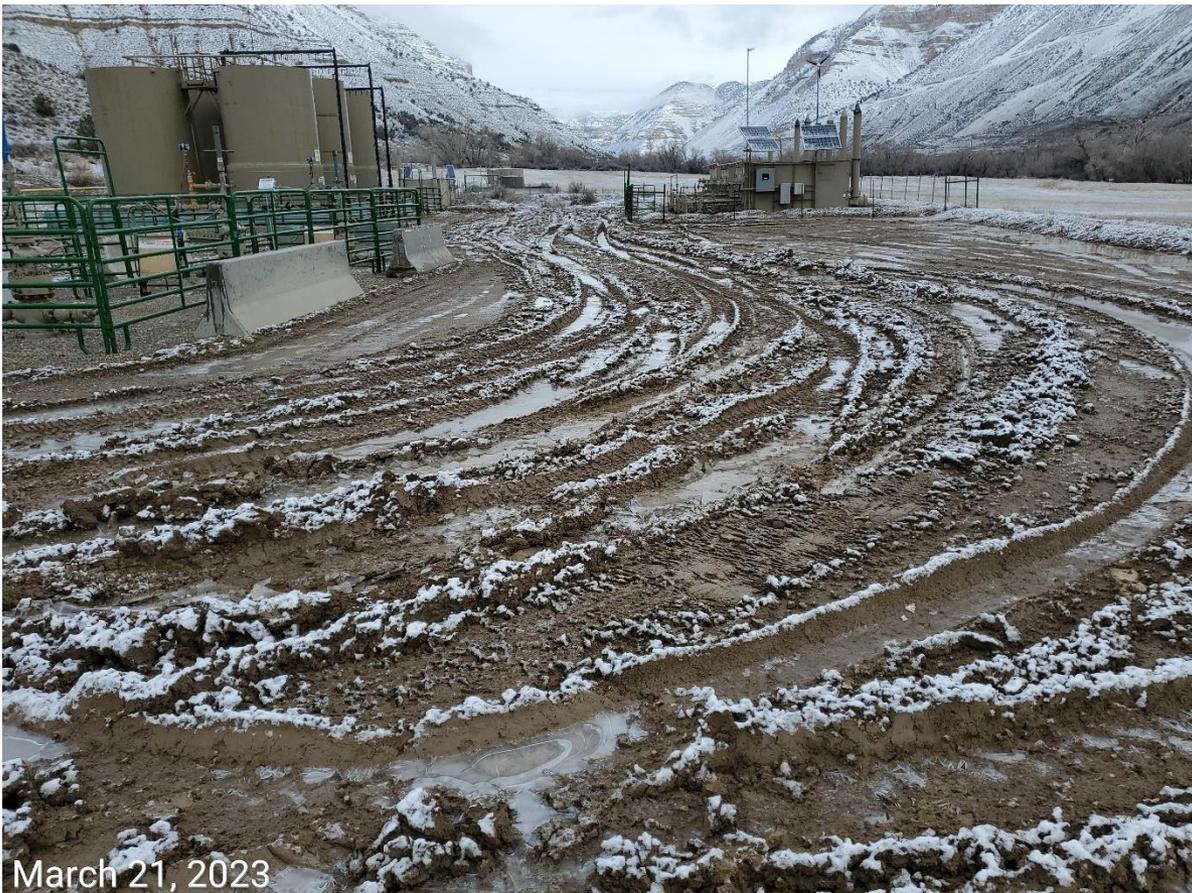
**Photo 8:** See comments under photo 1.

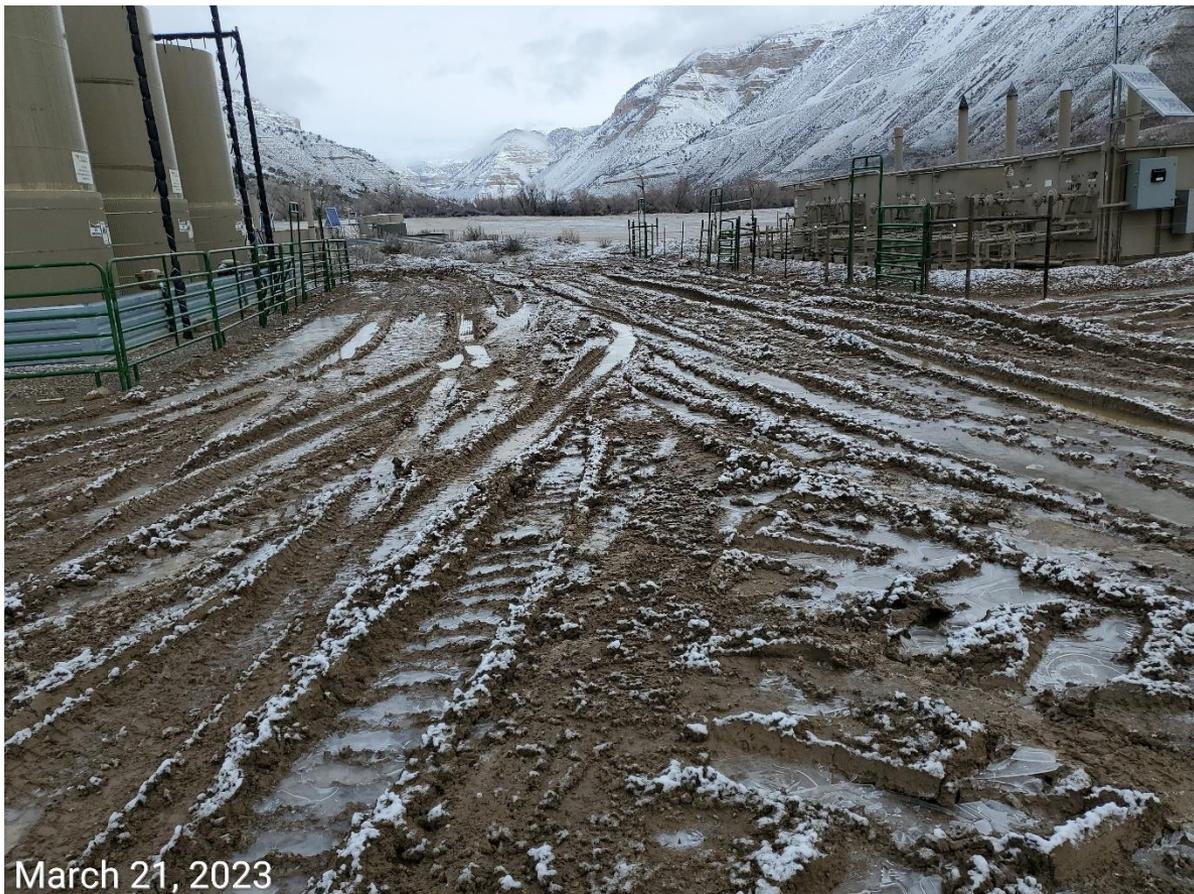
**Photo 9:** See comments under photo 1.

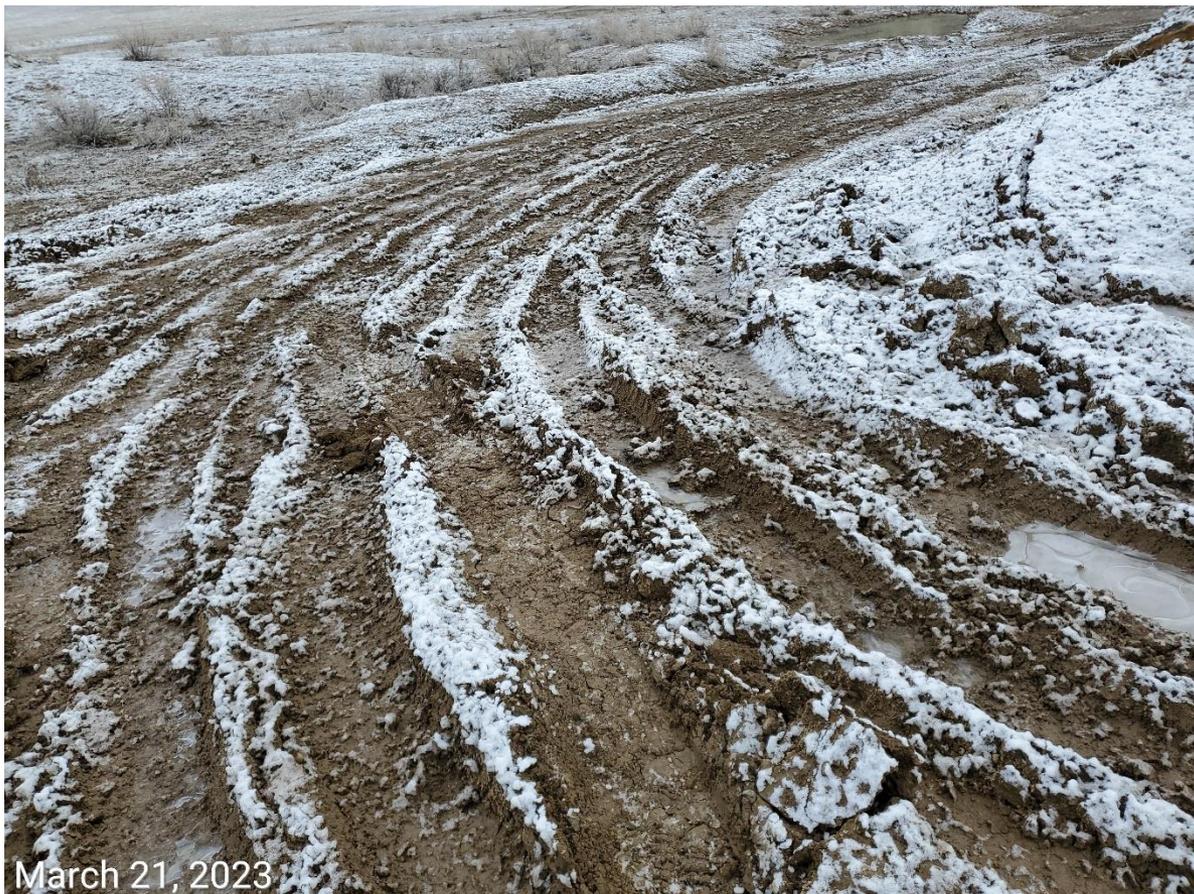
**Photo 10:** See comments under photo 1.

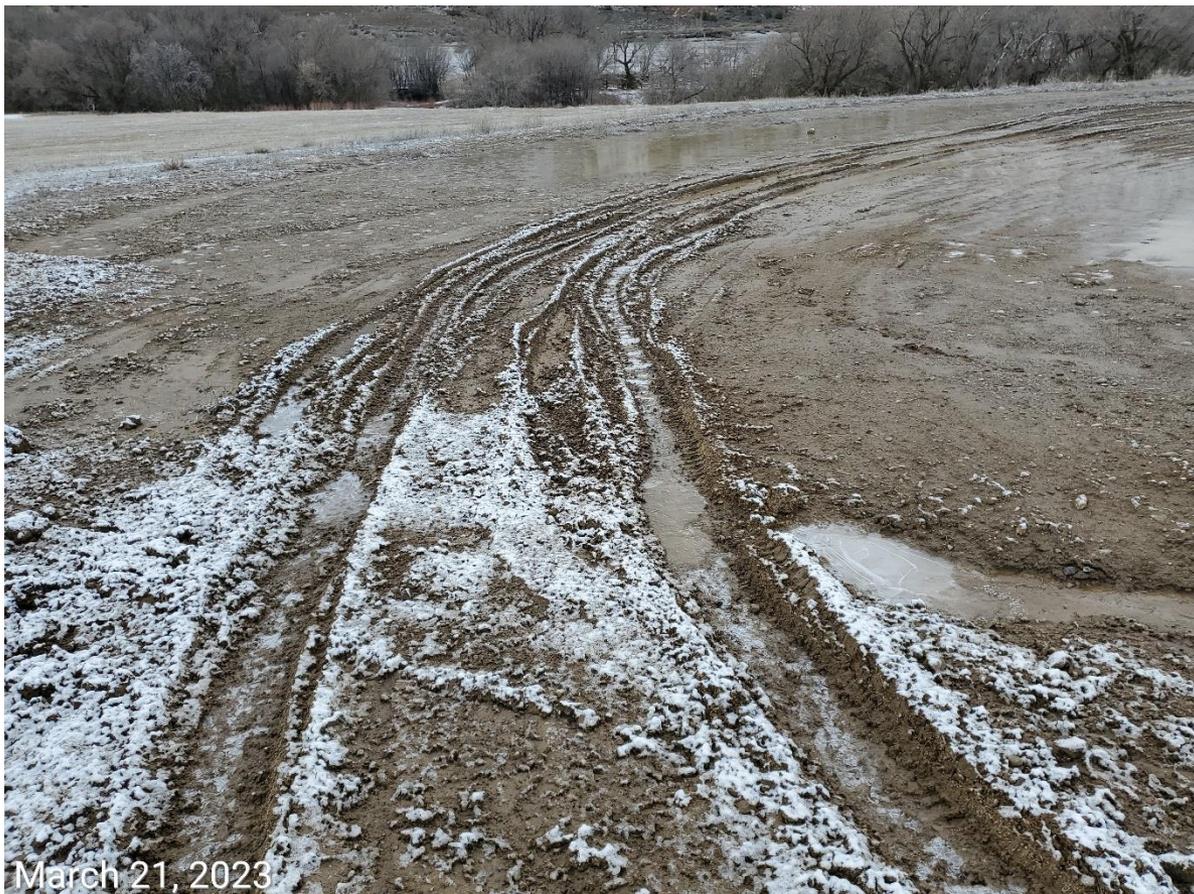
**Photo 11:** See comments under photo 1.

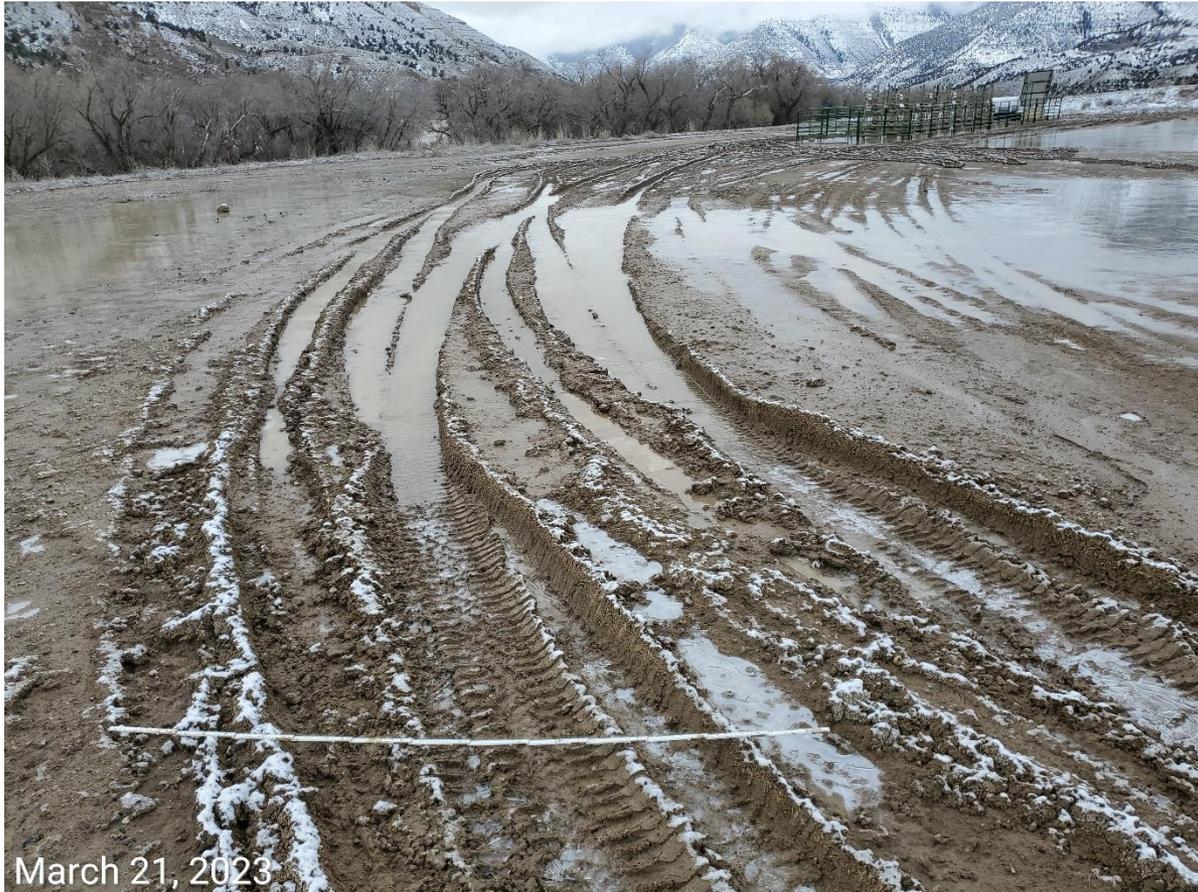
**Photo 12:** See comments under photo 1. Photos 12-16 also show that the eastern working pad areas have not been properly engineered/graded to allow for adequate stormwater discharge, resulting in ponding at production equipment, ponding on the pad, and further destabilization; BMPs to allow for proper discharge, as well as to minimize stormwater contact/ponding at production equipment also required.

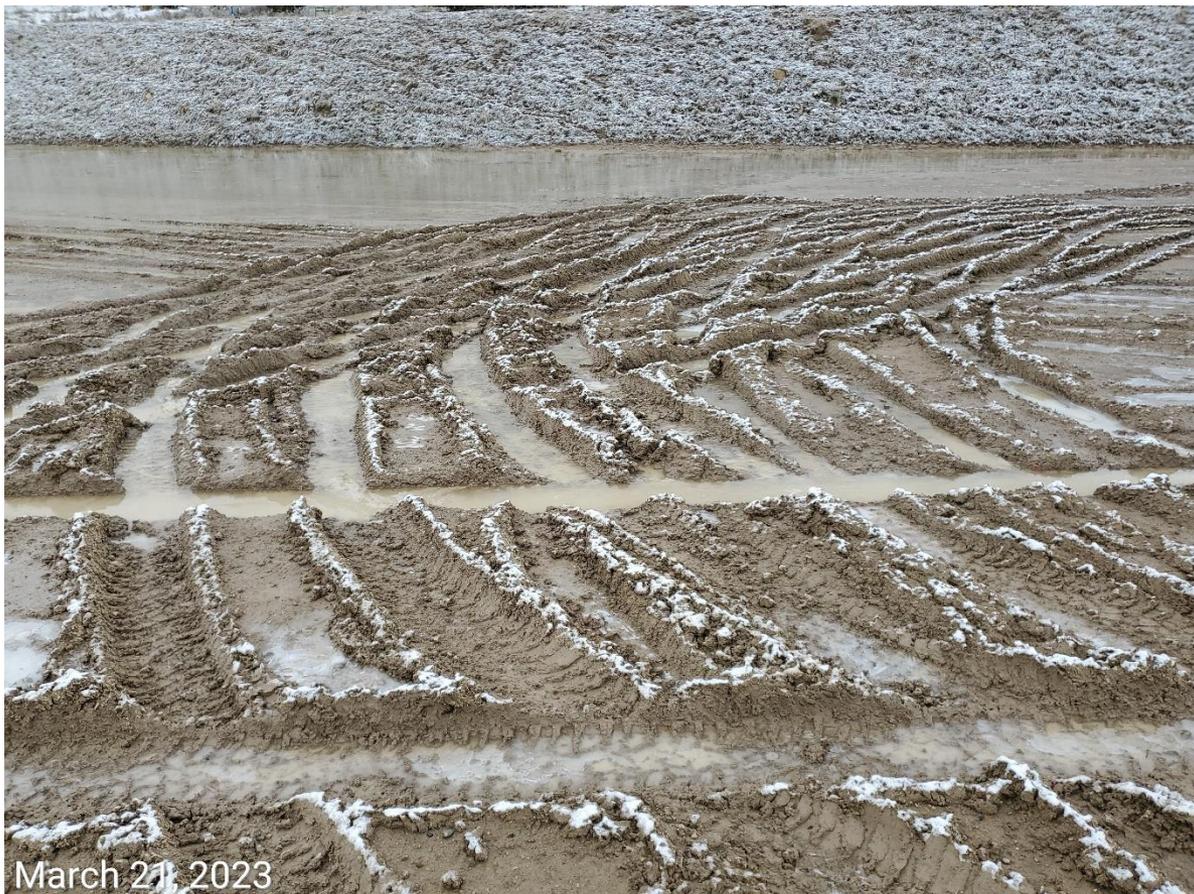
**Photo 13:** See comments under photo 1 and 12.

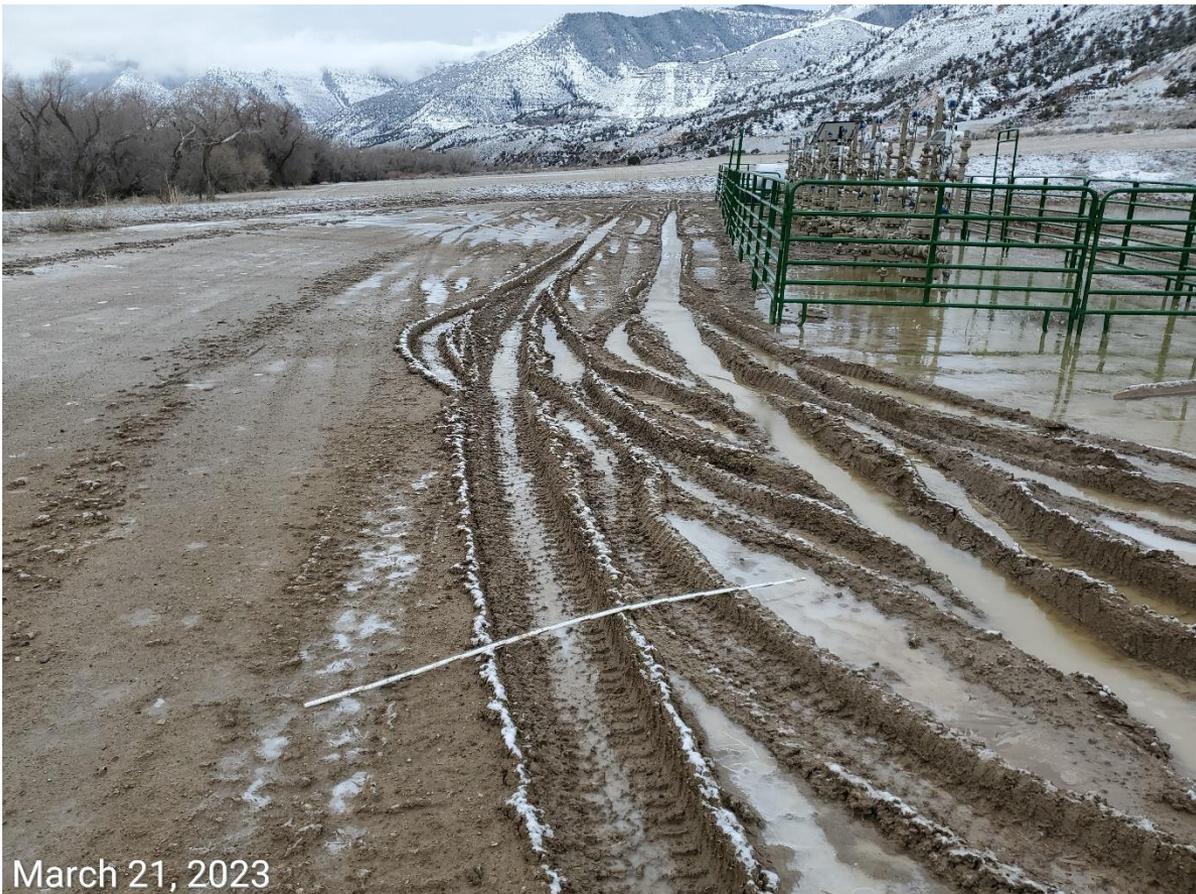
**Photo 14:** See comments under photo 1 and 12.

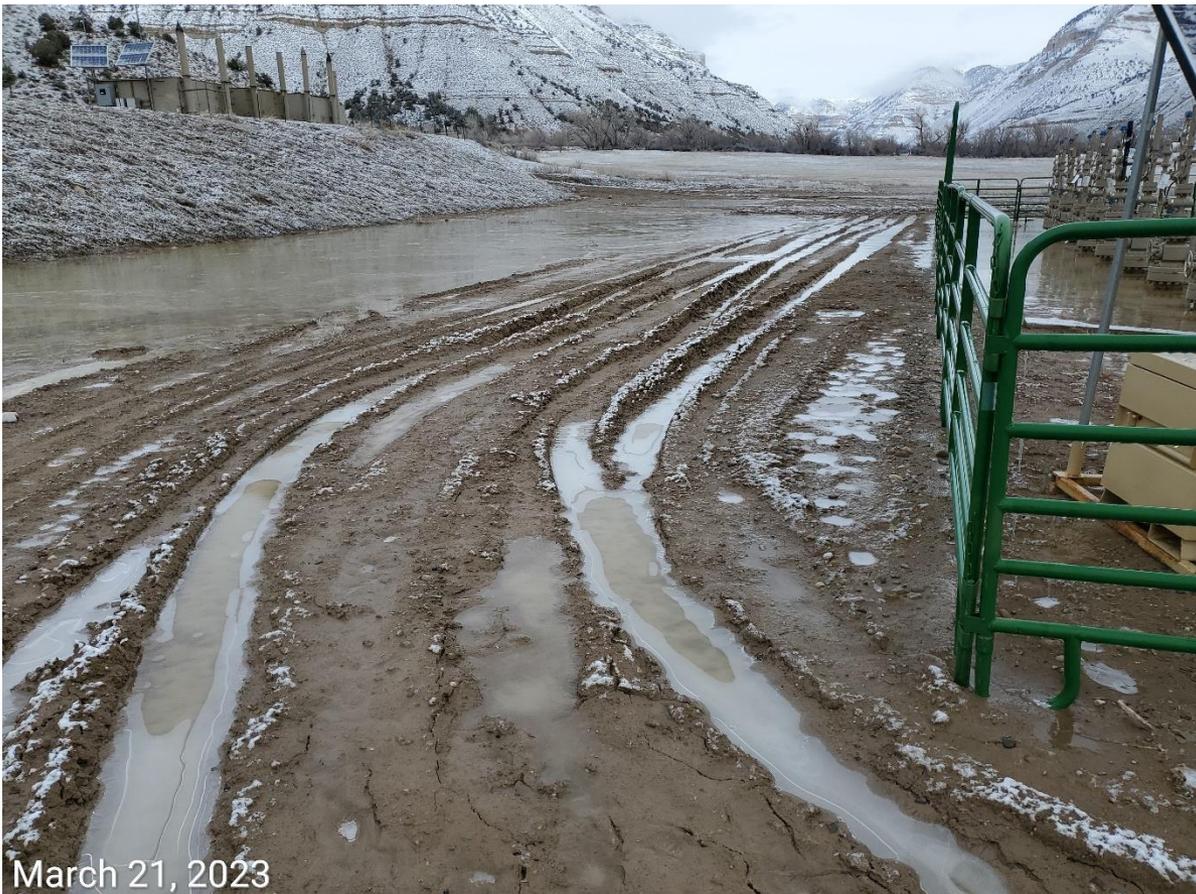
**Photo 15:** See comments under photo 1 and 12.

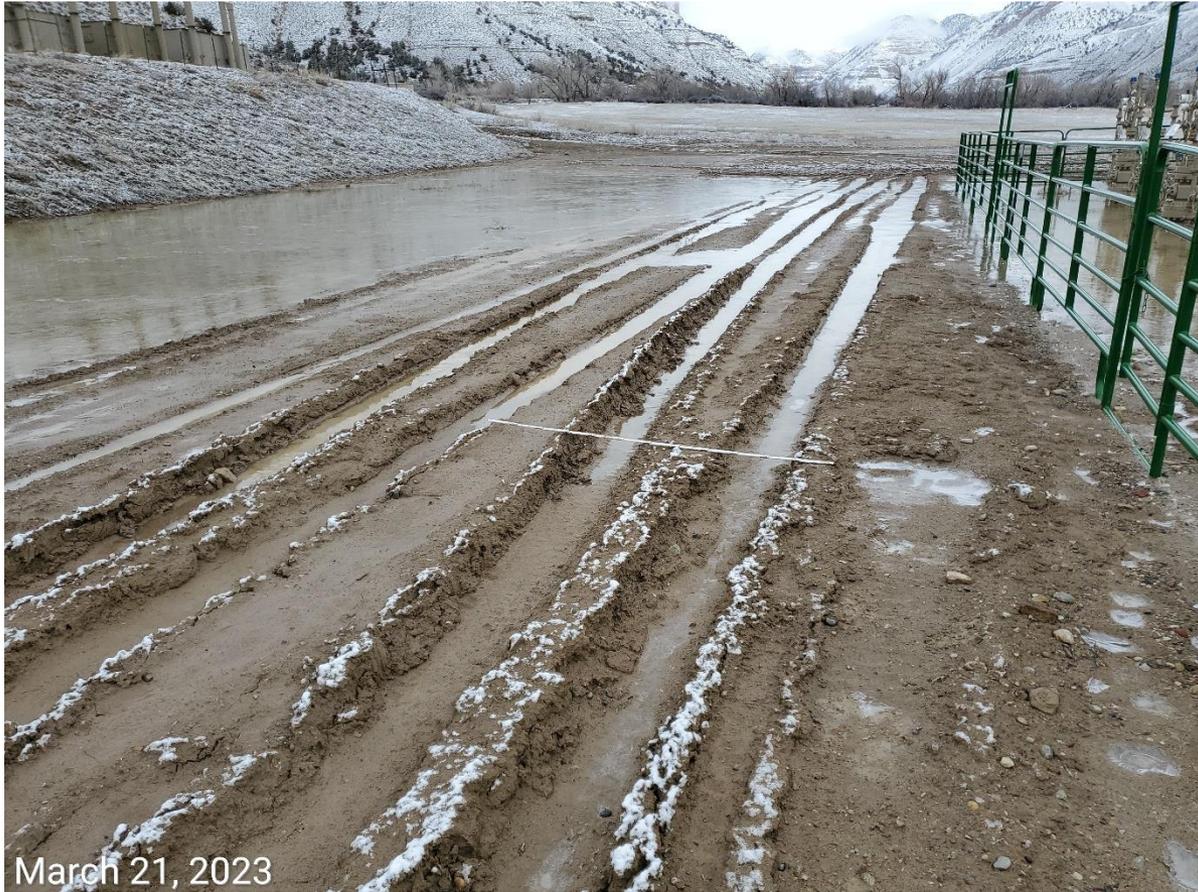
**Photo 16:** See comments under photo 1 and 12.

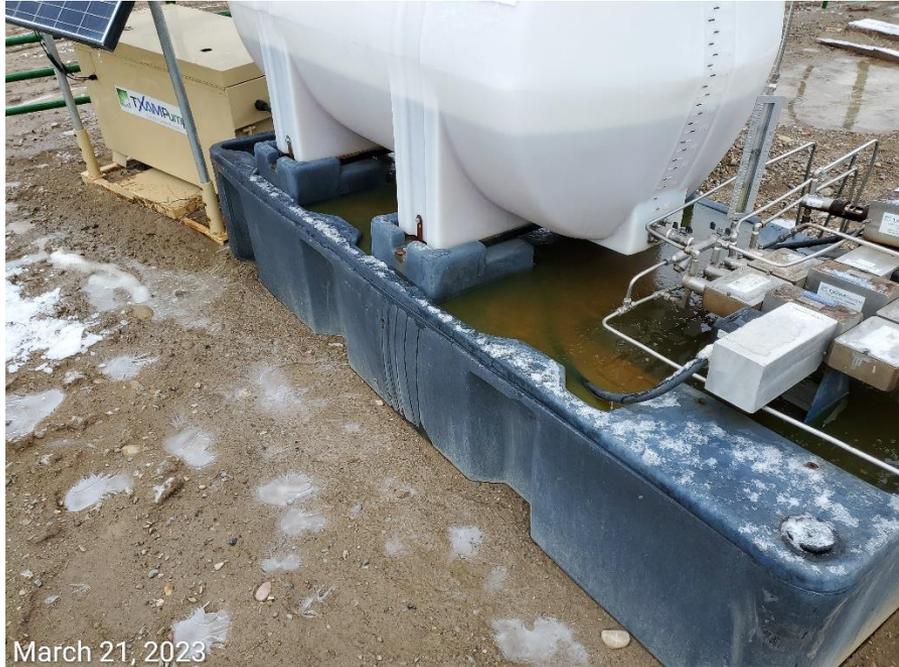
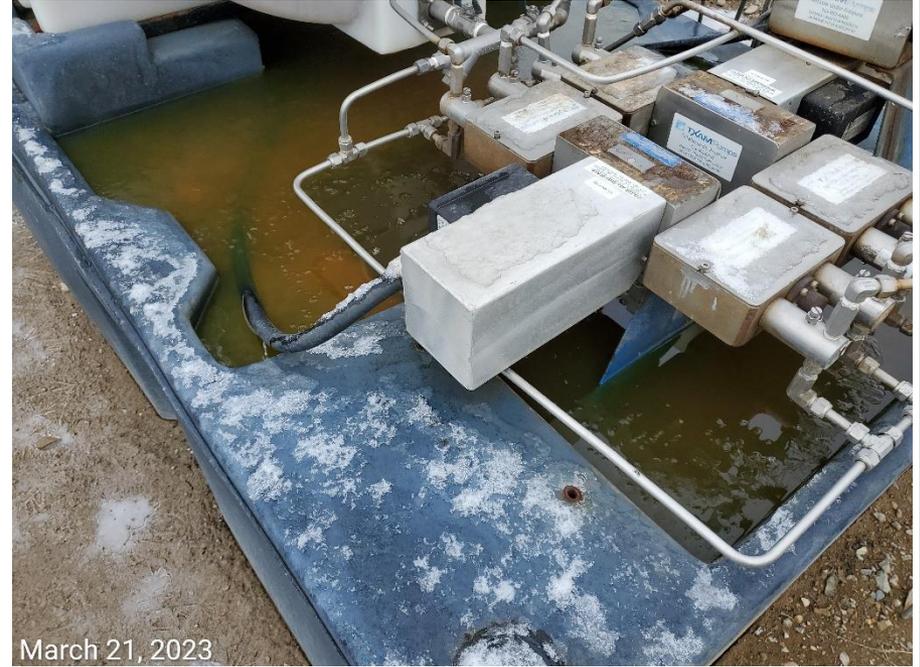
**Photo 17:** Photo taken from the methanol tank on the east end of the Location. Photo shows the secondary containment BMP appears to have filled; discolored fluids observed; possible leak at tank; containment no longer appears adequate to contain a spill
