Inspection Photos

API: 071-09060

Operator: WAPITI OPERATING LLC

Inspection Date: 3/22/2023

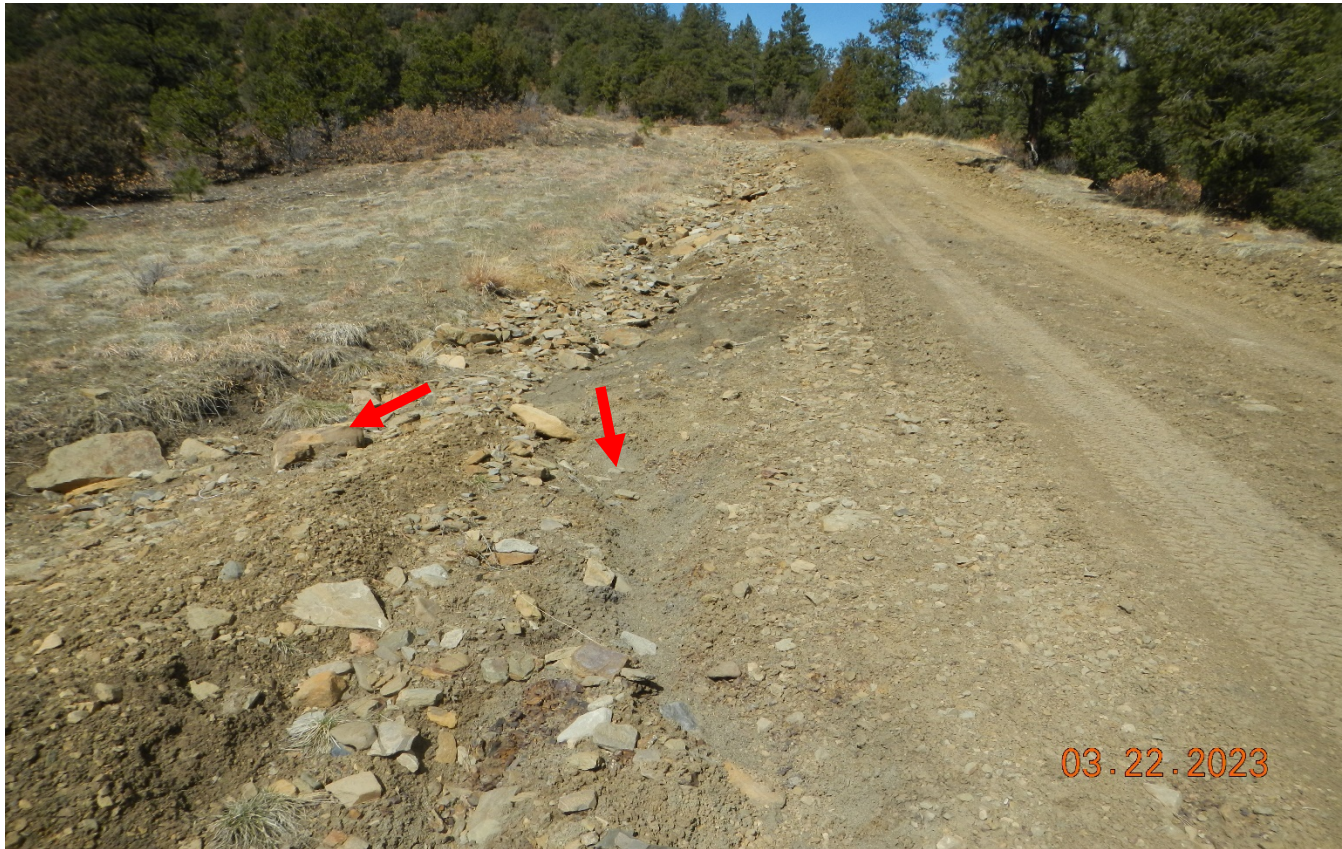
Photo 1. Facing northwest along the main road near the VPR C 140. Stormwater has caused erosion past the diversion which will continue to erode down the roadside.

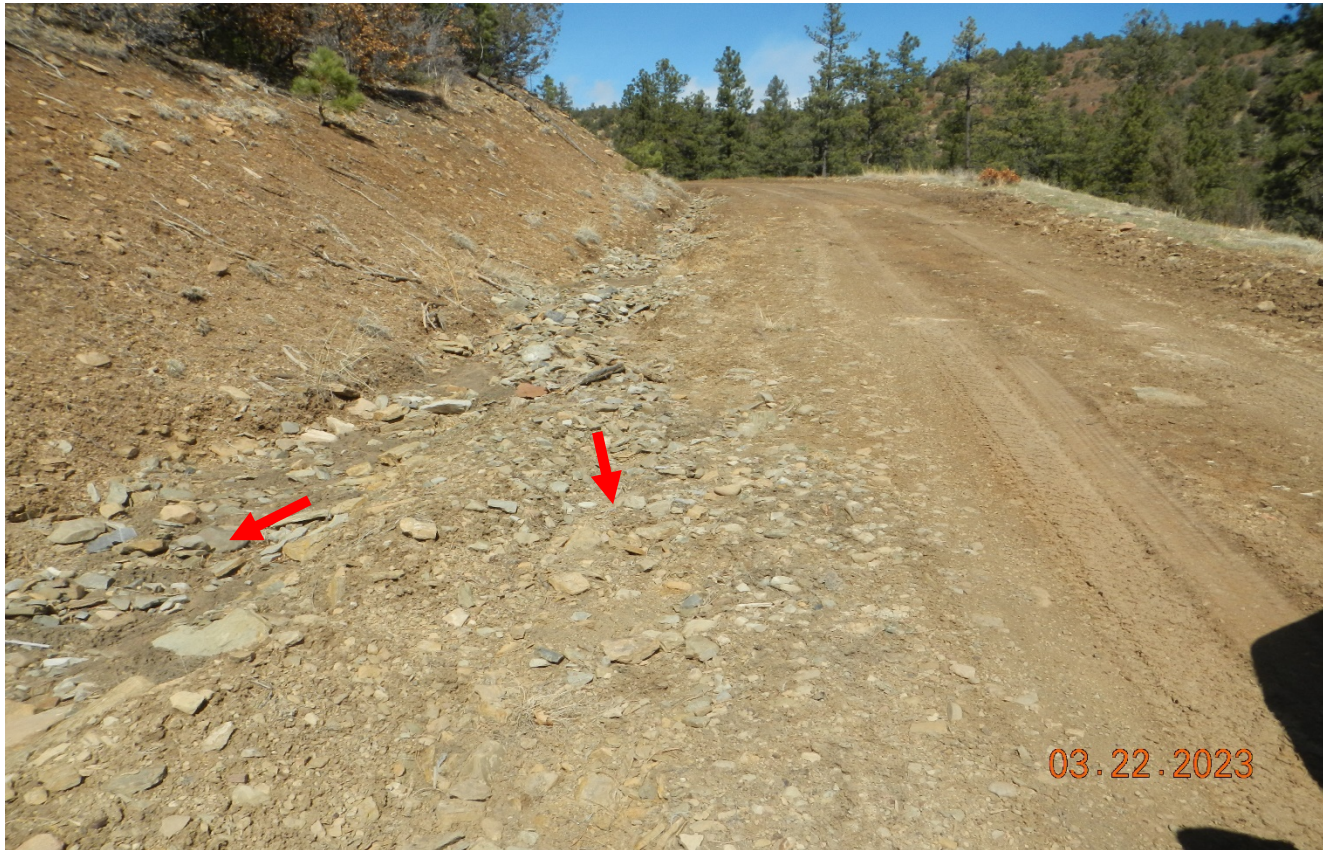
Photo 2. Facing northwest along the main road near the VPR C 140. Stormwater has caused erosion past the diversion which will continue to erode down the roadside.

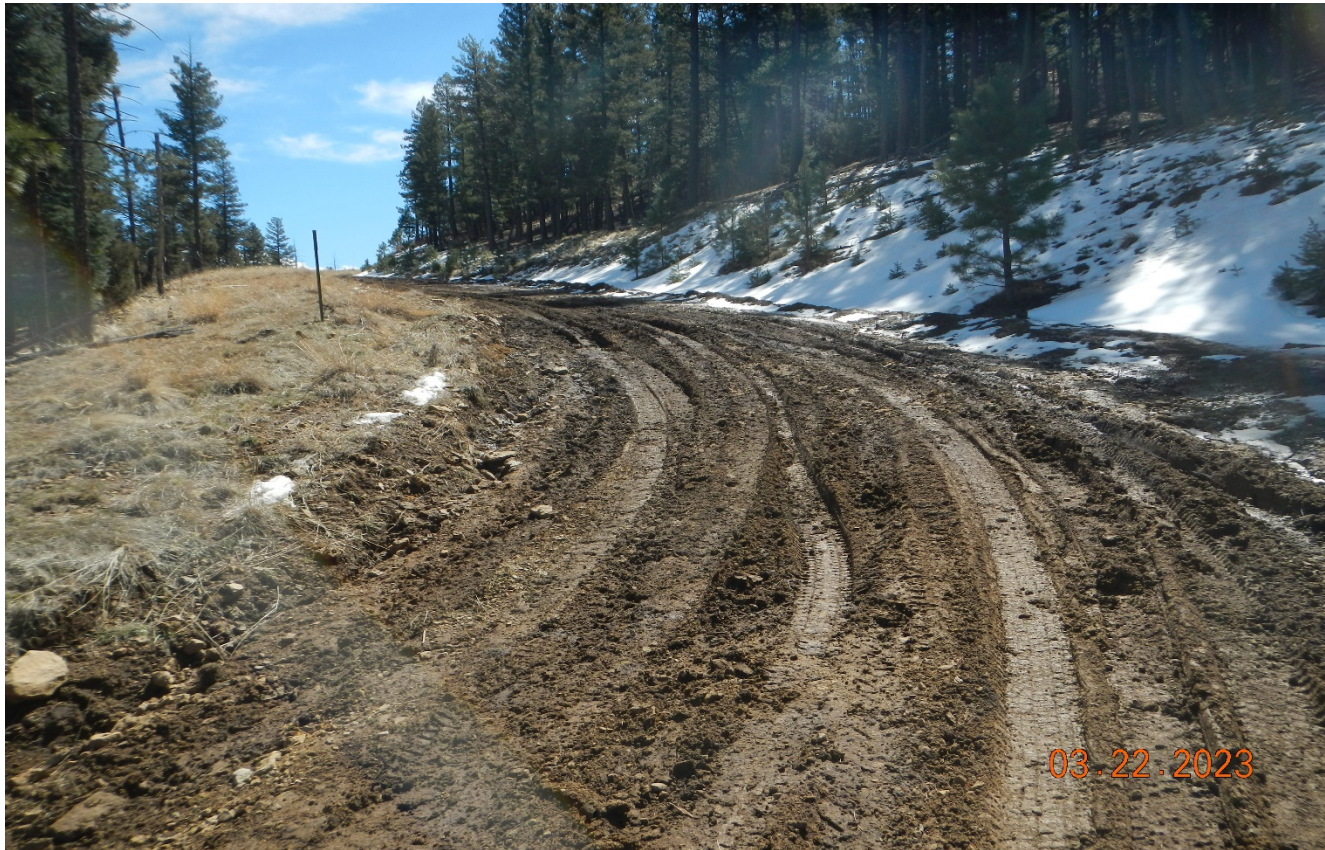
Photo 3. The road is rutted and not stabilized at the switch back of the main road traveling to the location.
