Storm Water Management and Erosion control

Location Name: TEP ROCKY MOUNTAIN LLC WILLIAMS-66S96W /36SWSE

Location #: 335010

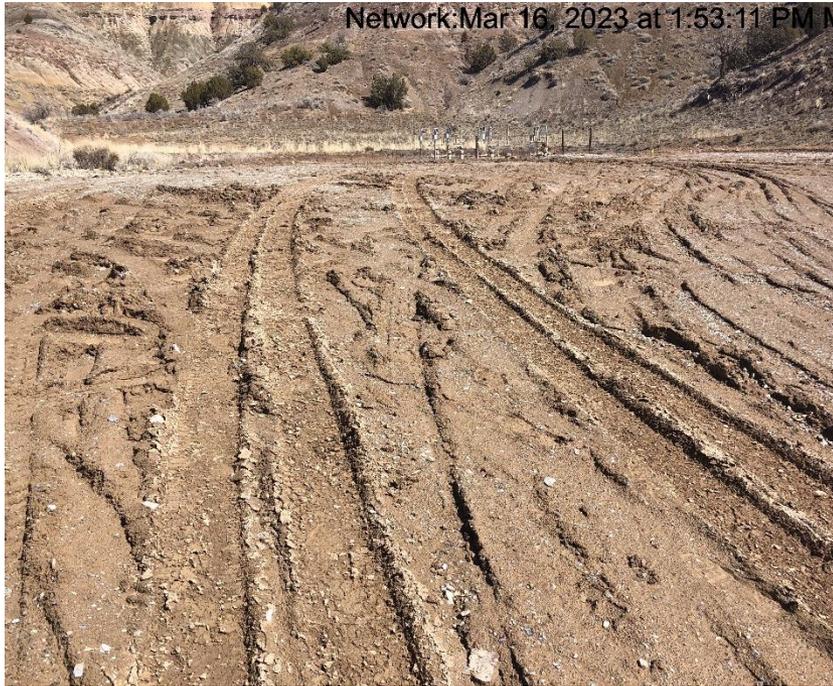
Photo #9346 Location lacks stabilization.

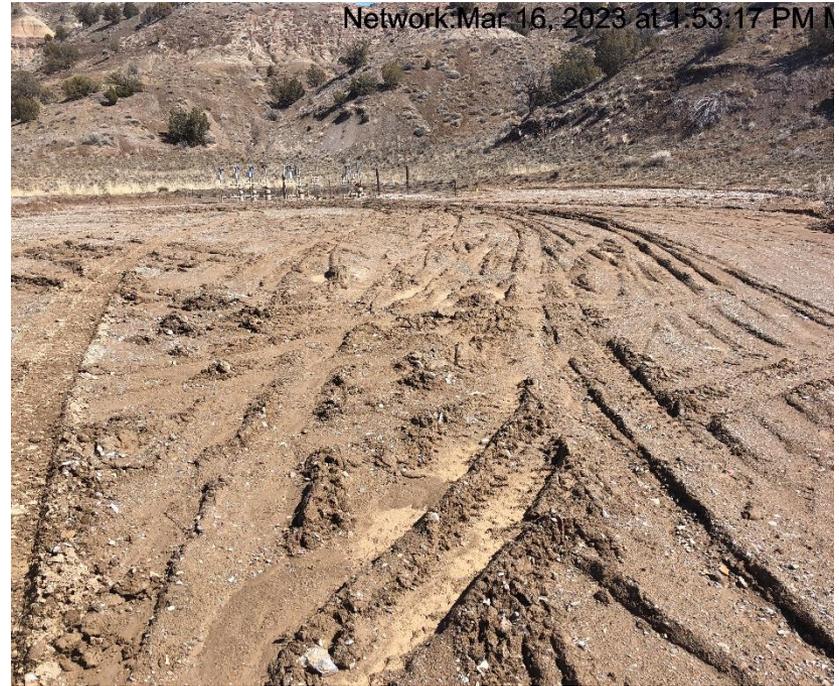
Photo #9347 Location lacks stabilization.

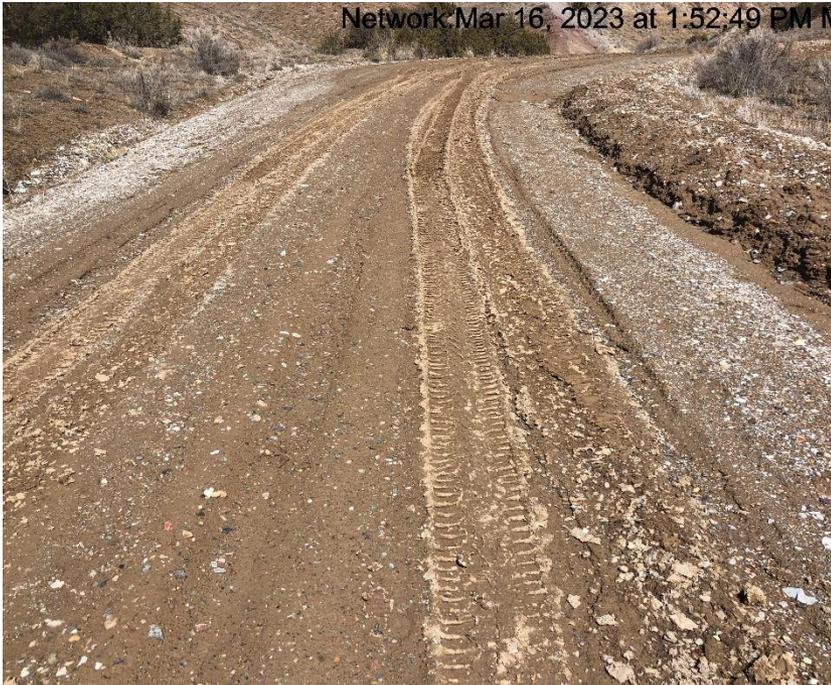
Photo #9345 Location lacks stabilization

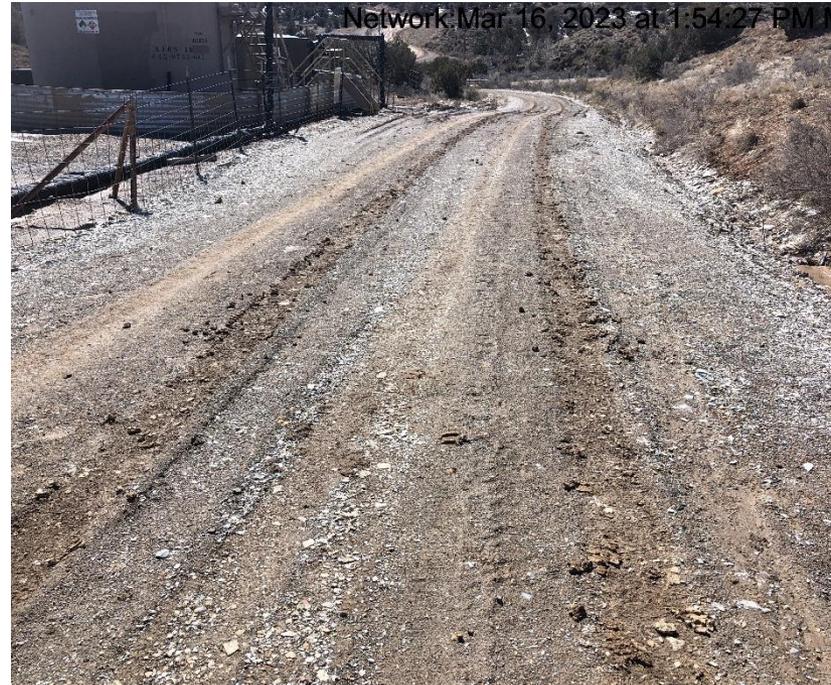
Photo #9353 Insufficient tracking BMP.

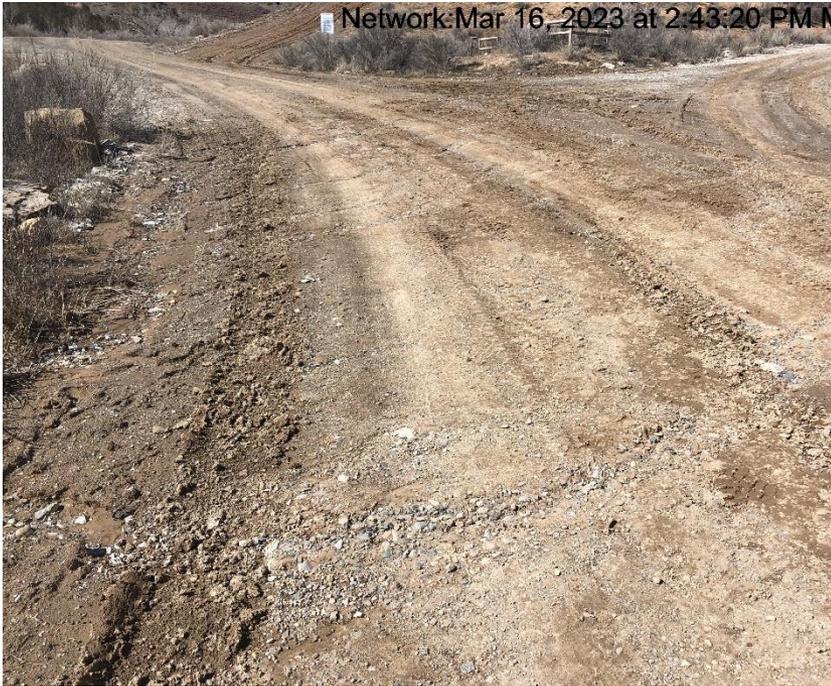
Photo #9368 Insufficient tracking BMP.

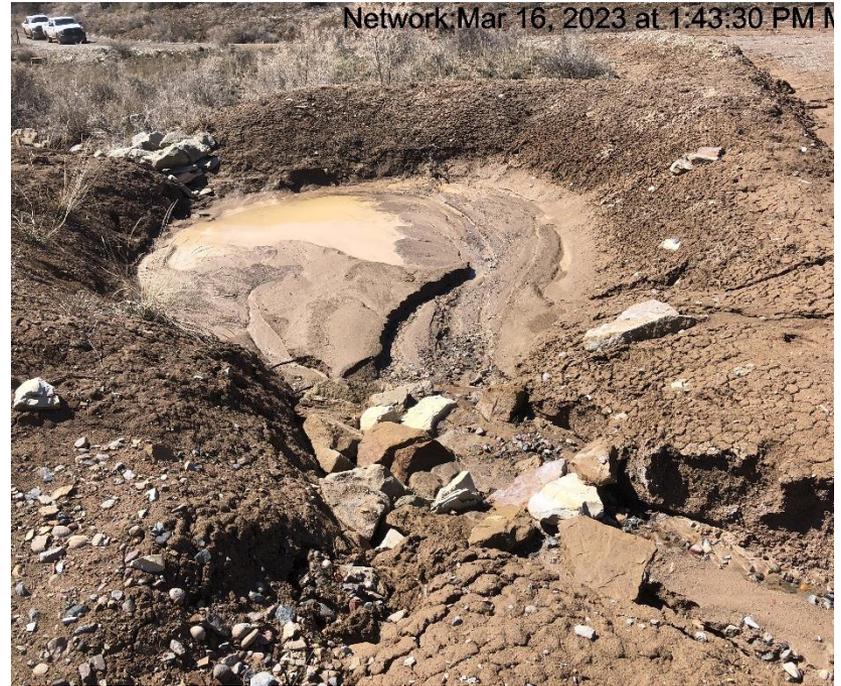
Photo #9368 Sediment traps insufficient.

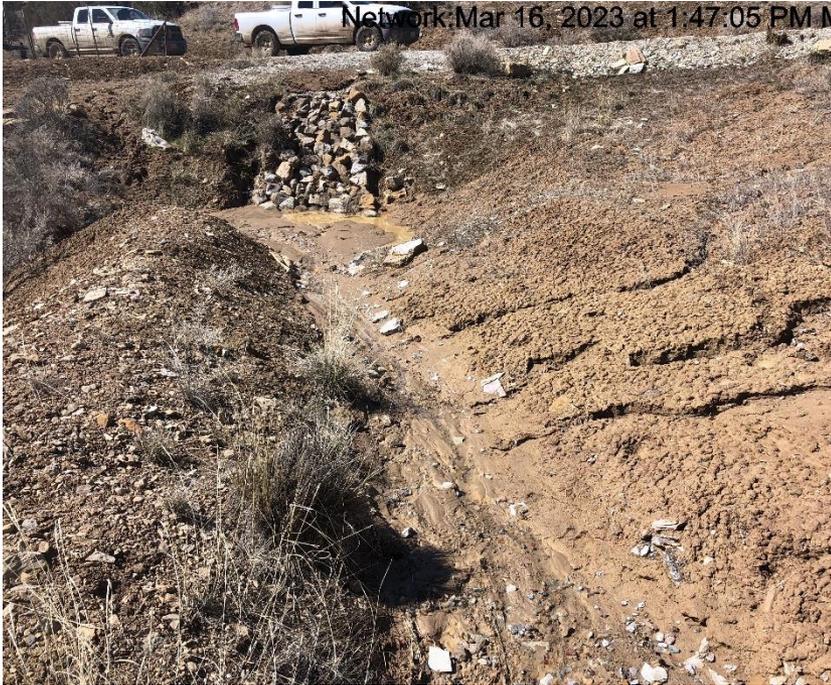
Photo #9338 Sediment trap insufficient

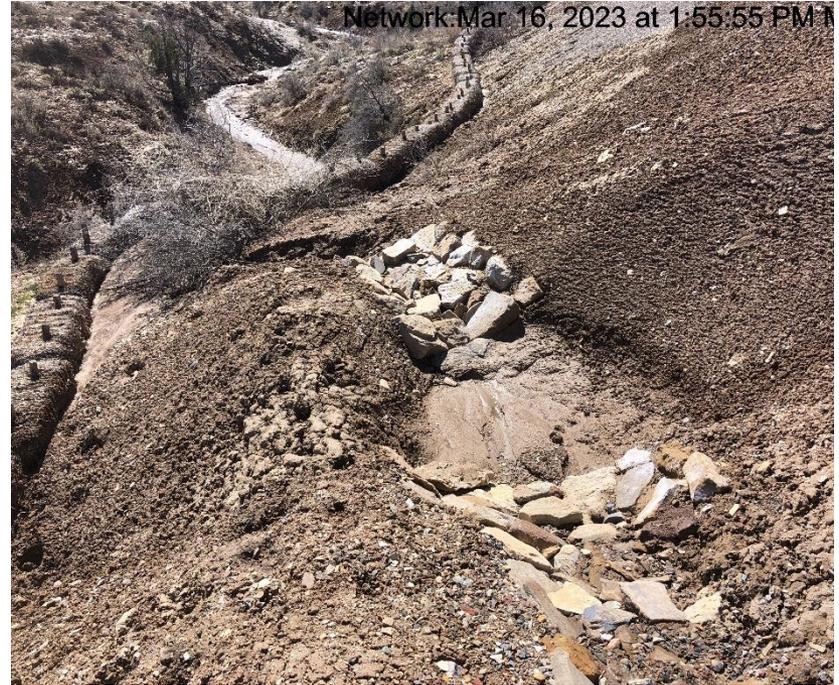
Photo #9354 Sediment trap insufficient

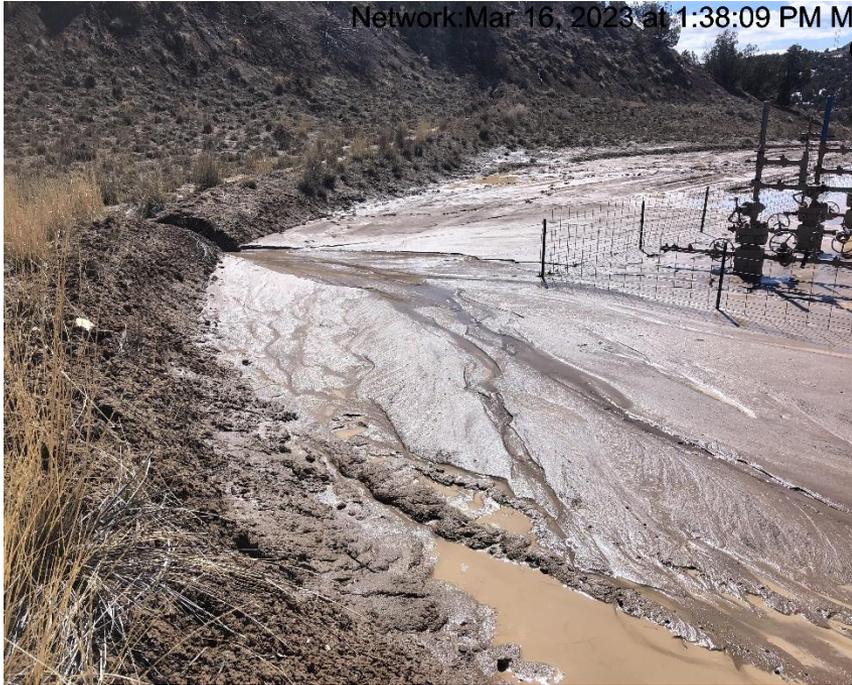
Photo #9338 Run on to location is not being controlled.

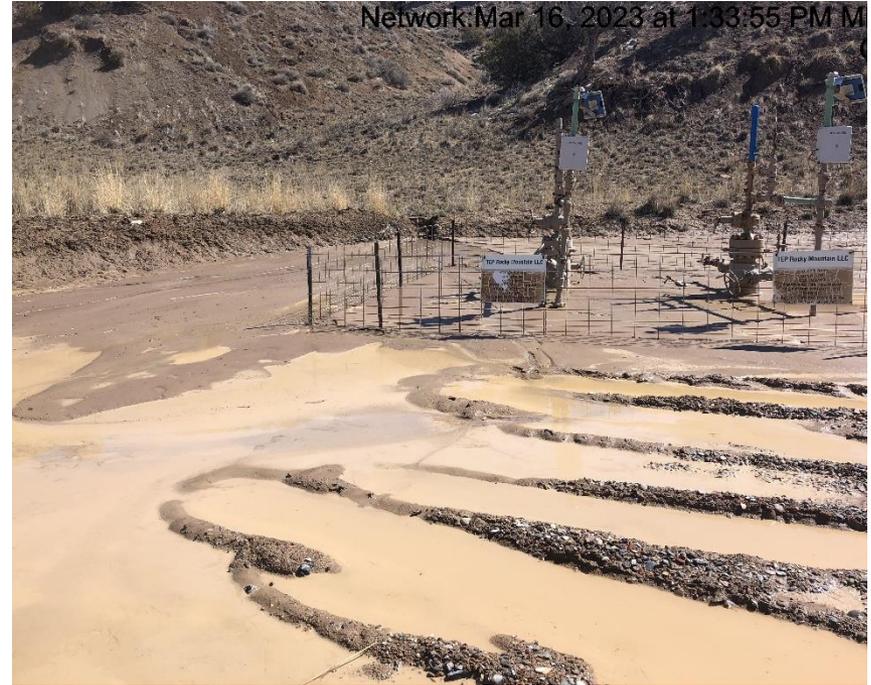
Photo #9294 Run on to location is not being controlled.

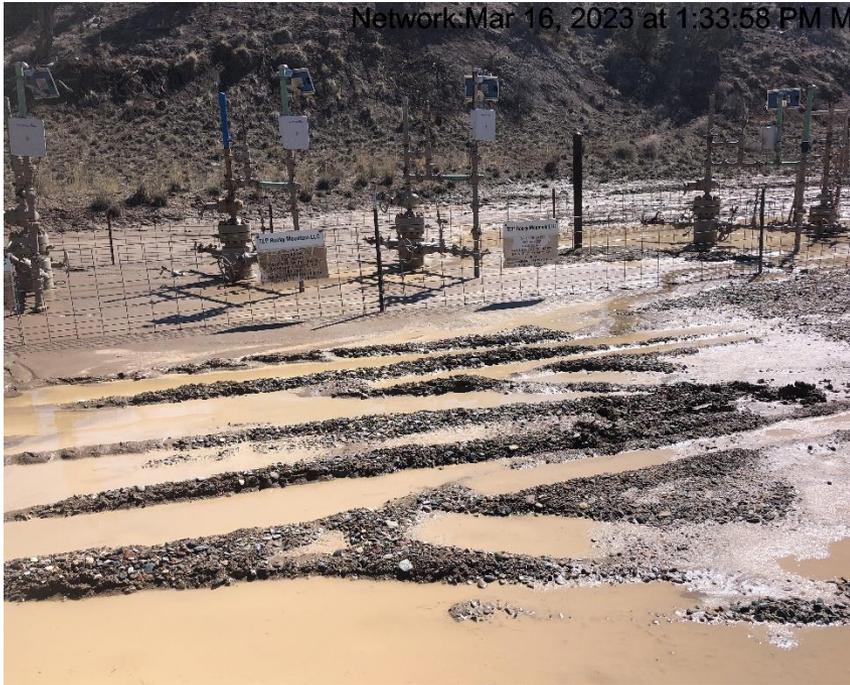
Photo #9295 Sediment encroaching on equipment.

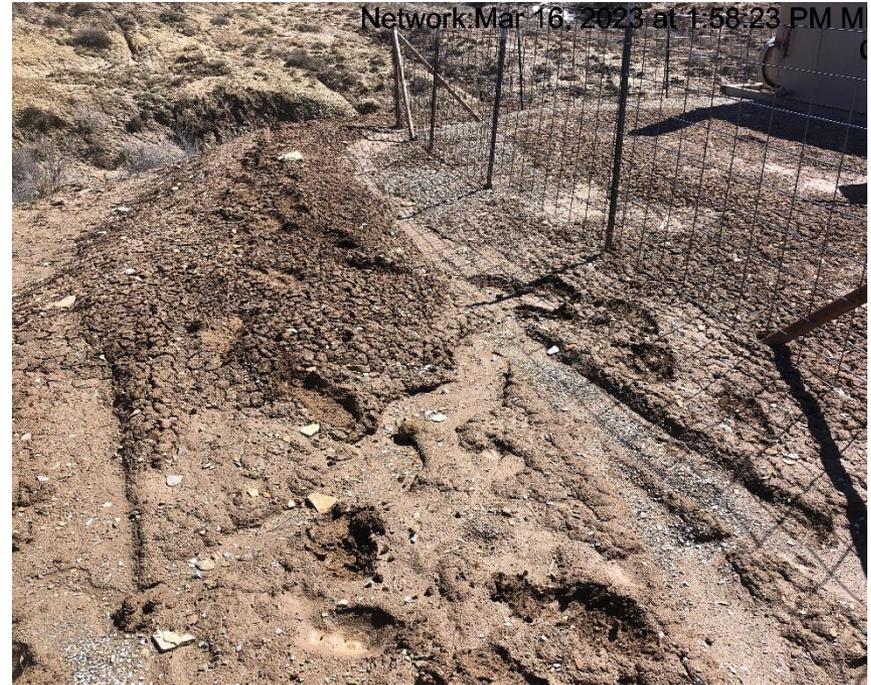
Photo #9358 Berms insufficient.

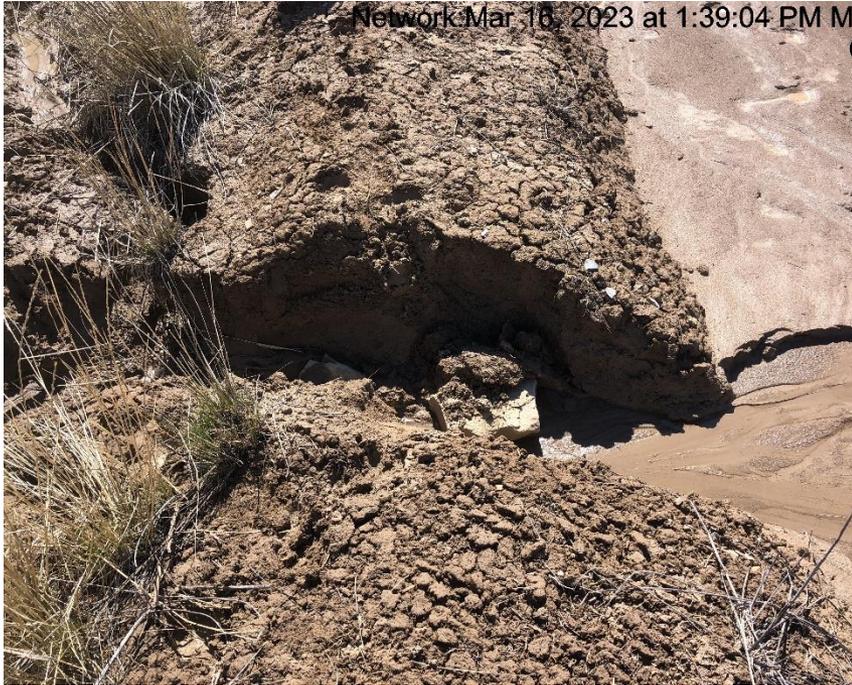
Photo #9310 Berms insufficient.

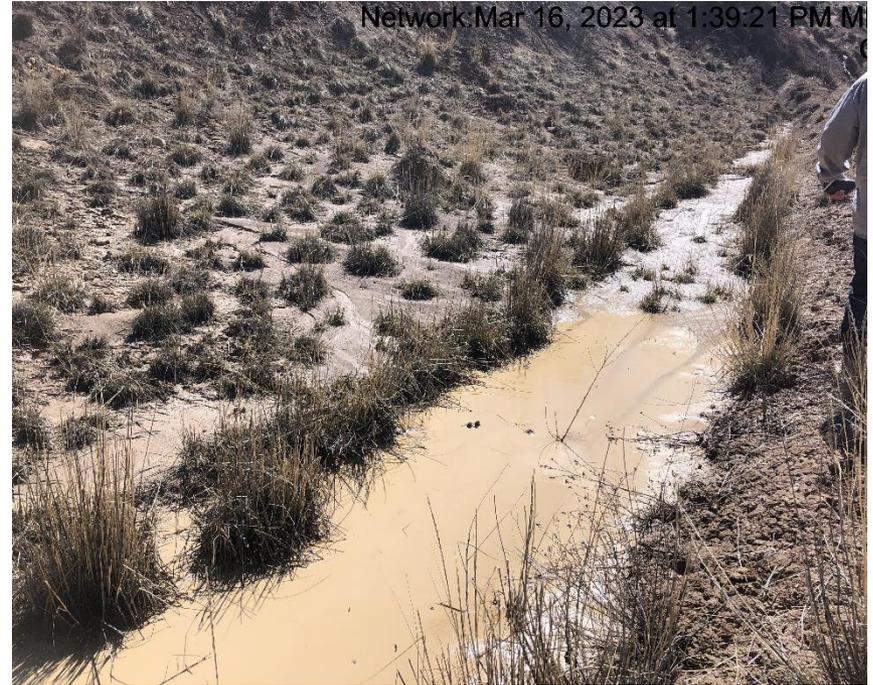
Photo #9312 Ditches insufficient.

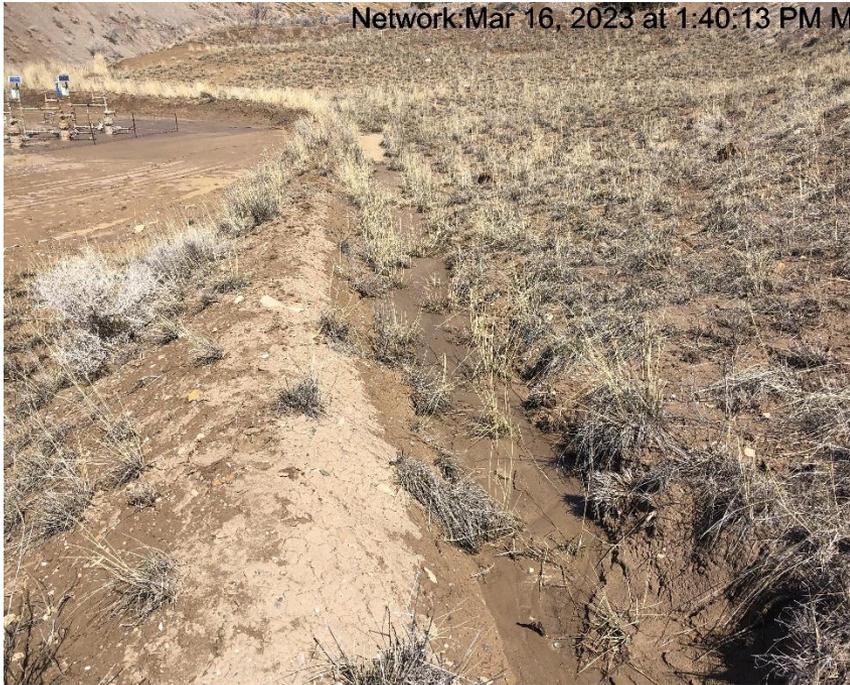
Photo #9316 Ditches insufficient.

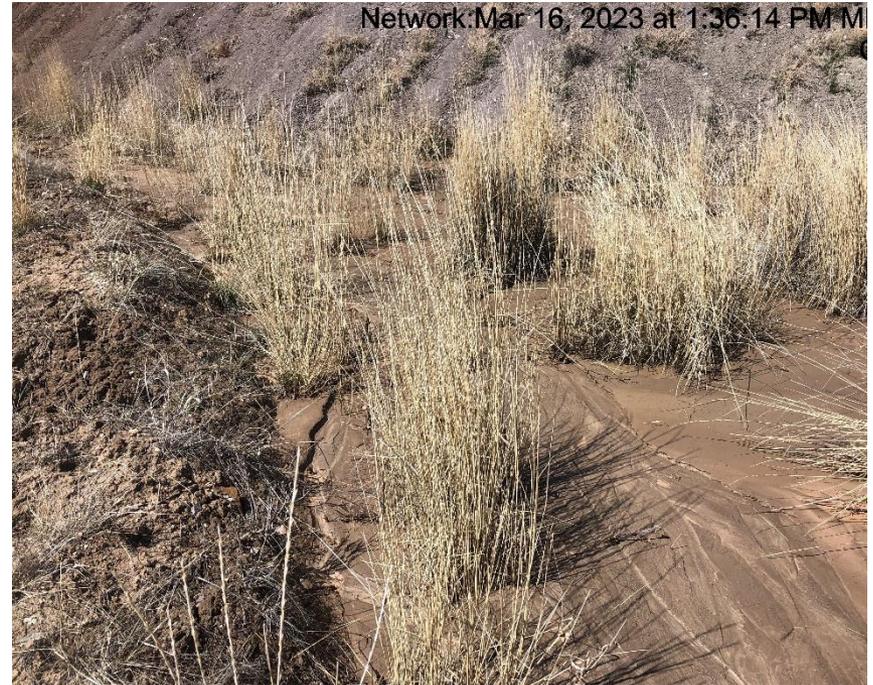
Photo #9300 Ditches insufficient.

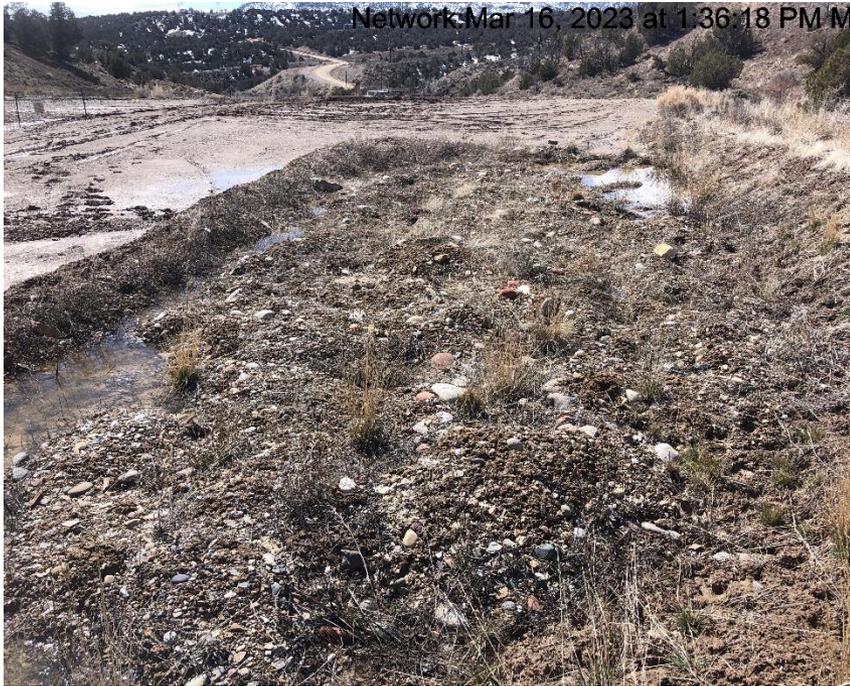
Photo #9301 Insufficient Stock piled soils BMPs.

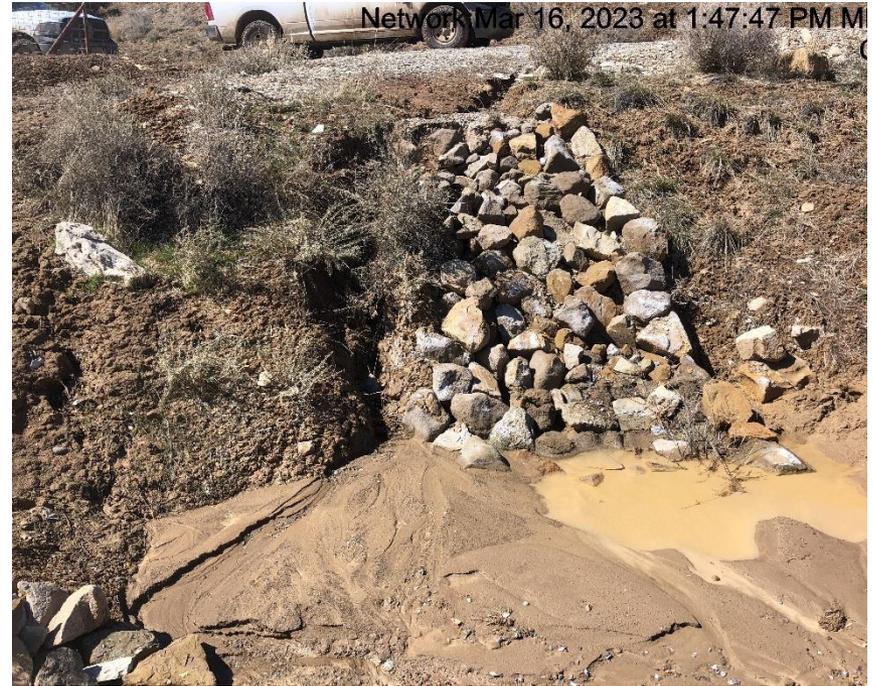
Photo #9340 Rip rap BMP insufficient

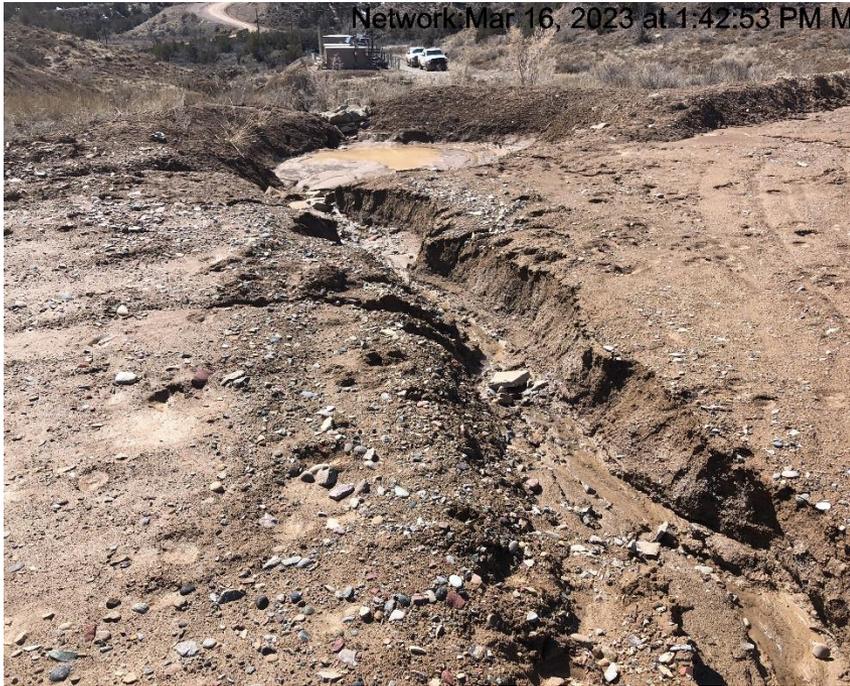
Photo #9319 Multiple Gully erosion channels.

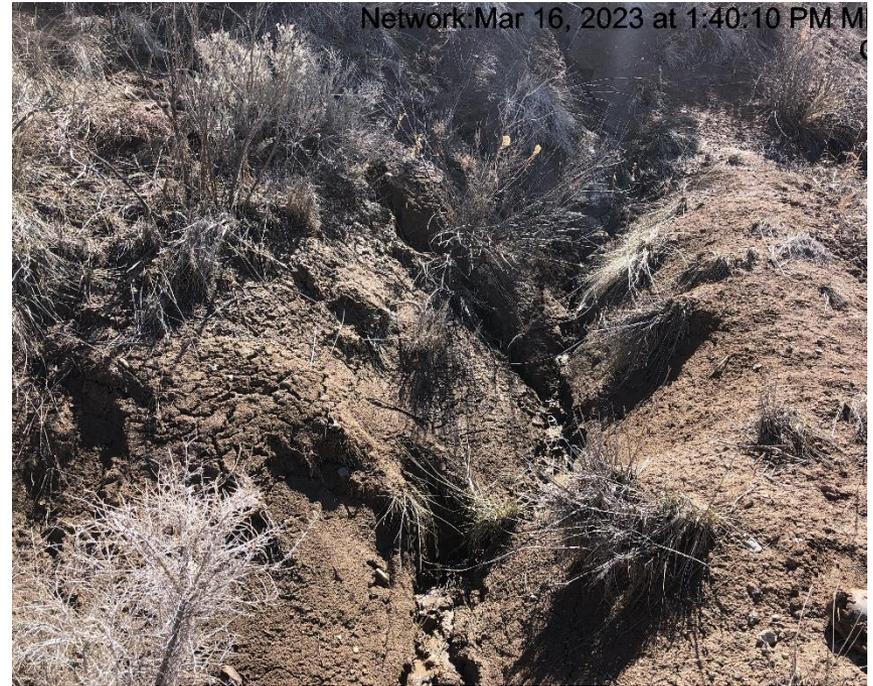
Photo #9315 Multiple Gully erosion channels.

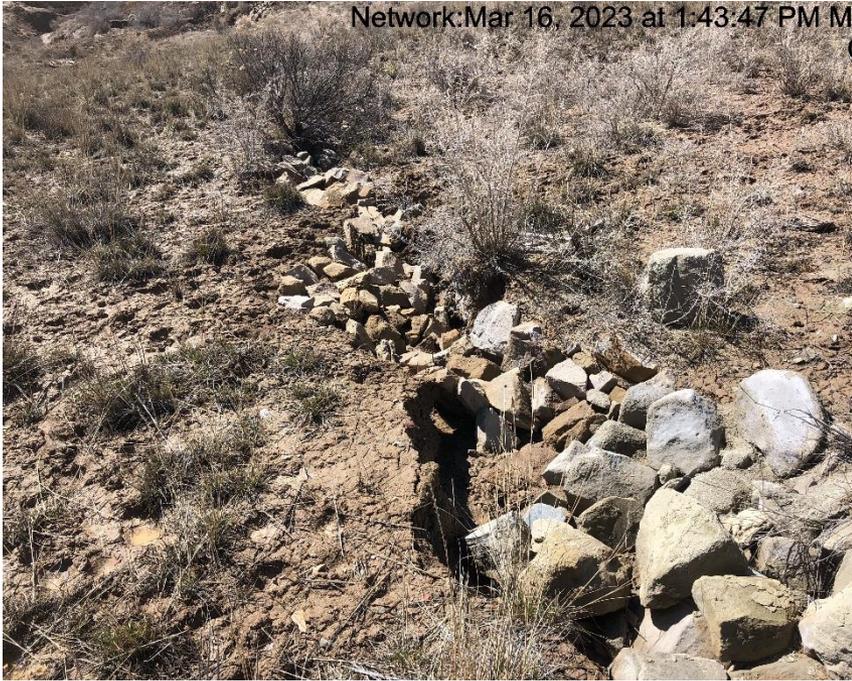
Photo #9322 Multiple Gully erosion channels.

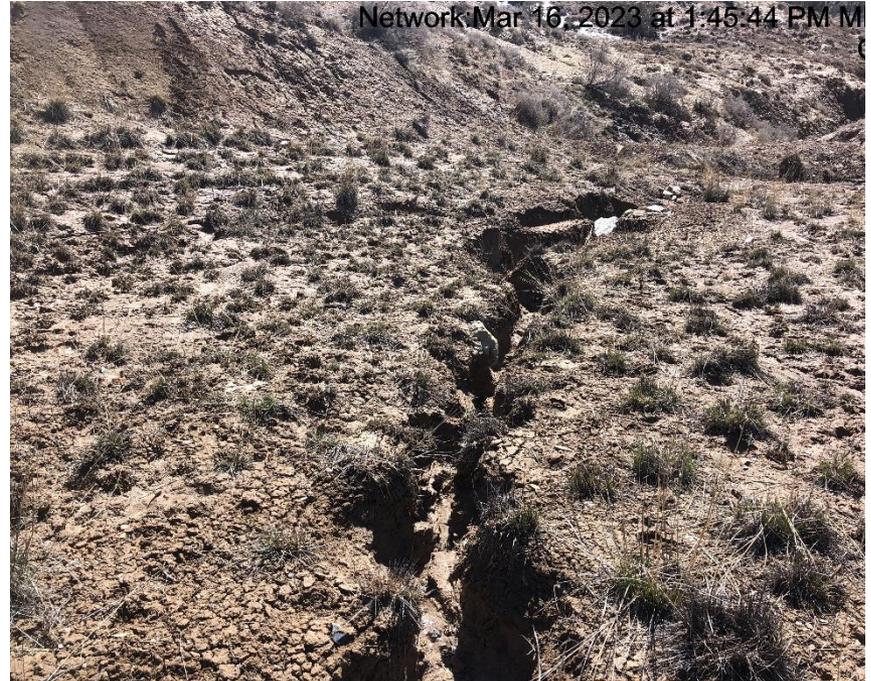
Photo #9334 Multiple Gully erosion channels.

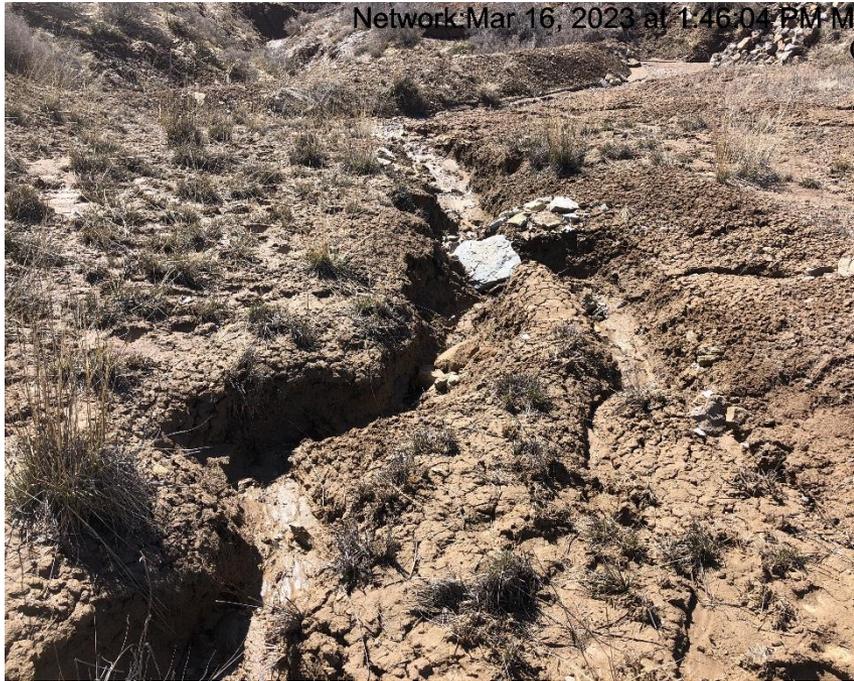
Photo #9335 Multiple Gully erosion channels.

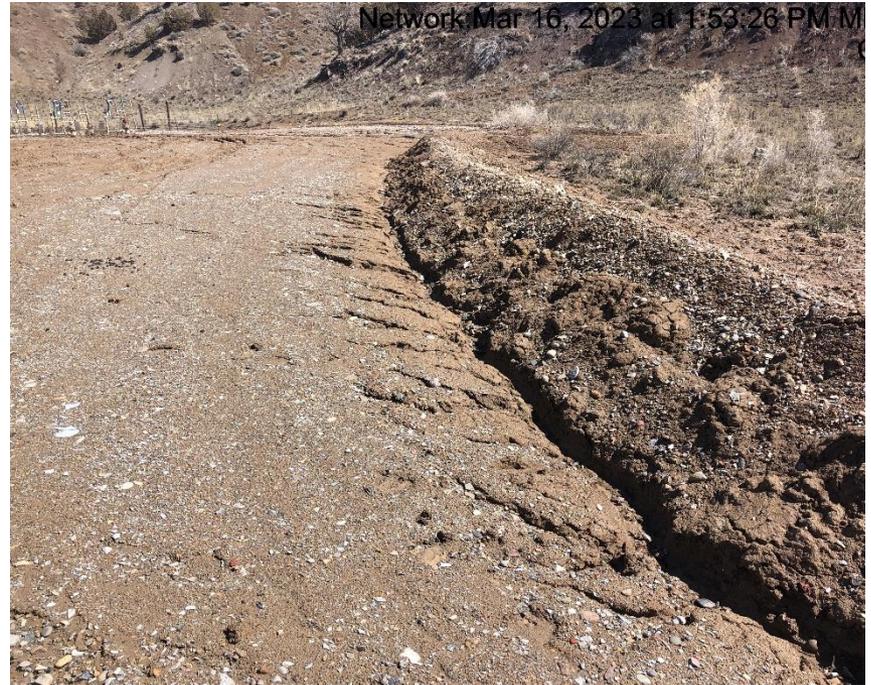
Photo #9349 Insufficient velocity BMPs.

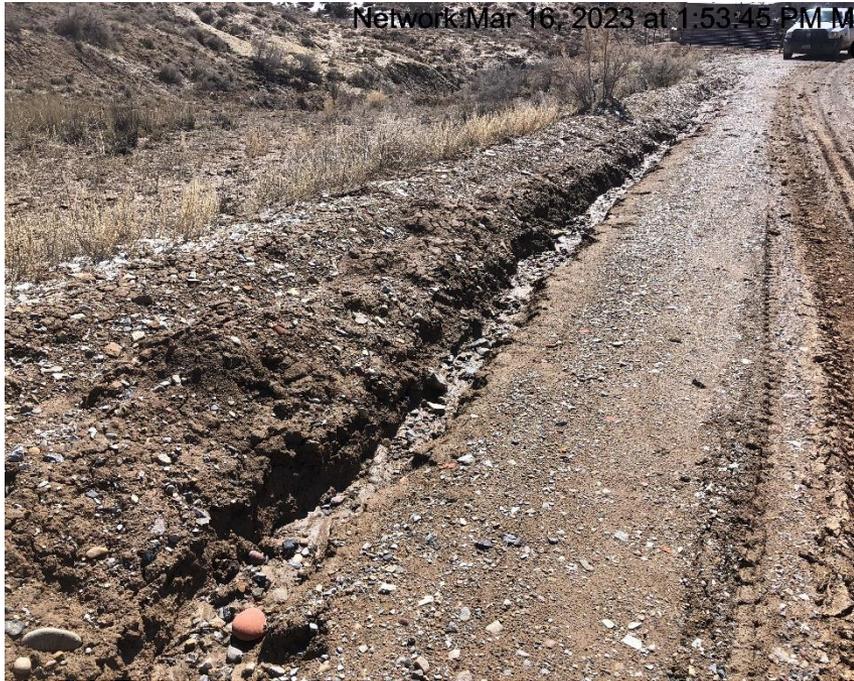
Photo #9351 Insufficient velocity BMPs.
