## Inspection Photos

Location Name: Sack #44-31 Release ID 484022

Location ID: 328359

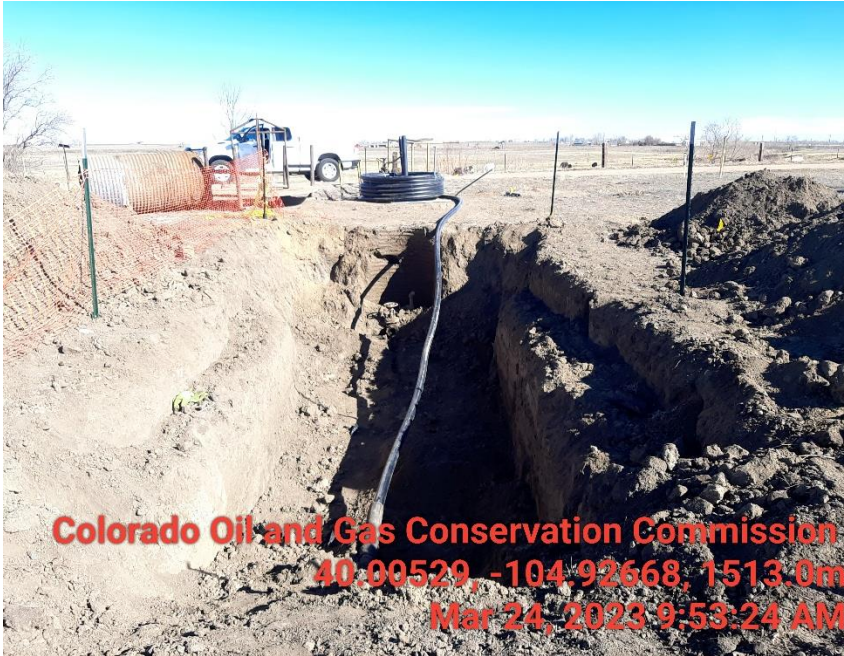
Photo 1 North end of line replacement operator installed a 3" SDR 11 line inside of a 4' steel line.

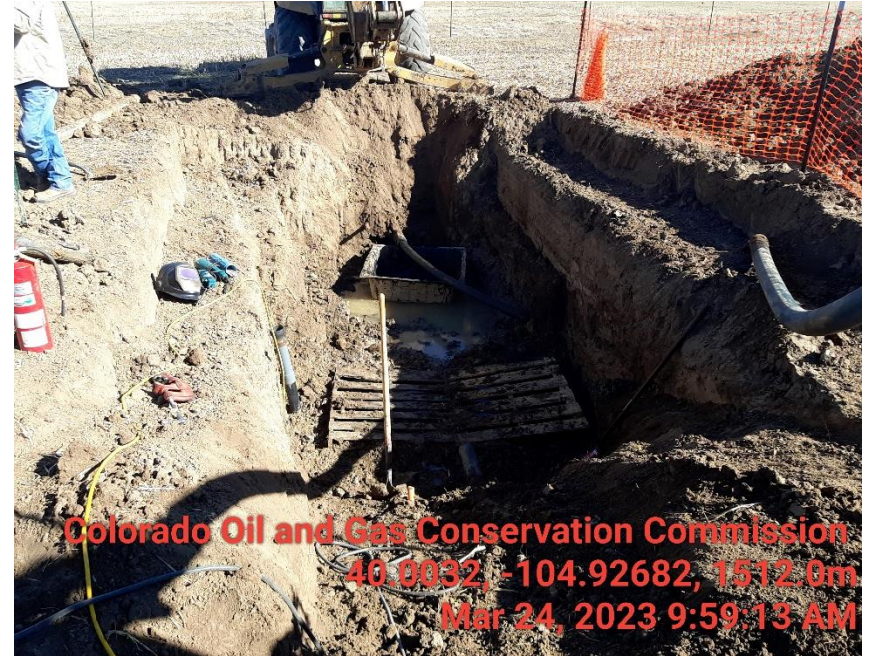
Photo 2 South end of line replacement closest to well

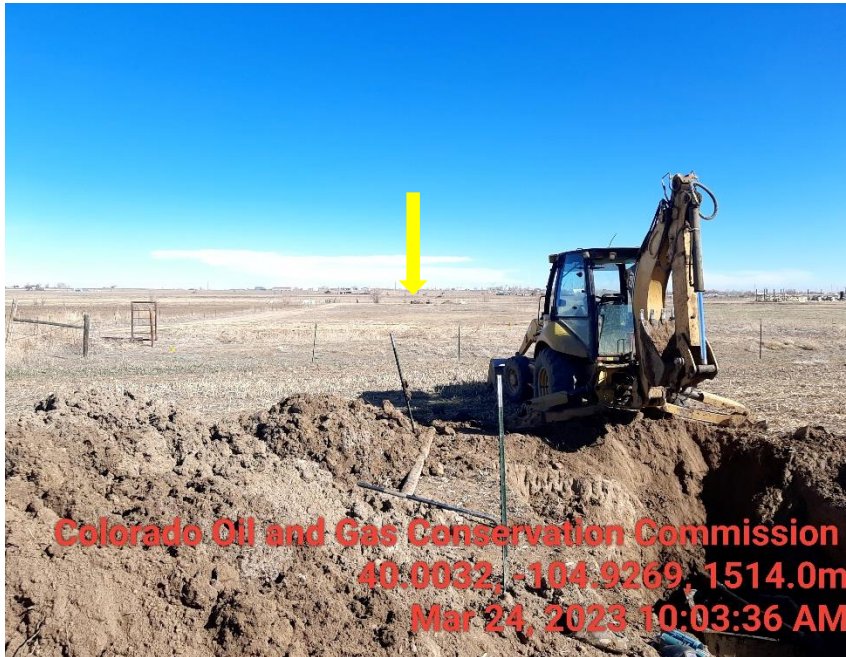
Photo 3 Photo of both excavations of line replacement

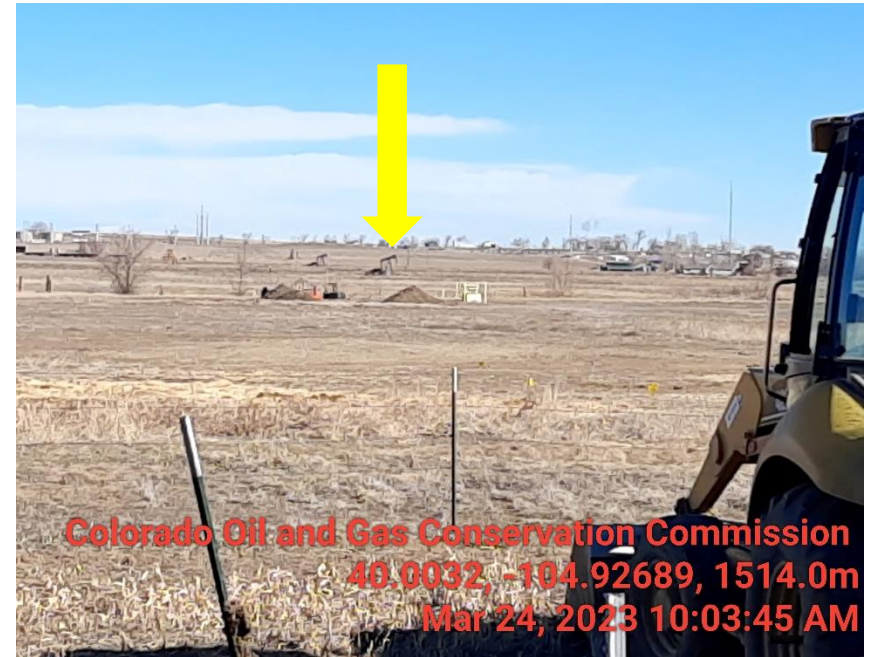
Photo 4 Photo of both excavations of line replacement

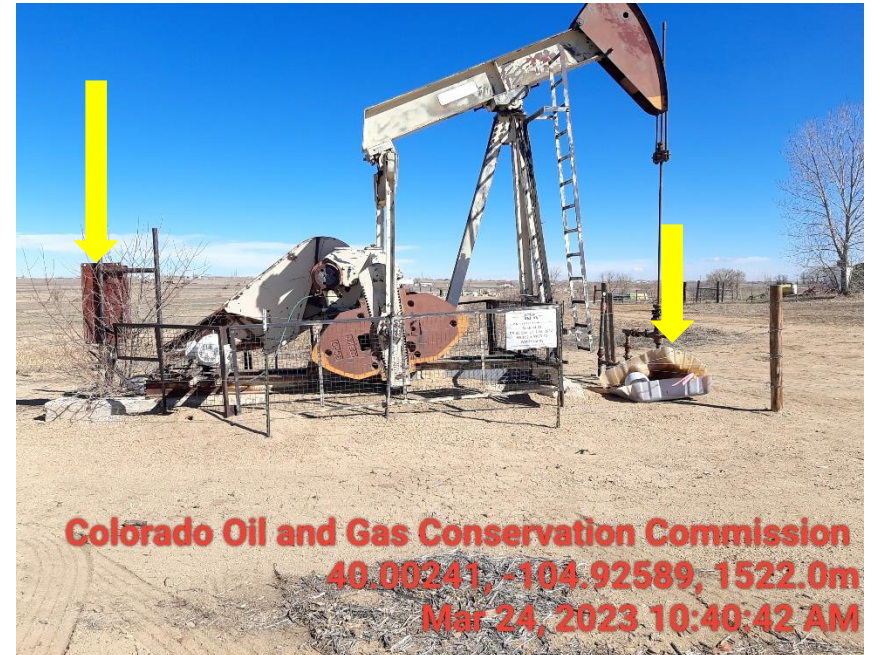
Photo 6 Trash and Debris. (plastic container and tree growing next to motor)

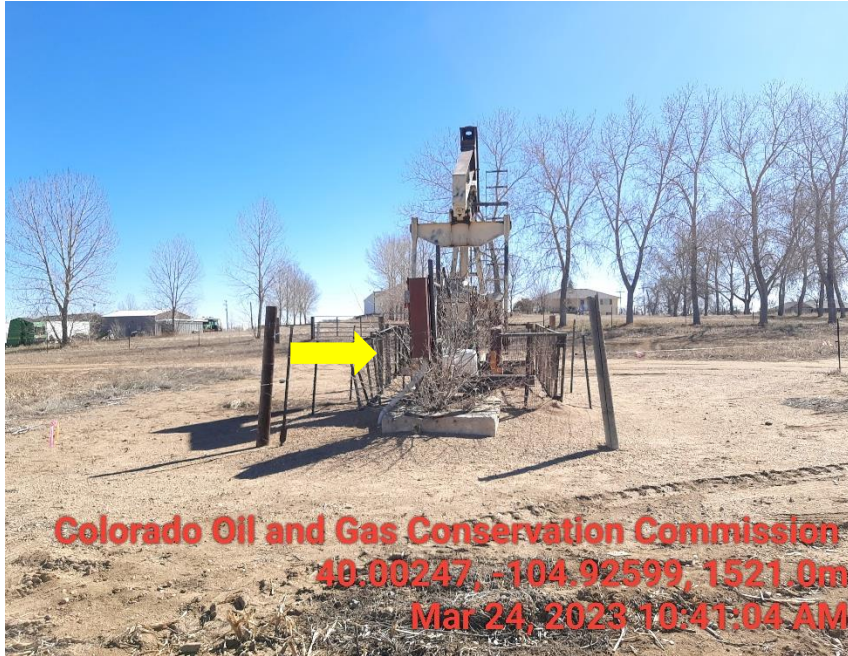
Photo 7 Tree growing next to motor
