TEP
Scott 41C
Location # 427016

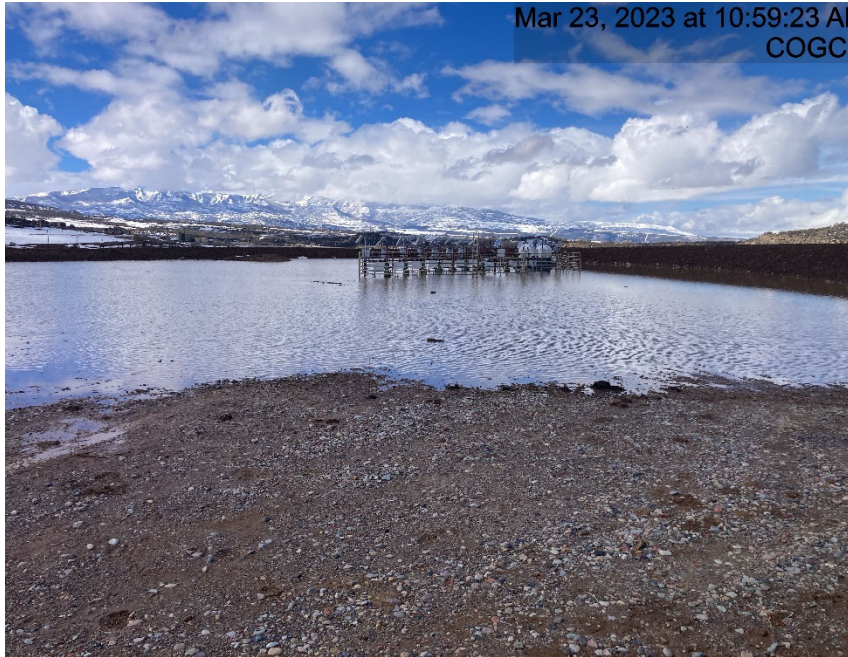
Well heads with no access due to water

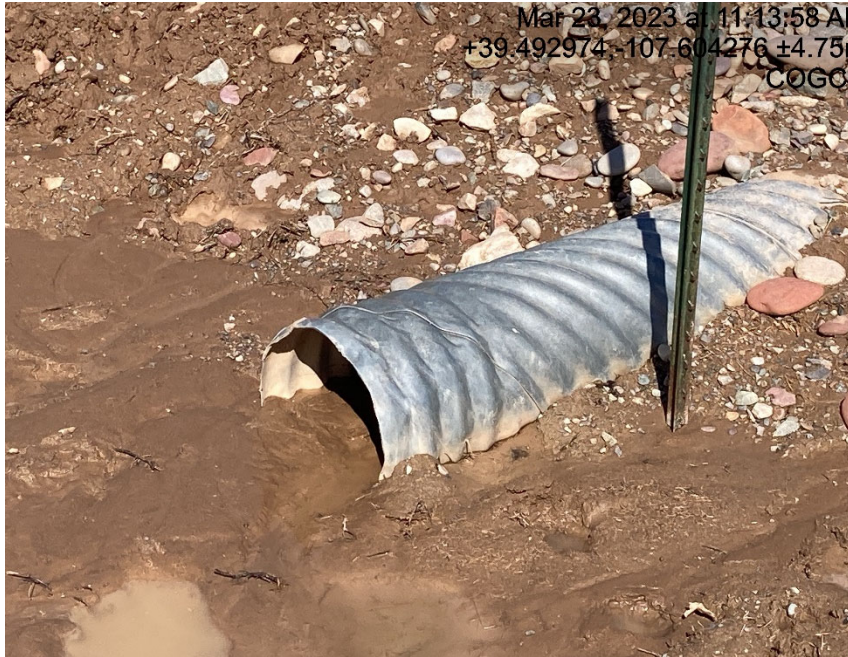
Culvert needs maintained

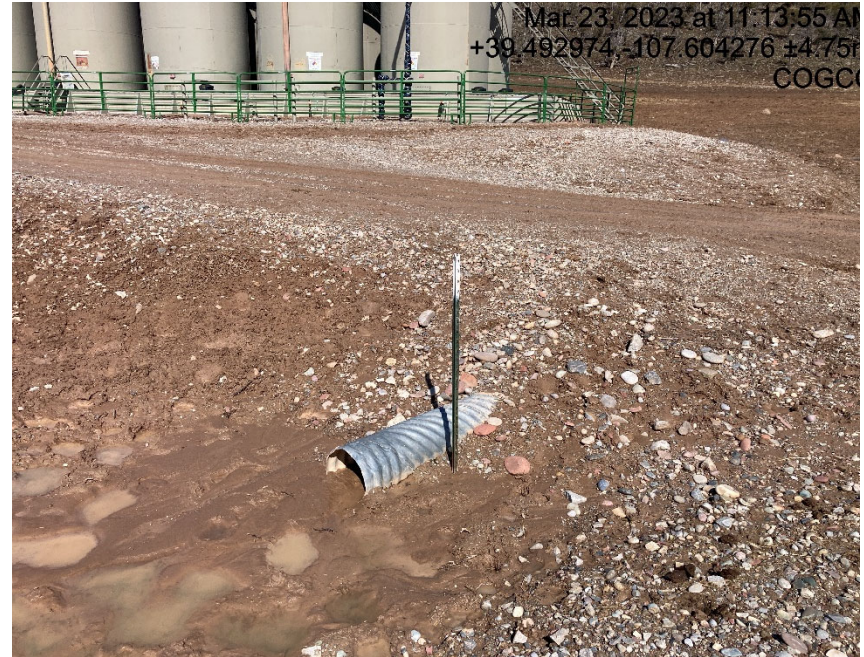
Culvert needs maintained

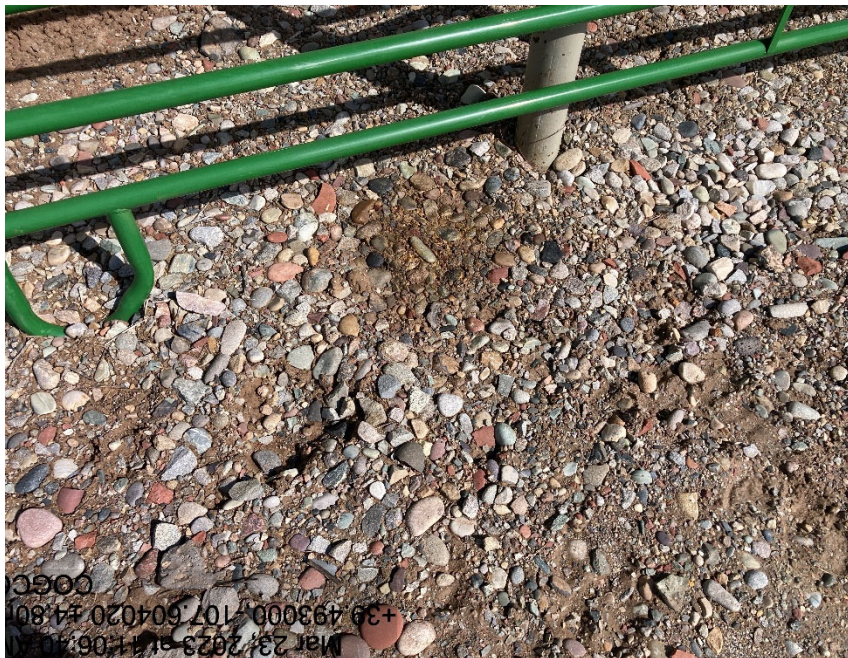
Staining

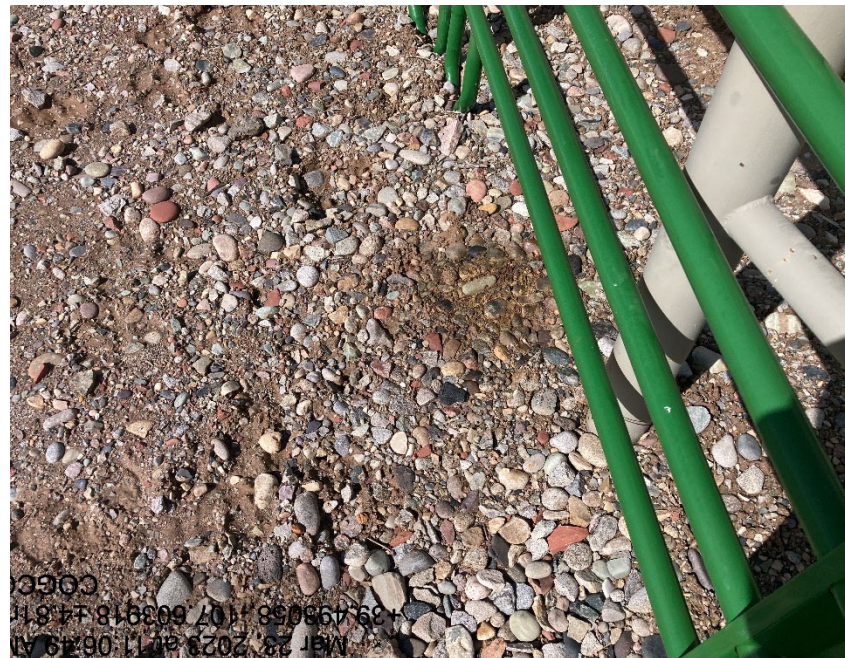
Staining

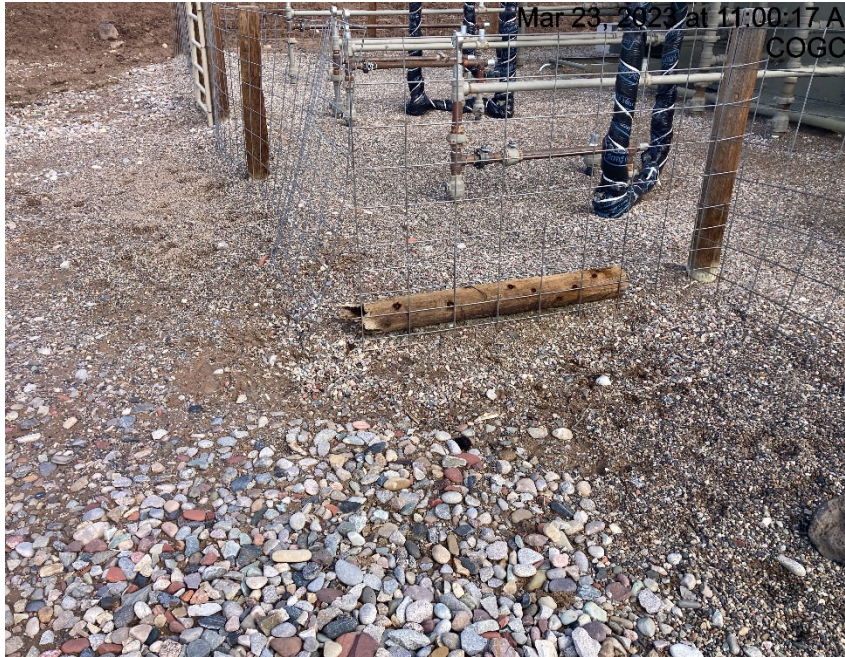
Debris

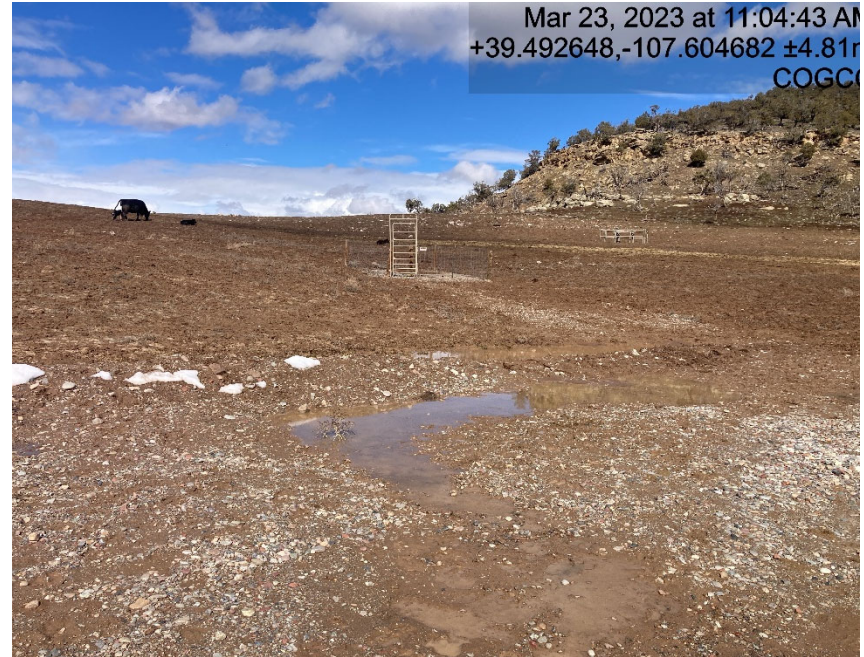
Area where ECD was, fencing is still in place and not needed

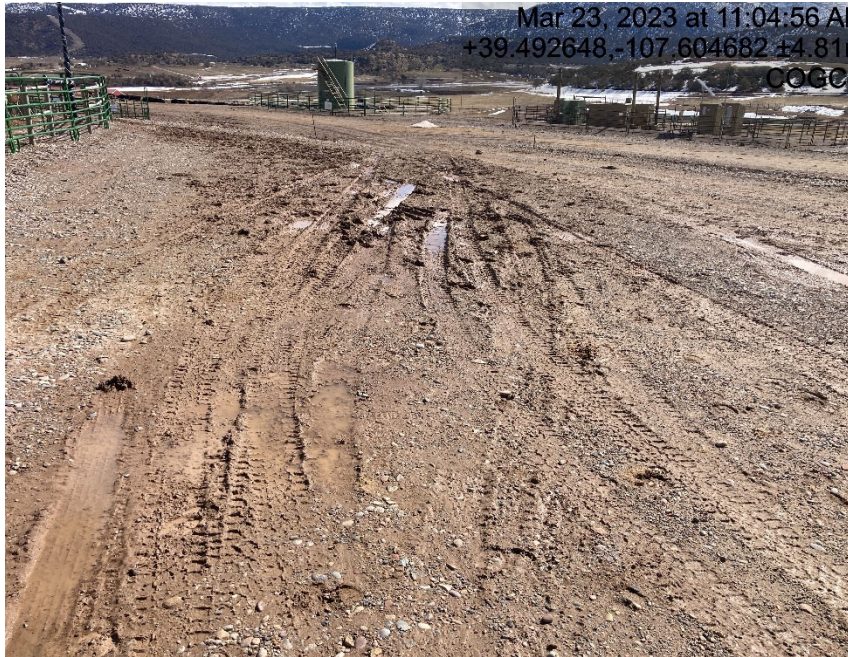
Lack of stabilization/compaction

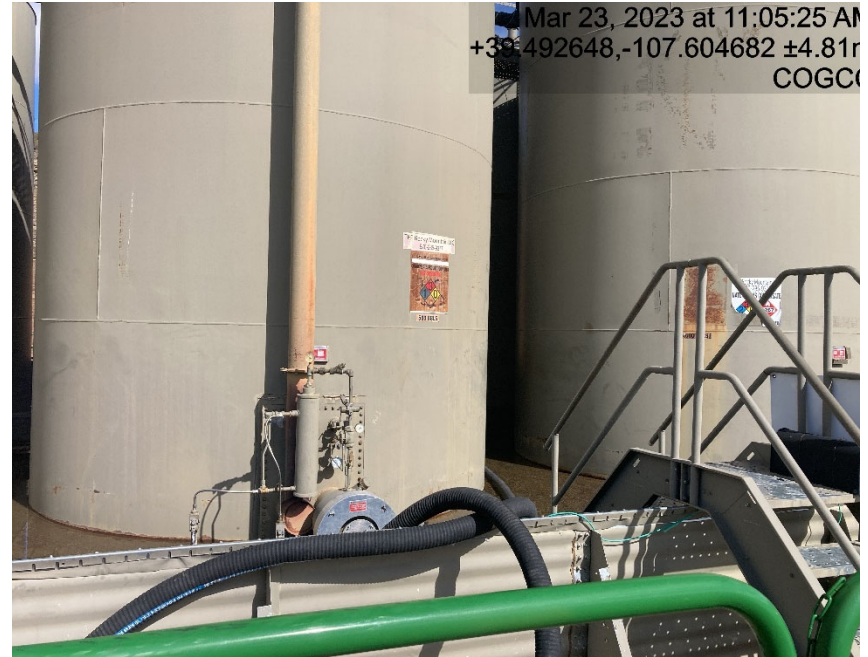
Tank labeling

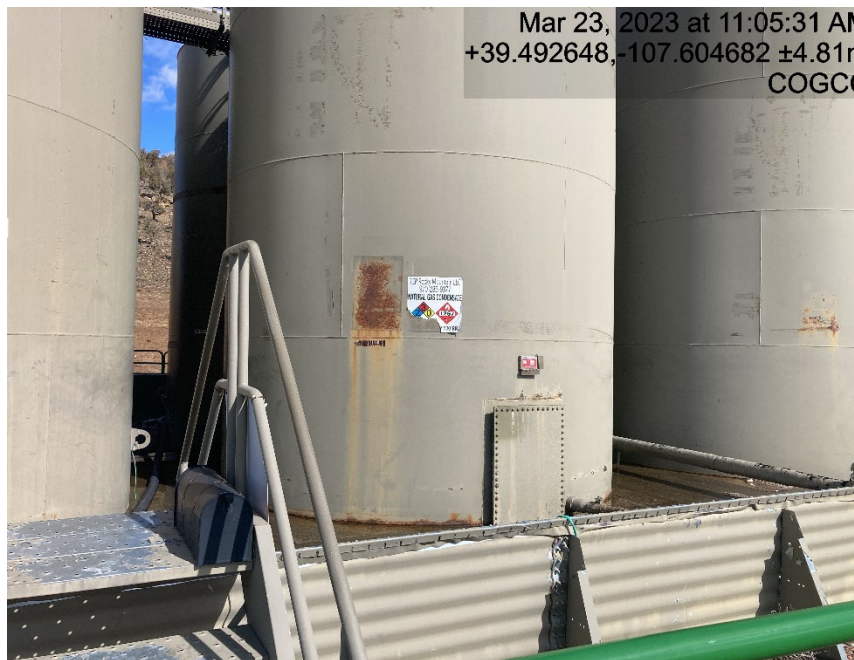
Tank labeling
