## Inspection Photos

Location Name: TEP ROCKY MOUNTAIN LLC CLOUGH RWF 424-13 Pad

Location ID: 335484

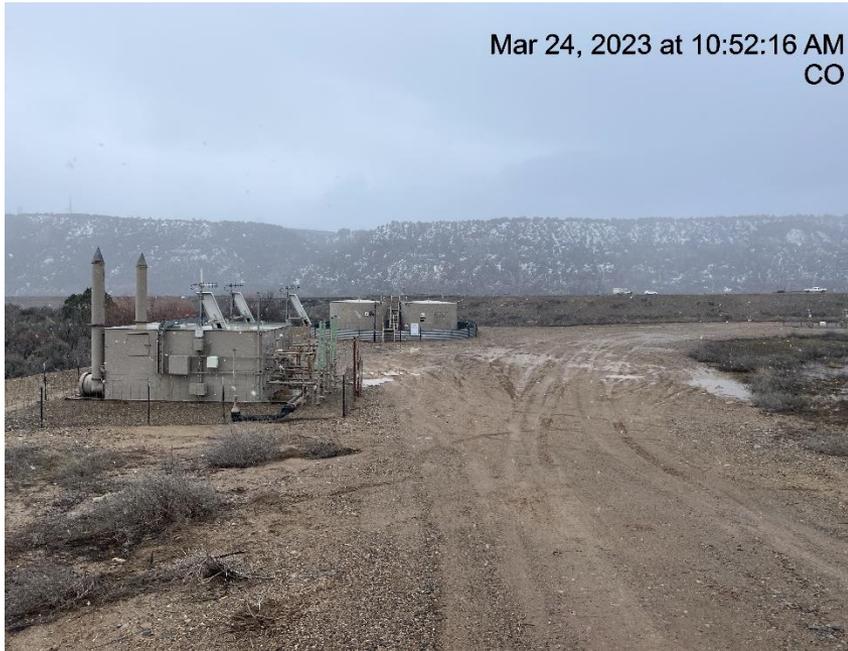
Photo # 3154 From entrance to location

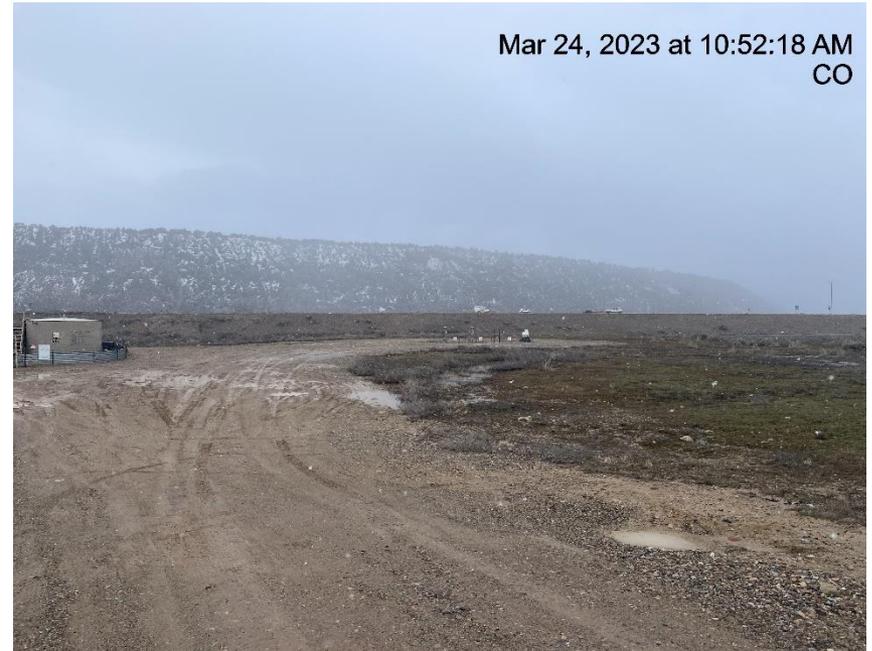
Photo # 3055 From entrance to location

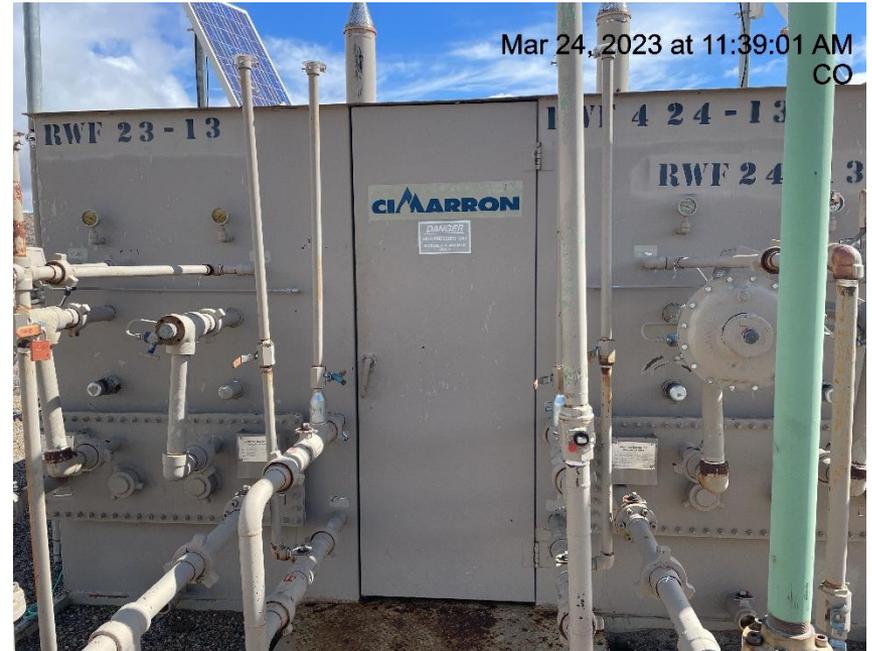
Photo # 3178 Meter calibration info not conspicuously posted

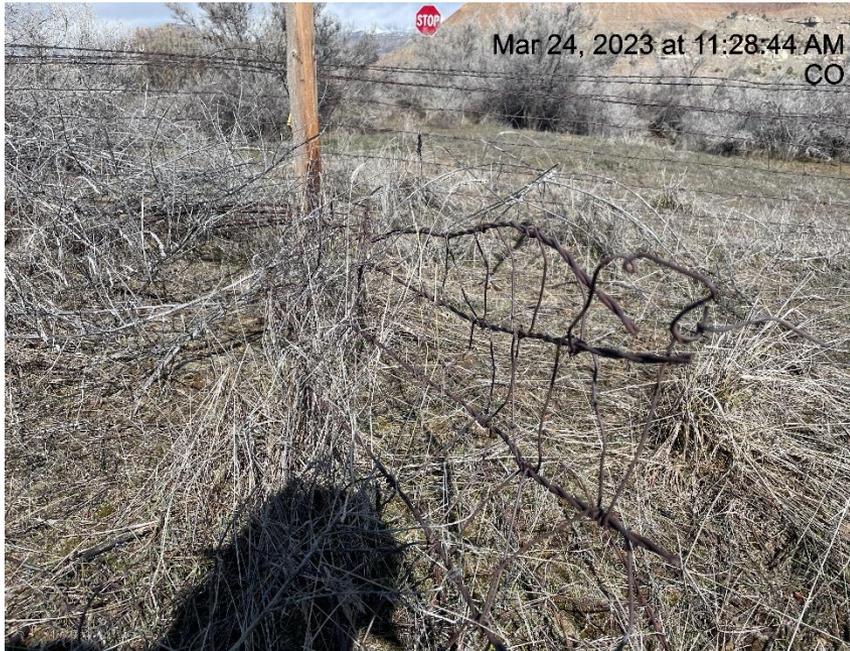
**Photo # 3161 Debris/Wildlife Hazard – Barbed wire laying on the ground**

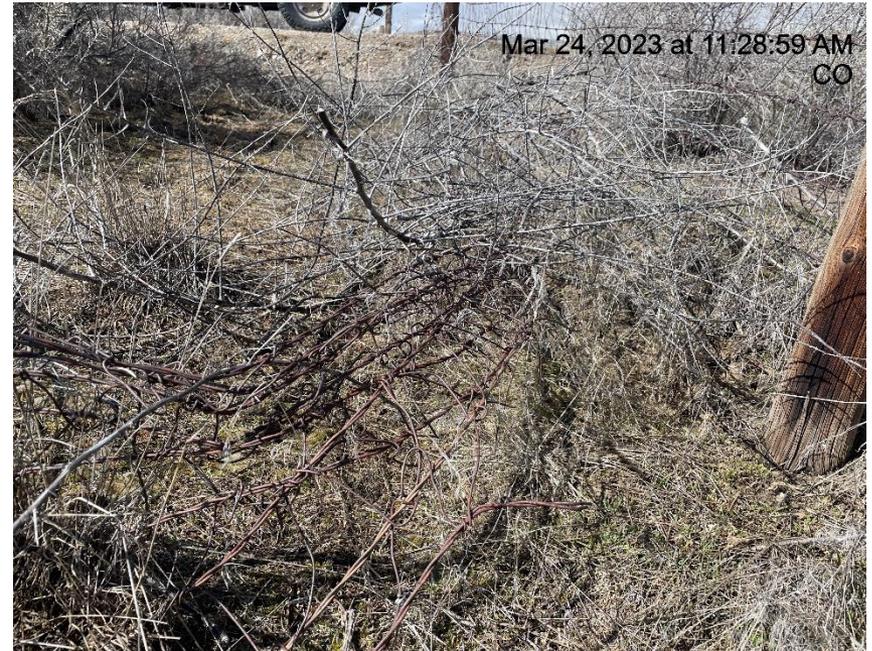
**Photo # 3162 Debris/Wildlife Hazard – Barbed wire laying on the ground**

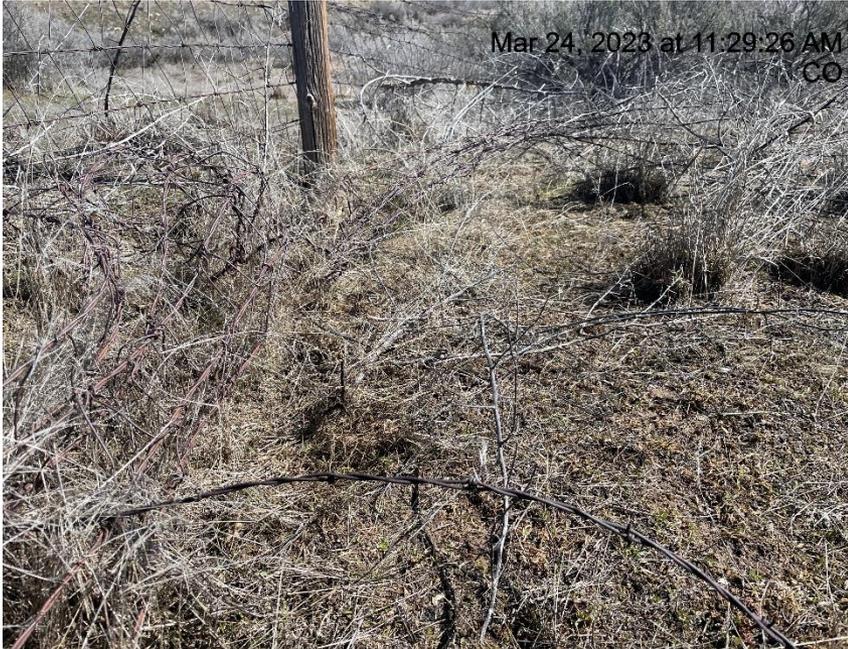
**Photo # 3163 Debris/Wildlife Hazard – Barbed wire laying on the ground**

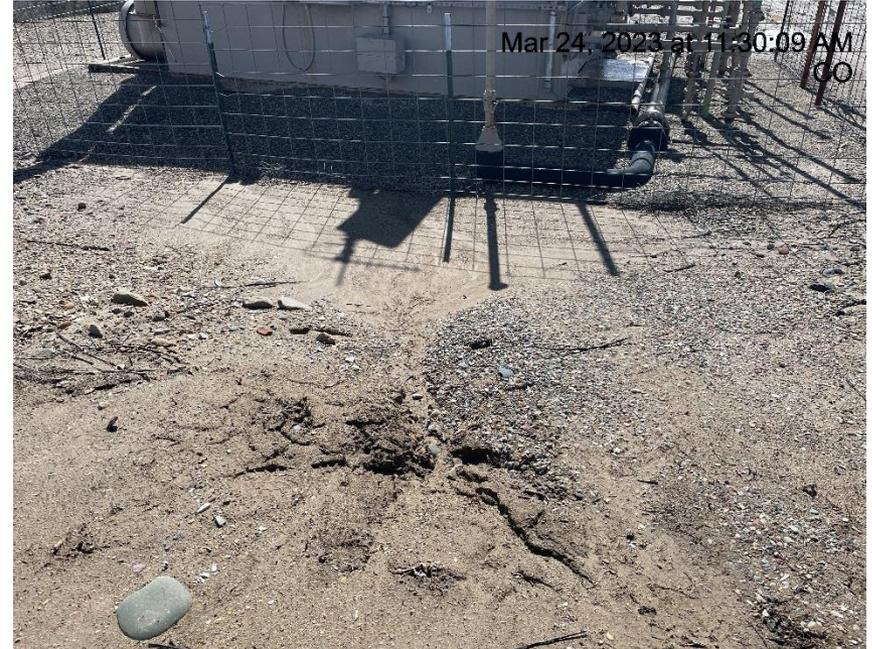
**Photo # 3165 Rill erosion/sediment encroaching on equipment**

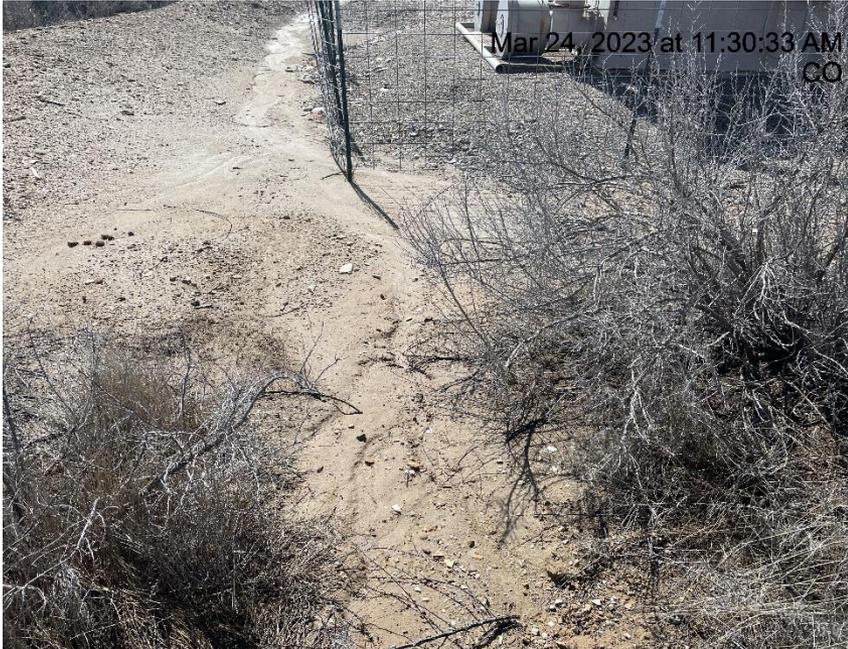
Photo # 2821 Rill erosion

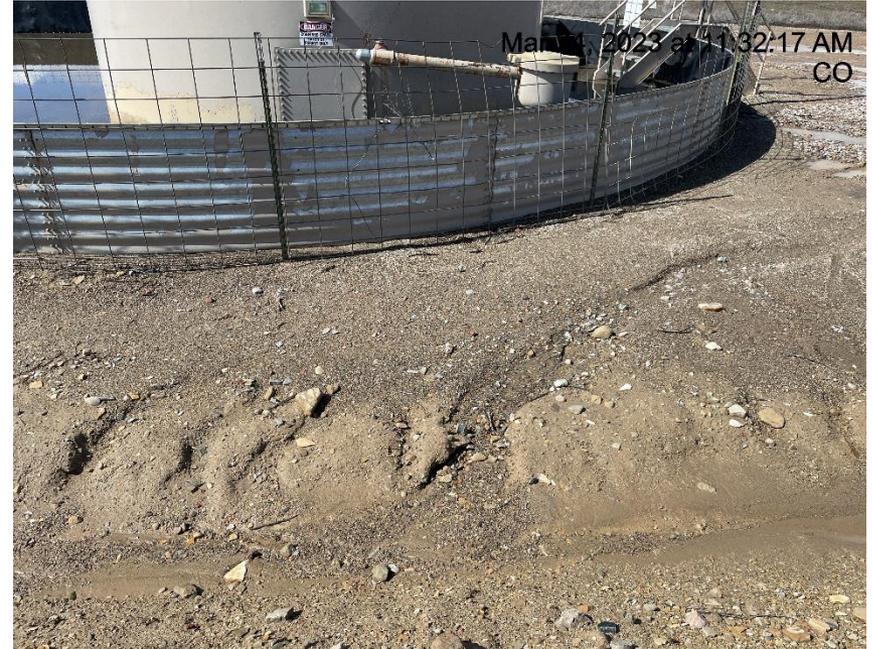
Photo # 3170 Rill erosion

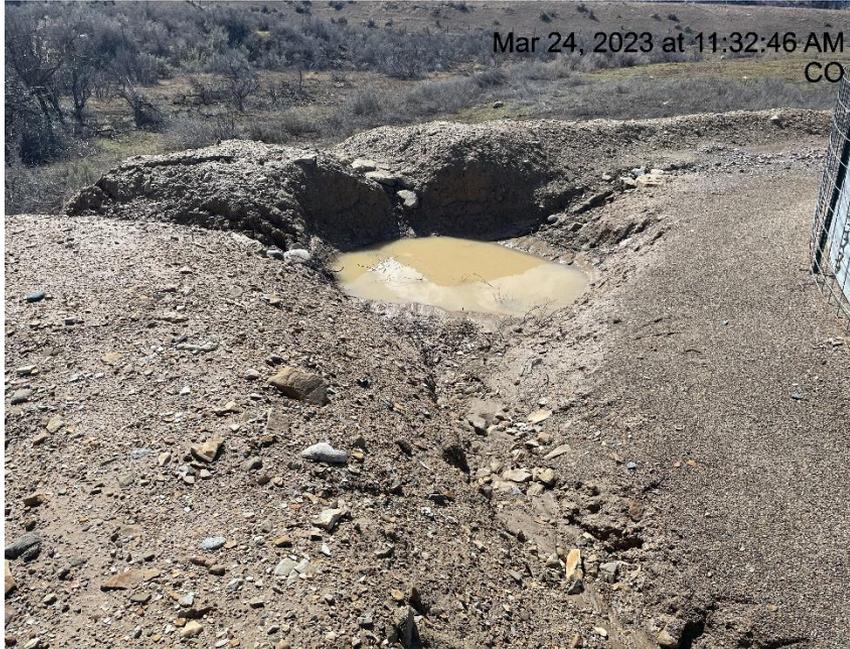
**Photo # 3172 Ditch & sediment trap need maintenance**

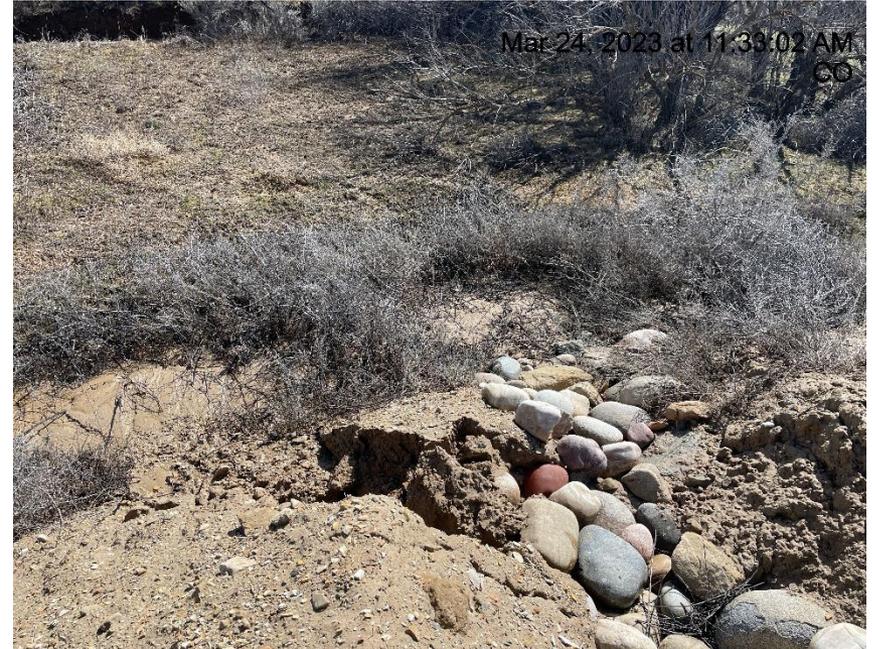
**Photo # 3173 Berm & Rip Rap need maintenance/transport of sediment off location**

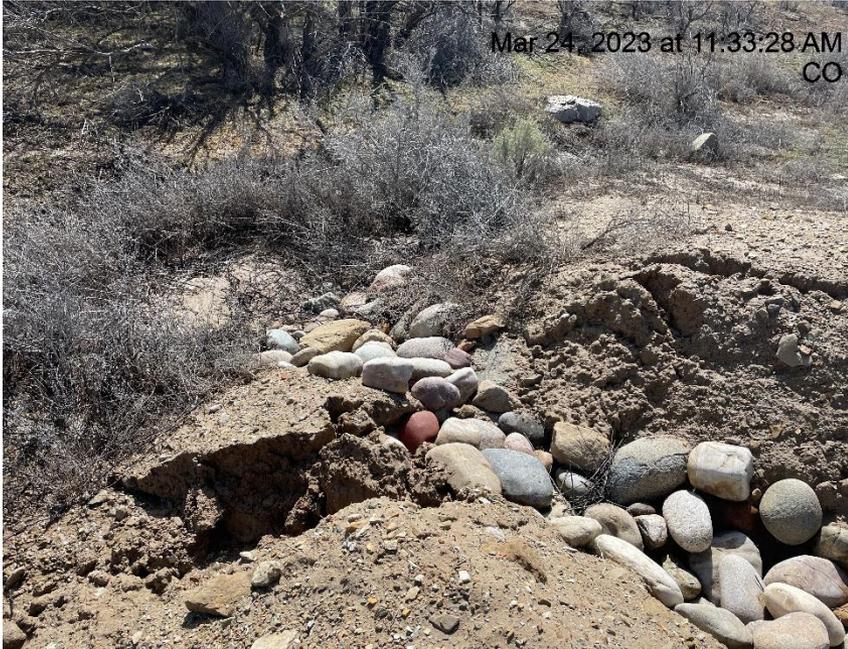
**Photo # 3174 Berm & Rip Rap need maintenance/transport of sediment off location**

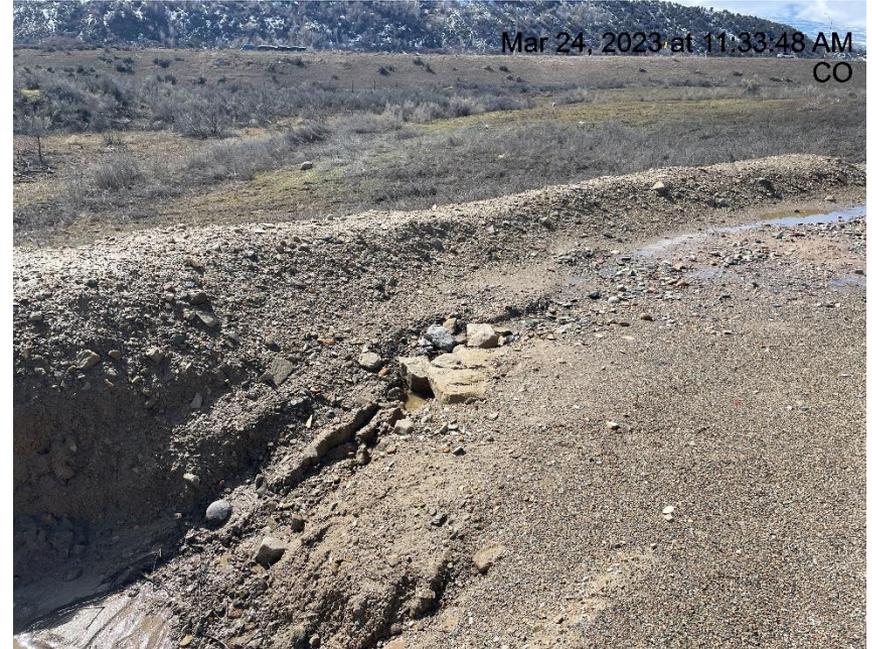
**Photo # 3176 Sediment trap/rip rap need maintenance**
