# Inspection Photos

3/24/2023

Operator: CHEVRON USA INC - 16700

Location #314671

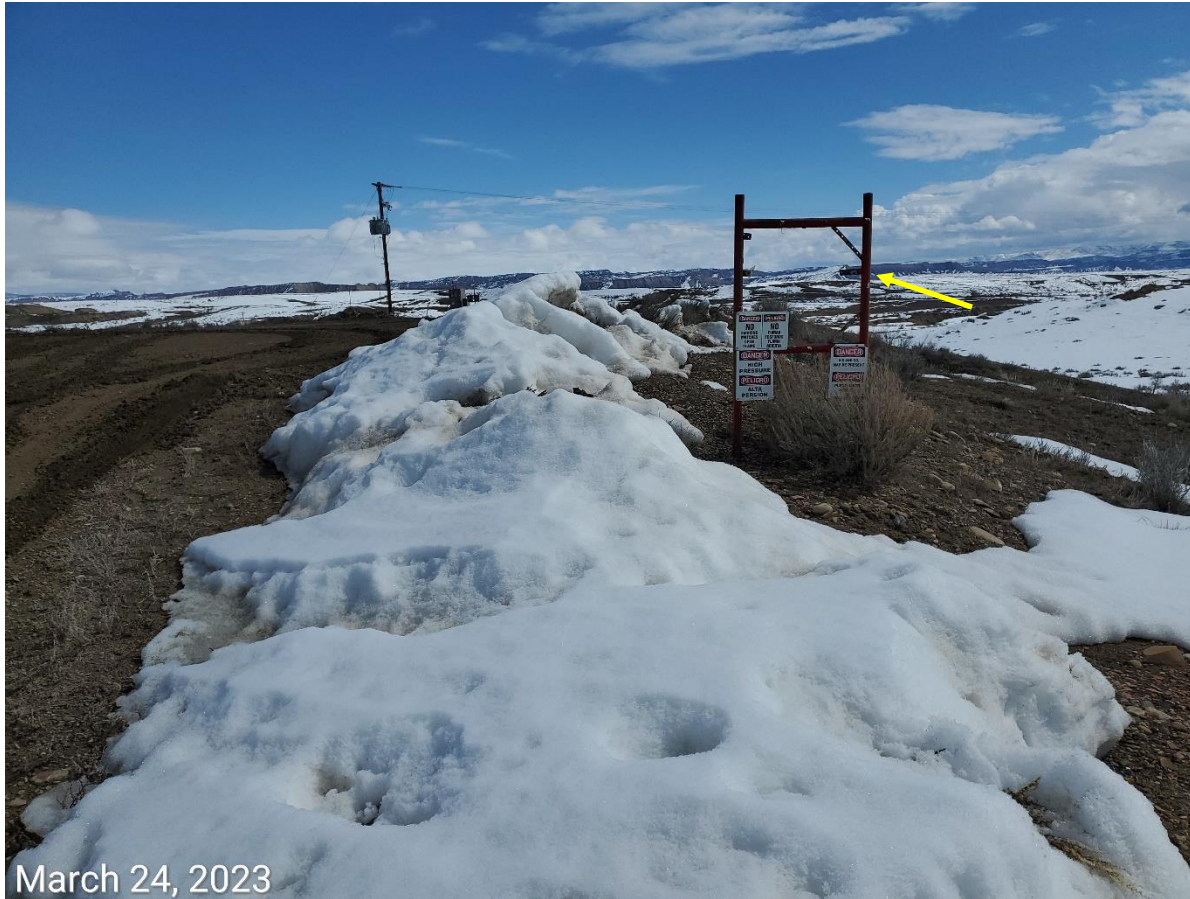
**Photo 1:** Photo shows sign at Location entrance in disrepair.

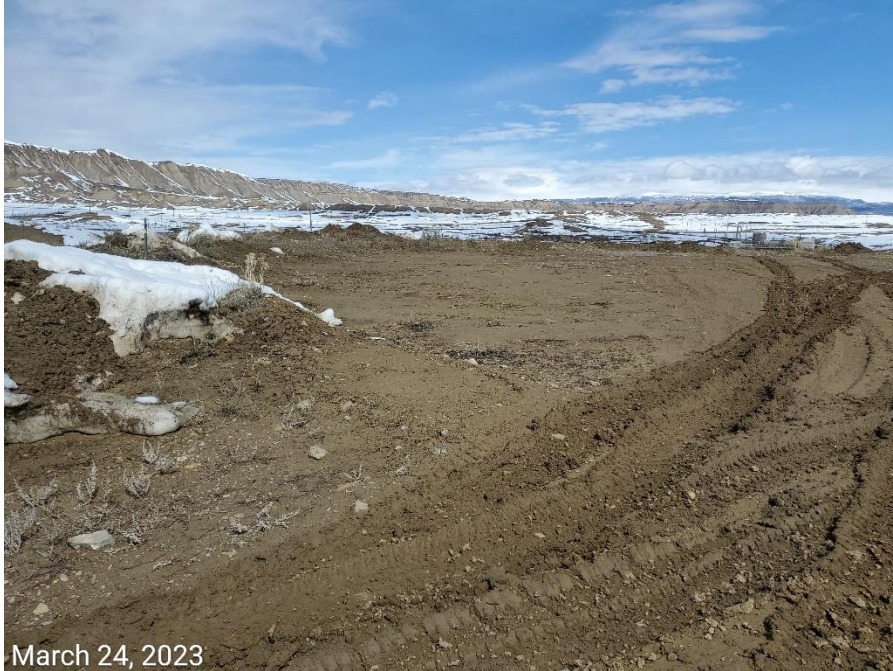
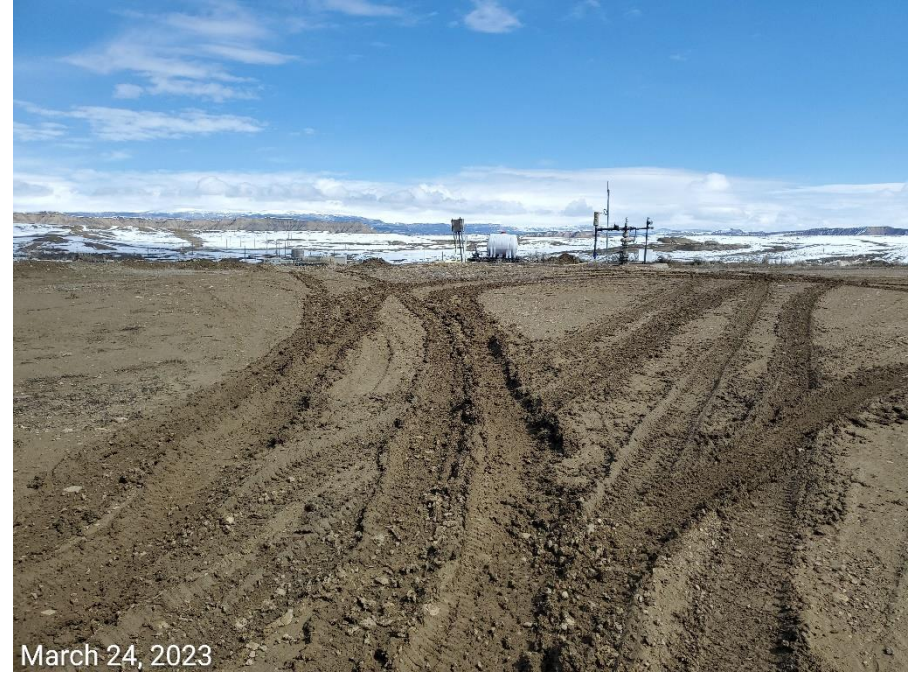
**Photo 2:** Photos 2-3 taken from the south end of the Location Photos provide an overview of the Location from west, northwest, northeast to east. Photos also show BMPs to minimize erosion, degradation/tracking and sediment transport are missing or insufficient on the Location.

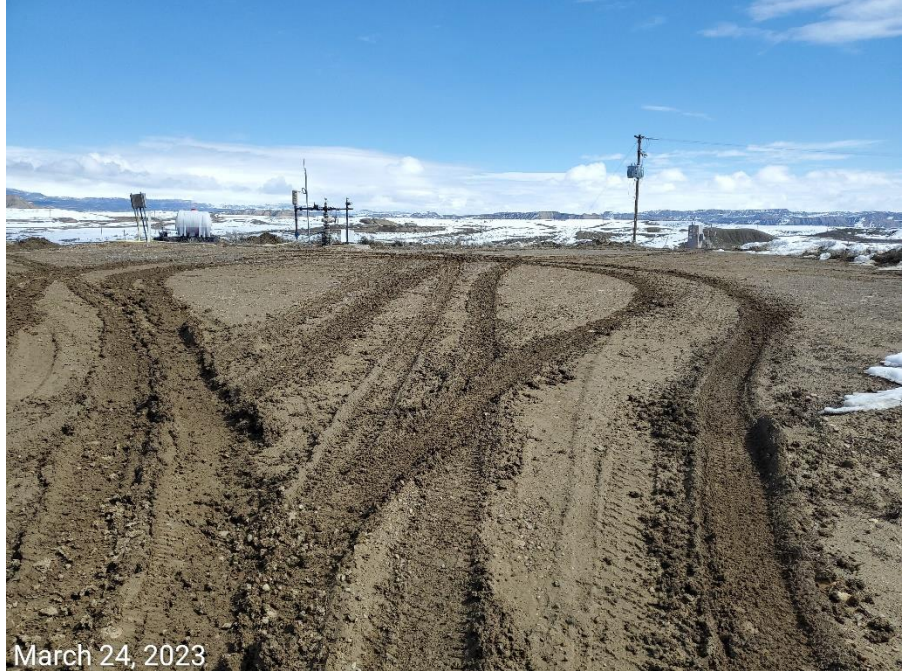
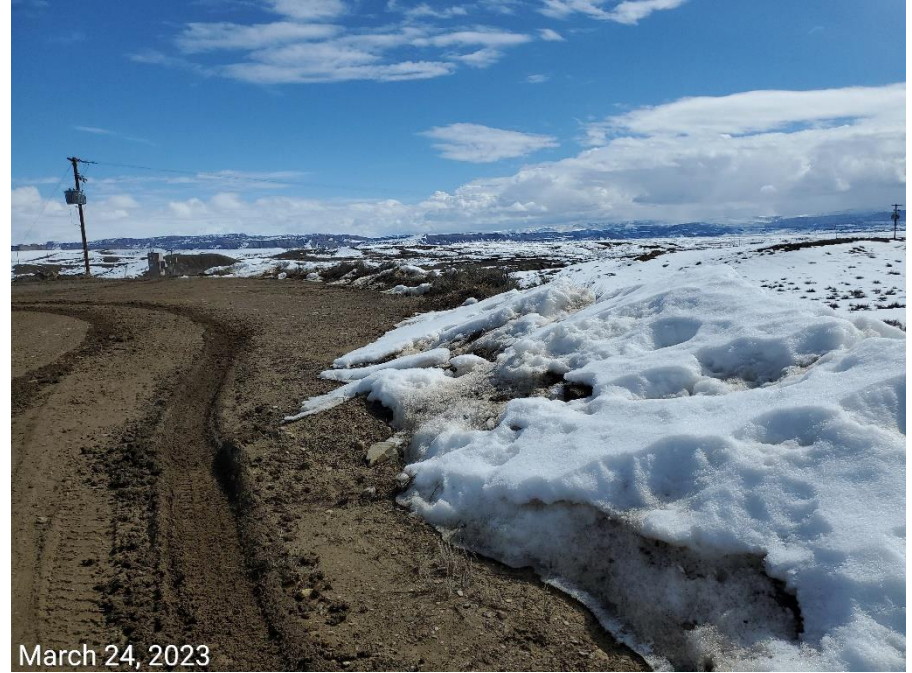
**Photo 3:** See comments under photo 2.

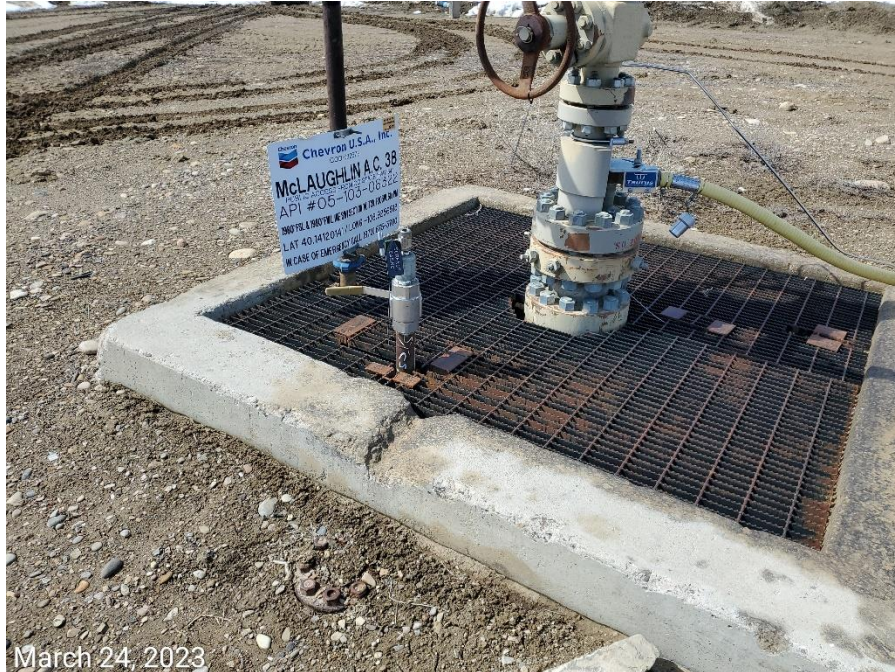
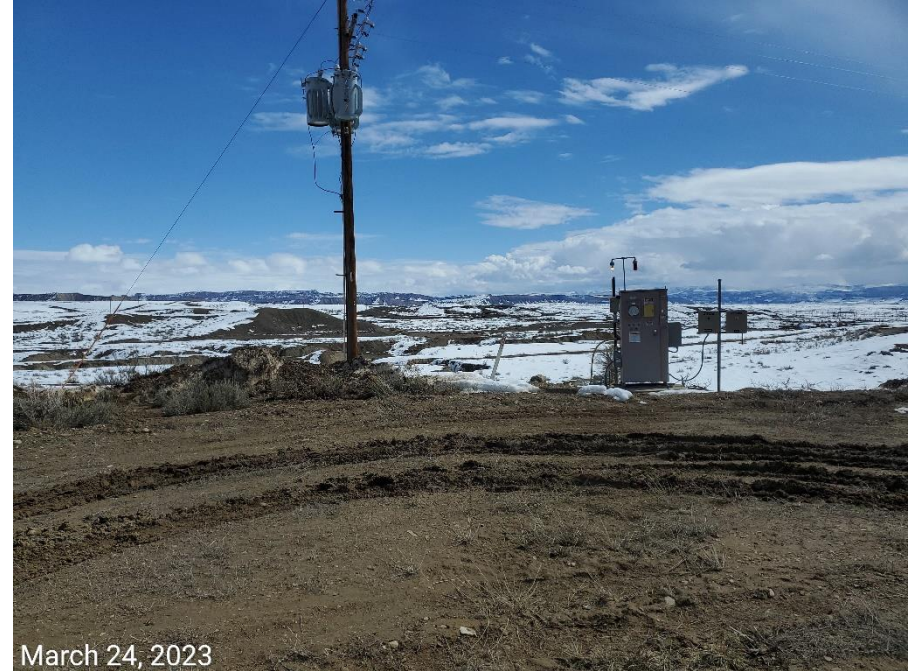
**Photo 4:** Well/utility equipment.

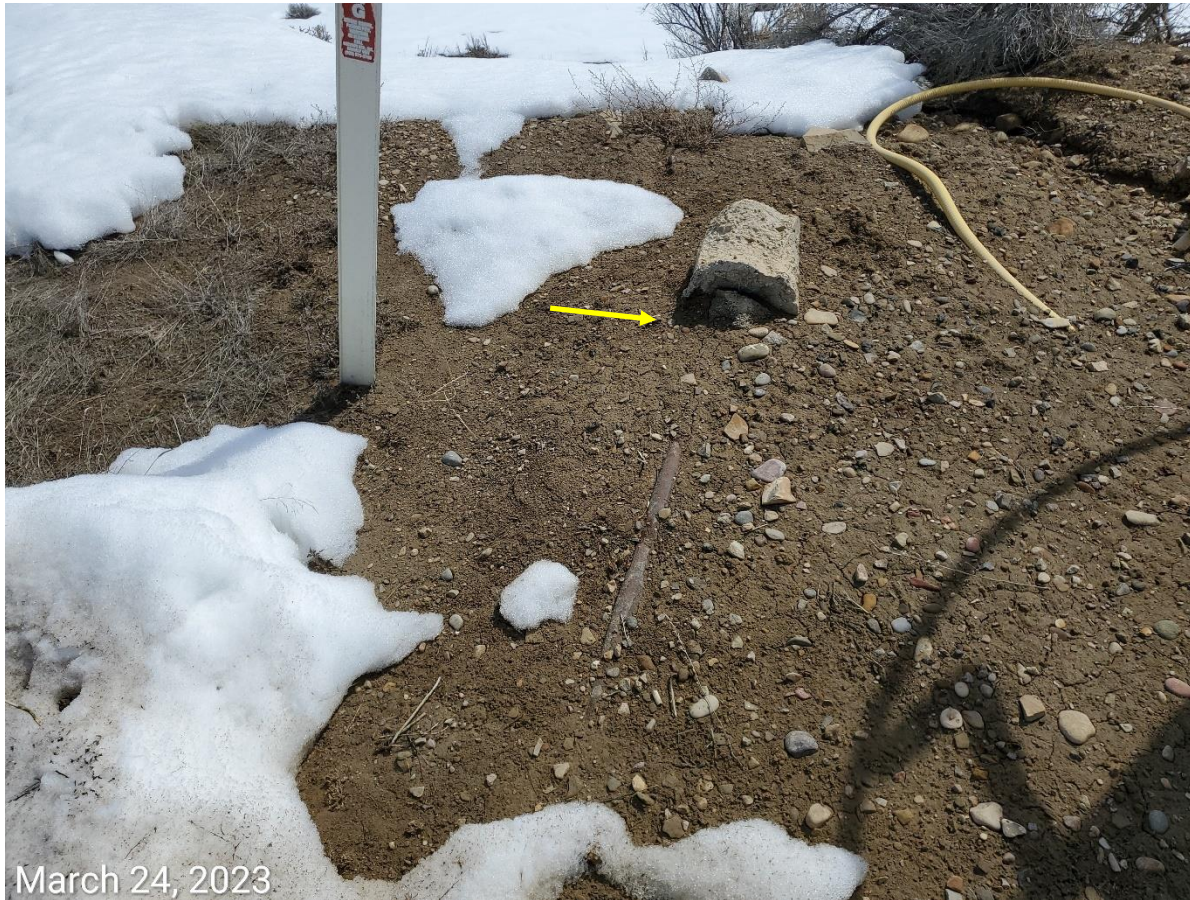
**Photo 5:** Photo shows partially buried pipe/concrete trash debris.

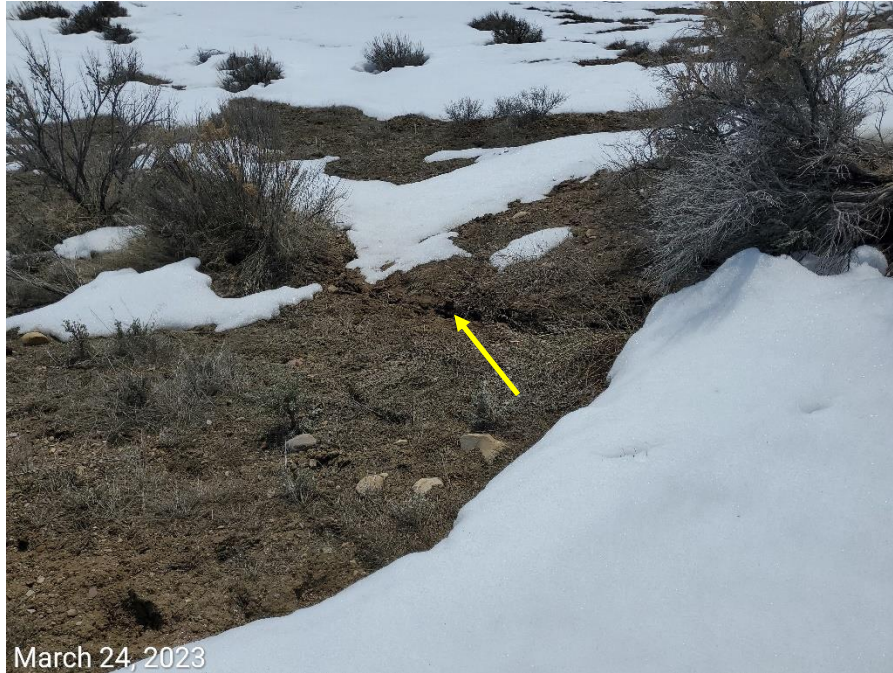
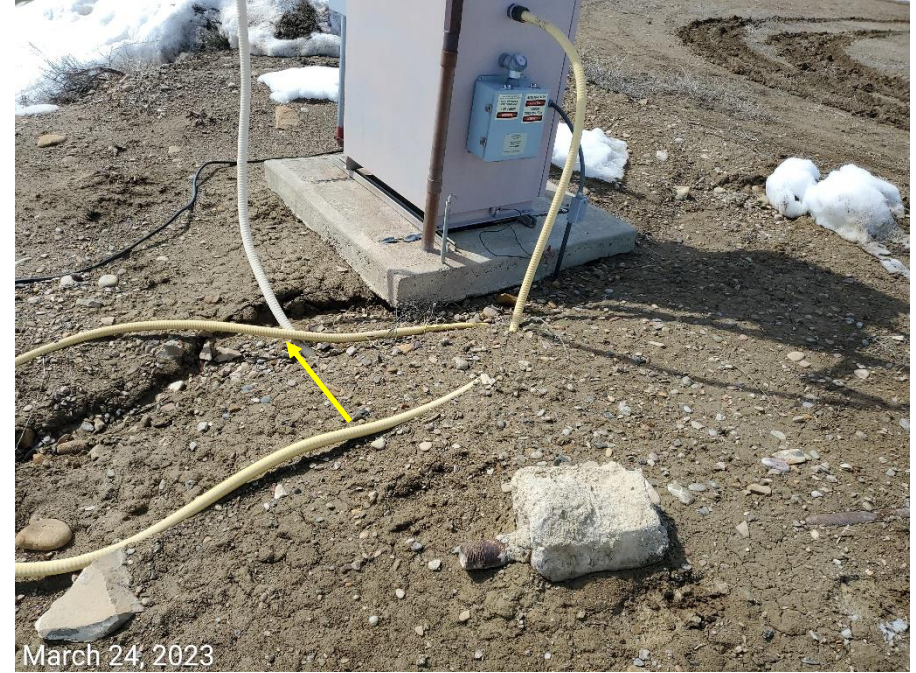
**Photo 6:** Photo taken from the east end of the Location. Photo shows BMPs to manage runoff from the Location are missing or insufficient, resulting in degradation to the off-site slopes east of the Location.

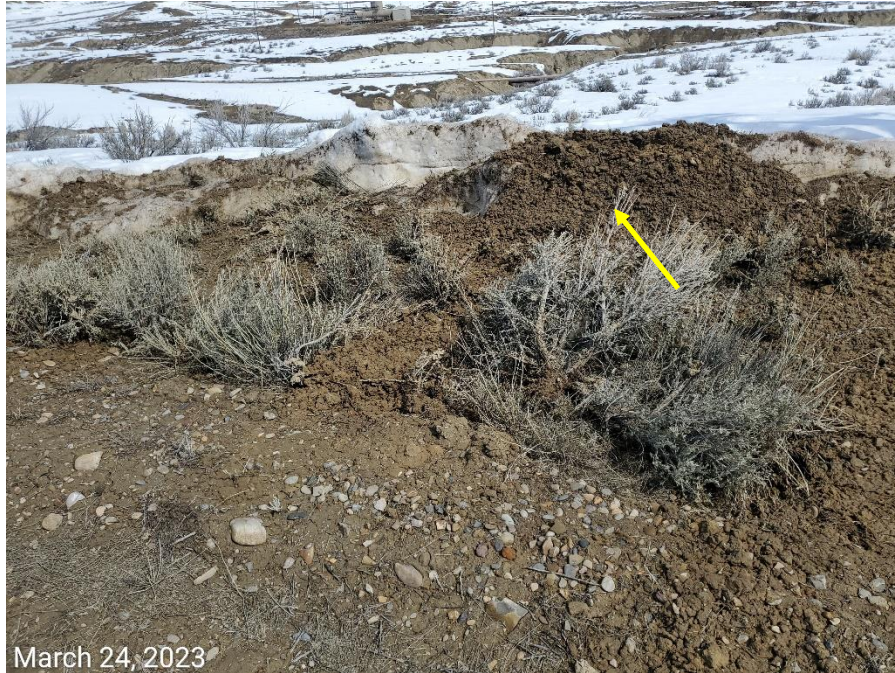
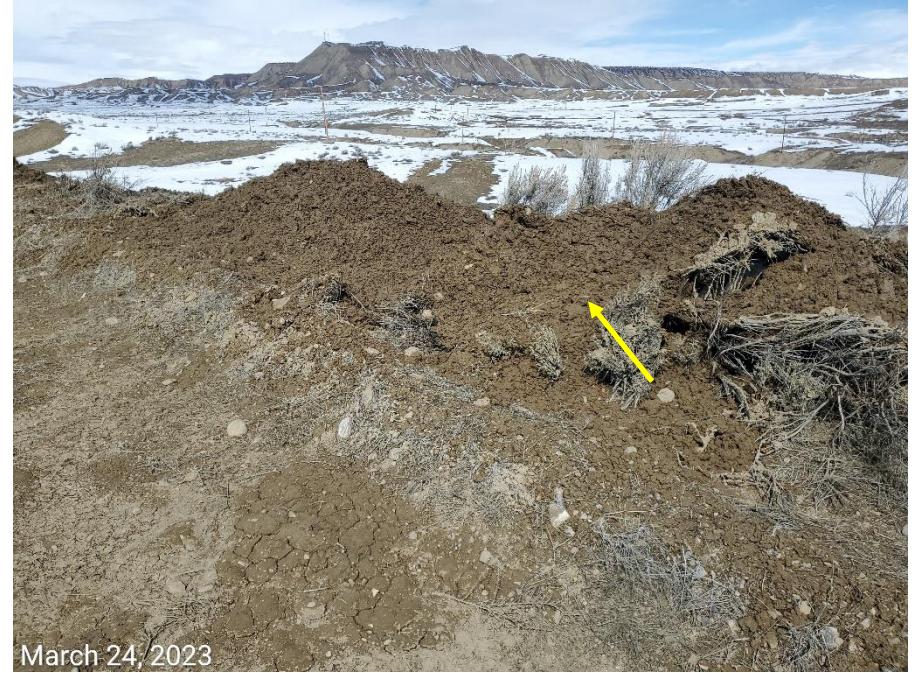
**Photo 7:** Photos examples showing soils stockpiles that have been pushed beyond the perimeter of the working pad, therefore expanding the disturbance of the Location. Soils are unconsolidated and are a pollutant source. Photo also shows vegetation covered by soils. BMPs to minimize sediment transport missing.

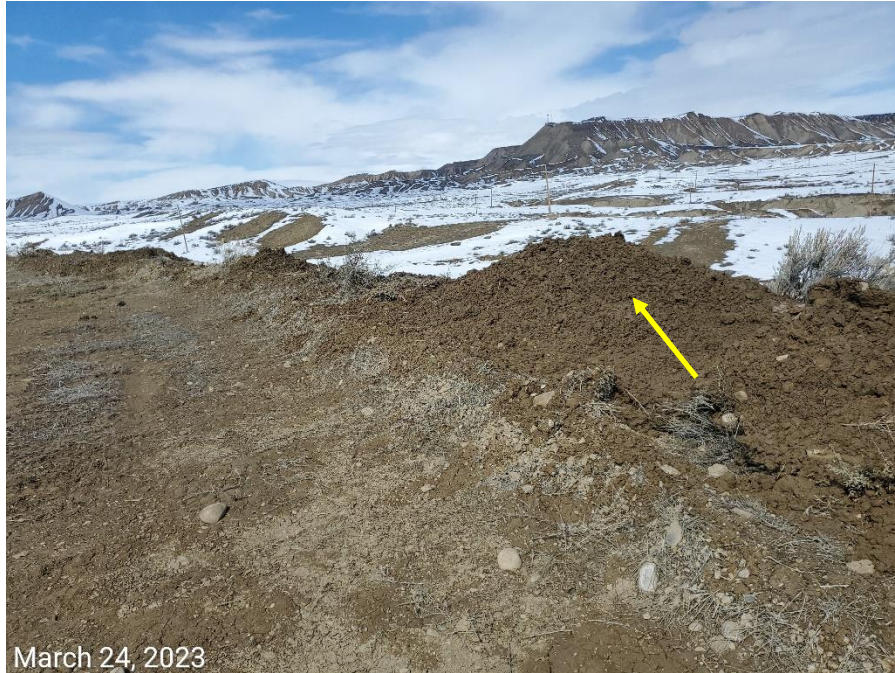
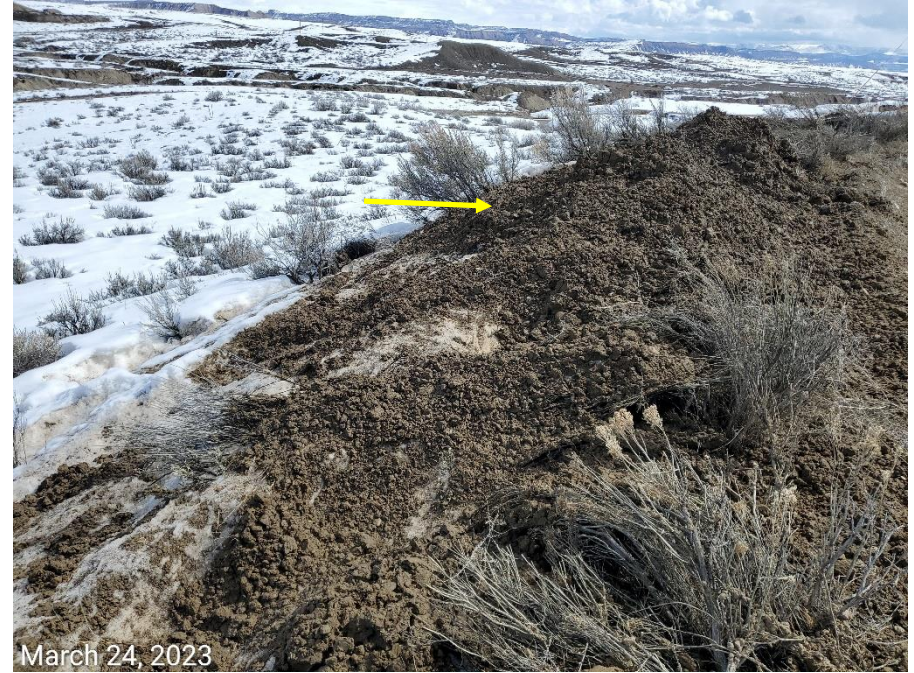
**Photo 8:** See comments under photo 7.

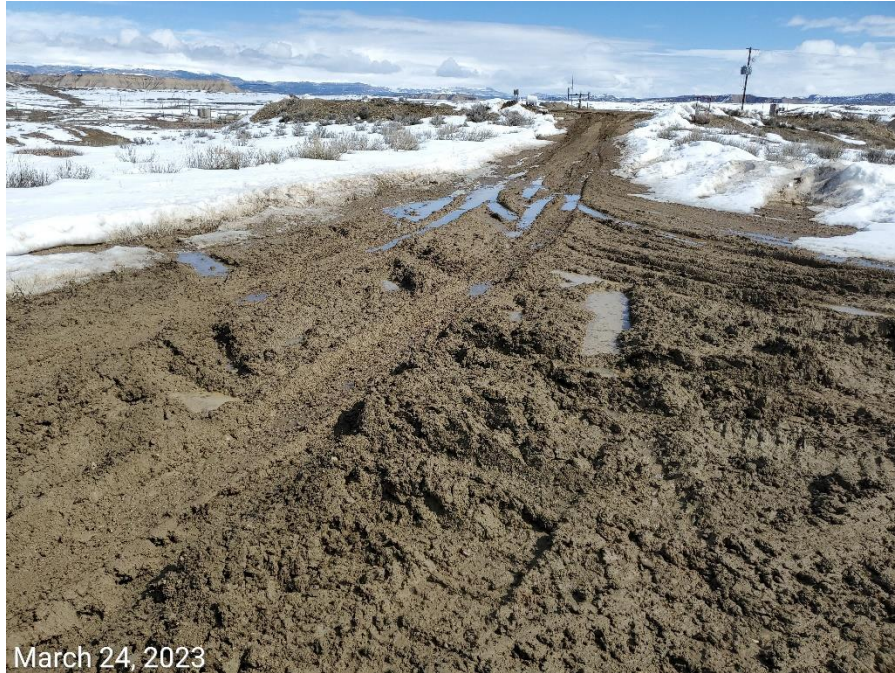
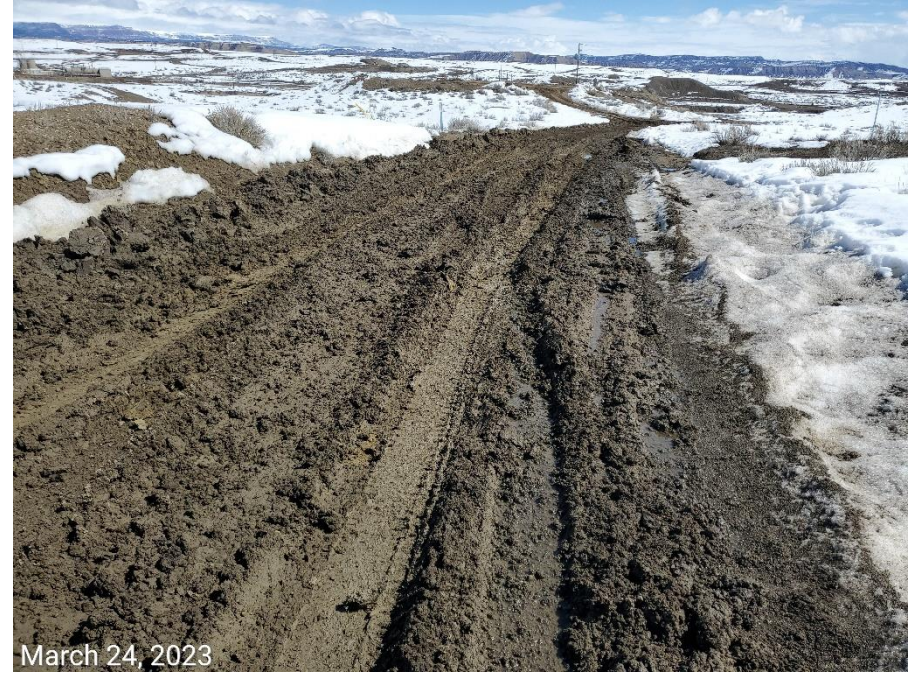
**Photo 9:** Photos 9-12 taken from the access road. Photos show BMPs to stabilize, as well as to minimize erosion, degradation/tracking and sediment transport are missing or insufficient at the access road. There are areas of the Access road that does not appear to be properly engineered to adequately manage stormwater.

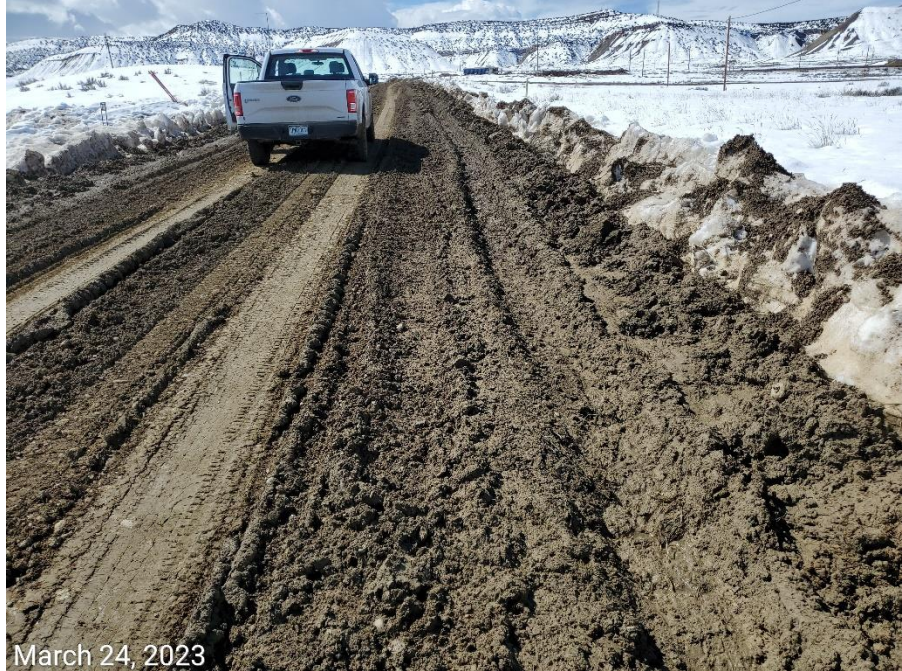
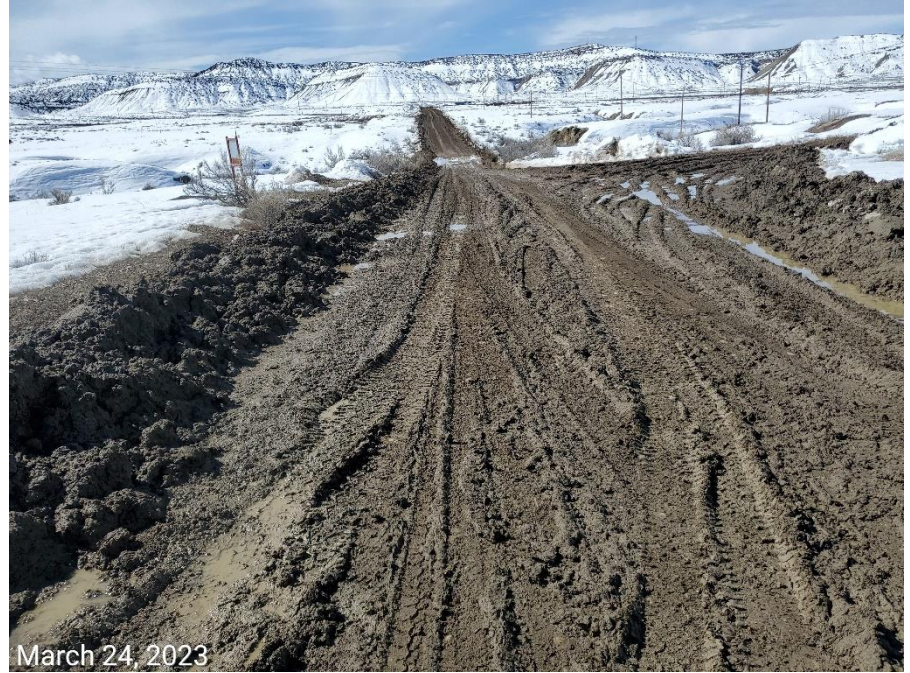
**Photo 10:** See comments under photo 9.

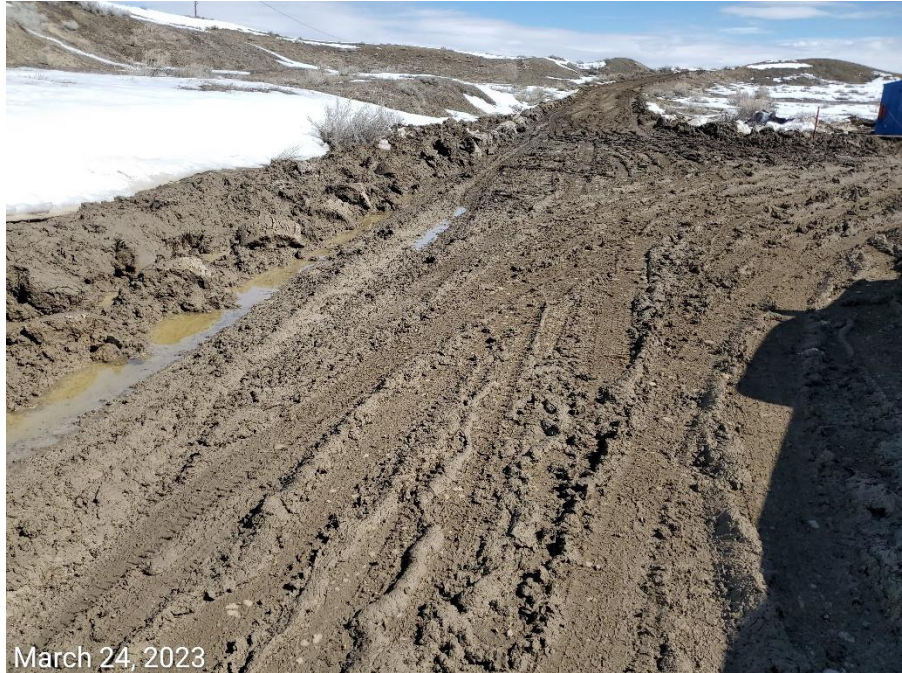
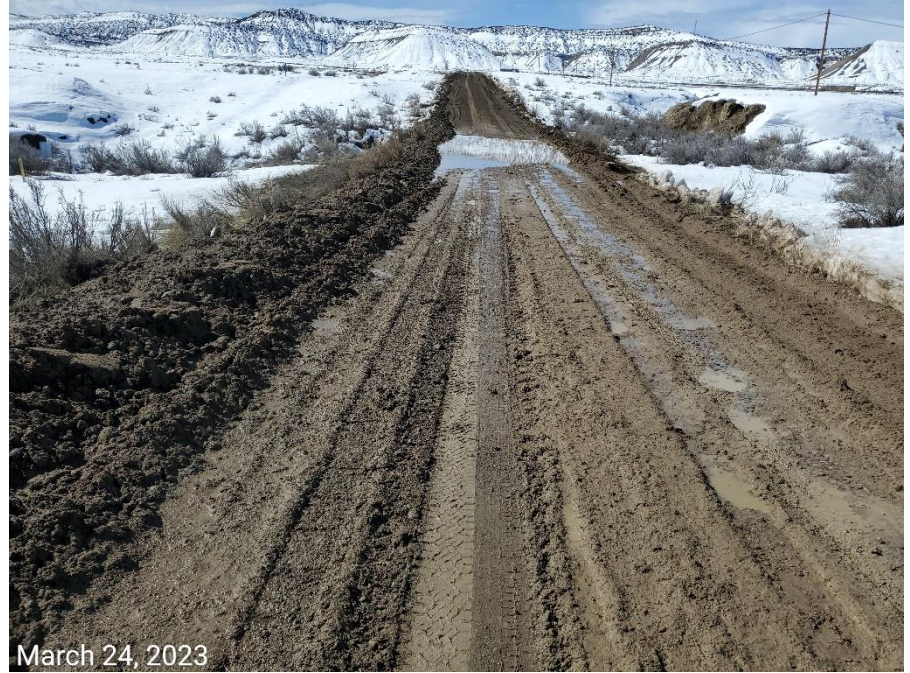
**Photo 11:** See comments under photo 9.

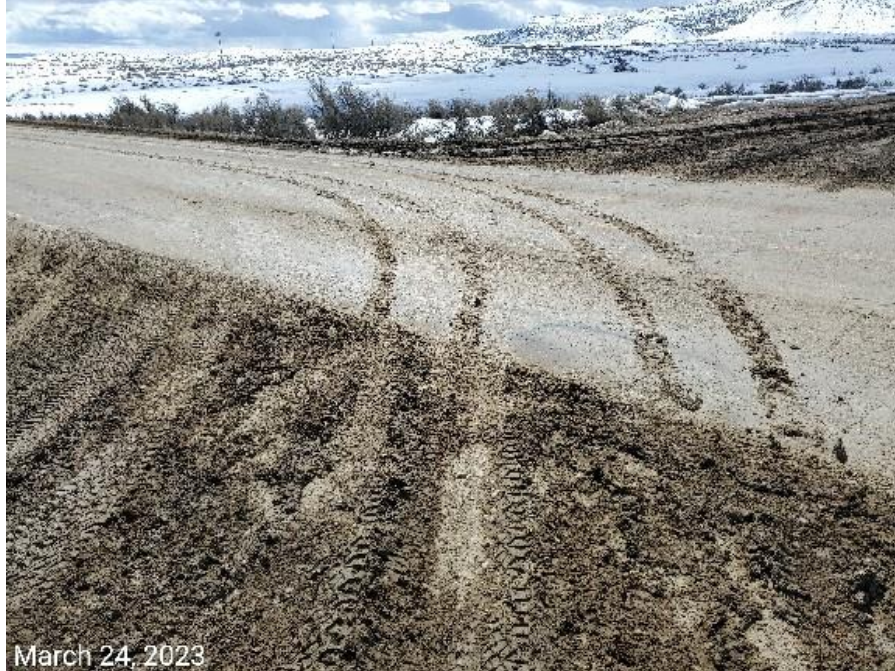
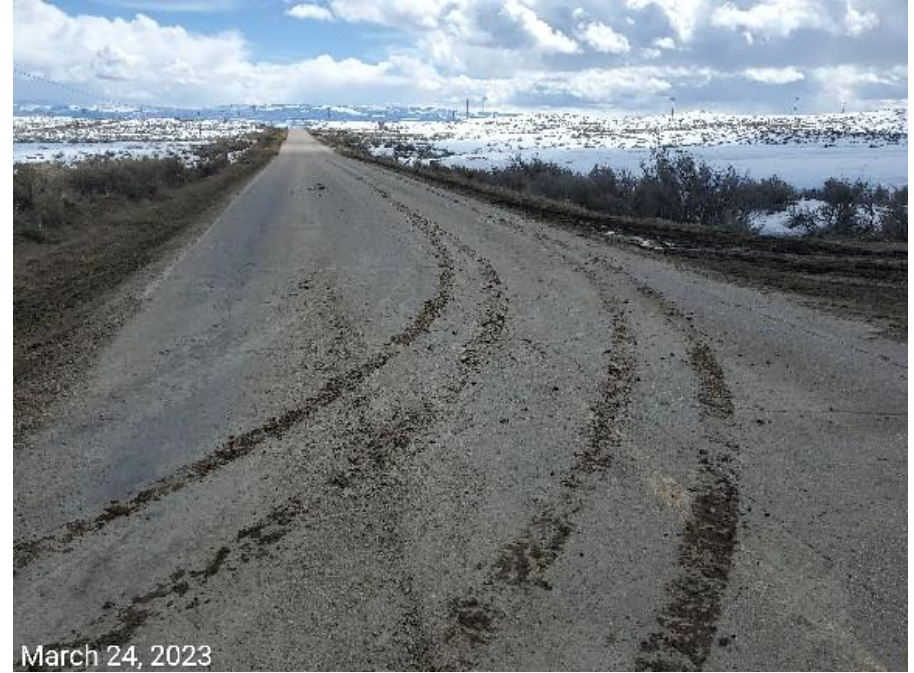
**Photo 12:** See comments under photo 2. Photo shows tracking/rutting and off-site sediment transport onto Highway 64 from the access road. Refer to inspections #696204791 and #696204758.
