Inspection Photos

API: 071-07604

Operator: EVERGREEN NATURAL RESOURCES

Inspection Date: 3/27/2023

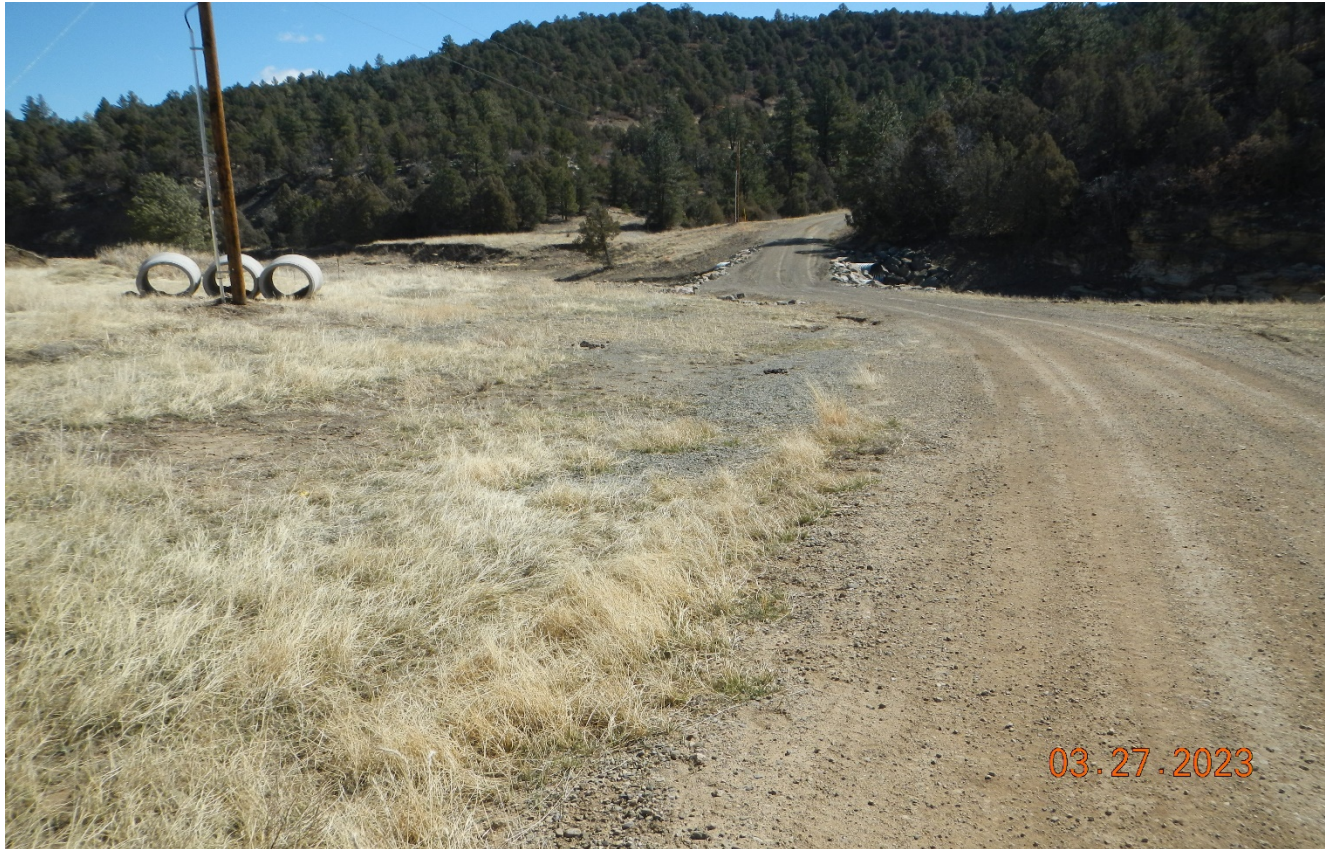
Photo 1. Facing east toward the access road stream crossing. The old cement culverts still remain and need to be removed.

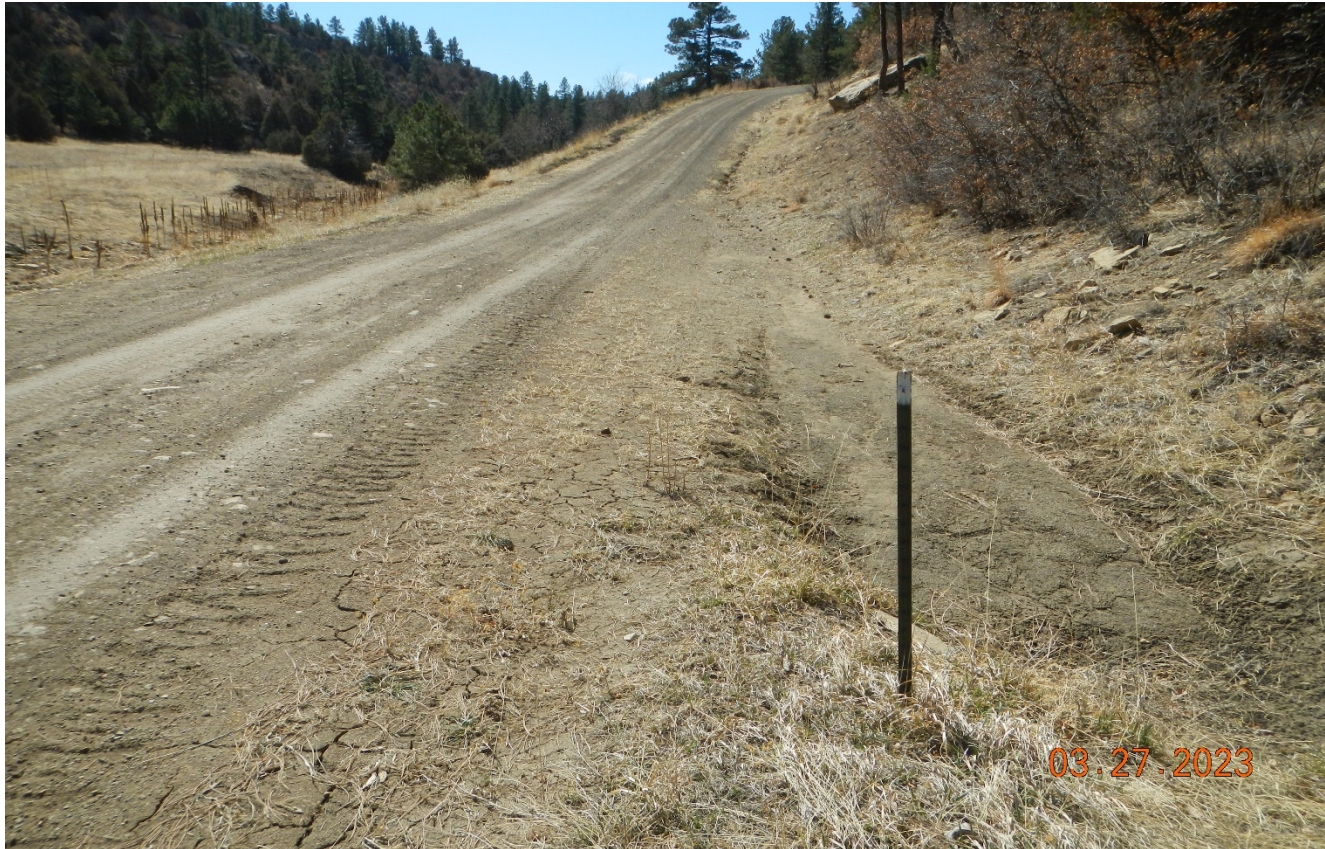
Photo 2. Facing southeast along the access road. This culvert along the access road has filled back in with sediment and needs to be cleaned out.

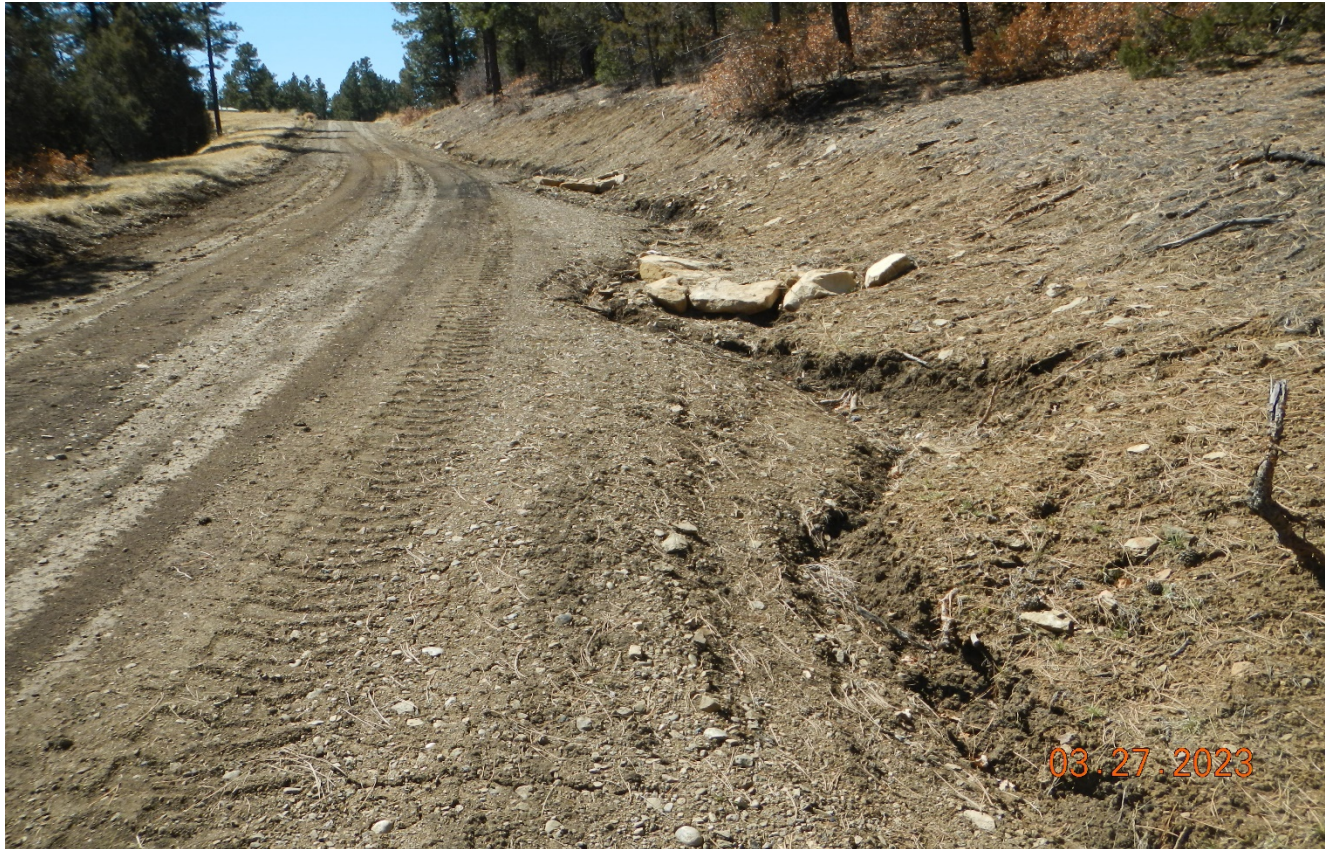
Photo 3. There was repairs made since previous inspection however erosion is occurring around the rock check dams. BMP maintenance is needed.

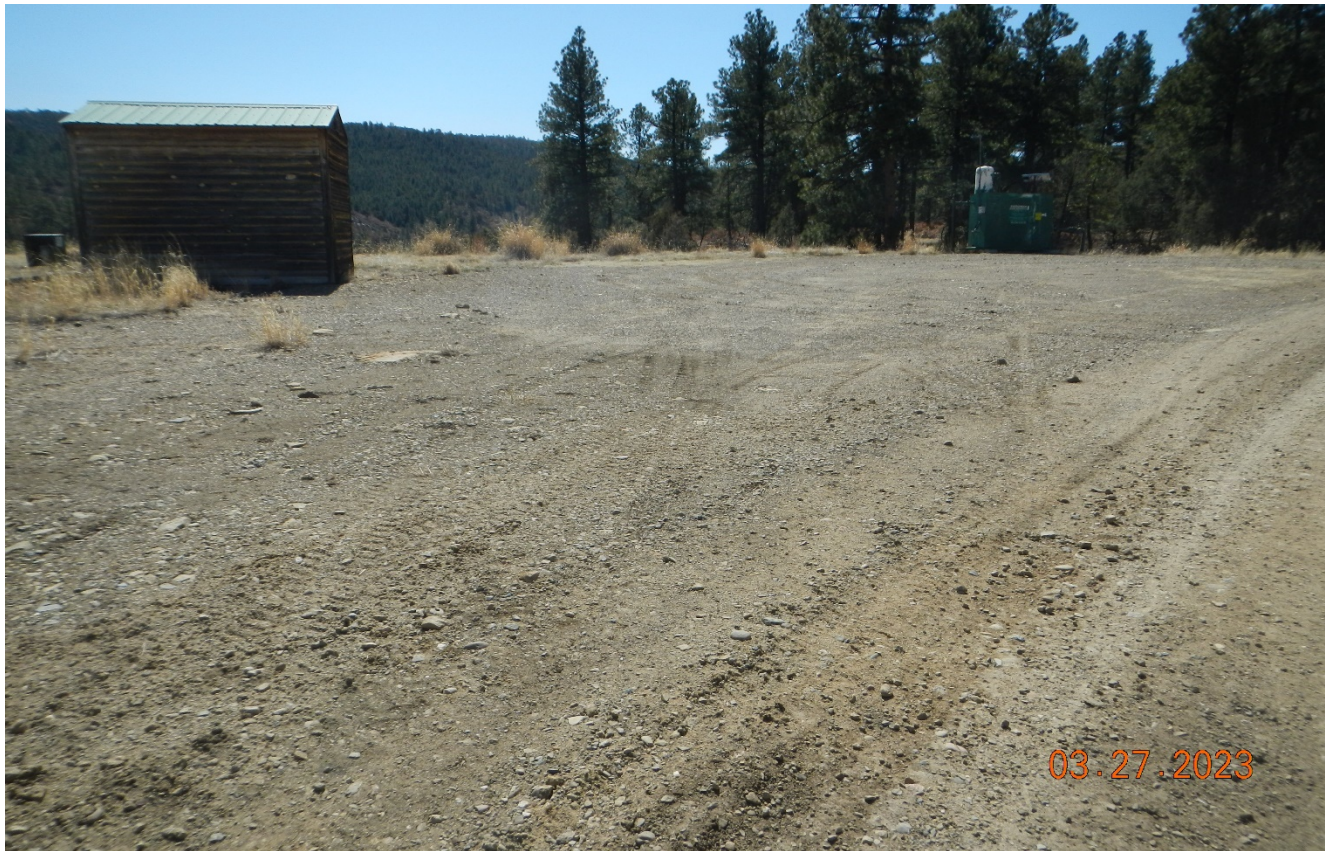
Photo 4. Facing south toward the well site.
