Inspection Photos
Location Name: Facility 1
Spill ID: 484038

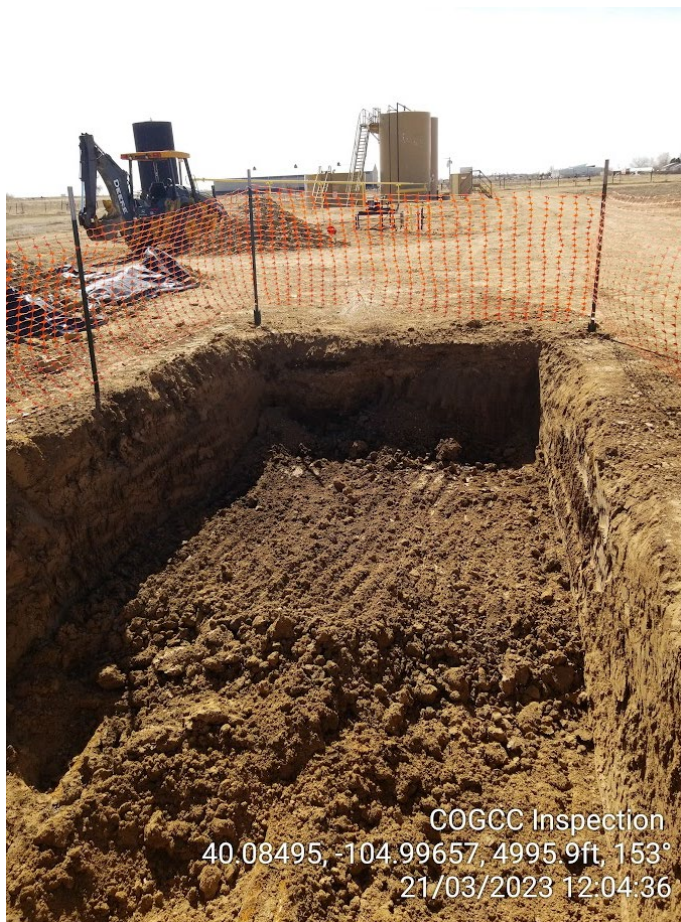
Photo 1 – Excavation

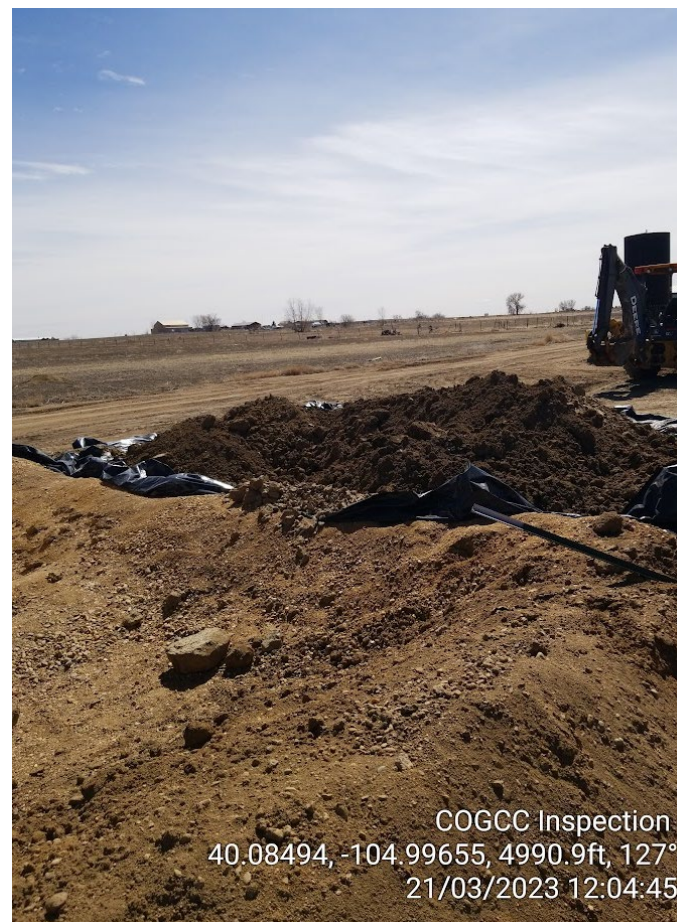
Photo 2 – E&P waste stockpiled

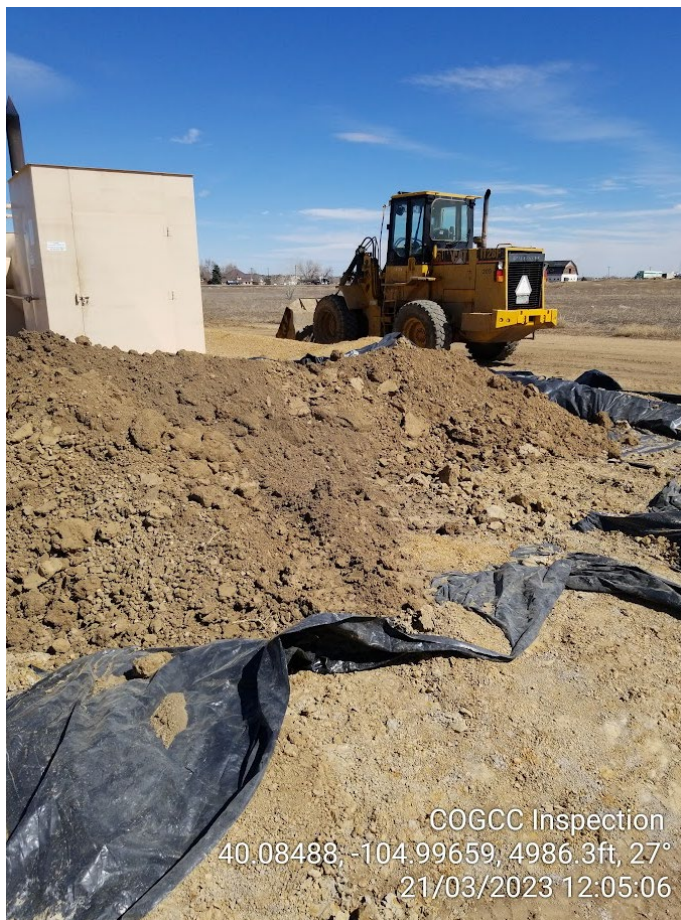
Photo 3 – No stormwater controls around E&P waste

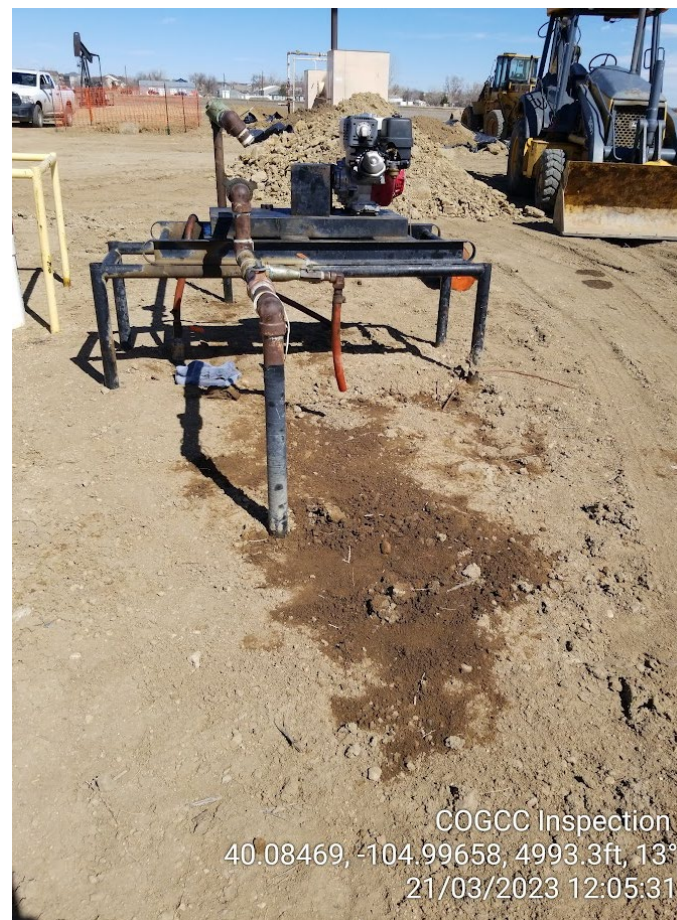
Photo 4 – Staining

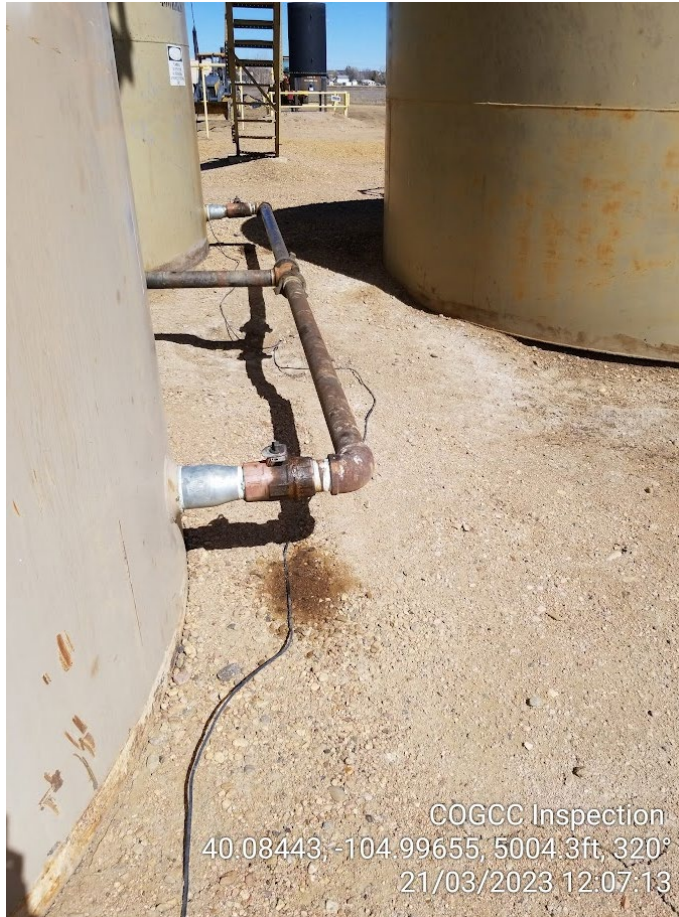
Photo 5 – Staining

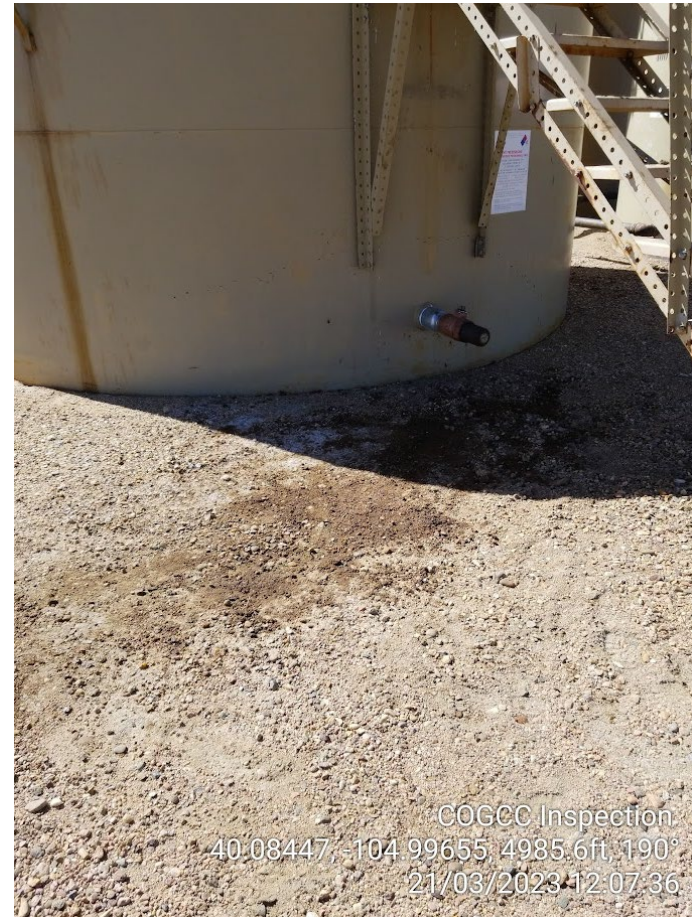
Photo 6 – Staining
