Interim Reclamation and Stormwater Inspection

Date: 03/23/2023

Operator: P O & G OPERATING LLC - 10634

Inspection Photos
Location Name: Lowe 2-B
Location ID: 463256

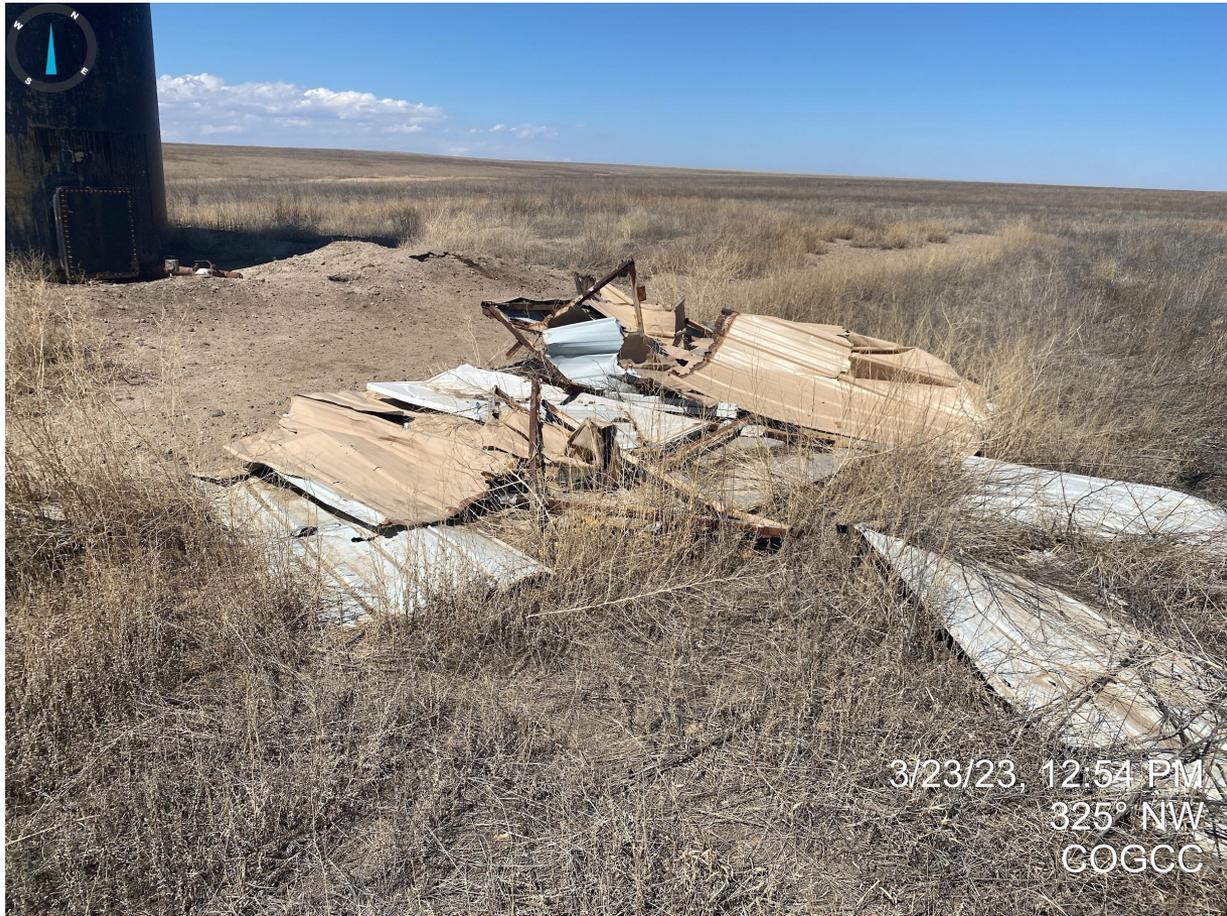
Photo 1. Facing northwest at the location. Remnants of a shed was observed in a previous inspection (Doc #700600163) on 09/30/2020, and have not been removed at the time of this inspection. This is now considered trash/debris and needs to be removed.

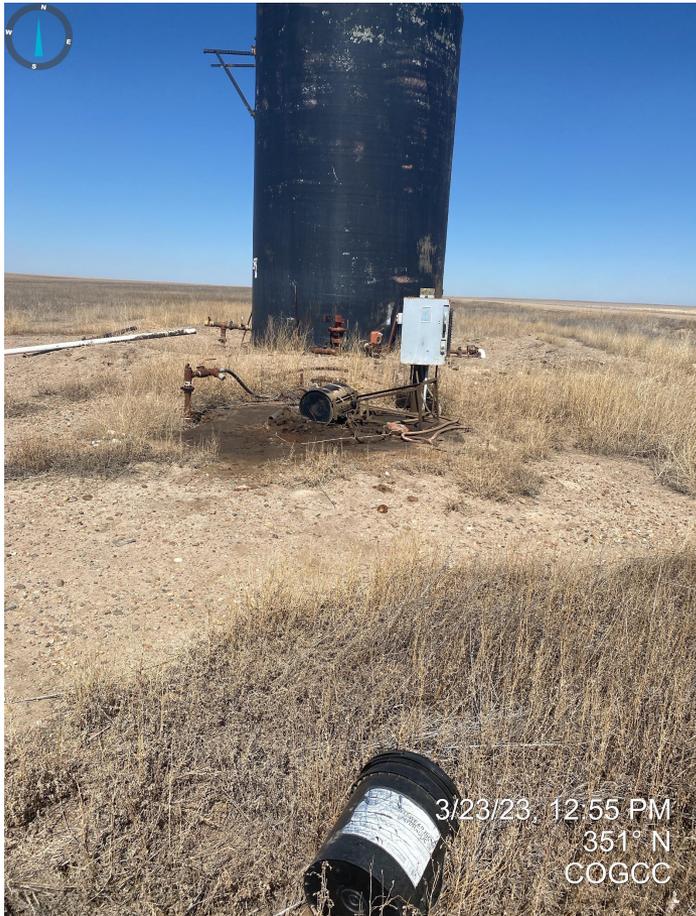
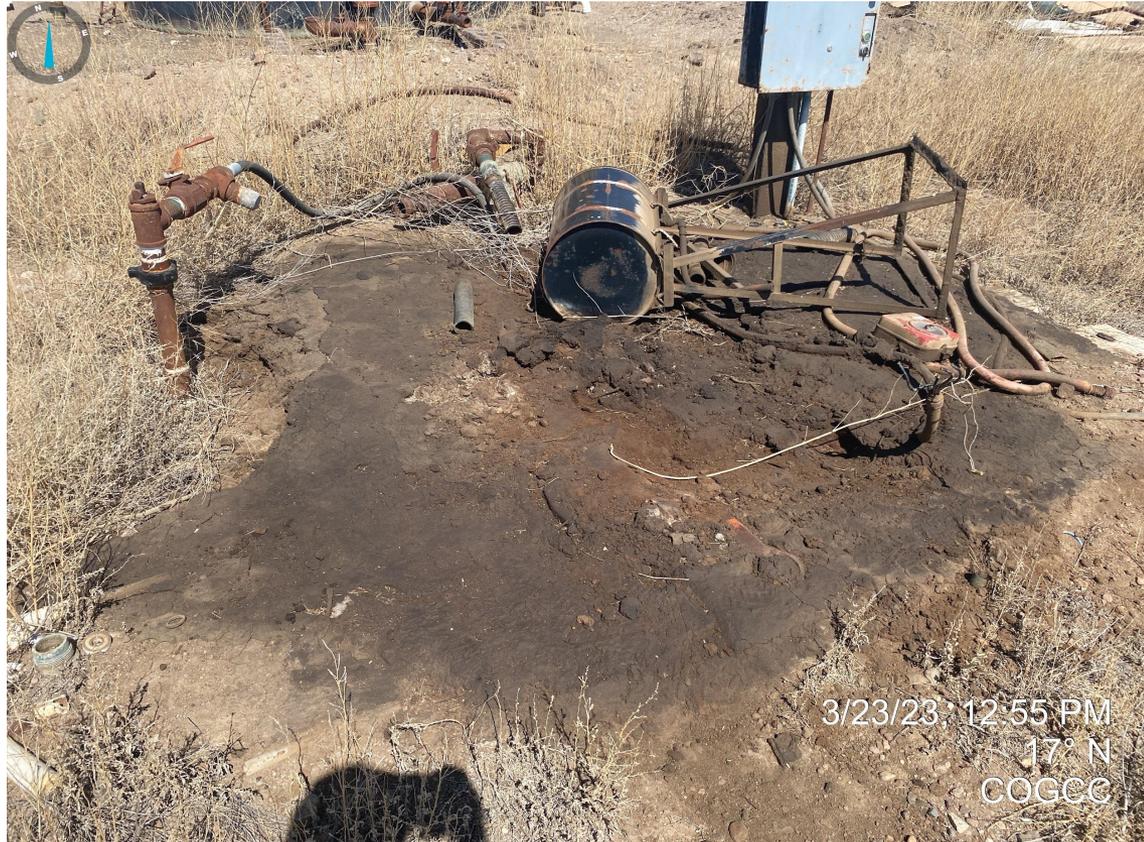
Photos 2 & 3. Facing north at location. Debris and stained soil observed during this inspection. Previous inspection conducted on 09/30/2020 (Doc #700600163) identified this stained soil and required cleanup with a corrective action; it does not appear the operator has performed any cleanup or remedial action to address this, at the time of this inspection.

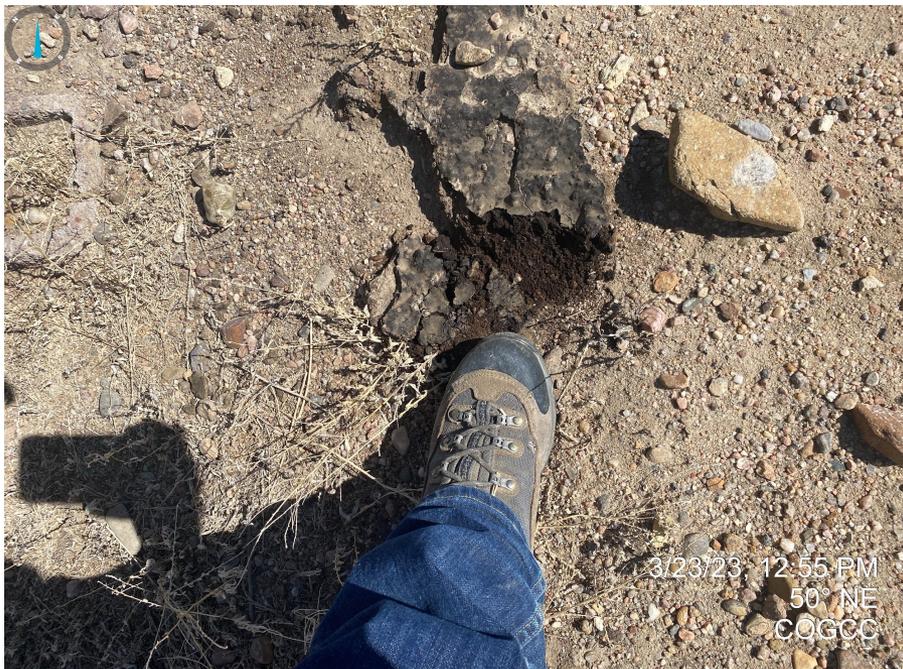
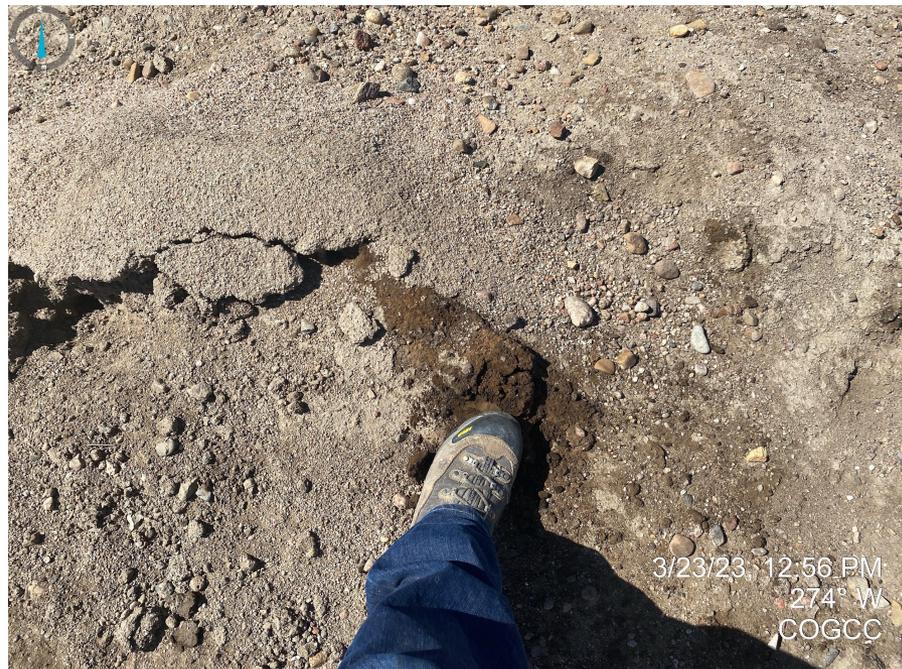
Photos 4 & 5. Close up photos of unknown material that will require disposal. Material had a chemical smell.

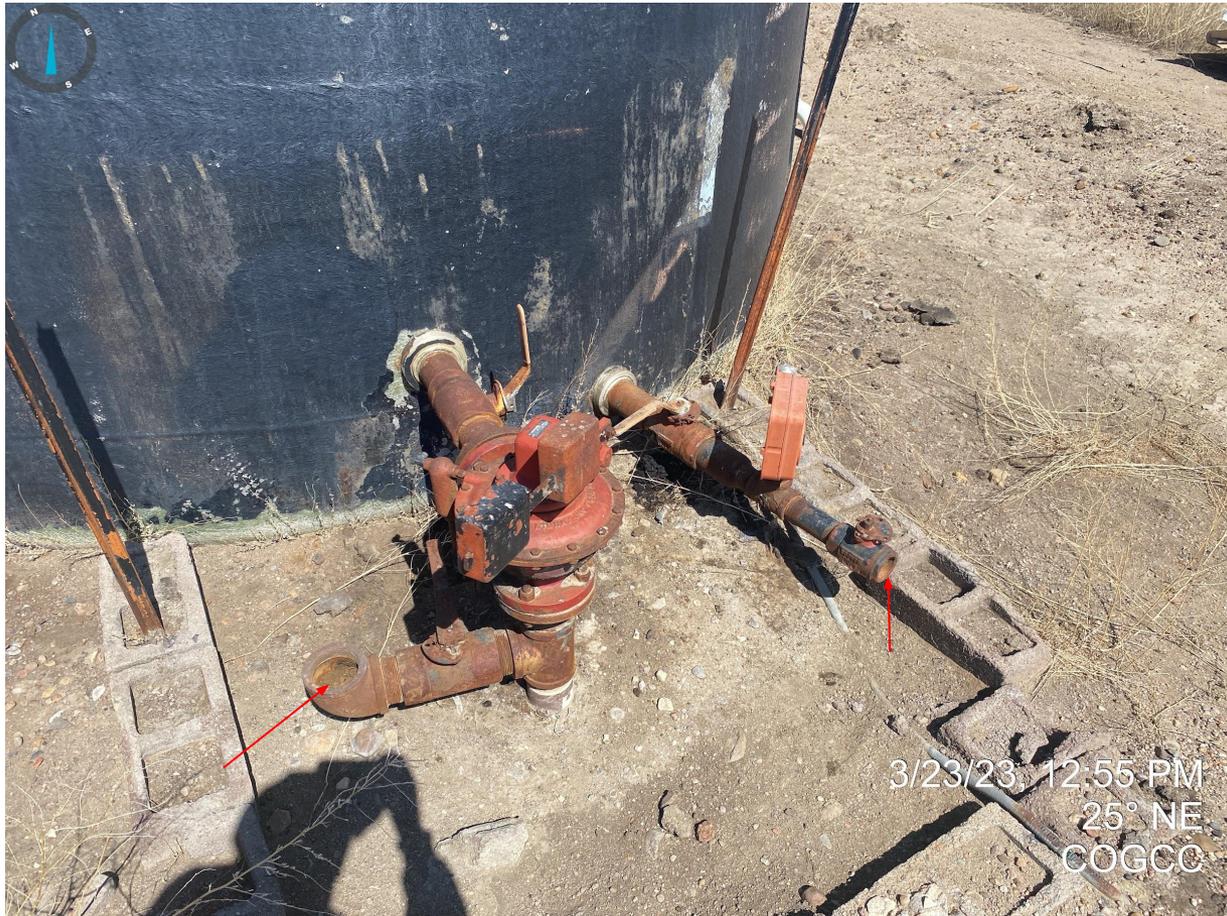
Photo 6. Loadout lines without bull plugs or caps.

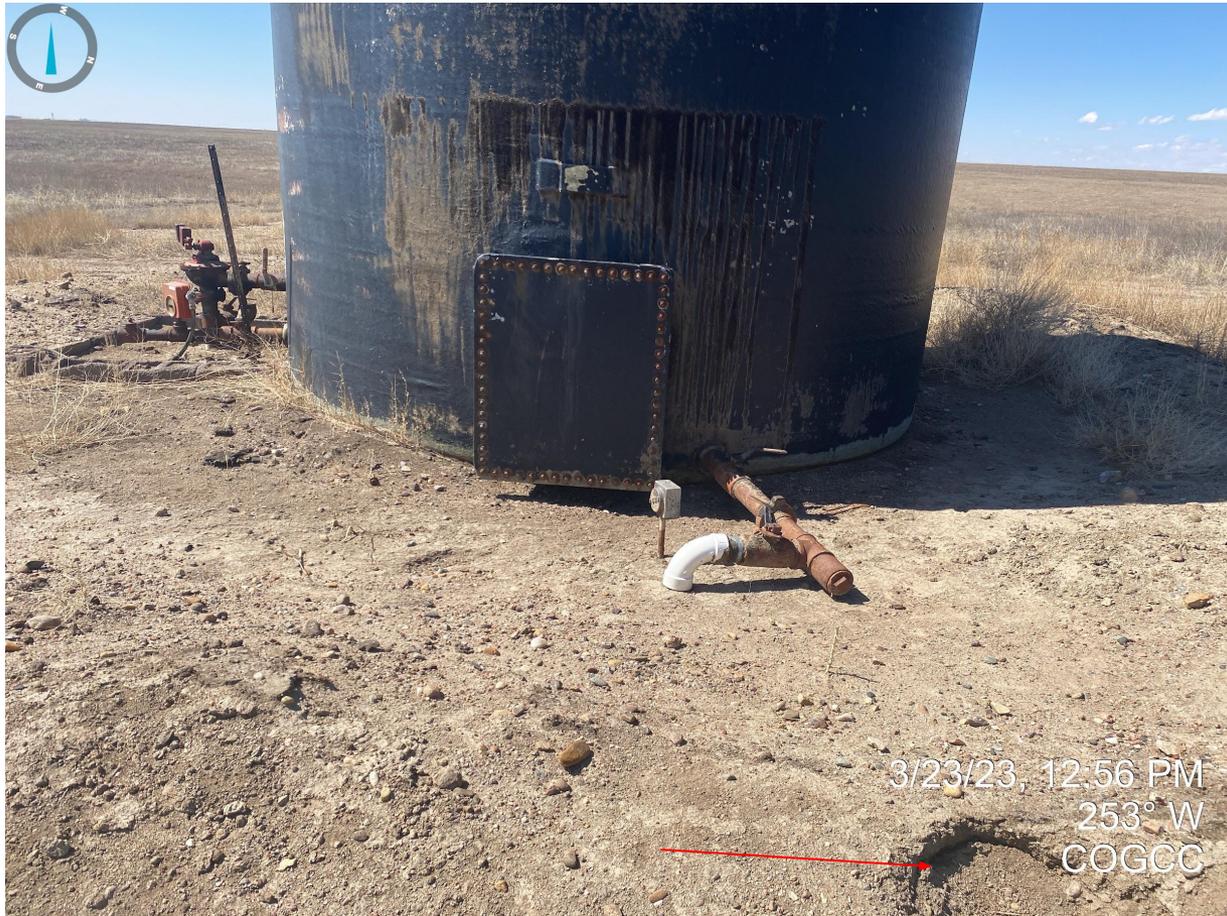
Photo 7. Facing west at battery. Earthen berm appears inadequate to contain 150% of tank volume with evidence of animal burrows, breached berm walls, and inadequate free board.

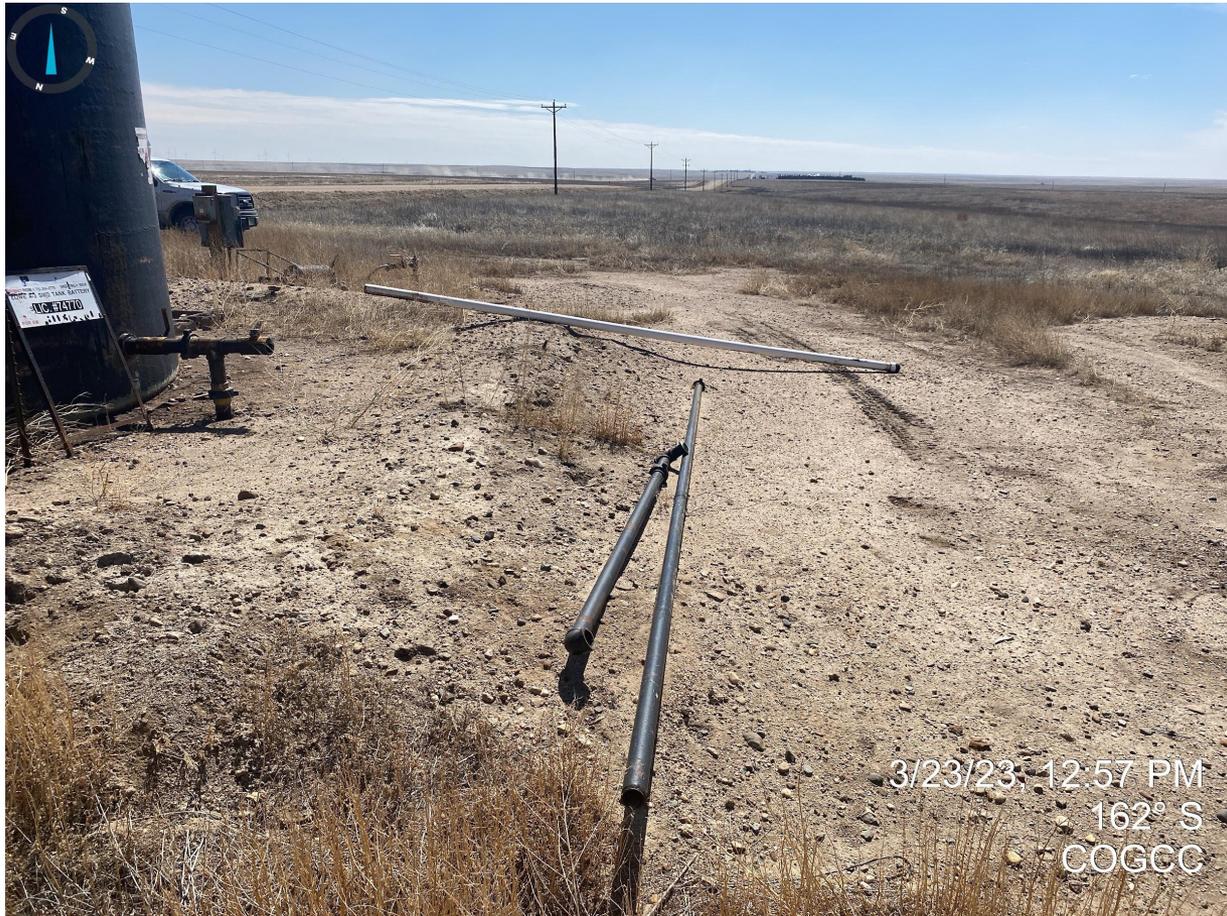
Photo 8. Unused equipment being stored on location.

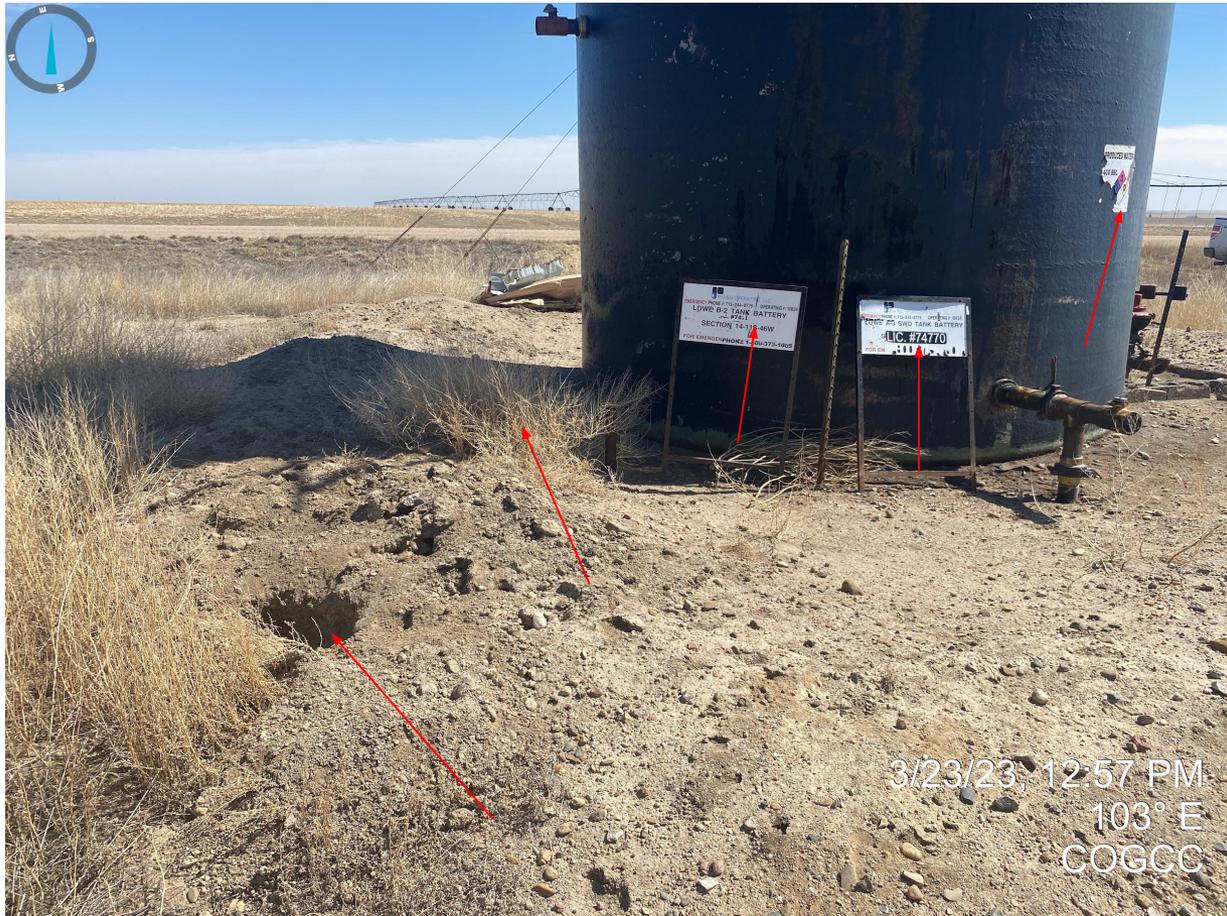
Photo 9. Facing east at battery. Animal burrow within earthen berm, undesirable vegetation (e.g. kochia) and illegible emergency contact/NFPA labels. Sign at left has two different emergency contact numbers.

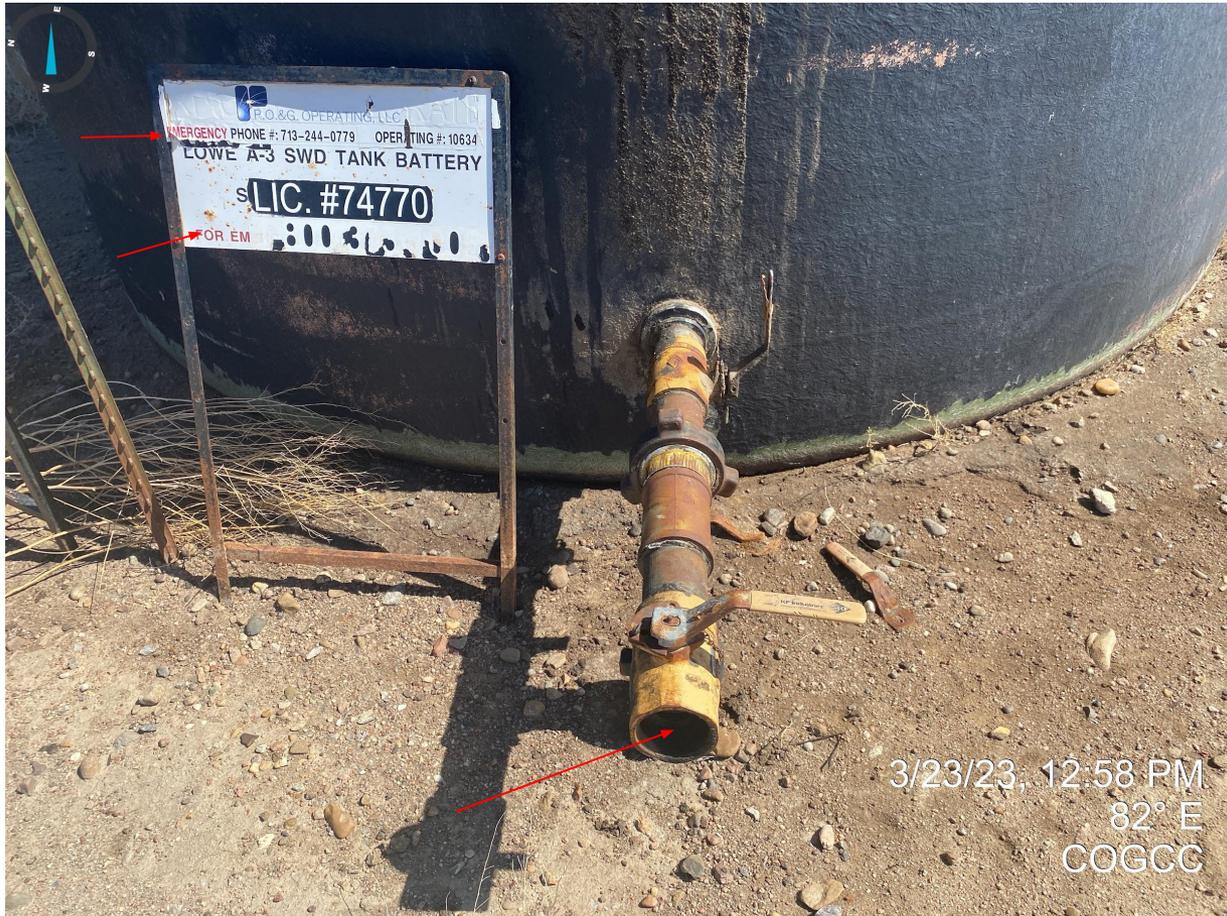
Photo 10. Loadout lines without bull plug/cap. See comments in Photo 9 for additional.

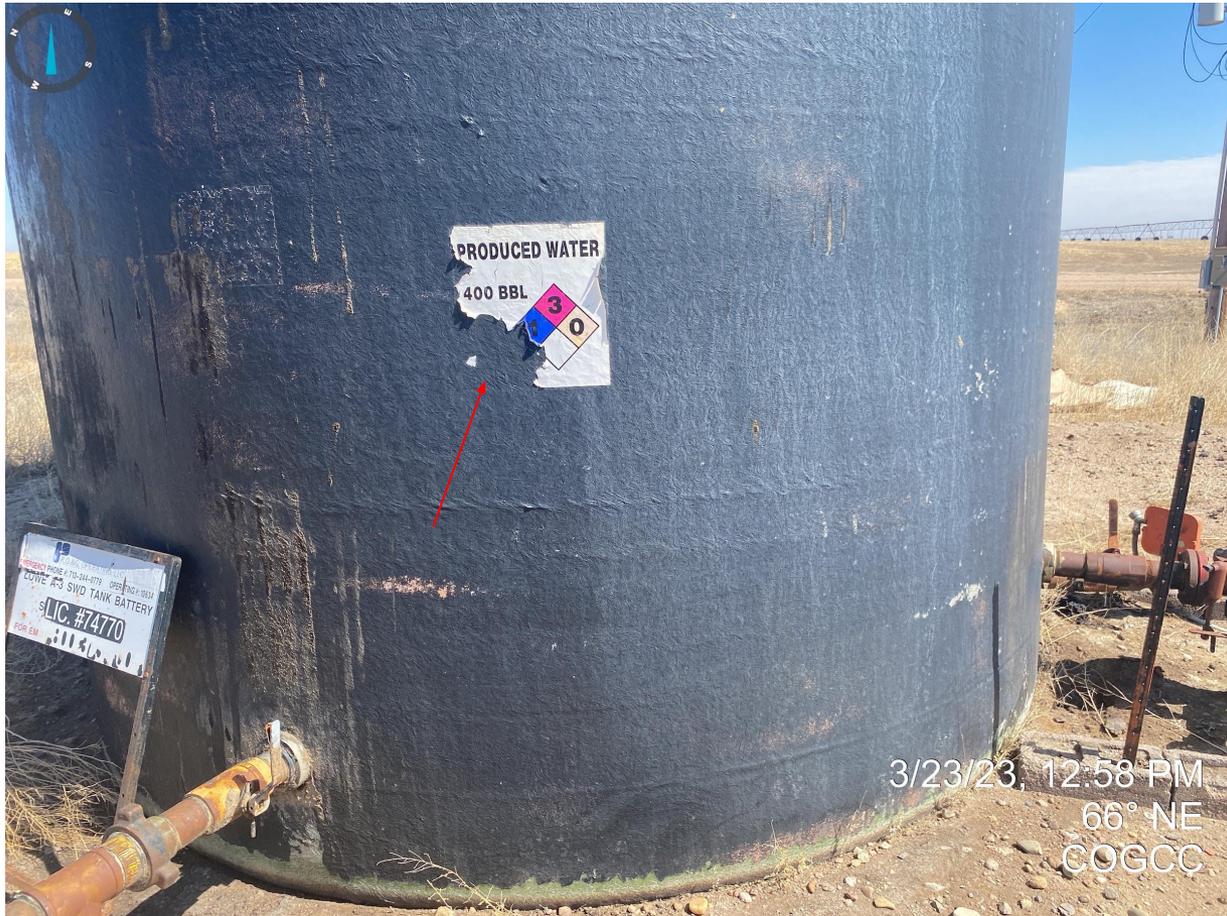
Photo 11. See comments in Photo 10.

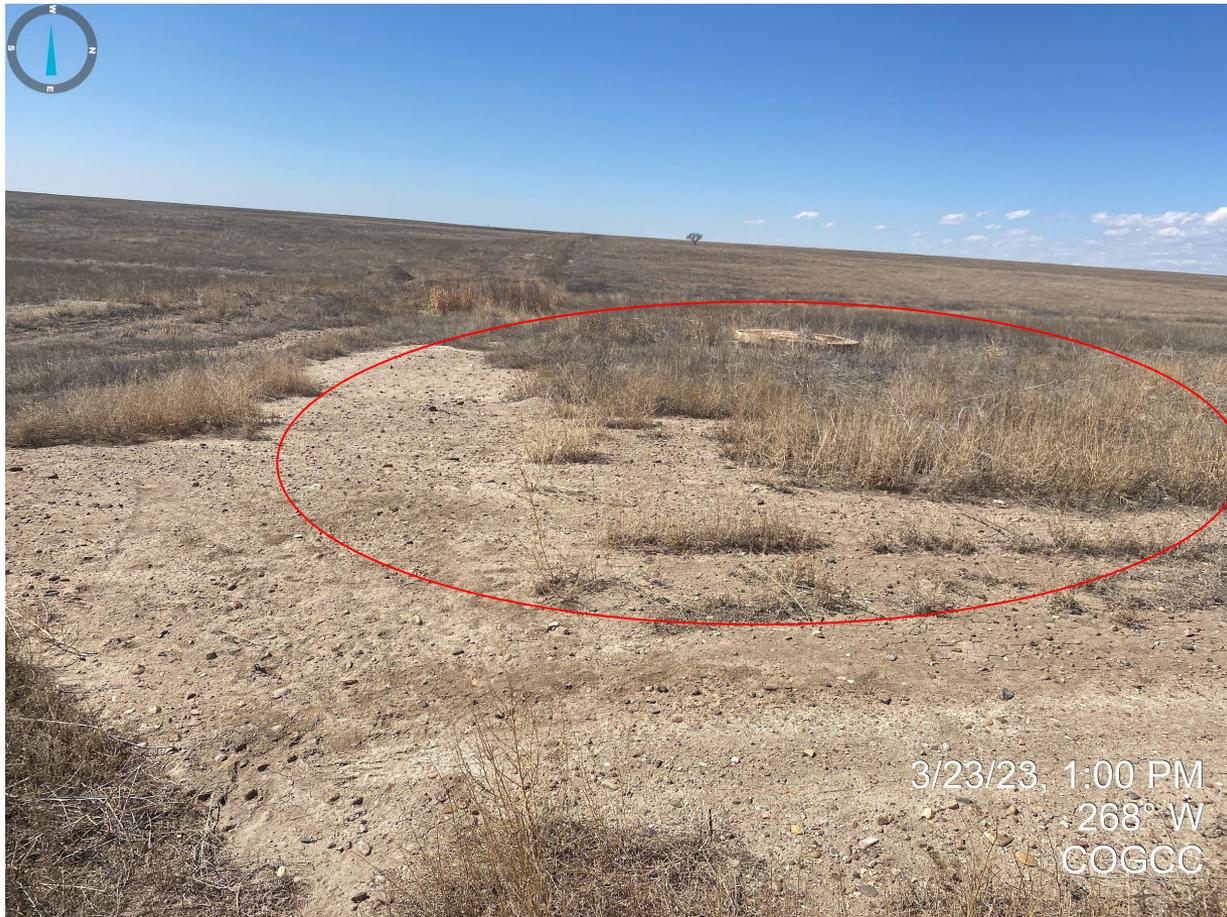
Photo 12. Facing west from battery; undesirable vegetation (e.g. kochia) observed throughout the interim areas.

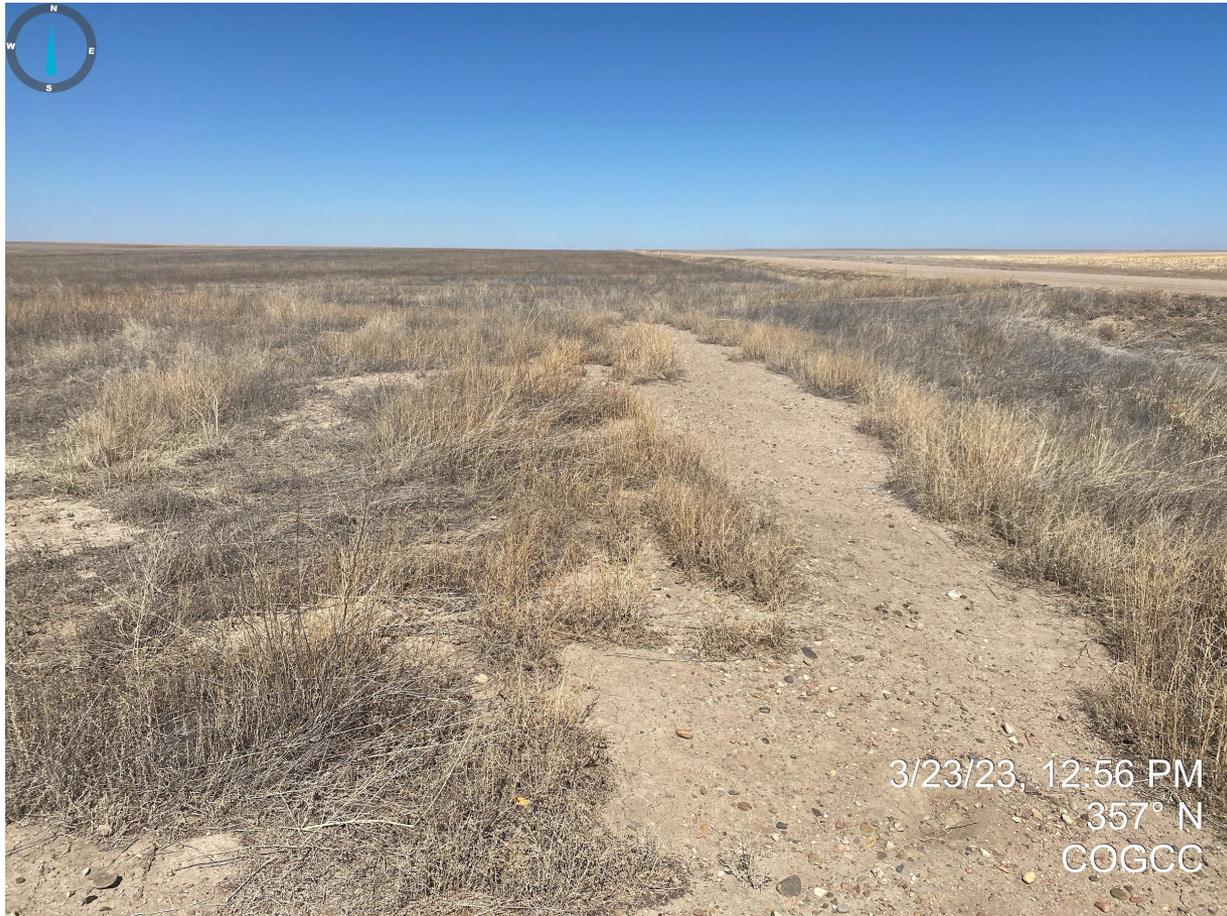
Photo 13. Facing north from battery; see comments in Photo 12.

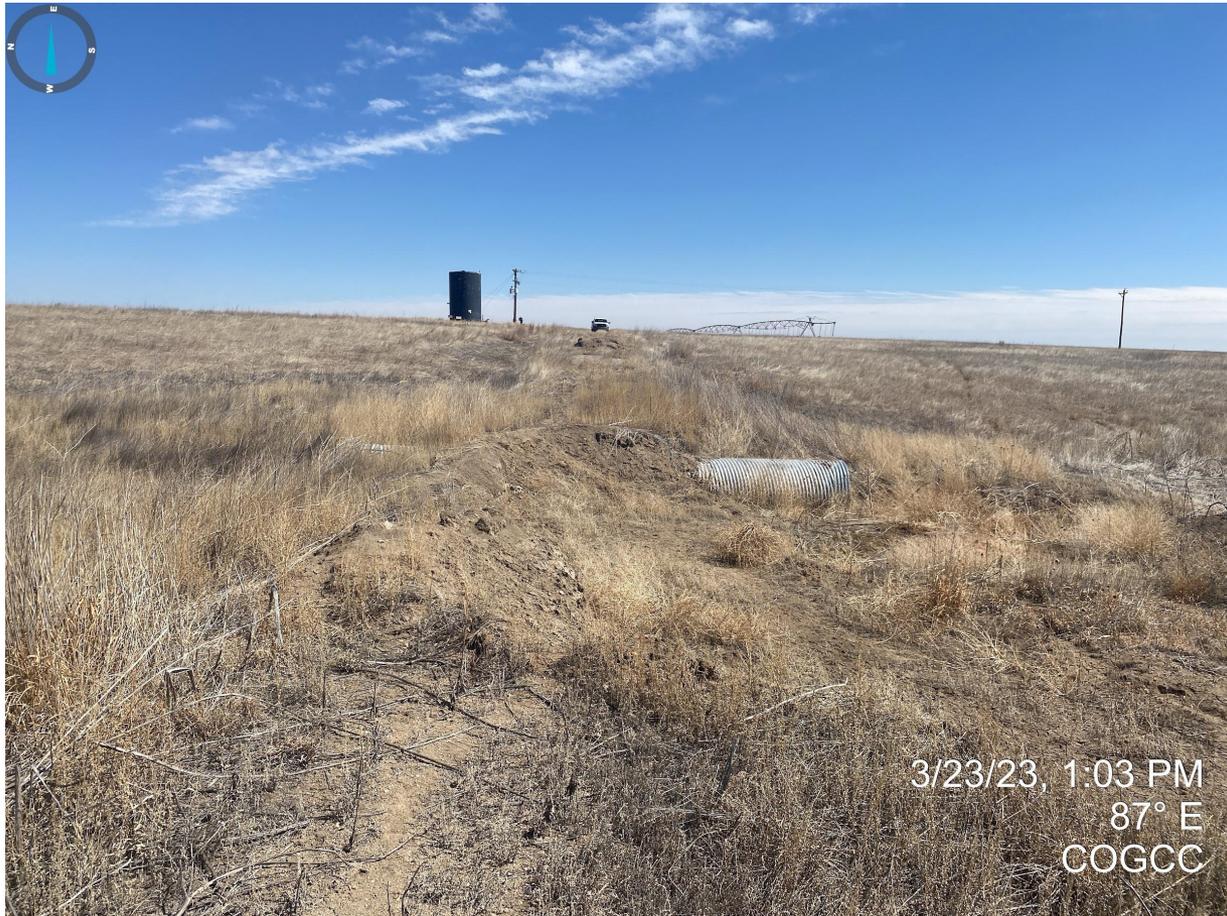
Photo 14. Facing east from access/lease road. It appears the road has been excavated and is not accessible to Staff or emergency services and will need to be repaired.
