**TEP Rocky Mountain LLC
GM 14-27
Location #335306**

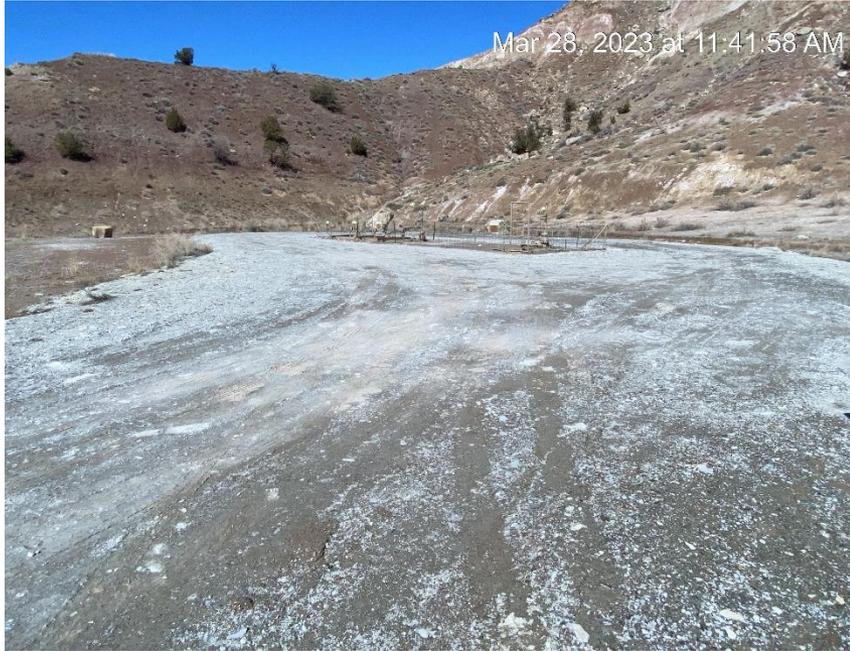
View from entrance to location

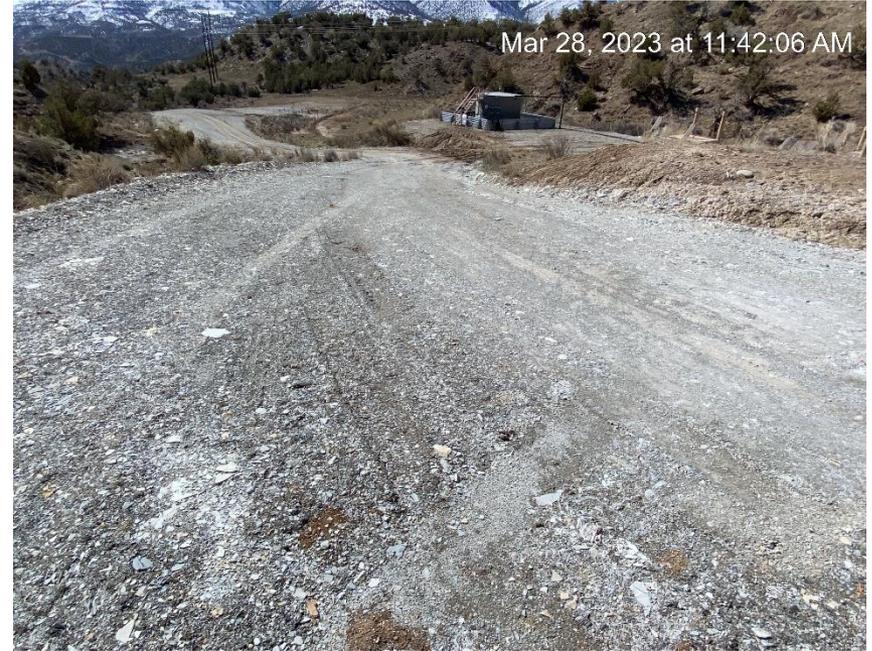
**View from location entrance of lease road and
production facility**

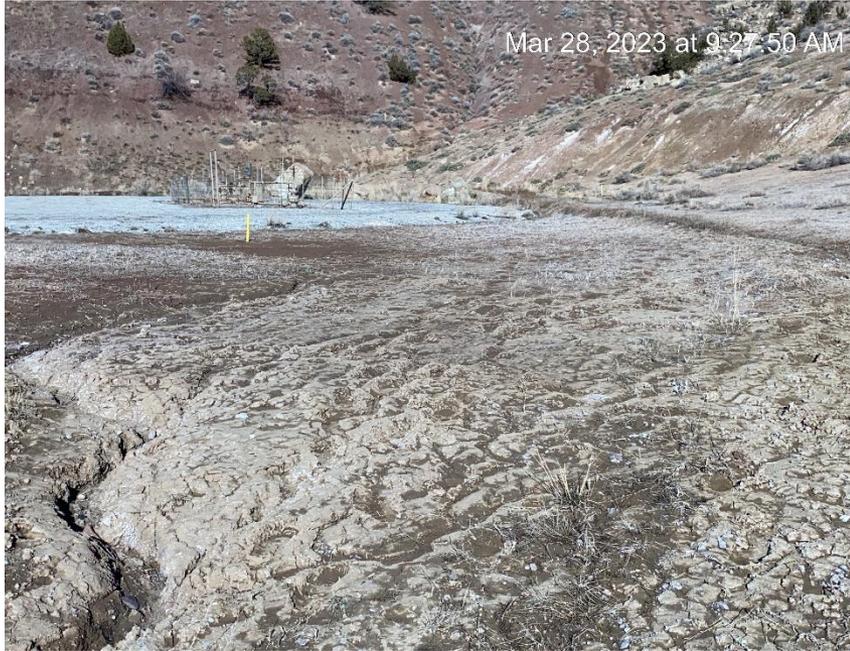
SouthEast corner location erosion

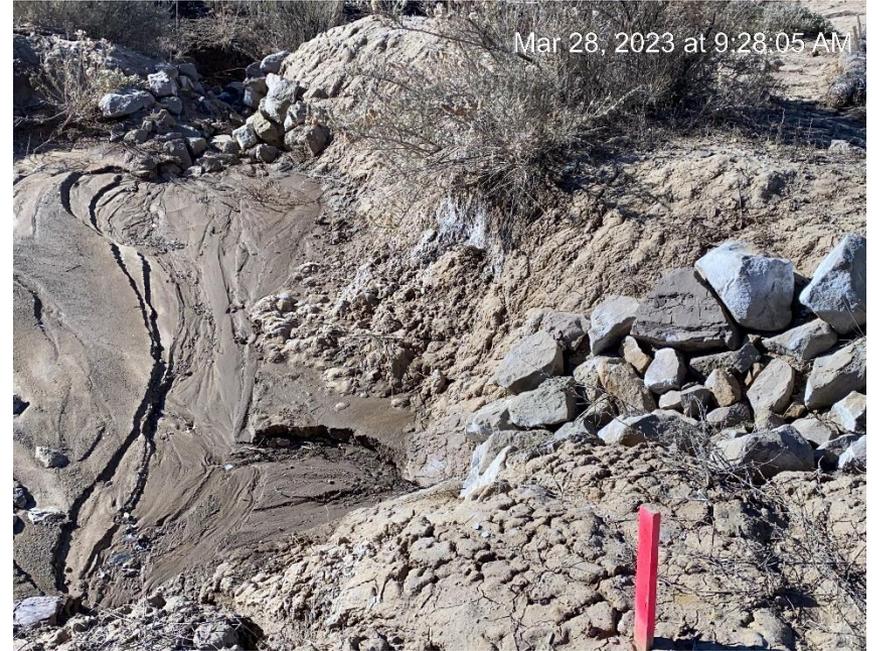
SouthEast corner trap erosion and sediment fill

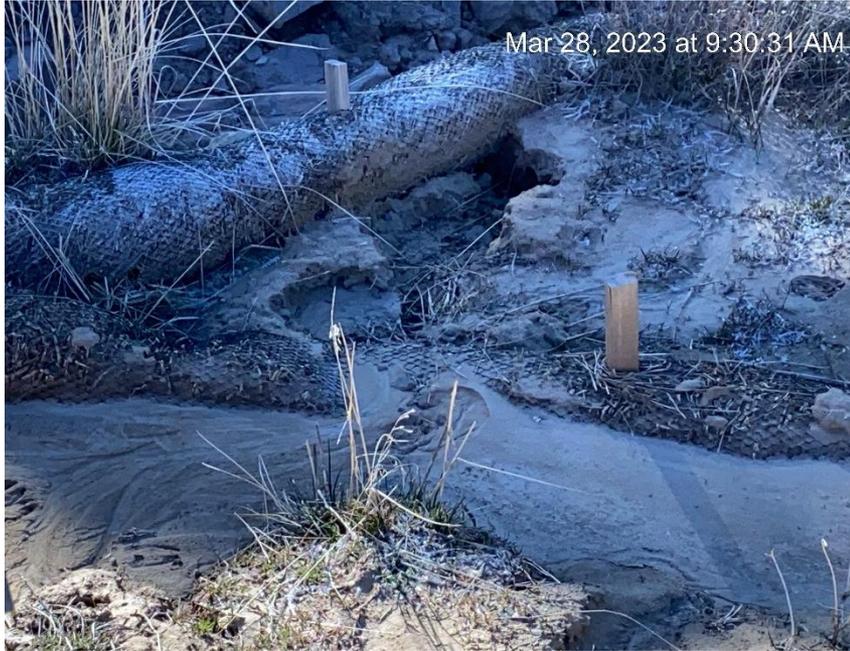
Sediment migration and erosion

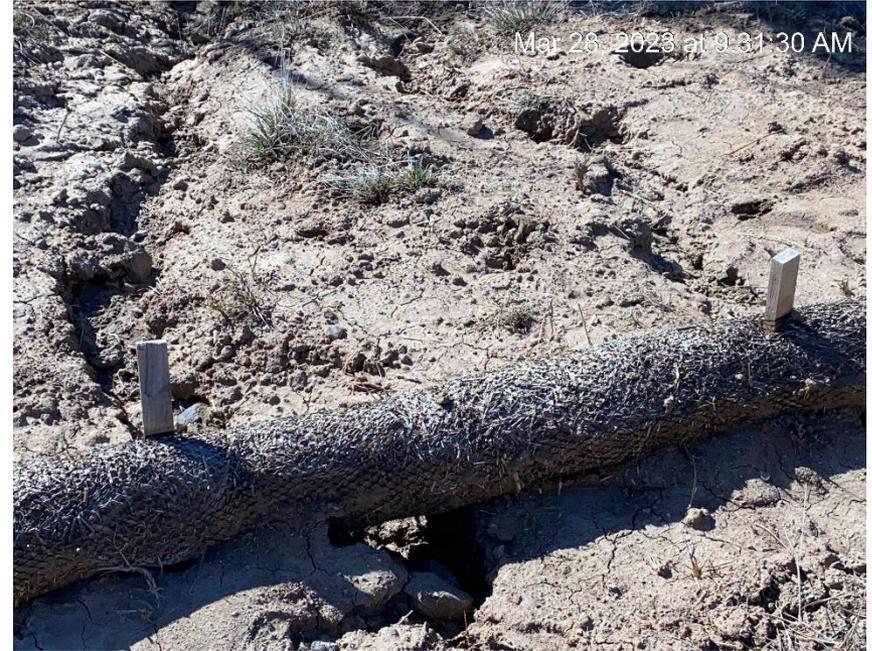
Erosion underneath waddle

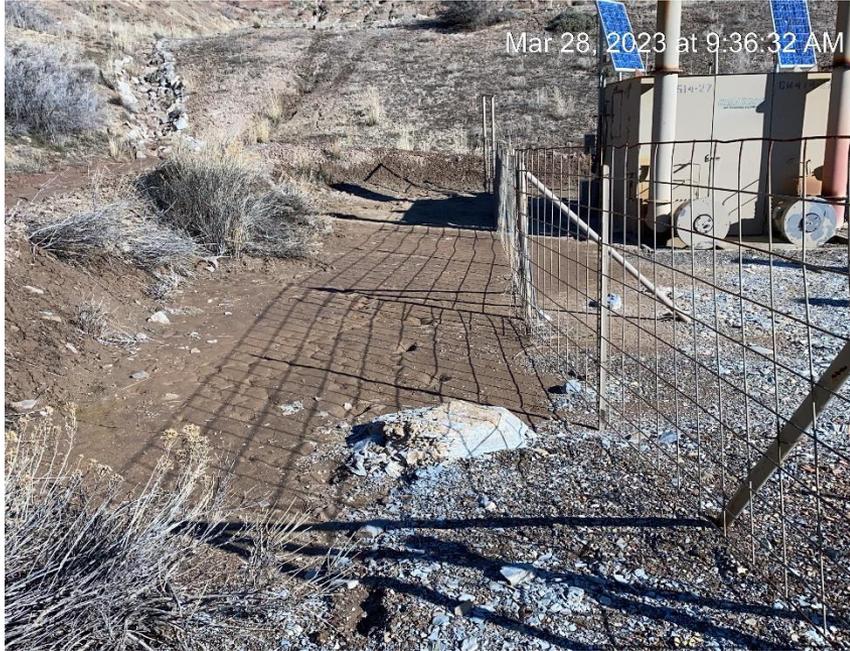
Sediment migration on separator pad

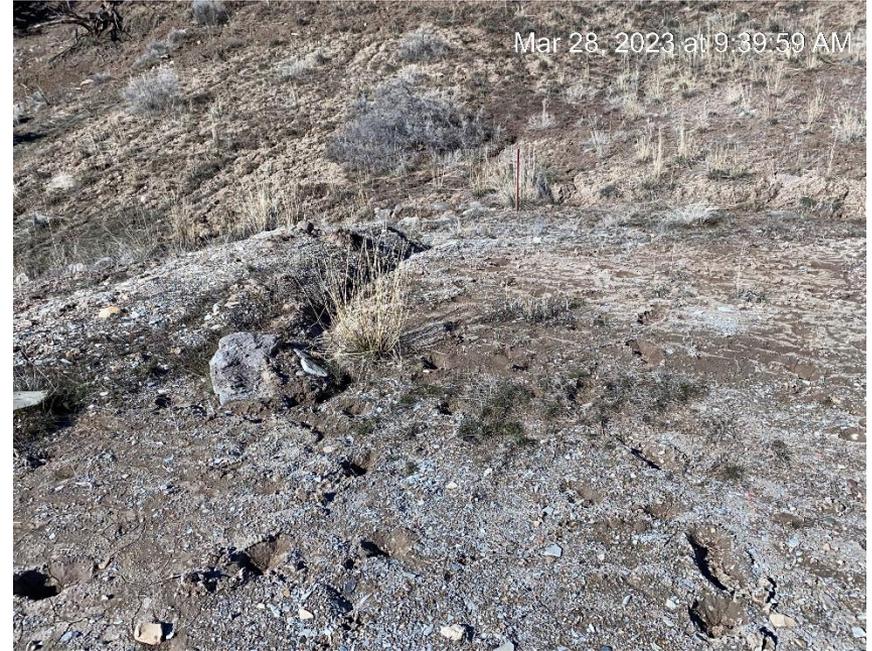
Northwest corner erosion from location
