April 12-14 API# 05-123-05372

Storm Water / Reclamation Location Status as of 3-26-23

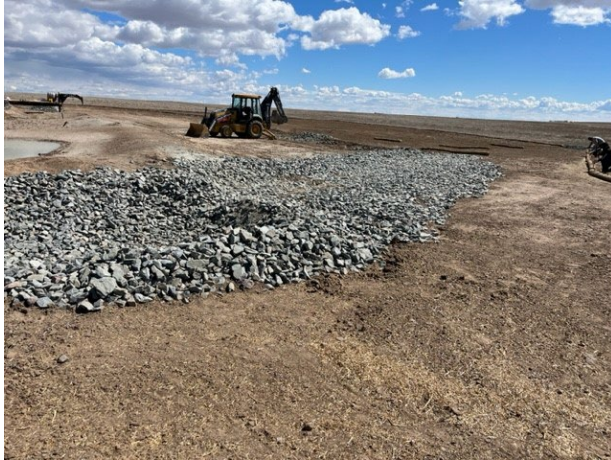
Pad entrance water bar and up stream sediment trap.

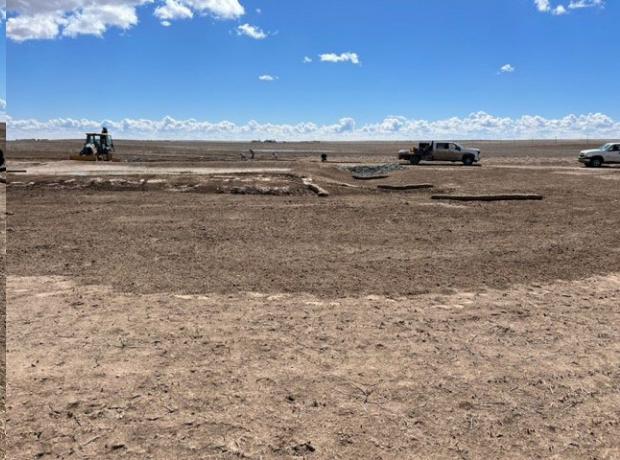
View from north of the west most pit. sediment migration mitigated, Areas of disturbance scarified and seeded. Waddles placed up stream of the armored sediment trap.

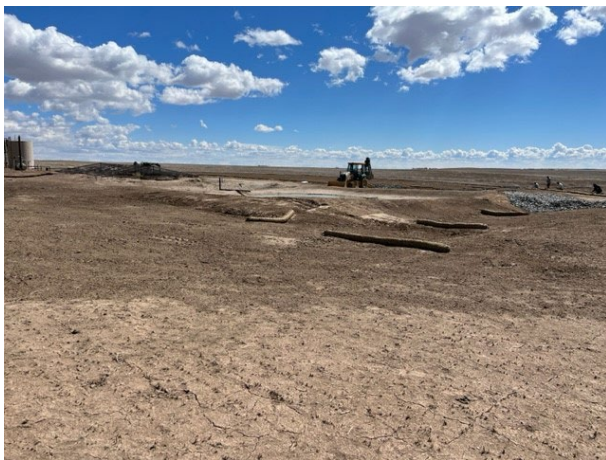
View from northwest of the west most pit.

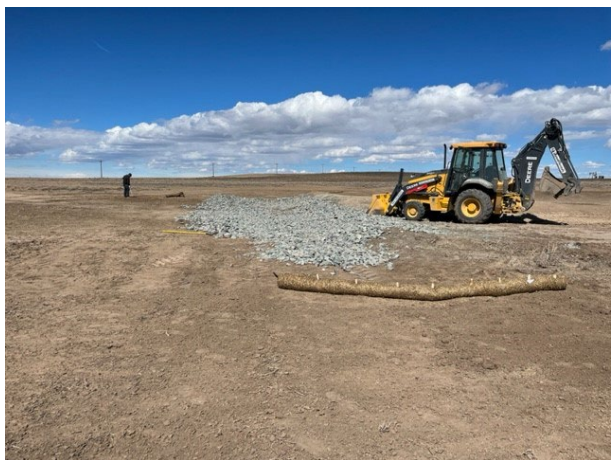
View from south of pad entrance water bar.

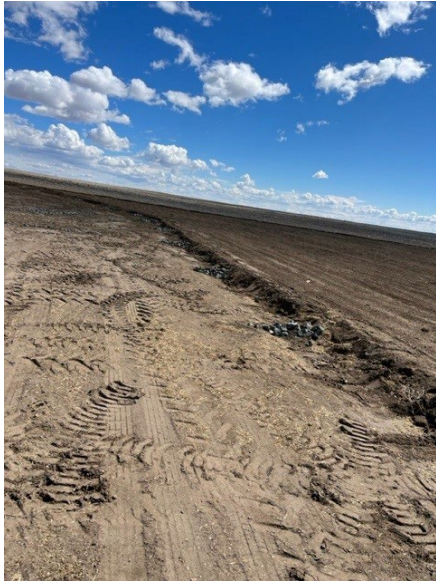
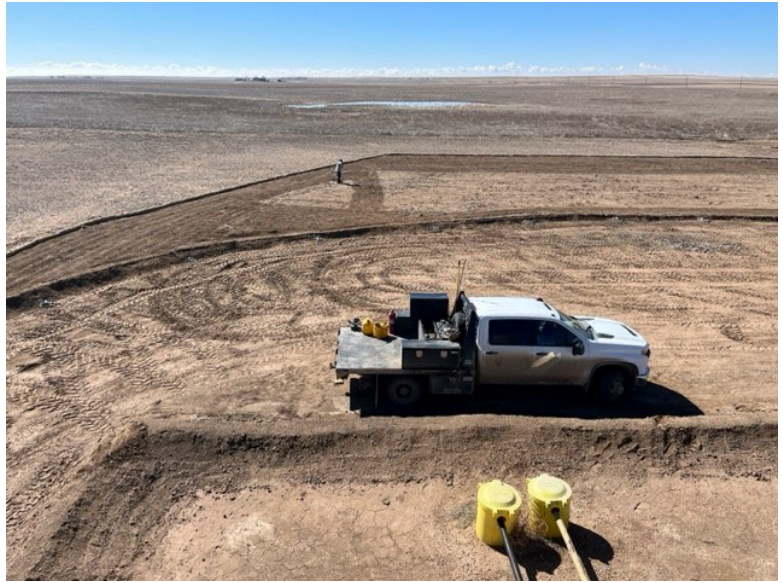
Check dams installed at current working surface berm and ditch. Berm has been compacted by equipment and then walked and recompactd by personnel.

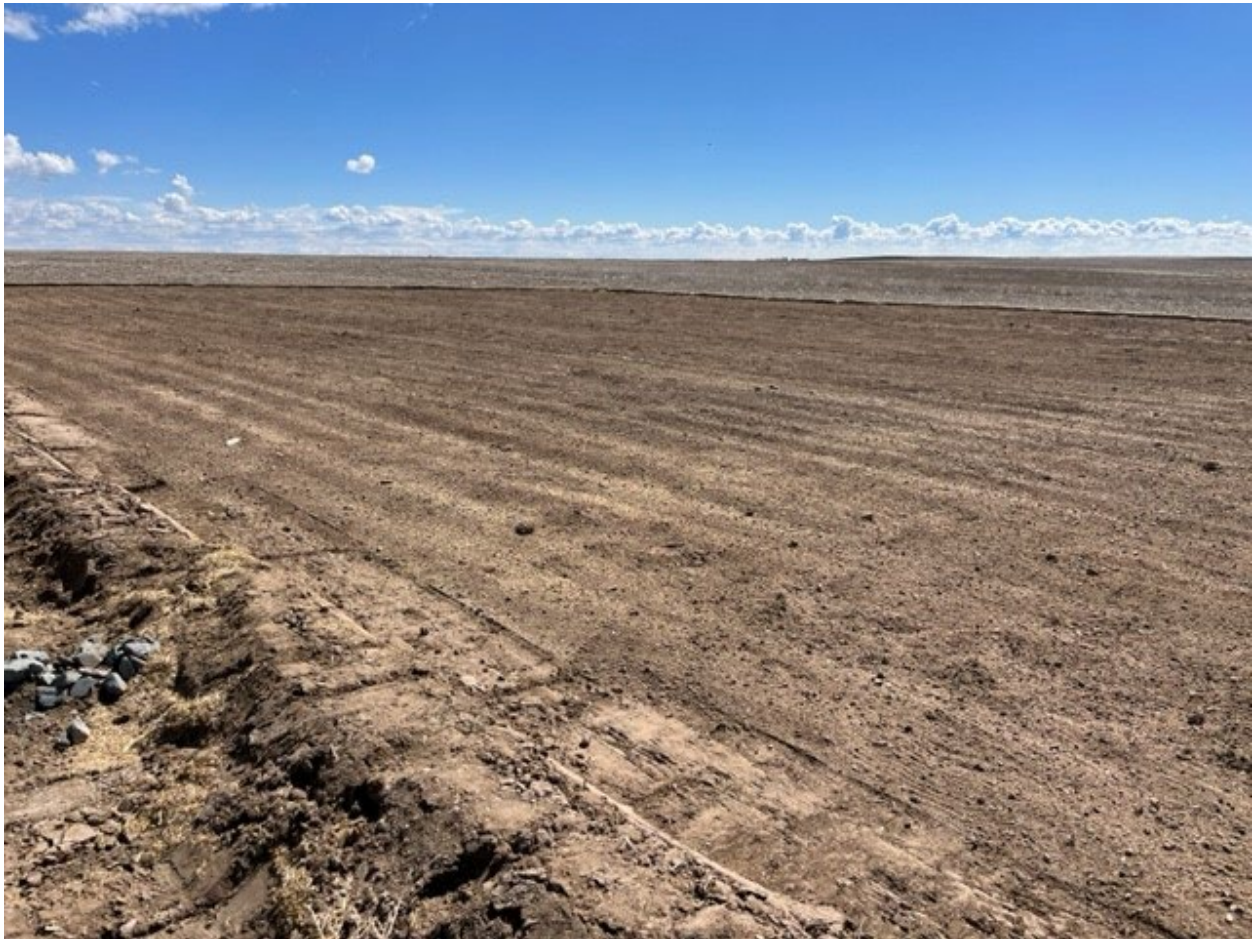
Prior working surface for the April well and pump jack. Scarified and seeded.

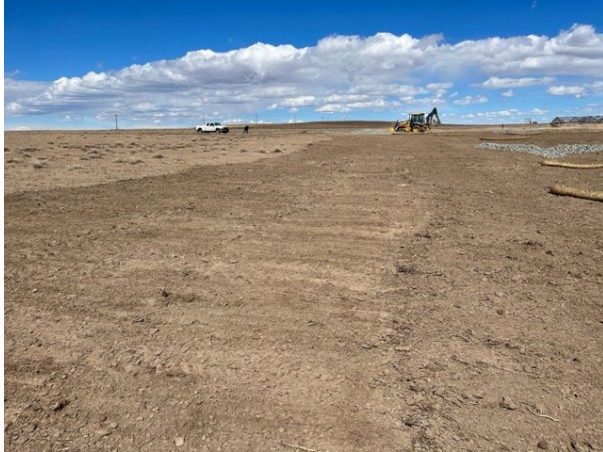
Area west of the April reclaimed working surface scarified and seeded.

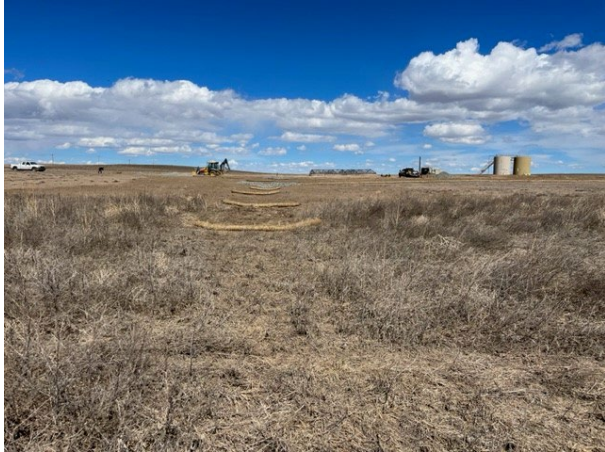
South of the location looking north. Sediment migration mitigated; waddles installed below the lower armored sediment trap. All working and reclaimed areas scarified and seeded.

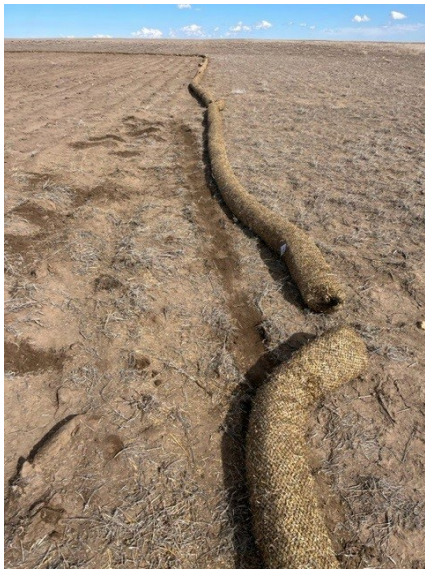
Waddles keyed slightly prior to staking to ensure full contact with the ground.

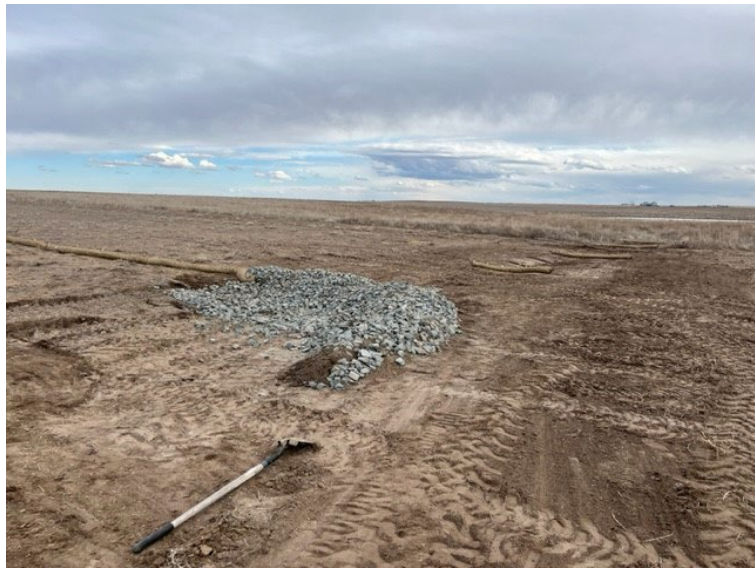
Farthest south sediment armored sediment trap. Series of waddles below.

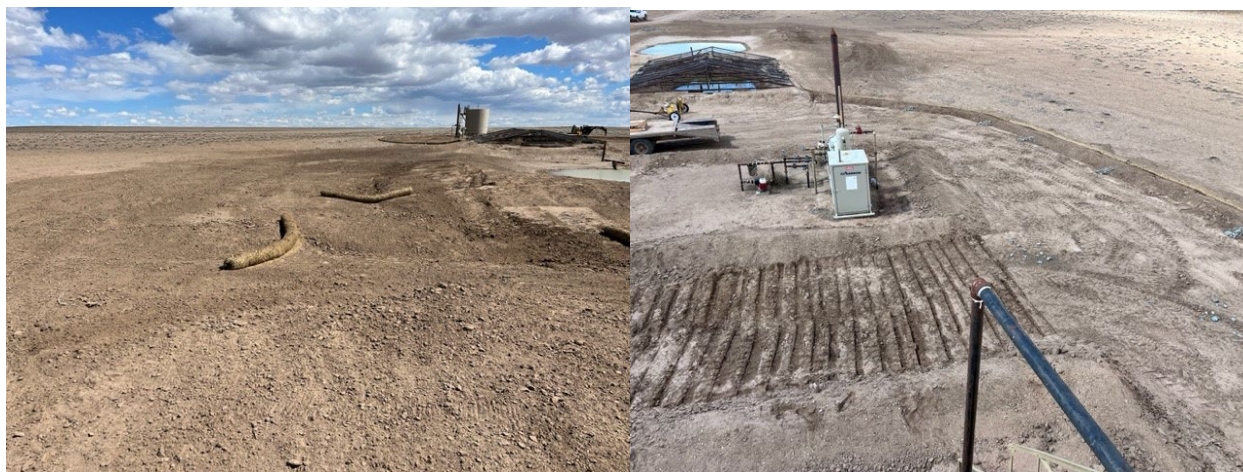
Areas of previous sediment migration.

Left Picture: NW corner of west most pit looking eastward.

Right picture: view of area between the tank berm and production unit berm.

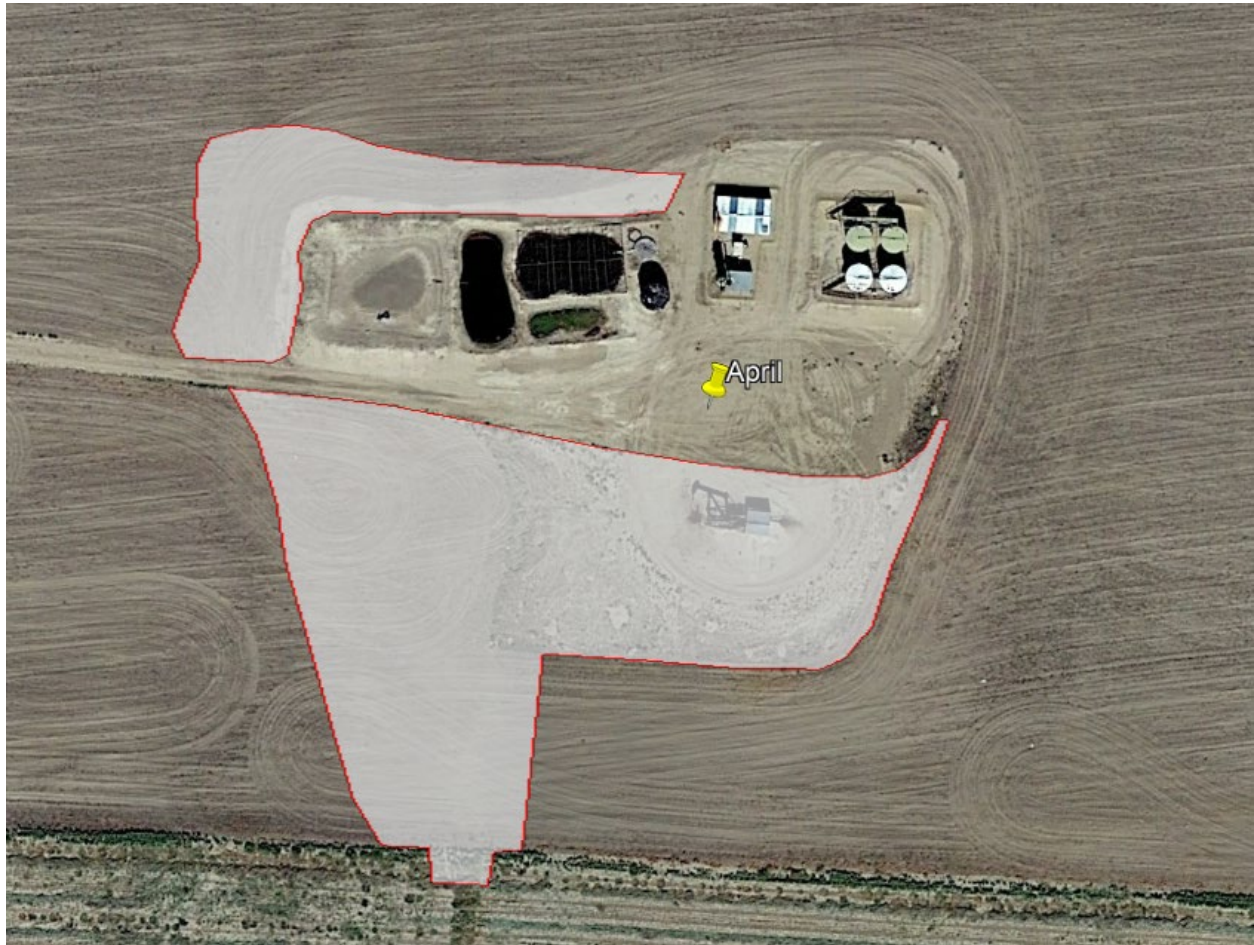
Seed mix used in reseedling. Four 50lb bags purchased all having lot number G-230301. 3 bags applied to current scarified surface area 1 bag retained for reseedling the area of pit reclamation.
