Storm Water Management and Erosion control

Location Name: TEP ROCKY MOUNTAIN LLC PUCKETT/TOSCO-66S95W /34NESW

Location #: 334570

Location Overview: Location is located in a 411 a. internal buffer zone and approximately 466 yards from the Colorado River.

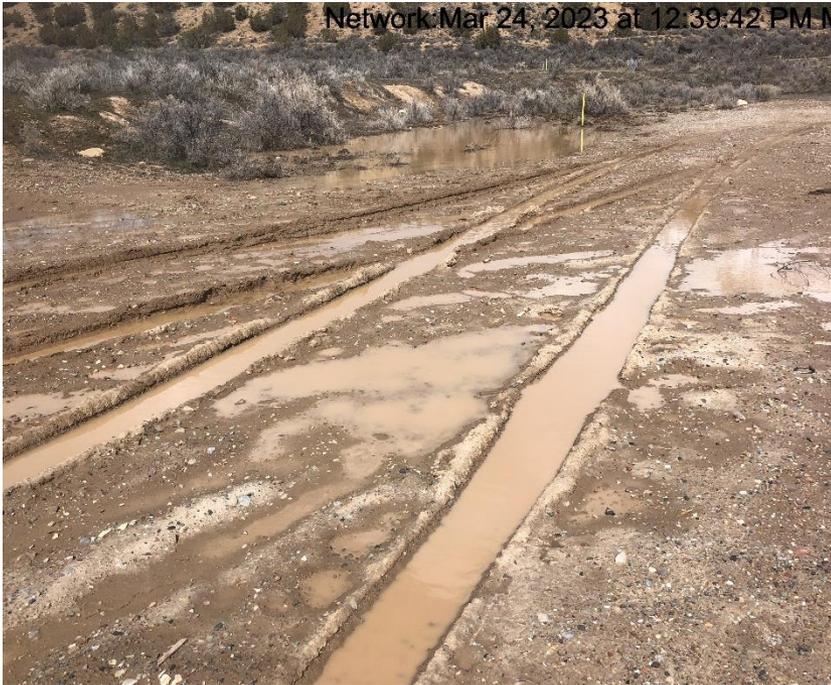
Photo #9389 Location lacks stabilization.

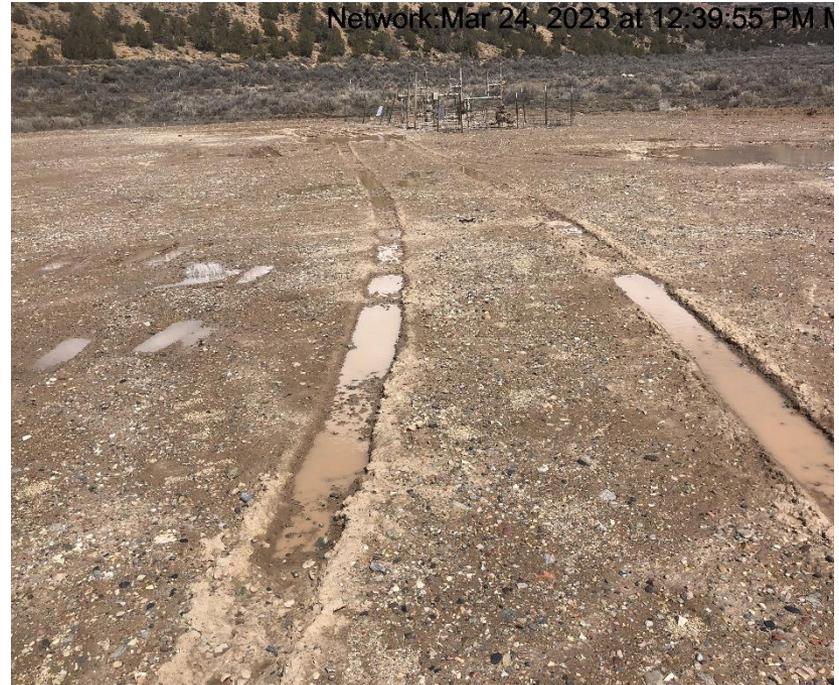
Photo #9390 Location lacks stabilization.

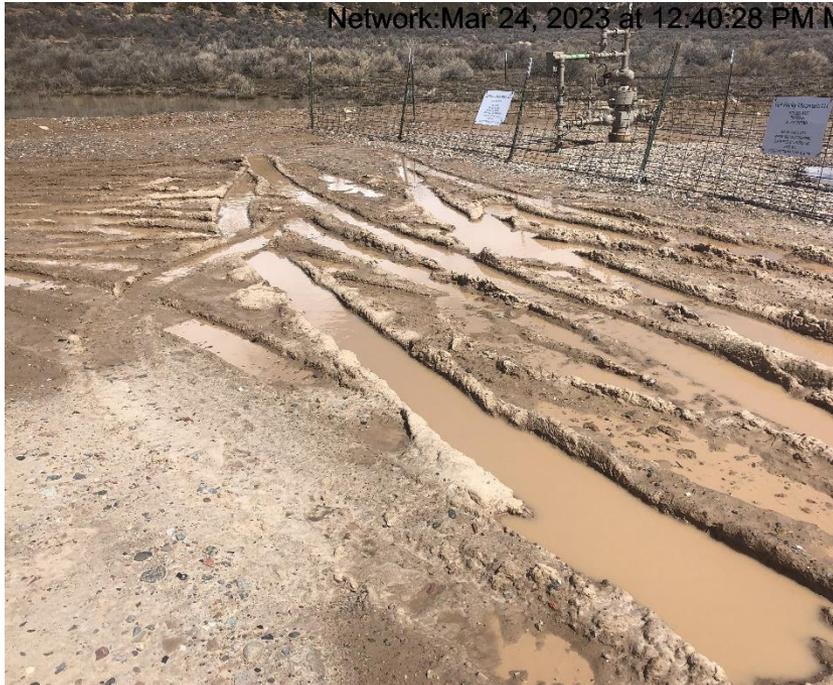
Photo #9392 Location lacks stabilization.

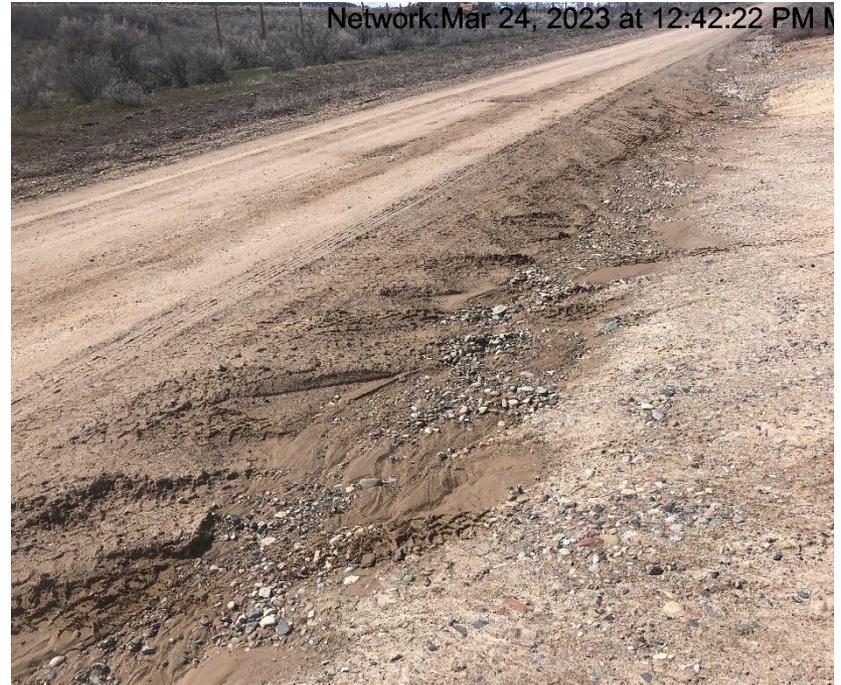
Photo #9396 Insufficient tracking BMP at entrance to location.

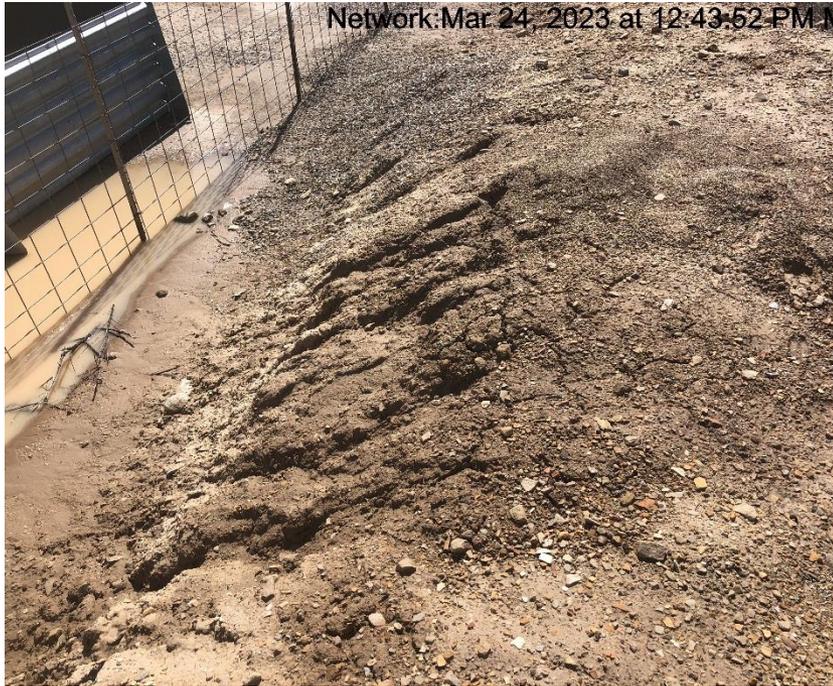
Photo #9403 Rill erosion on berms.

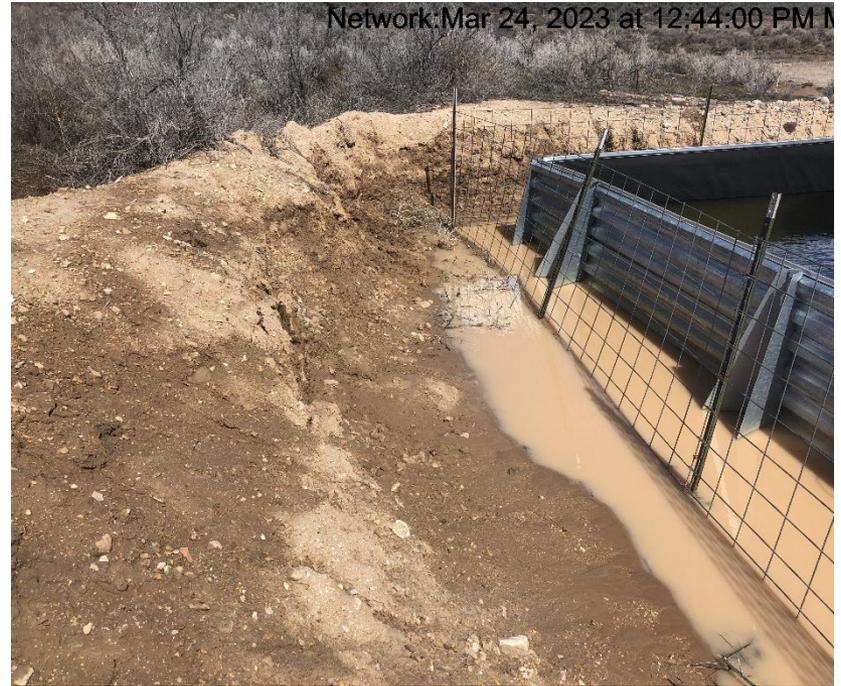
Photo #9404 Berm degradation. Sediment encroaching on secondary containment.

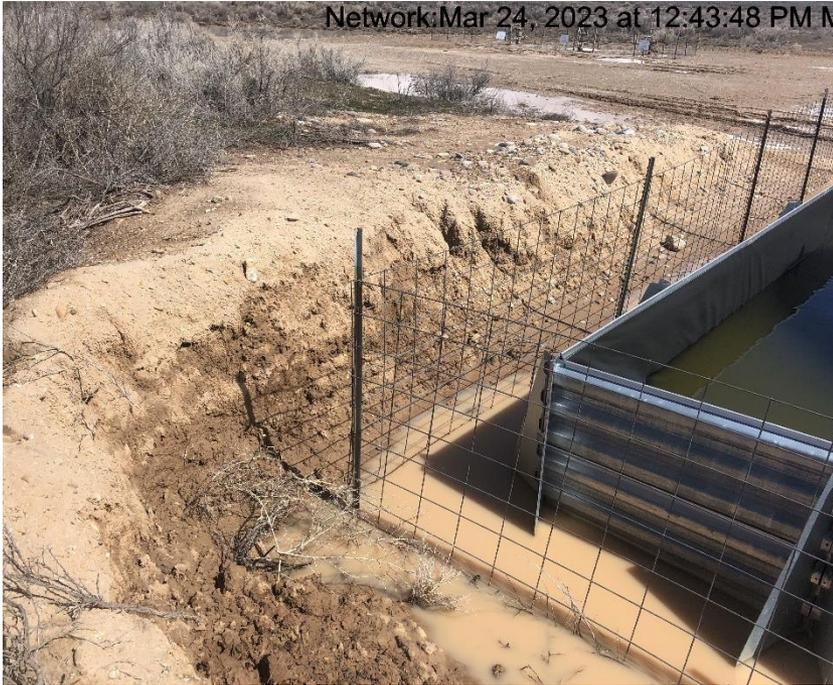
Photo #9406 Run on to location is not being controlled.

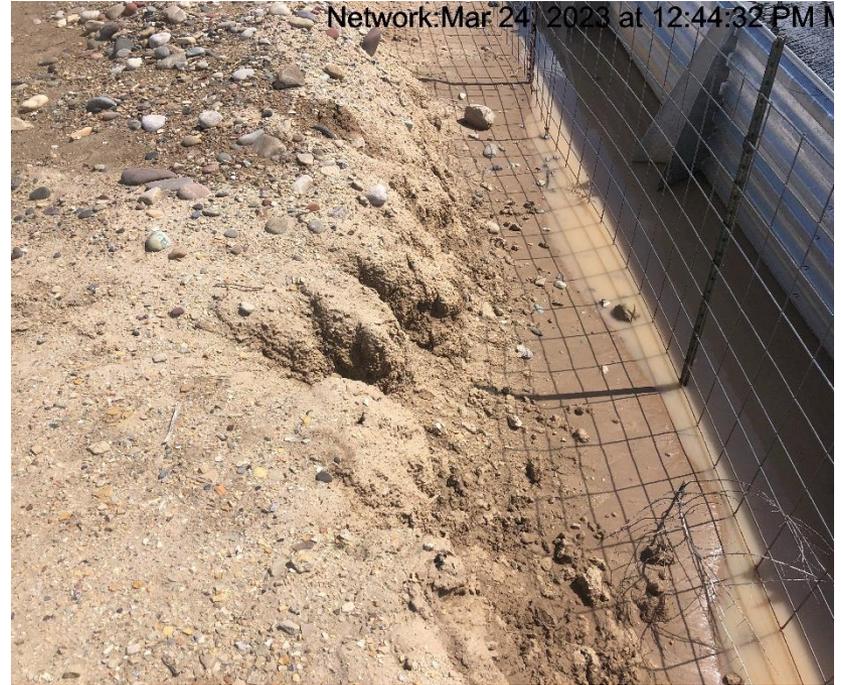
Photo #9407 Run to location is not being controlled.

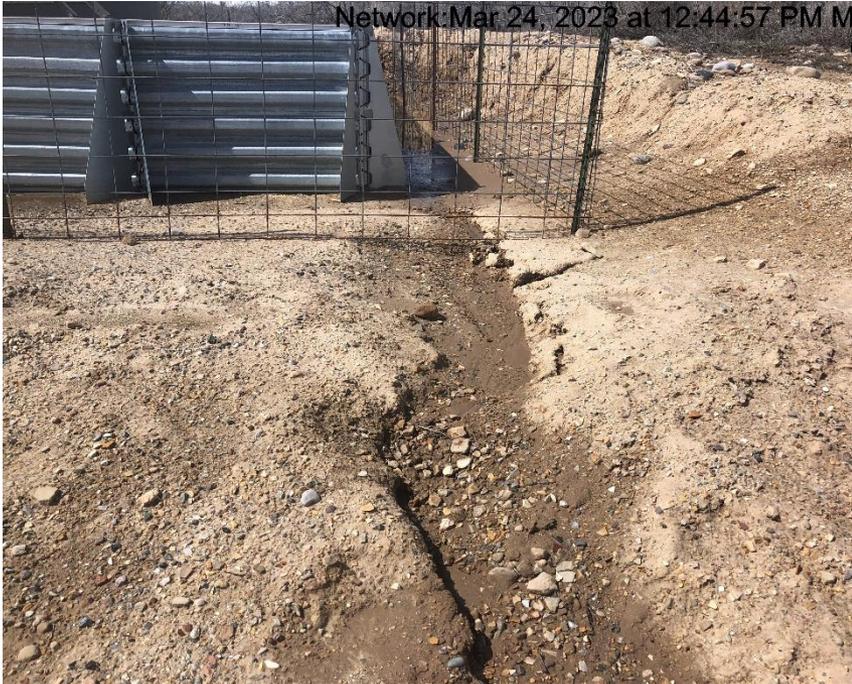
Photo #9409 Run on to location is not being controlled.
