Inspection Photos

Location Name: TEP ROCKY MOUNTAIN LLC CLOUGH RWF 522-27 pad

Location ID: 335128

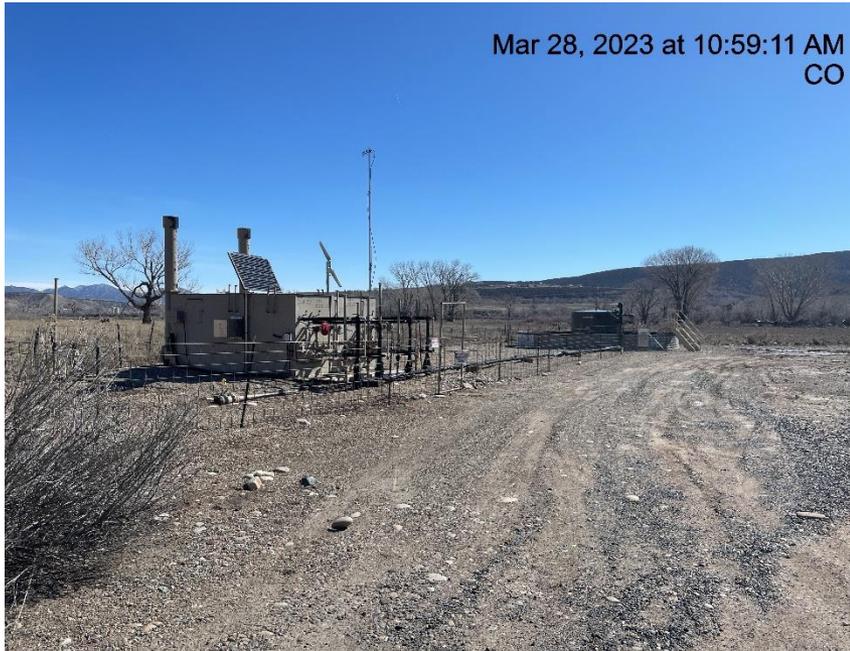
Photo # 3552 From entrance to location

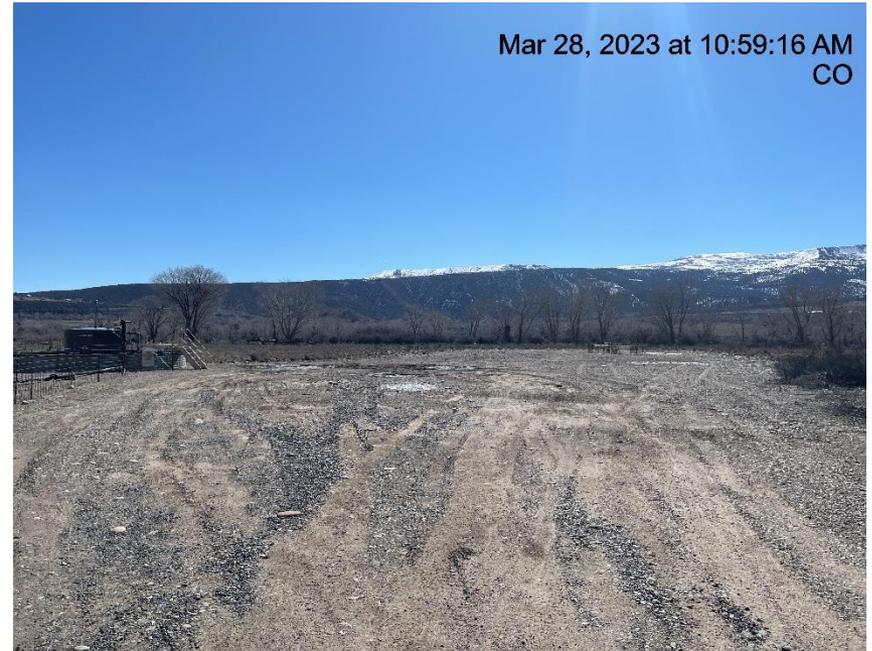
Photo # 3553 From entrance to location

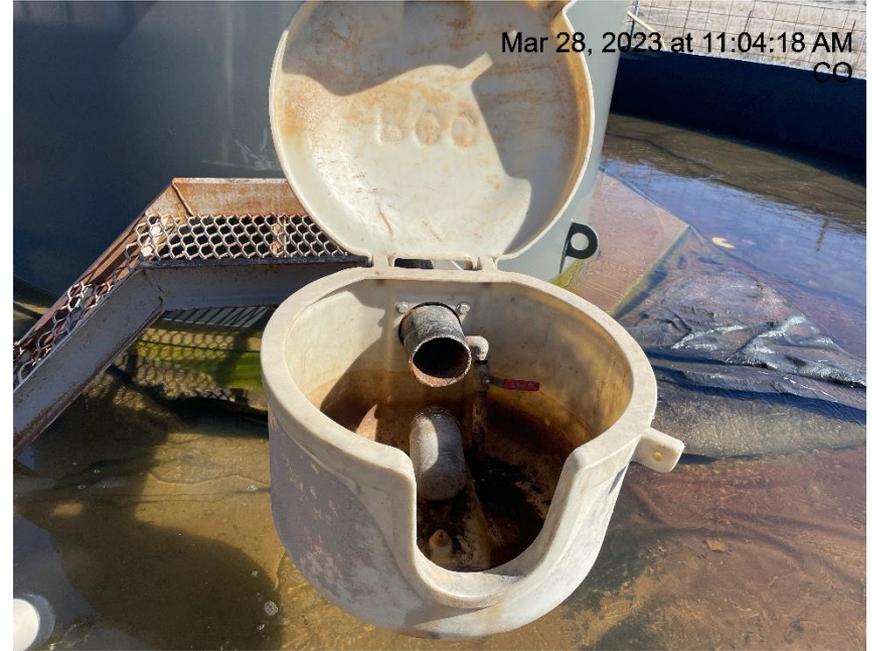
Photo # 3558 Open ended load line

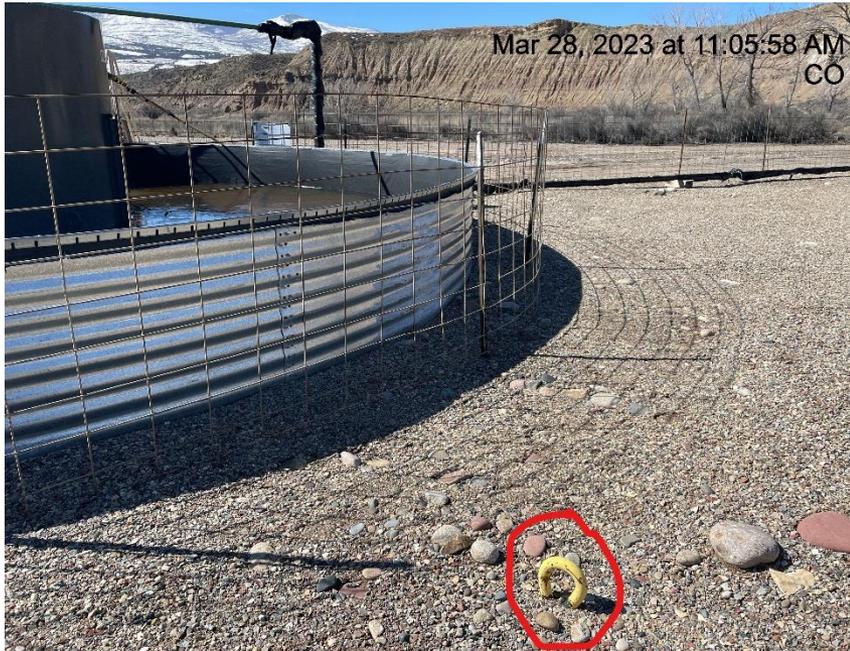
Photo # 3562 Unmarked deadman

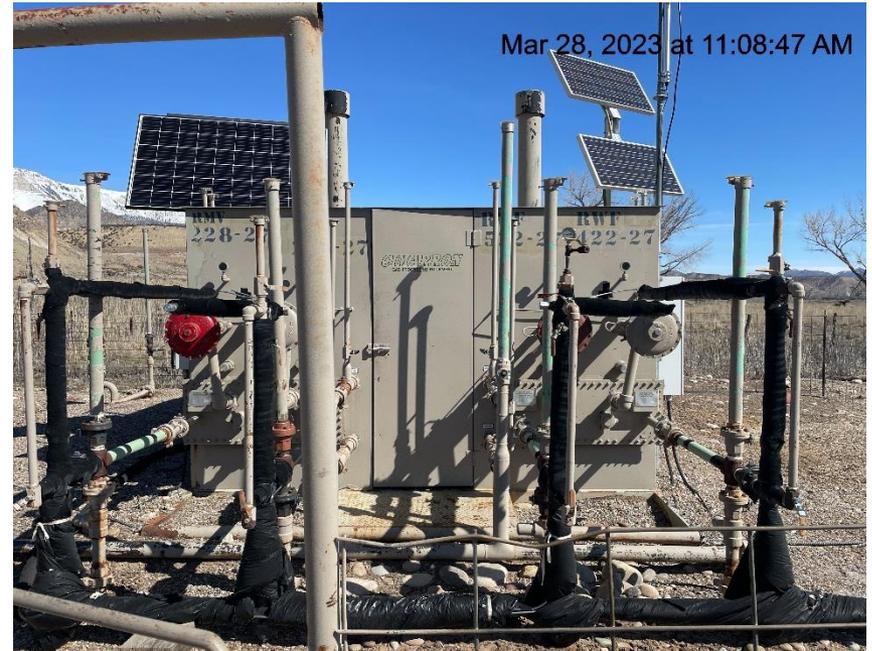
Photo # 3566 Meter calibration info not conspicuously posted

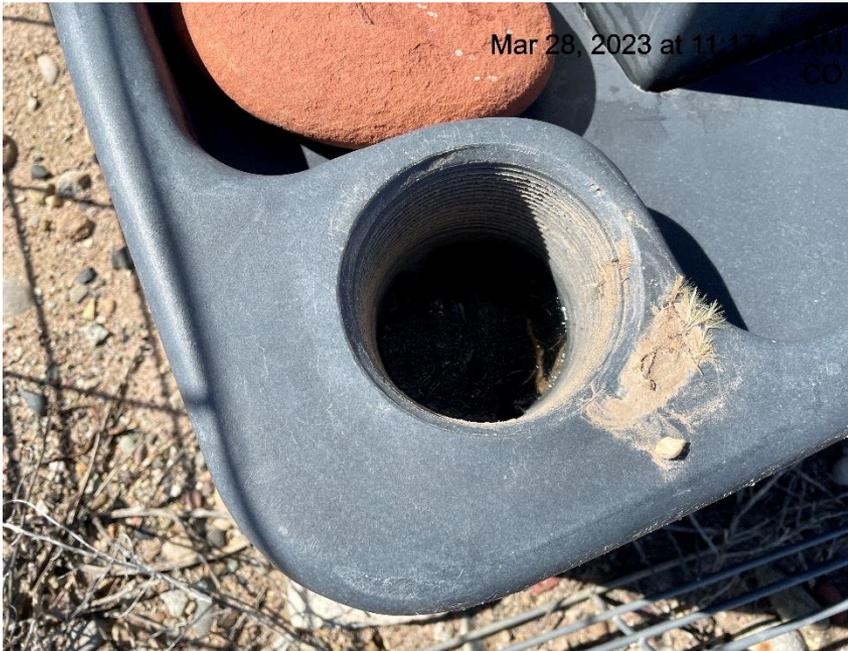
Photo # 3576 Chemical containment full/Failure to maintain chemical BMP (located on remote location – CLOUGH RMV 226-27 pad location # 324161)

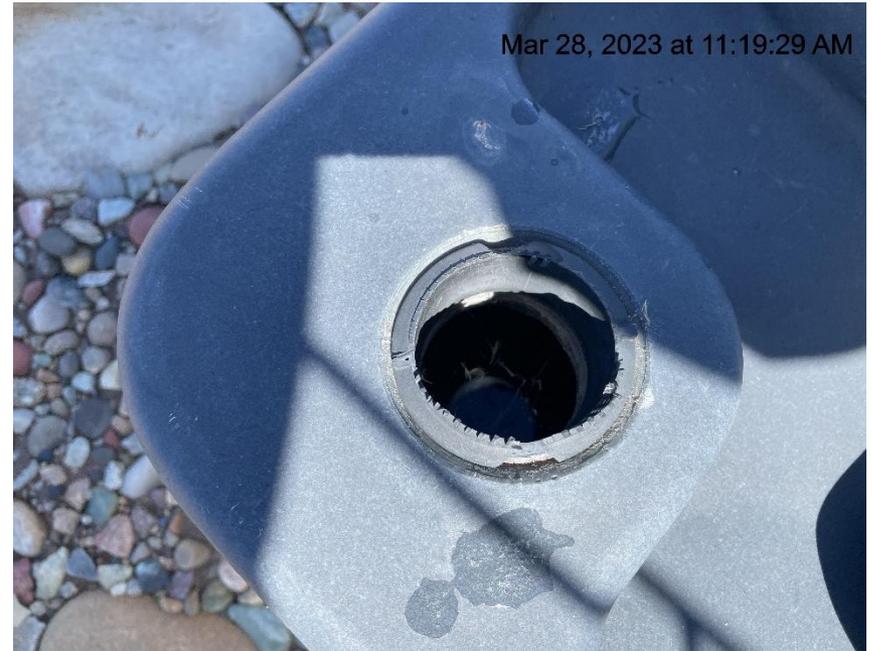
Photo # 3580 Chemical containment full/Failure to maintain chemical BMP (located on remote location – CLOUGH RMV 226-27 pad location # 324161)
