# Inspection Photos

API: 071-08799

Operator: OGRIS OPERATING LLC

Inspection Date: 3/29/2023

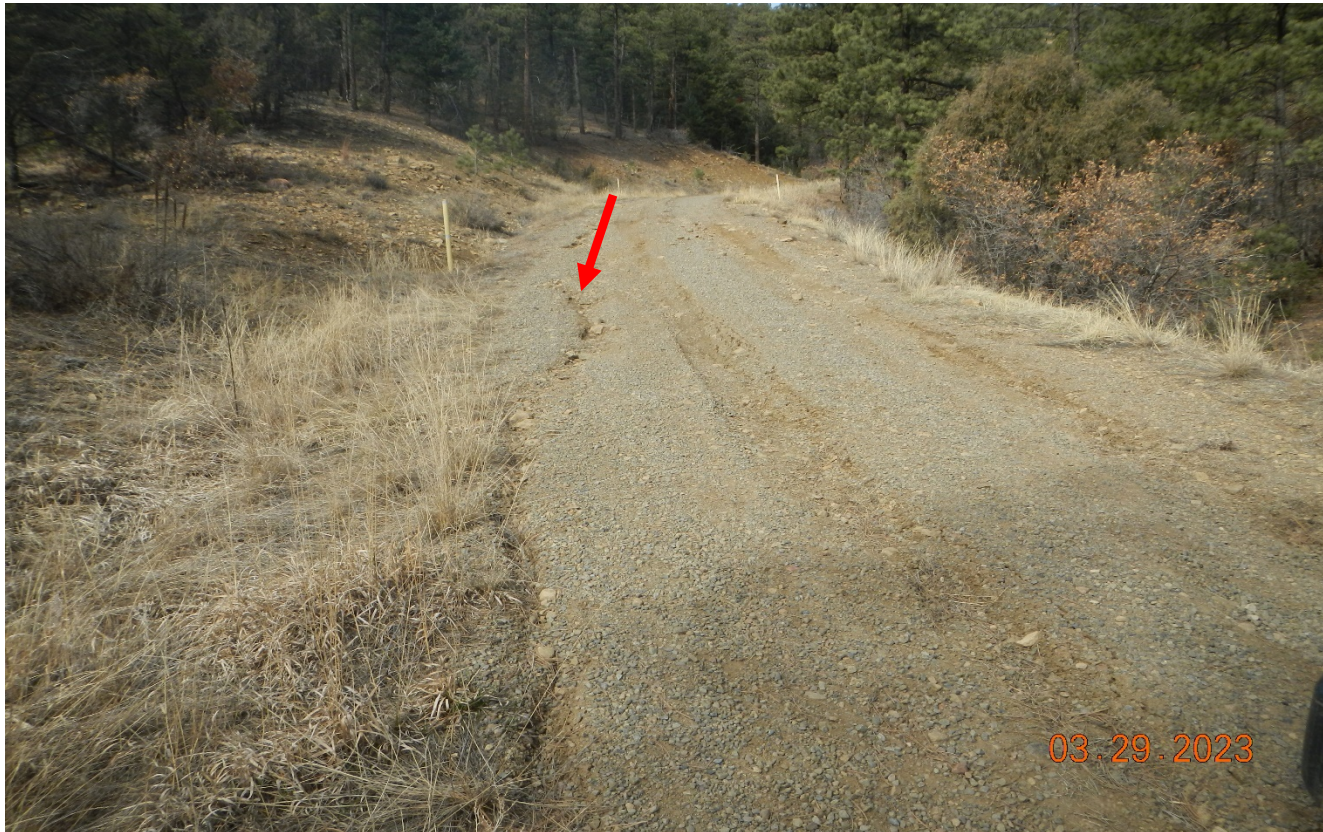
**Photo 1.** Facing toward the access road. There are signs of erosion from stormwater not diverted toward the culvert. Grading should be performed to direct stormwater toward the culvert.

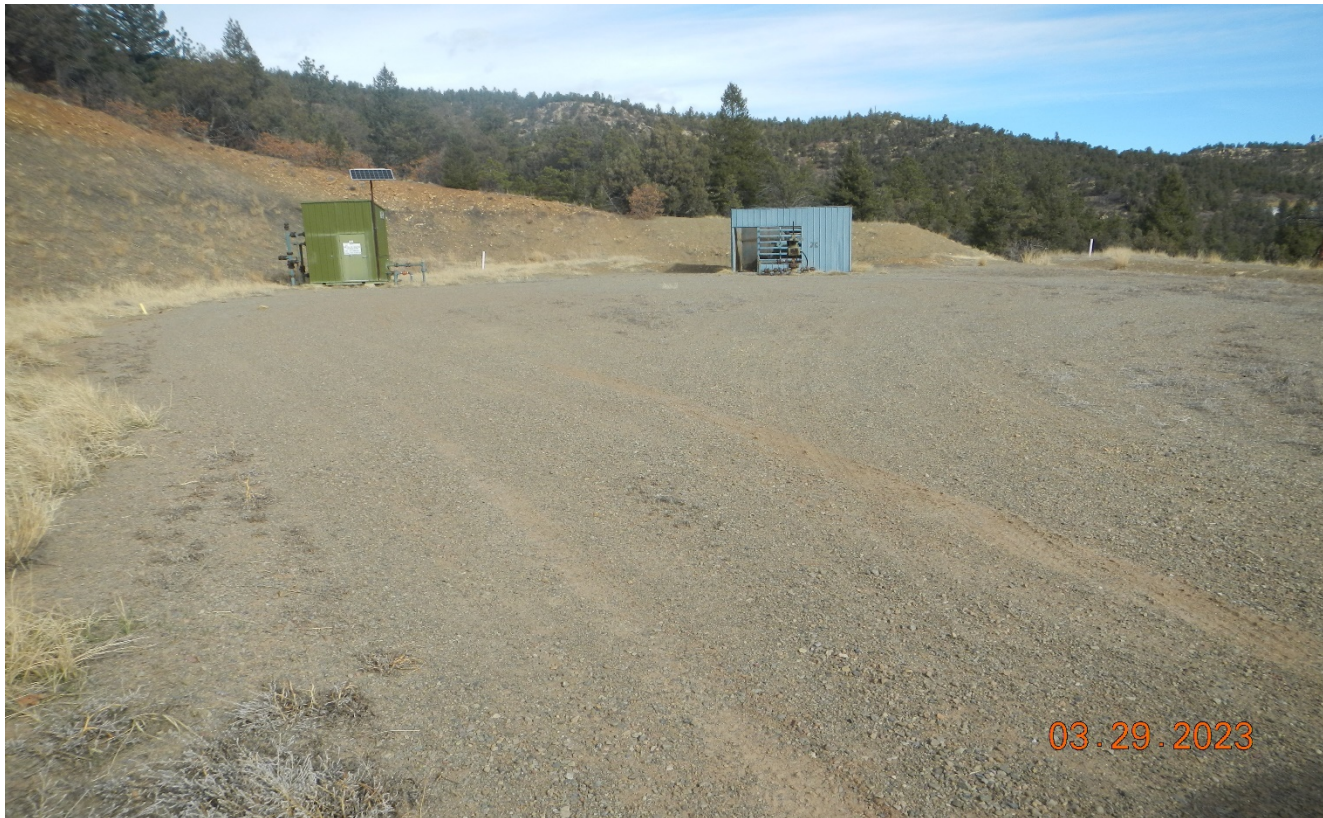
**Photo 2.** Facing north toward the wellsite.

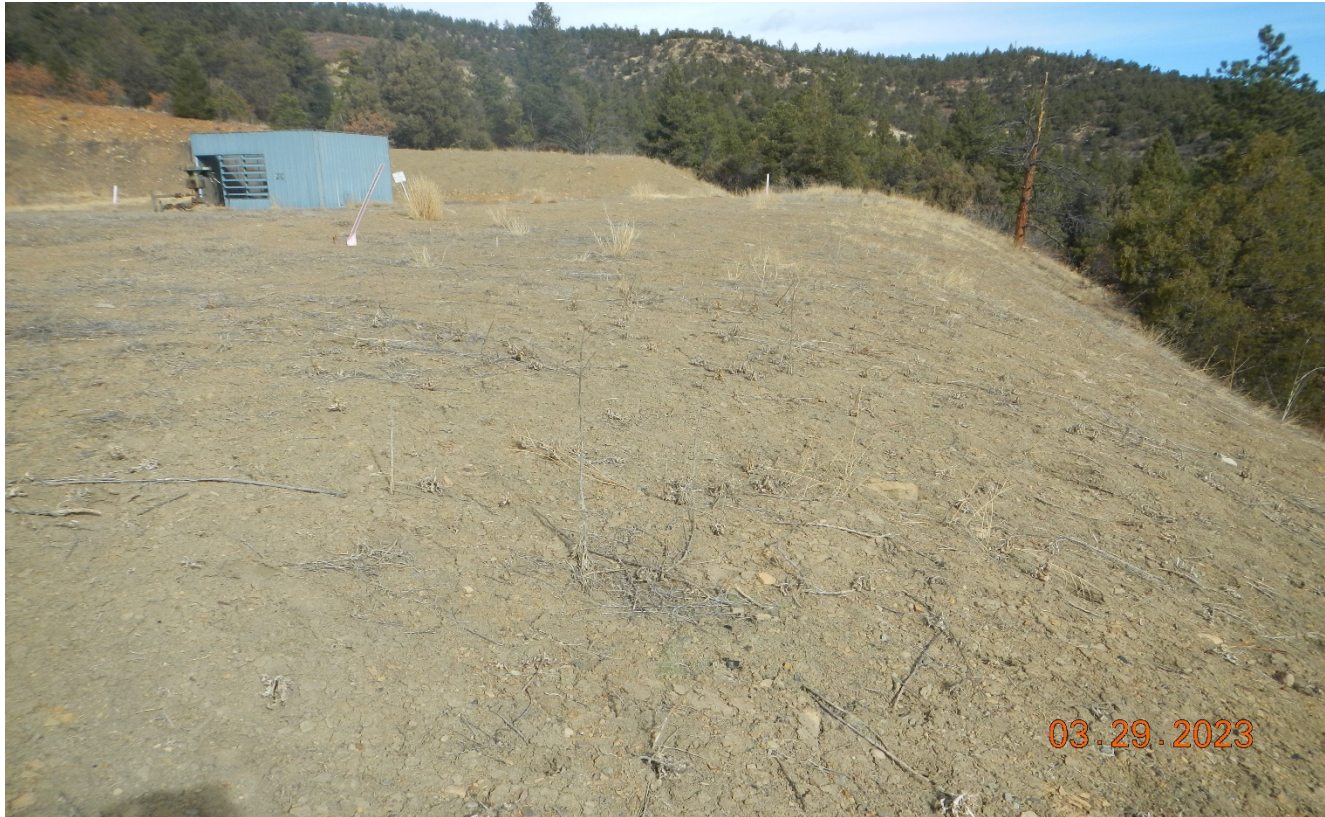
**Photo 3.** Facing toward the fill slope which needs to be reseeded and stabilized. There are also noxious weeds in this area (Canada thistle) which will need to be controlled.
