Inspection Photos

Location Name: TEP ROCKY MOUNTAIN LLC CLOUGH RMV 230-28 pad

Location ID: 335151

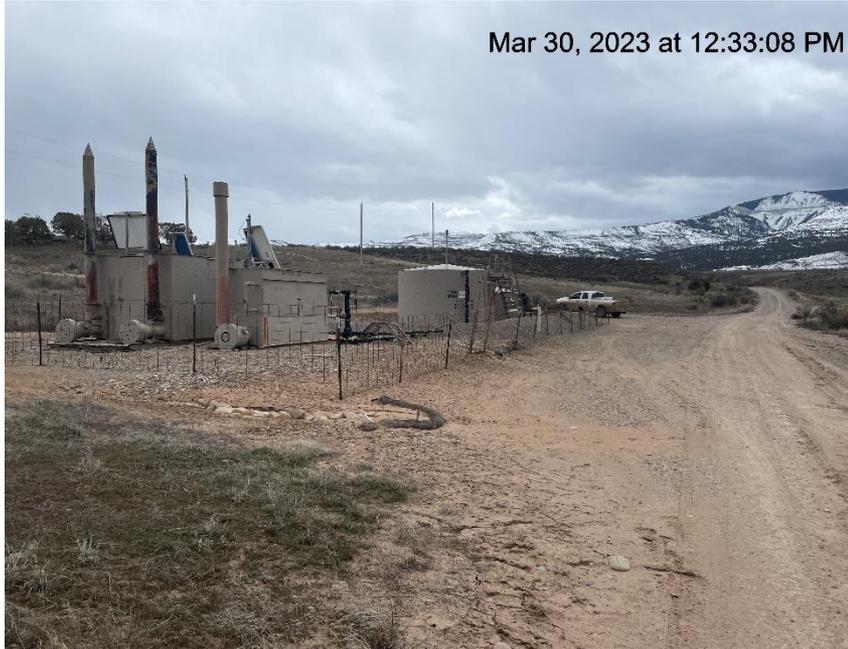
Photo # 3795 From entrance to location

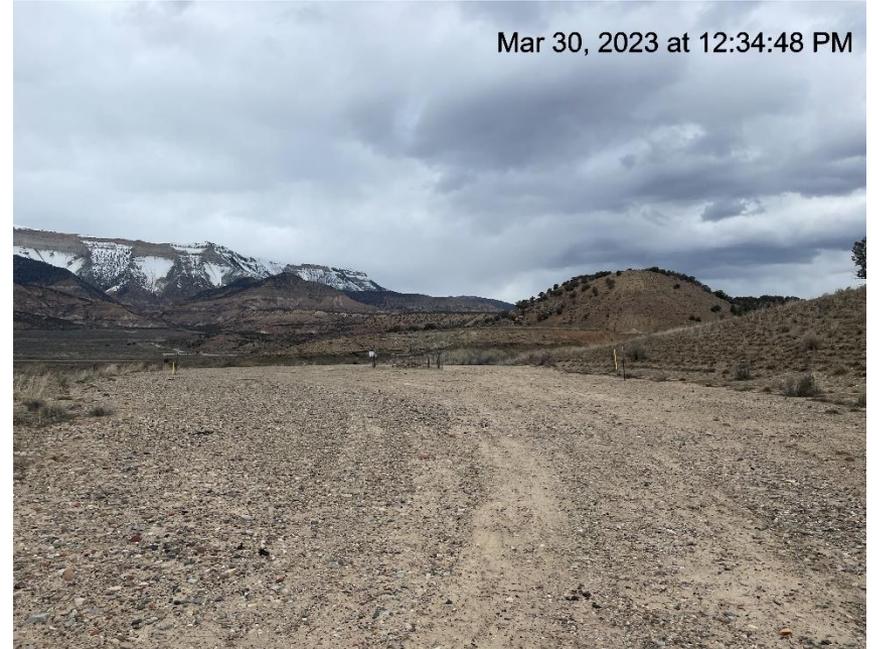
Photo # 3796 From entrance to upper tier of location

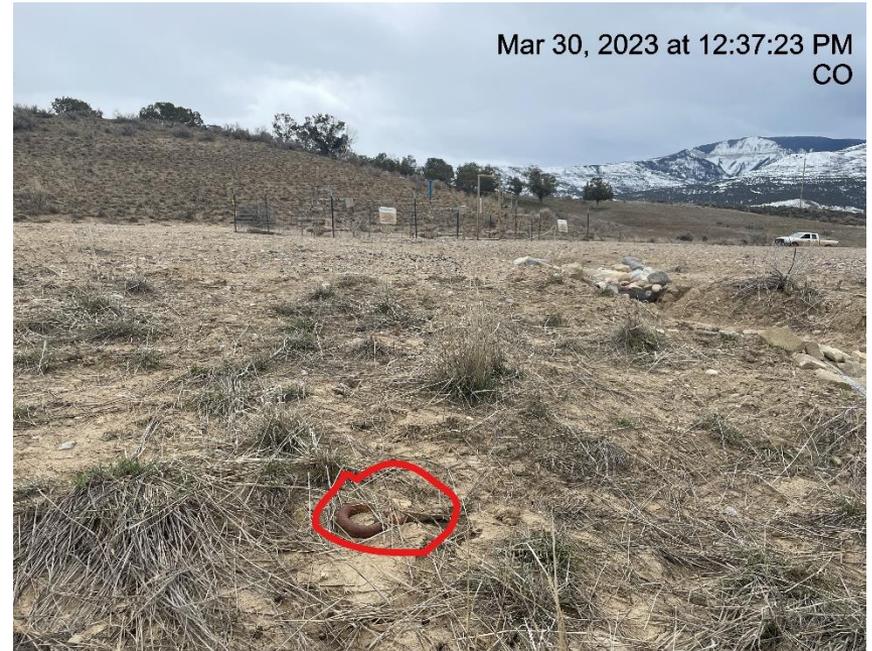
Photo # 3800 Unmarked deadman

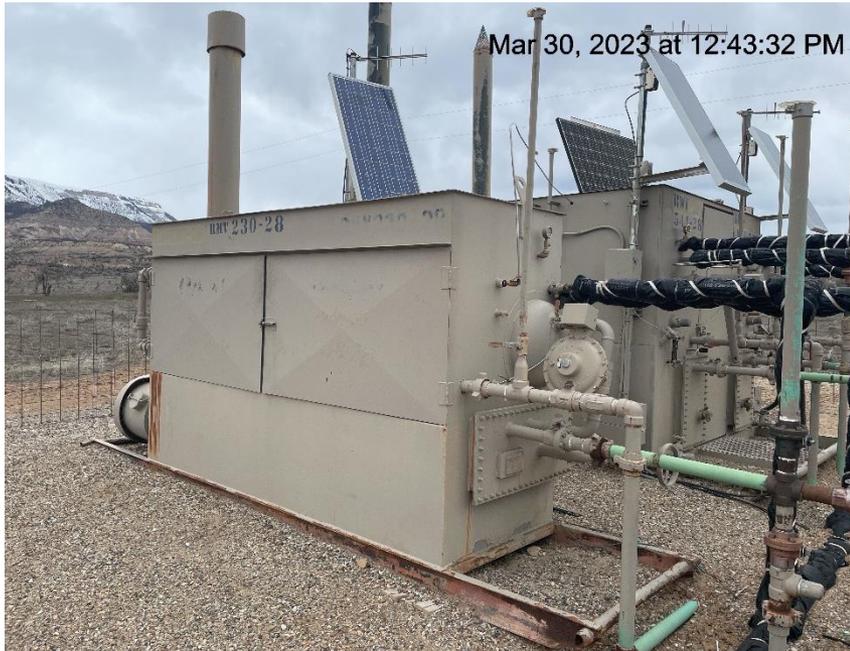
Photo # 3810 Meter calibration info not conspicuously posted

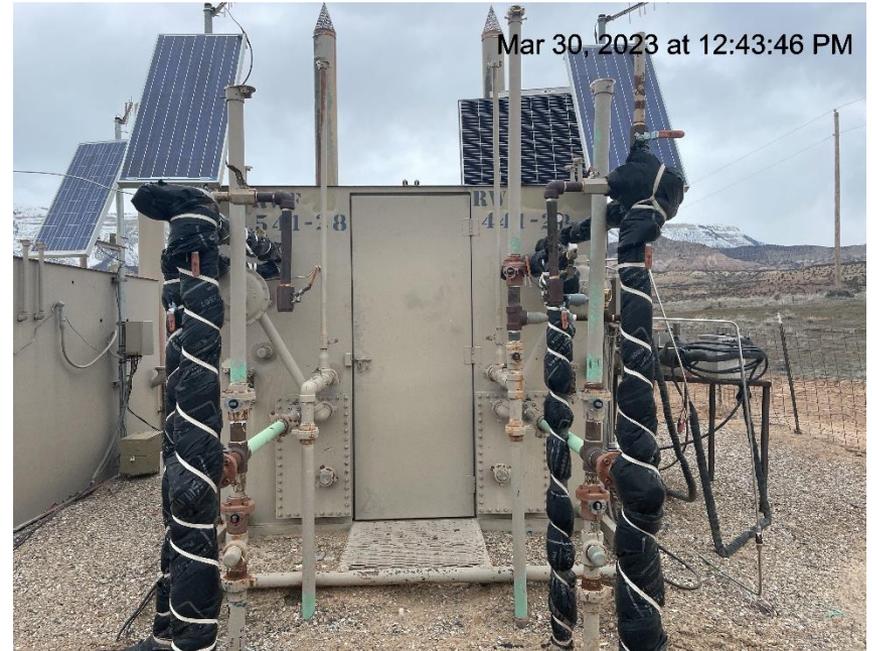
Photo # 3811 Meter calibration info not conspicuously posted

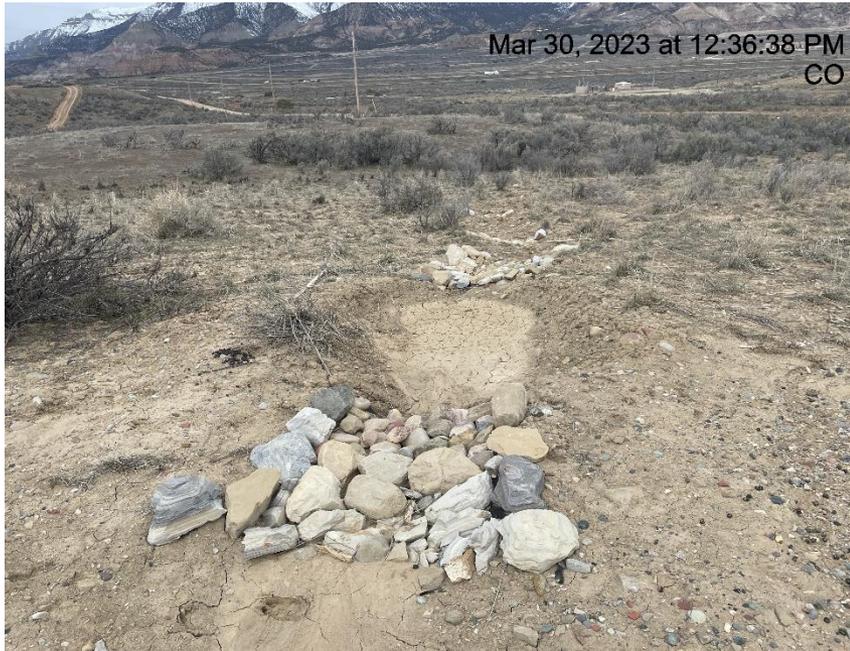
Photo # 3798 Sediment Trap needs maintenance (upper tier of pad, NW edge of pad across from wellheads.)

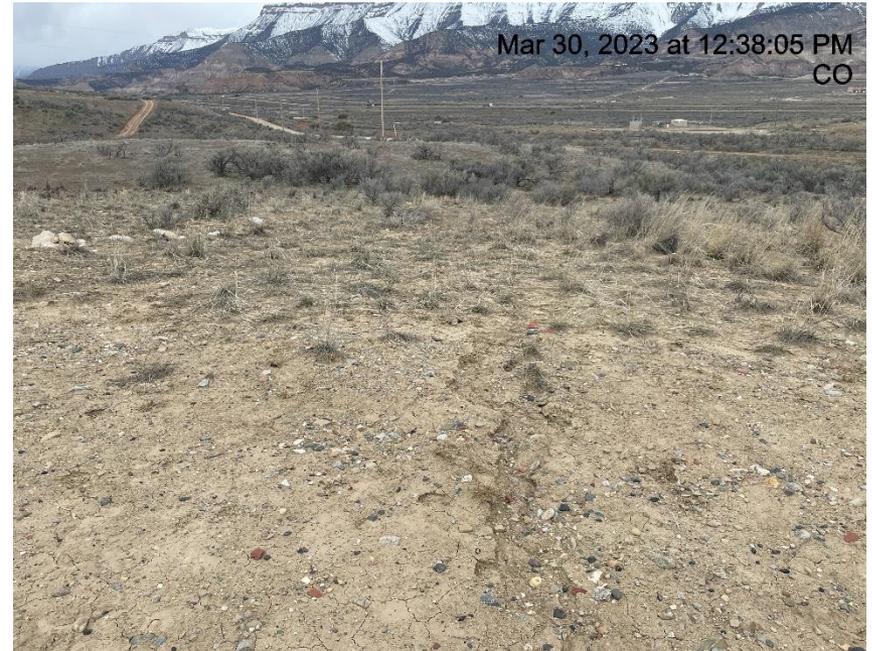
Photo # 3802 Rill erosion & transport of sediment off location (upper tier of pad NW edge of pad past sediment trap)

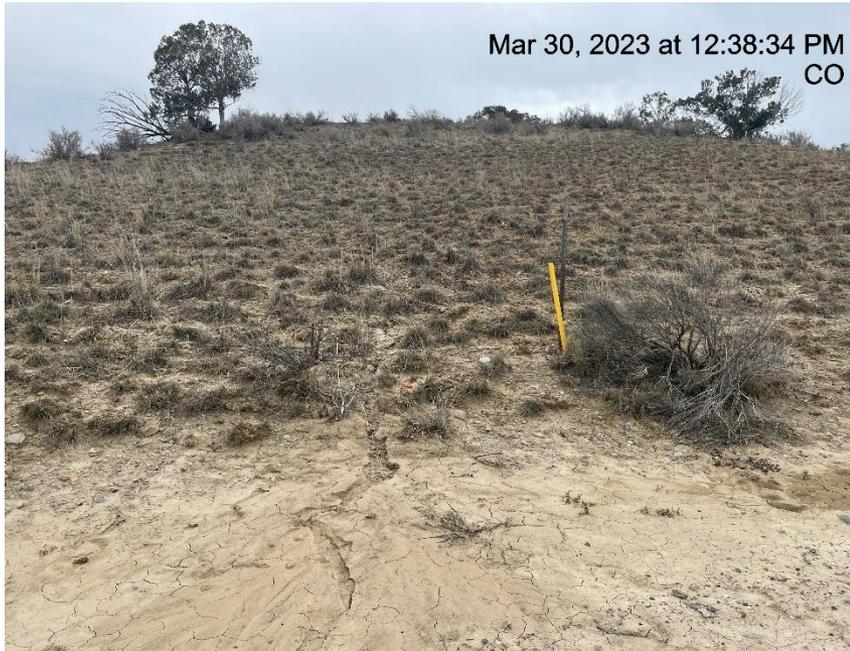
Photo # 3803 Rill erosion & transport of sediment onto location (upper tier NE side of pad)

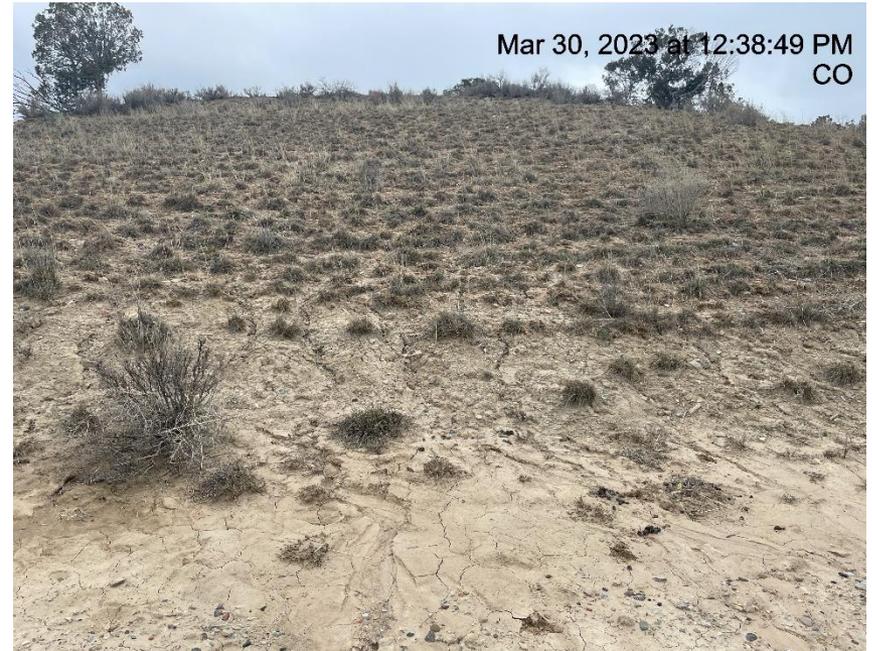
Photo # 3804 Rill erosion & transport of sediment onto location (upper tier east side of pad)

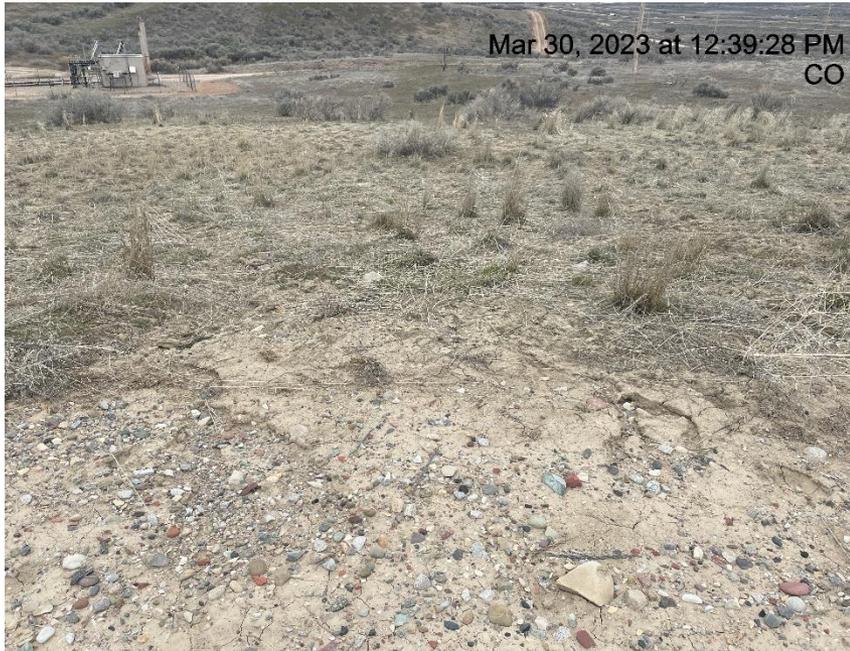
Photo # 3805 Rill erosion & transport of sediment off location (upper tier of pad, SW area)

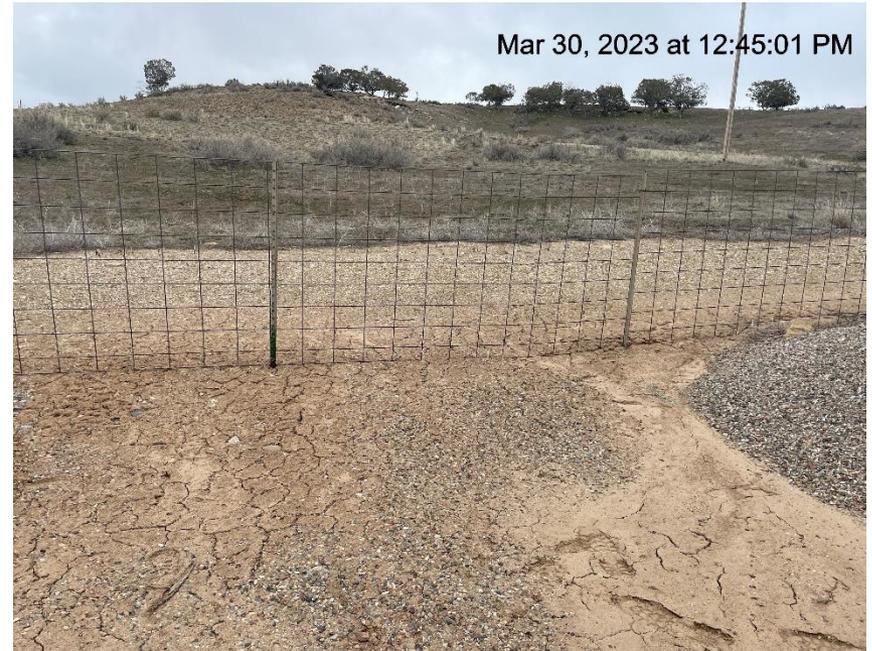
Photo # 3813 Erosion & transport of sediment onto location

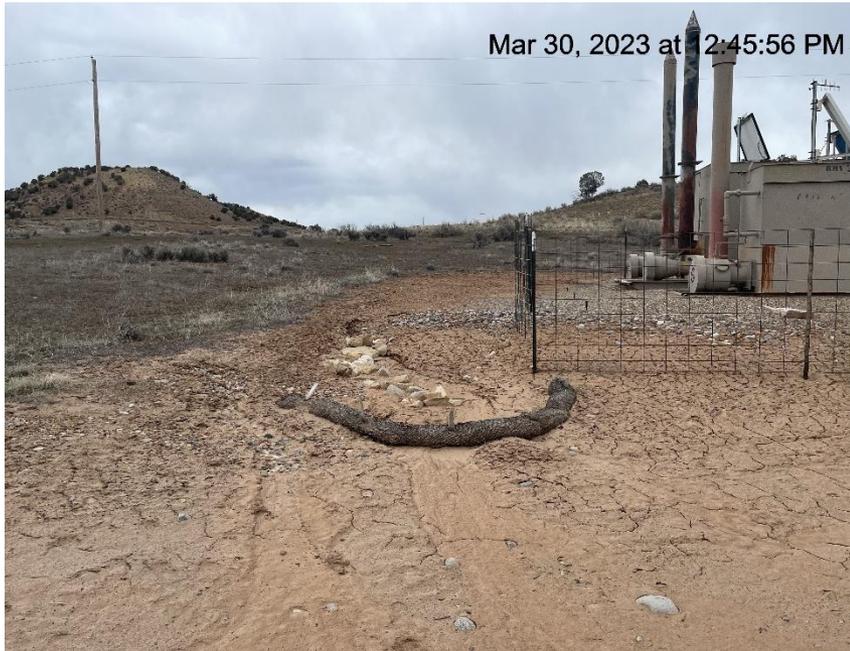
Photo # 3814 Erosion/transport of sediment off location/insufficient BMP's

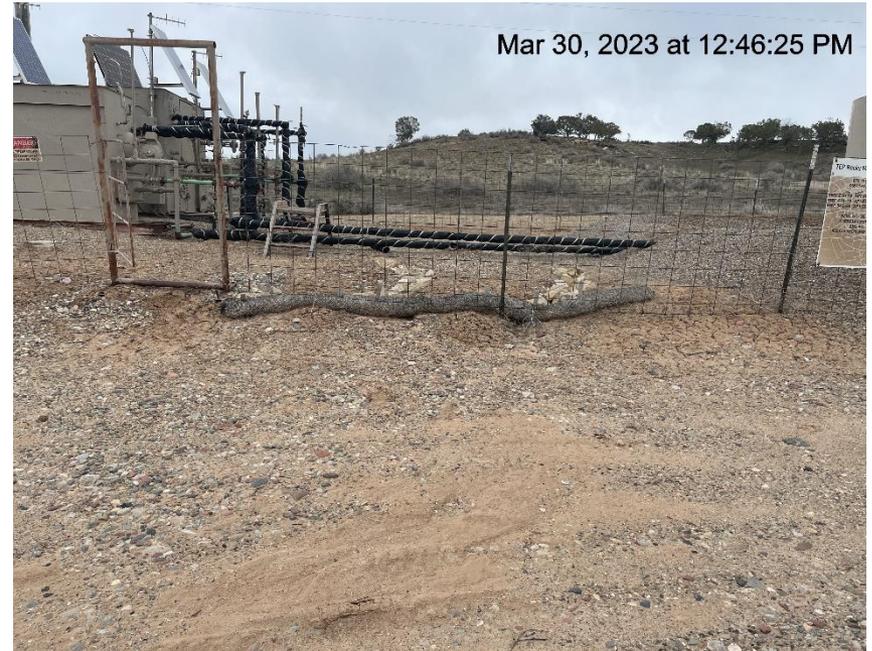
Photo # 3816 Erosion/transport of sediment off location/insufficient run off controls/BMP's

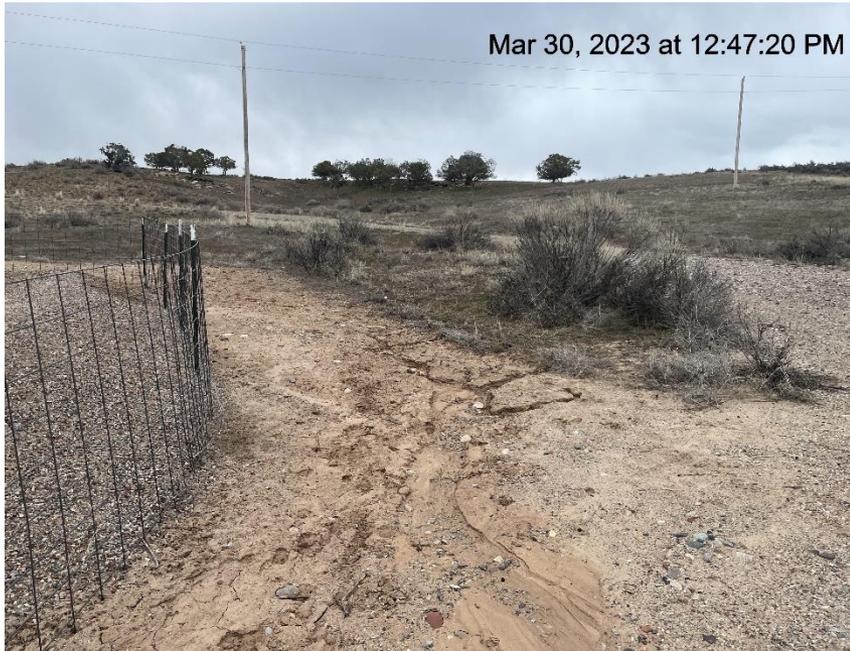
Photo # 3820 Rill erosion & transport of sediment off location onto lease road/insufficient BMP's

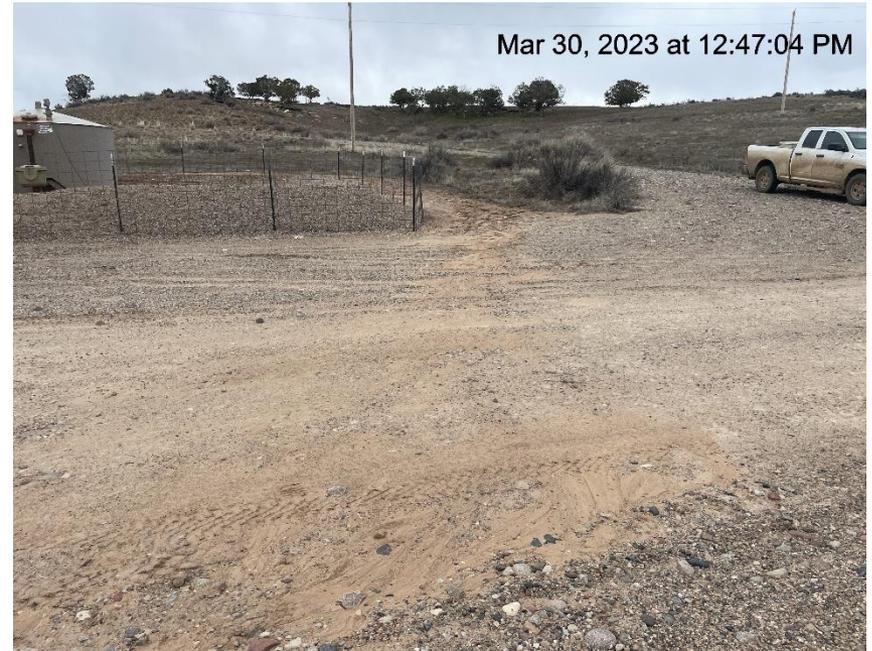
Photo # 3818 Rill erosion & transport of sediment off location onto lease road/insufficient BMP's
