## Inspection Photos

Location Name: TEP ROCKY MOUNTAIN LLC VASSAR/HEATH RMV 99-28 pad

Location ID: 324008

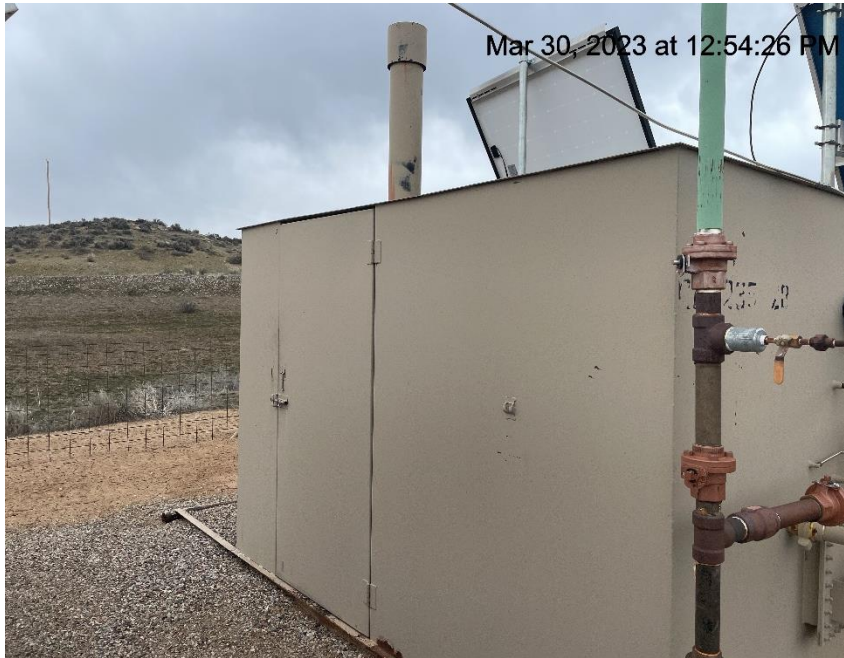
**Photo # 3831 Meter calibration info not conspicuously posted**

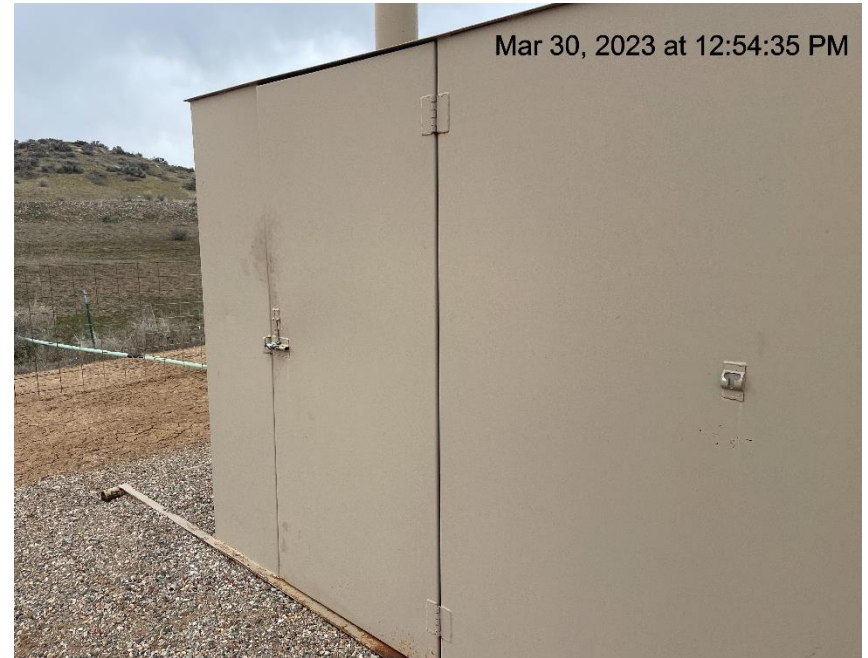
**Photo # 3832 Meter calibration info not conspicuously posted**

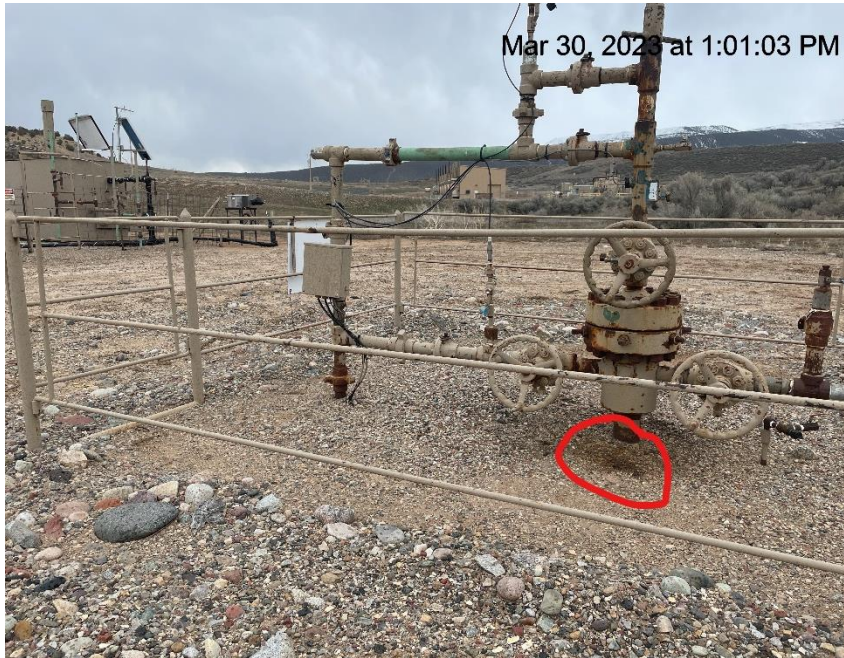
Photo # 3844 Stained soils & gravel near wellhead

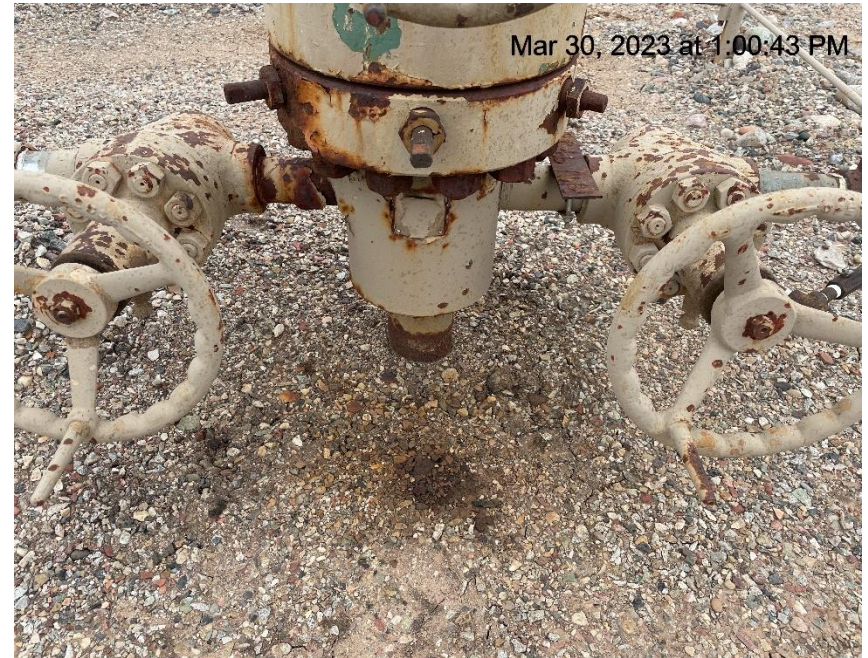
Photo # 3845 Stained soils & gravel

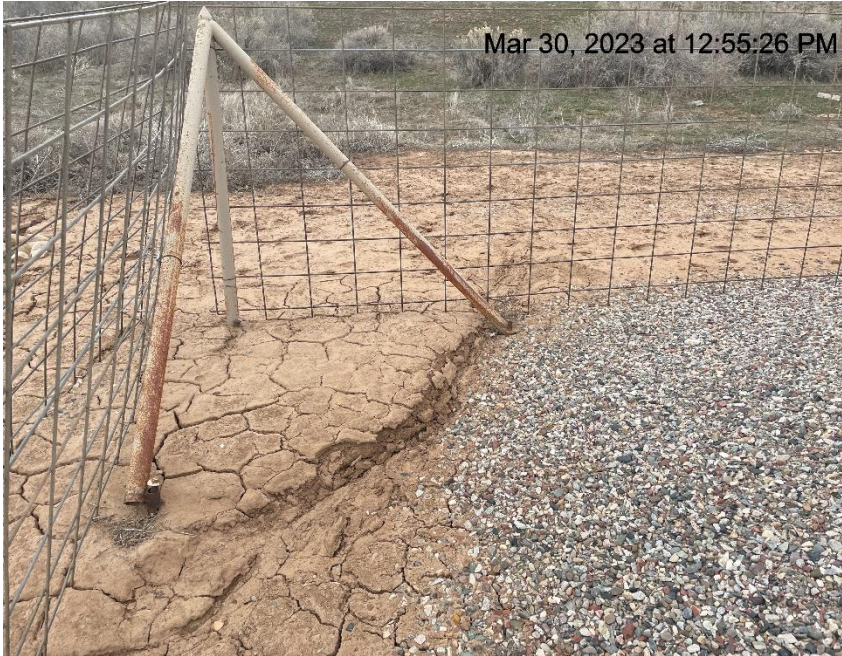
**Photo # 3833 Rill erosion & transport of sediment off location**

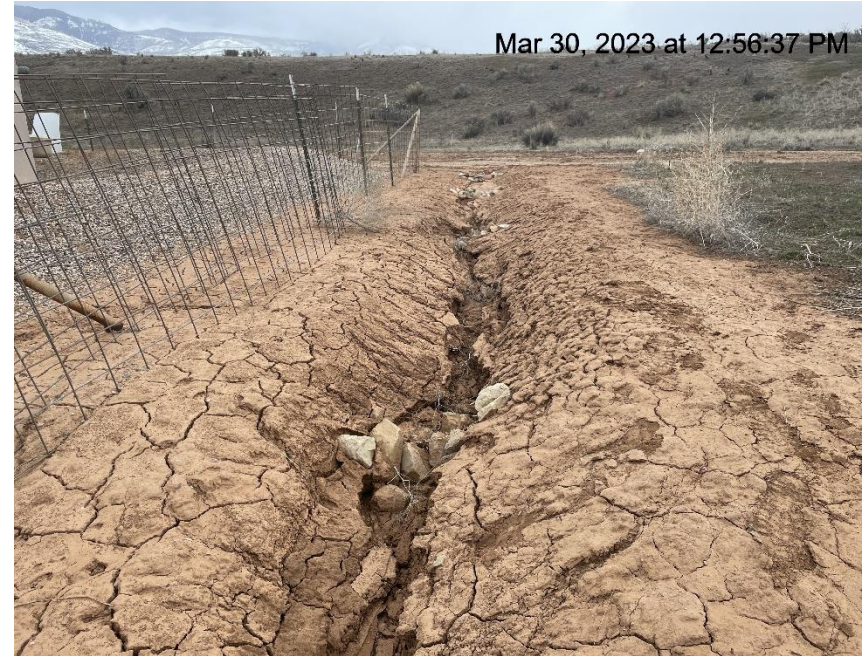
**Photo # 3837 Ditch & check dams need maintenance**

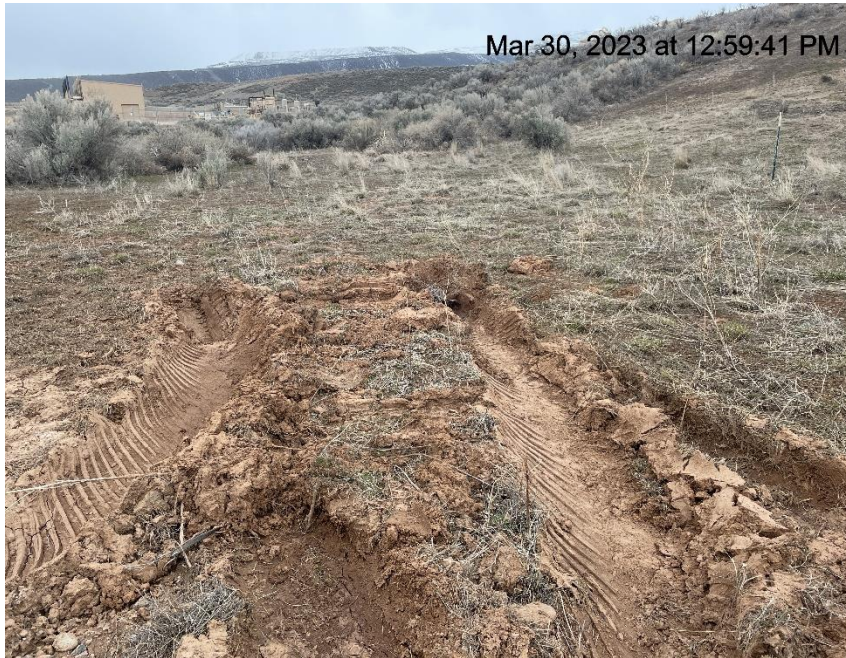
**Photo # 3841 Failure to minimize surface disturbances and restrict vehicle traffic to working pad area**

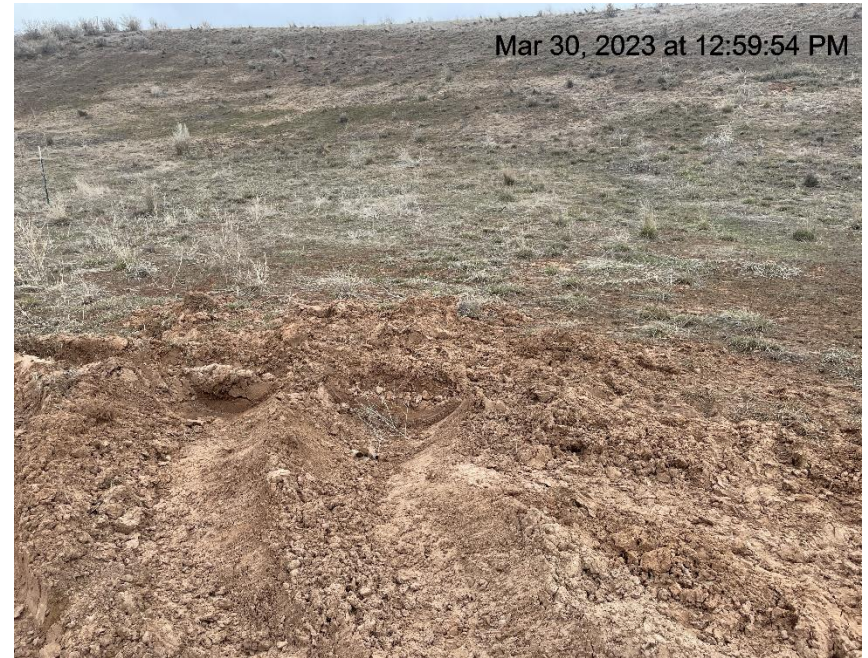
**Photo # 3842 Failure to minimize surface disturbances and restrict vehicle traffic to working pad area**

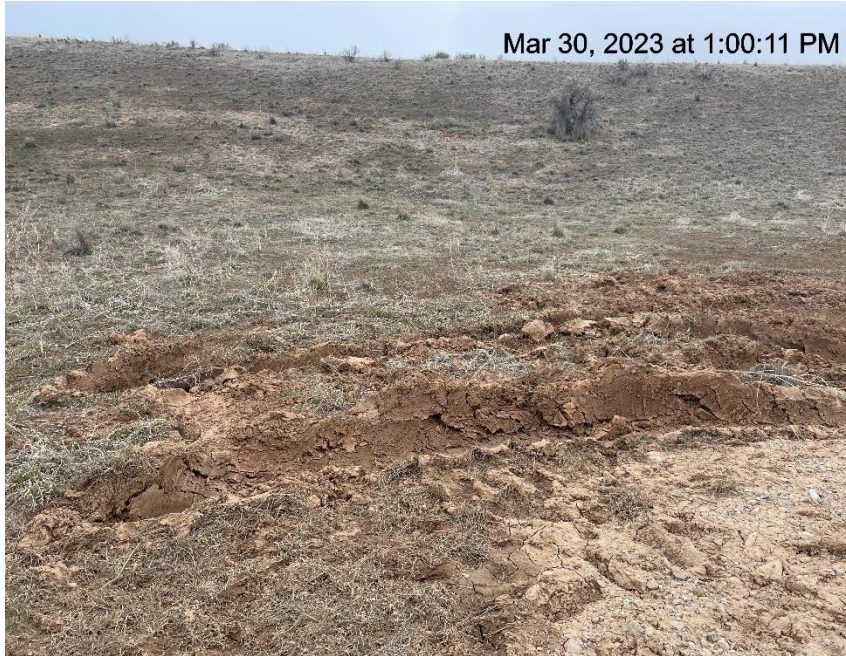
**Photo # 3843 Failure to minimize surface disturbances and restrict vehicle traffic to working pad area**

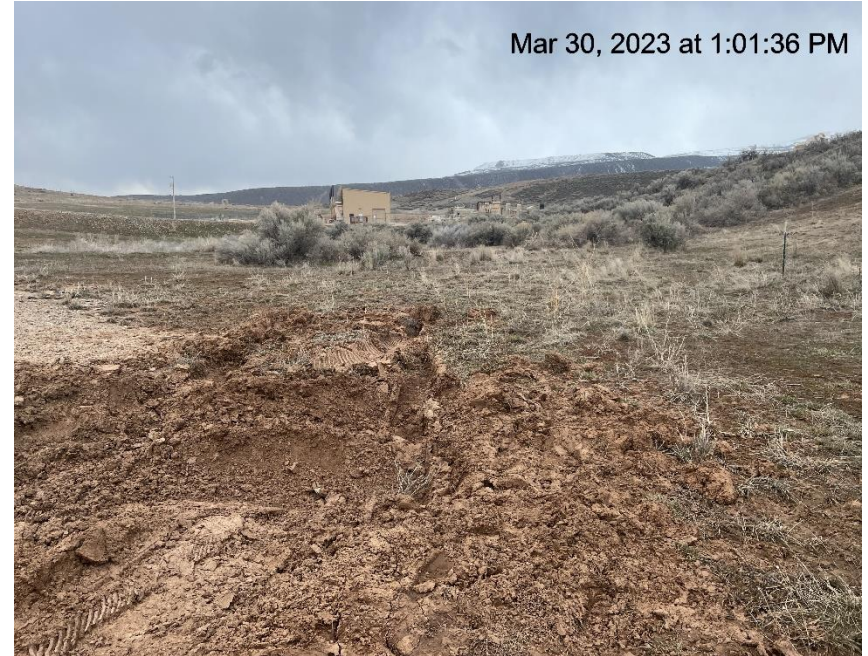
**Photo # 3846 Failure to minimize surface disturbances and restrict vehicle traffic to working pad area**

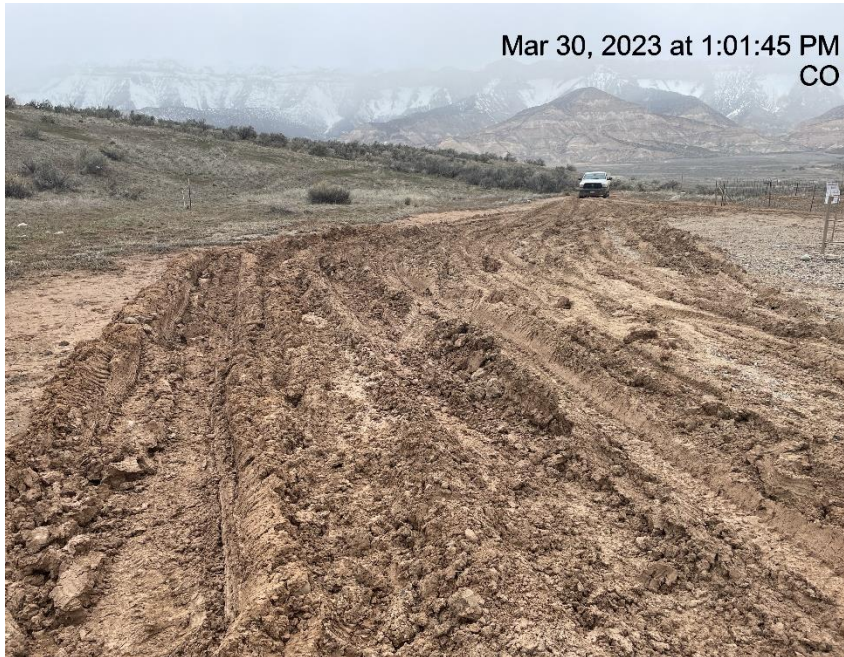
**Photo # 3847 Lack of stabilization/insufficient tracking  
BMP's**

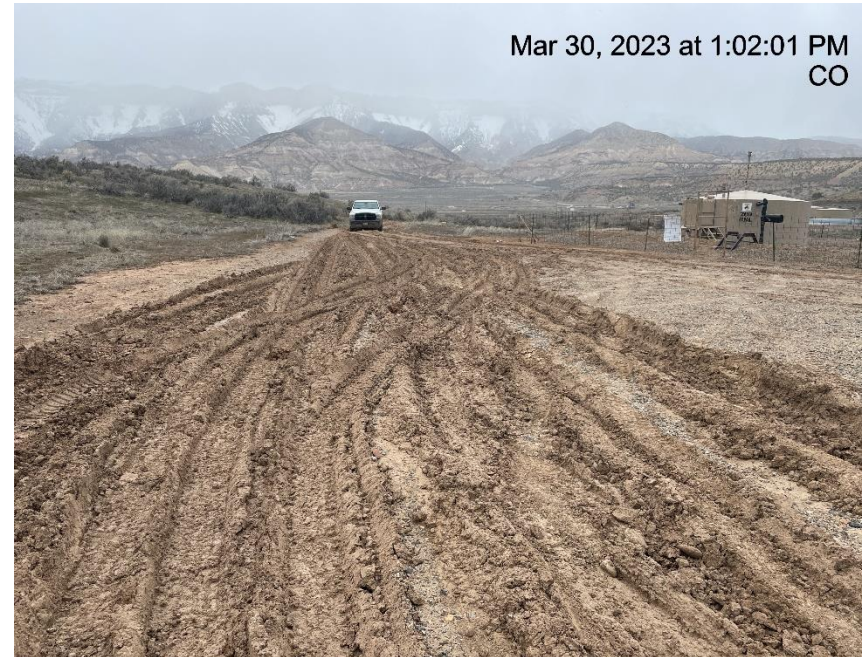
**Photo # 3848 Lack of stabilization/insufficient tracking  
BMP's**

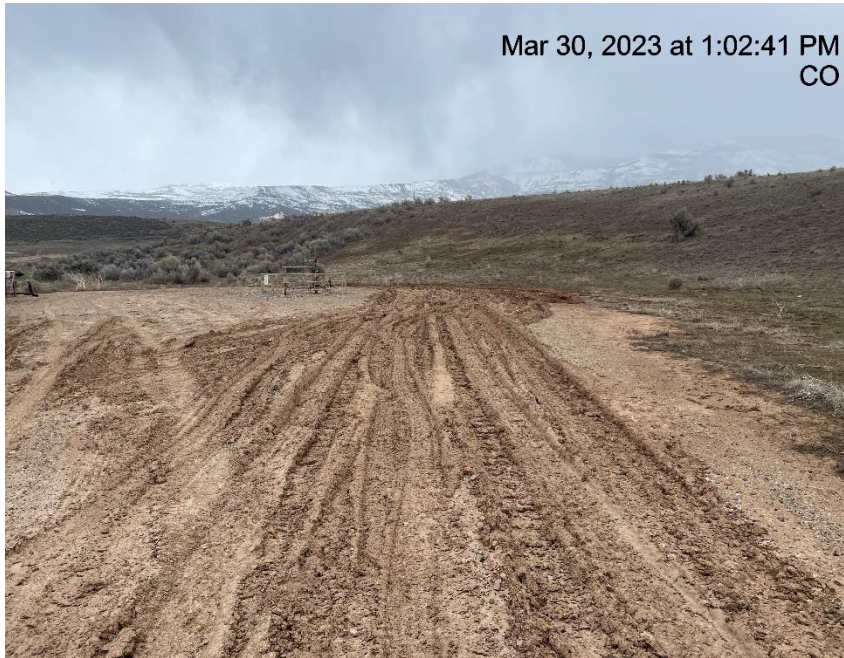
**Photo # 3849 Lack of stabilization/insufficient tracking  
BMP's**

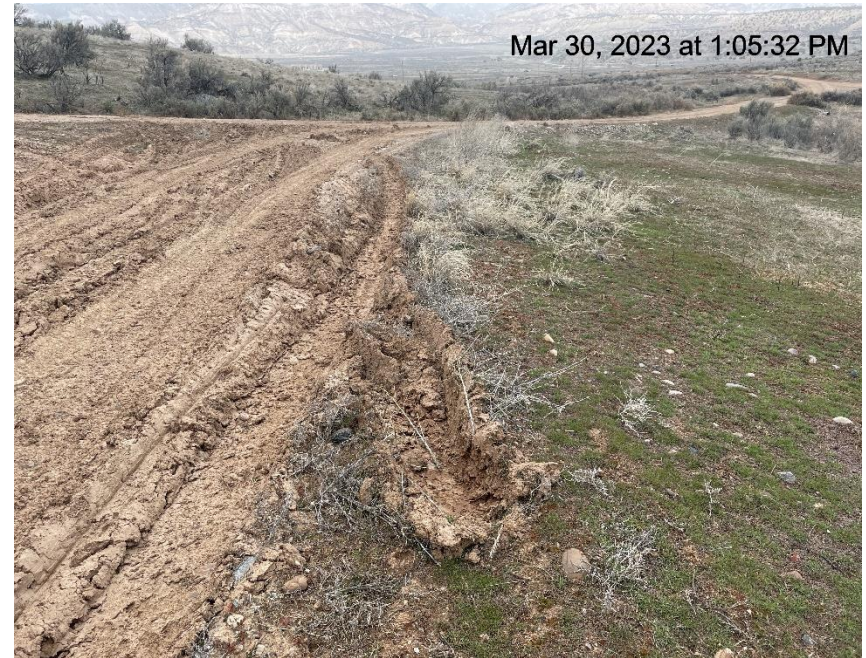
**Photo # 3852 Lack of stabilization/insufficient tracking  
BMP's/Failure to minimize surface disturbances and restrict  
vehicle traffic to designated access road**

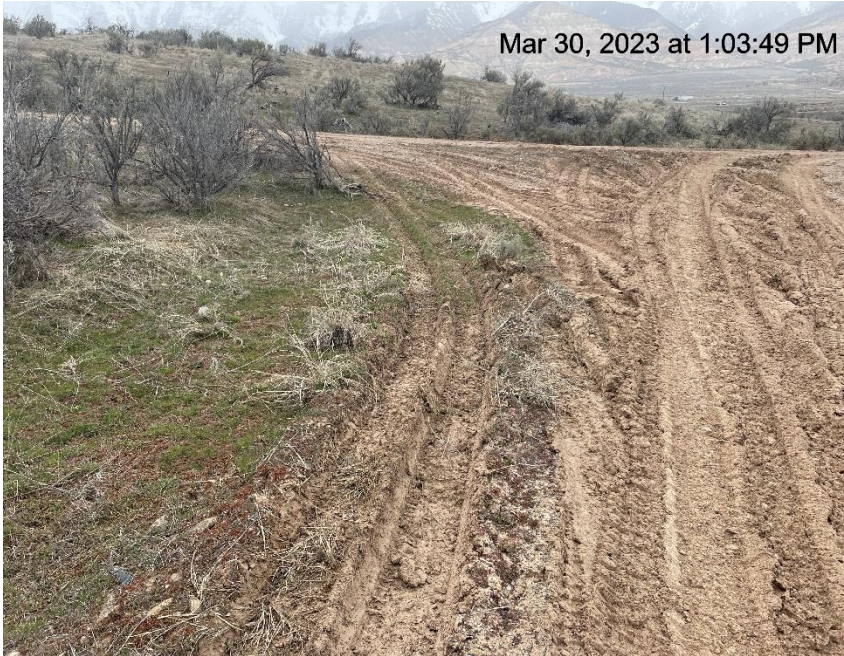
**Photo # 3853 Failure to minimize surface disturbances and restrict vehicle traffic to designated access road/Lack of stabilization/insufficient tracking BMP's**

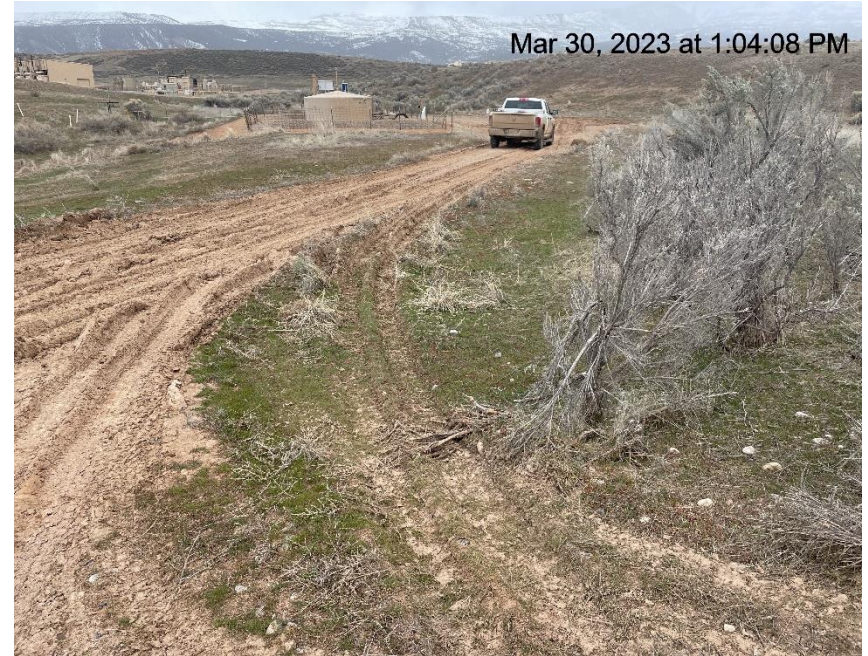
**Photo # 3854 Failure to minimize surface disturbances and restrict vehicle traffic to designated access road**

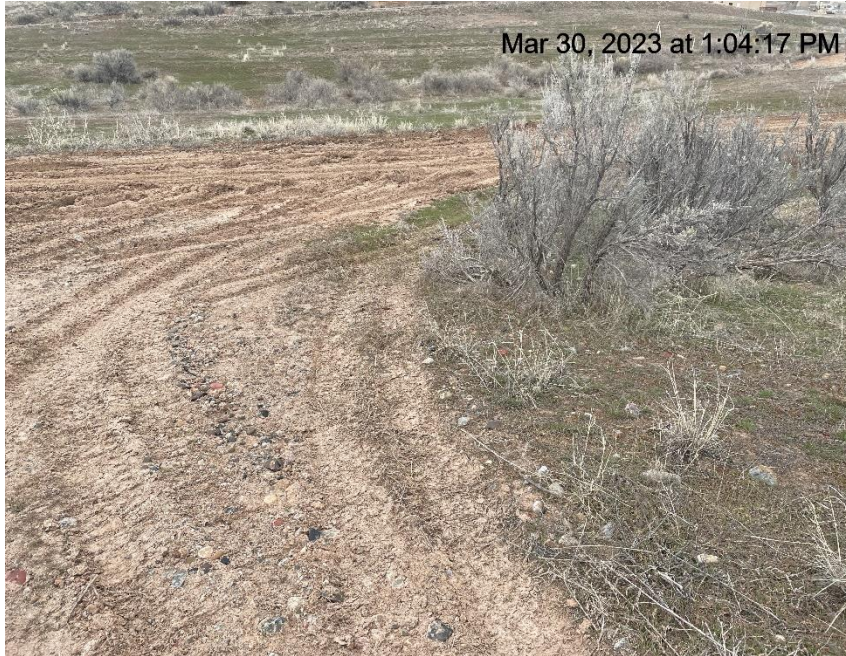
**Photo # 3855 Failure to minimize surface disturbances and restrict vehicle traffic to designated access road**

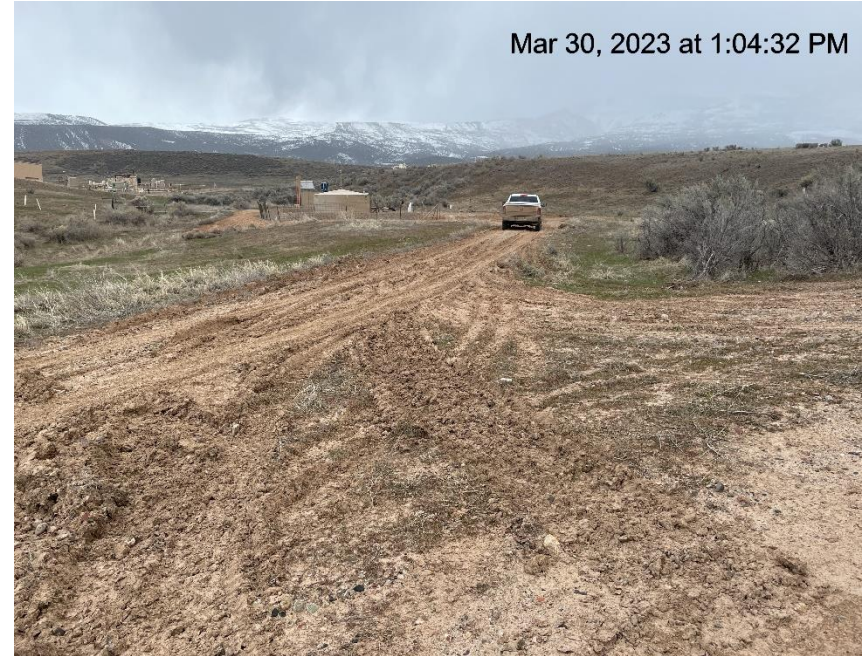
**Photo # 3856 Failure to minimize surface disturbances and restrict vehicle traffic to designated access road/Lack of stabilization/Insufficient tracking BMP/Vehicle Tracking**

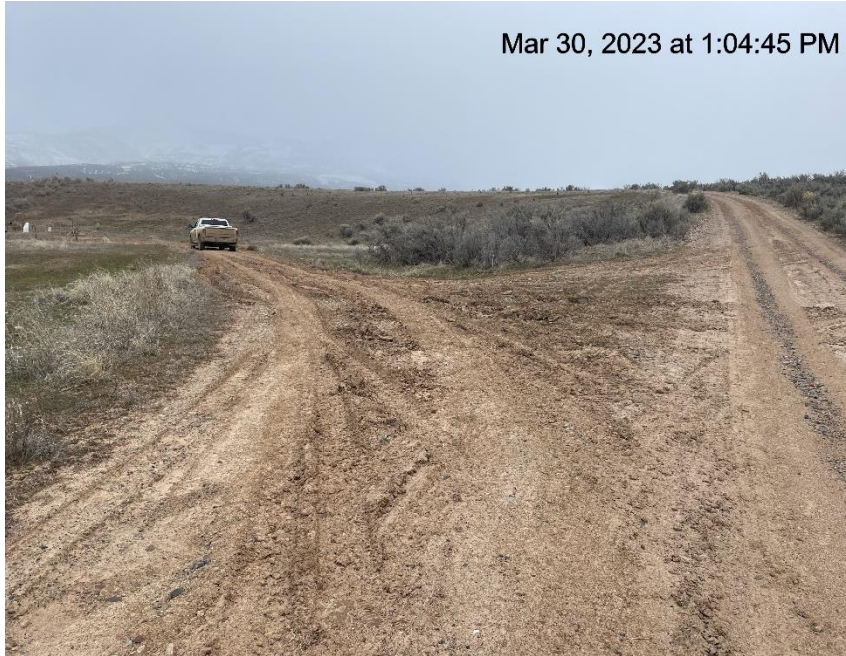
**Photo # 3857 Lack of stabilization/Insufficient tracking  
BMP's/Vehicle Tracking**

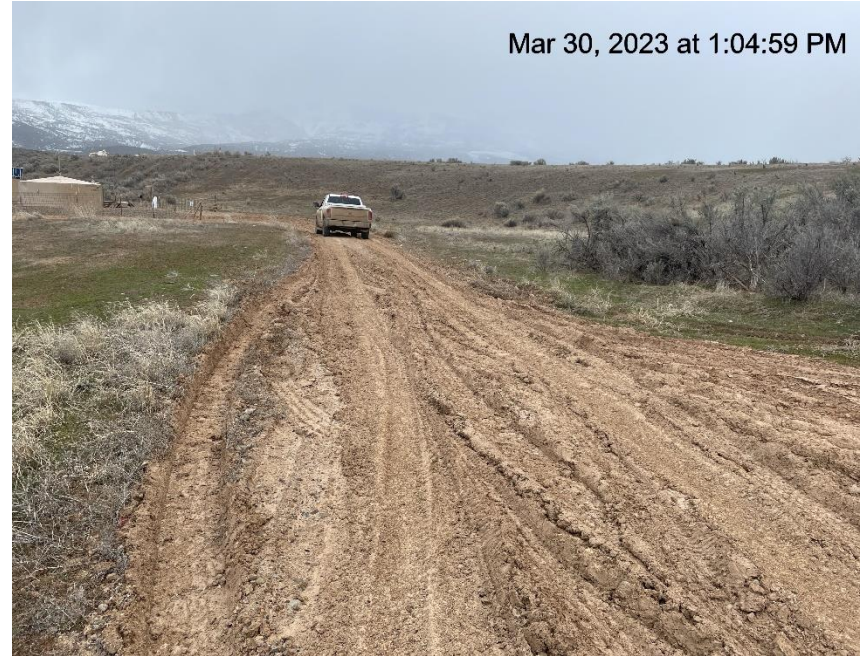
**Photo # 3859 Failure to minimize surface disturbances and  
restrict vehicle traffic to designated access road/lack of  
stabilization/insufficient tracking BMP's**
