Inspection Photos

Location Name: TEP ROCKY MOUNTAIN LLC CLOUGH 14-22 pad

Location ID: 335218

COLORADO
Oil & Gas Conservation
Commission
Department of Natural Resources

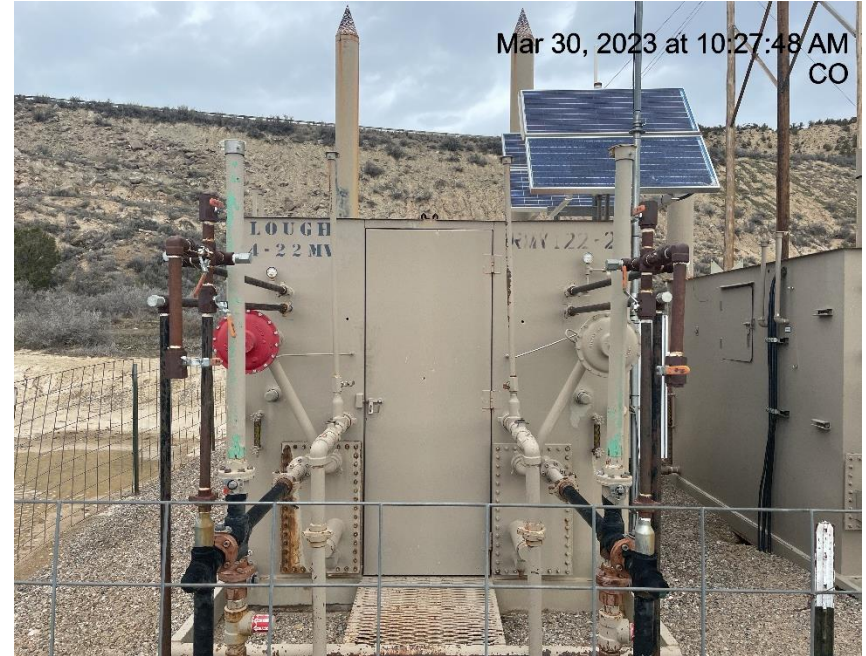
Photo # 3631 Meter calibration info not conspicuously posted

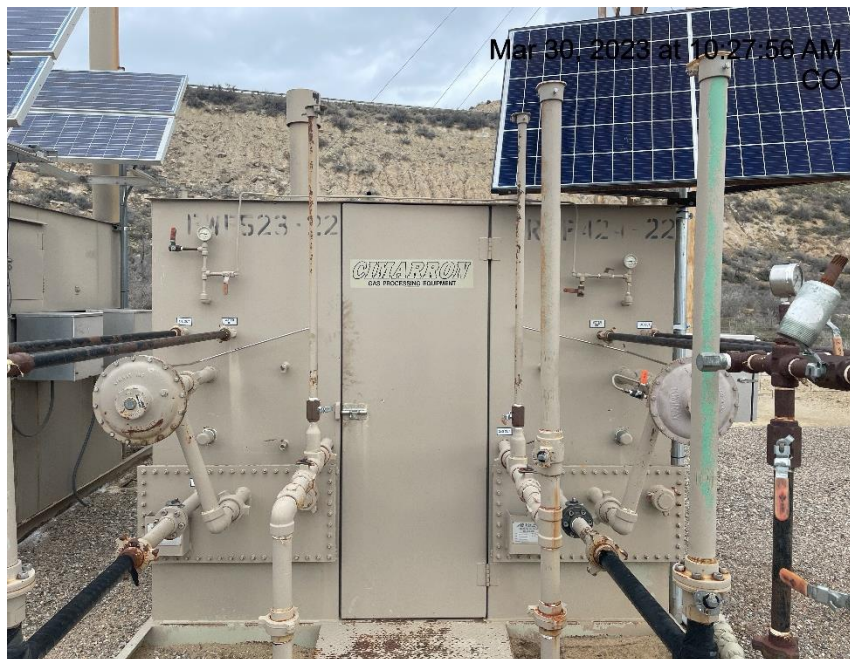
Photo # 3632 Meter calibration info not conspicuously posted

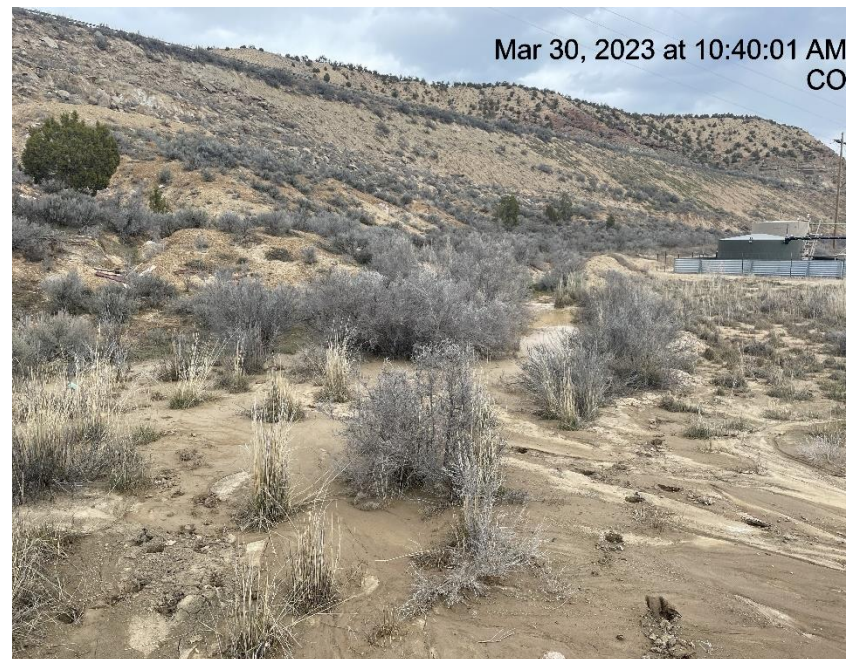
Photo # 3641 Insufficient run on controls/BMP's & transport of sediment onto location (NW side of pad)

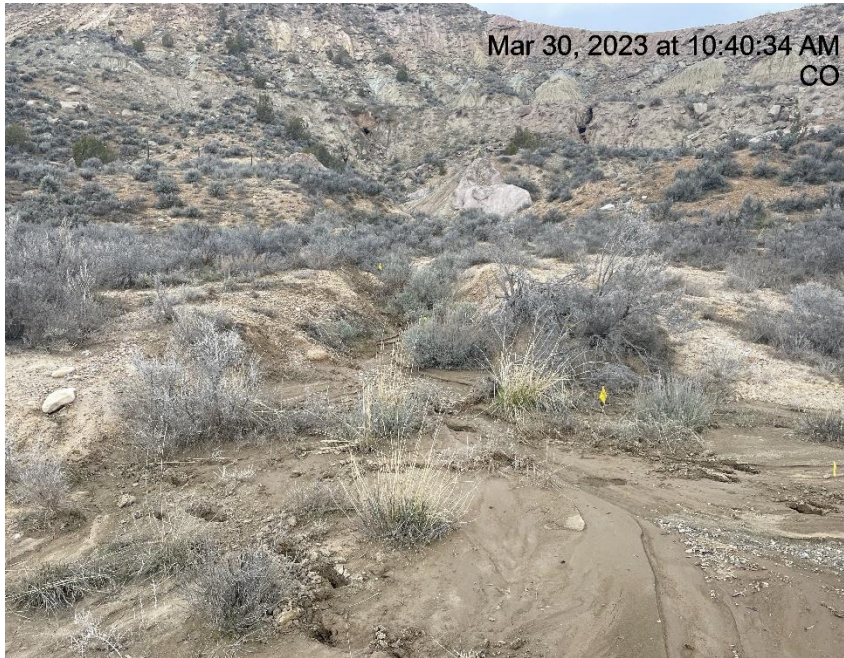
Photo # 3643 Insufficient run on controls/BMP's & transport of sediment onto location/sediment choking off vegetation (NW side of pad)

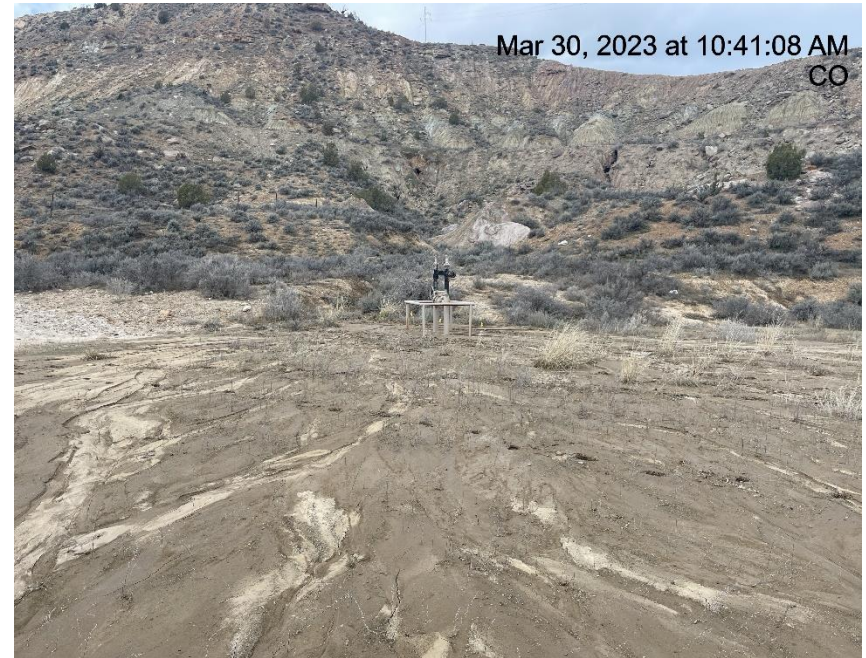
Photo # 3645 Insufficient run on controls/BMP's & transport of sediment onto location/sediment choking off vegetation (NW side of pad)

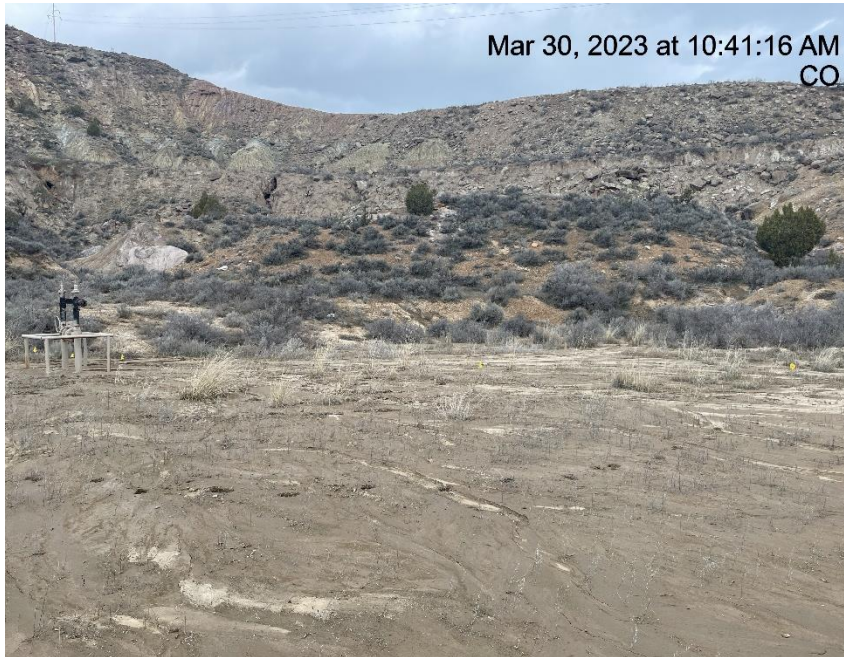
Photo # 3646 Insufficient run on controls/BMP's & transport of sediment onto location/sediment choking off vegetation (NW side of pad)

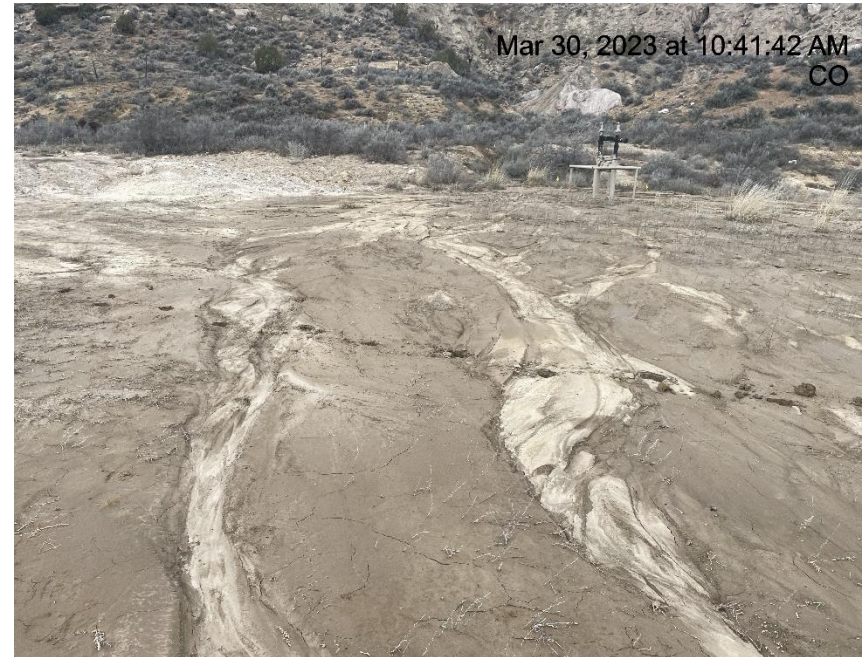
Photo # 3647 Insufficient run on controls/BMP's & transport of sediment onto location/sediment choking off vegetation/Rill erosion (W/NW side of pad)

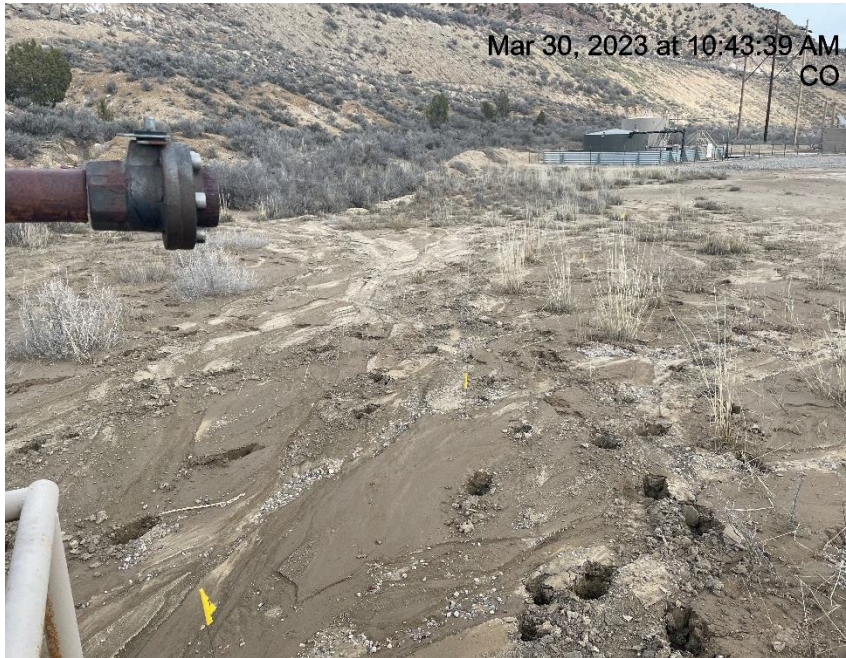
Photo # 3653 Insufficient run on controls/BMP's & transport of sediment onto location/sediment choking off vegetation/Rill erosion (NW side of pad)

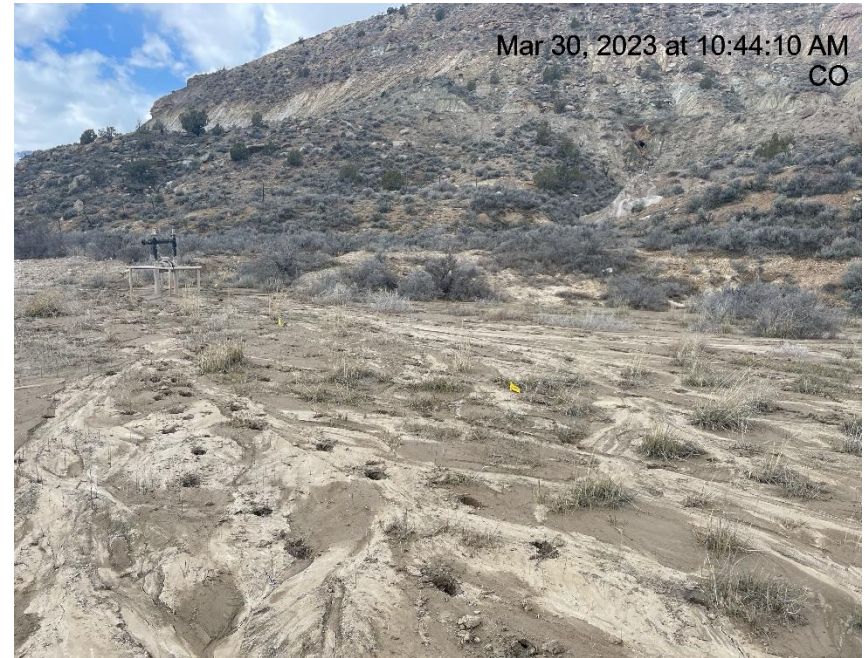
Photo # 3655 Insufficient run on controls/BMP's & transport of sediment onto location/sediment choking off vegetation/Rill erosion (NW side of pad)

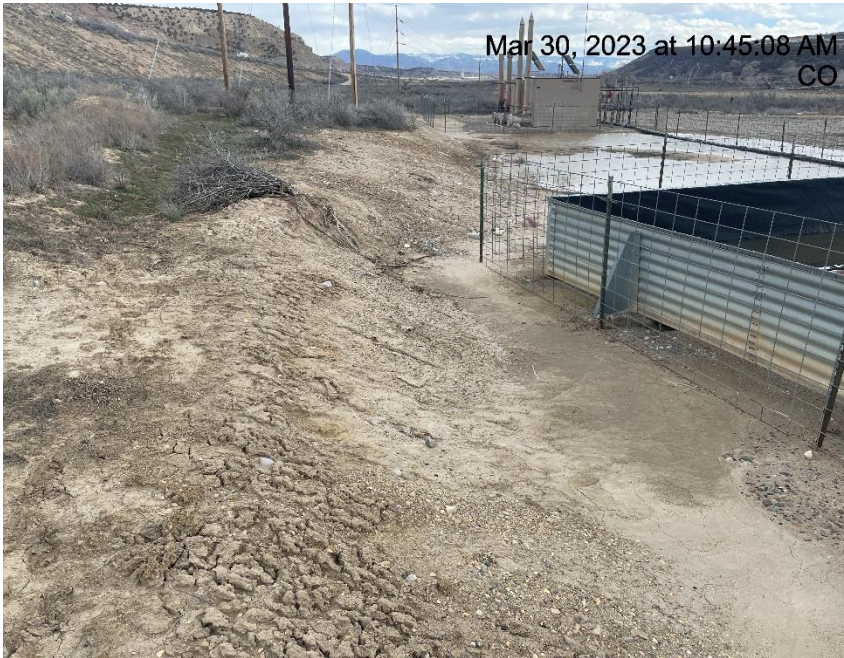
Photo # 3657 Rill erosion & transport of sediment onto location

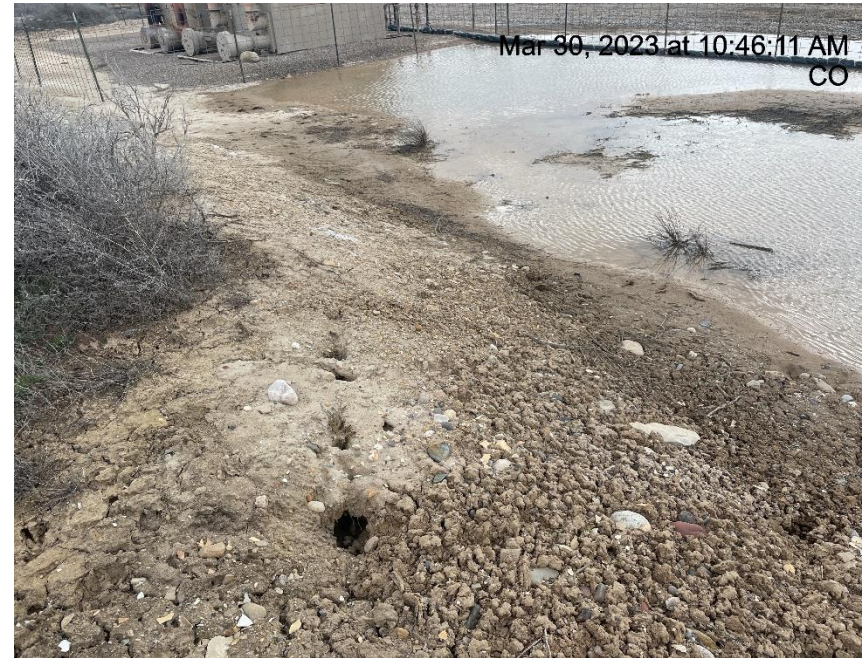
Photo # 3660 Tunnel erosion

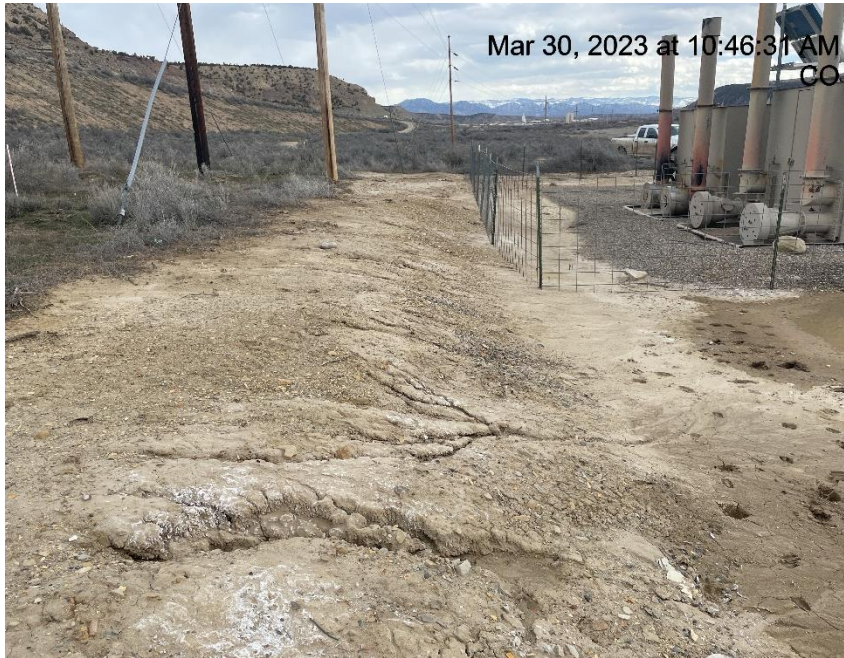
Photo # 3662 Rill erosion & transport of sediment onto location

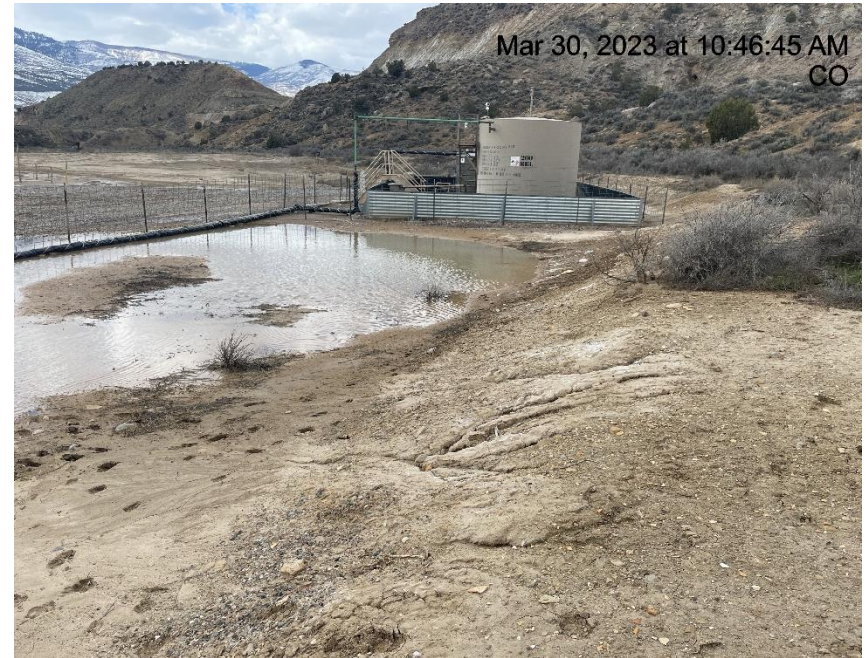
Photo # 3663 Rill erosion & transport of sediment onto location

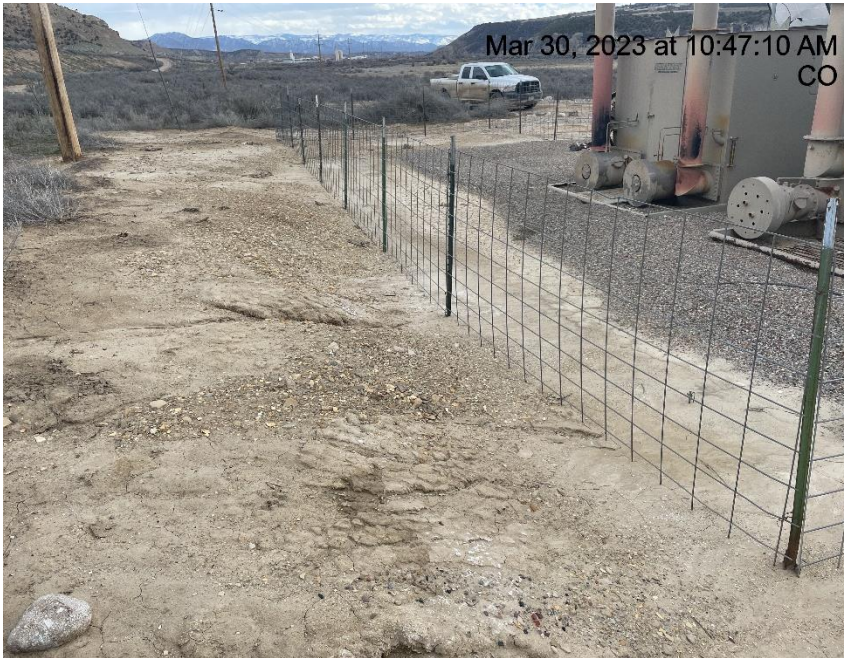
Photo # 3664 Rill erosion & transport of sediment onto location

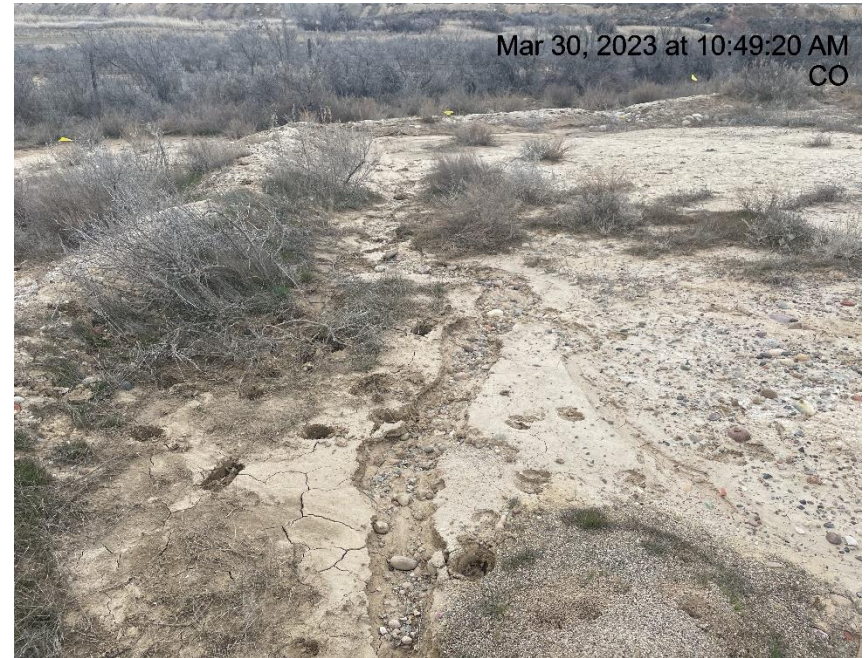
Photo # 3669 Rill erosion (SE side of pad)

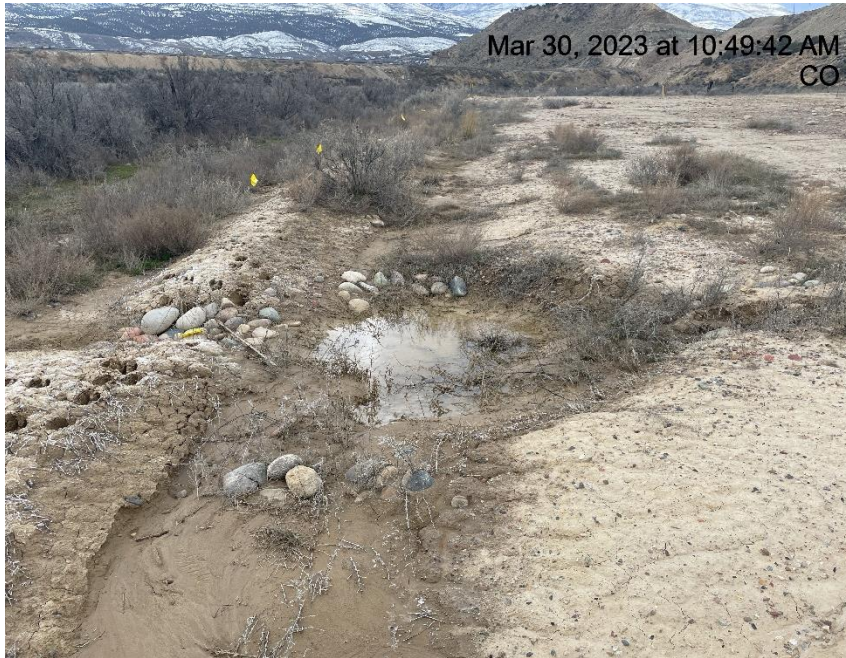
Photo # 3671 Sediment trap needs maintenance (SE corner of pad)

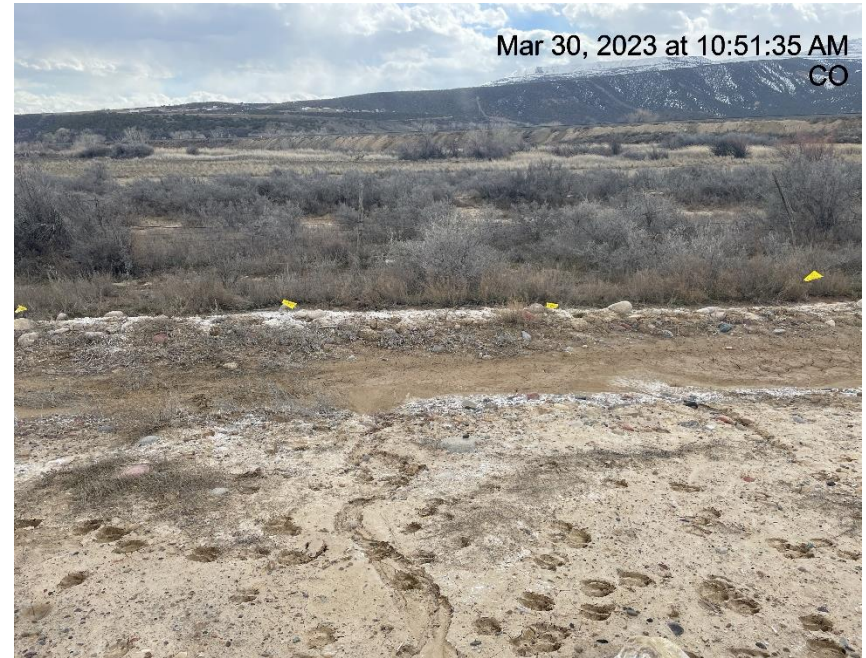
Photo # 3675 Rill erosion (south side of pad)

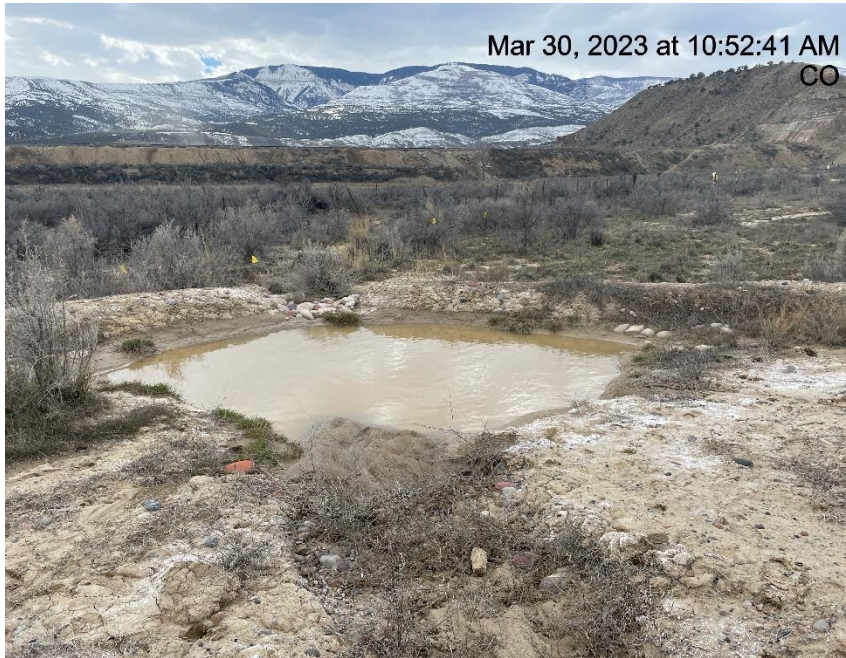
Photo # 3681 Sediment Trap needs maintenance (SW side of pad)

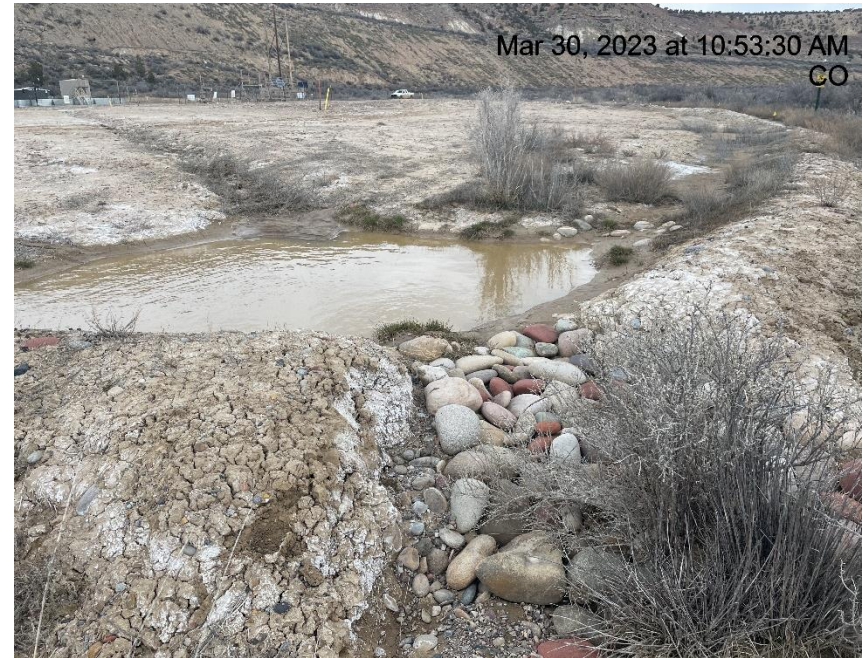
Photo # 3684 Sediment Trap needs maintenance (SW side of pad)

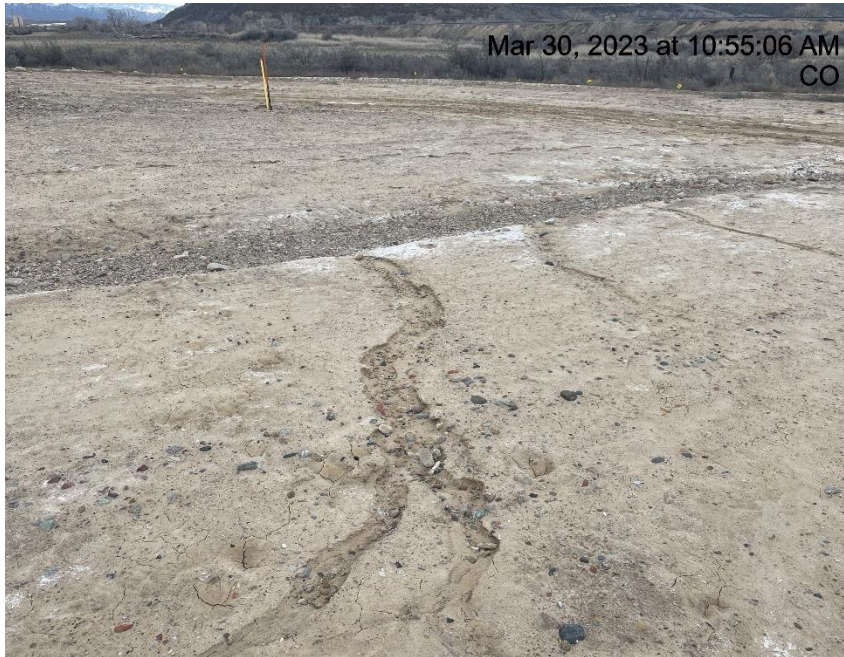
Photo # 3688 Rill erosion (SW side of pad)

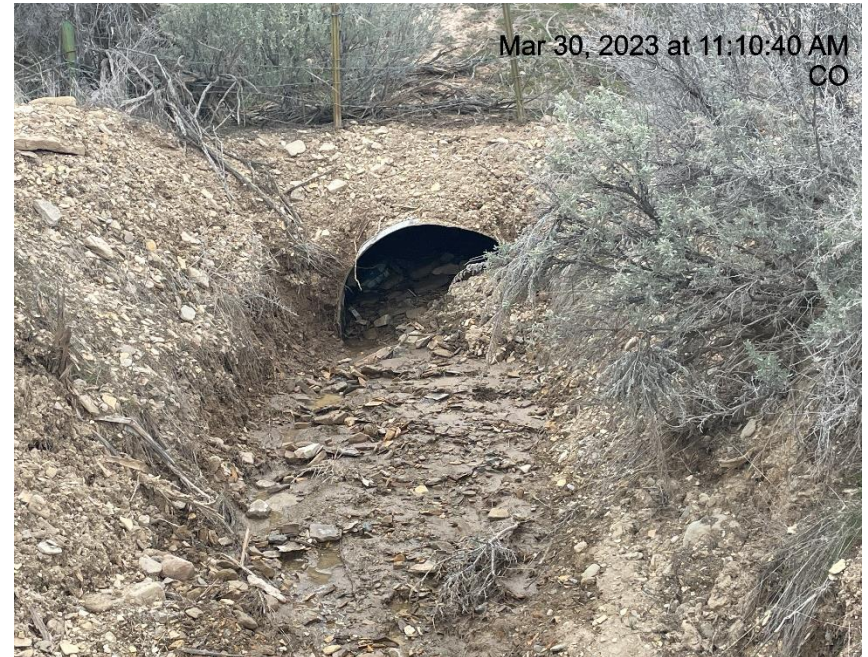
Photo # 3703 Culvert needs maintenance (1/10th mile down access road)

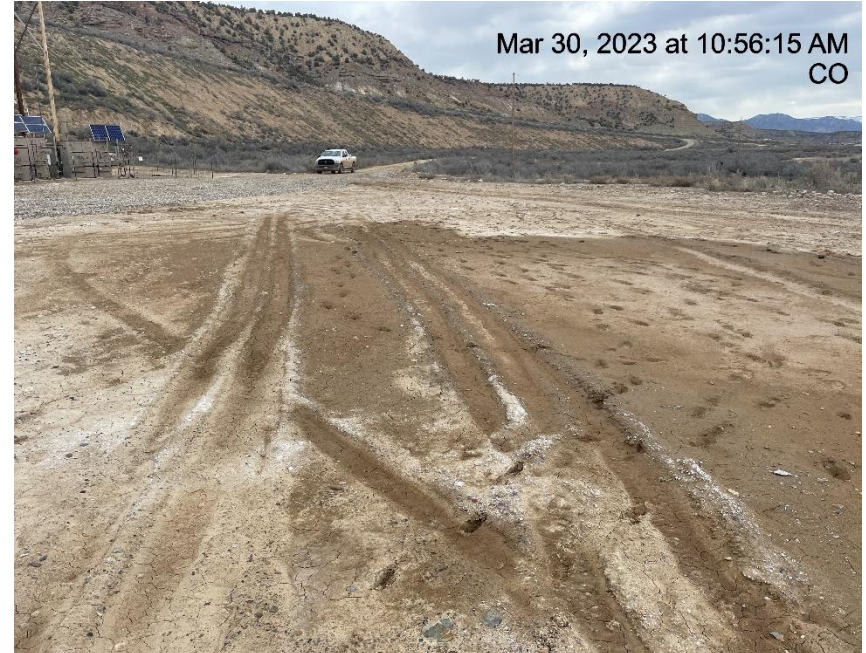
Photo # 3692 Lack of stabilization/Insufficient tracking BMP's on location

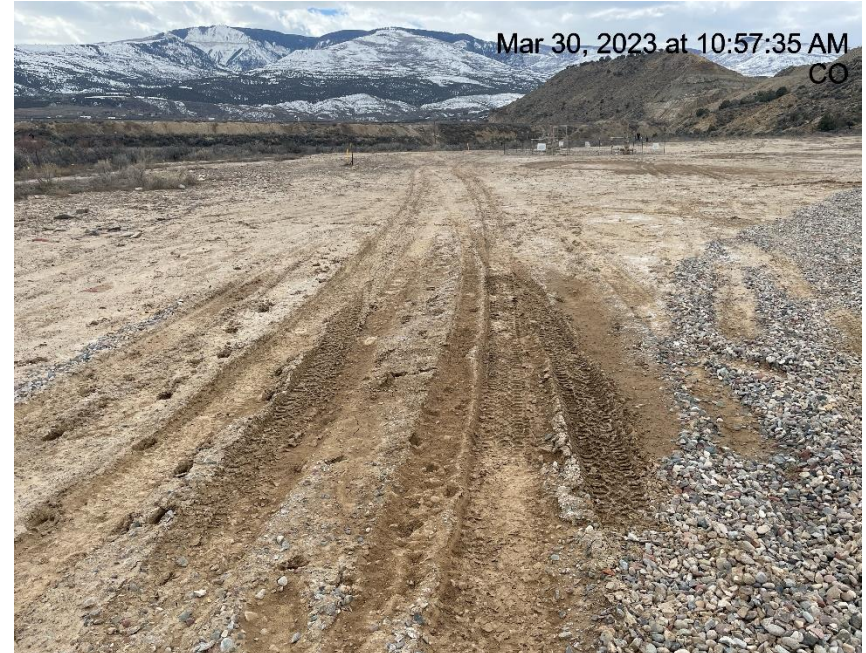
Photo # 3693 Lack of stabilization/Insufficient tracking
BMP's on location

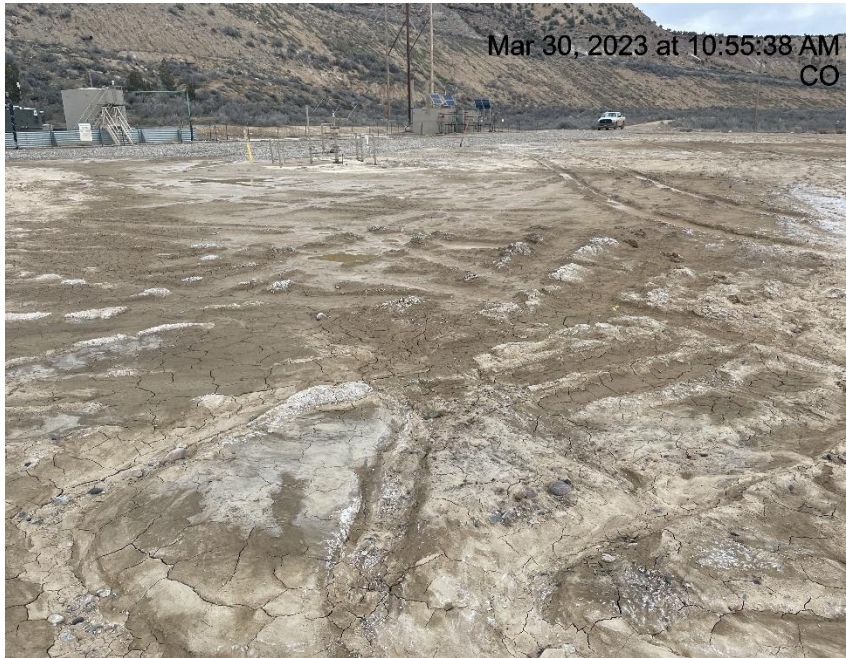
**Photo # 3689 Lack of stabilization/Insufficient tracking
BMP's on location**

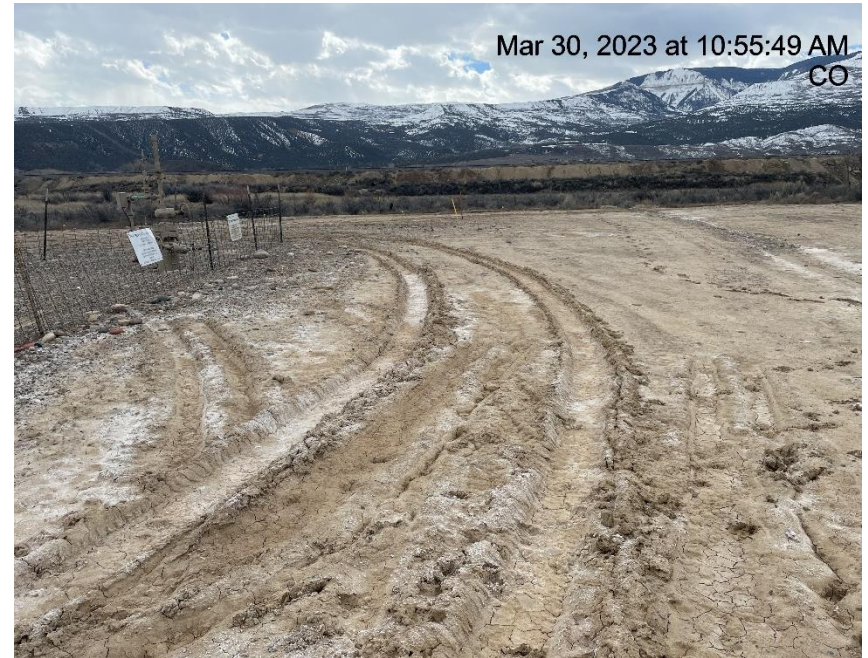
**Photo # 3690 Lack of stabilization/Insufficient tracking
BMP's on location**

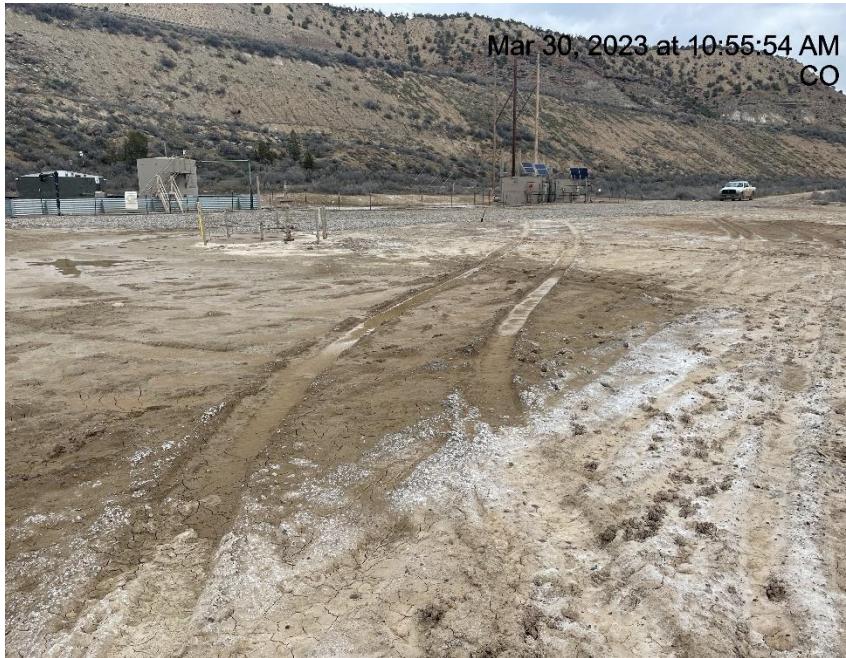
Photo # 3691 Lack of stabilization/Insufficient tracking BMP's on location

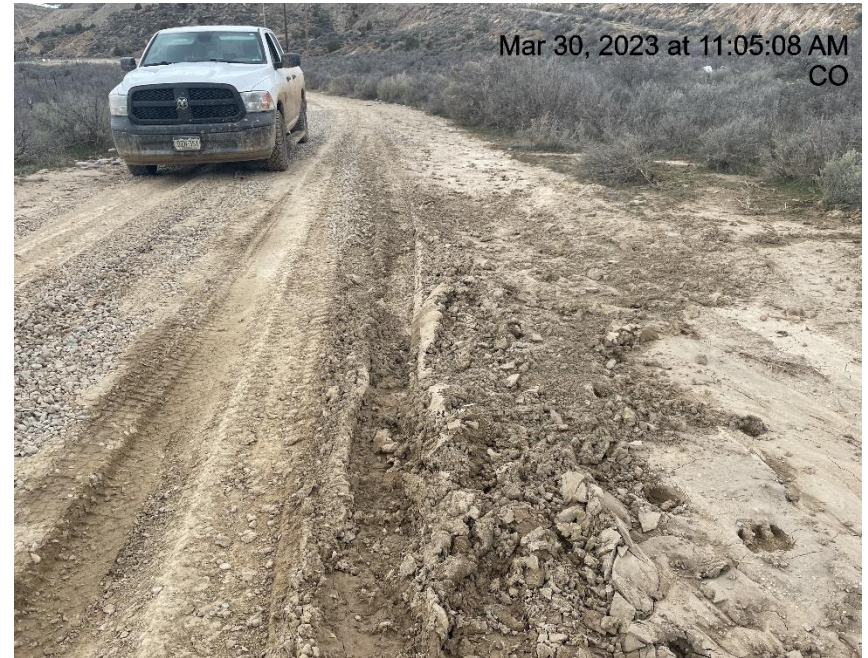
Photo # 3695 Lack of stabilization/Insufficient tracking BMP's on access road

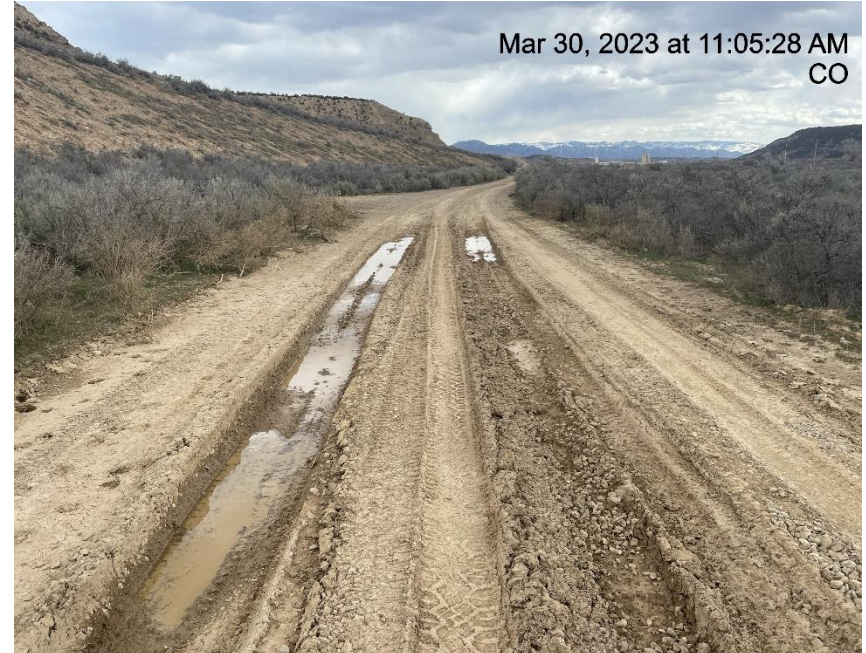
Photo # 3696 Lack of stabilization/Insufficient tracking BMP's on access road

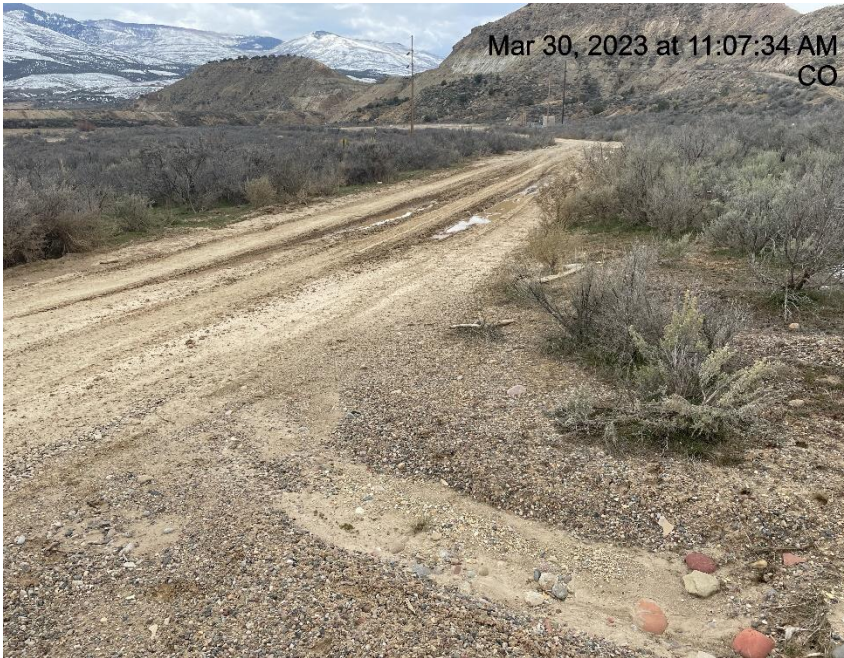
**Photo # 3698 Lack of stabilization/Insufficient tracking
BMP's on access road**

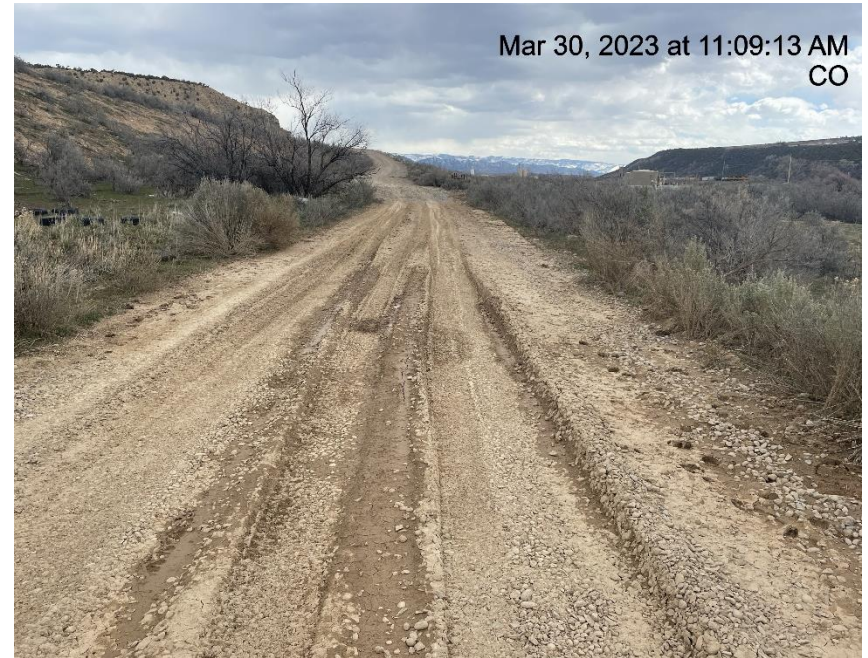
**Photo # 3700 Lack of stabilization/Insufficient tracking
BMP's on access road**
