Inspection Photos
Location Name: YC-2
API #: 083-06374

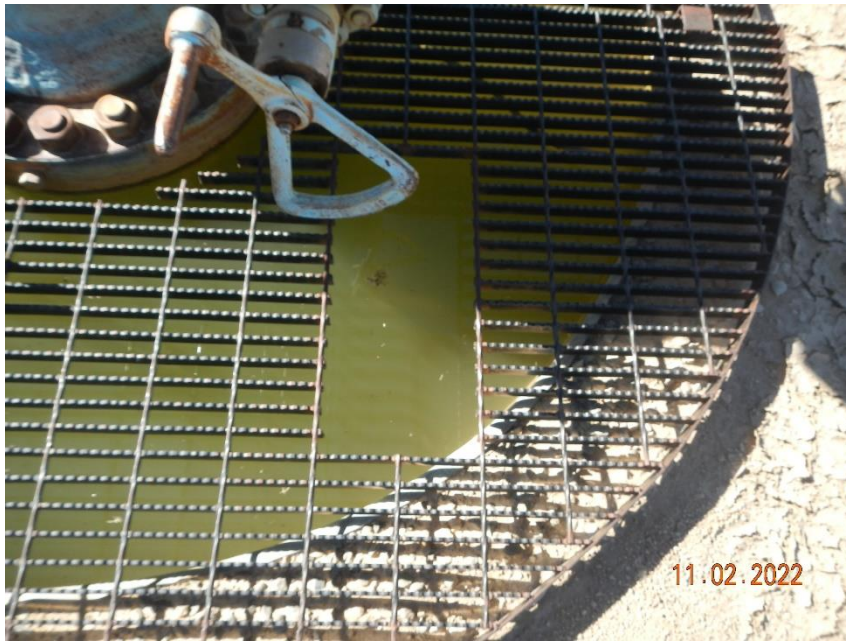
11/2/22 inspection photo. Opening in cellar grate, standing fluid,

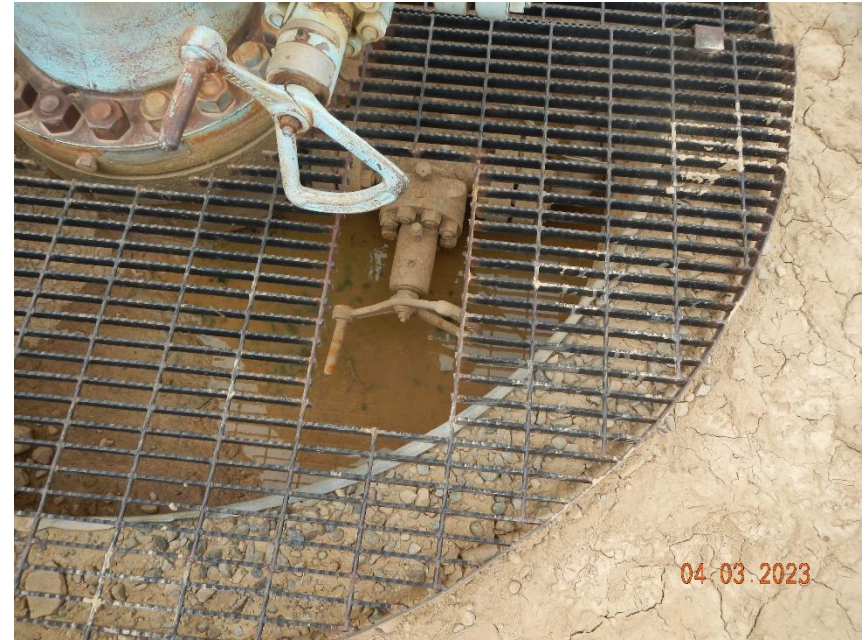
4/3/23 photo showing grate opening still present.

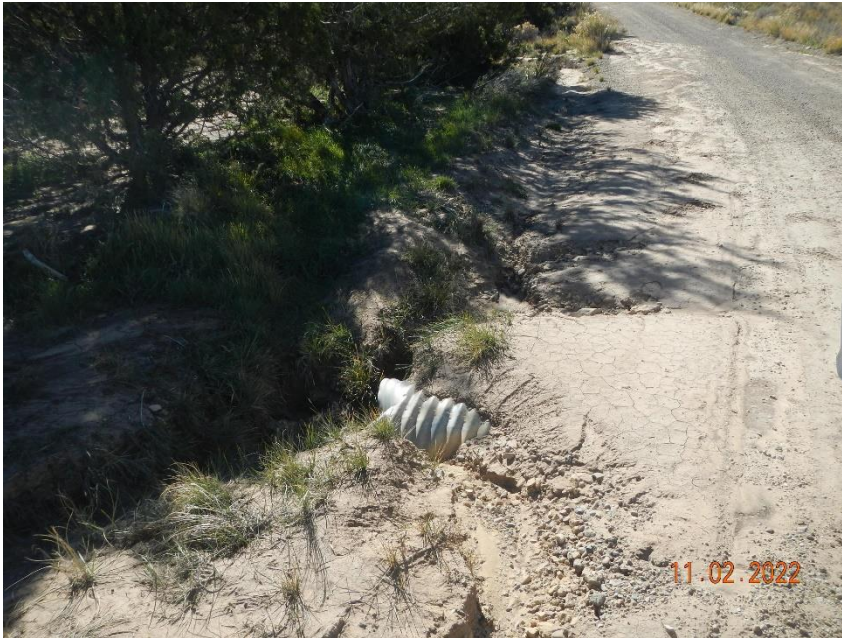
Crimped culvert 11/2/22 inspection photo

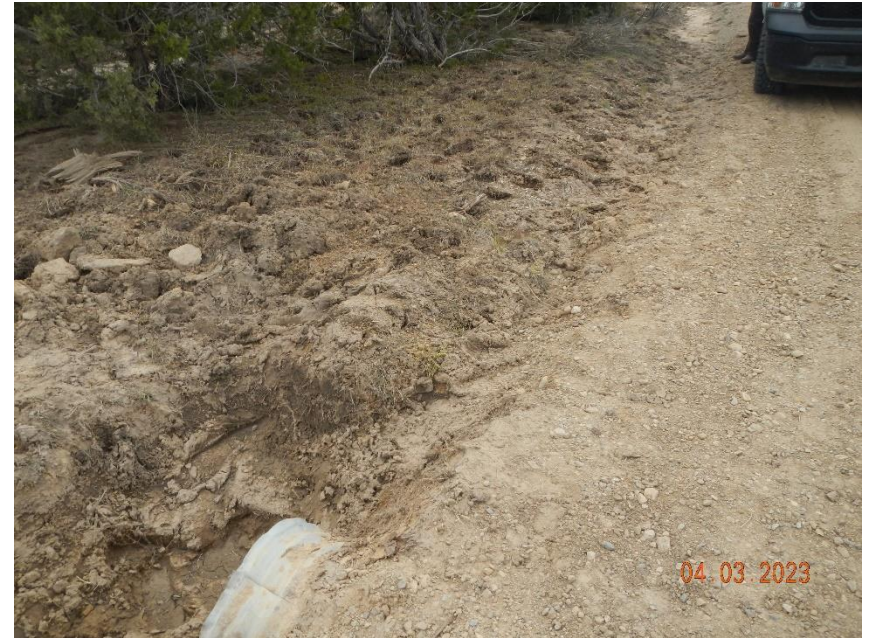
4/3/23 photo, culvert

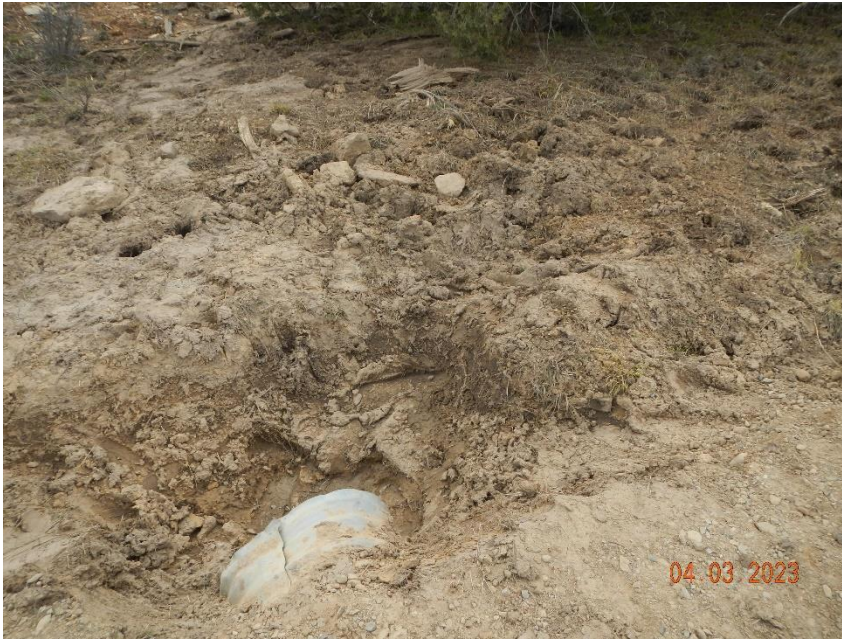
Crimped culvert repaired. No inlet protection, soft erosive soils

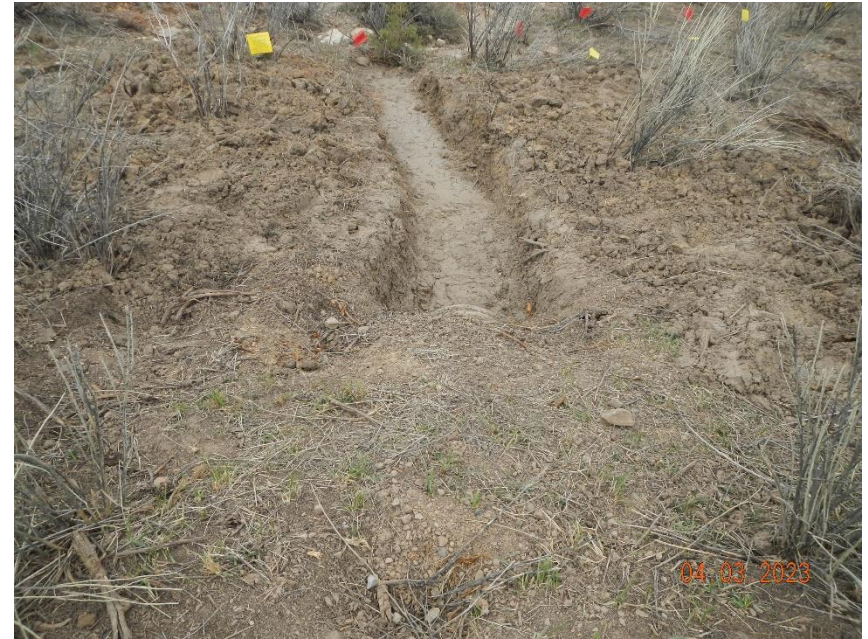
Culvert outlet, no outlet protection

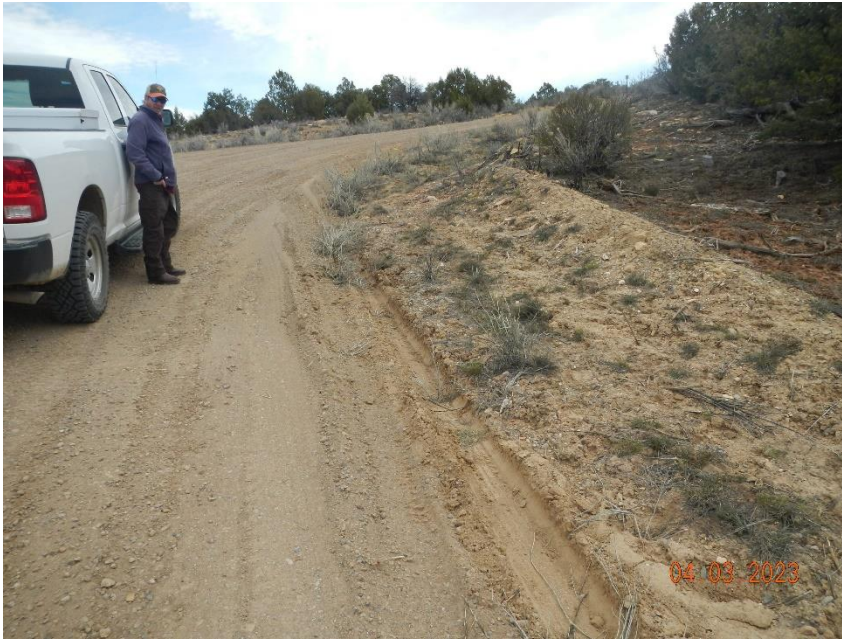
Looking east and uphill at ditch east of culvert

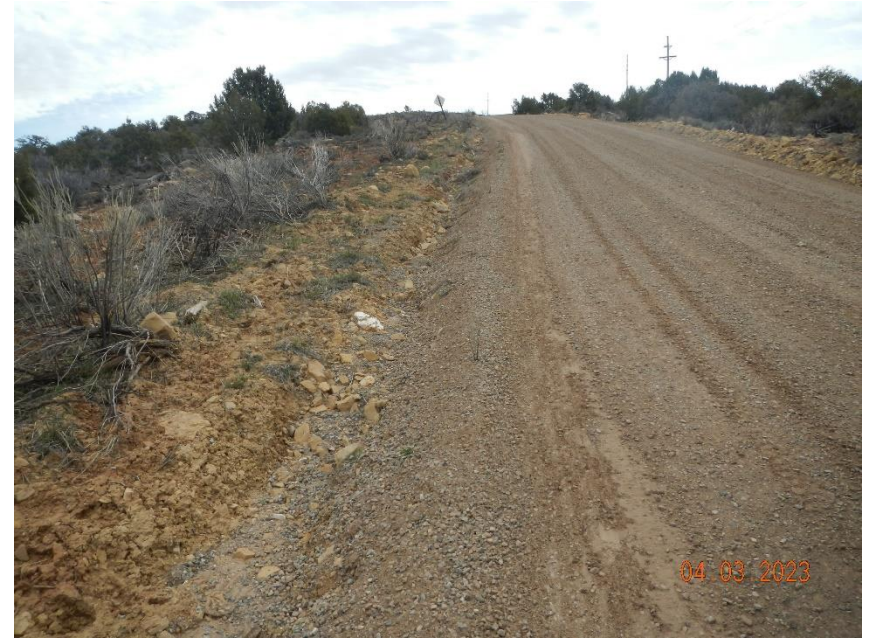
East side of roadway east of YC-2 looking east and uphill
