Inspection Photos

Location Name: TEP ROCKY MOUNTAIN LLC CLOUGH RWF 413-20 Pad

Location ID: 335217

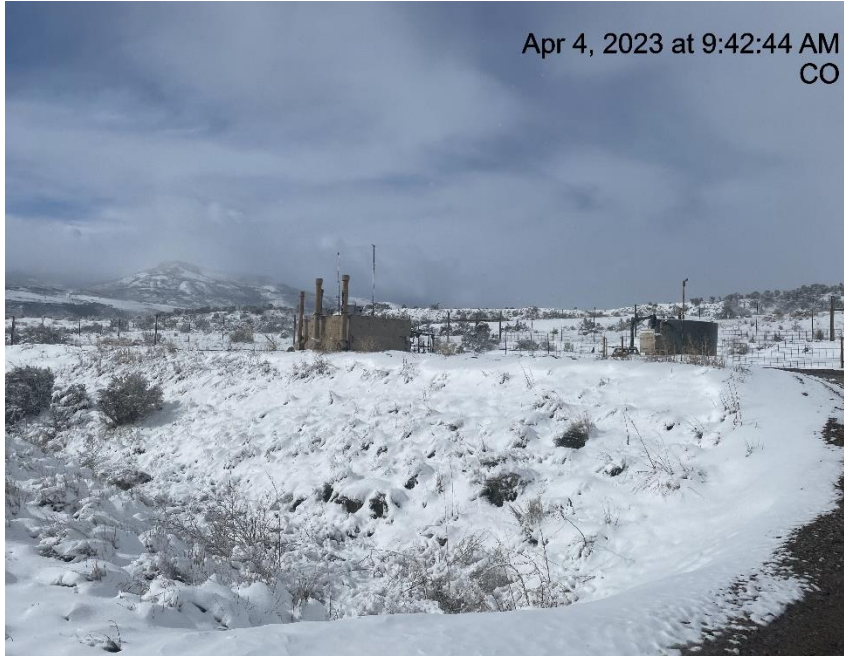
Photo # 4143 From entrance to location

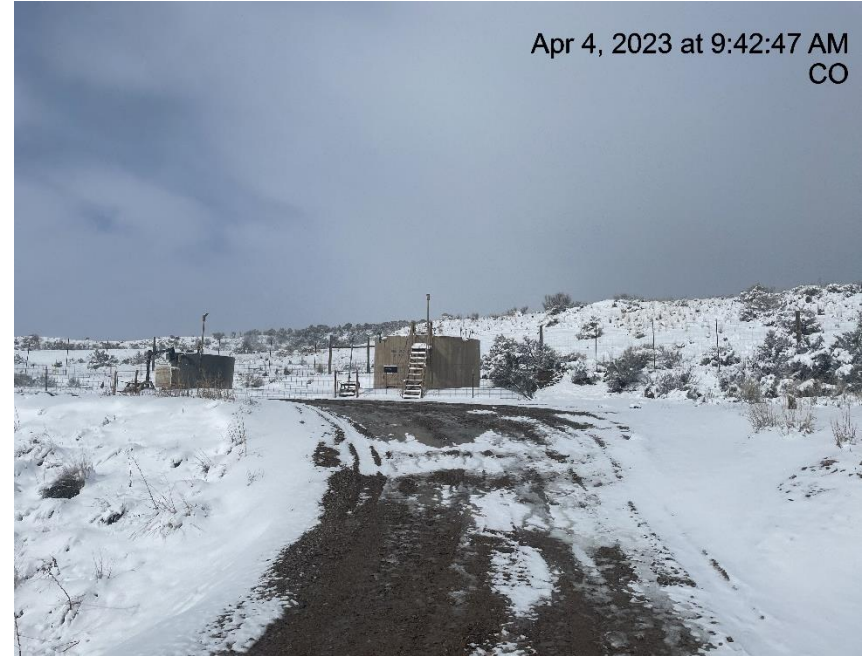
Photo # 4144 From entrance to location

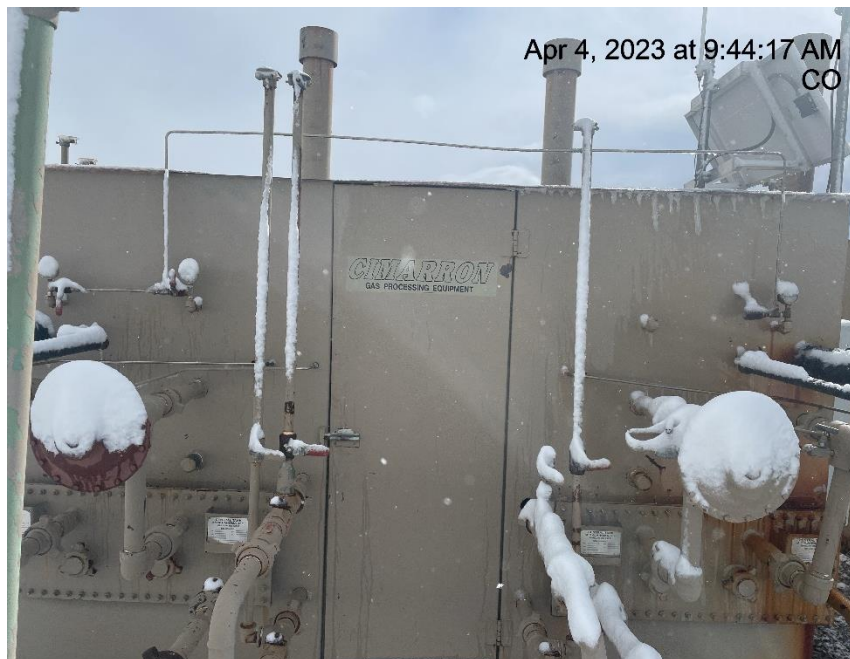
Photo # 4147 Meter calibration info not conspicuously posted

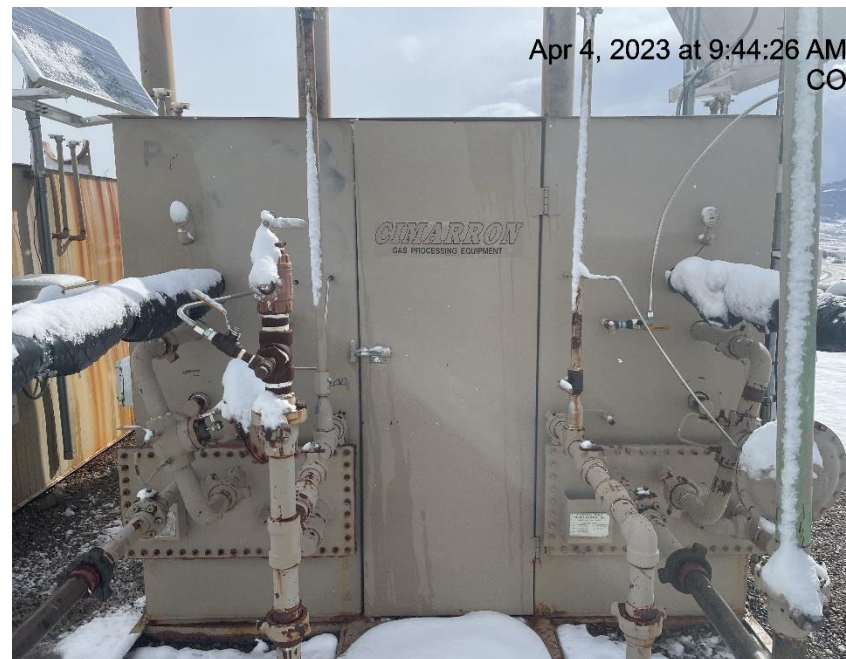
Photo # 4148 Meter calibration info not conspicuously posted

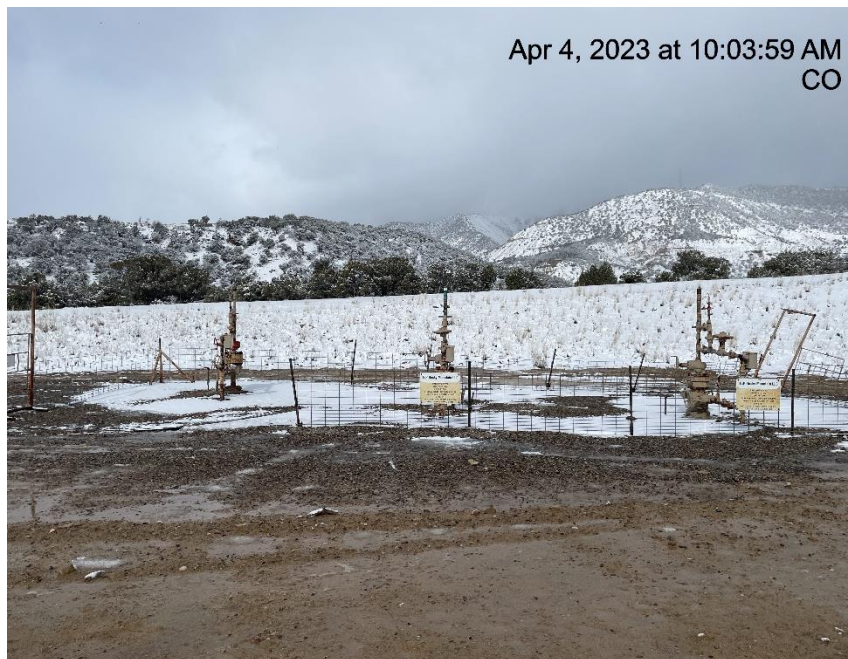
Photo # 4167 RMV 206-20 wellhead sign not conspicuously posted

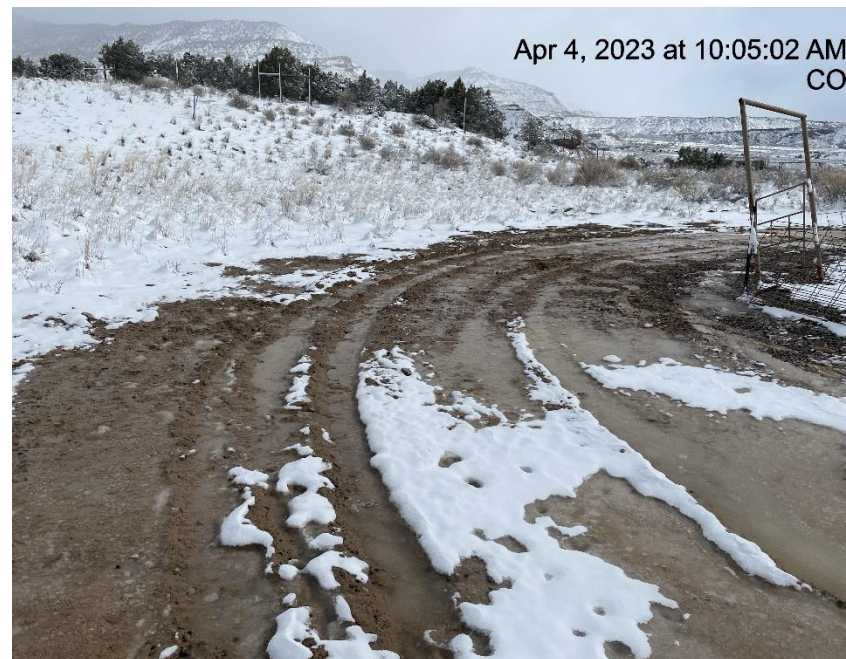
Photo # 4117 Lack of stabilization/Insufficient tracking BMP's

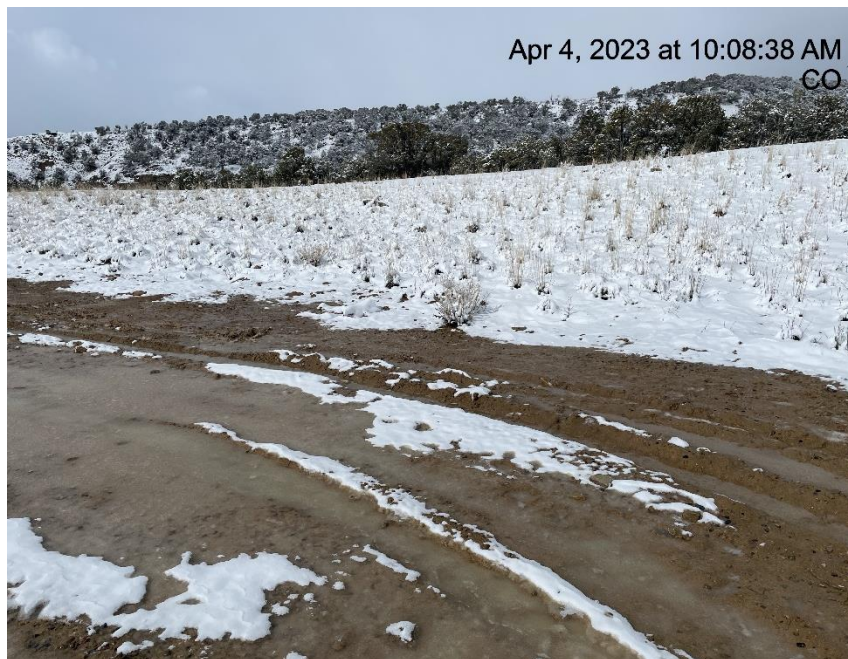
**Photo # 4178 Lack of stabilization/Insufficient tracking
BMP's**

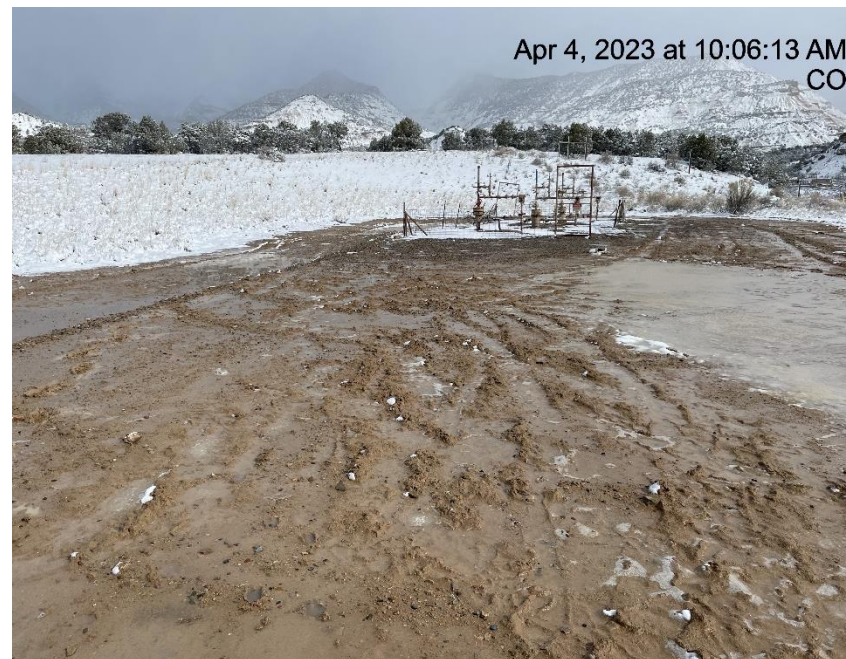
**Photo # 4172 Lack of stabilization/Insufficient tracking
BMP's**
